Darroch Eagle Timber Sale Implementation Monitoring Review

Report Prepared by Mark T. Story, Forest Hydrologist, November 13, 2007

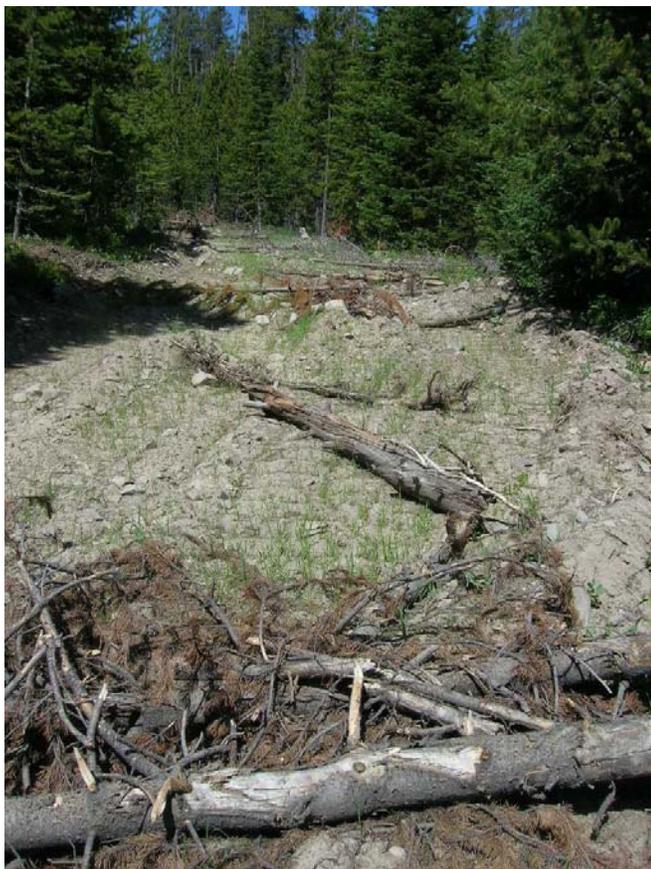
Temporary road into unit 14. This road was closed in September of 2006. At the time of the road closing the road was covered with several inches of road dust and was not ripped. The road was seeded and slashed. Re-vegetation would likely improve if the road had been ripped.

1. Temporary roads should be thoroughly ripped when closing since soil compaction in temporary roads can be deep and persistent. If sufficient slash and tree trunks are not available for slash coverage consider cutting a few adjacent trees to augment available slash. The additional organic materials help maintain soil moisture, improve revegetation microenvironments, and reinforce road closure intent.

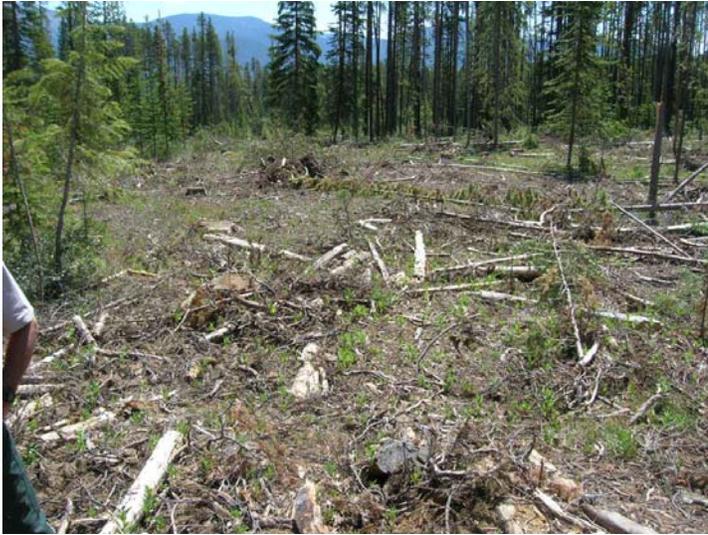
Unit 15 (and all of the tractor units) were harvested with a feller buncher which cut trees near ground level and deposited slash through much of the sale unit. This resulted in very little exposed soil and limited erosion increase potential.

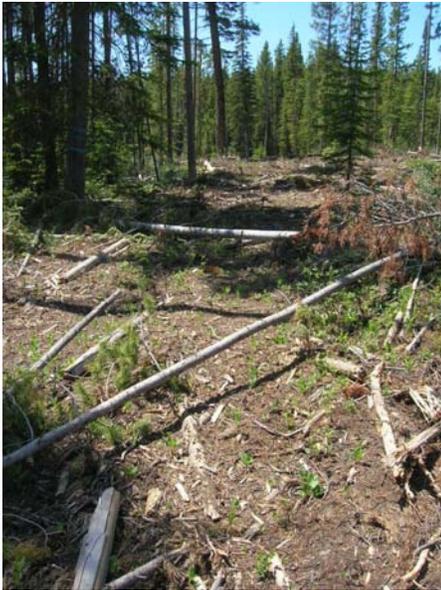
Skid trail in unit 15. In all of the tractor units reviewed, most of the skid trails were covered with a layer of slash and logs. Skid trail seeding was generally not necessary. Ripping and waterbars were judged to not be needed to achieve satisfactory erosion protection.

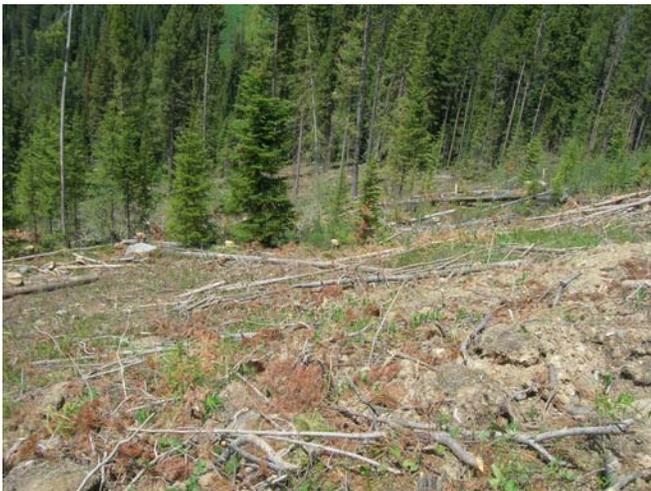
Skyline unit 1C. This unit was harvested in October and November of 2006 with partial suspension. The operator was given authorization to fall trees first then determined and secured approval for the exact corridor locations. Skyline corridors were maintained 75' apart except at convergence zones near the landings.

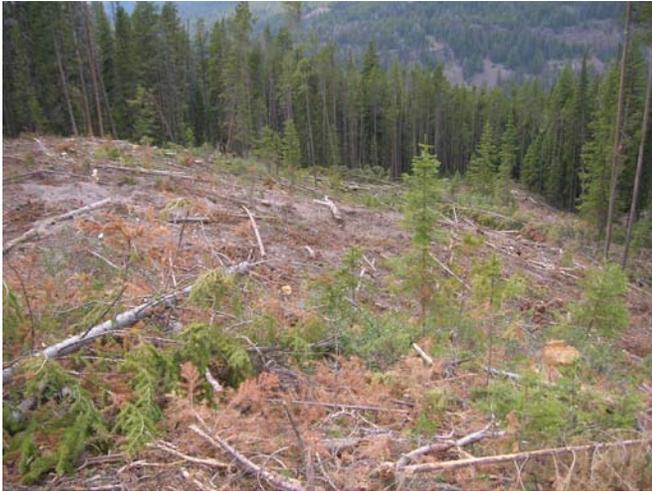
Tractor harvest unit 13. Parts of this unit exceeded 35% and resulted in localized areas of skid trail impact. The skid trails were slashed during skidding operations and also after skidding was completed.

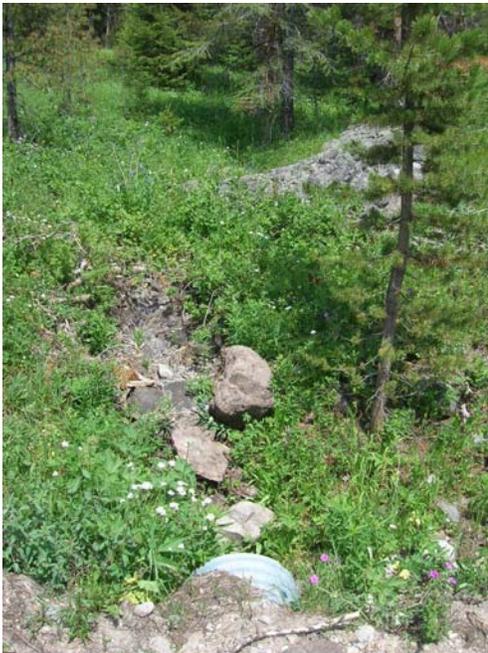
SMZ in the upper part of unit 13. Only part of the stream courses in this unit were shown on the sale area map as protected stream courses (BT6.5, CT 6.51). The sale administrator marked the additional stream courses with SMZ flagging. The stream courses were adequately protected.
