Boulder Creek Colorado River cutthroat trout (CRCT) Restoration

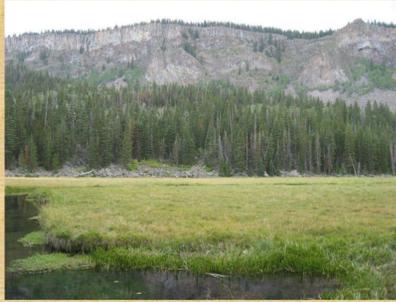
Headwater meadow of East Fork Boulder Creek.

1. Use the piscicide rotenone to remove nonnative trout from the headwater meadow in East Fork Boulder Creek downstream to fish barriers
 2. Monitor the success of the removal efforts

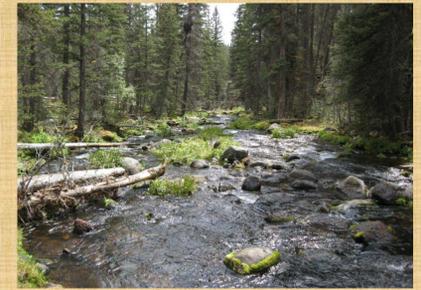
East Fork Boulder Creek below headwater meadow

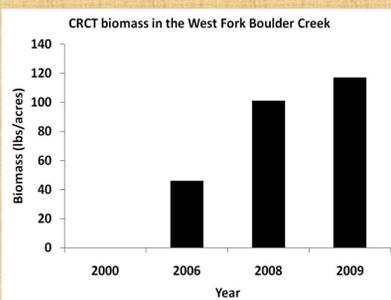
CRCT biomass in West Fork Boulder Creek above East Fork confluence.

- Monitoring has shown that reintroduced CRCT are continuing to increase in abundance and biomass.
- Short Lake was renovated with rotenone in 2005-2006; reintroduction success is still being monitored.

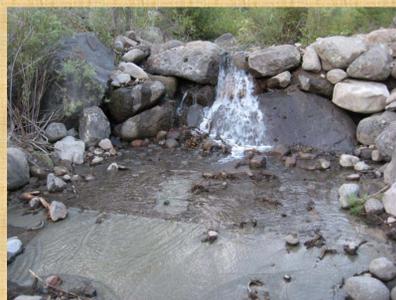
Fish barrier on Boulder Creek

- Fish barriers were constructed on Boulder Creek in 2009, approximately 0.5 miles downstream from the confluence of the East and West Forks.
- Proposed project would:

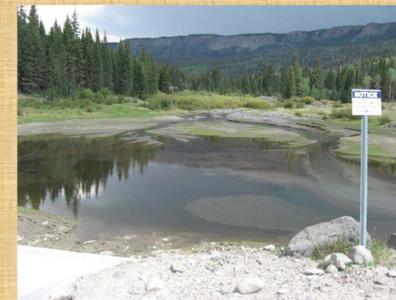
West Fork Reservoir.

- East and West Forks Boulder Creek are completely dewatered below West Fork Reservoir and King's Pasture Reservoir by hydroplant operations.
- Average annual unregulated flow is approximately 4 cubic feet per second (cfs) in the West Fork and 21 cfs in the East Fork.

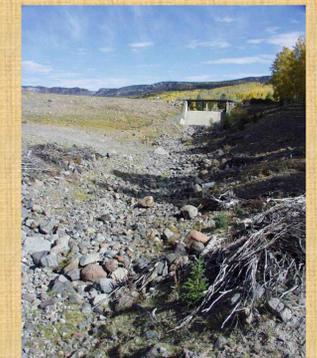
Dry stream channel below King's Pasture Reservoir.

- A condition of the FERC relicensing of the Boulder Hydroplant is the release of 2 cfs back into the East Fork below King's Pasture reservoir.
- The flow restoration would return flows to 0.6 miles of completely dewatered stream and improve flows in an additional 4.9 miles of stream.

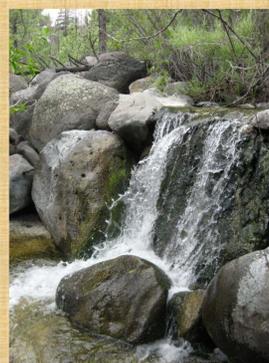
Fish barrier on West Fork Boulder Creek.

- Individuals from both East and West Fork populations helped to create the Dougherty Basin Lake brood stock.
- West Fork Boulder Creek from West Fork Reservoir to fish barriers (constructed in 2000) was renovated with rotenone to remove nonnative trout in 2000-2001, and CRCT were reintroduced in 2001.

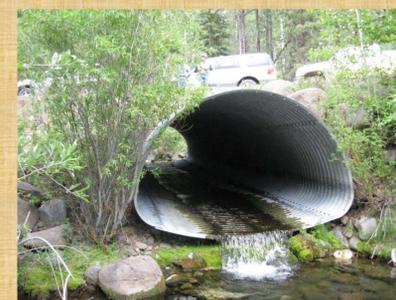
Forest Road 30166 crossing in June 2009.

- Undersized culverts where Forest Road 30166 crosses the East and West Forks Boulder Creek had altered stream morphology, causing both culverts to become perched.

- The perched culverts were an impediment to fish passage.
- In summer 2009 the culvert on the East Fork was replaced using a properly sized box culvert with a natural bottom that will facilitate fish passage.

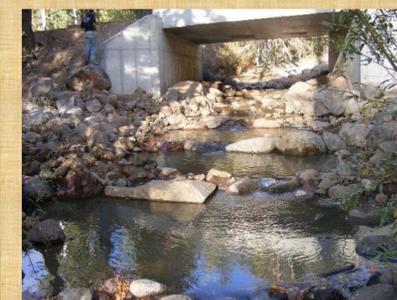
Forest Road 30166 crossing in autumn 2009.
