# White Mountain National Forest

## Brickett Place Site Restoration Project

## 2010 Update & Progress

Prepared by the  
Saco Ranger District

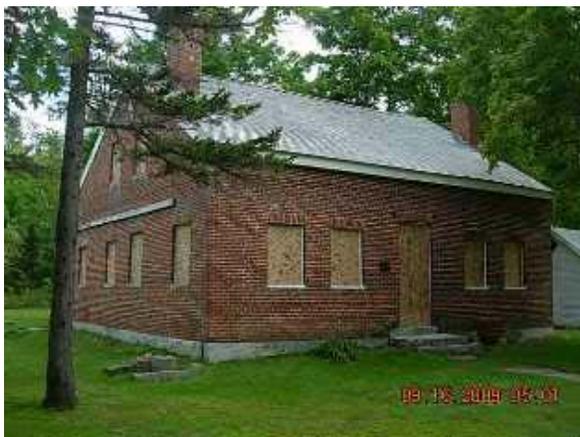
Figure 2: Brickett Place Window and Door Removal

Two of the four phases of this work were completed this year. For the **first phase** of work the NPS-HPTC Carpentry Team addressed the windows and the doors. Damage around these areas provided an obvious sign something was happening at the Brickett Place. As shown in the Figure 2, 40 window sashes and two exterior doors were removed in 2009. The house was secured for the winter and the materials were transported by truck to the “Jenkins Shop,” a NPS facility in Frederick, Maryland that specializes in refinishing historic materials.

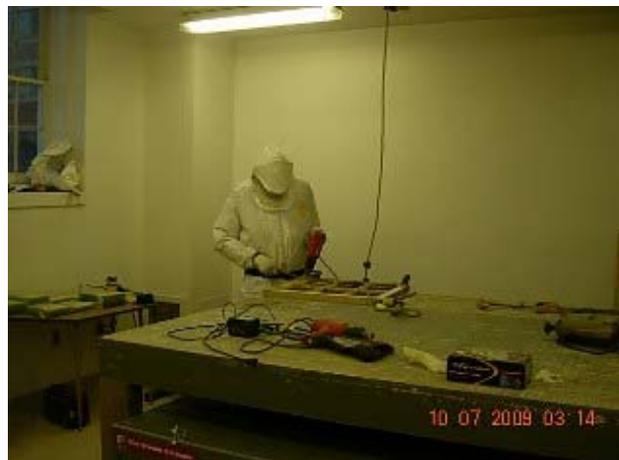
Figure 3: Window Rehabilitation

The windows and doors were stripped, de-glazed, re-glazed and repainted. The crew repaired and re-glazed 236 glass window panes. This work, which can be tedious and slow, was completed over the 2009-2010 winter.

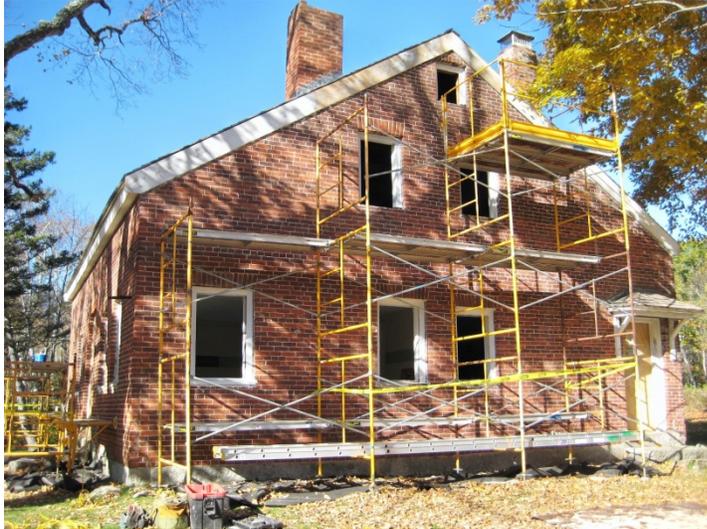
Figure 4: Window and Door Installation

June 2010 was a very busy month for the Brickett Place and great progress was made in the completion of phase one and the commencement and completion of **phase two** of the restoration project. Early in the month, the NPS crew returned to the house and completed the installation of the newly rehabilitated windows and doors.

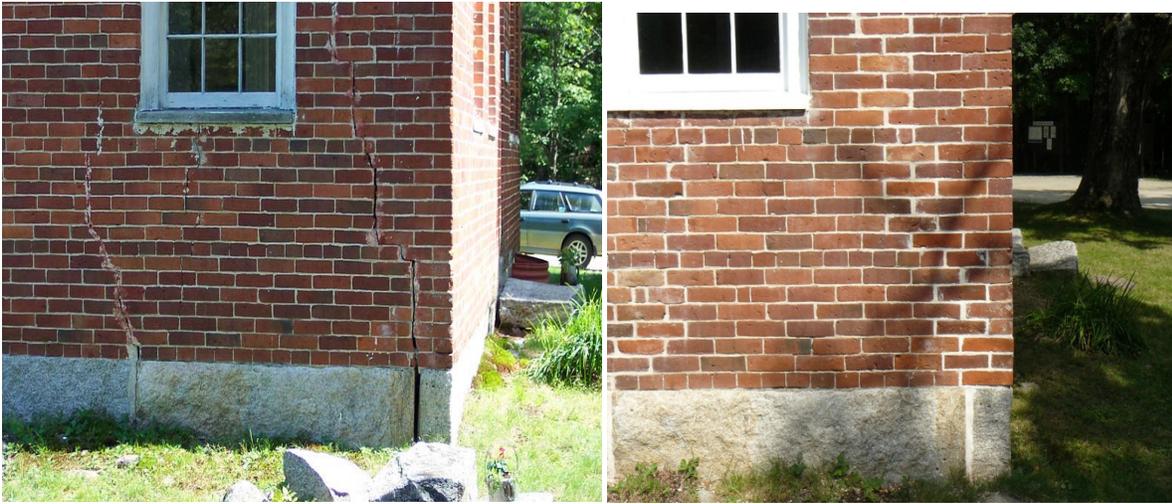
Figure 5: SE wall and foundation before and after

The NPS Masonry team arrived on site in late June and re-pointed the exterior replaced broken brick and “stitched” all of the settlement cracks. The settlement cracks were stitched using mechanical (Helifix) ties, designed to hold replacement bricks and the granite foundation stones in tension. Figure 5, shows before and after repairs to the southeastern wall and foundation. Figure 6, shows the dramatic repairs to the northern wall and the replaced window well and drainage improvements. Figure 7, shows window and “Jack arch” repairs.

Shortly after their departure, a White Mountain National Forest Crew completed the drainage work in preparation for the masonry work. A subsurface drainage system was designed and installed on the north and east sides of the structure to reduce water draining toward the structure and splash back that had been causing brick deterioration.
