**Forest Service**  
Pacific Southwest  
Region

Angeles  
National Forest

May 10-14, 2010

# Station Fire BAER Revisit

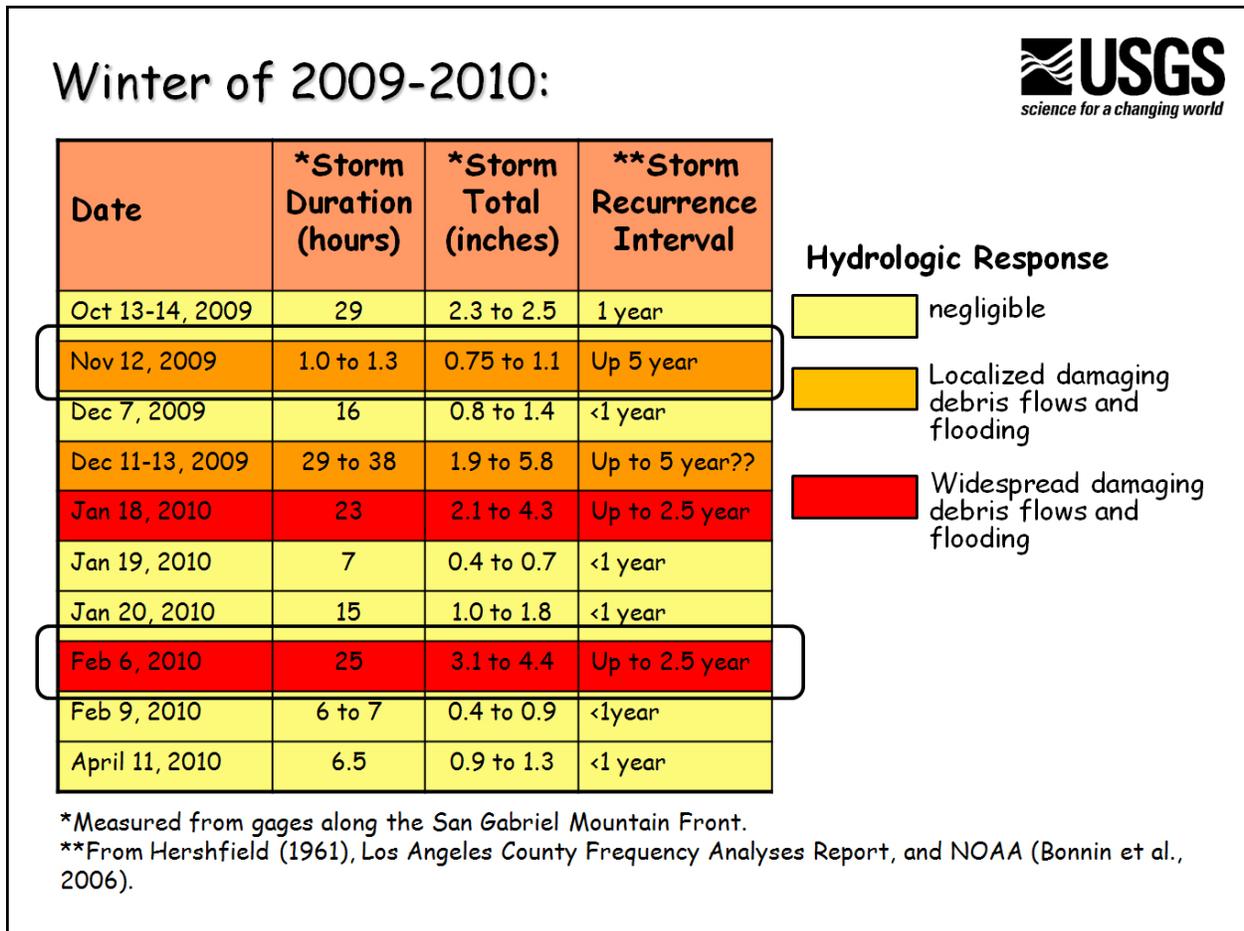
Figure 1: Slide presented by Dr. Sue Cannon, US Geological Survey, regarding precipitation events and associated watershed responses observed during 2009-2010 winter.

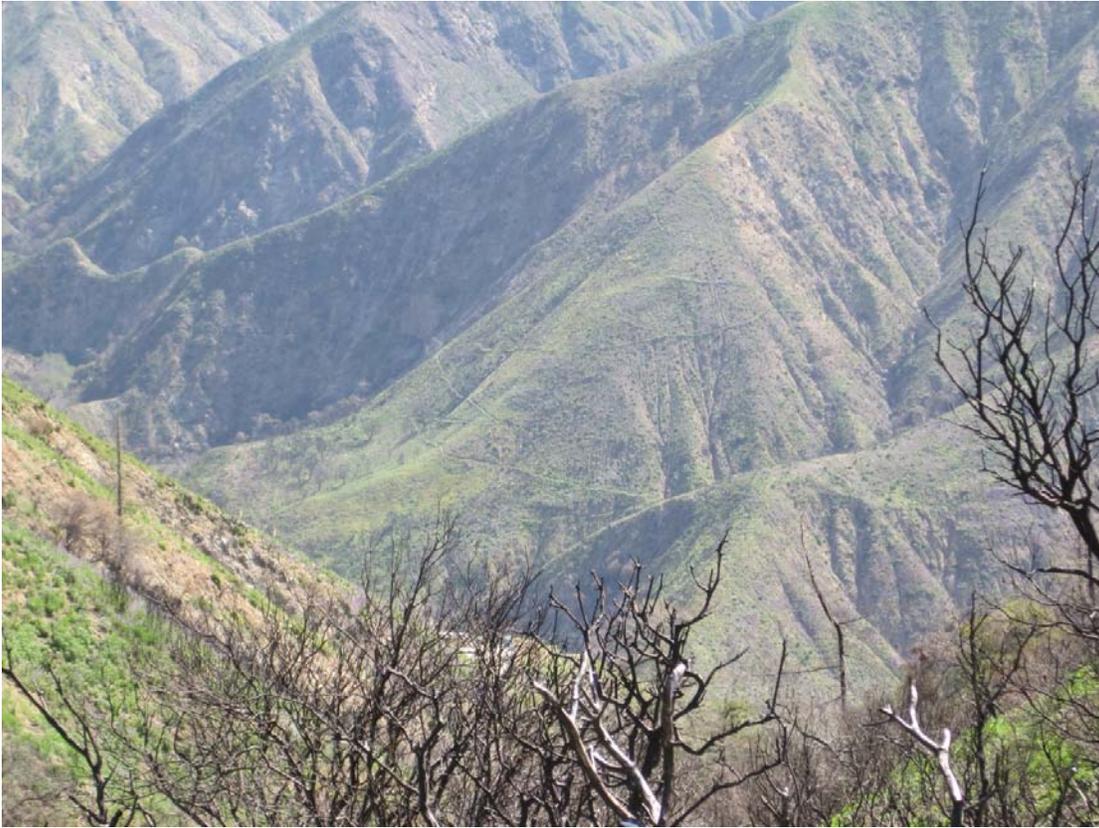
**Figure 2: Typical mountain slopes viewed during the week of May 10, 2010 showing variable levels of vegetative recovery. The level of vegetative recovery varied by aspect, elevation, bedrock, soil type, and the level of precipitation normal for the particular area of the fire.**

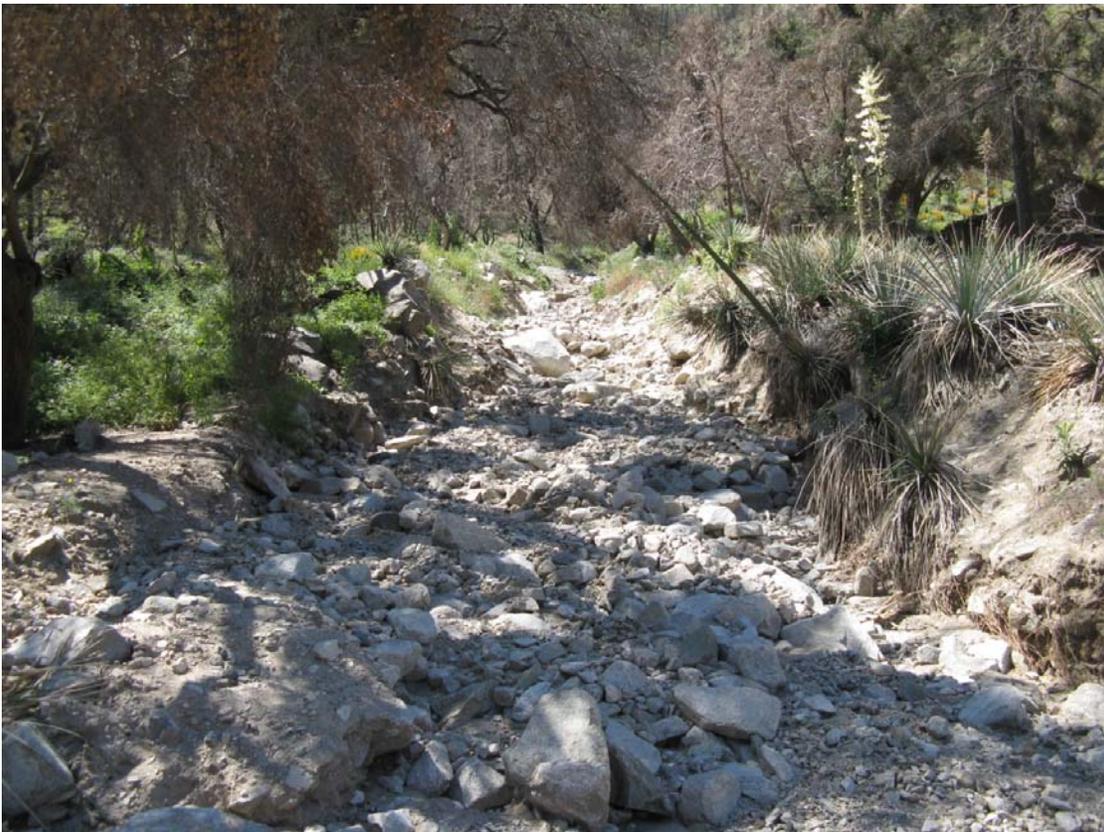
**Figure 3: A debris flow path that existed before the fire, was re-activated during the 2009/2010 winter.**

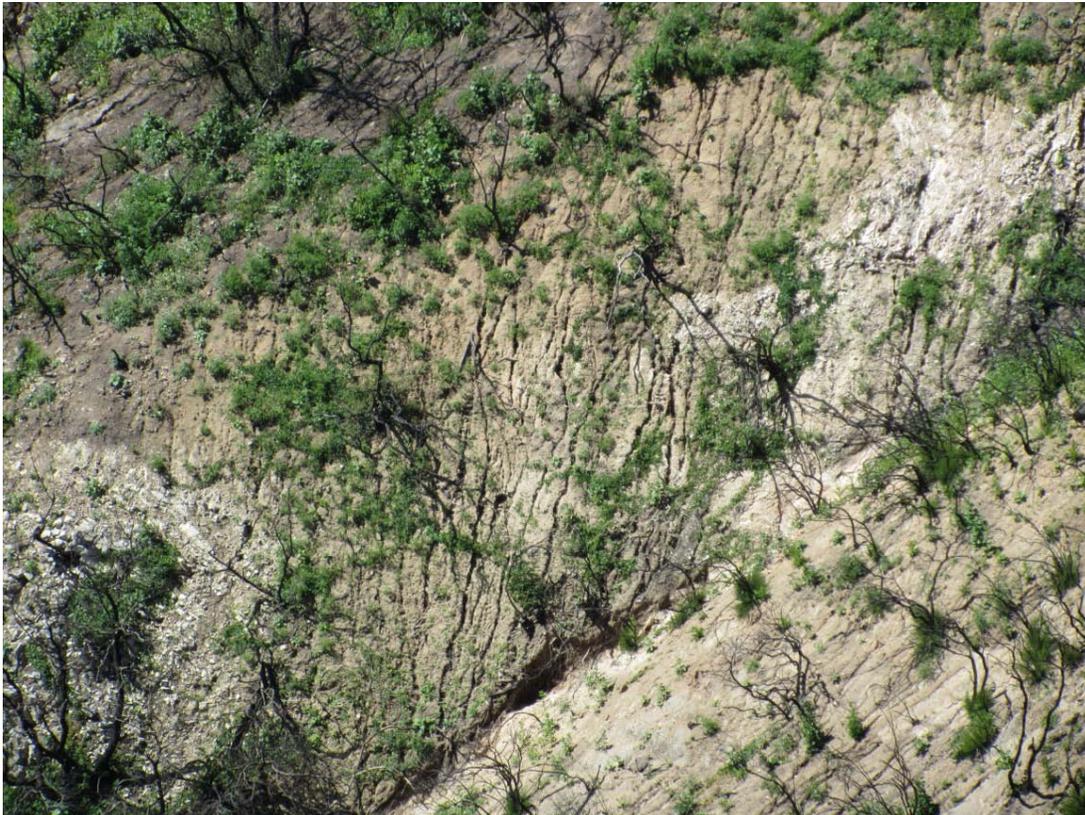
**Figure 4: Rill networks have formed which will concentrate runoff more efficiently and quickly the coming winter (2010/11).**

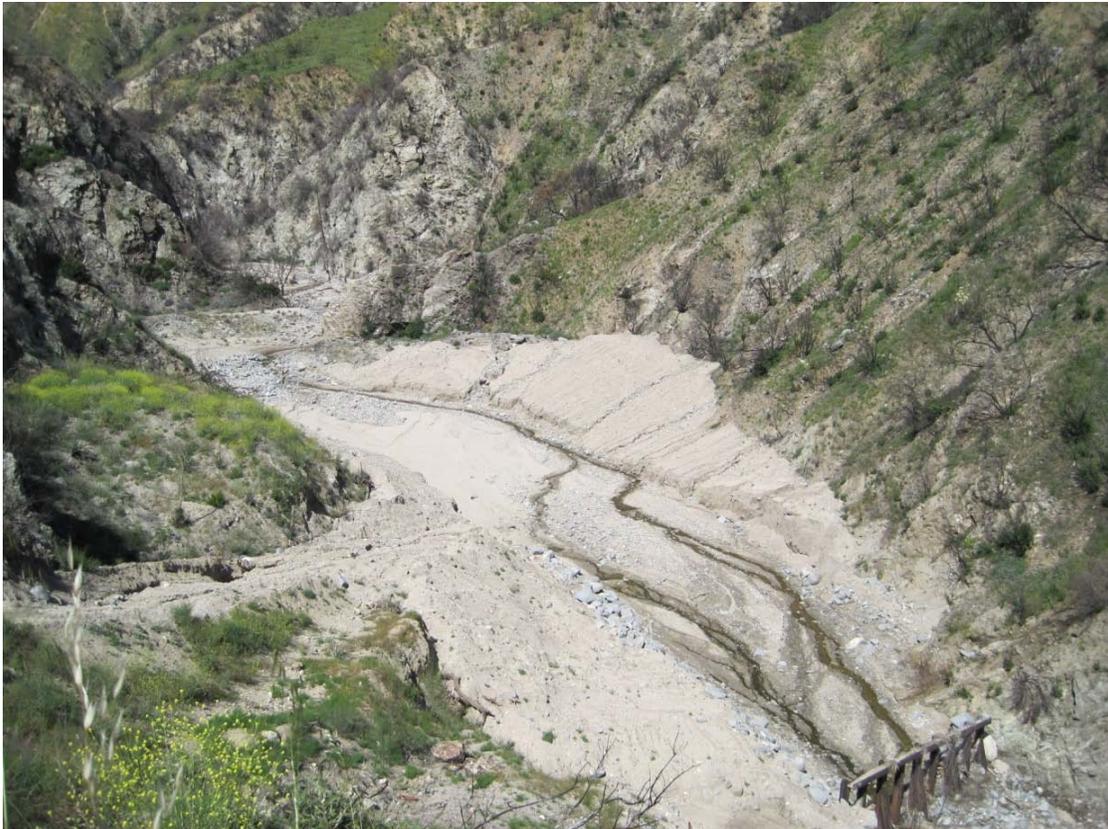
**Figure 5: Large quantities of sediment were transported and deposited during the 2009/2010 winter. This material could be transported further down stream in coming winters.**

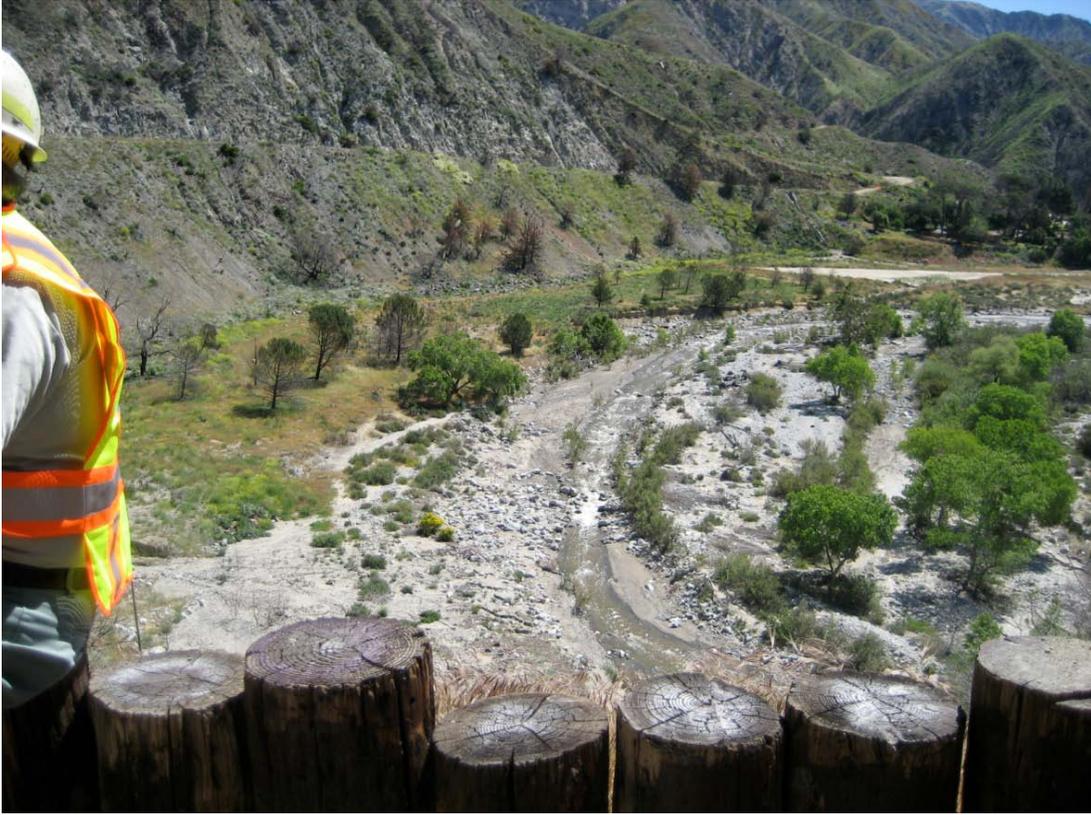
**Figure 6: Big Tujunga Creek – May 11, 2010. Riparian vegetation and aquatic habitat was significantly altered during the first winter, post-fire flows.**

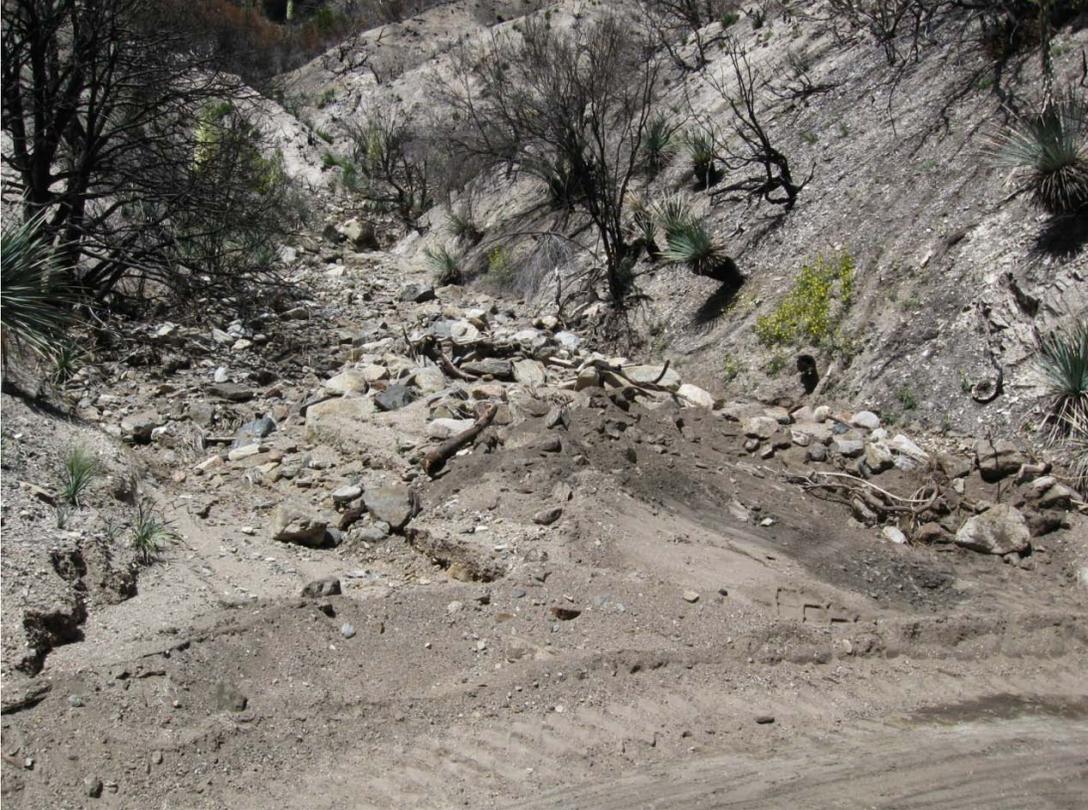
**Figure 7: Large sediment loading in channels impacted road drainage.**

- **Recommendation:** Expand to other roads/areas where necessary for storm response & monitoring & culvert & drainage clean out.
- **Trail Evaluation and Implementation:** Recommendation: Further evaluate where BAER treatment trail prescription may be necessary (currently unidentified trails/segments). Improve/maintain/monitor existing in trail treatments for effectiveness.

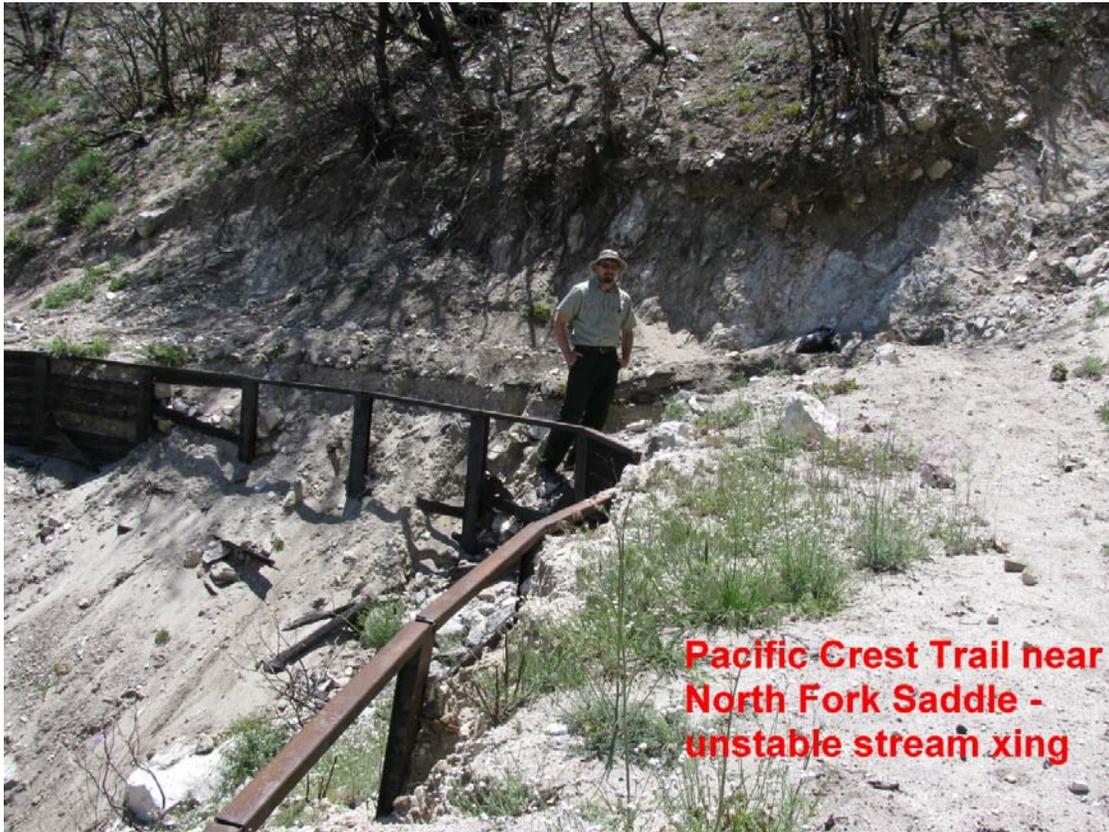
**Figure 8: Trails have been damaged at stream crossings and dry ravel has narrowed or covered over the trail tread.**

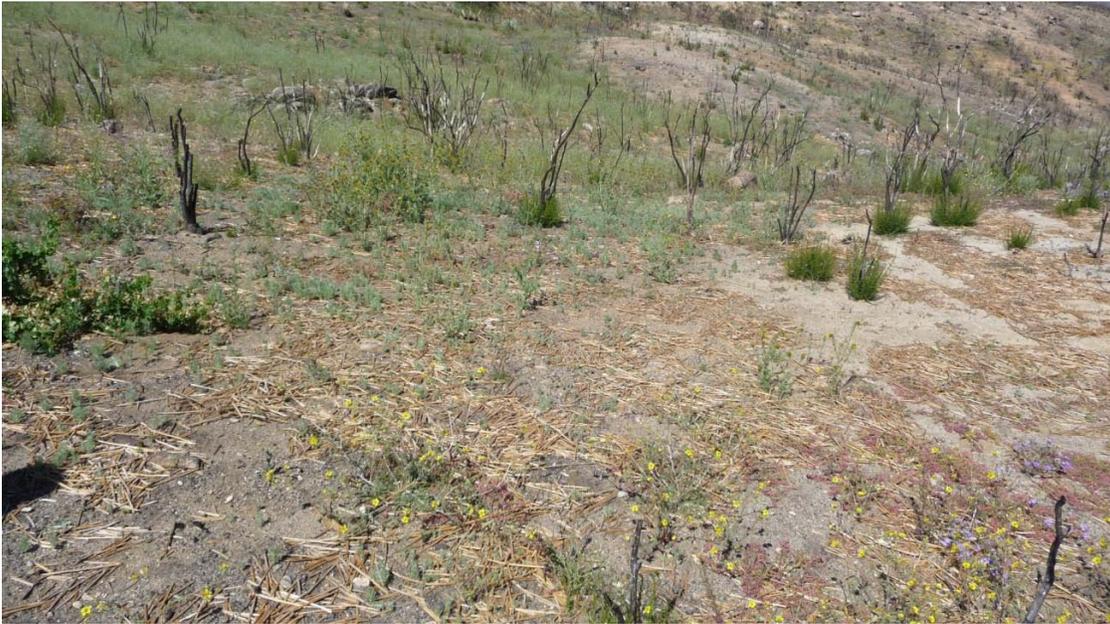
**Figure 9: Wood straw was applied to the soil surface at this heritage site to prevent erosion, but wind and runoff water has caused movement and clumping of the mulch material reducing its effectiveness.**

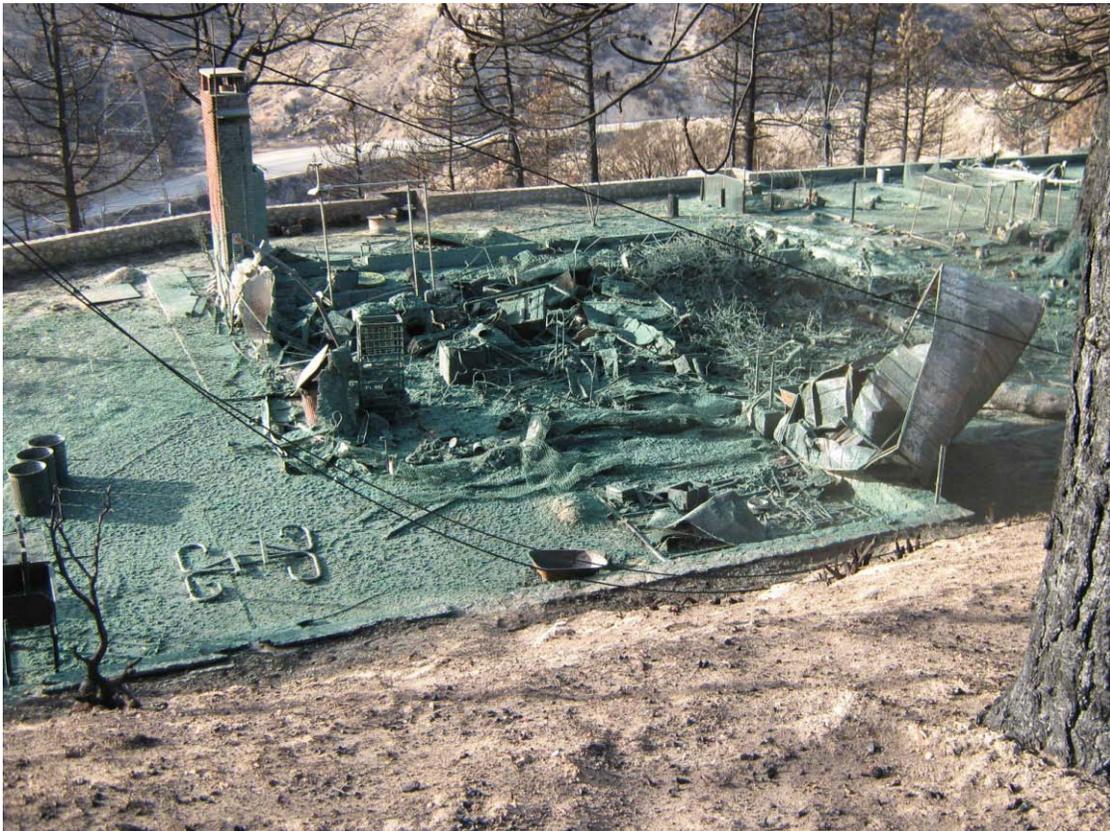
**Figure 10: Ground based hydromulch applied to burned structures effectively prevented off-site movement of hazardous materials.**

- **Hazardous Material Stabilization:** Recommendation: Implemented. Close vault toilets. Remove hazmat from Monte Cristo Station or install geofiber to allow for future cleanup so any deposited sediment from runoff from upslope next winter can be separated from actual hazardous materials. This would reduce cost for remediation. Check sites to determine if maintenance of hydromulch, straw wattles, etc. to determine if retreatment is necessary for 2010/11.

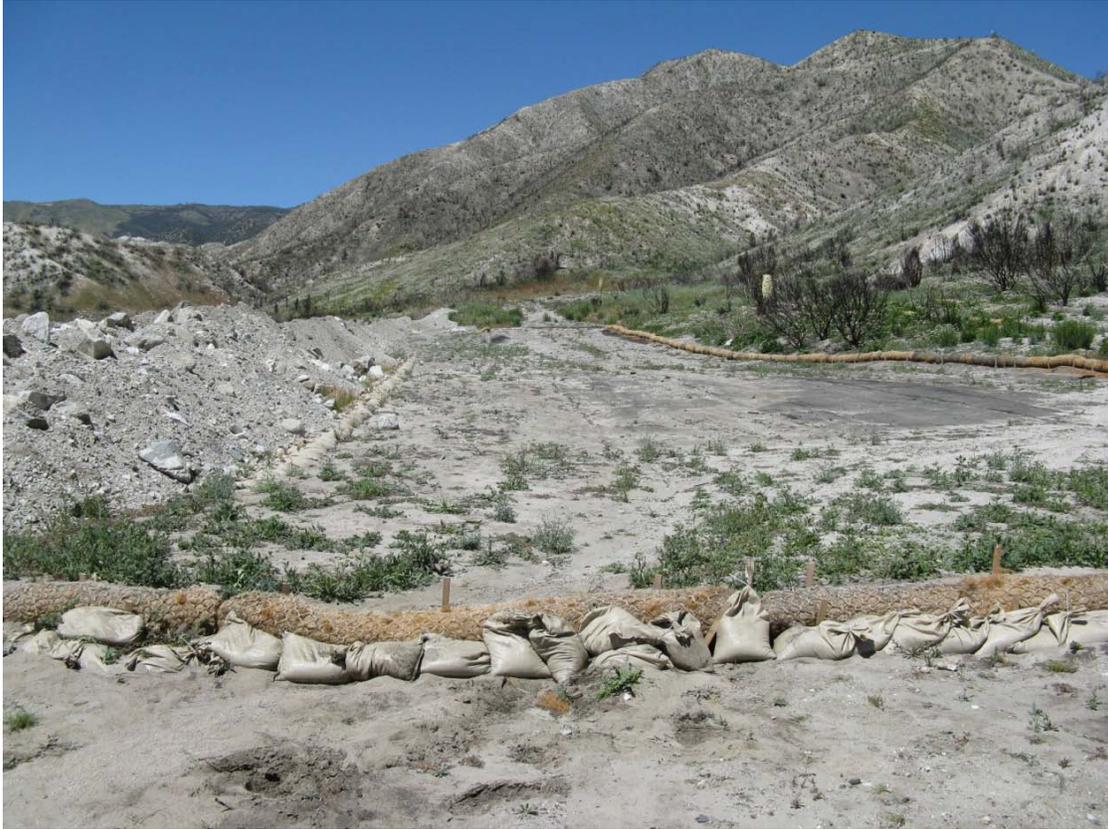
**Figure 11: A former shooting range was effectively stabilized with filter fabric and coir logs to prevent off-site movement of lead particles.**

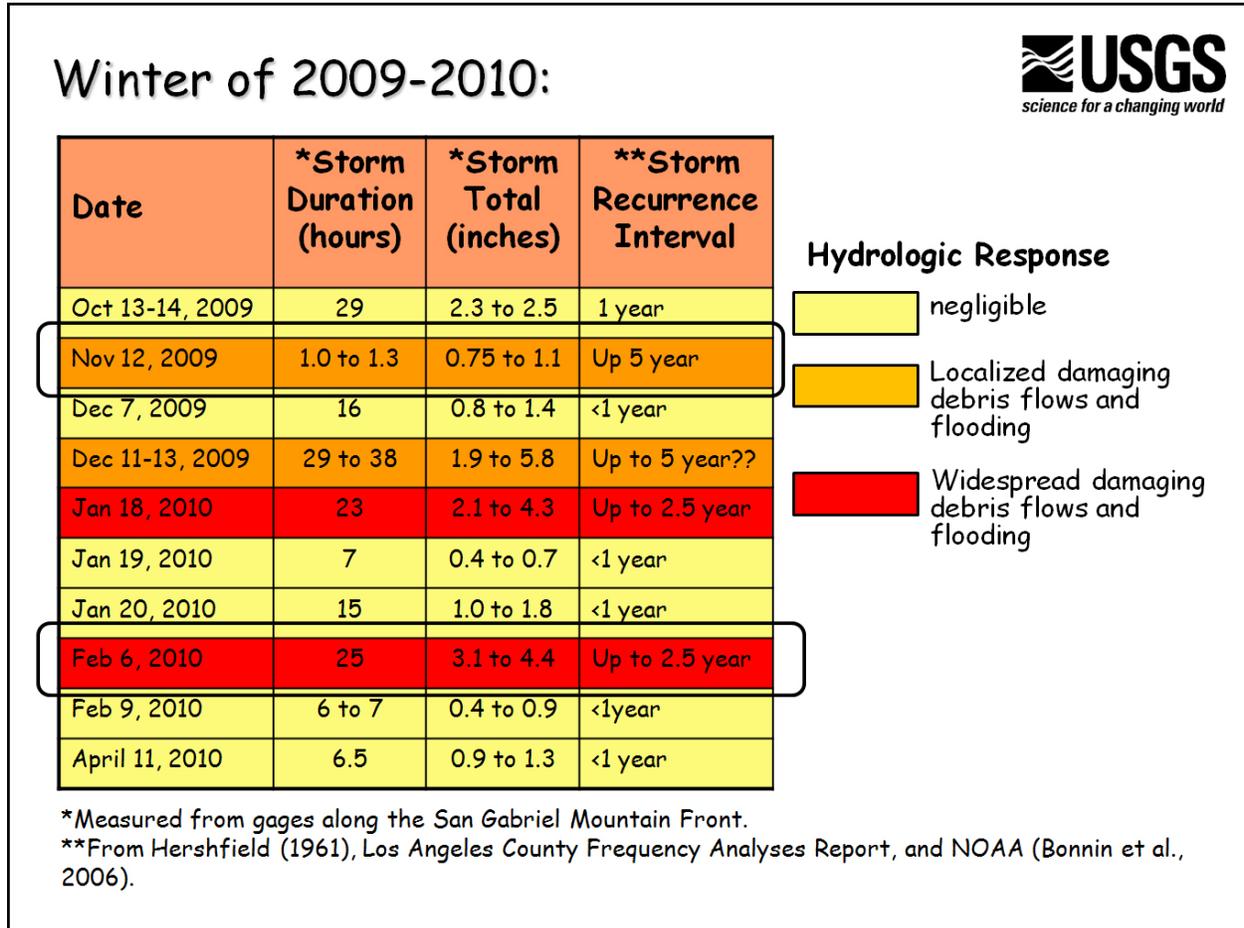
Figure G1: Table showing the details of storm events and their response.

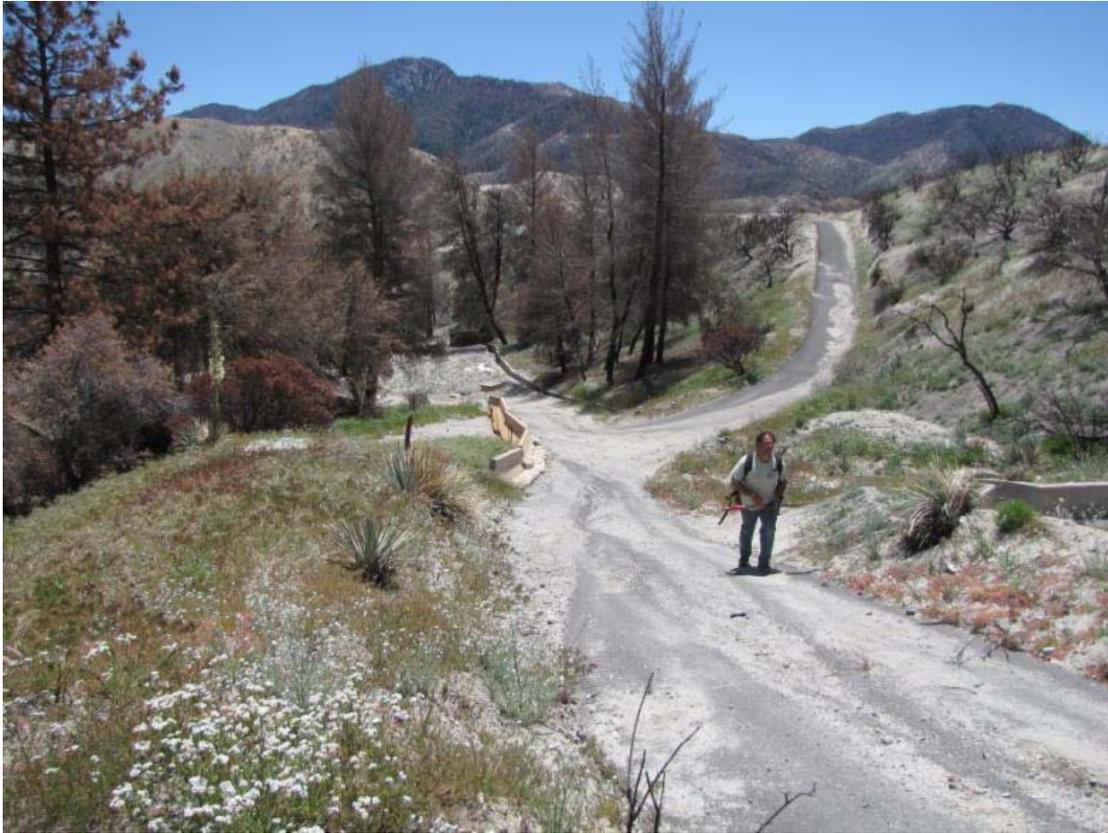
**Figure G2: View from debris source area along k-rails to deposition area at Monte Cristo Fire Station.**

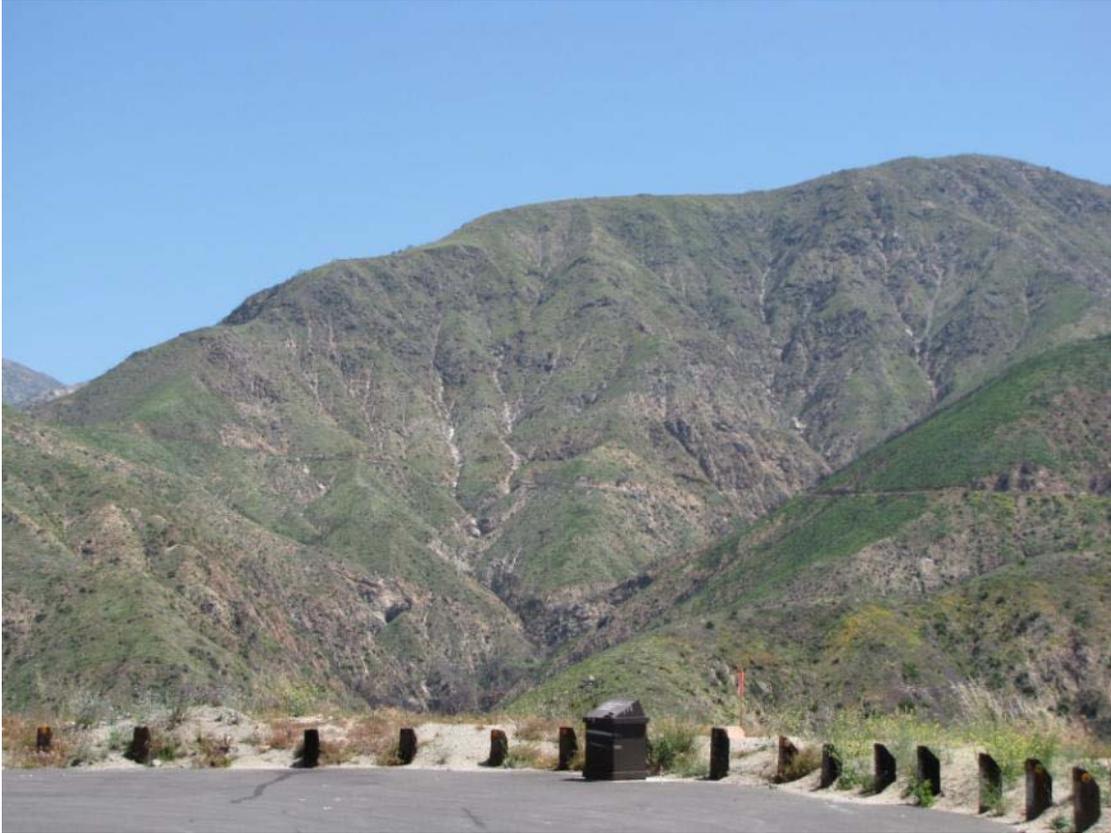
**Figure G3: View of slopes along Arroyo Seco. Drainage network shows 1st order channels effectively scoured to bedrock.**
