Pine Creek/Sulphurbeds Allotment: Dipping Vat Spring

2010 Update

Mary O'Brien, Wayne Hoskisson, and Mindy Wheeler
Grand Canyon Trust

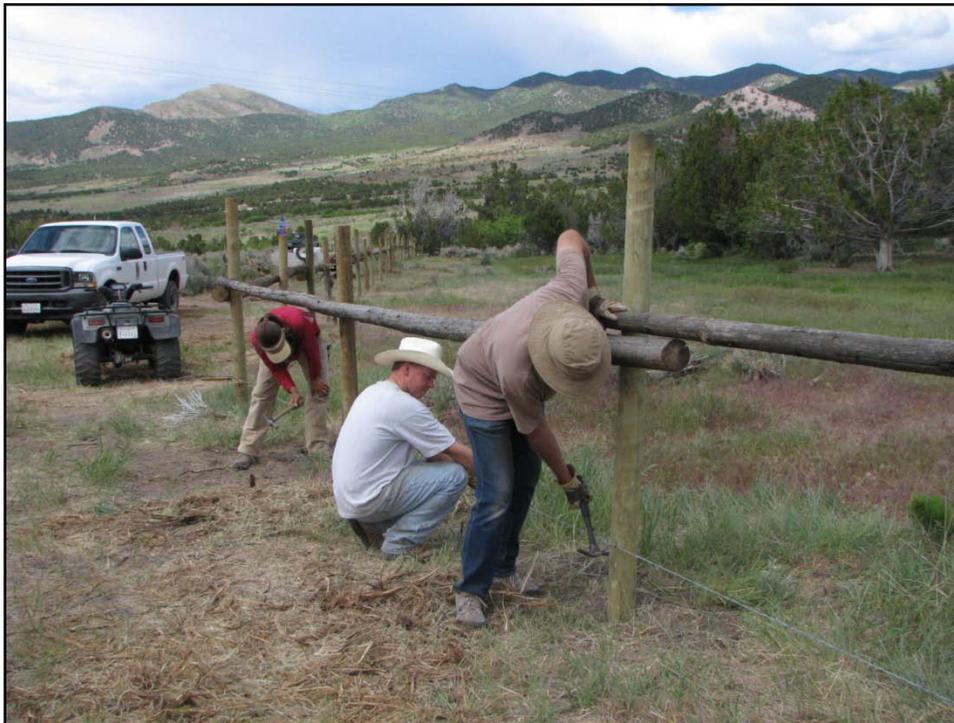
Fig. 1 (05/29/09) West side of pole/post/wire wetlands fence.

A post, pole, and wire fence (Figs. 1-2) was constructed at the end of May and beginning of June 2009 by Forest Service, Grand Canyon Trust and Great Old Broads for Wilderness volunteers, and hunters with the UDWR Dedicated Hunter Program. However, the upper (south) end of the fence was not post and pole, but merely a wire fence with T-posts.

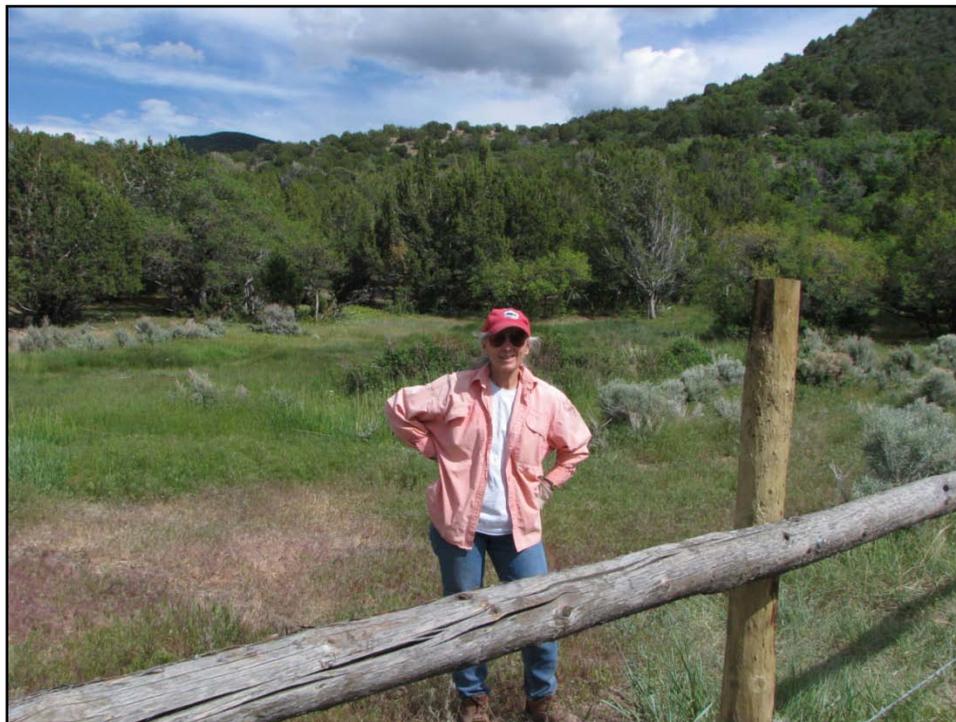
Fig. 2 (05/29/09) Western side of enclosure, looking SE. at the meadow. Note drier, cheatgrass-dominated portion near fence behind volunteer.

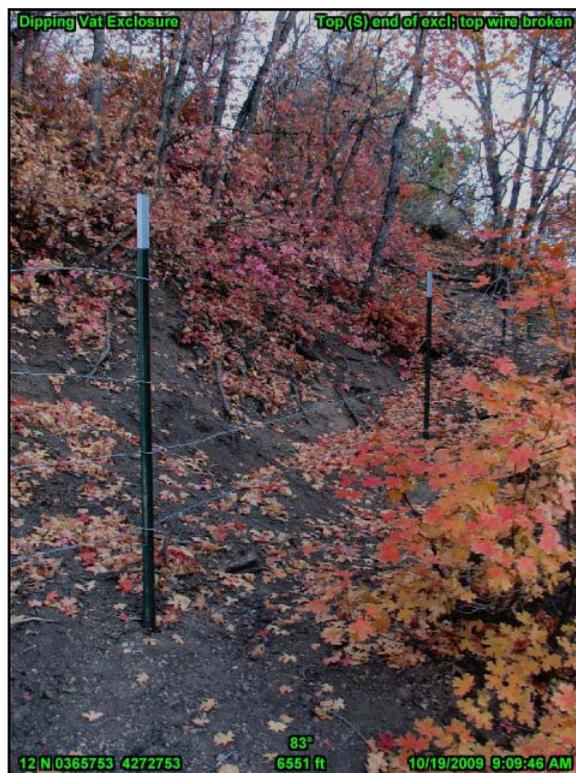
Fig. 3 (10/19/09) Top wire broken at top (south) end of enclosure

As of October 18, 2009, wires in the upper fence (wire and T-post) were broken and loose (Figs. 3-4). Unless the fence is fixed prior to cattle entry in 2010, the wetlands will be trampled by cattle. In addition, although cattle were scheduled to exit Cove Creek Pasture by Sept. 30, 2009, water was still flowing from the spring in the pipe (Fig. 5), and spraying out of the pipe near the unused sheep dipping vat (Fig. 6).

Cove Creek Pasture was rested in 2008, and grazing in 2009 was scheduled for grazing July 26 after the fence was constructed through Sept 30. As of October 19, cattle did not appear to have entered the wetlands, despite the loose and broken wires on the top end of the enclosure (Figs. 3-4).

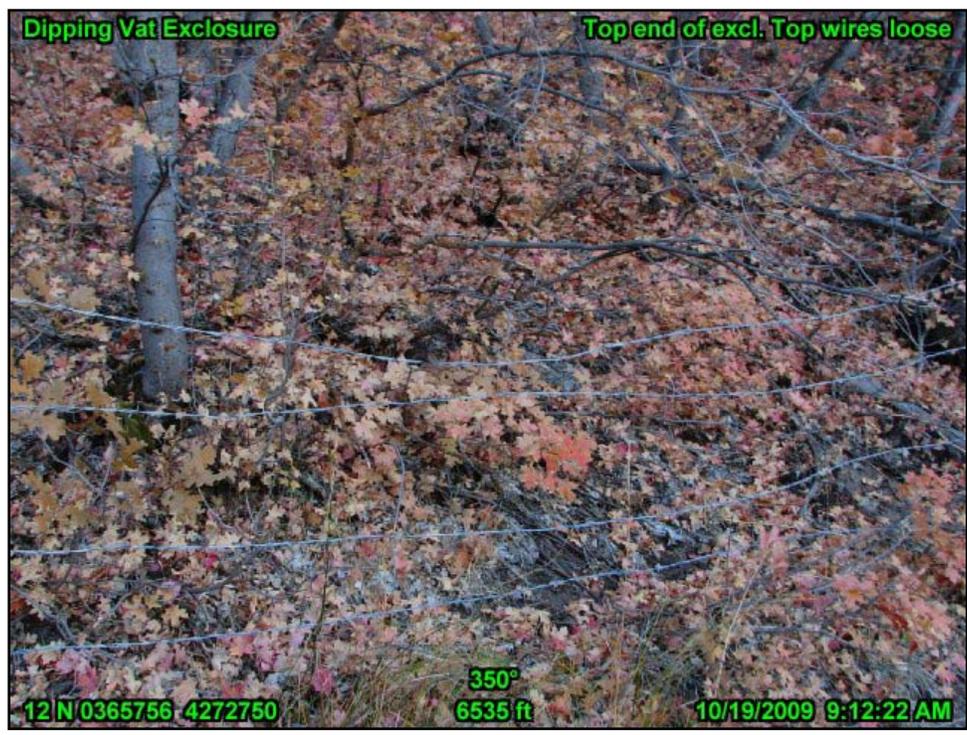
Fig. 4 (10/19/09) Top wires loose at top (south) end of enclosure

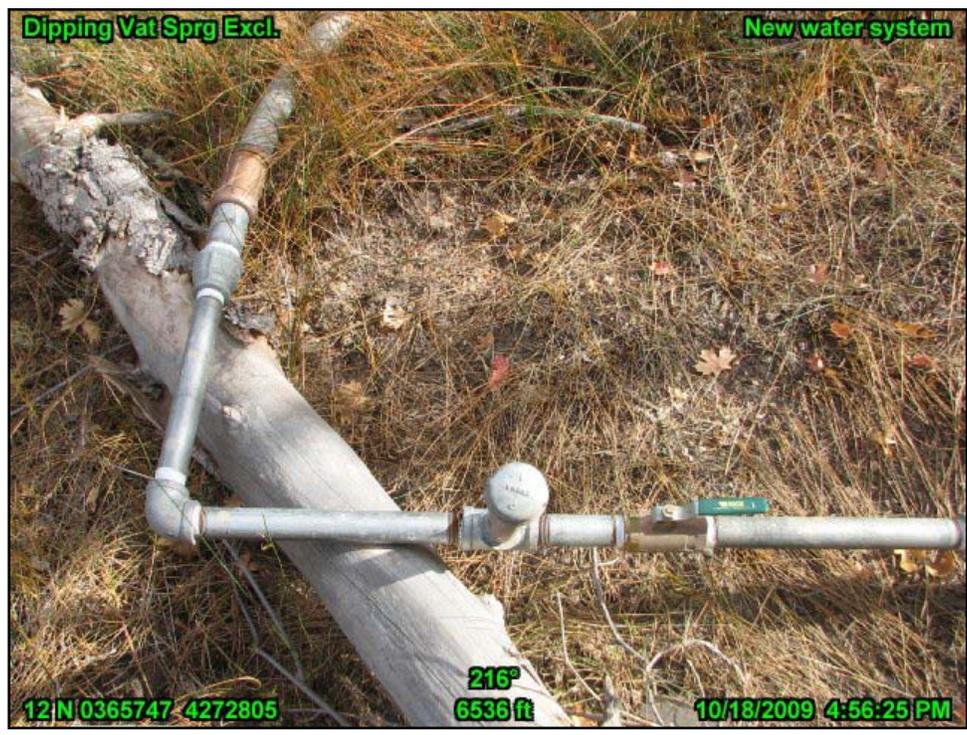
Fig. 5 (10/18/09) Water system installed for piping spring water to cattle

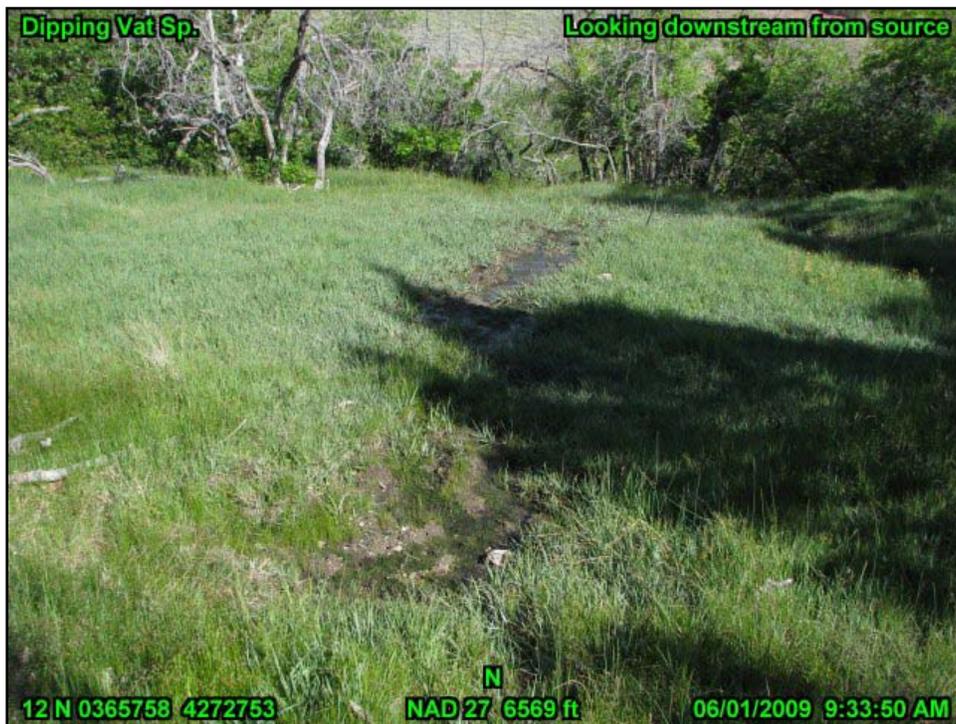
Fig . 7 (06/01/09) Looking downstream through the wetlands at the origin of Dipping Vat Spring.

Gambel oak grows immediately around the origin of Dipping Vat Spring (Fig. 7). A little further out and downstream, pinion and juniper dominate. A sagebrush flat adjoins Dipping Vat Spring on the west side (Figs. 10-11). The lower 150 m of the brook length is largely open on the west side with pinion and juniper on the east side. This open area is at the edge of the sagebrush flat (Fig. 11). Grass, sedge and rush dominate the ground cover near the brook.

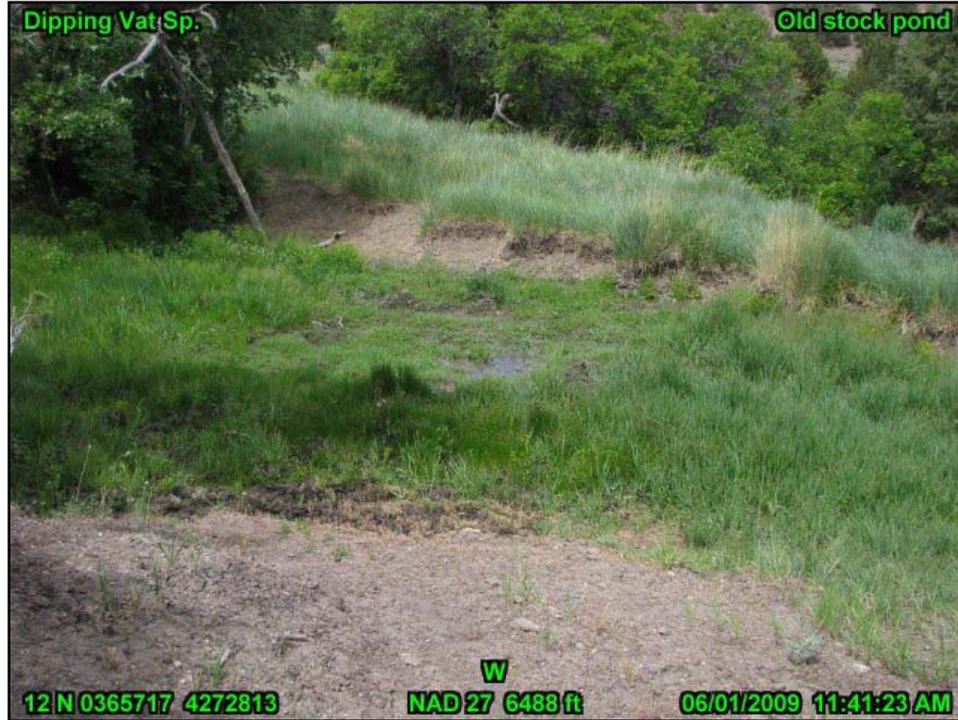
Fig. 9 (06/01/09) The earthen bank of the old check dam is in upper center. Note the bare ground on the slope in the foreground. Compare with Figs. 1-2 (2006) Appendix A.

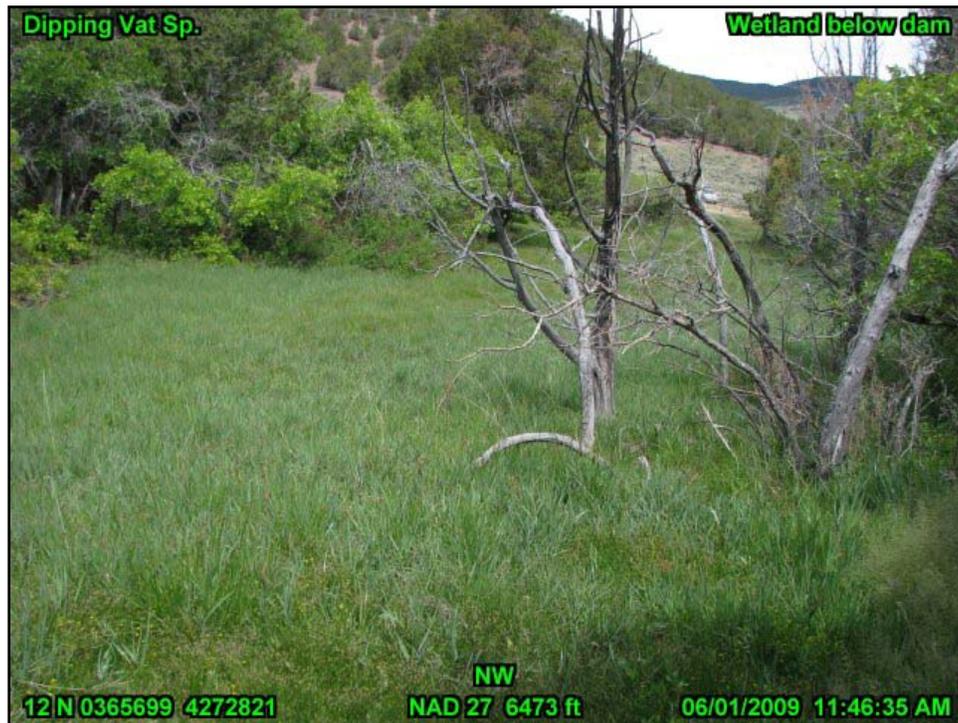
Fig. 10 (06/01/09) Spring brook and wetlands below the check dam. The sagebrush flat can be seen in the background.

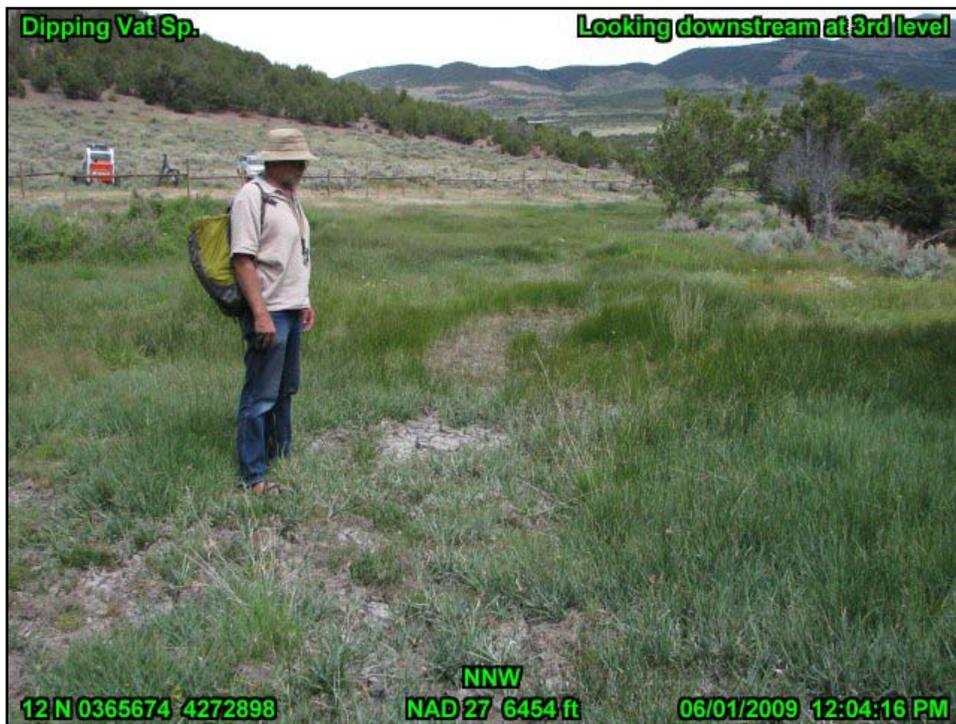
Fig. 11 (06/01/09) View of mid portion of the Dipping Vat Spring brook. The sage brush flat is visible to the west (left). The foreground is trampled and forming hummocks

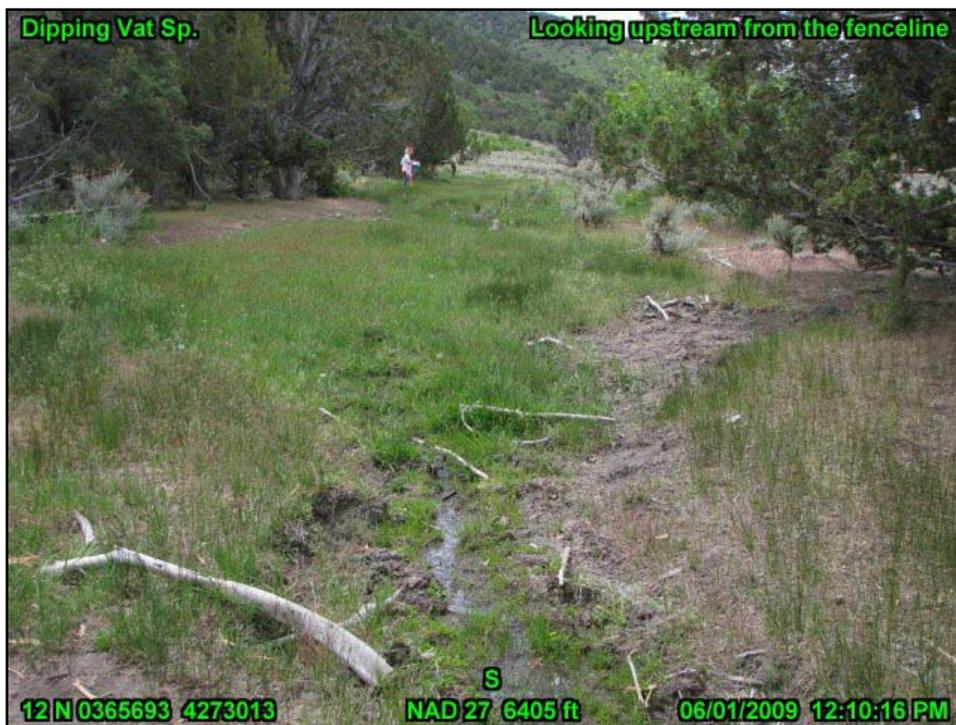
Fig. 12 (06/01/09) Looking upstream from the fence at the northern end of the newly constructed enclosure. Compared to the ground immediately along the brook the vegetation is relatively sparse. Note trampling on the brook.

Spring Description: Dipping Vat Spring emerges in seeps on the toeslope of a ridge and through a flowing pipe. The seeps and pipe are at the same level; the pipe is on the north side of the wetlands created by the seeps. This upper portion of the wetlands is nearly level and about 30 ft. wide and 20 ft. long (Fig. 7). The pipe flows into a non-functioning sheep trough (i.e, a long, shallow wood trough; Fig. 8). After this initial portion of the wetland, the brook flows in a narrow ravine to another wetland segment created by what appears to be an old check dam (Fig 9). Compare with the 2006 spring evaluation. Tall grasses are now growing on the check dam and the hummocks are covered with tall and vigorous grass (Compare Fig. 9 with with Figs. 1-2 in Appendix A, below). The brook breaches the dam and continues flowing downslope through a verdant riparian zone (Fig. 10). Following this, the width narrows as it flows to the north. Shortly after the check dam, the slope flattens to 2-3% (Fig. 11). On June 1, 2009, the spring brook flowed the entire length of the exclosure (approximately 250 m.). The brook flowed a short distance beyond the fence line but was barely enough to wet a narrow strip of land (Fig 12).

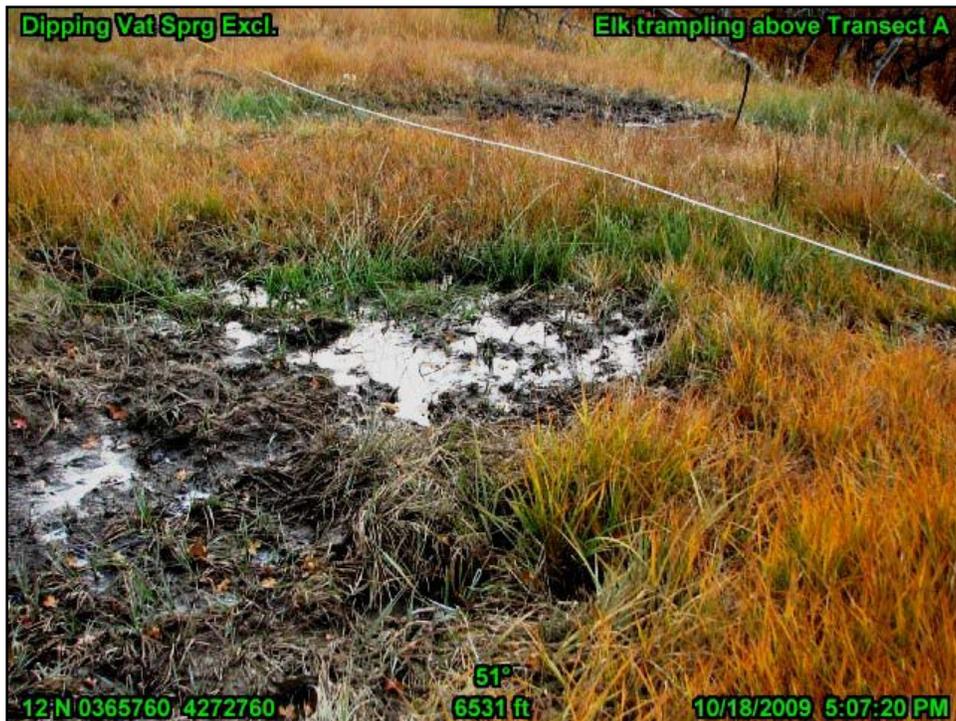
Fig. 15 (10/18/09) Elk trampling above Transect A.

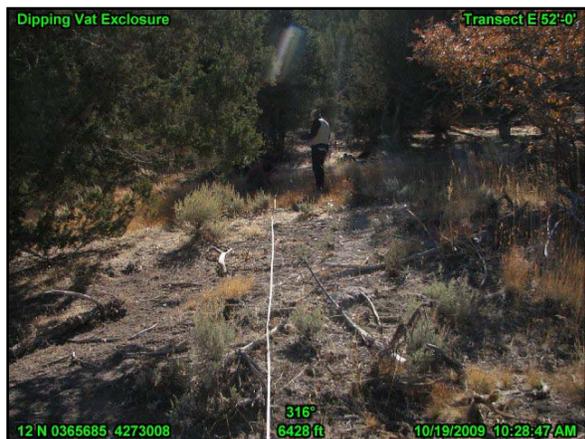
Fig. 22 (10/19/09) Transect E 52'-0'; lower, drier end of fenced wetlands.

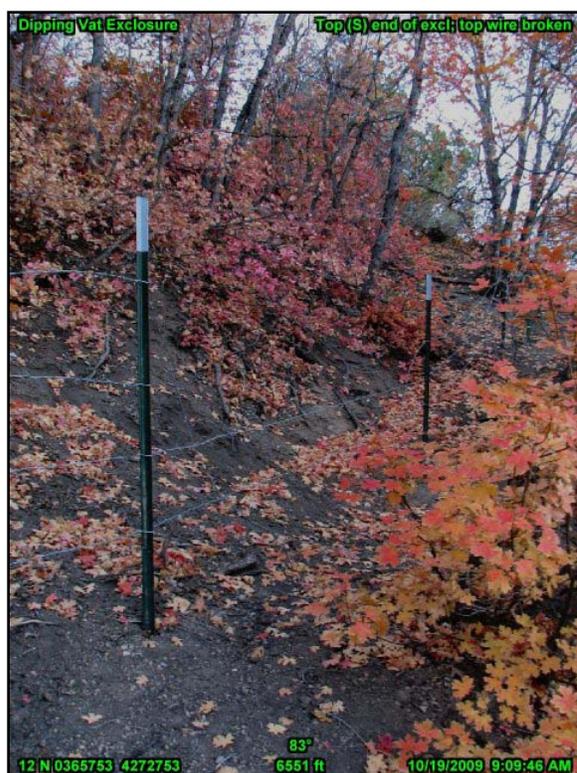
Fig 24 (10/19/2009) Fence in upper part of enclosure broken

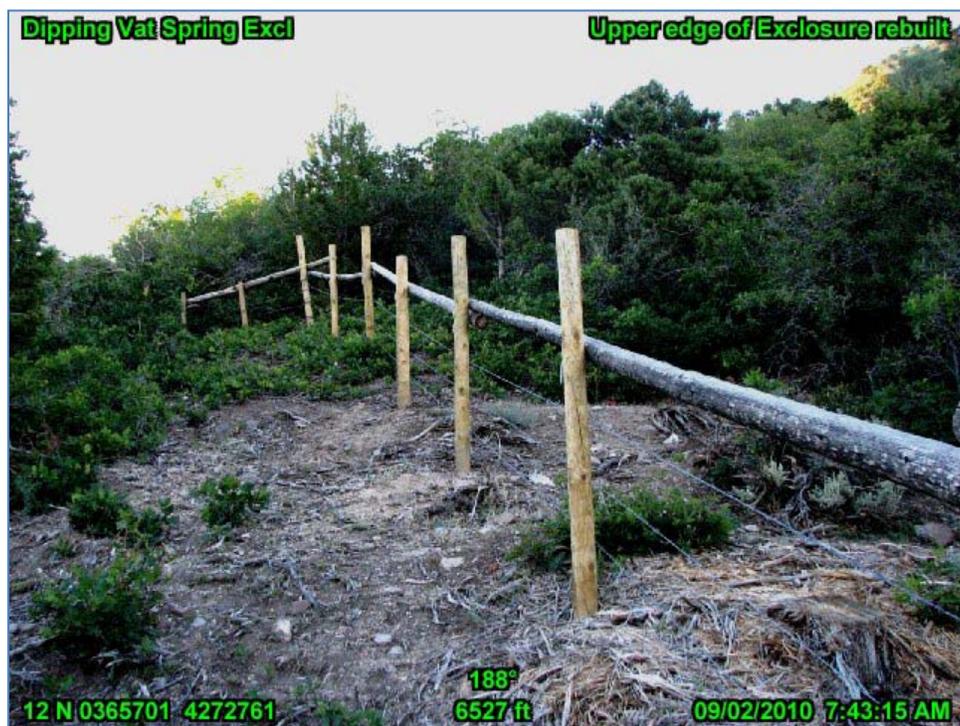
Fig 25 (9/2/2010) Upper fence of exclosure rebuilt.

Cattle were to be on the Cove Creek Pasture between June 16 and August 15 in 2010. At the time of our visit September 1 and 2, unauthorized cattle were present in Cove Creek Pasture (reported to the District September 1 and 2). The Dipping Vat enclosure fence was in good shape and the wires at the top end of the pasture had been mended (Figs 25 and 26).

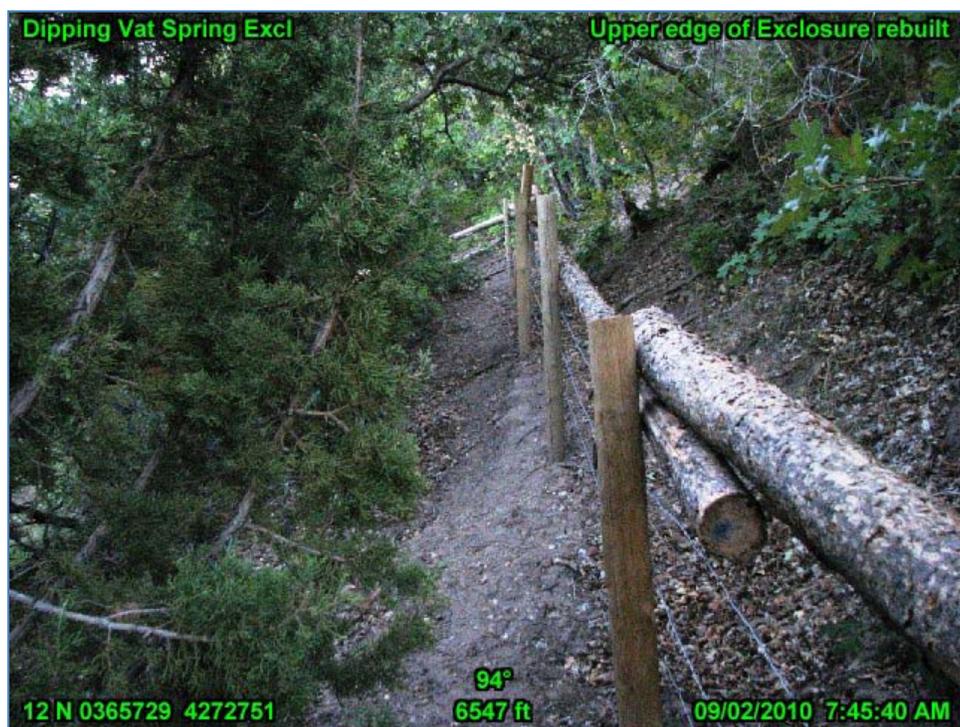
Fig 26 (9/2/2010) Upper edge of exclosure fence rebuilt.

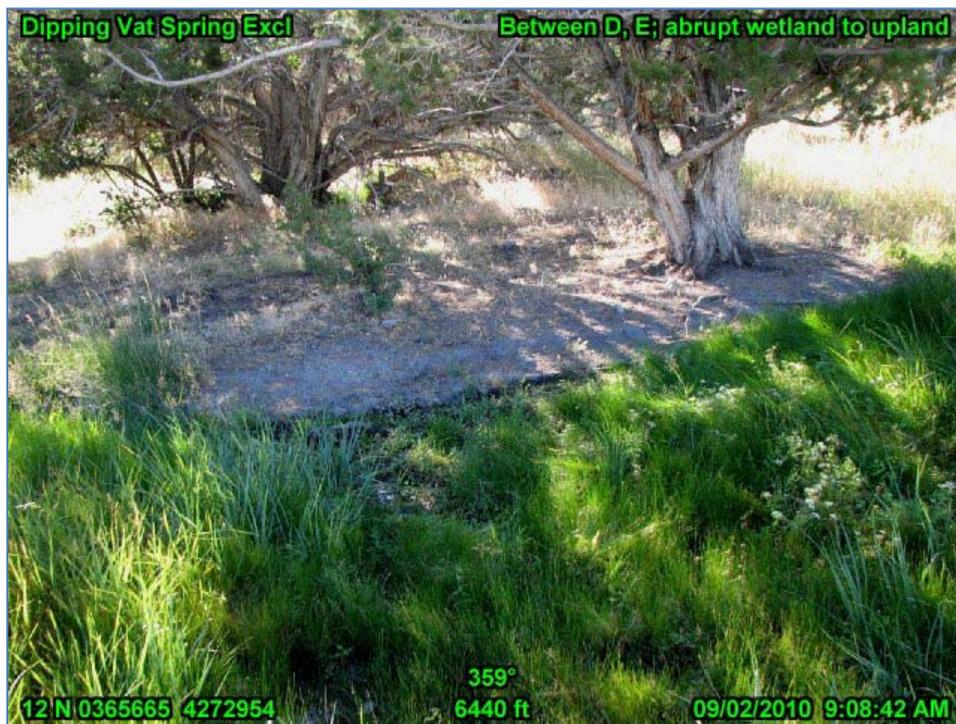
Fig 27 (9/2/2010) Abrupt wetland/upland boundary between Transects D and E.

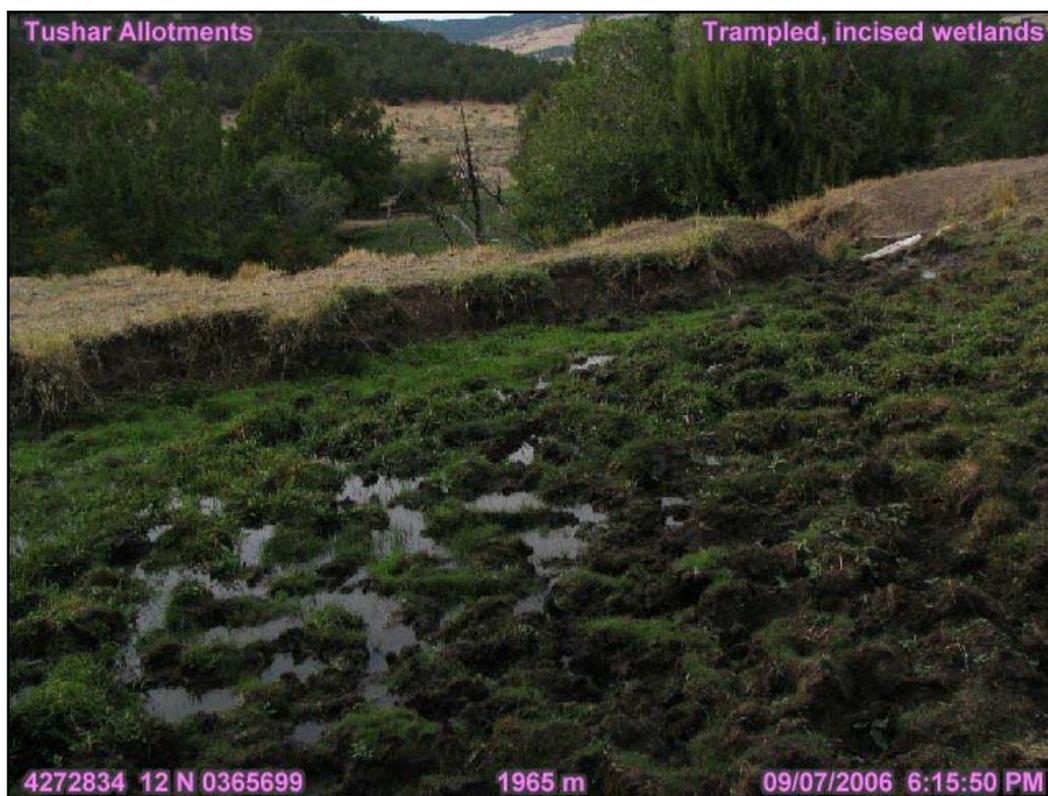
Dipping Vat Spring is a currently un-used sheep watering trough, with a pipe disconnected to a watering trough, and trampled, incised, over-grazed spring-seep wetlands below (Fig. 1). The land adjacent to the wetlands is overgrazed (Fig. 2) During 2008, the Cove Creek Pasture is being rested, and shows the potential for restoration of the wetlands (Fig. 3) via fencing, and piping of water further downslope.

Fig. 1 (09/07/06) Wetlands below Dipping Vat Spring
(pasture was rested in 2008)

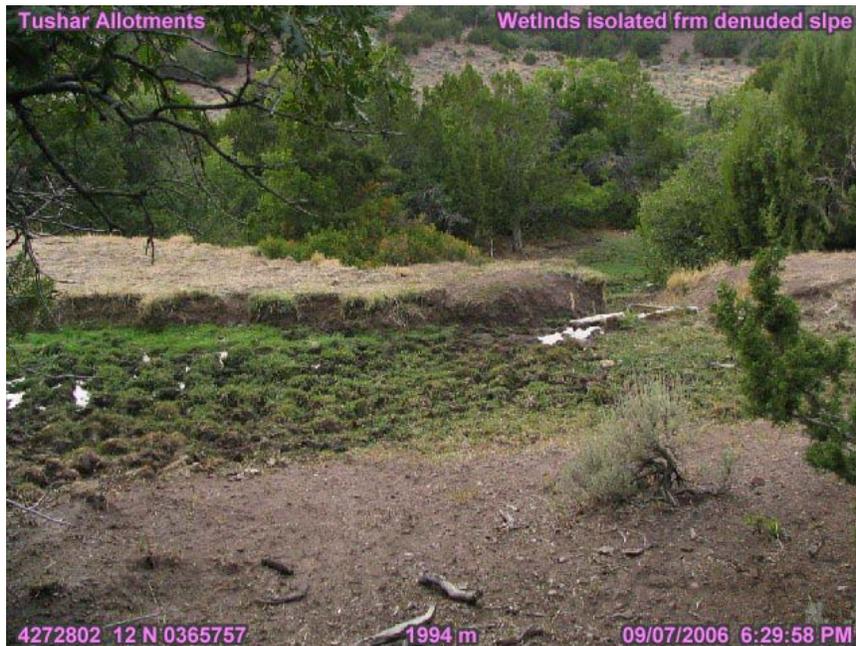
Fig. 2. (09/07/06) Denuded slope above incised Dipping Vat Springs wetlands

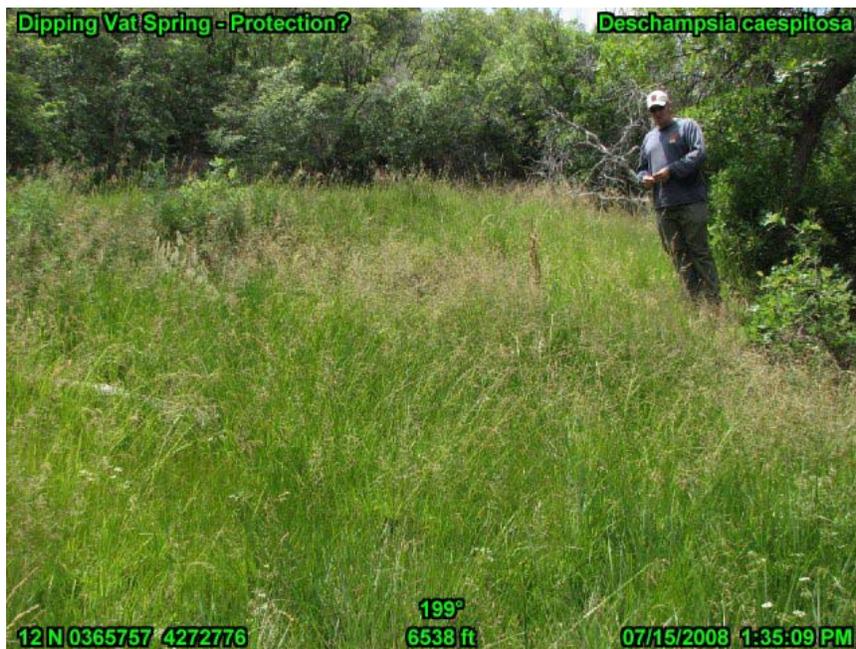
Fig. 3 (07/15/08) Dipping Vat Spring wetland during a year it is rested. Redtop (*Agrostis stolonifera*), an exotic wetland grass and native Nebraska sedge (*Carex nebrascensis*) are present.
