## PROJECT REVIEW APPLICATION

## **Bonneville-Hood River 115kV Line Outage Action Summary**

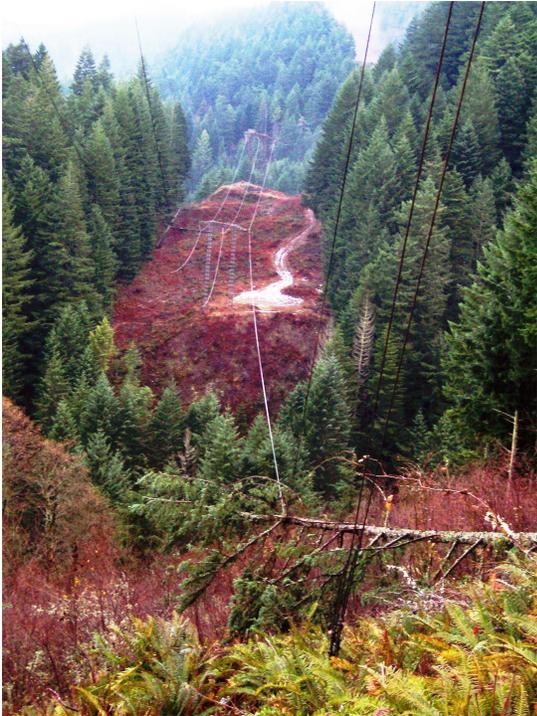
Figure 1. Down tree causing emergency response

On 11/27/10, a 24" (Diameter at Breast Height) x 90' tall Doug Fir tree blew over and came to rest on the 3<sup>rd</sup> position of the Bonneville-Hood River 115 kV line between structures 3/1-3/2. The resulting impact of the tree seriously damaged structures 3/2 and 3/3, twisting the steel lattice structures and cross arms. The line was out of service leaving Cascade Locks, OR without power for approximately 4 hours. On 11/29/10, TLM removed the tree from the line and began to assemble equipment to replace the damaged steel structures with wood pole structures. The November weather conditions in the Gorge had been very turbulent with high wind, ice and snow storms and above average rainfall. The ground was saturated and the potential for experiencing another outage in this area was high. Cascade Locks has only a radial feed line supporting its power needs at this time and if something happened to that line, the City would likely sustain a very long term outage. Therefore, rapid emergency response efforts were necessary.

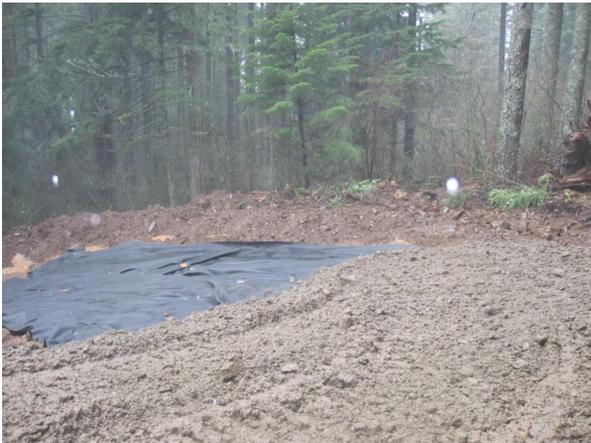
Figure 1. Hairpin turn 1.

The access to structures 3/2 & 3/3 is approximately 1.5 miles from the closest paved road. The existing access road surface is mostly native surface (clay) and traverses over steep slopes and switchbacks. For BPA to have the ability to remove the damaged structures and replace with new wood pole structures, several large heavy pieces of equipment needed access to the site including work trucks, boom trucks, cranes, track hoes, and a track mounted driller to bore holes to set the new poles. The condition of the road at that time would not sustain the weight of these vehicles due to the wet weather conditions. The native surface soil is mostly clay which becomes extremely slick when wet and does not provide for safe travel over the roadway with work vehicles. Another impact of wet native surface roads is they become inaccessible almost immediately due to ruts and holes created with minor use.

In response to these conditions, BPA hired a contractor to improve the road surface from the beginning of the access road to structure 4/2, so that safe and reliable access could be provided. On December 7, 2010, the road contractor mobilized on-site. The scope of the road work included placing rock, adding fabric where necessary, and rolling and grading the finished surface. Upon completion of these tasks, water bars were installed on the road and all disturbed areas were seeded and covered with straw. As a part of the road work, two hair pin corners were widened to accommodate the large equipment and materials. Approximately eight trees were removed to support these actions. These two corners were located immediately to the west of Structure 4/2. BPA will continue to monitor conditions at the site and the contractor will return when the conditions are favorable to add more rock where necessary, stabilize the water bars, and apply more seed and straw as needed.

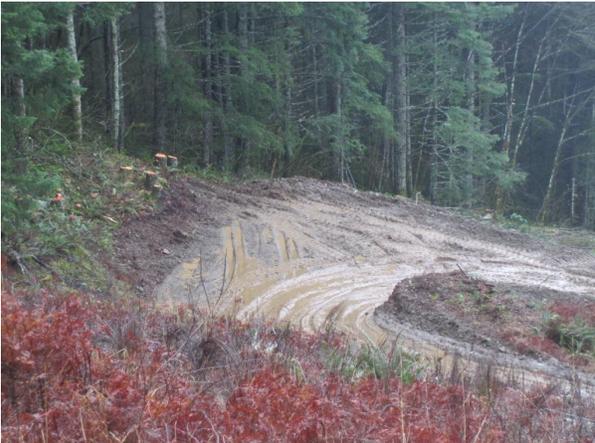
Figure 1. Hairpin turn 2.
