Historical & Archaeological Restoration – Recovery Act Projects– (Montezuma, Dolores & Archuleta Counties)

The San Juan National Forest has a rich historic and prehistoric legacy reflected in its old ranger stations, fire lookout towers, and archaeological sites. Several of these unique and irreplaceable resources have received Recovery Act funding for restoration projects.

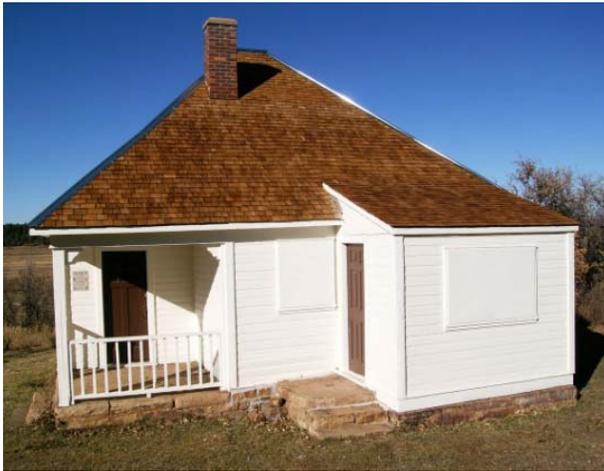
GLADE GUARD STATION:

The Recovery Act is funding utility reconstruction at the Glade Guard Station to prepare the historical cabin for public rental in the future. The cabin's potable water supply system has been reconstructed, its wastewater-disposal system replaced, and a new propane storage tank installed.

The Glade Guard Station's water system has been retrofitted to solar power, and its water well and treatment system upgraded for water filtration and disinfection. In addition, a water hydrant is being installed to supply water to the barn and corral. A new wastewater system will be installed to

provide for collection and disposal of sewage and gray water generated in the residence.

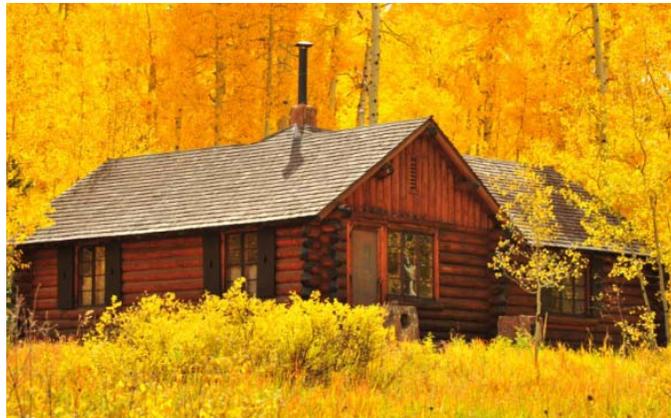
ASPEN GUARD STATION:

At the Aspen Guard Station, a Civilian Conservation Corps-era ranger's cabin, Recovery Act funding was used to replace an unreliable spring water source with a safer groundwater well. The new water system includes a solar-powered pump, water line between the well and cabin, chlorination system to disinfect the water, and pressure tanks to provide storage and adequate pressure to fixtures.

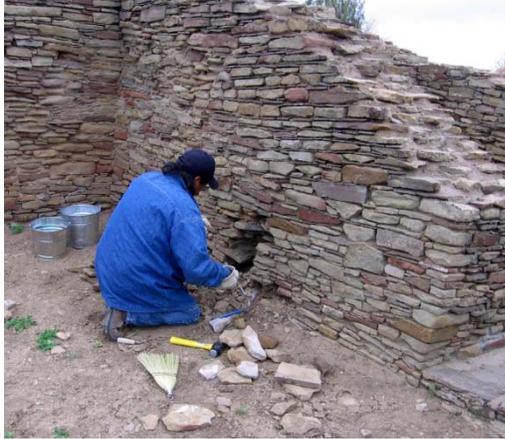
CHIMNEY ROCK ARCHAEOLOGICAL AREA:

The Recovery Act is funding several projects at Chimney Rock Archaeological Area that will help preserve cultural resources, improve facilities and enhance visitor experience. Moisture monitors have been installed in prehistoric walls to help archaeologists evaluate the efficiency of past stabilization efforts and to identify and address future stabilization problems in advance before damage occurs.
