Fitchburg Furnace: Past Achievements and Future Goals

Built in 1868 and acquired by the Daniel Boone National Forest in 1973, the Fitchburg Furnace is a double-stack, steam-blast iron furnace. One of the largest charcoal-fired furnaces ever built and the only twin stack furnace in the world, it now stands a monument to its creator and the historic iron industry of Kentucky. Though it never achieved its full potential, the furnace remains a testament to the genius and determination of the designer, Frank Fitch.

Today, the furnace is a popular destination for tourists and school groups. Since 2004, the Forest Service has been working to stop the decline of the massive structure and to improve access for the public. This work has resulted not only in the stabilization of the furnace, but also in the discovery of additional foundations and some of the original machinery that forged cast iron from local ores. While the restoration work completed to date will help ensure the long-term survival of the impressive structure, additional plans are being shaped to develop improved interpretation at the site.

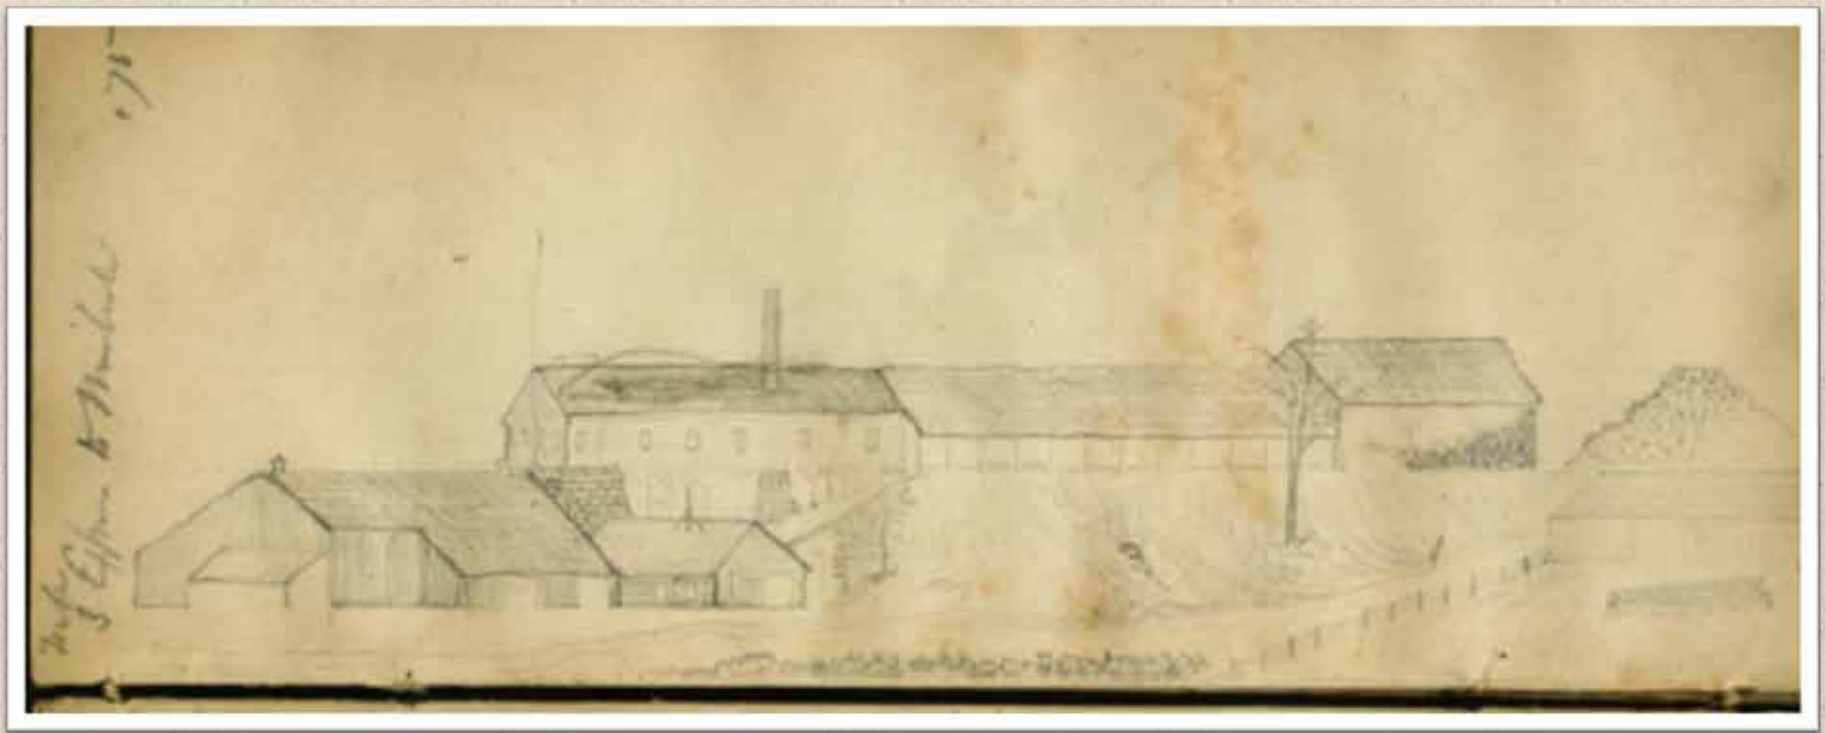
Sketch from 1867
Notebook

Here is a sketch of Frank's vision of the entire furnace complex. There are two important issues to note here; first, this sketch was prepared a year before construction even began on the furnace. Second, the stone furnace, which seems huge to us today, is only a very small part of the overall complex which here includes a casting shed in front, a large building to house boilers and machinery in back, with additional sheds stretching out behind that. Frank Fitch dreamed large.

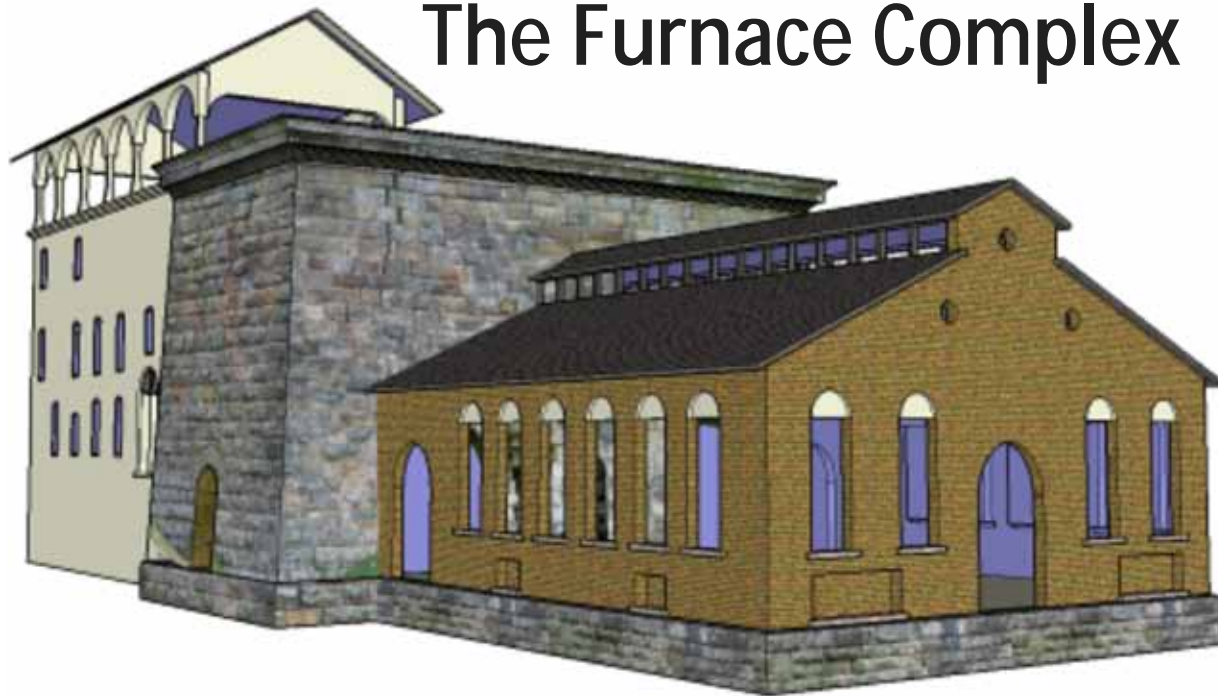
The Furnace Complex

This artist's conception, based on historic photographs and archeological findings, shows the furnace flanked by the four-story power house in back and the casting shed in front. The furnace went into blast for the first time on March 4, 1870.

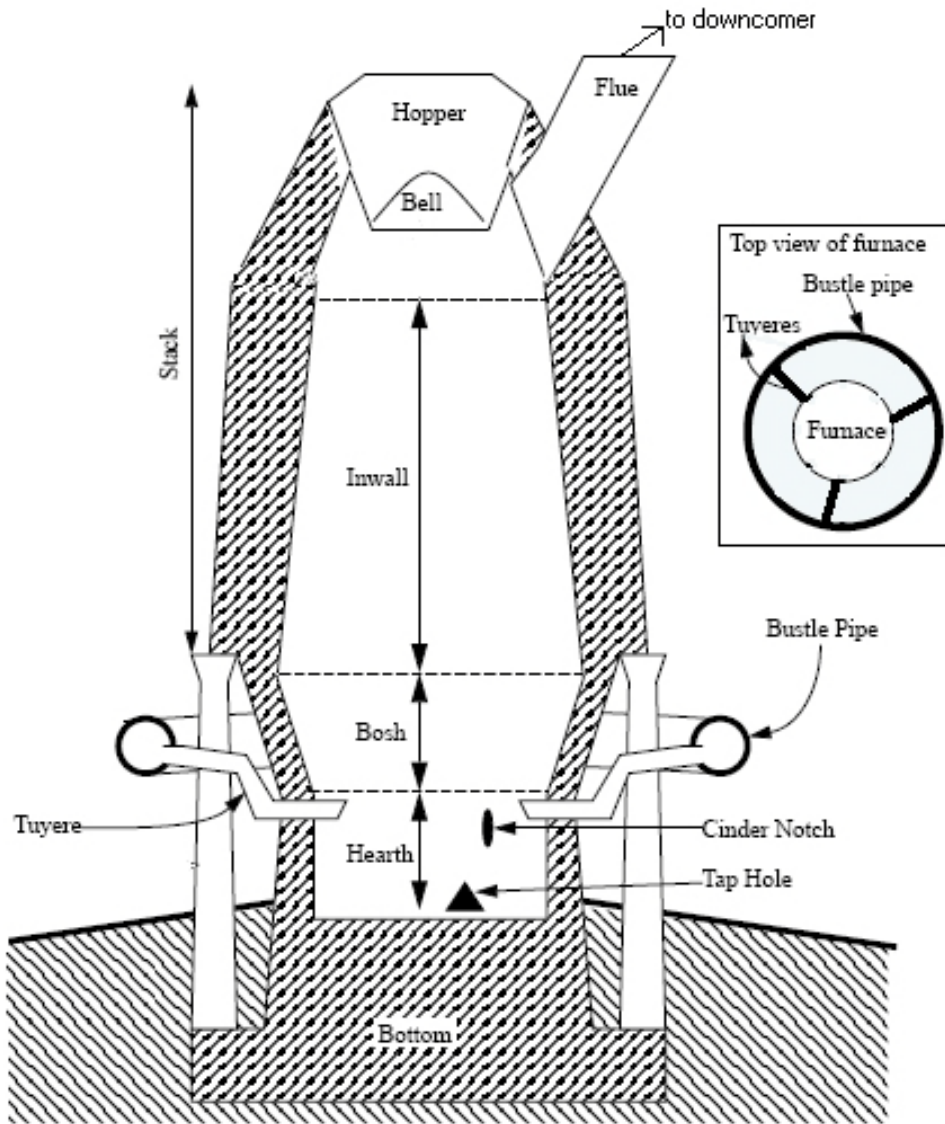
The sloping surface of the lower cone supports the weight of the ore, fuel and flux. Bustle pipes encircle the stack at the base and feed air into the stack through tuyeres. The air could be sent in pre-heated by stoves on top of the furnace (making it a hot blast furnace) or not pre-heated (making it a cold blast furnace). As the charcoal burns, it produces carbon monoxide which combines with ore to form liquid iron which collects at the bottom of the stack. The flux reacts with the remaining materials in the ore to form slag, which the crews drain off periodically through the firing process (Gordon 1996: 100-101).

During firing, the molten iron remains puddled behind a dam stone; when ready, a clay plug in the dam stone would be pulled out with long handled tongs, allowing the molten iron to gush out into long, gently sloping channels of sand inside the casting house. Gutter men, equipped with long paddles-like tools, worked in the casting house, diverting the iron from the main channel into smaller, side channels. These side channels would produce iron bars from 4-6 feet in length. The main channel was known as the "sow" while the side channels were called "pigs," hence the term "pig iron" (Fig n.d.)

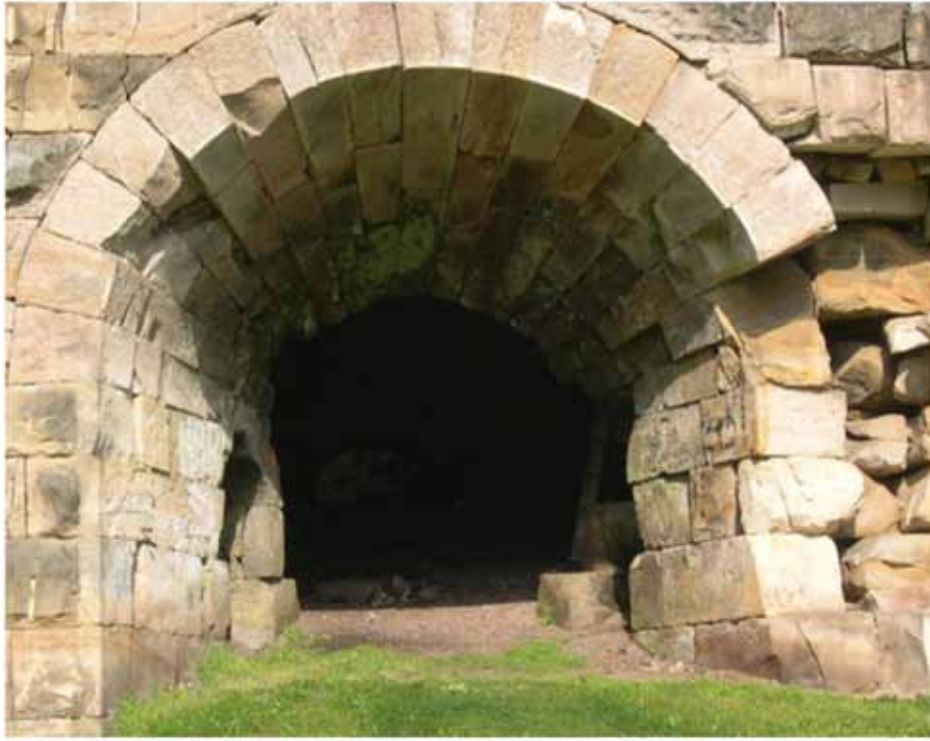
Another feature of the Fitchburg Furnace was the use of a bell and hopper design at the top of the stacks, which served to keep in hot gasses even while workers added material to the stack.

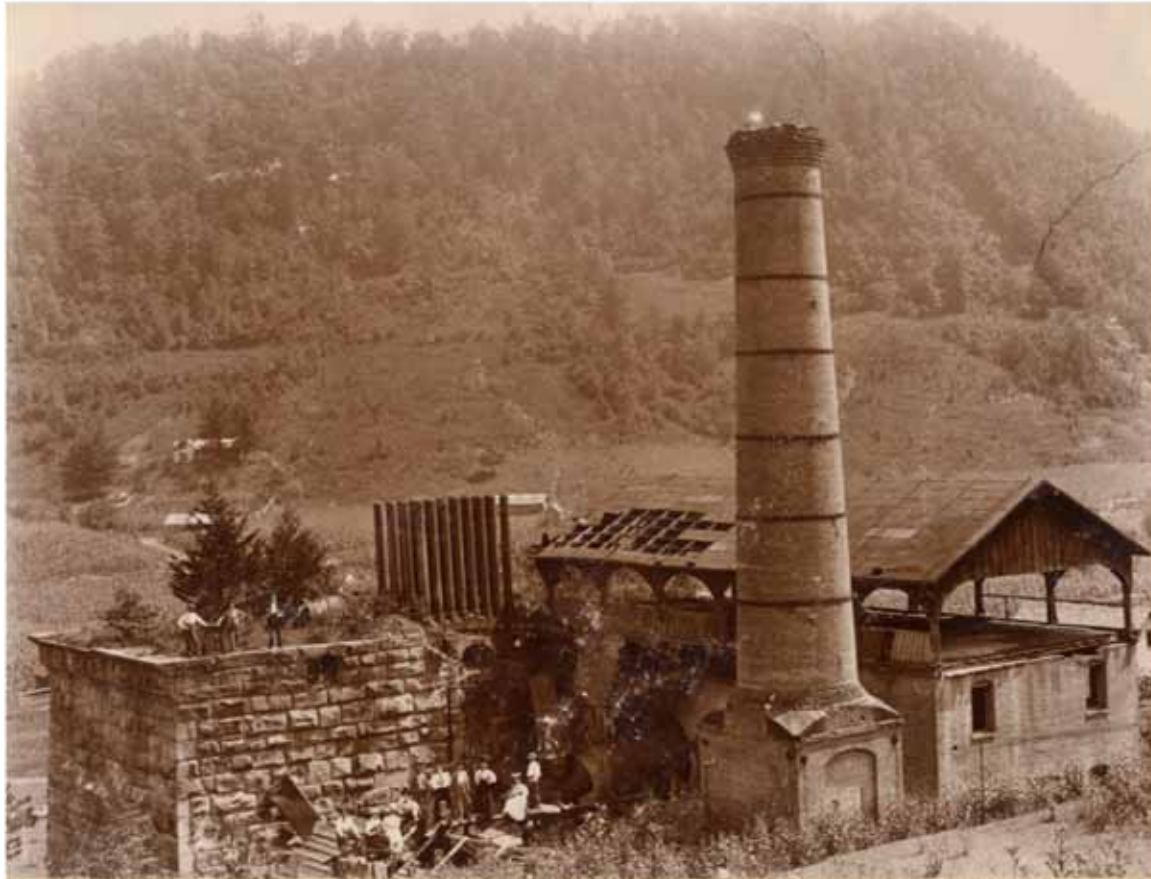
*Remains of Fitchburg Furnace Sep. 1895.
Built in 1868-9*

Following the end of operations, the Red River Company could no longer make payments on its debts and the property passed into other hands. Photographs from 1895 show the furnace and power house intact, but the casting shed already gone.

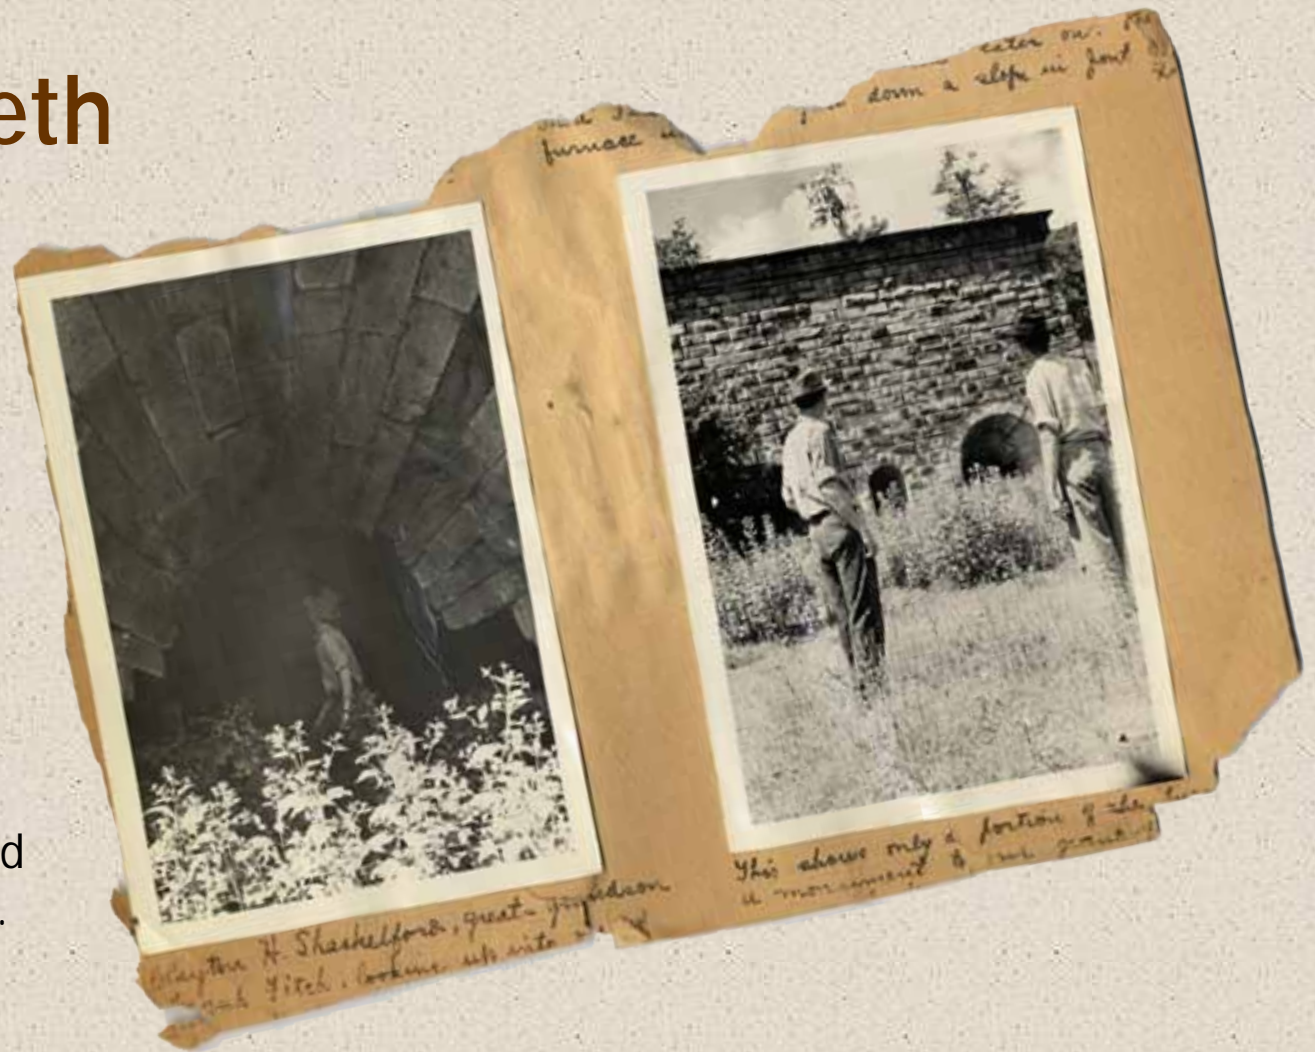
Following the work of the YCC, little more was done for the next 30 years at Fitchburg Furnace. Vegetation and trees grew up on top of the furnace and cracks both large and small developed and grew across the structure. One crack on the south end was especially alarming as it was of some size and seemed to be getting larger when compared to historic photographs.

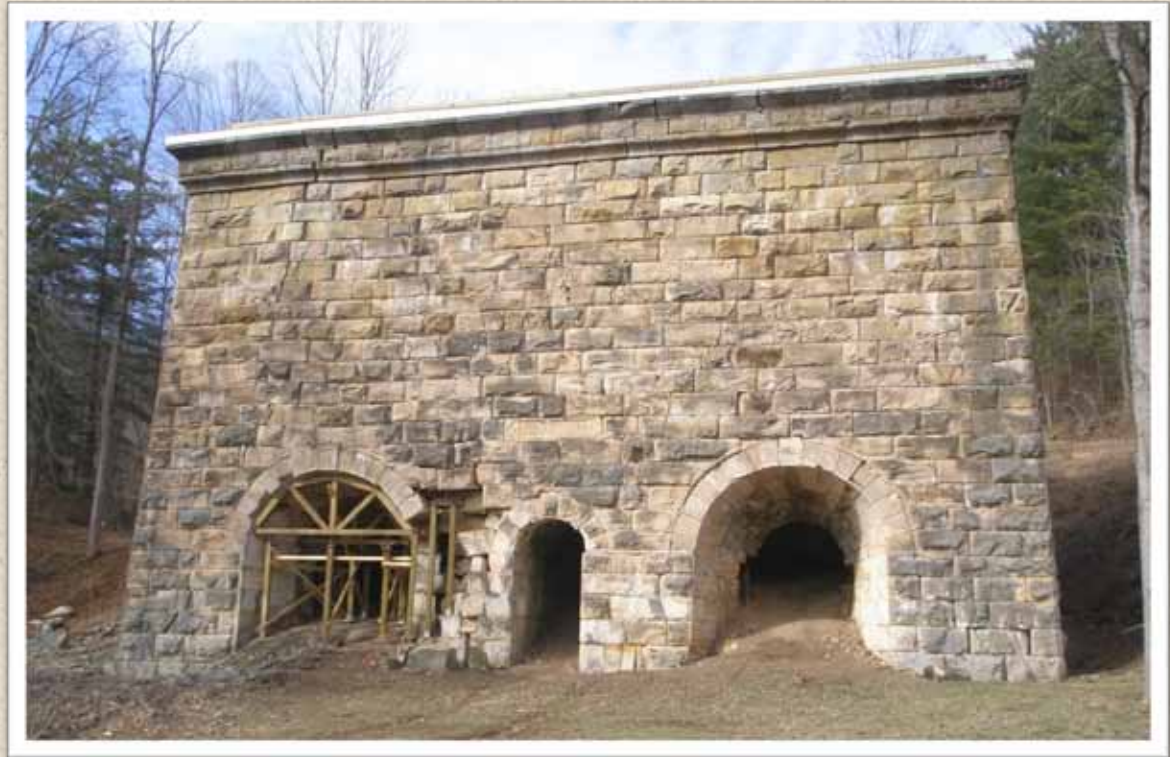
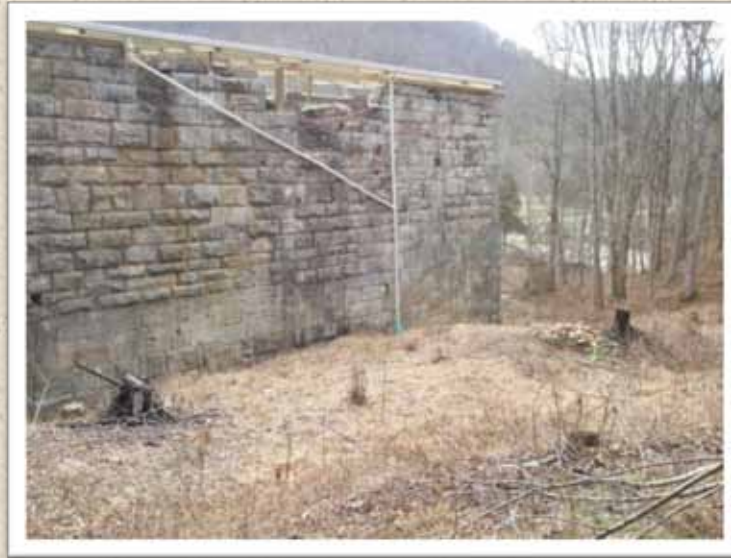
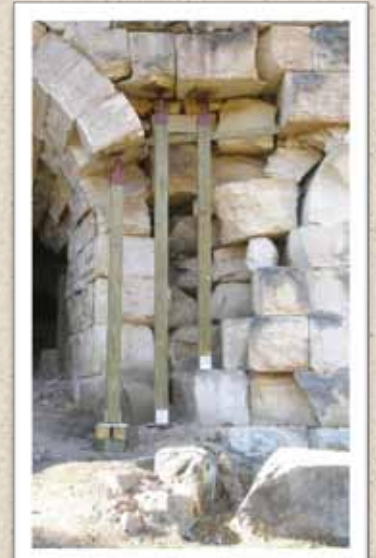
Engineering

First, a very intensive engineering study was undertaken to assess the weakness of the structure and prioritize repairs. As a result of this study, the first actions recommended were buttressing the foundation on the south side, installation of temporary arch supports where stones were missing, and the construction of a protective, translucent roof that would keep water out of the structure but still let in light.

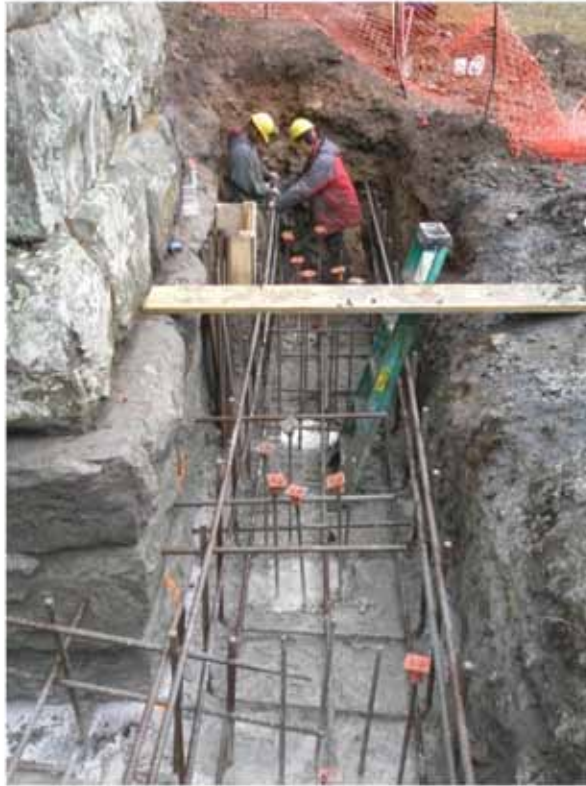
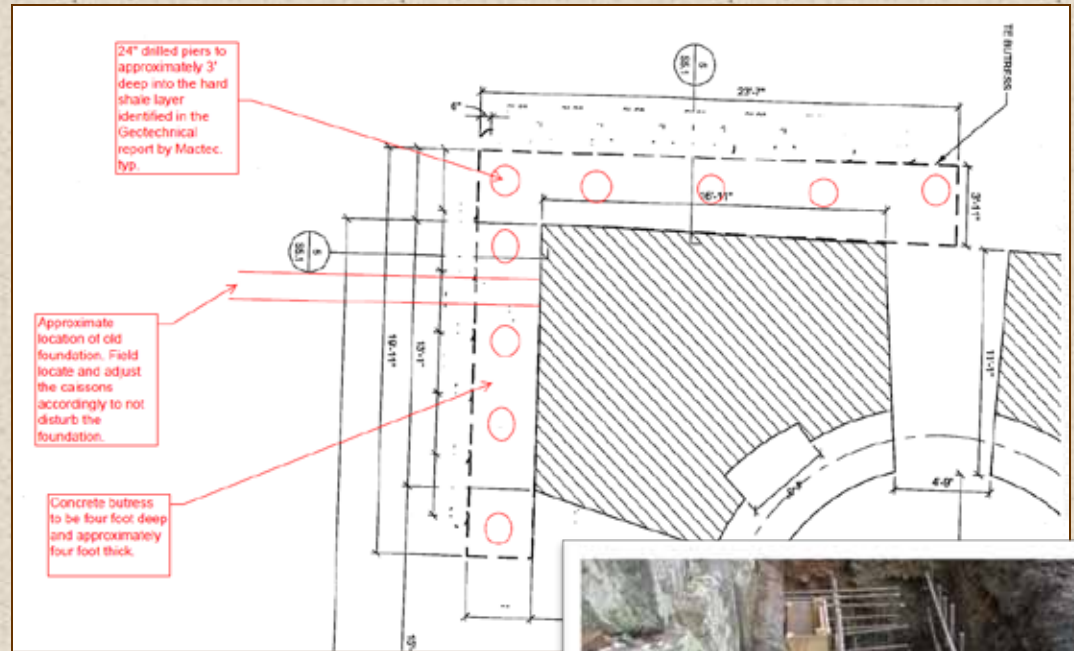
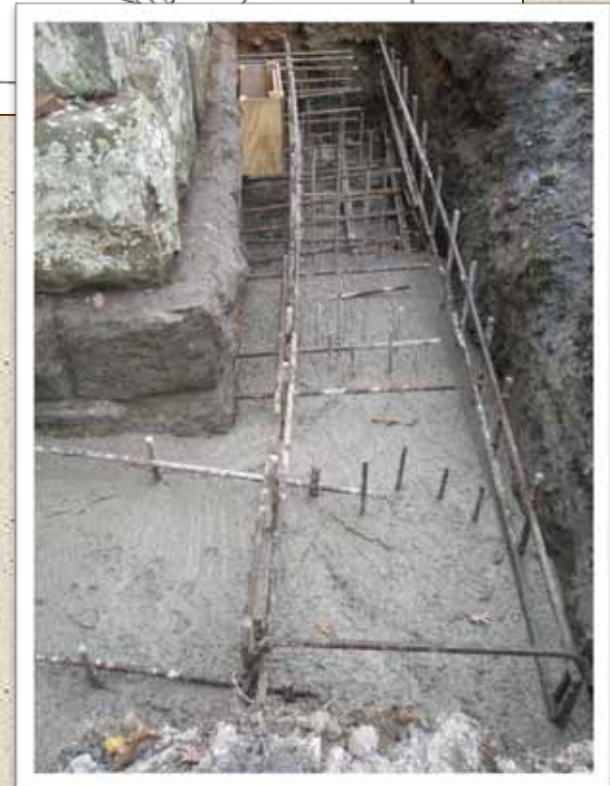
Foundation

The engineering assessments concluded that the southeast corner of the furnace was slipping and settling. To address this problem a concrete buttress was built around the corner. The buttress was anchored to the underlying bedrock with nine 24" casions set 20' deep. The casions were tied to a rebar framework, which is anchored into the sides of the foundation.

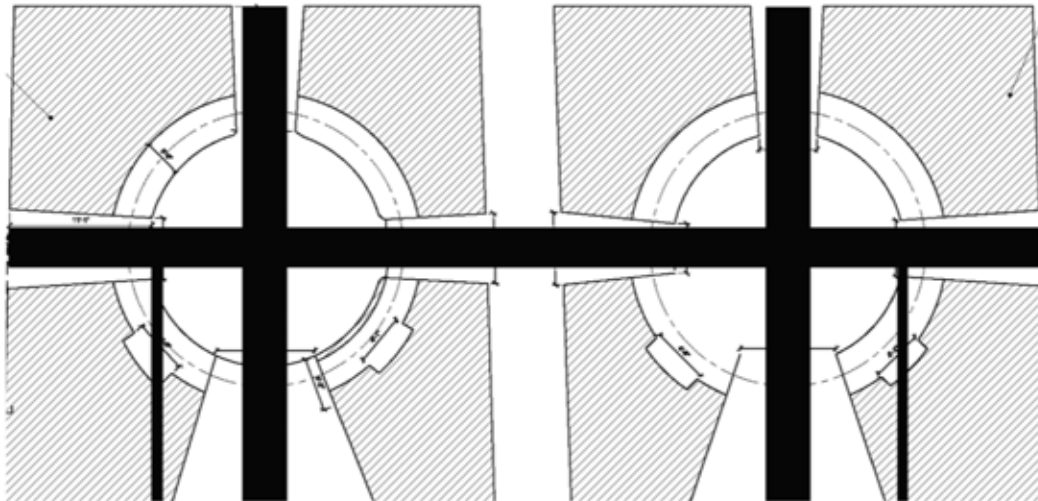
A number of interesting discoveries were made during installation of the roof and buttressing. Work on the roof revealed vents, low walls, and iron splatter (splash iron). Work around the foundation uncovered slag deposits and previously undiscovered channels under the furnace.

Further exploration determined that there are likely five channels built into the foundation with a primary channel running the length of the structure. Smaller, auxiliary channels run perpendicular to the primary channel.

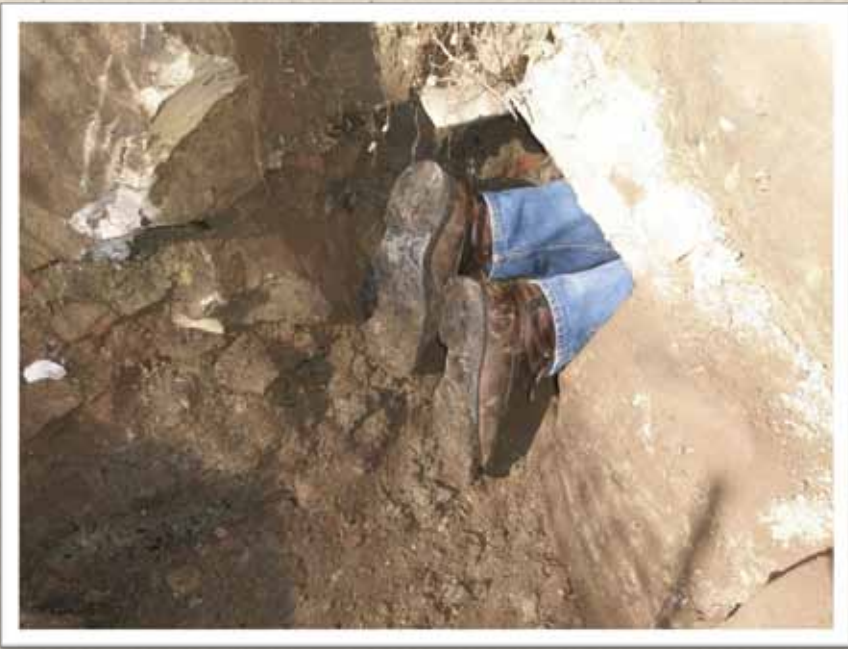
Exploring the Primary Channel

The channels are relatively free of debris. They are primarily filled with dirt and small stone fragments. The only artifacts found were a few small pieces of iron. A few erosion channels were found in the fill. These drain toward the front and side of the furnace.

The function of the channels is not known. We think they provided ventilation to help keep the furnace from over heating. The hottest temperatures are at the base of the hearth and the largest channels pass directly under this area of the furnace.

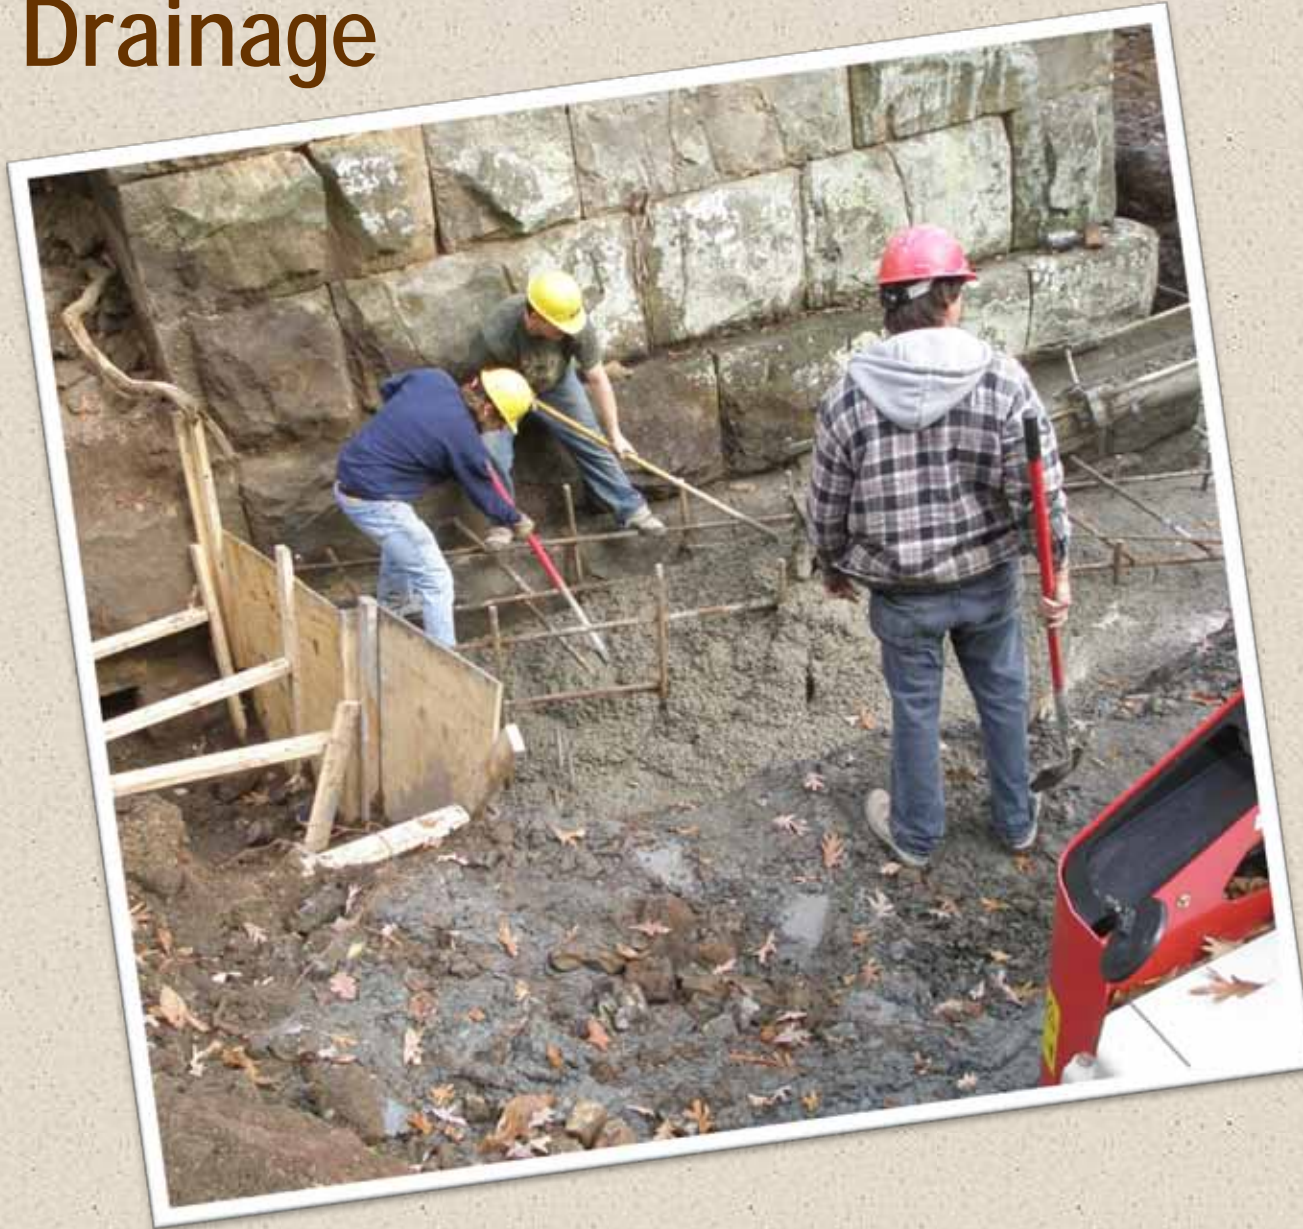
Further issues: Drainage

Work around the foundation also revealed that water percolated out of the hillside behind the furnace on a constant basis. Therefore, until a drain could be installed, the possibility remained that water could collect behind the buttress and run into the foundation via the newly discovered channels under the furnace.

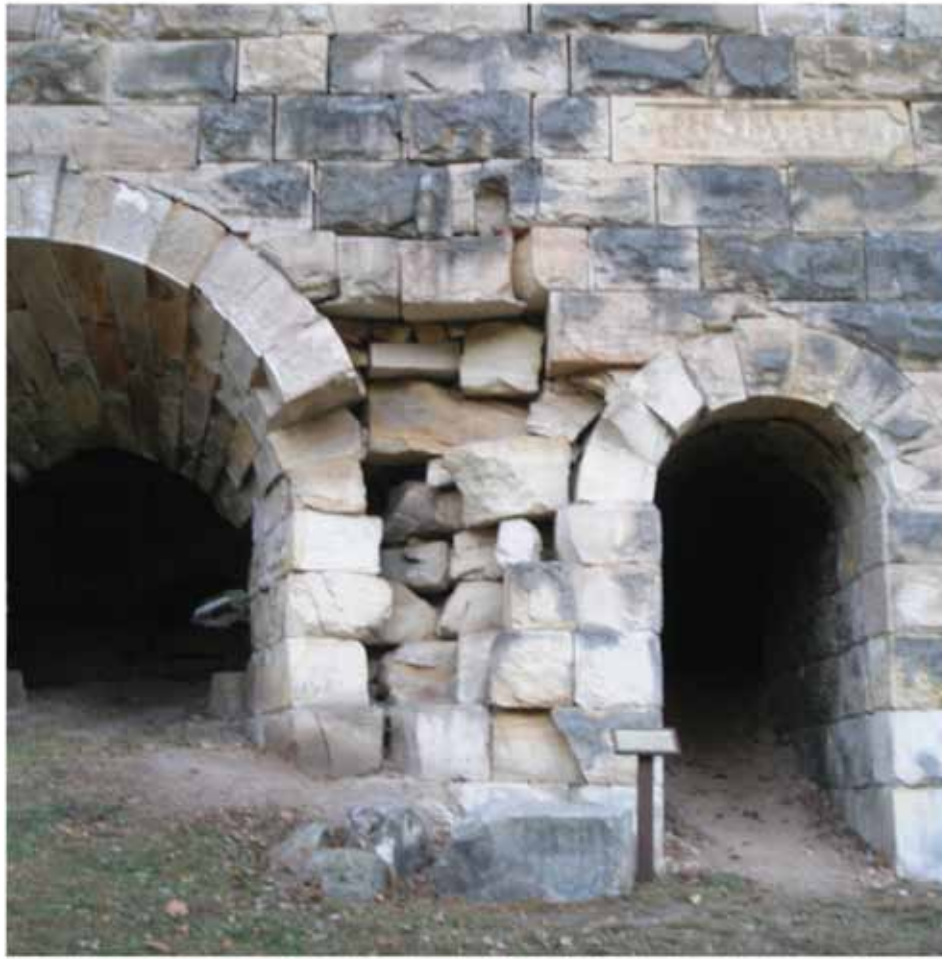
Missing Stone

Despite attempts to blow up the furnace, the interlocking nature of the construction resulted in a very stable structure. However, the arch supports were installed until funds could be procured to and the missing stone. To aid in this effort, the original stone quarry was located and permission obtained to quarry additional stone.

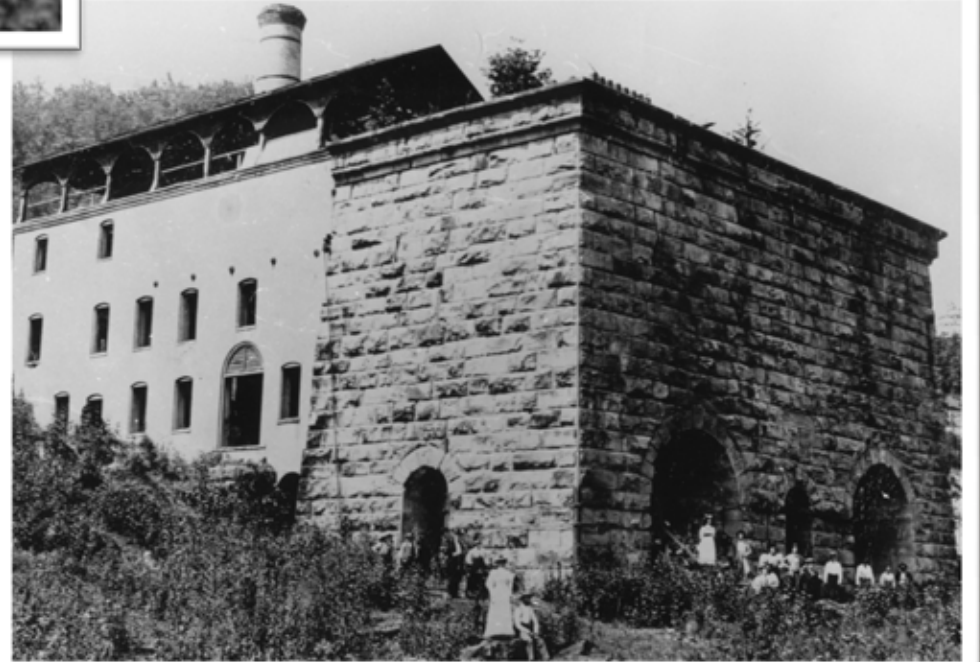
Power House

However, we knew that we should expect to encounter additional features in this area since this is where the power house had been located. The power house once contained the steam boilers that ran the blast machines and provided access to top of the furnace. This building had a sandstone foundation and brick walls.

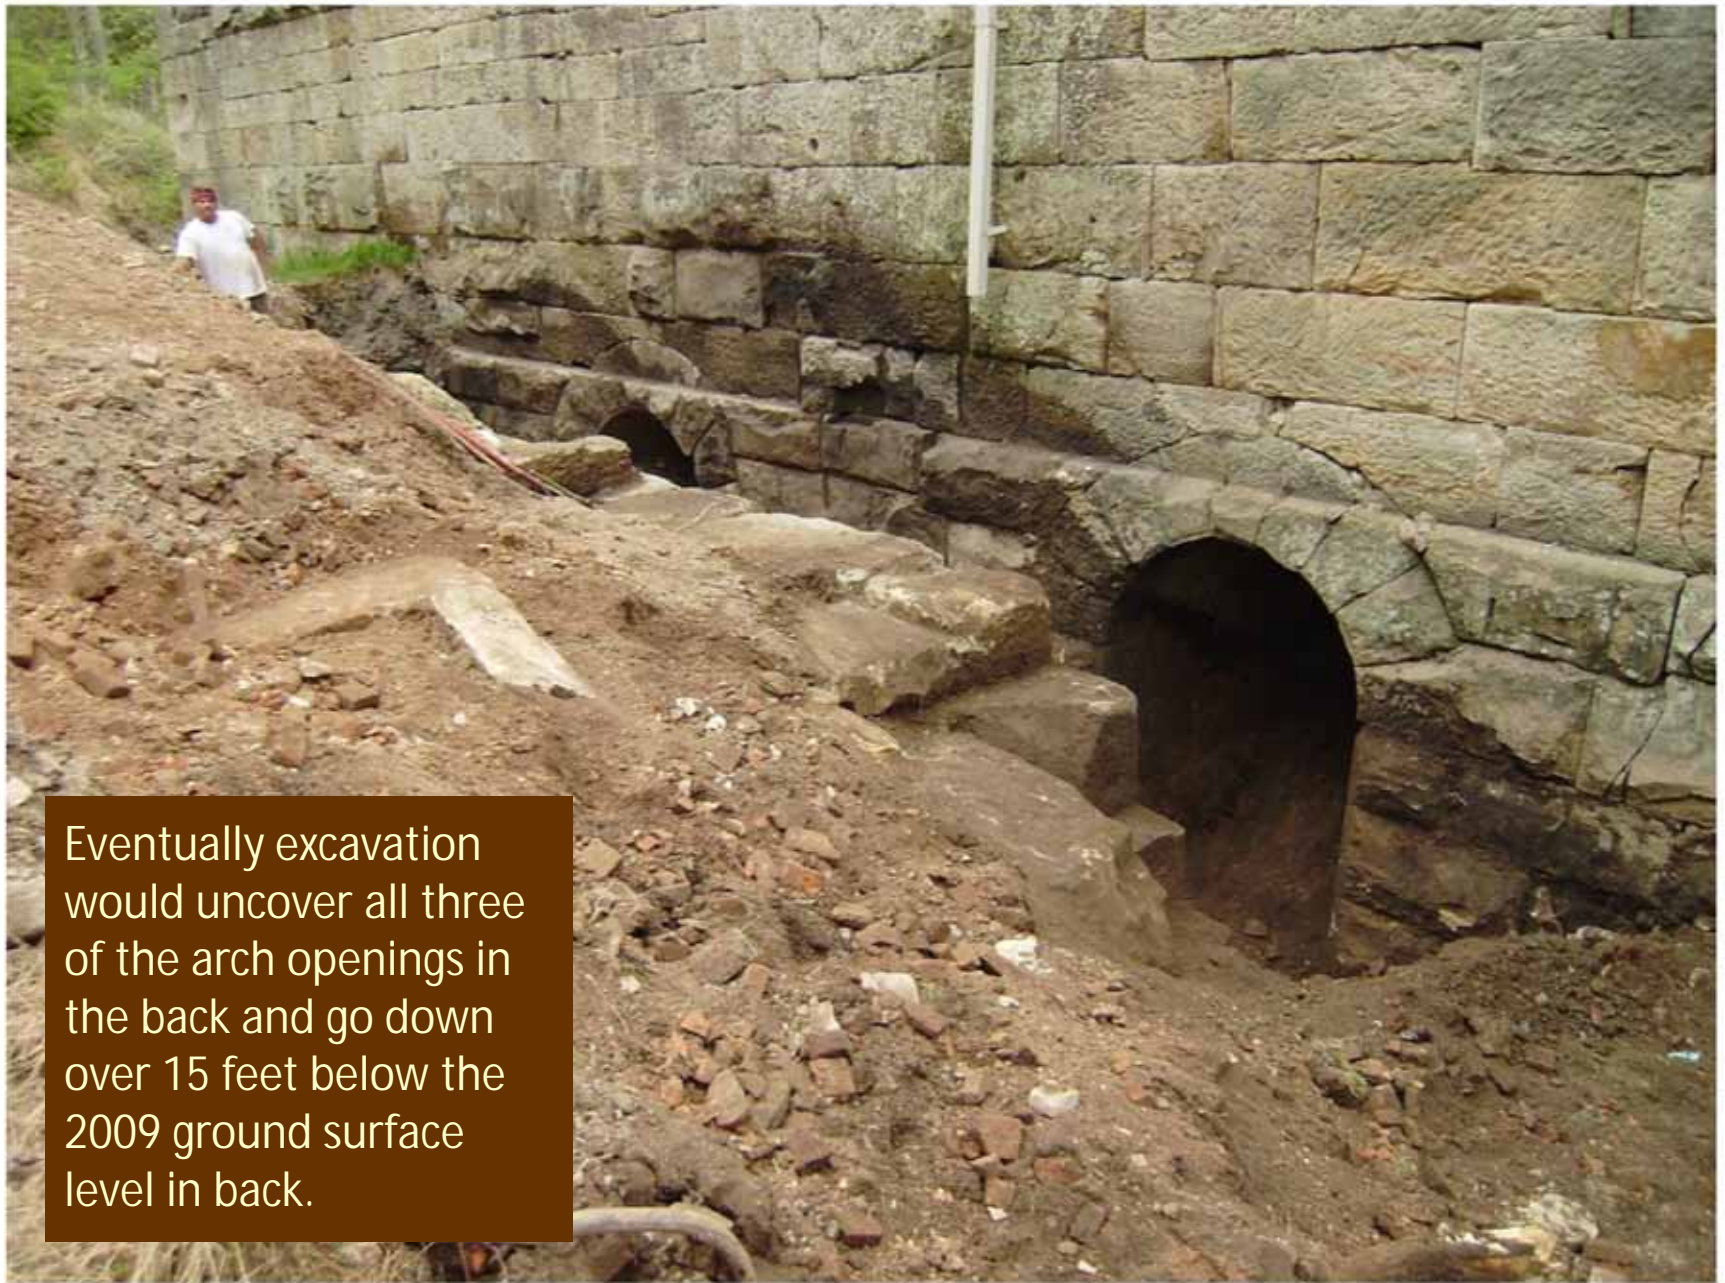
Eventually excavation would uncover all three of the arch openings in the back and go down over 15 feet below the 2009 ground surface level in back.

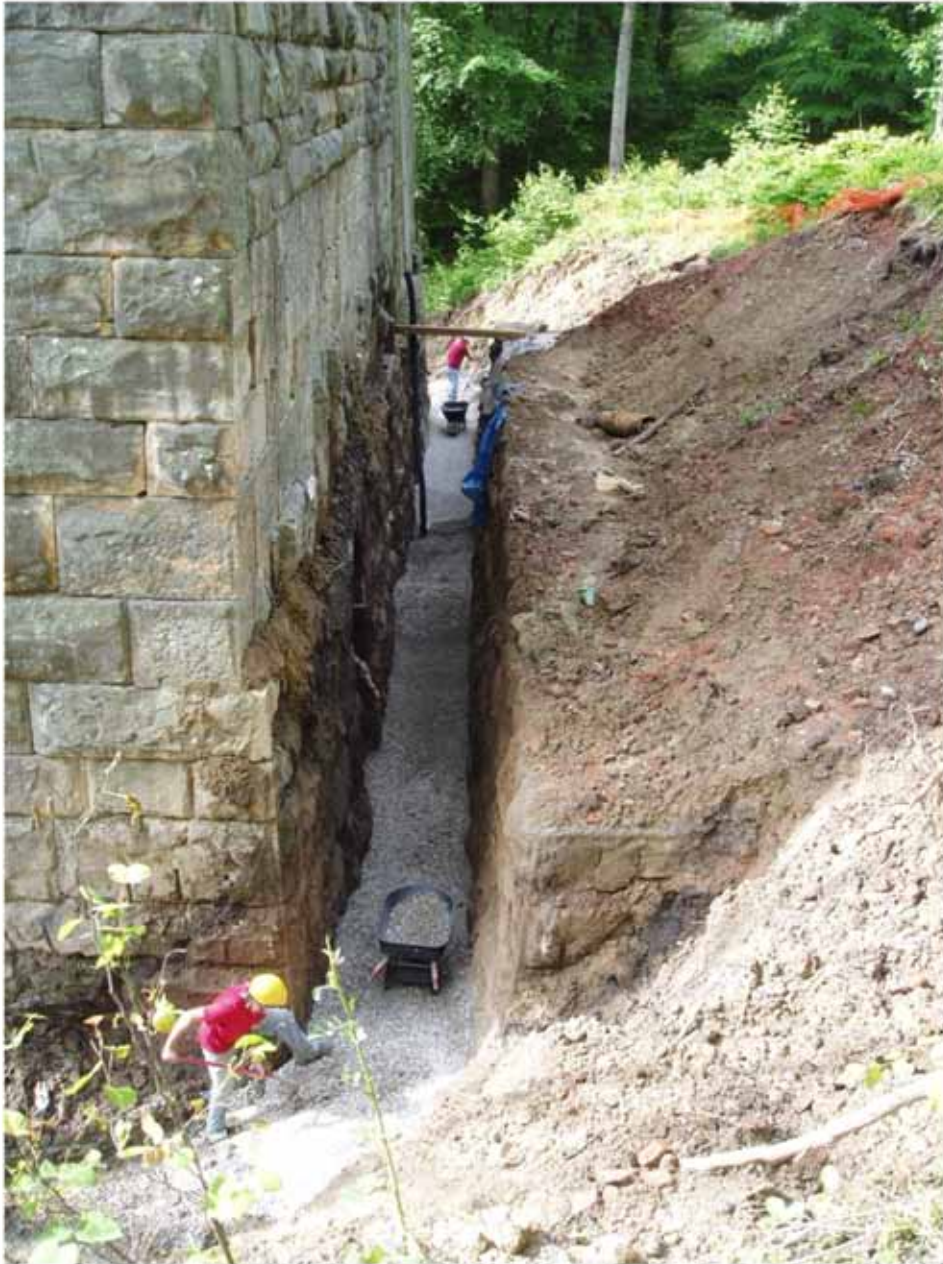
The natural spring was permanently diverted to the south. The trench remains open to allow visitors to see the newly uncovered foundation of the power house and back of the furnace.

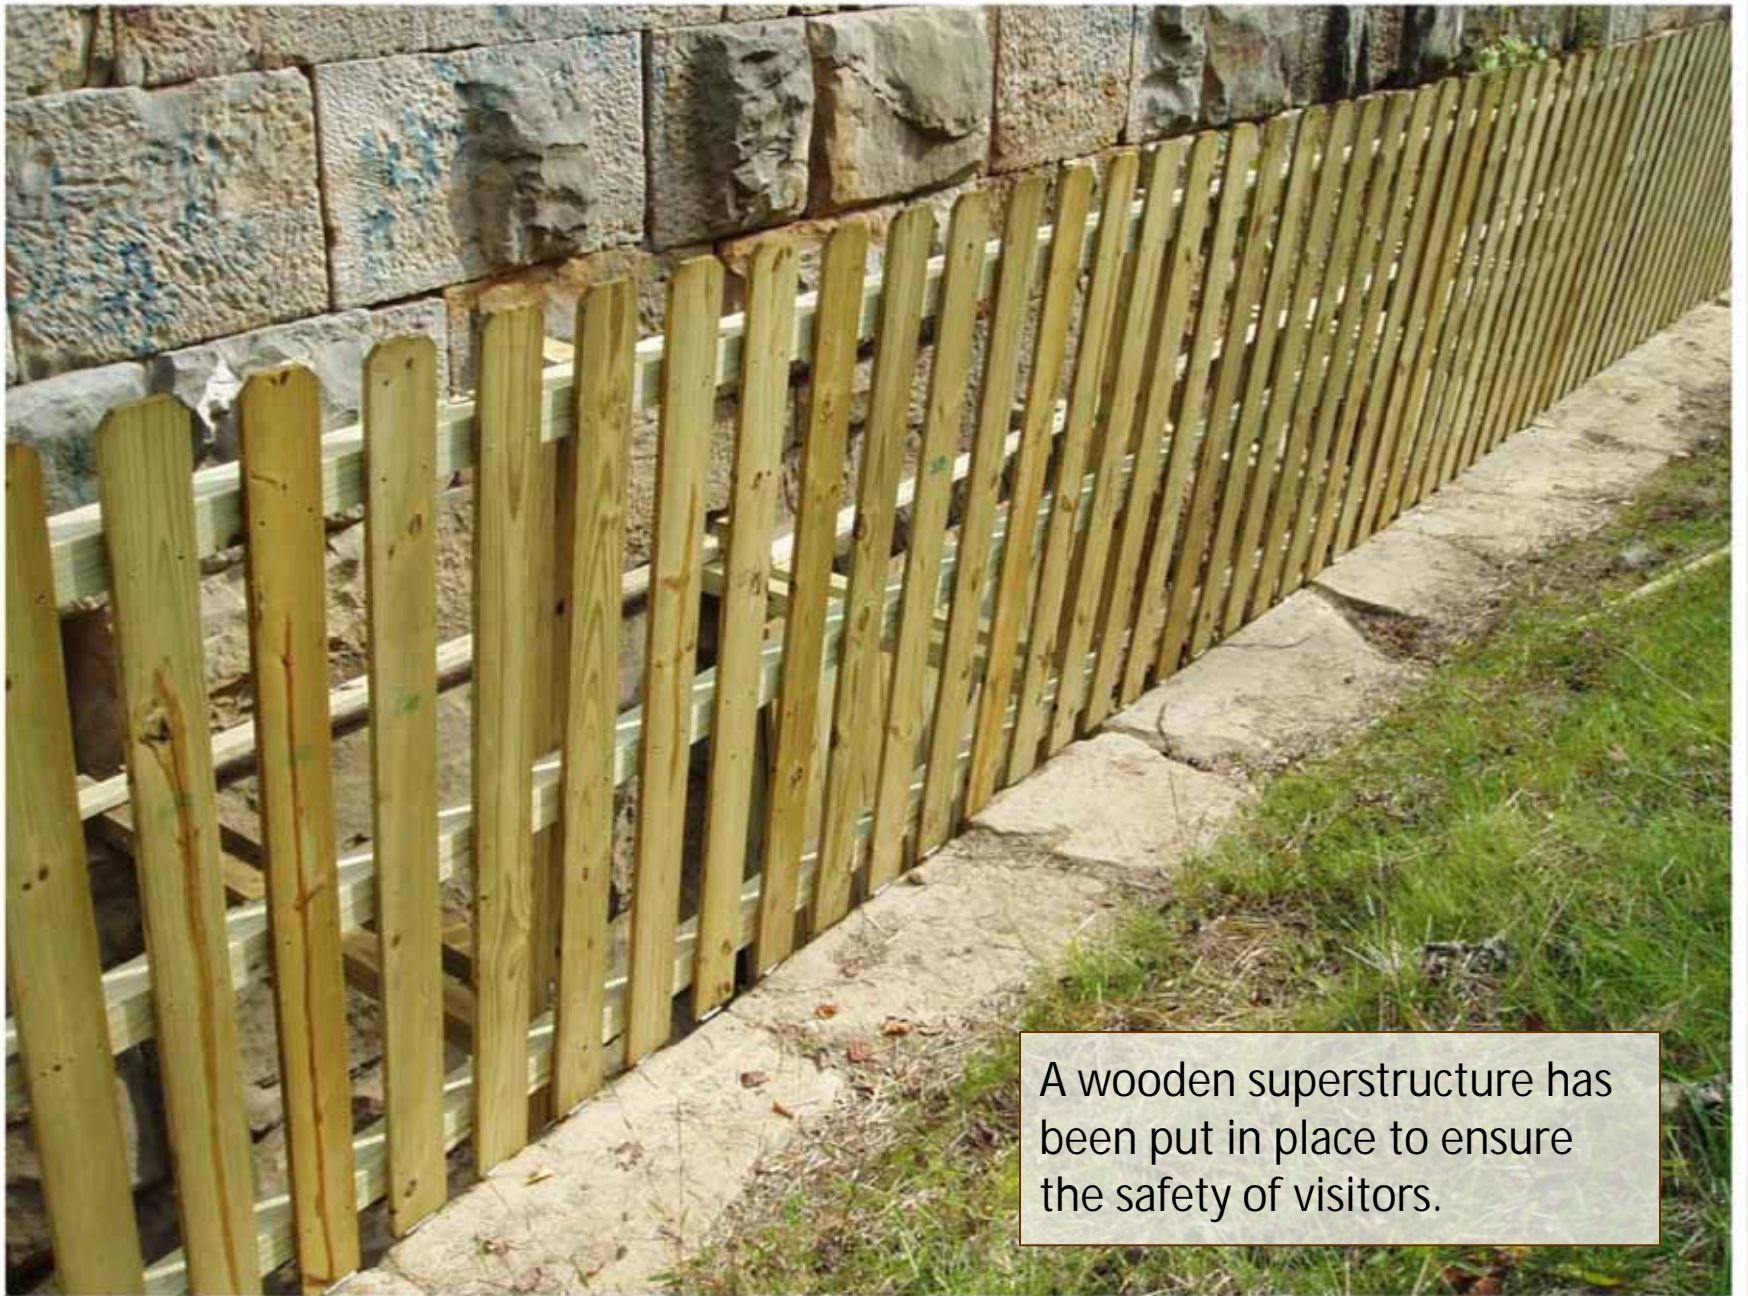
A wooden superstructure has been put in place to ensure the safety of visitors.
