Fitchburg Furnace: Past Achievements and Future Goals

Built in 1868 and acquired by the Daniel Boone National Forest in 1973, the Fitchburg Furnace is a double-stack, steam-blast iron furnace. One of the largest charcoal-fired furnaces ever built and the only twin stack furnace in the world, it now stands a monument to its creator and the historic iron industry of Kentucky. Though it never achieved its full potential, the furnace remains a testament to the genius and determination of the designer, Frank Fitch.

Today, the furnace is a popular destination for tourists and school groups. Since 2004, the Forest Service has been working to stop the decline of the massive structure and to improve access for the public. This work has resulted not only in the stabilization of the furnace, but also in the discovery of additional foundations and some of the original machinery that forged cast iron from local ores. While the restoration work completed to date will help ensure the long-term survival of the impressive structure, additional plans are being shaped to develop improved interpretation at the site.

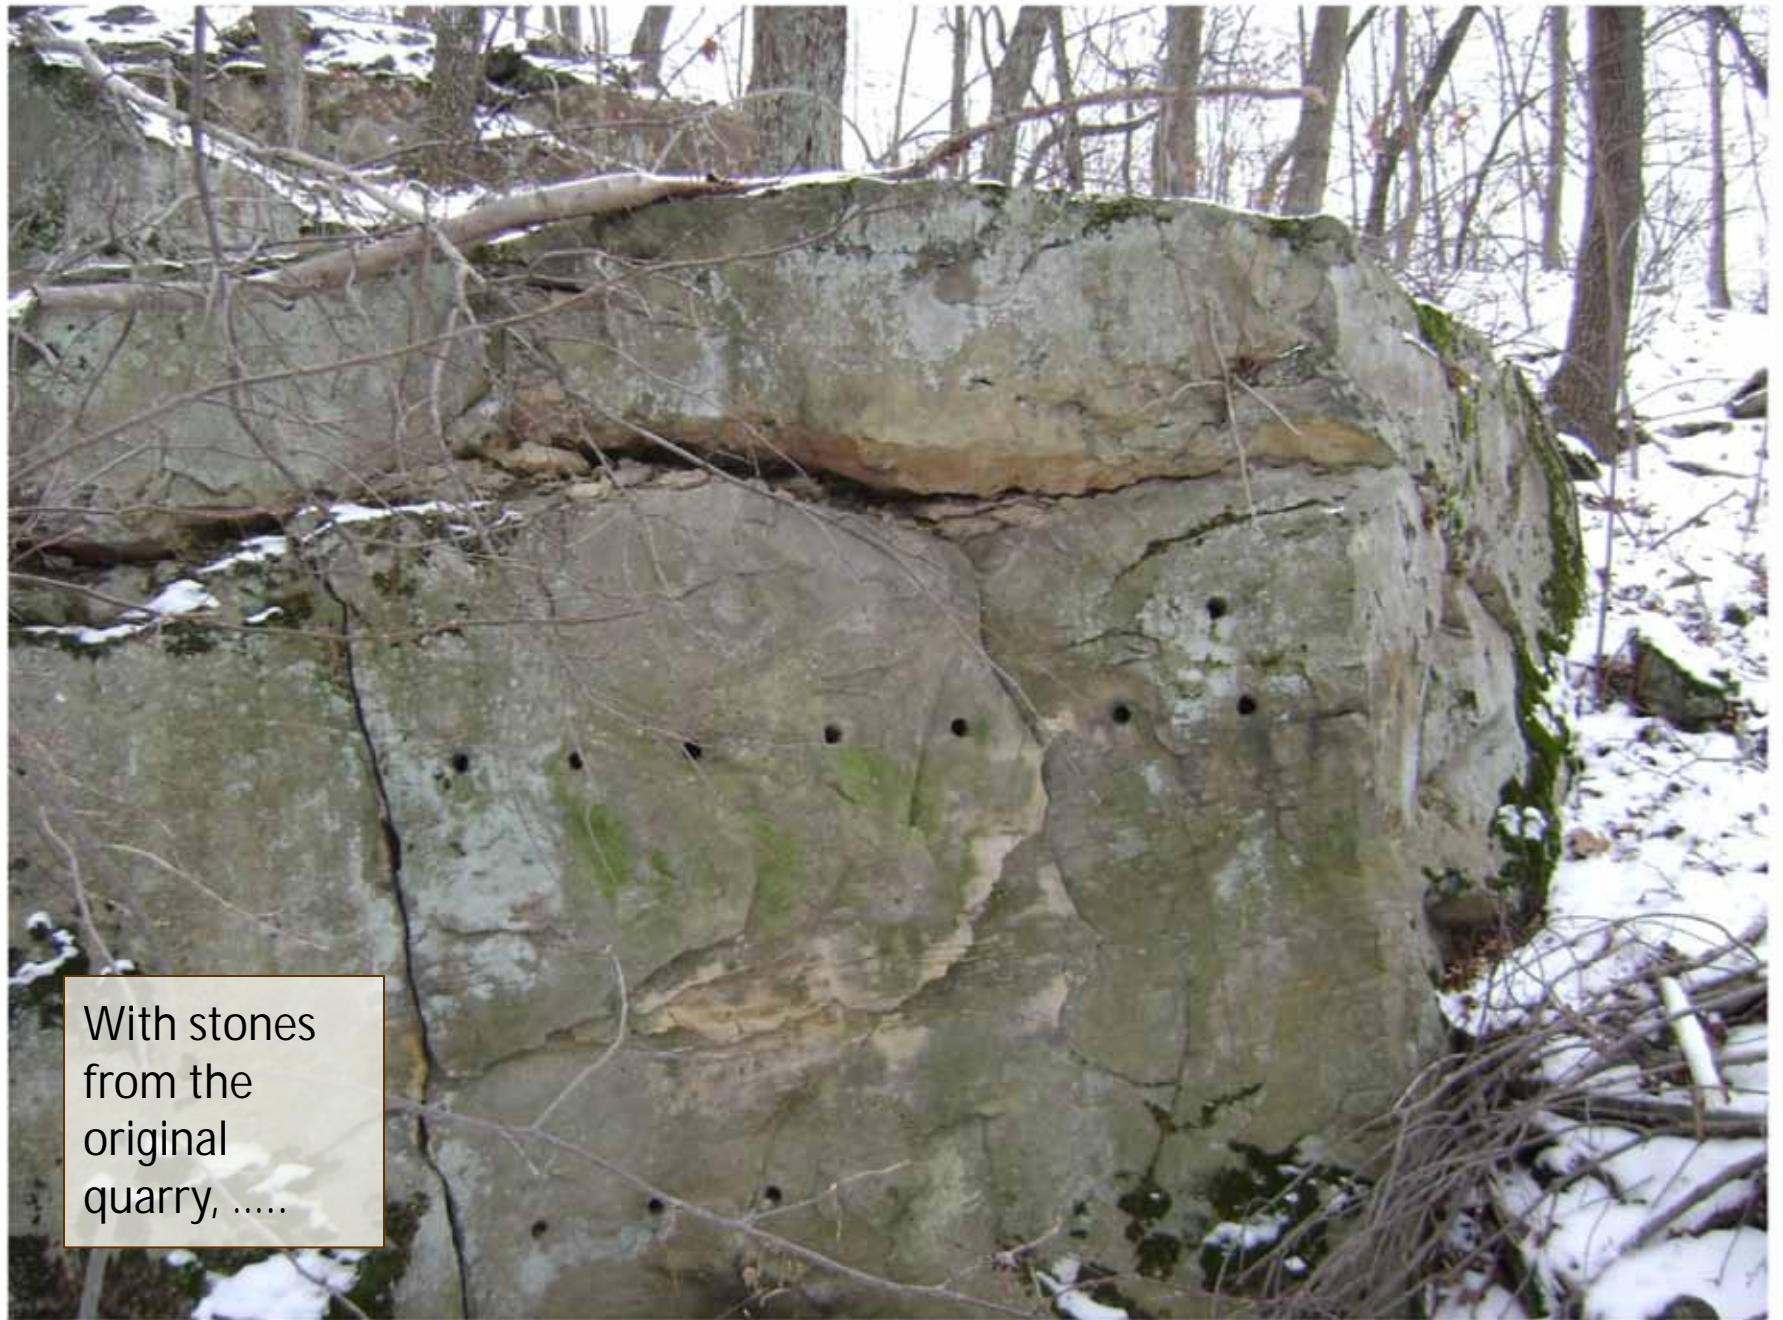
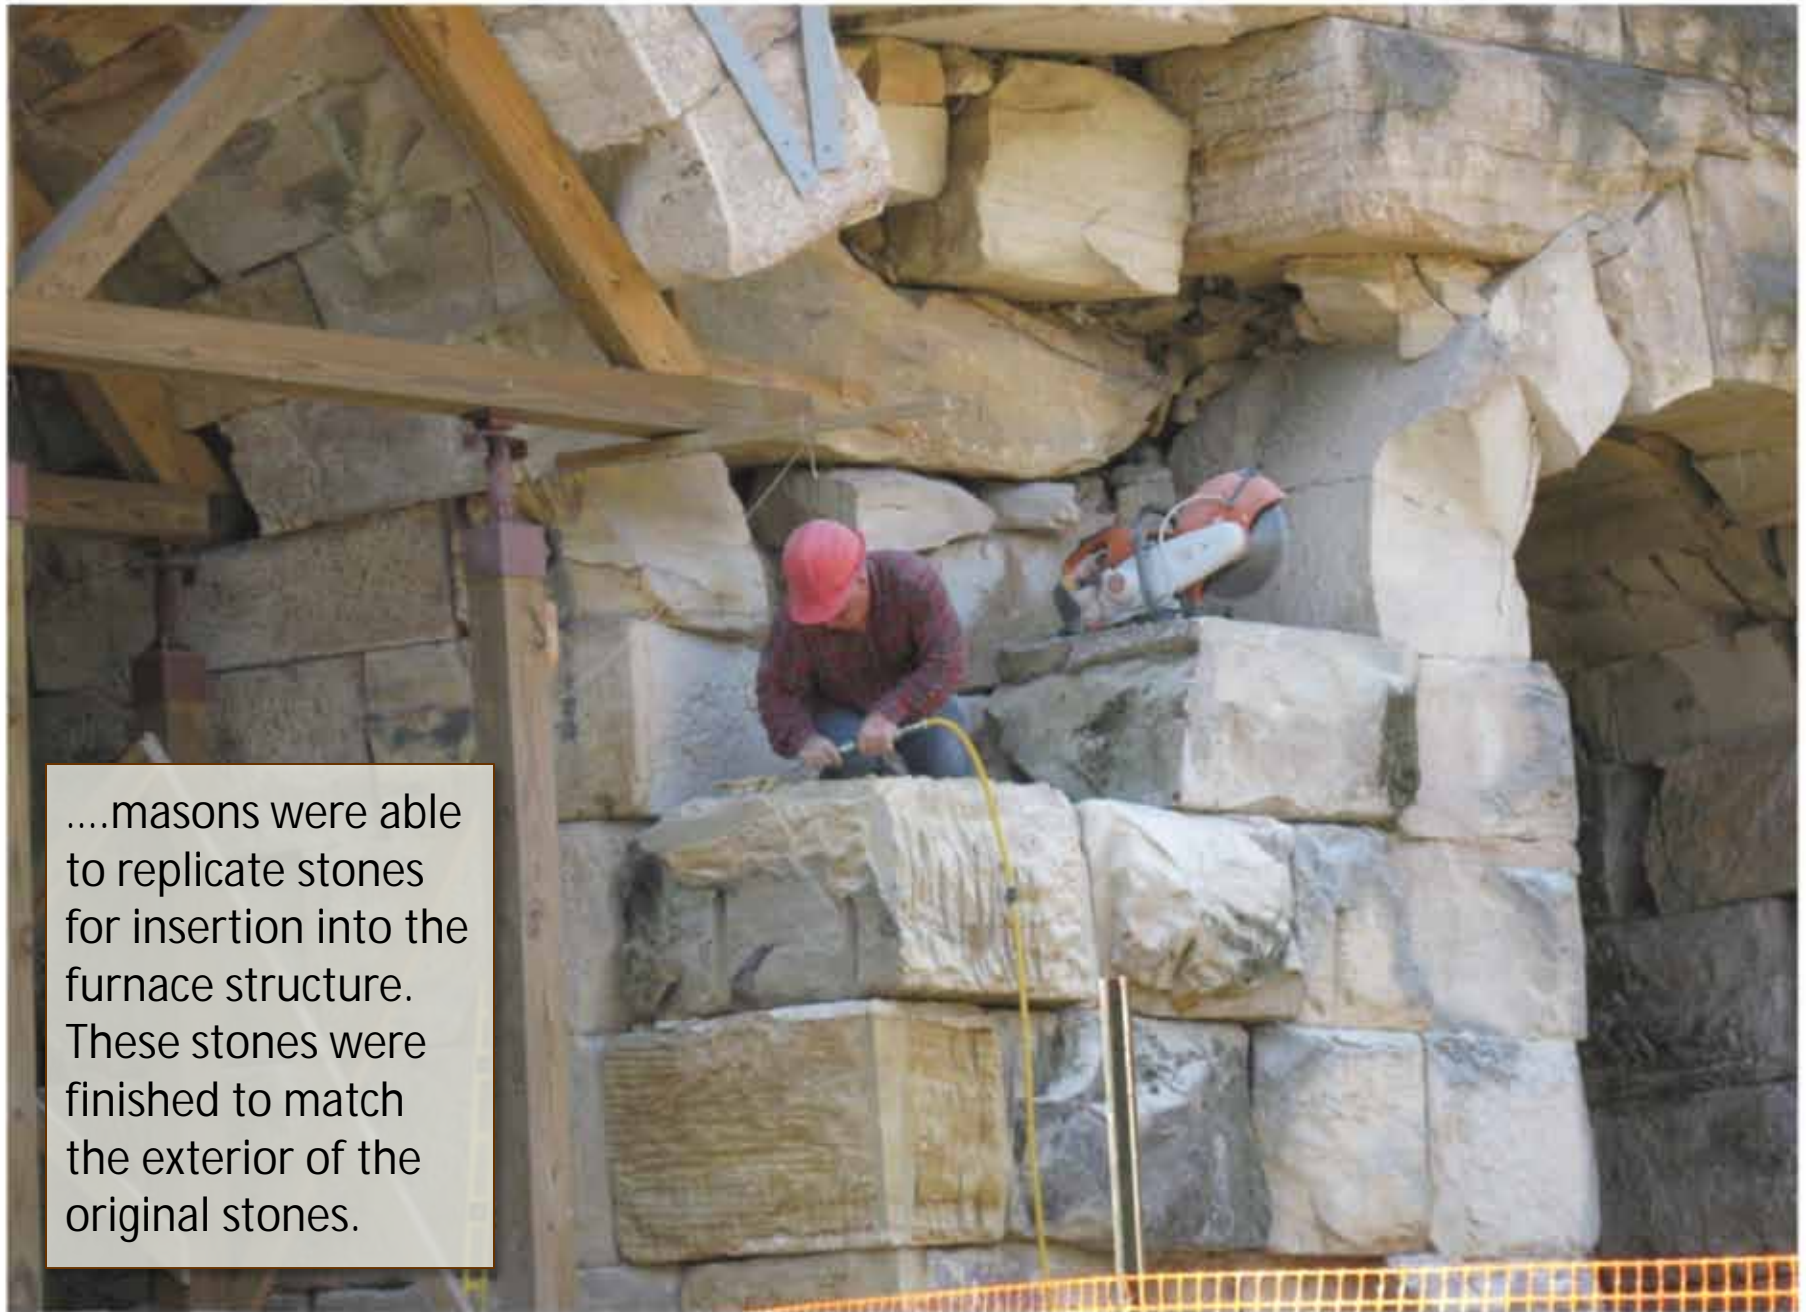
With stones
from the
original
quarry,

....masons were able to replicate stones for insertion into the furnace structure. These stones were finished to match the exterior of the original stones.

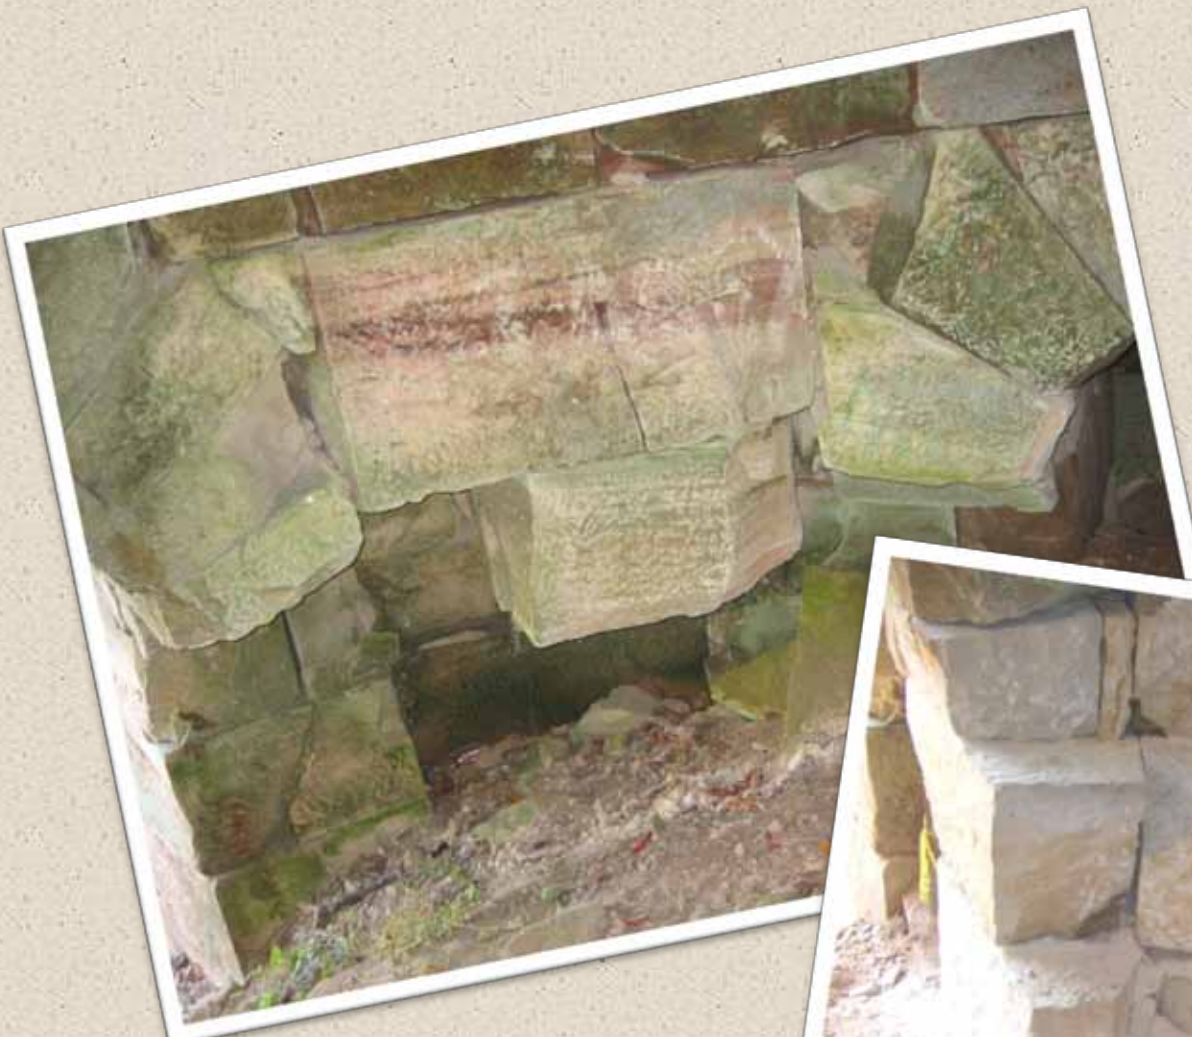
Before and after stone restoration

Some additional excavation was conducted inside the south stack to inform the placement of stones inside the north stack.

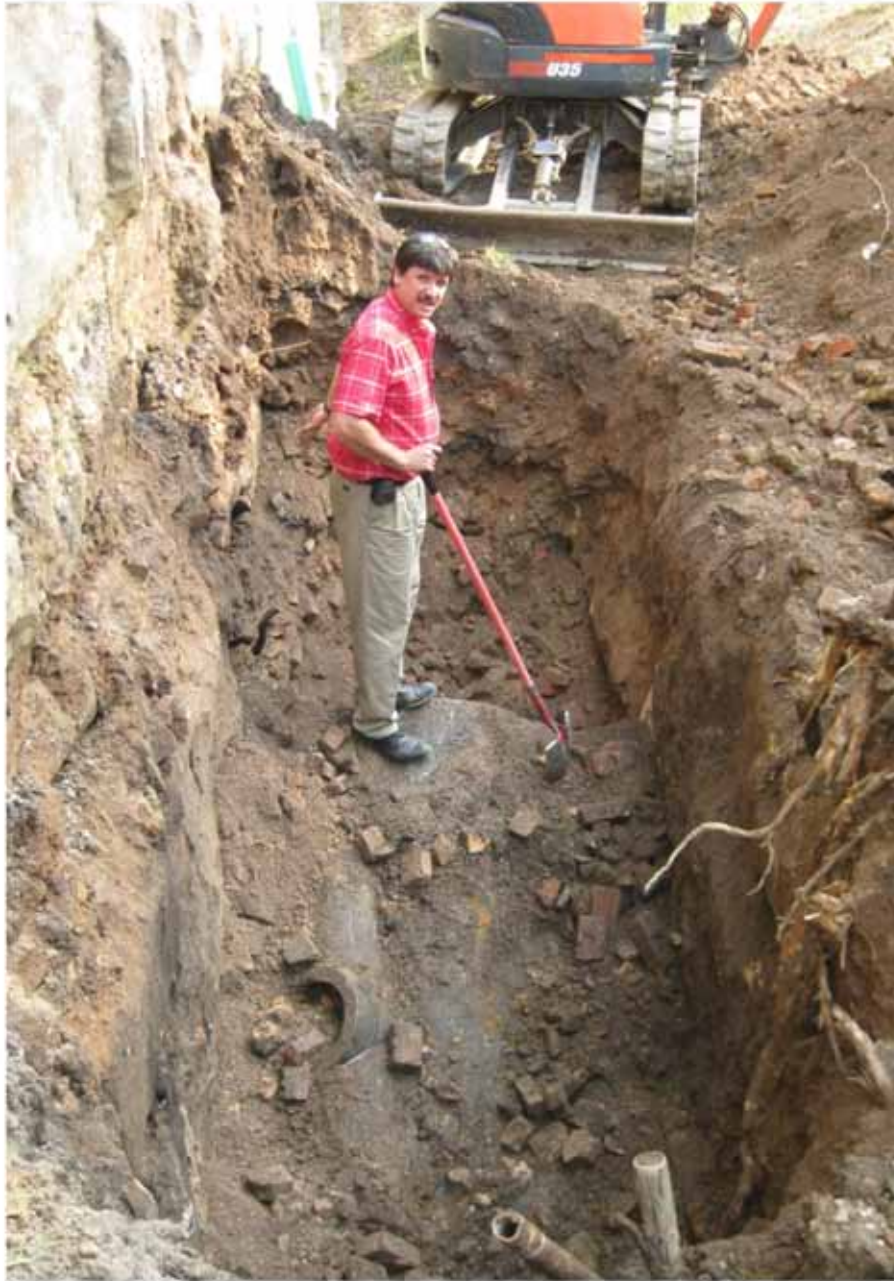
Boiler

A large amount of machinery and piping was recovered from the excavation in back of the furnace. Many of the pieces were impossible to identify and all were simply fragments of larger pieces.

However, recognizable pieces include a boiler tank,.....

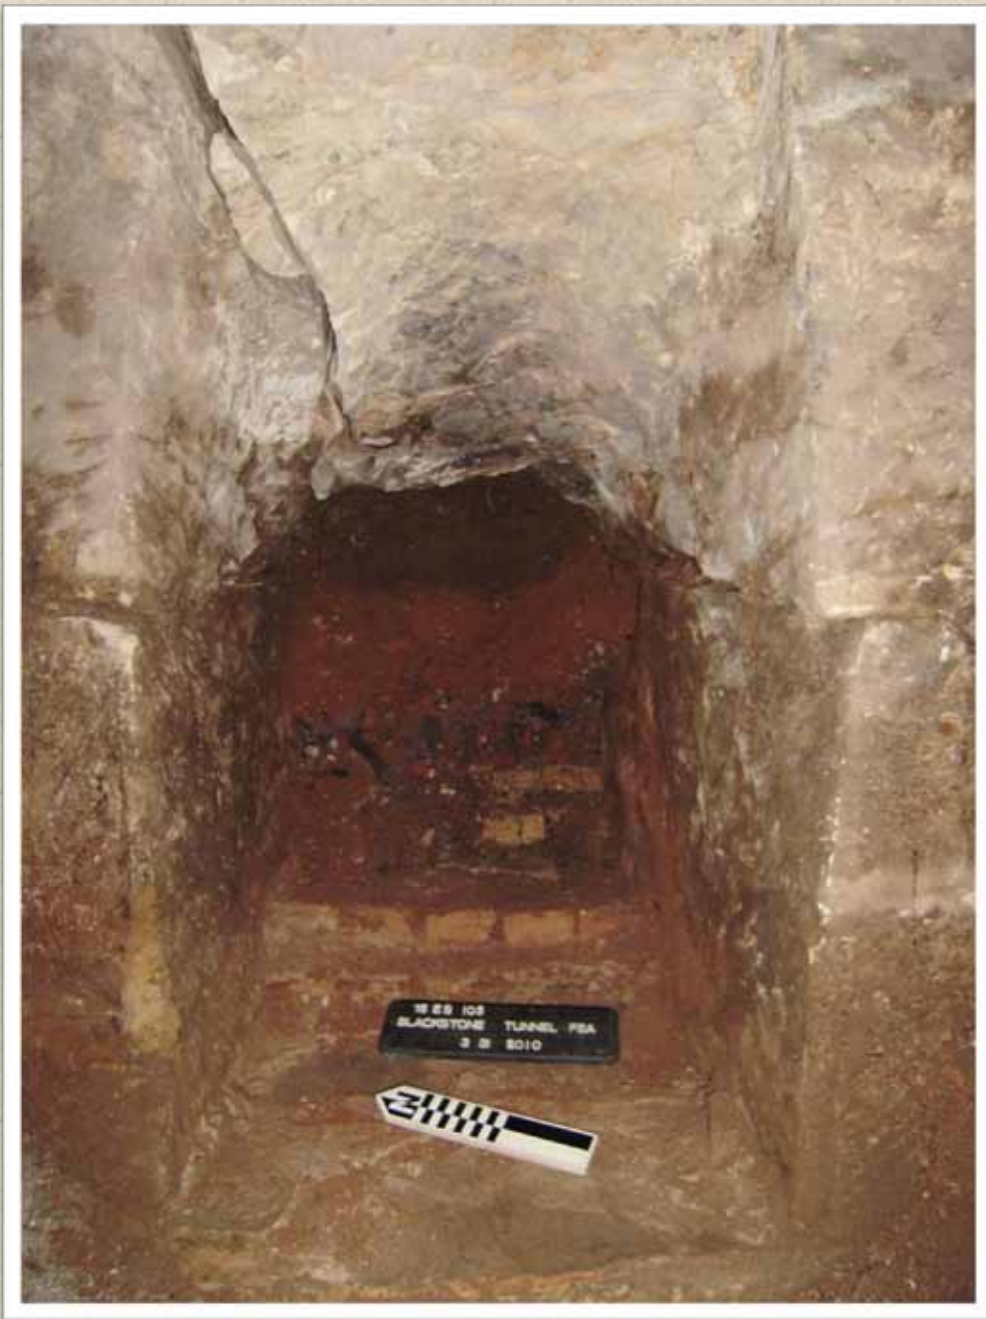
Tuyere Openings

Excavation inside the stacks in preparation for stone work also revealed new information. Several bricked up openings were discovered in the channel surrounding the interior crucible. These openings were likely where the tuyere blasted air into the stack.

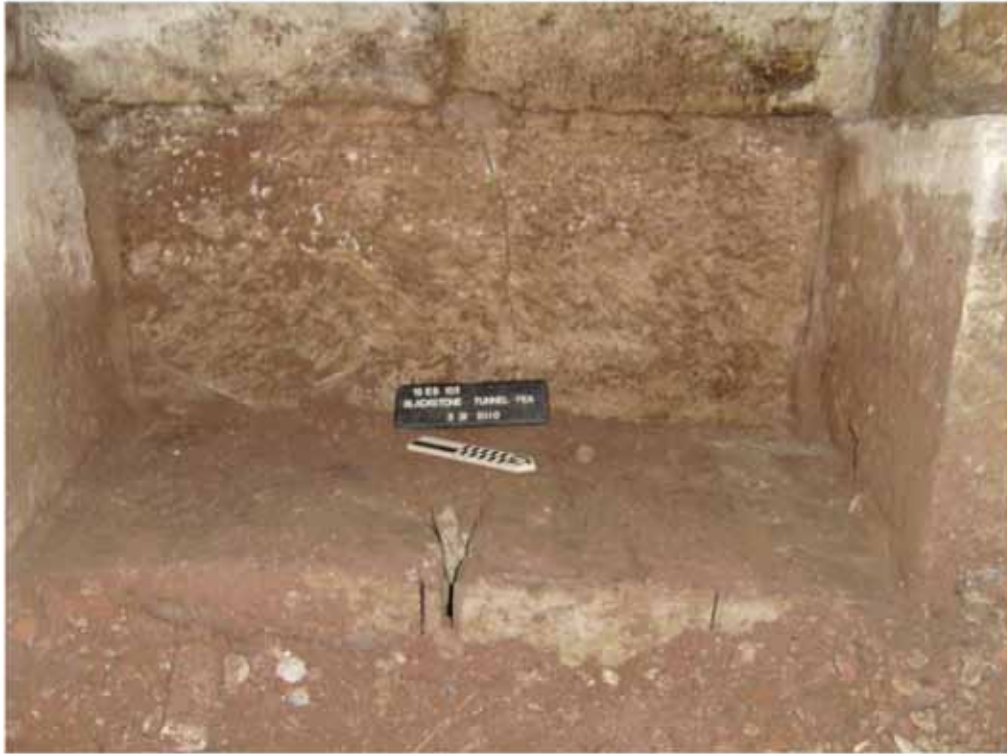
Niches

Everywhere we turned, we began to see niches carved into the stone structure of the furnace. They were in the stacks, in the powerhouse wall, and in the tunnel surrounding the stack where the bustle pipes were once located. There was once much more to see at the furnace, and we believe these niches held beams and supports for all of the piping that once encircled the furnace.

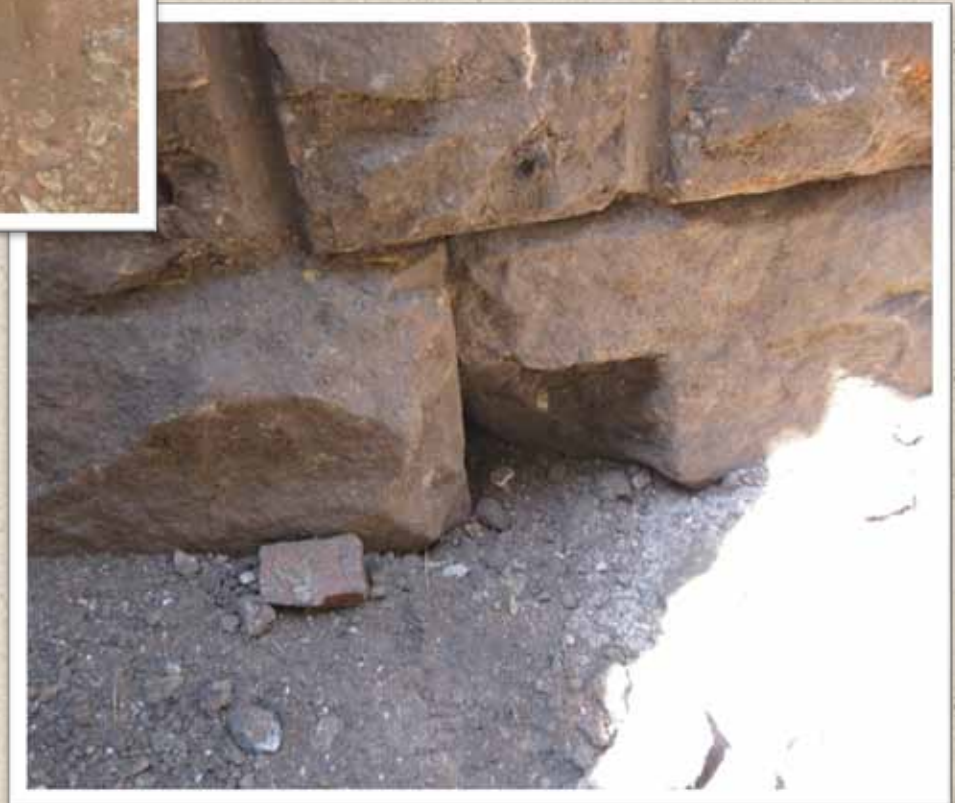
Power House Foundation

It also became very apparent that much of the foundation of the power house remains in place, just below the surface and running uphill behind the furnace.

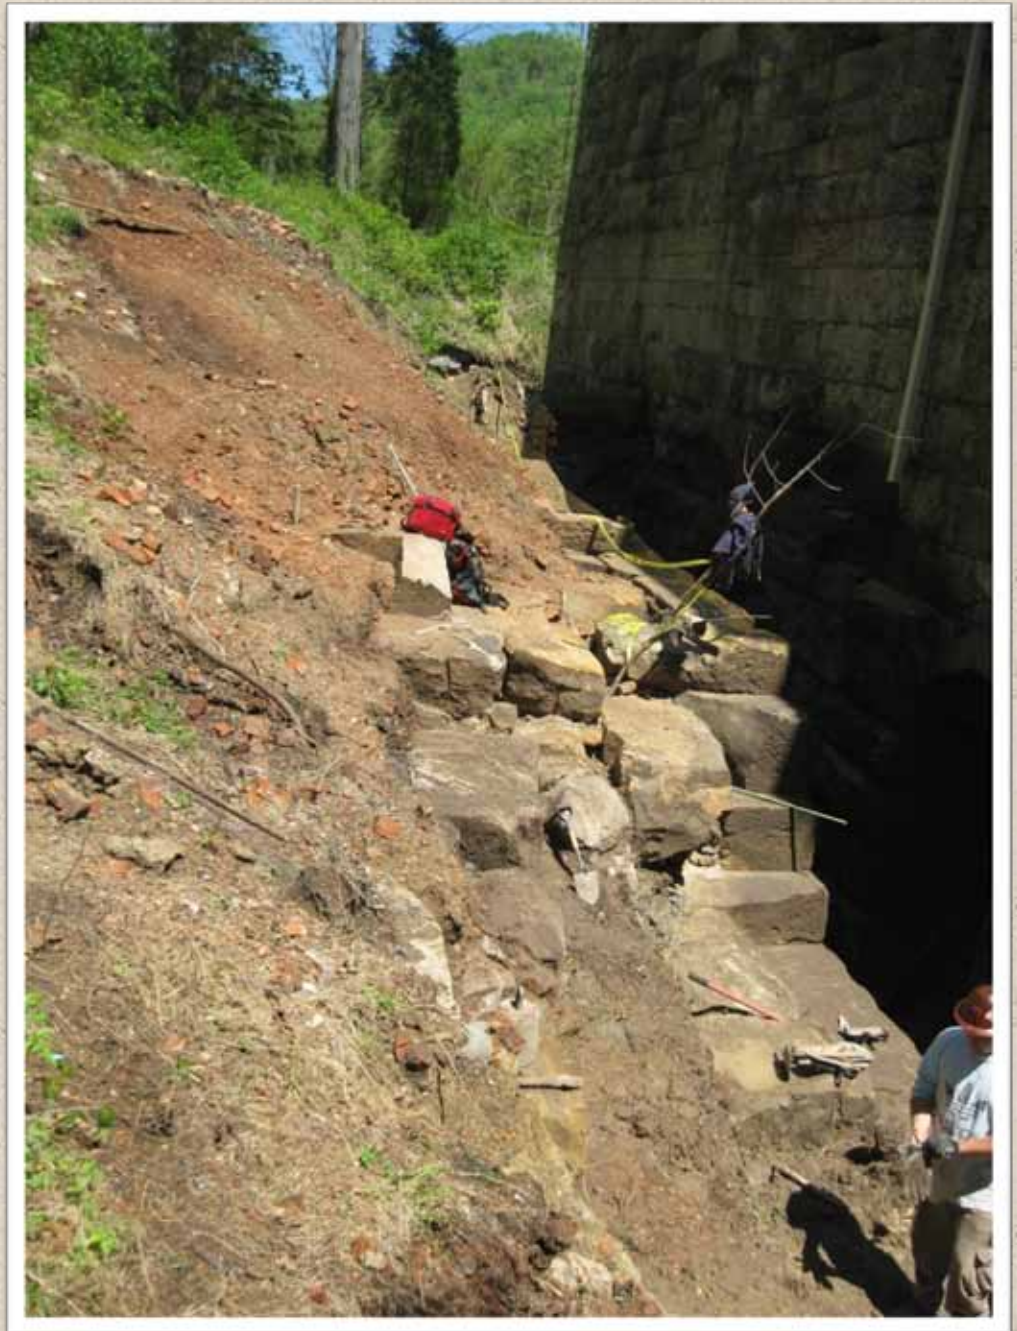
Additional Missing Stone

Excavations were carried out around the stones to be replaced. In several cases, we found more missing stones below the ground surface. The south arch of the northern stack was especially challenging as stone was missing for more than 3 feet below the current ground surface. Another loose stone was encountered in the south stack when soils were removed from a rear archway. That stone has now fallen from its place and additional stabilization measures are being designed for that area.
