Trail River Landscape Assessment

Prepared by the
U.S. Department of Agriculture
Chugach National Forest
Seward Ranger District
2008

**TRAIL RIVER LANDSCAPE ASSESSMENT
2007**

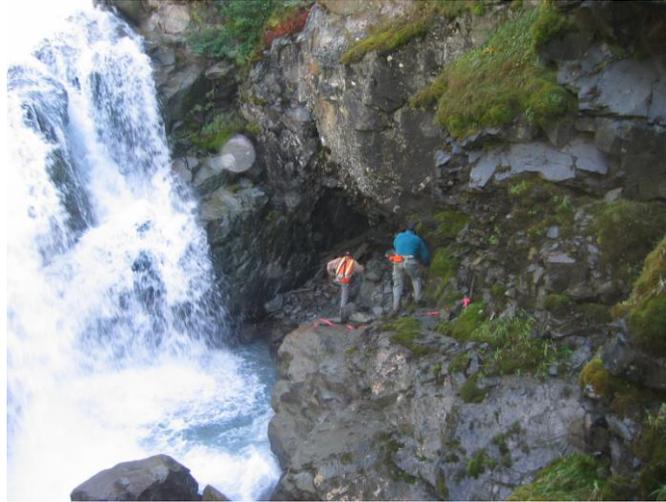
Figure 3.1 – Falls Creek Mine adit.

Because there are mine workings in the Trail River Watershed that have been inactive for many years, there are safety concerns regarding public entry of these old workings (See Figure 3.1). Over time, un-maintained mine workings can become extremely unstable and dangerous. Easily accessible and highly visible mines can pose severe hazards. Unstable workings, abandoned unexpended explosives are commonly found at old mines which can be highly dangerous to move or even touch.

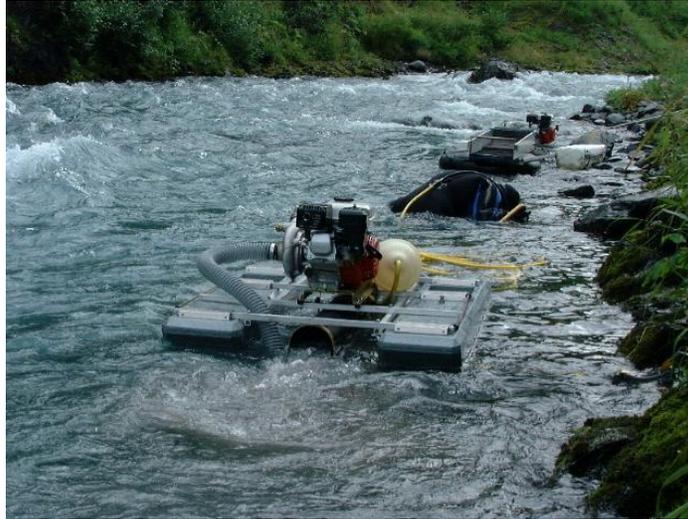
Figure 4.2. Suction dredging

Although there are both lode and place mining claims within the Trail River Watershed, little active mining is occurring and that which is occurring consists of small-scale suction dredging and prospecting (Figure 4.1). Placer activity is primarily occurring primarily along Falls Creek although some suction dredging and gold panning may occur on other streams throughout the Trail River Watershed. Prospecting and sampling for lode gold is occurring at and above Falls Creek, at the Case Mine in the Grant Lake area and in the Crown Point Glacier area. Most of the suction dredging, hand sluicing, and gold panning activities are conducted under a notice of intent rather than a plan of operations. A plan of operations is only required where operations may cause significant disturbance of surface resources (Figure 4.2).

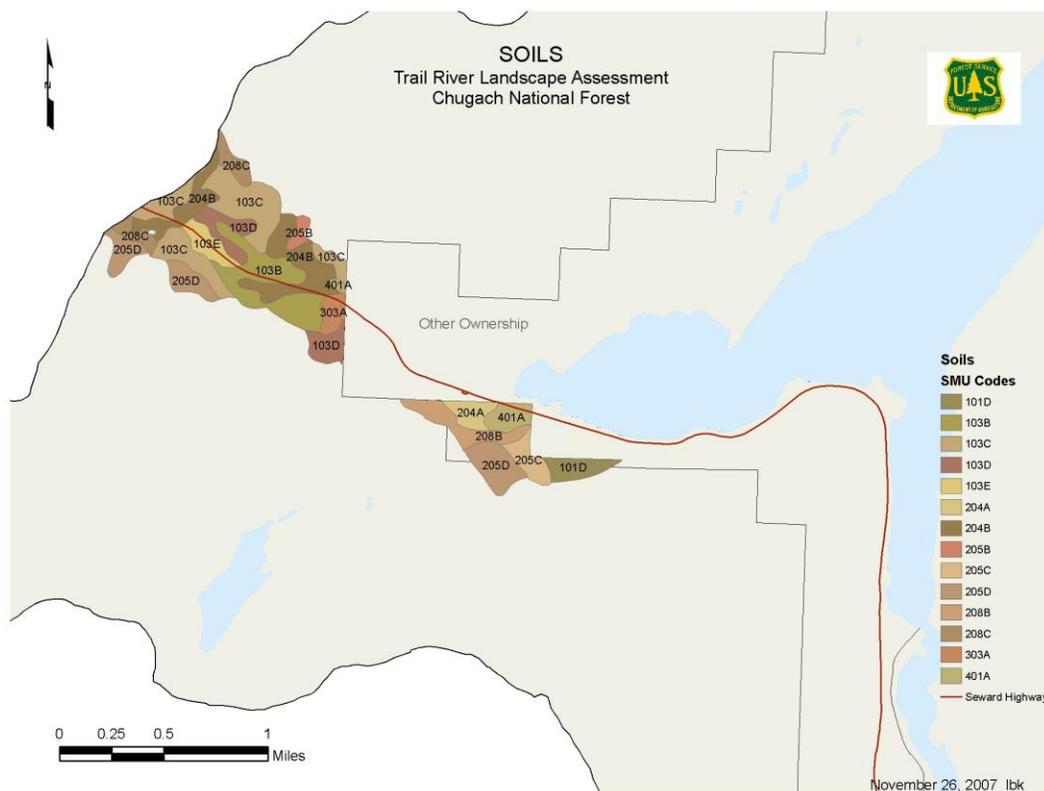
Figure 4.2.4. Mapped Soil Types in the Trail River Watershed.

utilizes this material. Most of the Forest, including the assessment area, lacks both descriptive and quantitative soil type mapping at any scale. The soil type scale would be needed to assess any project that may be proposed within the area. Figure 4.2.4 displays what is currently known and mapped within the watershed from the Forest GIS database. There are 483 inventoried acres out of the 124,406 assessment area. This is from work that was done by Dean Davidson in the Kenai road corridor. Some work has been done by the NRCS on the tip of the Lower Kenai near Homer, but it does not cover any of the assessment area. An electronic version of this older project has not been found, so rather than paste a scanned copy of the map legend that is not that good, please reference the hard copy for the legend and the map unit descriptions: Kenai Road Corridor Soil Survey (1989). A copy can be provided on request. This Survey does not meet Terrestrial Ecological Unit Inventory (TEUI) standards for soils (2005), or National Cooperative Soil Survey (NCSS) standards for soil inventory.

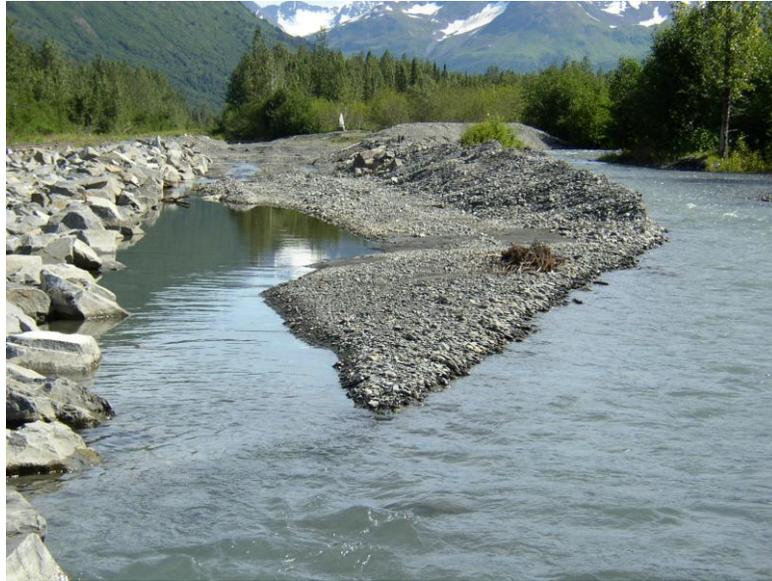
Figure 4.7. Newly constructed berm and rip-rap along the Alaska Railroad, Mile-36.6, August 2003.

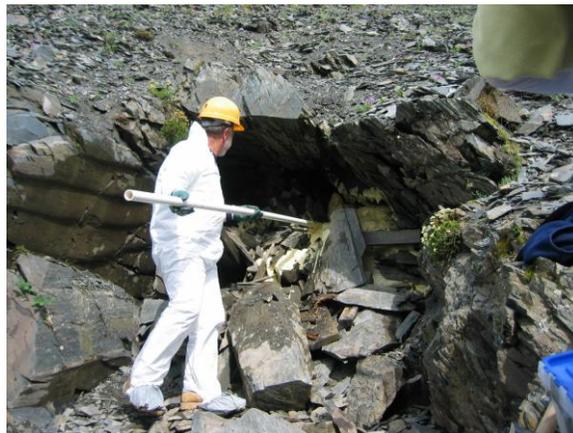
Figure 7.1. Foam closure of the Crown Point lower adit.
