# **WILDFIRE EFFECTS EVALUATION PROJECT**

## **APPENDIX E: CULTURAL SITES, ROADS, TRAILS AND BURNED AREA EMERGENCY REHABILITATION (BAER)**

### **UMPQUA NATIONAL FOREST**

April 2003

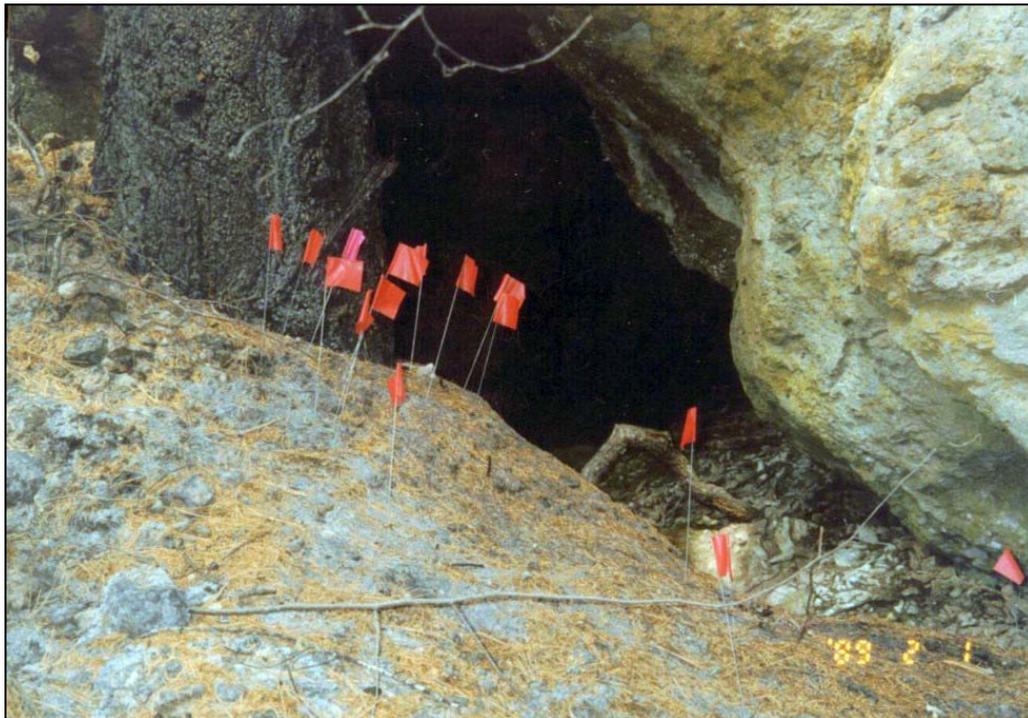
**Figure 1E: The area surrounding rockshelter 35DO619 was burned. This site can be seen from the road increasing the potential for looting and the outer rim of the shelter will be subject to increased erosion.**

Fragile archaeological sites include rockshelters, which where rock overhangs or shallow caves that served as shelters. Rockshelter (35DO212), located within the burned area, is one of the most important prehistoric sites so far investigated in western Oregon. This rockshelter has the largest assemblage of perishable artifacts recovered from an archaeological context in the region. At least three recorded rockshelters have been burned and impacts to these sites are being assessed. The impacts will include possible burning of the cultural deposits, erosion of the outer berm, and increased visibility that may lead to further looting.

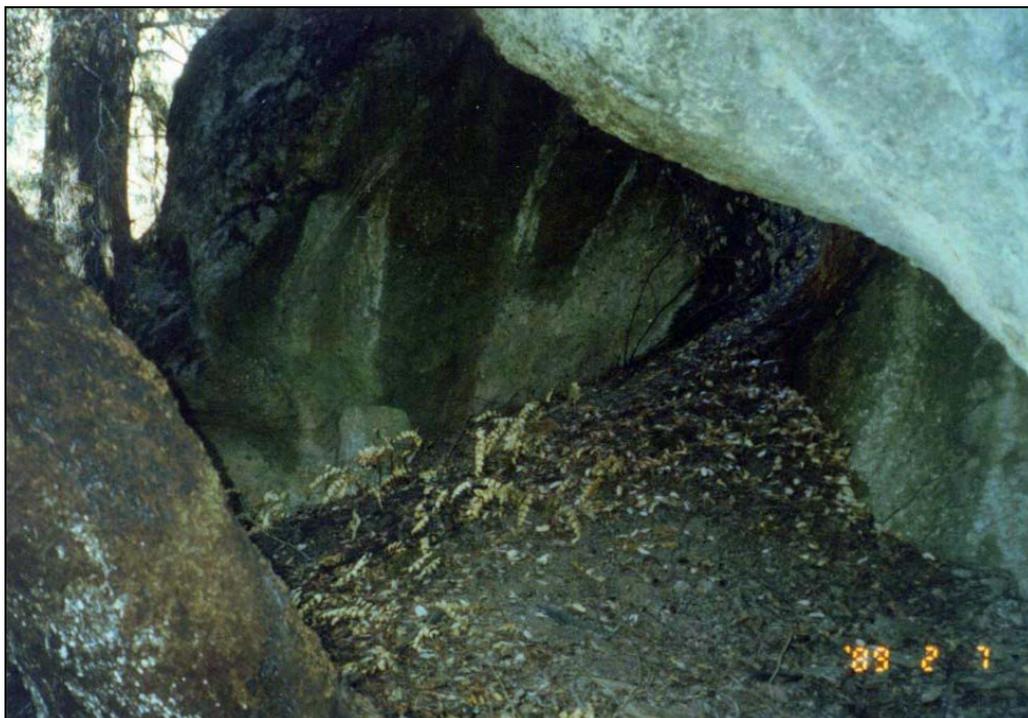
**Figure 2E: The interior of Rockshelter 35DO339 was burned possibly impacting the cultural deposits**

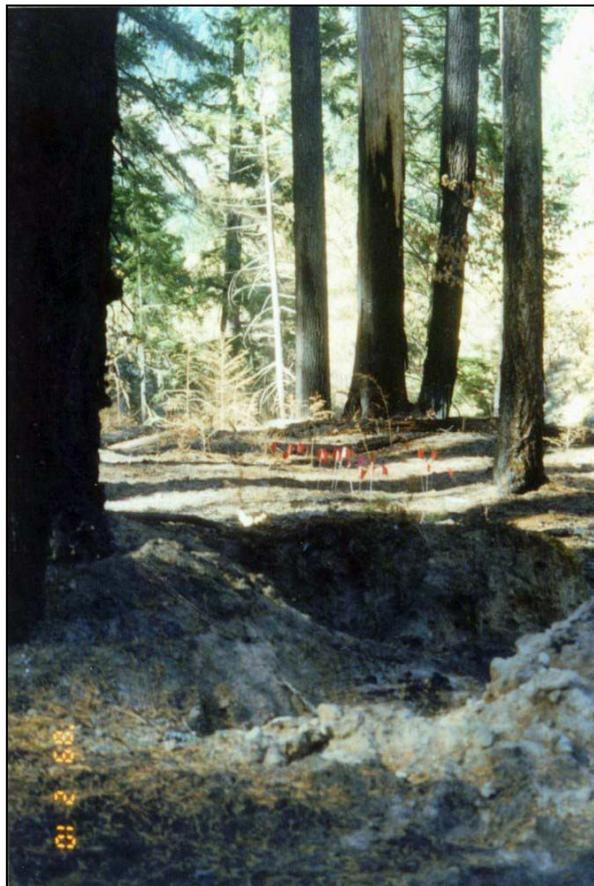
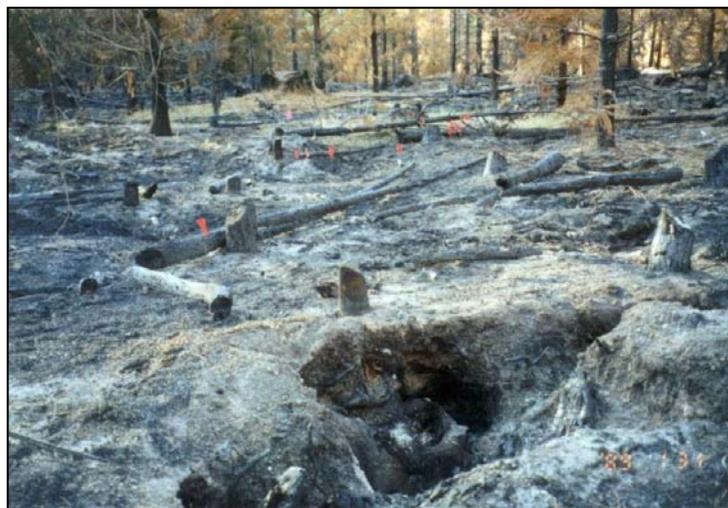
**Figure 3E (left): Lithic scatter site 15-02-363 was affected by both wildfire and fire suppression activities when dozer line construction impacted the site. Root casts left behind by the burn will collapse, threatening the integrity of the site. The site has increased visibility for looting activity.**  
**Figure 4E (above): Lithic Scatter site 15-06-194 showing a burned root that will increase erosion and threaten the integrity of the site.**

The effects of fire may also impact the integrity of lithic scatter sites. The burning of large tree roots leaves root casts within the archaeological deposits. These casts eventually collapse often resulting in a mixing of cultural components. Erosion will also occur that may affect the cultural integrity of the site. Increased surface visibility will intensify the potential for looting.

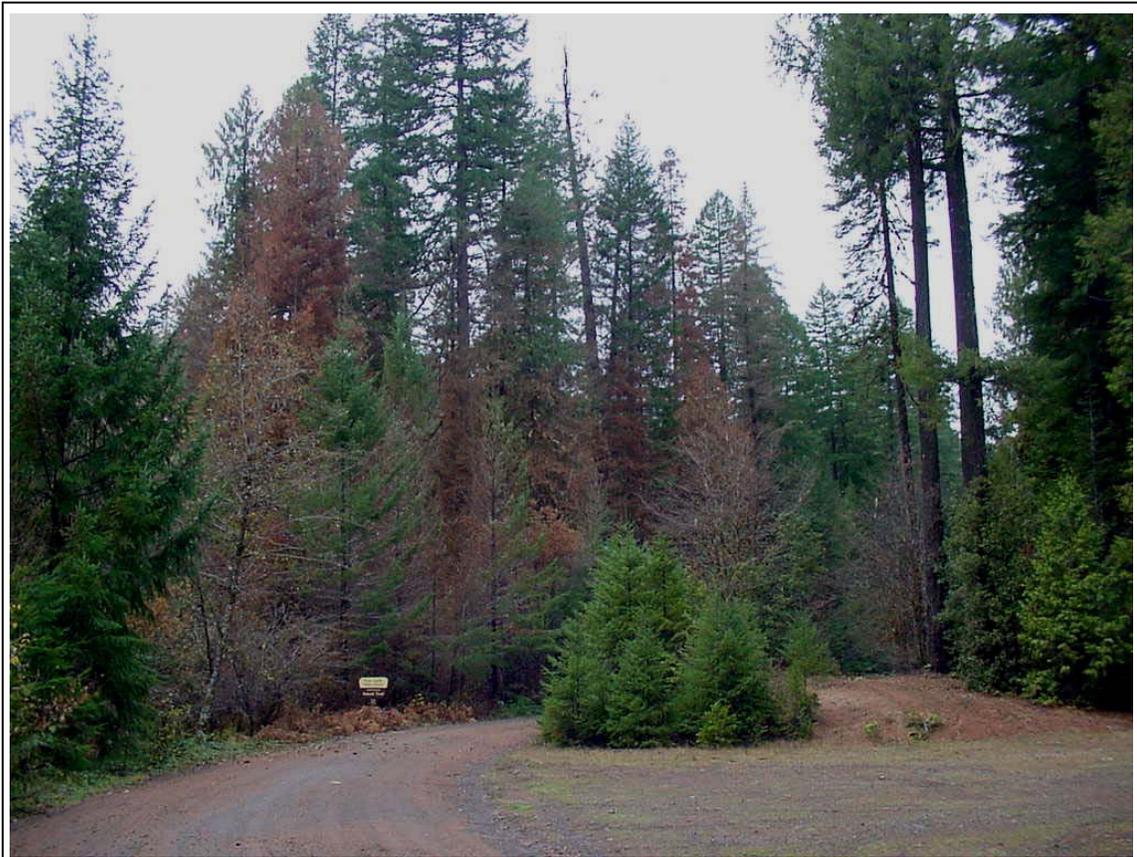
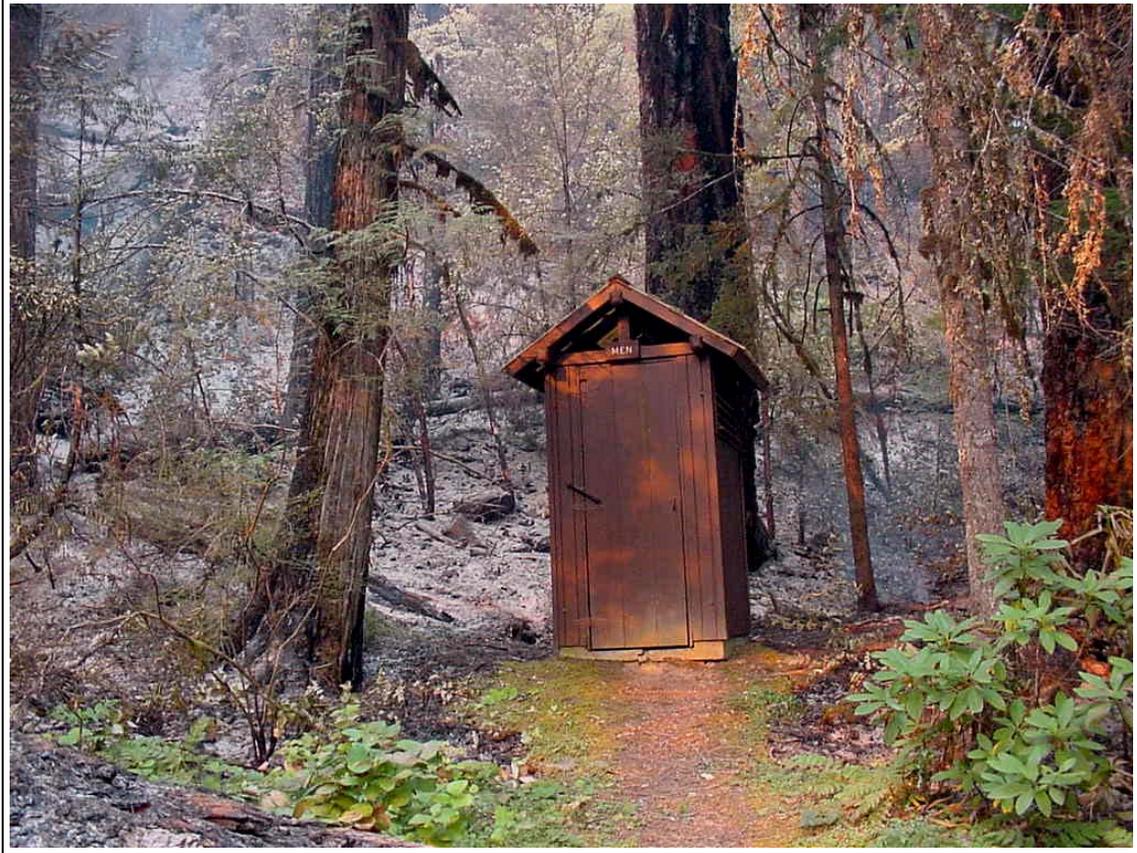
**Figure 5E: Fish Lake Trailhead after the Wildfire.**

The Big Bend Fire affected Fish Lake Trailhead, Beaver Swamp Trailhead, and Skimmerhorn Trailhead. The Boulder Fire affected Boulder Creek Annex Campground. Site facilities were not damaged, the primary effect was to vegetation.

Consideration should be given to long-term site management before falling large numbers of trees. It may be best to remove or re-locate facilities, rather than mitigate tree hazards for aging facilities that need replaced anyway.

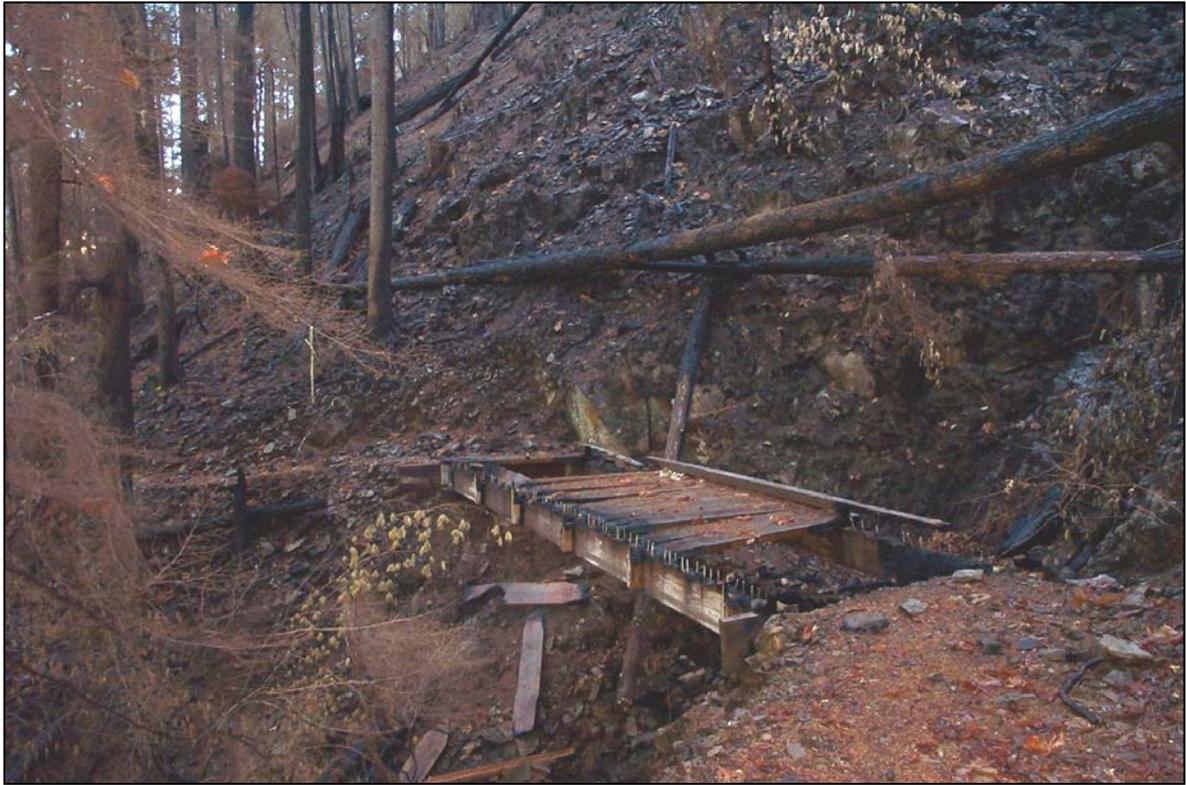
The Calf segment of the North Umpqua Trail received extensive impacts which includes 3,015 feet of rock slides, 58 trees larger than 11 inch diameter that are across the trail and an additional 15 trees standing that need to be felled. The fire also destroyed three trail bridges, which were 22, 25 and 26 feet in length.

**Figure 6E: Three Foot Bridges were Destroyed on the North Umpqua Trail**

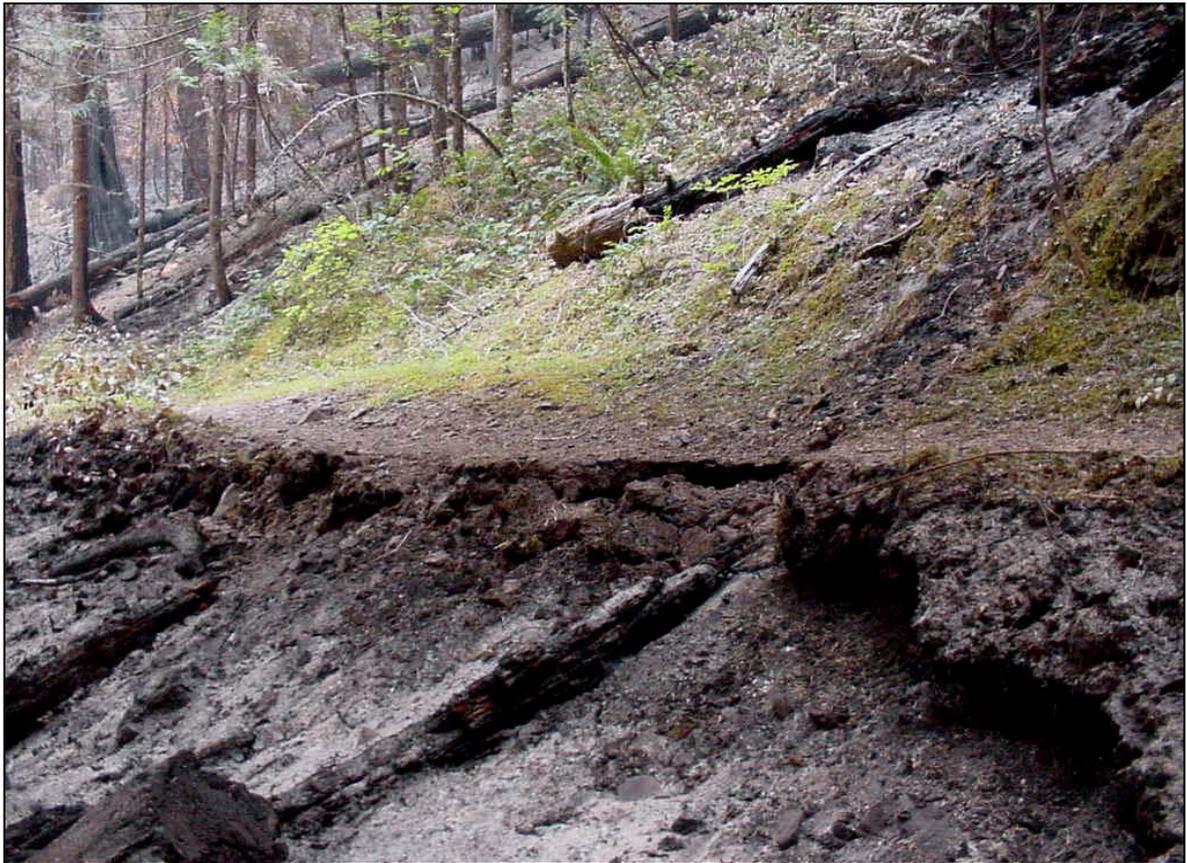
**Figure 7E: Undermined tread damage averages about one to two sites per mile.**

Other unknown, but predicted fire effects include slumps, slides, water runoff damage, and tread settling, especially in areas of high burn intensity. Tread repairs may not be possible and segments may need to be re-located. Costs to restore trails to standard may be as high as \$15,000 per mile. Log out in subsequent years is estimated at over \$100 per mile. Some areas will have dense brush and conifer seedling sprouting, which will affect future trail brushing costs.

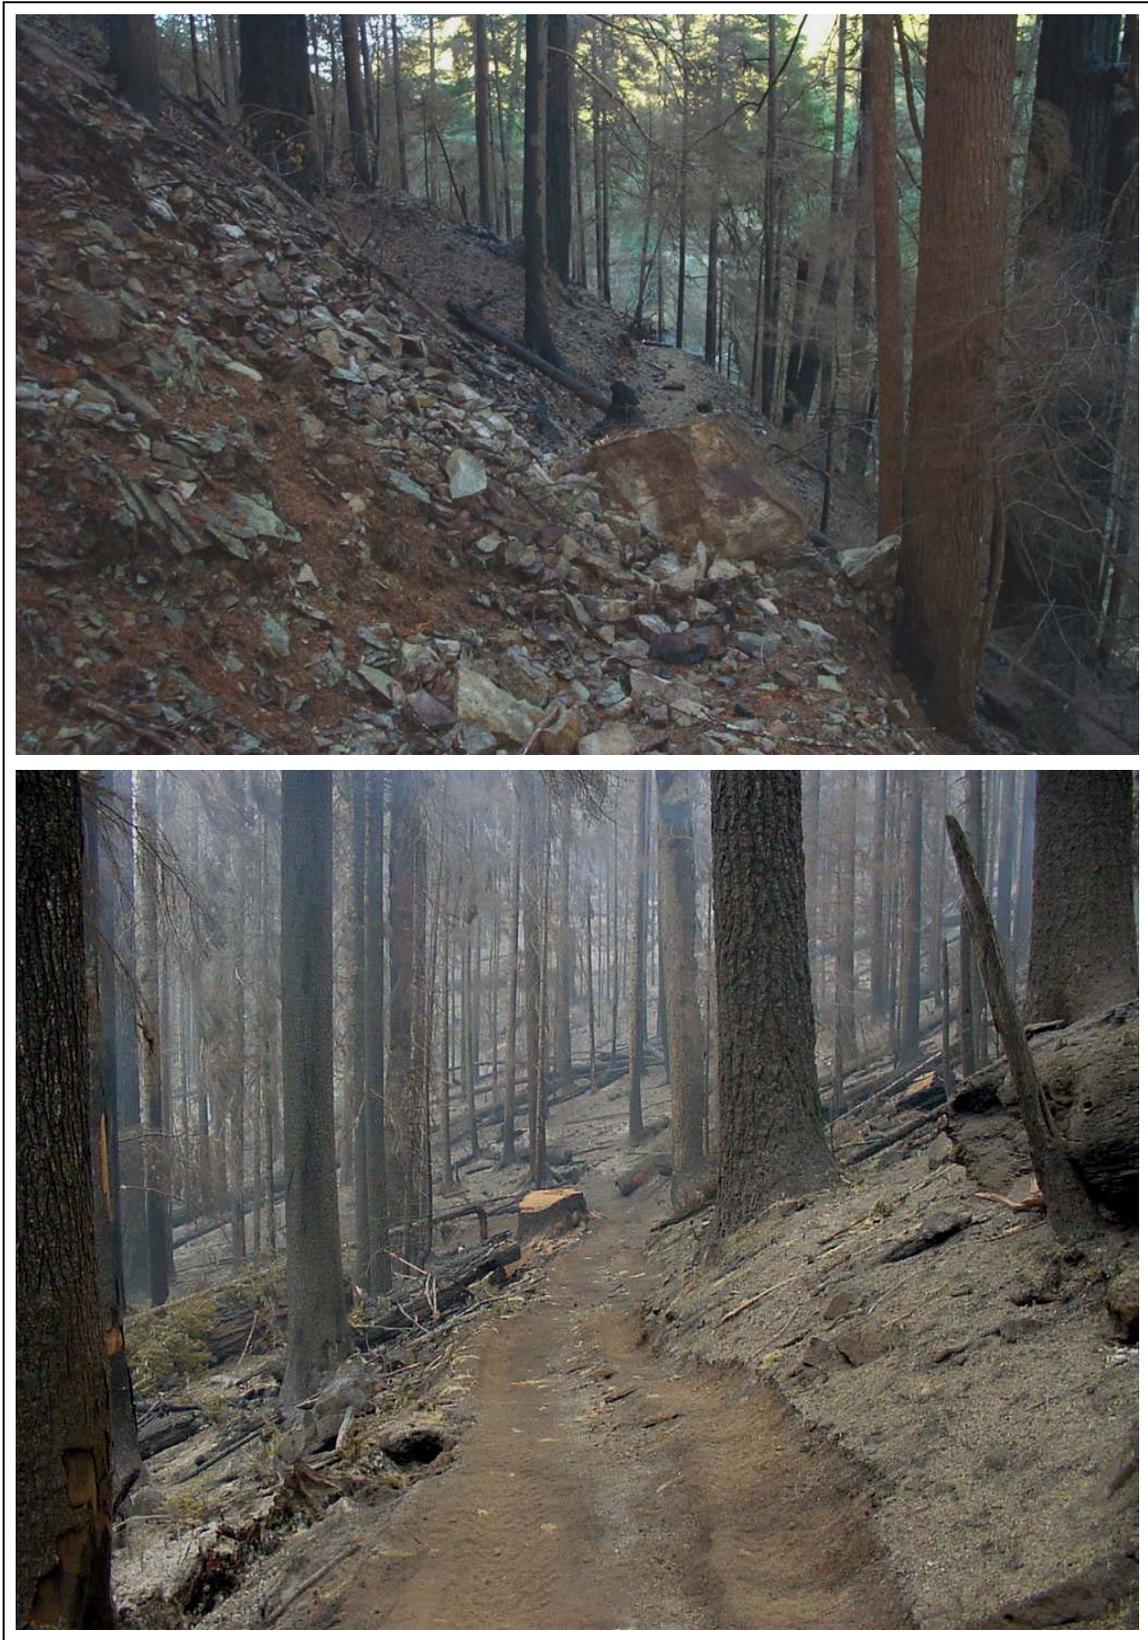
**Figure 8E: Wildfire Impacts to Trails including a Rock Slide on the North Umpqua Trail (Top Picture).**

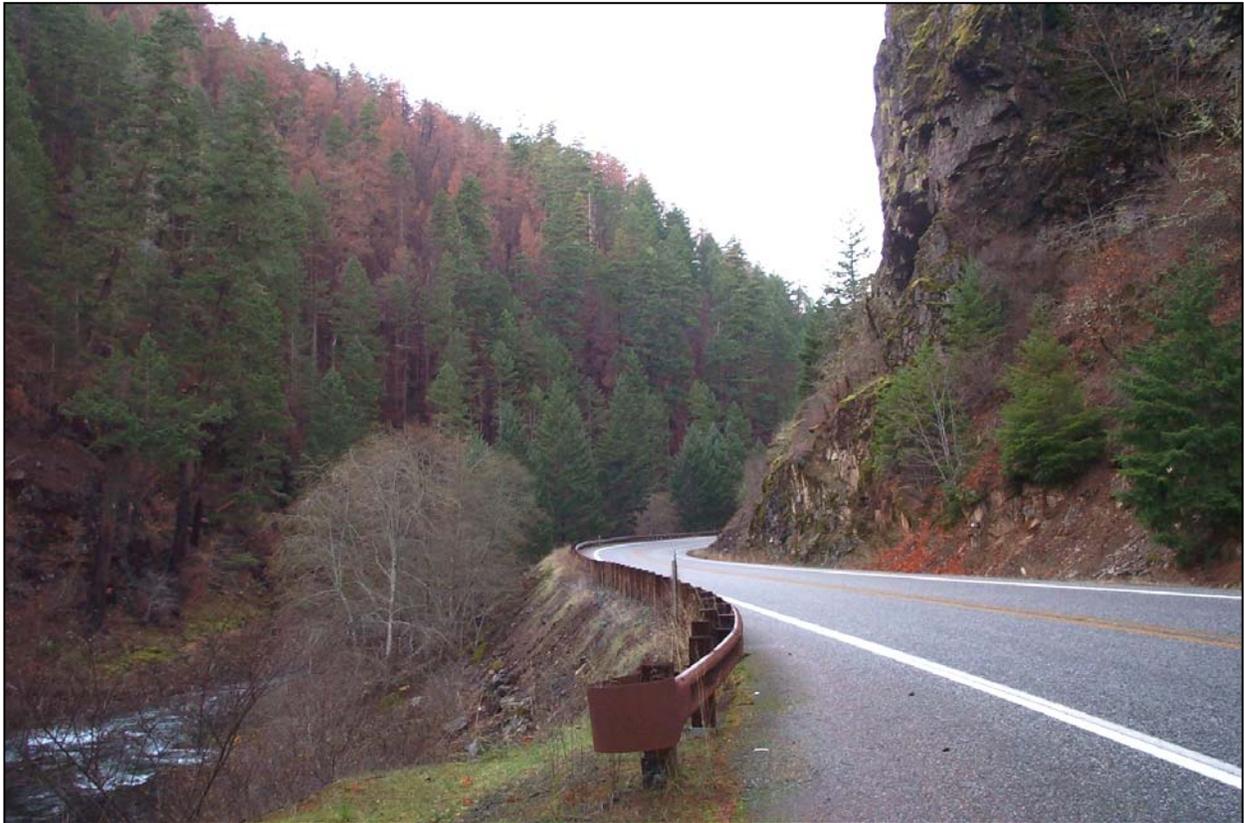
The Apple Fire affected the visual expectations of persons traveling Highway 138. Persons will view burned landscapes along the rivers edge as well as burned stands of timber up to 2 miles away. Fire is a natural occurrence in this landscape and provides diversity in stand composition and understory vegetation. With time the burned areas will have more vegetative and color diversity in the areas viewed especially during the fall season. Large snags will be evident in the isolated patches where the fire killed the large conifers.

**Figure 9E: Foreground Viewshed as seen from Highway 138**

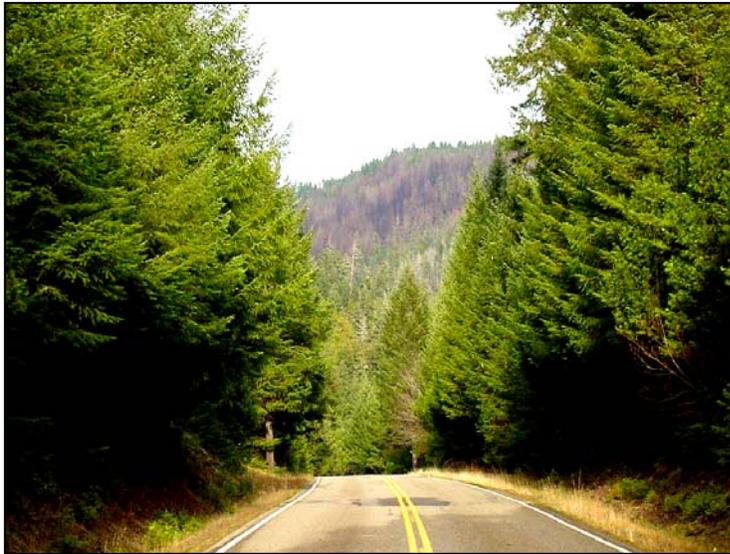
The Tiller Complex fires affected landscape character along South Umpqua Road 28 for about 20 miles. Burned areas are visible in the immediate foreground, to the horizon, depending on observer location. Burned areas are also visible in the immediate foreground from some popular recreation use areas. Although a natural event, the fires may negatively affect the scenic attractiveness of the corridor for some visitors. The number of fires and the acreages burned are higher than has ever been documented on the Tiller District.

**Figure 10E (above): Middleground viewshed example on South Umpqua Road 28. Figure 11E (right): Foreground viewshed example on South Umpqua Road 28**

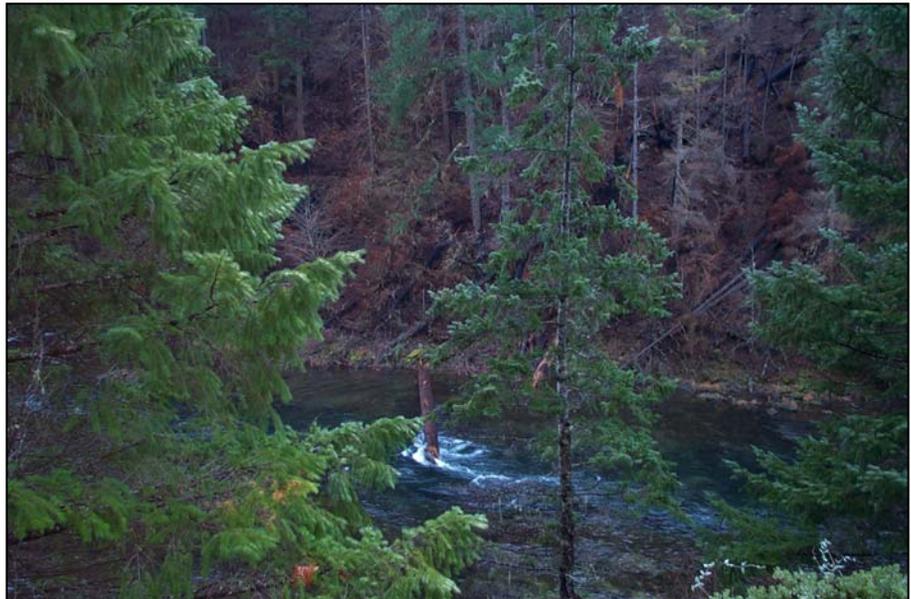
Persons floating the North Umpqua River from Horseshoe Bend Launch site to Apple Creek Bridge will find numerous large conifers which have fell into and along the rivers edge. Presently several locations have trees spanning the river requiring persons to portage around the trees to continue their float. The fire burned 3.7 miles of the river corridor to varying intensities, which will increase the number of down trees that this section of river will have. Winter storms traditionally move large trees through the system with an occasional tree catching, causing floaters to portage or change the travel routes. With an increased number of dead trees in this section of the river the effects will be an increase in down trees affecting persons floating this section of the river for decades.

**Figure 12E: Windfalls along the North Umpqua River**
