Forest Service
Pacific
Northwest
Region

1999

**ROGUE RIVER
WATERSHED ANALYSIS
MARIAL TO AGNESS
ITERATION 1.0**

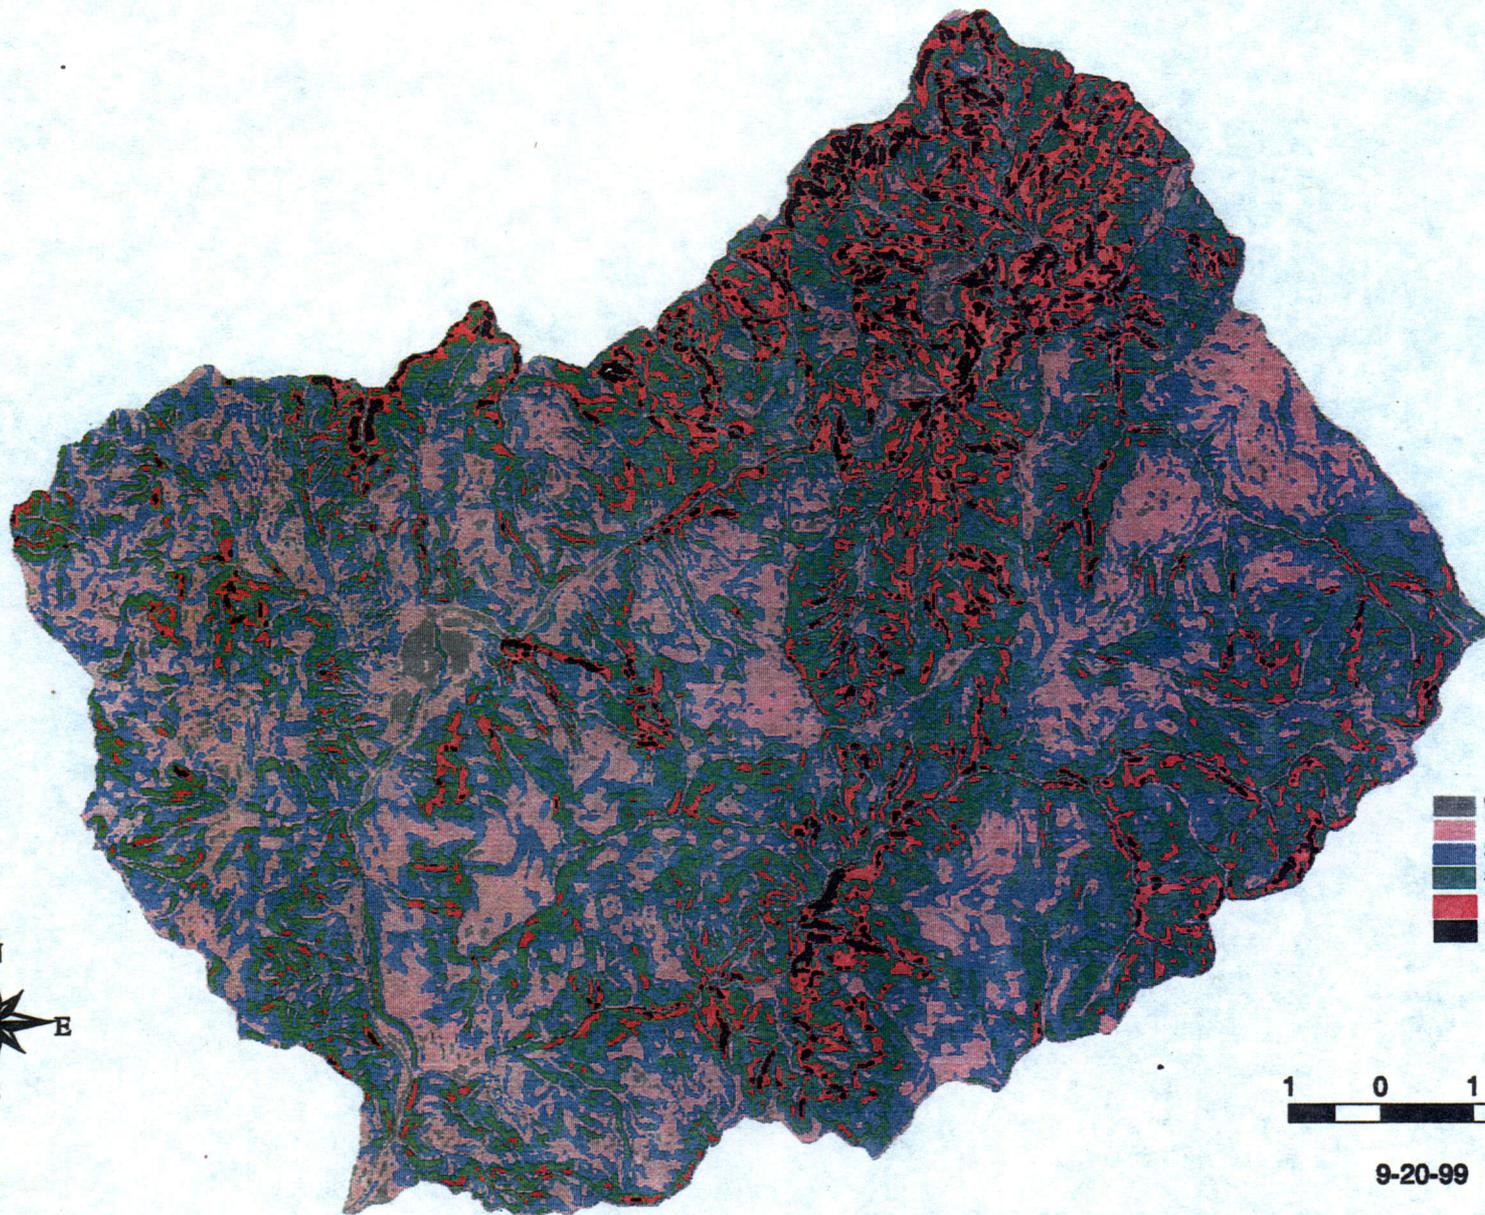
Rogue River Watershed, Marial to Agness Slope Classes

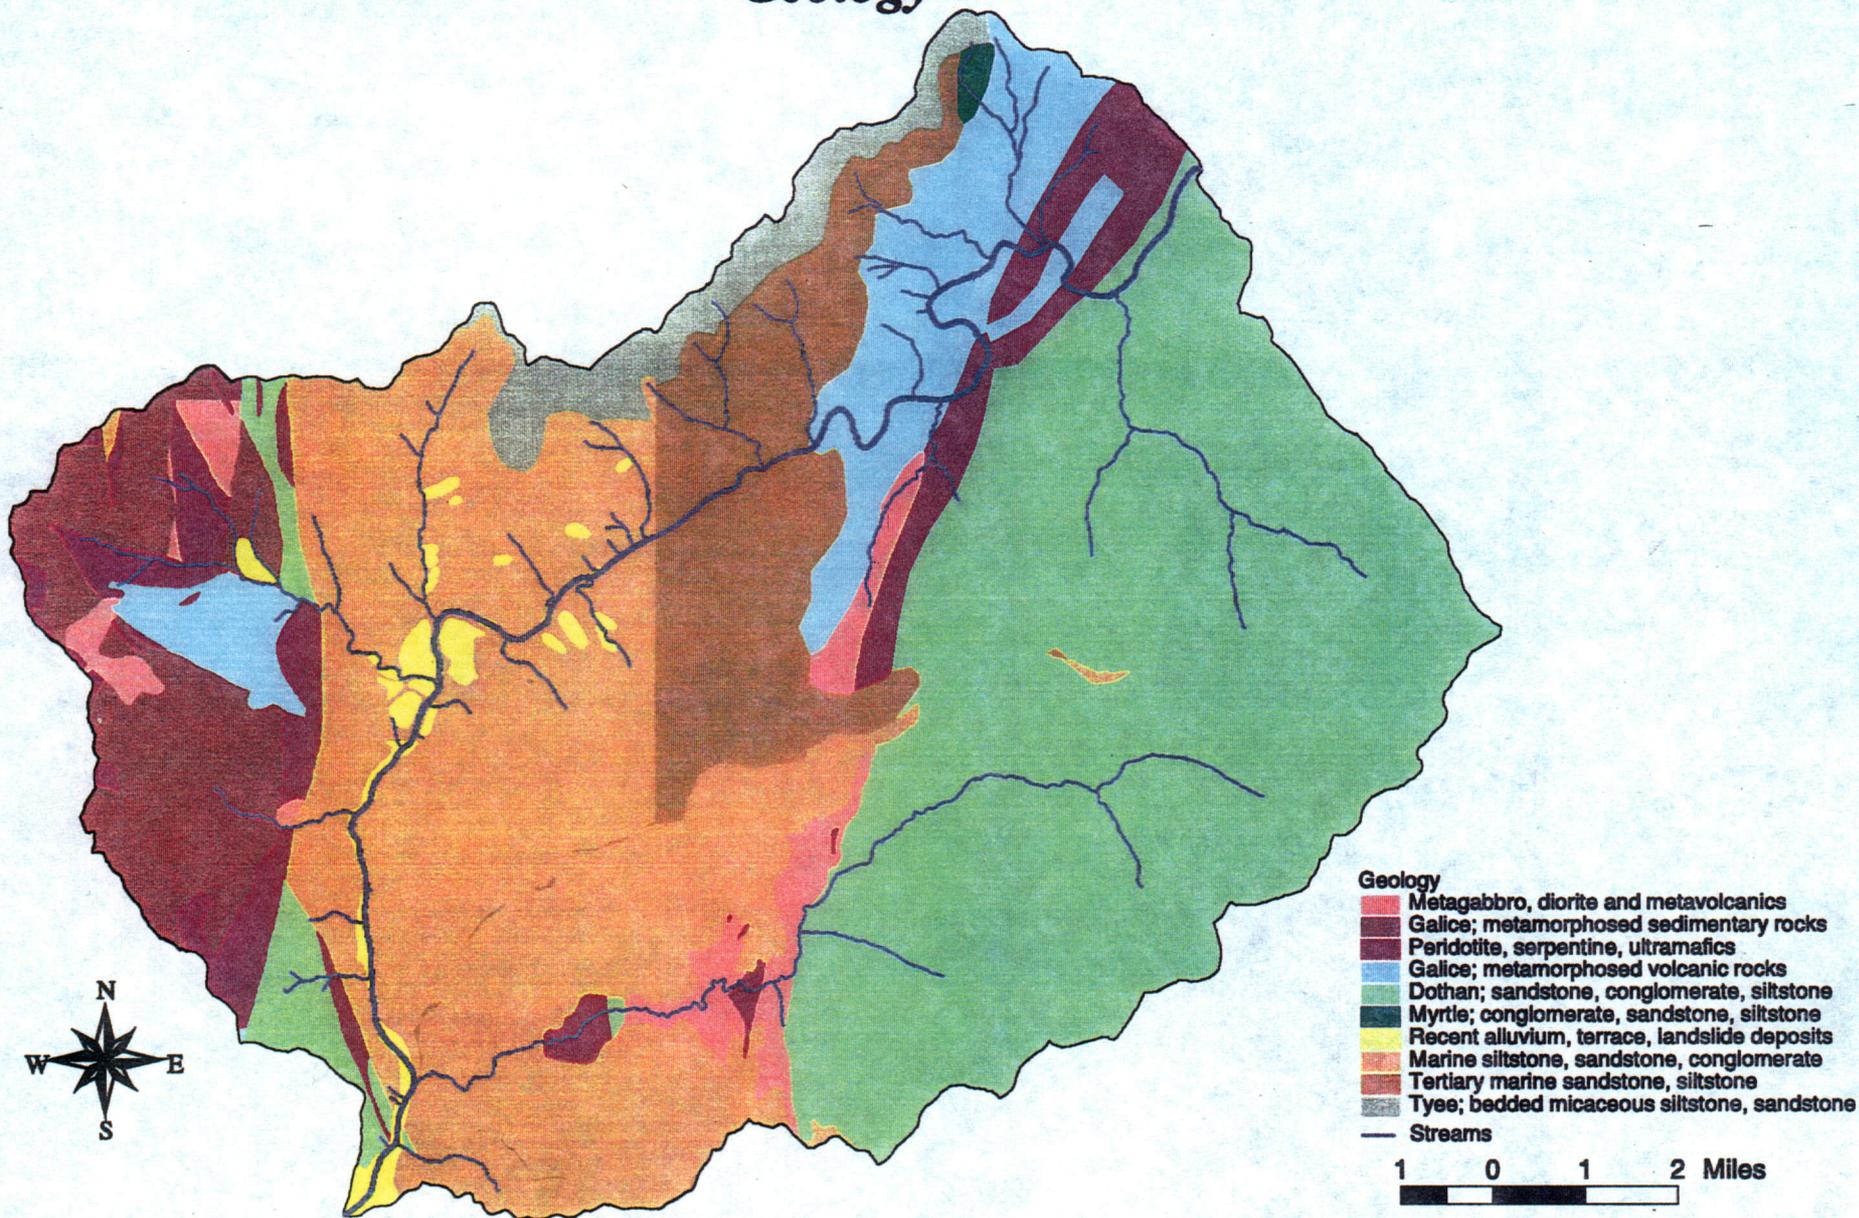
Page B-6

Rogue River Watershed, Marial to Agness Geology

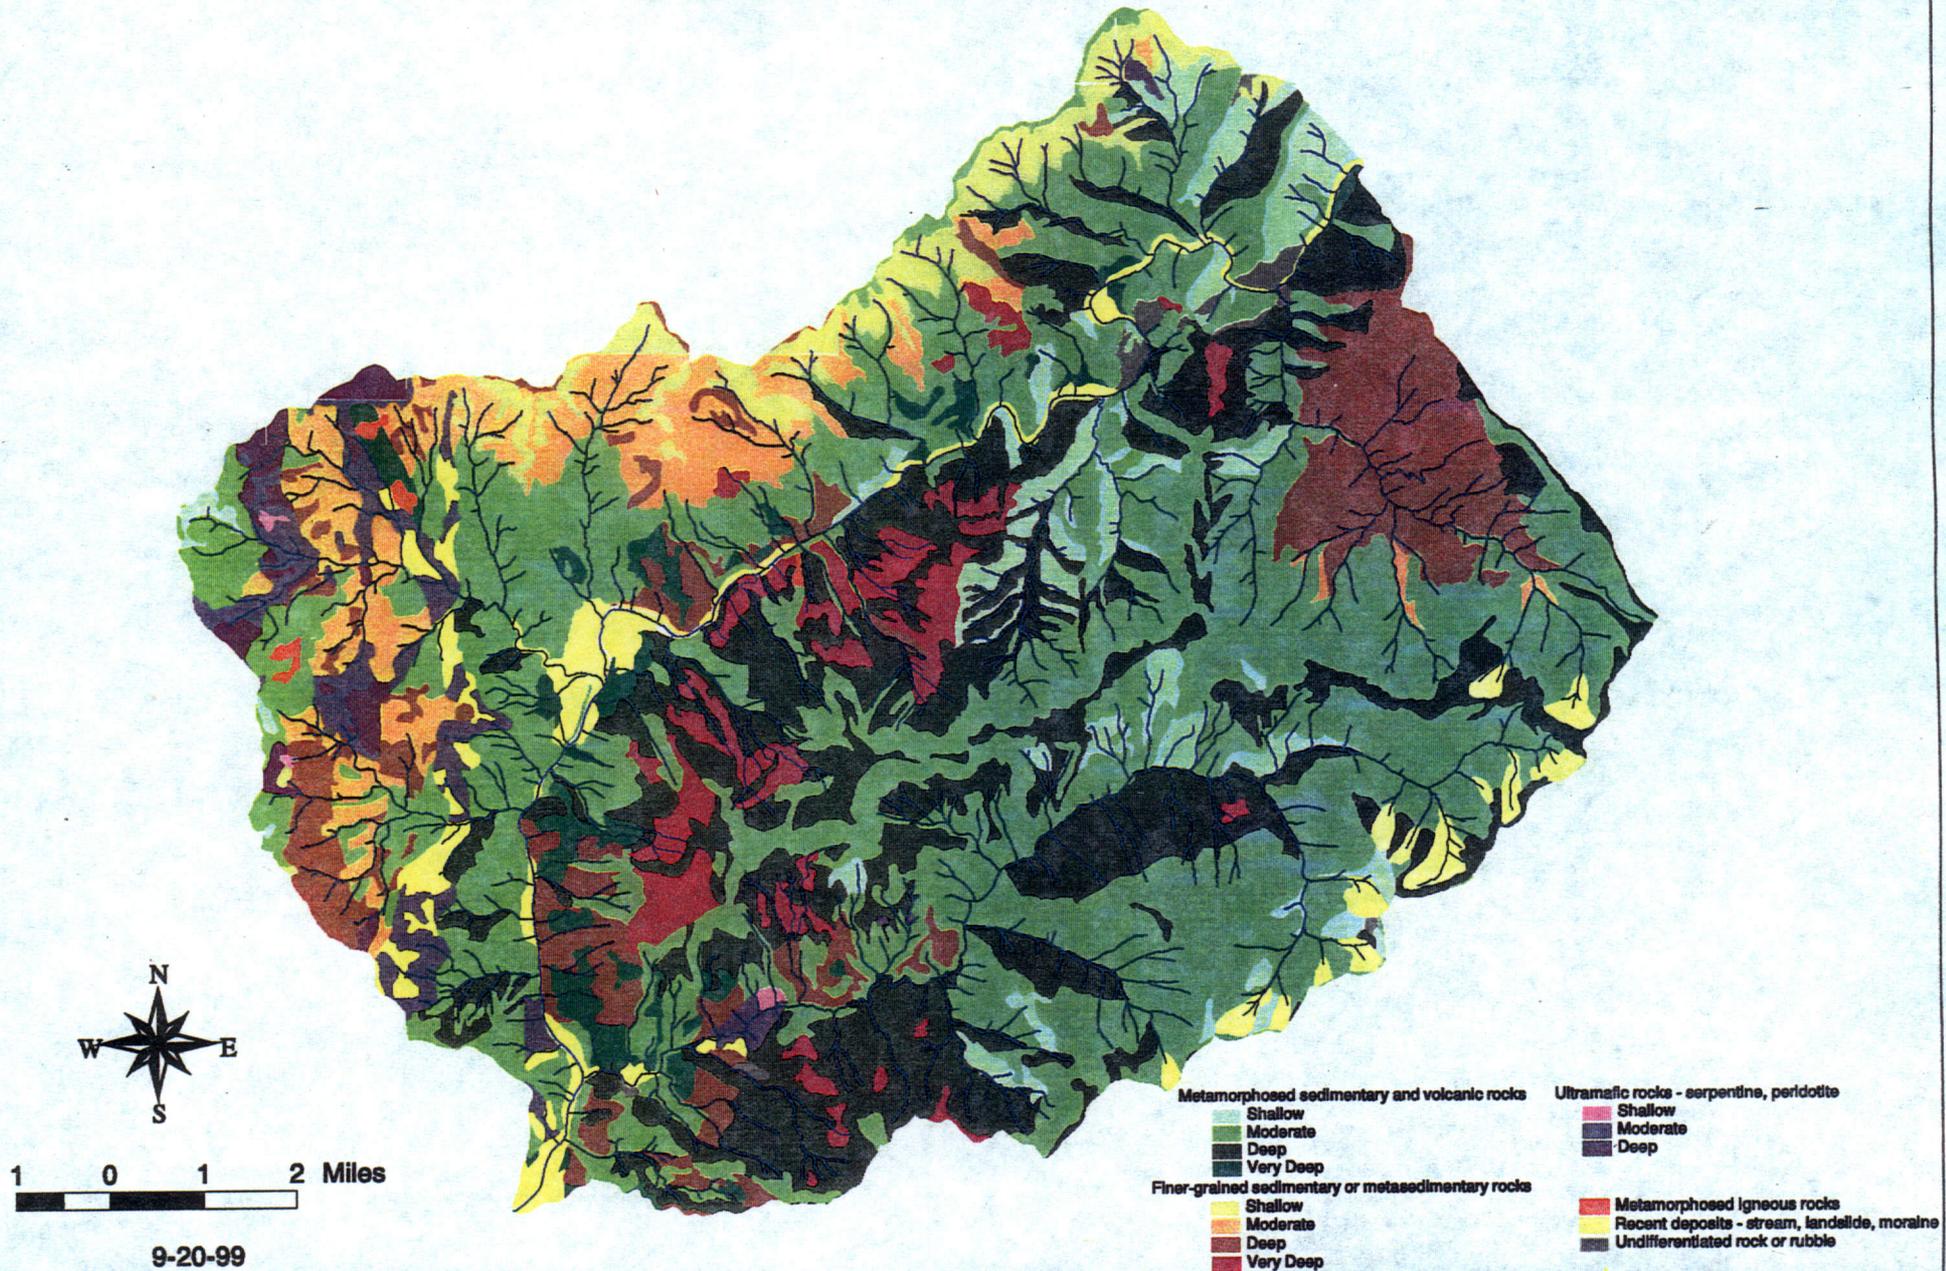
Page B-7

Rogue River Watershed, Marial to Agness Soil Depth and Parent Material

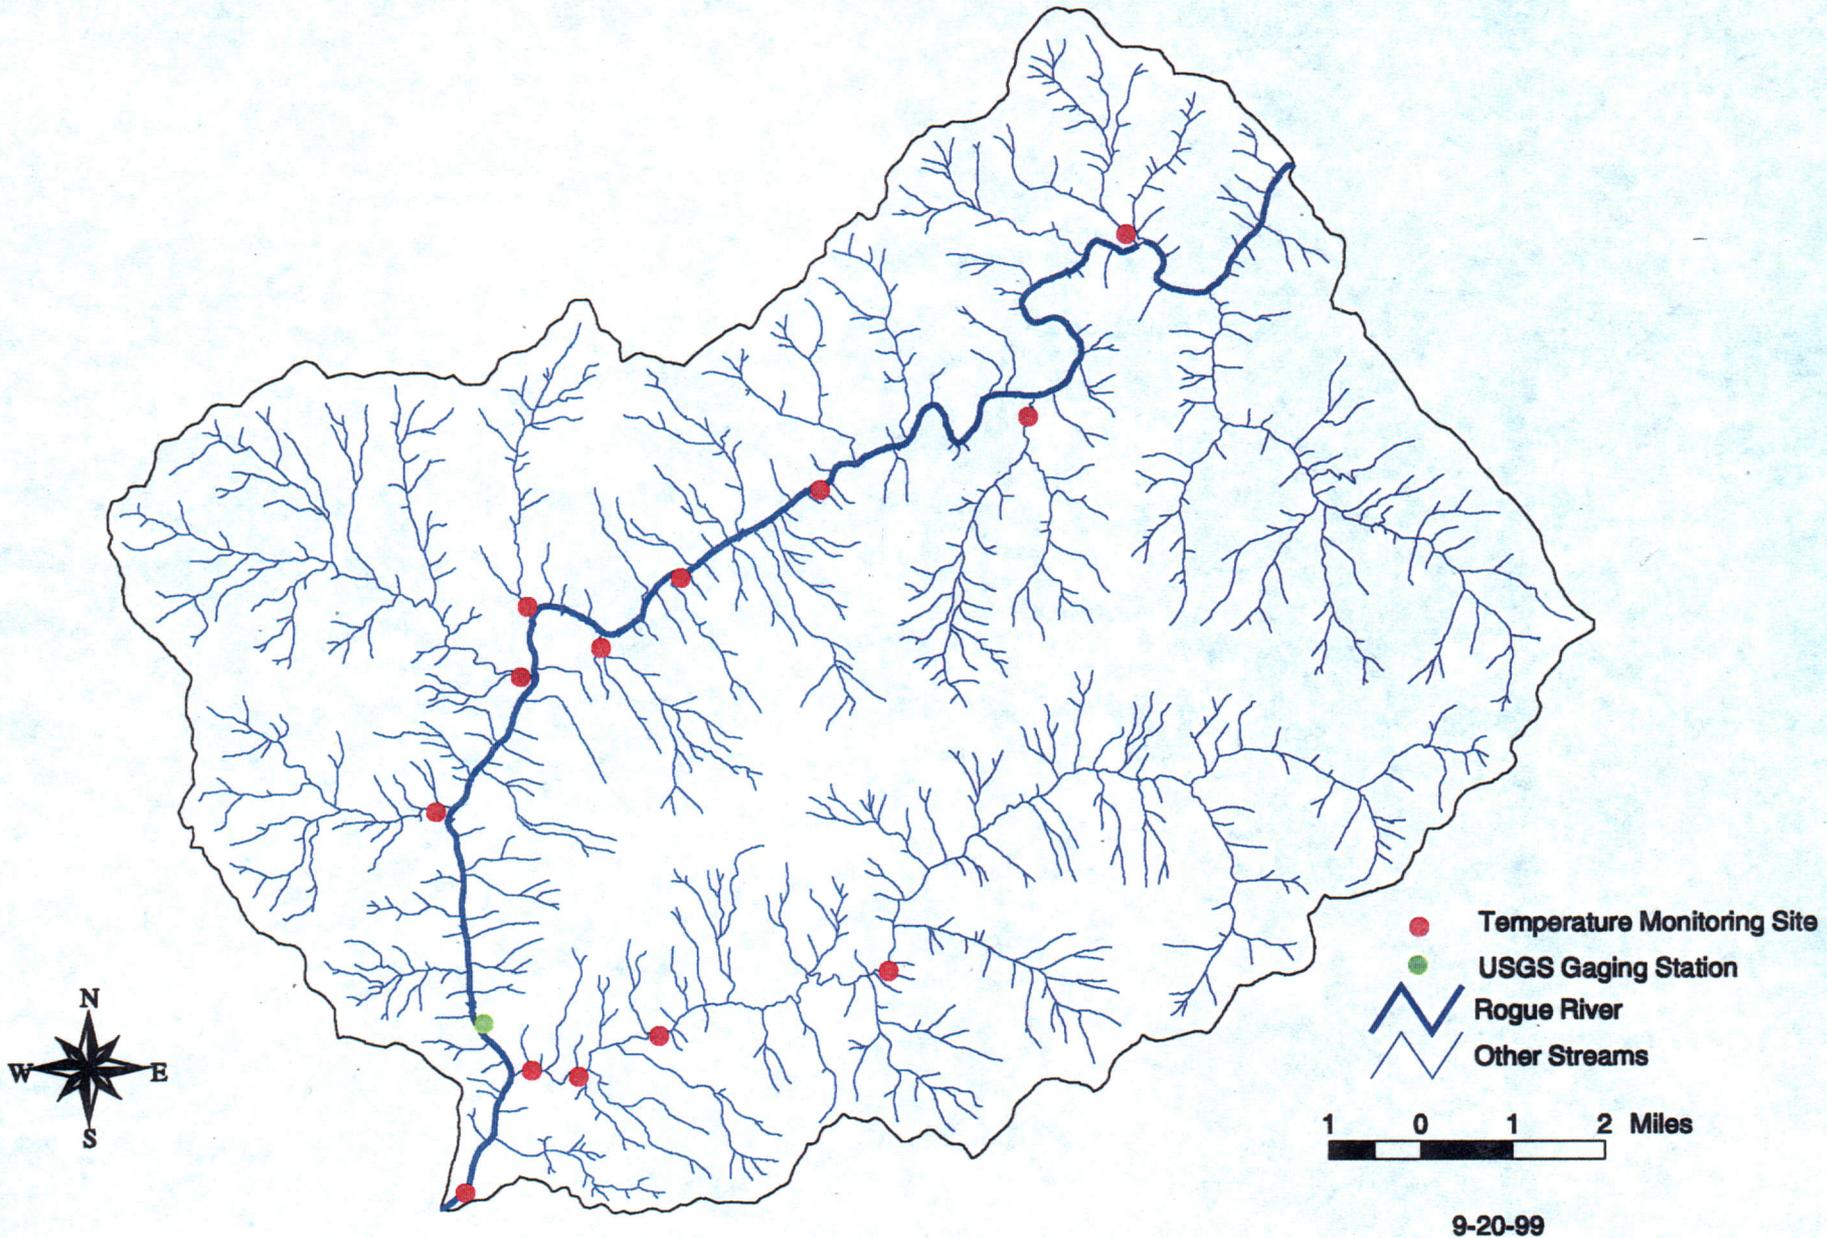
Page B-10

Rogue River Watershed, Marial to Agness Temperature Monitoring Sites

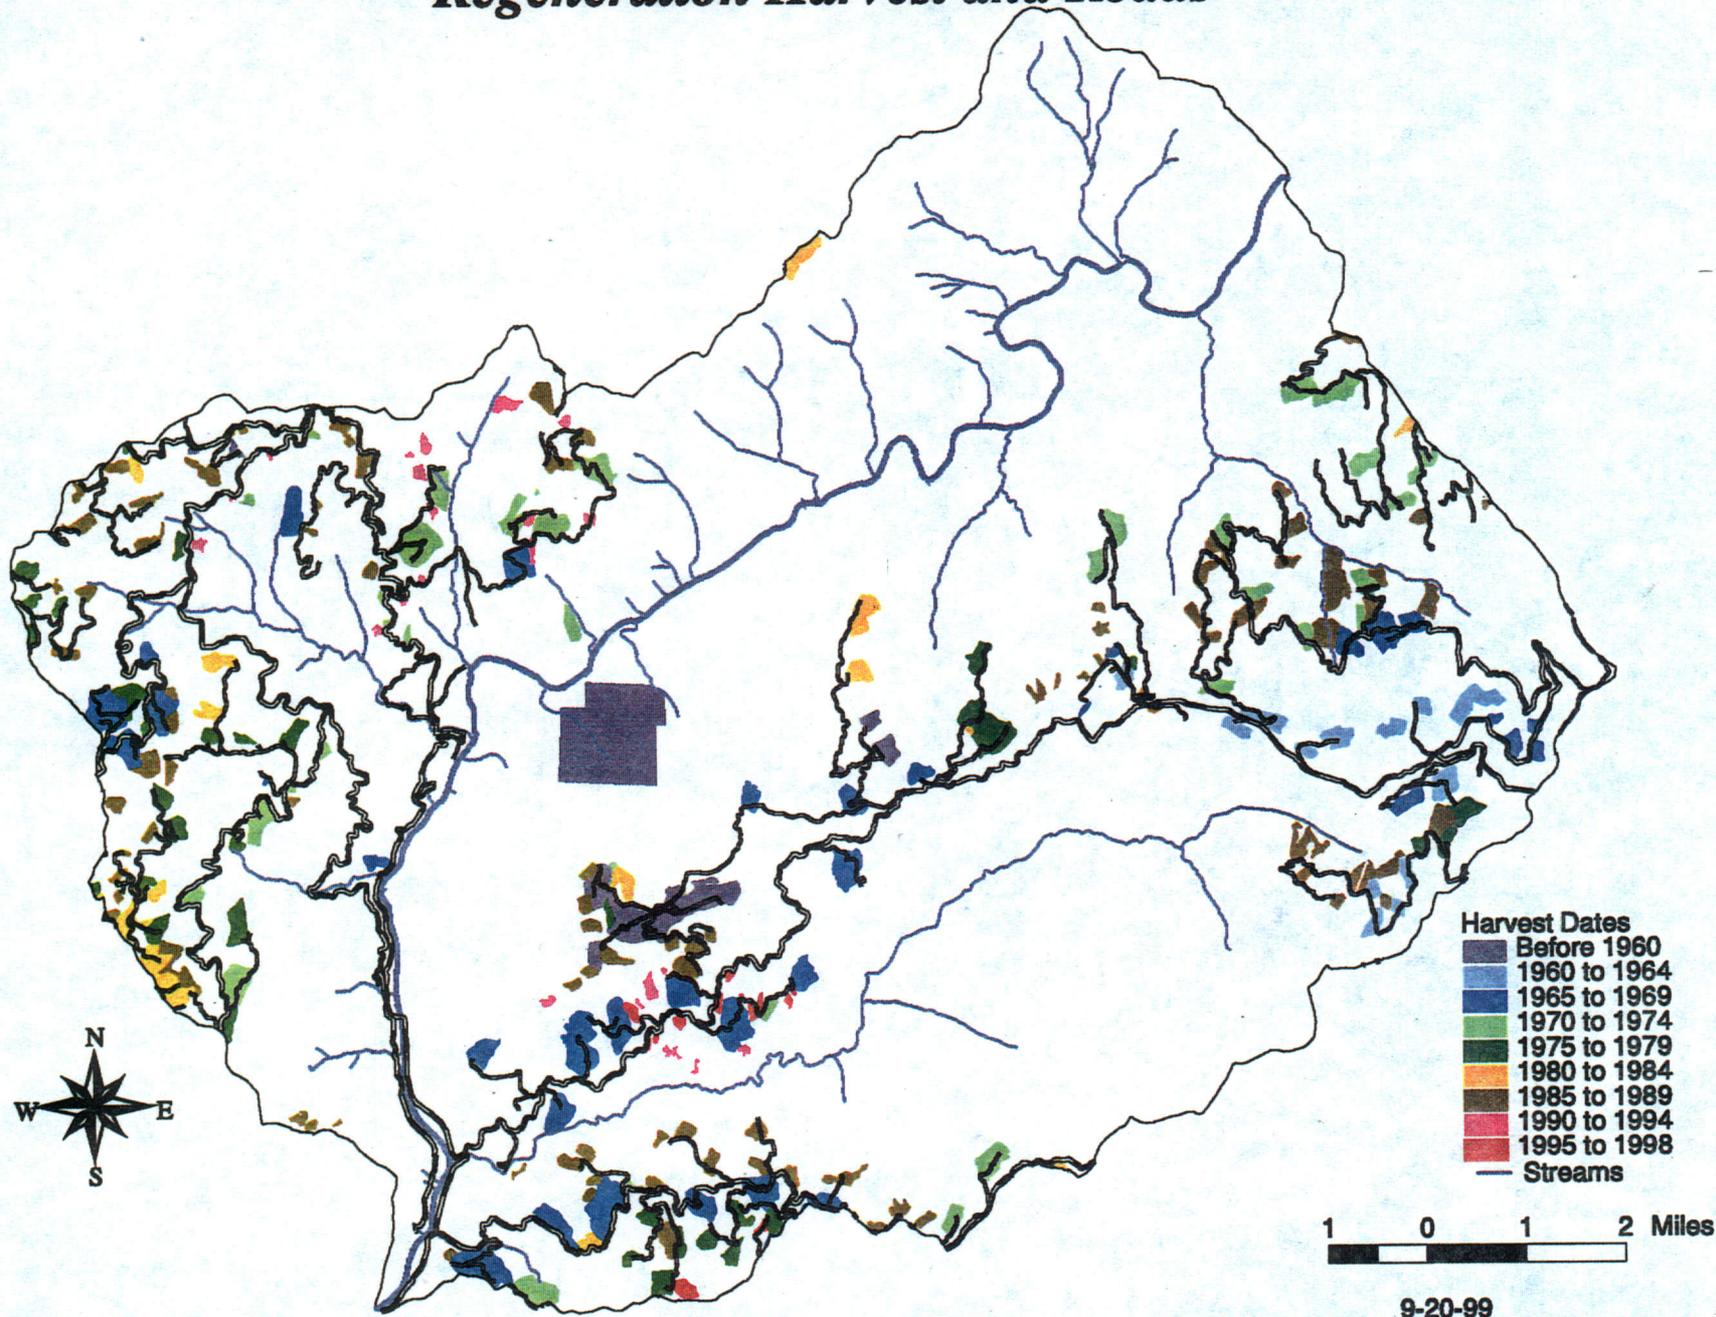
Page B-20

Rogue River Watershed, Marial to Agness Regeneration Harvest and Roads
