REMOVAL ACTION REPORT
Kelly Camp Mine, Colville National
Forest

December 2010

Prepared for:
USDA Forest Service

Prepared by:
URS
111 S.W. Columbia, Suite 1500
Portland, Oregon 97201-5850
25697239

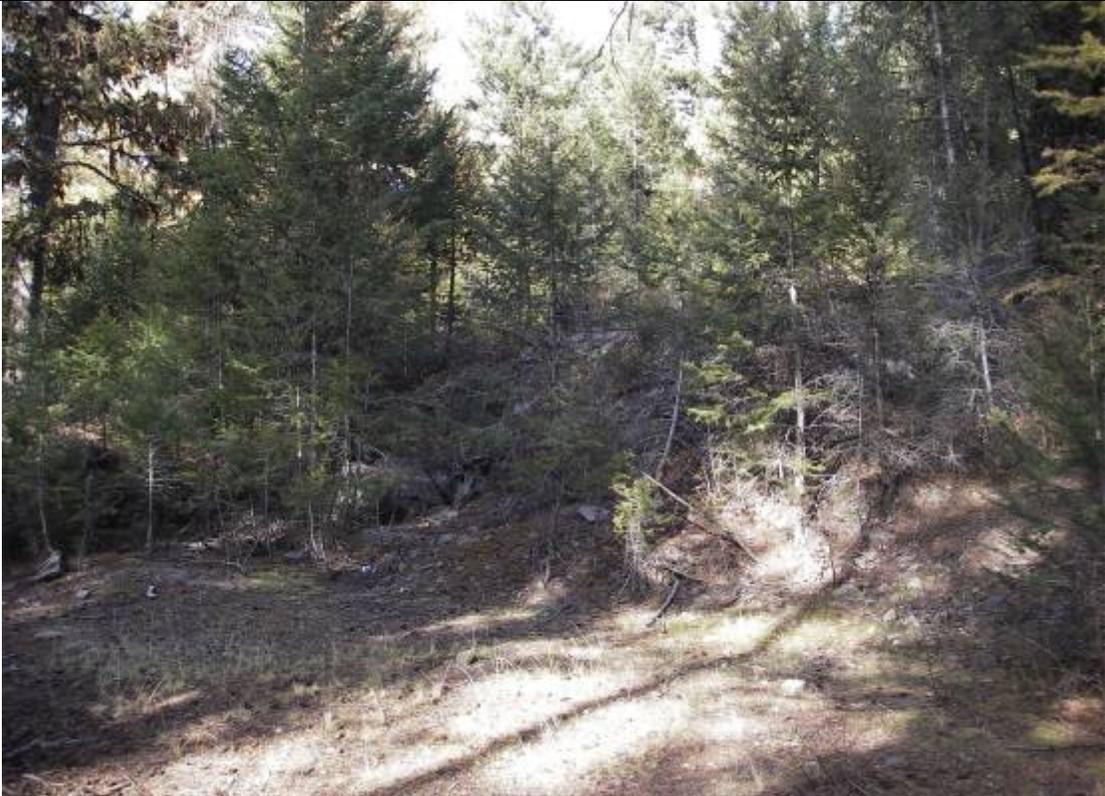
Client Name: United States Forest Service		Site Location: Kelly Camp Mine, Colville National Forest	Project No. 25697239
Photo No. 1	Date: October 18, 2010

Direction Photo Taken: North			
Description: UWRP prior to Removal Action.

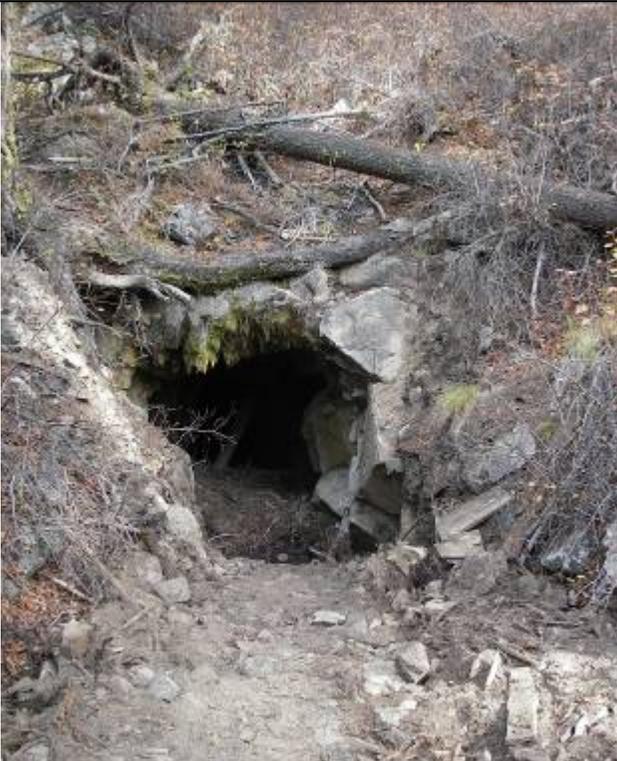
Photo No. 2	Date: October 18, 2010

Direction Photo Taken: North		
Description: Lower adit prior to Removal Action

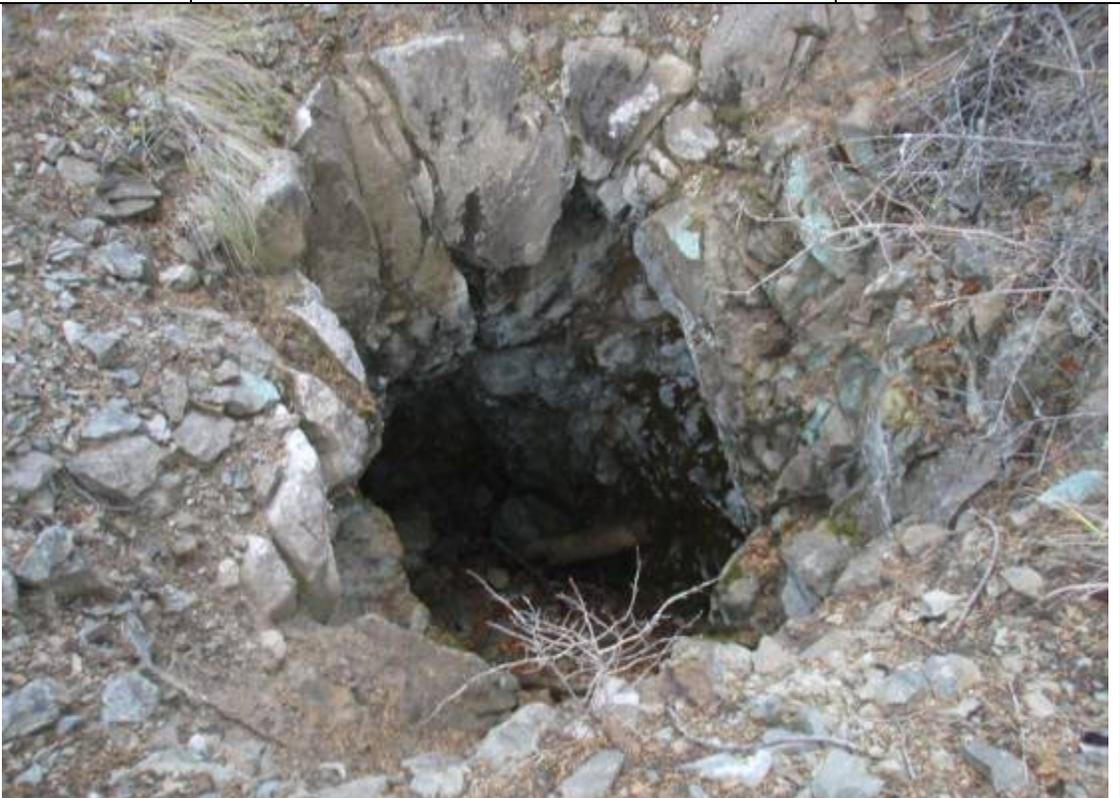
Client Name: United States Forest Service		Site Location: Kelly Camp Mine, Colville National Forest	Project No. 25697239
Photo No. 3	Date: October 18, 2010

Direction Photo Taken: West			
Description: Exploratory feature prior to backfilling.

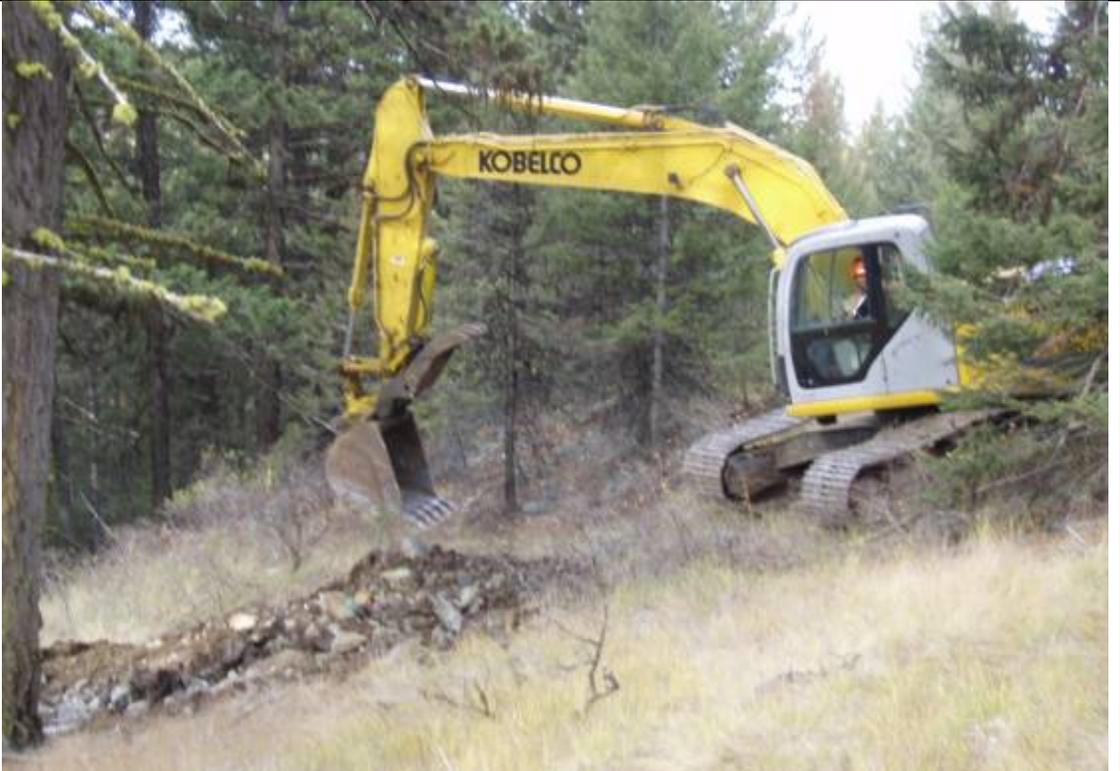
Photo No. 4	Date: October 18, 2010

Direction Photo Taken: West		
Description: Backfilling exploratory features.

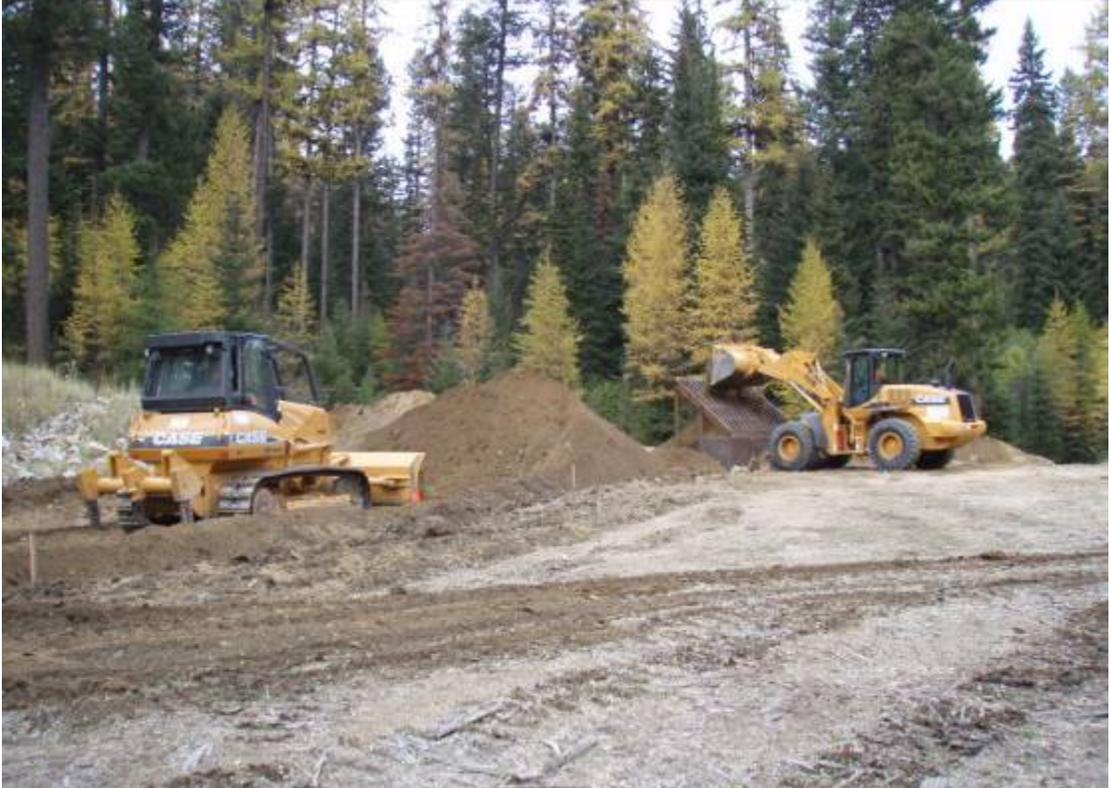
Client Name: United States Forest Service		Site Location: Kelly Camp Mine, Colville National Forest	Project No. 25697239
Photo No. 5	Date: October 18, 2010

Direction Photo Taken: Northwest			
Description: Excavating and screening Fill #1 borrow area material.

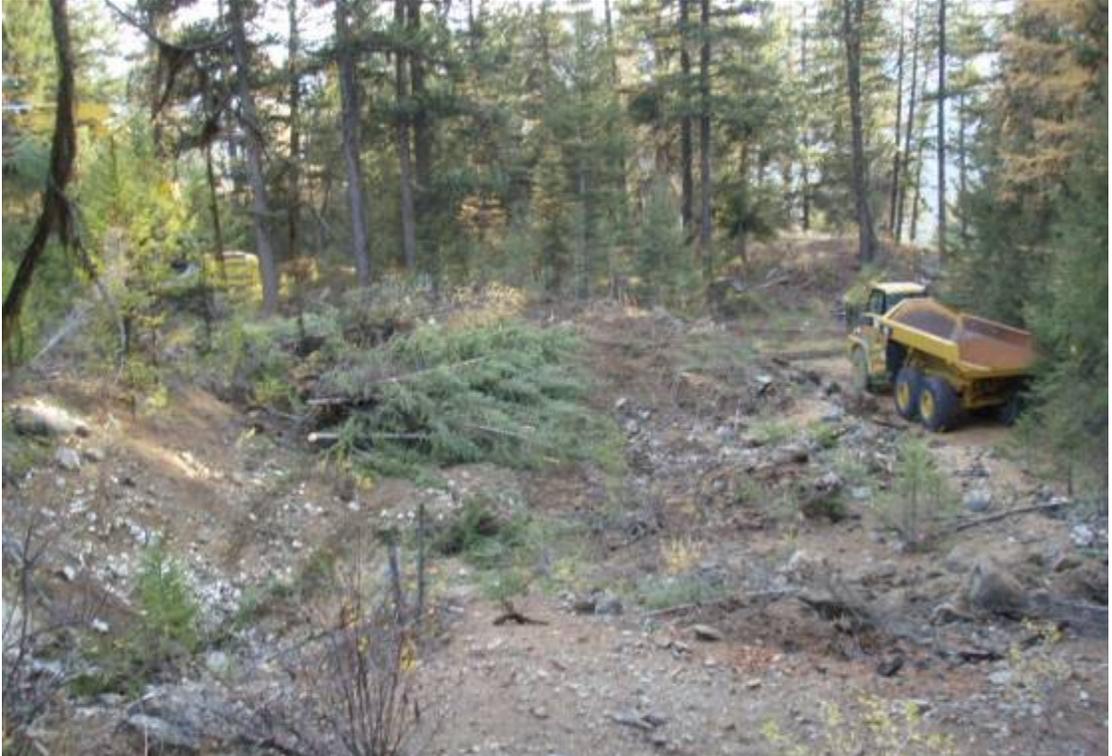
Photo No. 6	Date: October 19, 2010

Direction Photo Taken: South			
Description: View from upper adit of UWRP grubbing.

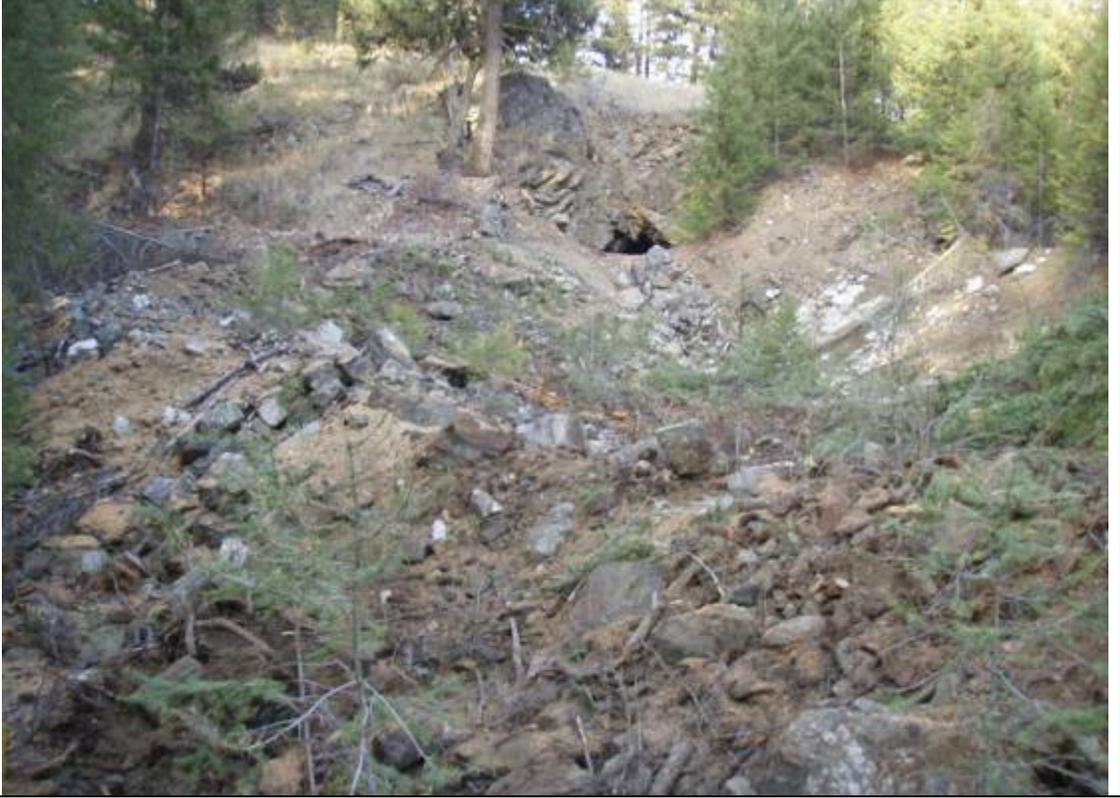
Client Name: United States Forest Service		Site Location: Kelly Camp Mine, Colville National Forest	Project No. 25697239
Photo No. 7	Date: October 19, 2010

Direction Photo Taken: North			
Description: View of UWRP during grubbing. Note the top of the upper adit at middle center.

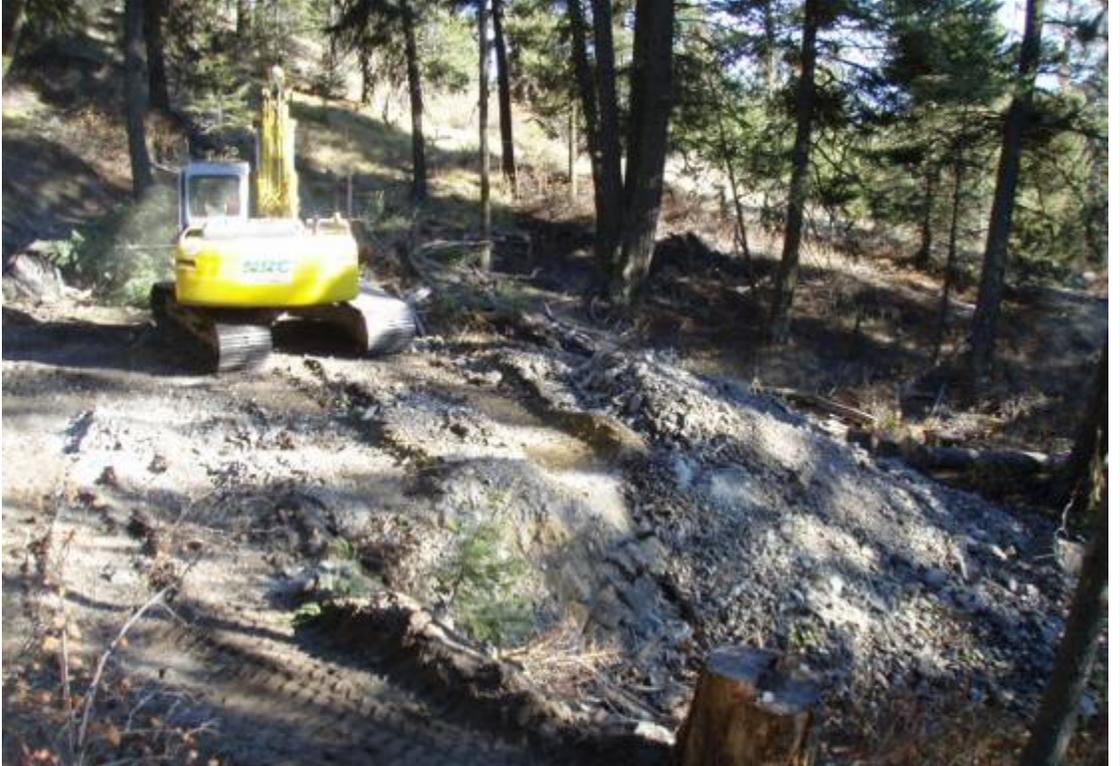
Photo No. 8	Date: October 20, 2010

Direction Photo Taken: Northeast			
Description: Grubbing the LWRP.

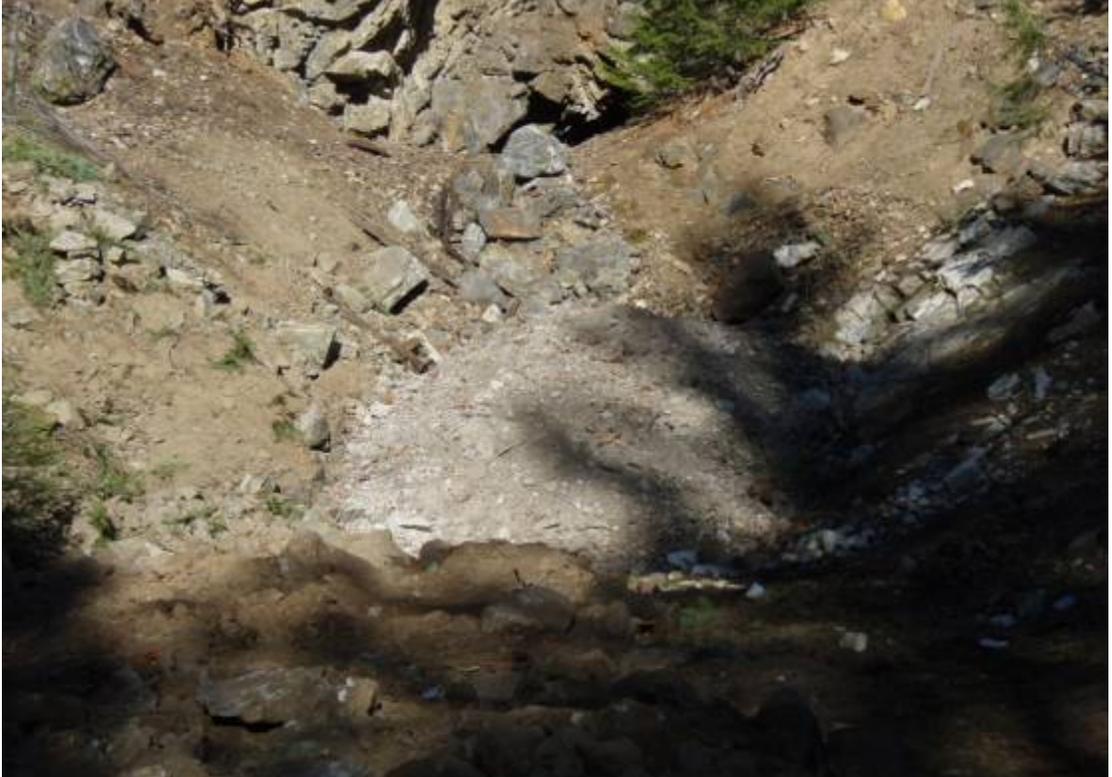
Client Name: United States Forest Service		Site Location: Kelly Camp Mine, Colville National Forest	Project No. 25697239
Photo No. 11	Date: October 20, 2010

Direction Photo Taken: North			
Description: Waste rock from LWRP placed on UWRP. Note the top of the upper adit visible at middle center.

- NRC cleared and stockpiled vegetation from the UWRP and access to upper shafts.
- NRC excavated the LWRP. Approximately 600 loose cubic yards of waste rock material from the LWRP was hauled and consolidated on the UWRP. Excavated to or slightly below the underlying original soil surface based on visual inspection.

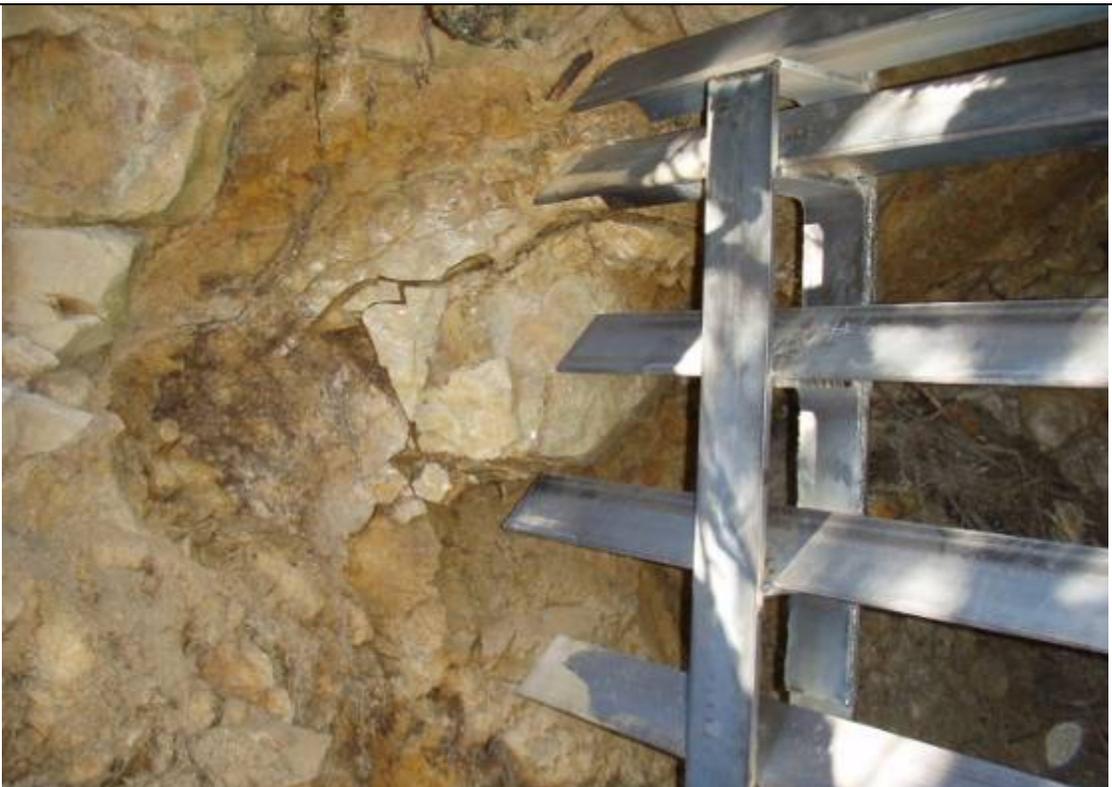
Photo No. 12	Date: October 21, 2010

Direction Photo Taken: Northwest			
Description: Rock dislodged during lower adit gate installation.

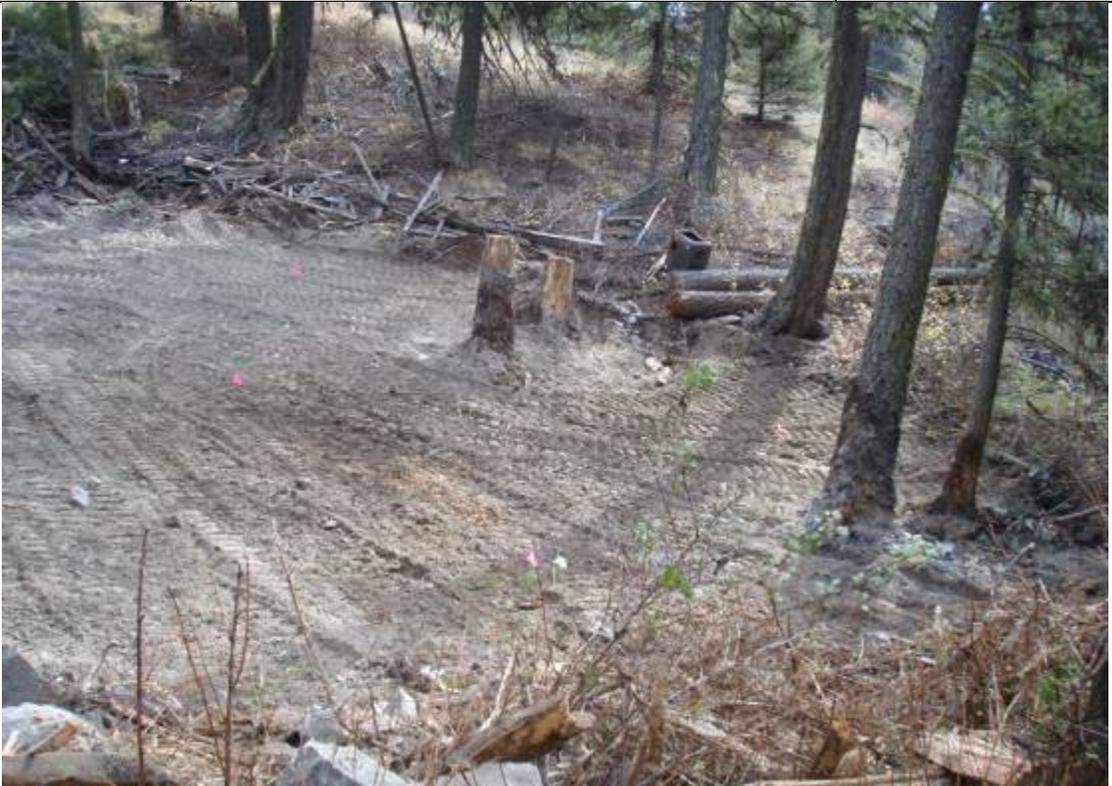
Client Name: United States Forest Service		Site Location: Kelly Camp Mine, Colville National Forest	Project No.: 25697239
Photo No.: 13	Date: October 22, 2010

Direction Photo Taken: Southeast			
Description: LWRP footprint following excavation. Flags mark locations of confirmation samples.

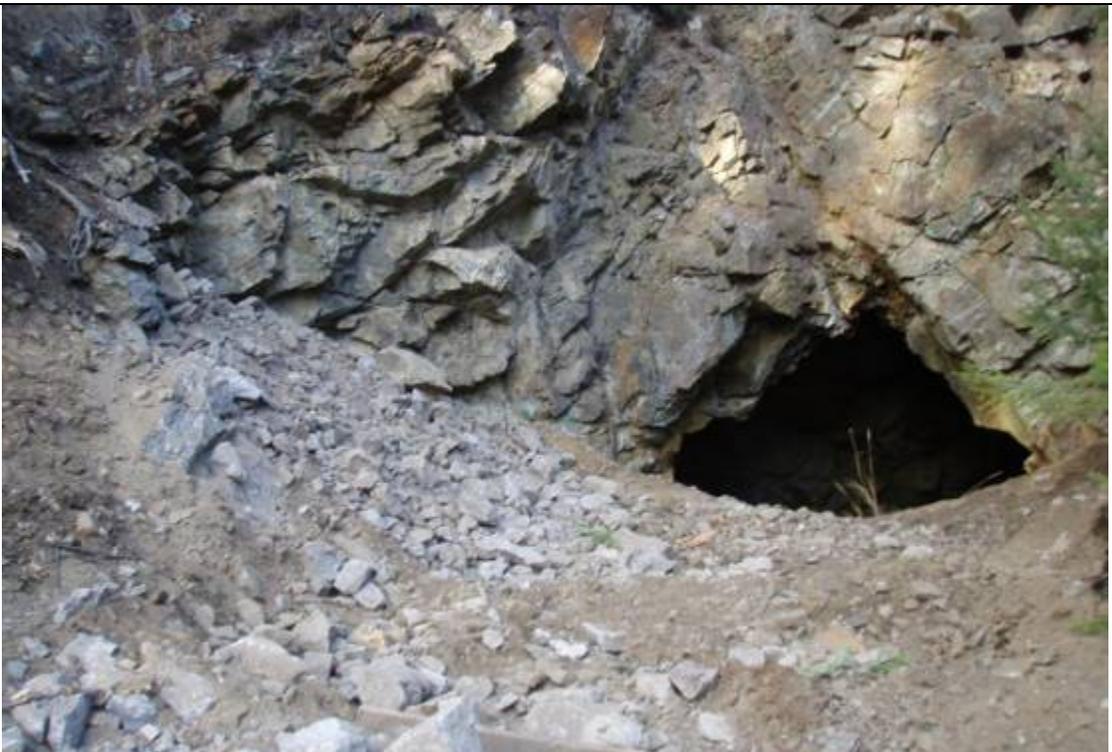
Photo No.: 14	Date: October 22, 2010

Direction Photo Taken: North		
Description: Western shaft following plugging and backfilling.

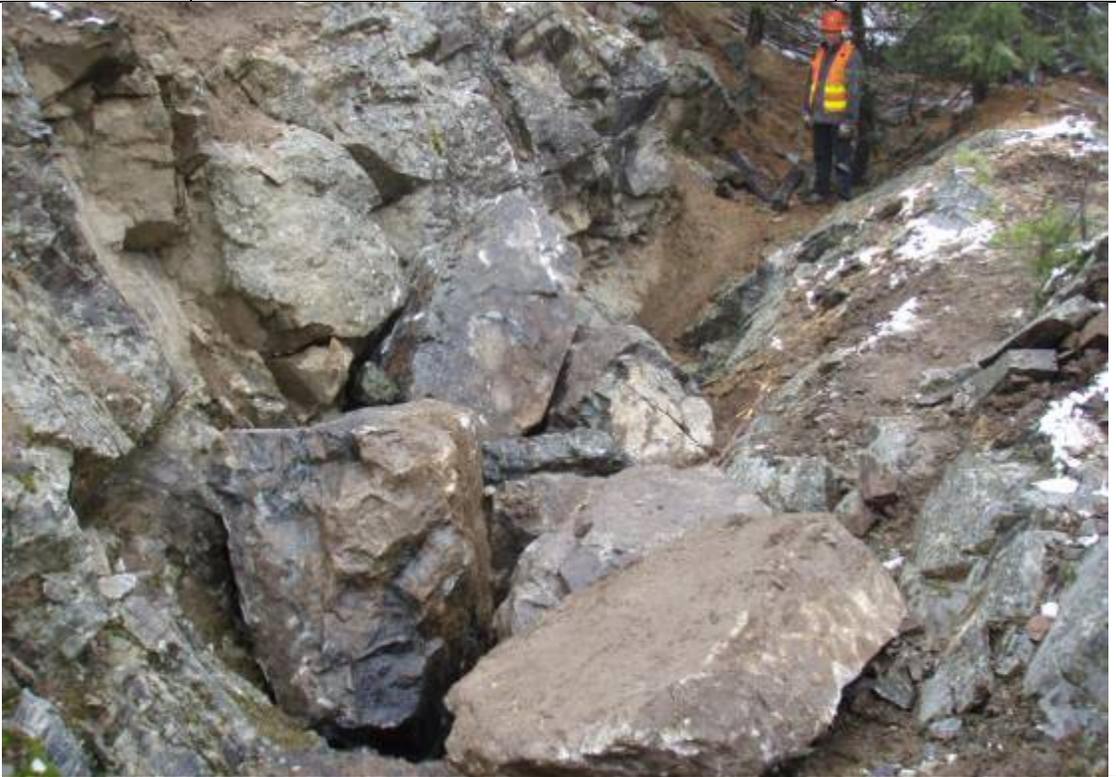
Client Name: United States Forest Service		Site Location: Kelly Camp Mine, Colville National Forest	Project No.: 25697239
Photo No.: 17	Date: October 25, 2010

Direction Photo Taken: East			
Description: Plugging eastern shafts with blast rock.

- The eastern shafts were plugged with blast rock and backfilled with waste rock material
- Additional loads of Bonaparte Lake peat moss material were received at borrow area Fill #1. Approximately 360 loose cubic yards were received during the week ending October 29, 2010.

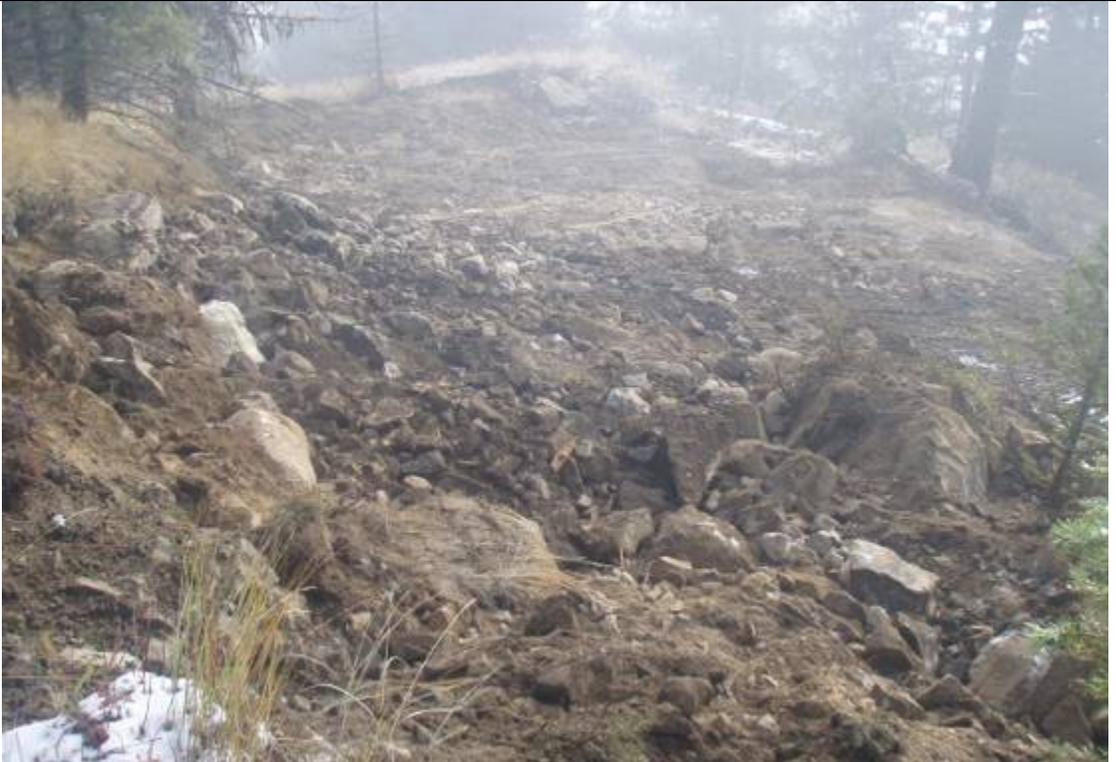
Photo No.: 18	Date: October 26, 2010

Direction Photo Taken: East		
Description: Eastern shafts following plugging and backfilling with waste rock.

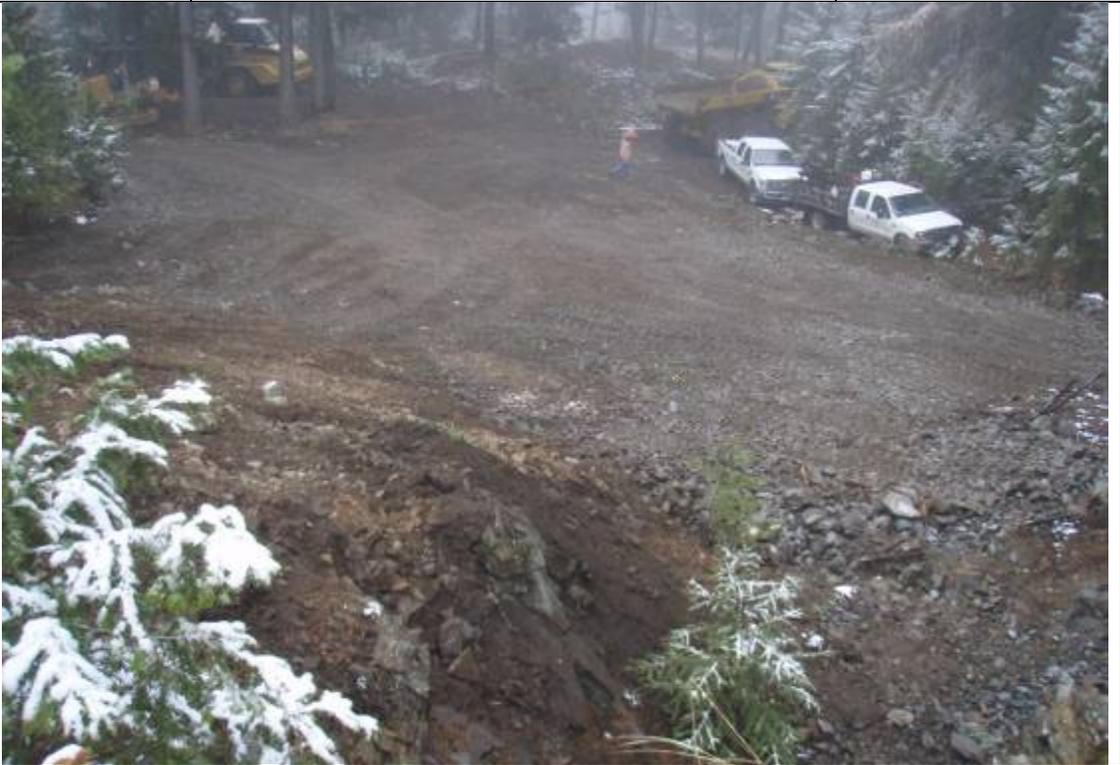
Client Name: United States Forest Service		Site Location: Kelly Camp Mine, Colville National Forest	Project No.: 25697239
Photo No.: 19	Date: October 25, 2010

Direction Photo Taken: Southwest			
Description: Graded consolidated waste rock pile as viewed from the backfilled eastern shafts.

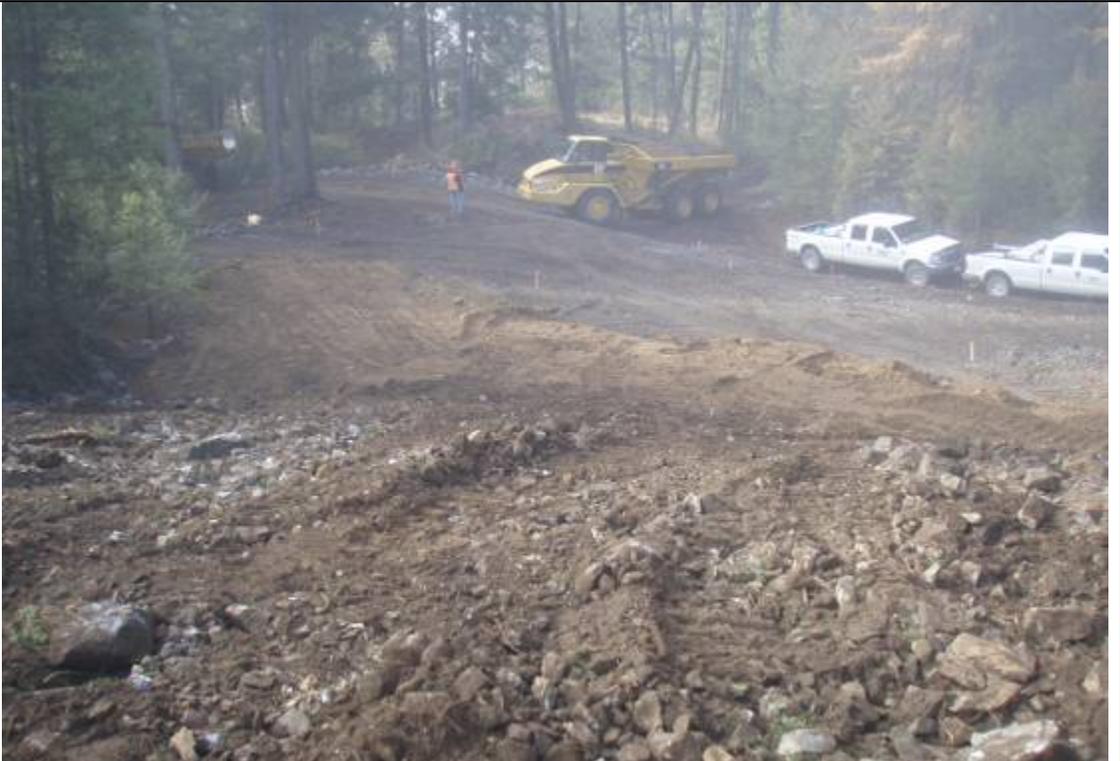
Photo No.: 20	Date: October 26, 2010

Direction Photo Taken: Southwest			
Description: Hauling and placing borrow material on consolidated waste rock pile.

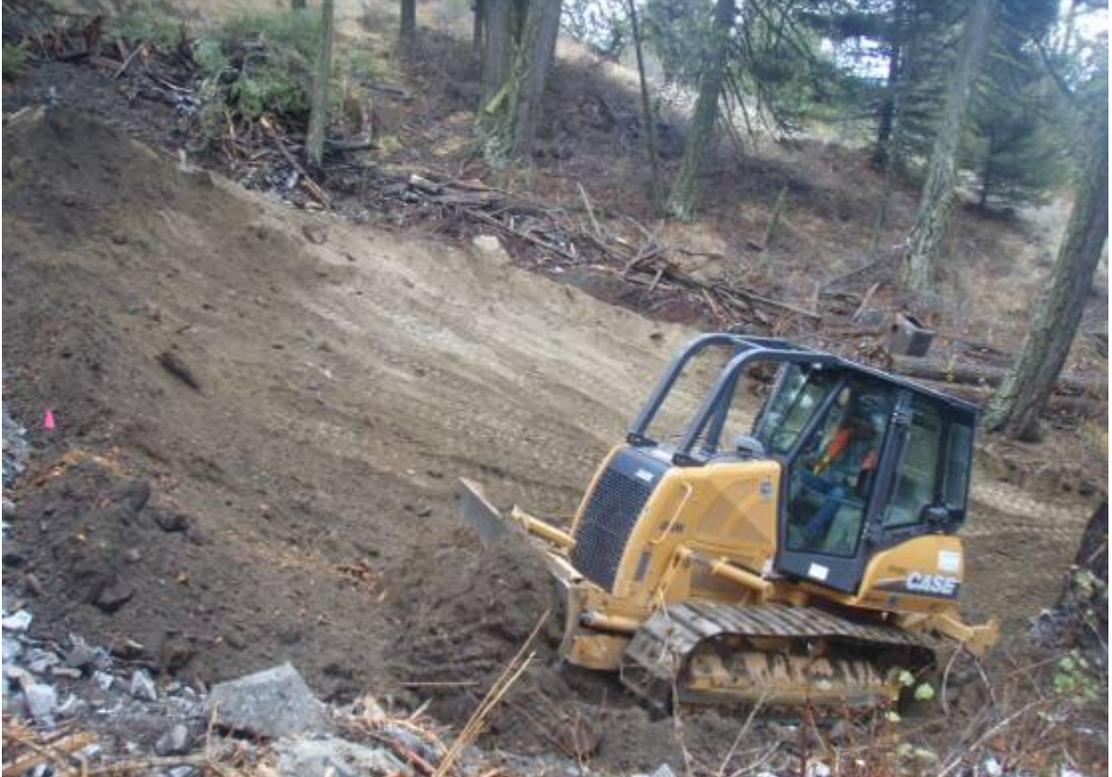
Client Name: United States Forest Service		Site Location: Kelly Camp Mine, Colville National Forest	Project No. 25697239
Photo No. 21	Date: October 26, 2010

Direction Photo Taken: East			
Description: Using dozer to over-excavate LWRP.

- The LWRP confirmation results were received and reviewed on October 26, 2010; some proposed cleanup criteria were exceeded, as shown on Table 1.
- At the direction of the OSC approximately 1 foot of additional soil was excavated below the presumed original soil surface at the LWRP. NRC removed the additional material from the LWRP on October 27, 2010. Approximately 120 loose cubic yards of additional material was hauled and consolidated with the UWRP.

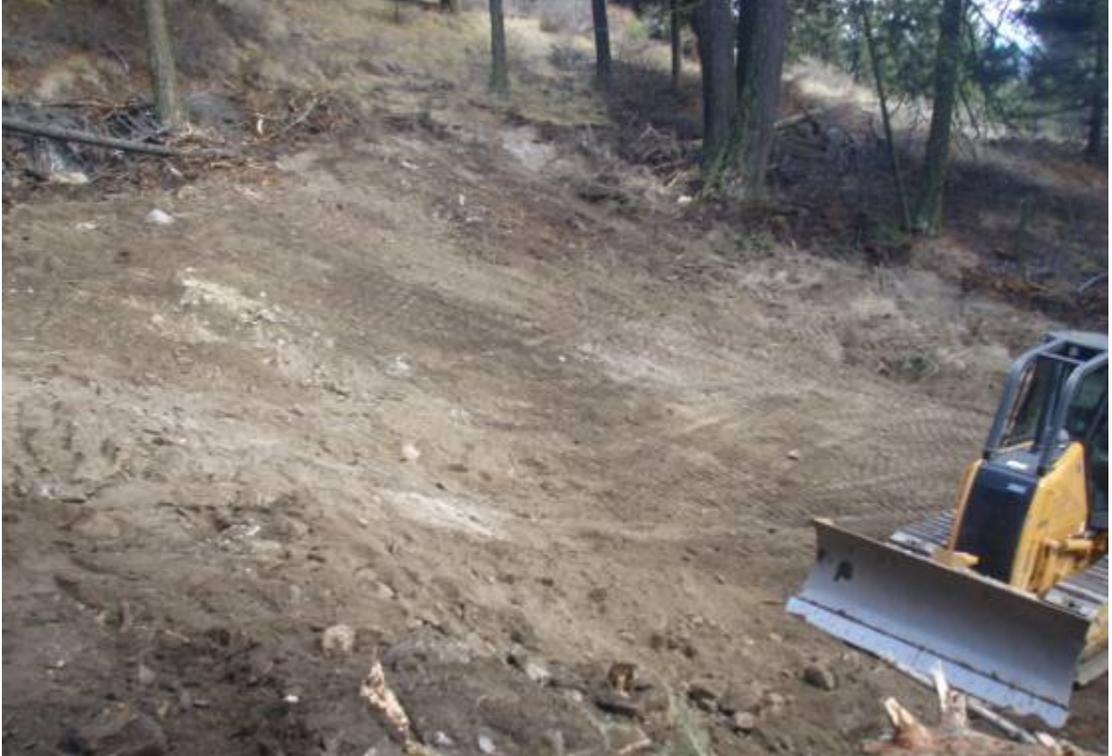
Photo No. 22	Date: October 27, 2010

Direction Photo Taken: Southeast			
Description: LWRP footprint following excavation of additional material.

- Following comparison to proposed soil cleanup criteria approximately an additional 120 loose cubic yards of soil from the LWRP footprint was excavated, hauled and consolidated with the UWRP.

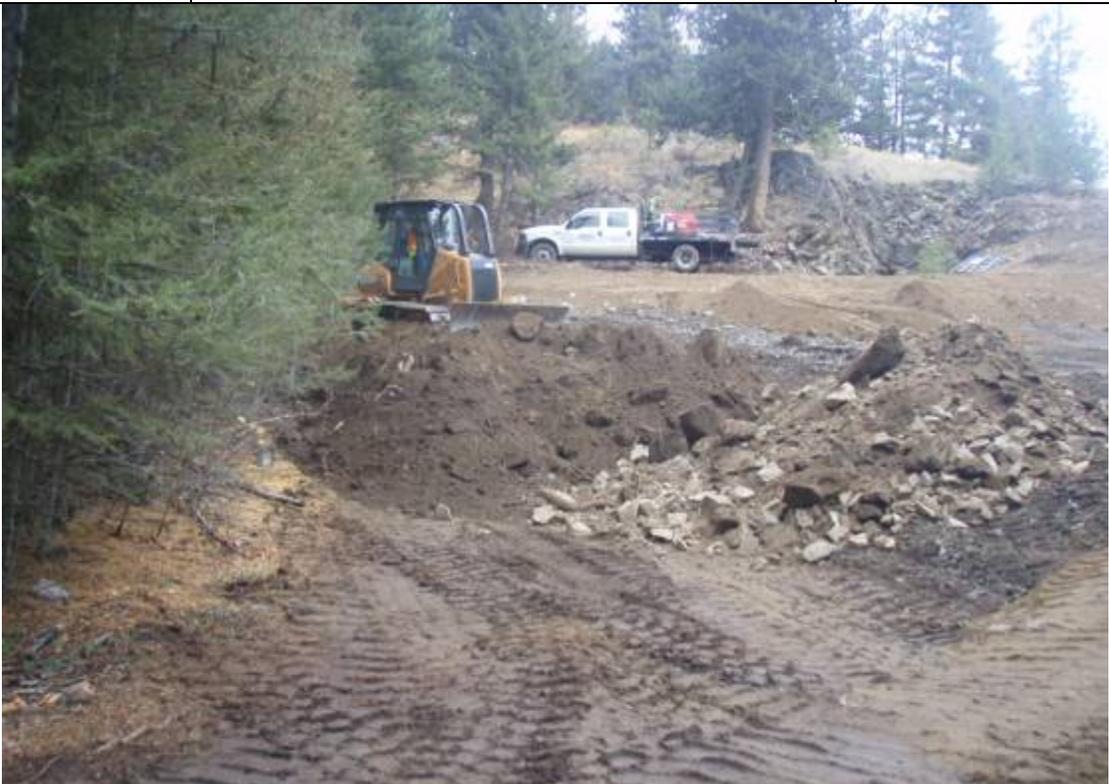
Client Name: United States Forest Service		Site Location: Kelly Camp Mine, Colville National Forest	Project No.: 25697239
Photo No.: 23	Date: October 27, 2010

Direction Photo Taken: North			
Description: Over excavation material from LWRP being graded at the consolidated waste rock pile.

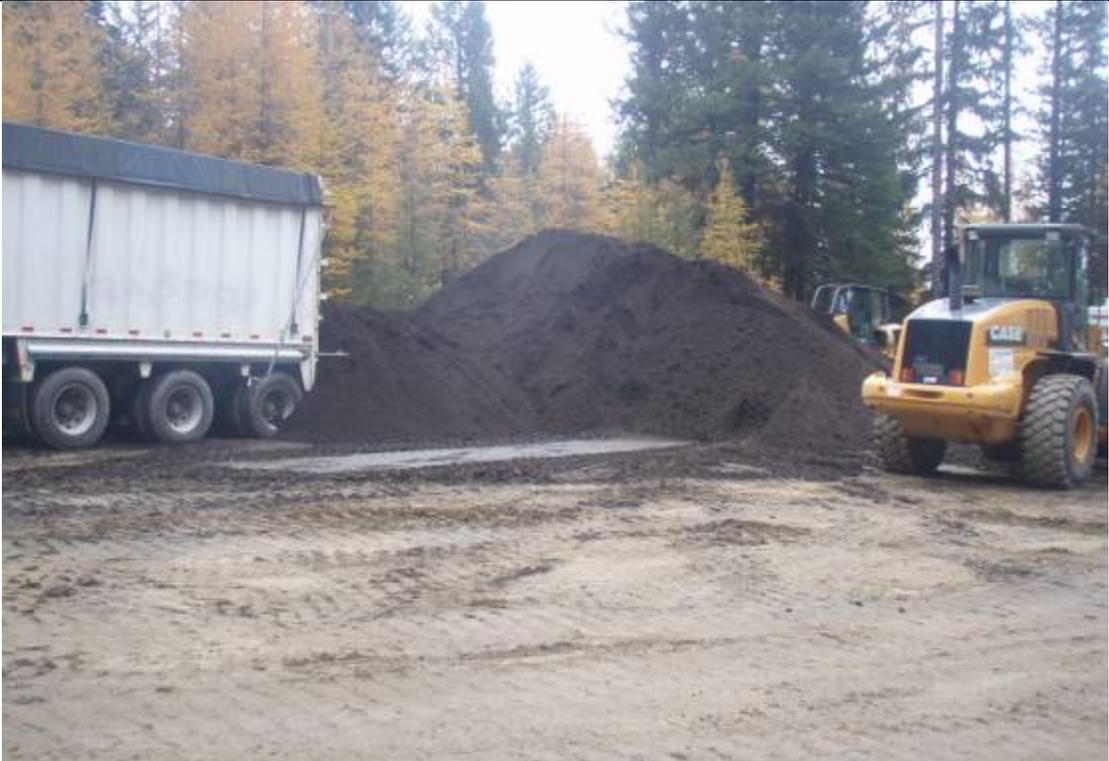
Photo No.: 24	Date: October 27, 2010

Direction Photo Taken: Southeast			
Description: Unloading and stockpiling Bonaparte Lake peat moss material at Fill #1 borrow area.

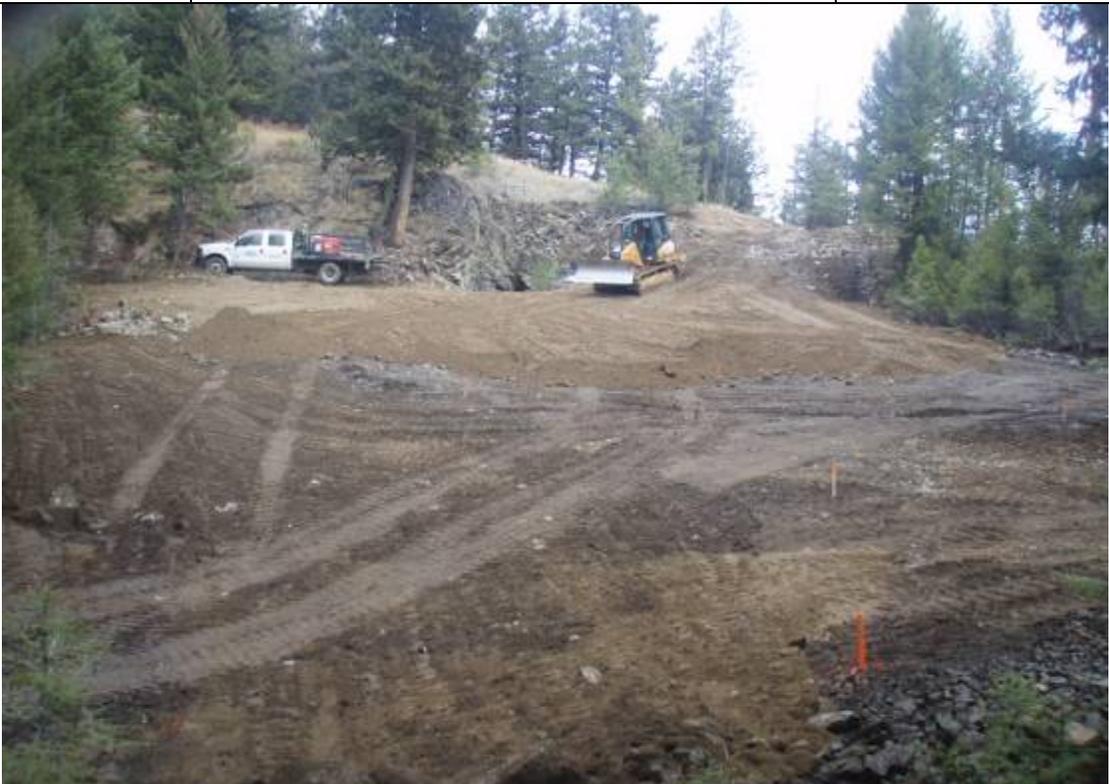
Client Name: United States Forest Service		Site Location: Kelly Camp Mine, Colville National Forest	Project No.: 25697239
Photo No.: 25	Date: October 27, 2010

Direction Photo Taken: North			
Description: Distributing and compacting borrow material on consolidated waste rock pile.

- Hauling of borrow material to cover the consolidated waste rock pile was completed. Approximately 944 loose cubic yards of borrow material was hauled from borrow area Fill #1, placed and compacted to a minimum depth of 12 inches with a dozer.

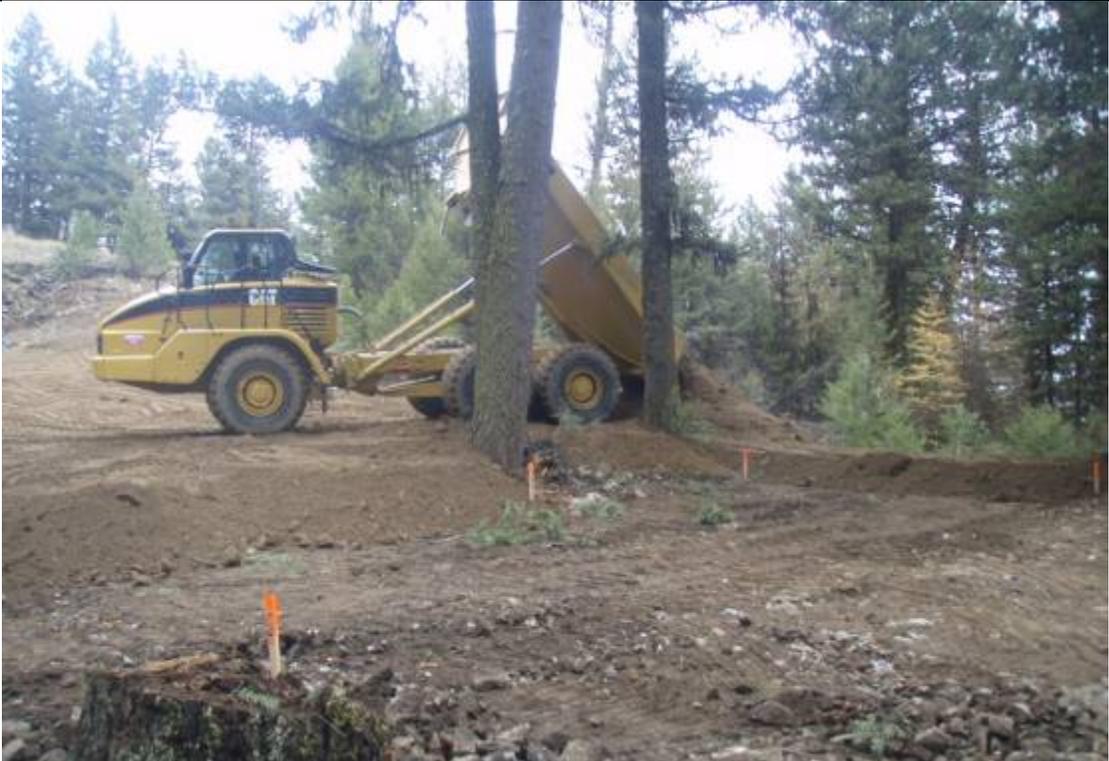
Photo No.: 26	Date: October 28, 2010

Direction Photo Taken: Northeast		
Description: Unloading borrow material at consolidated waste pile

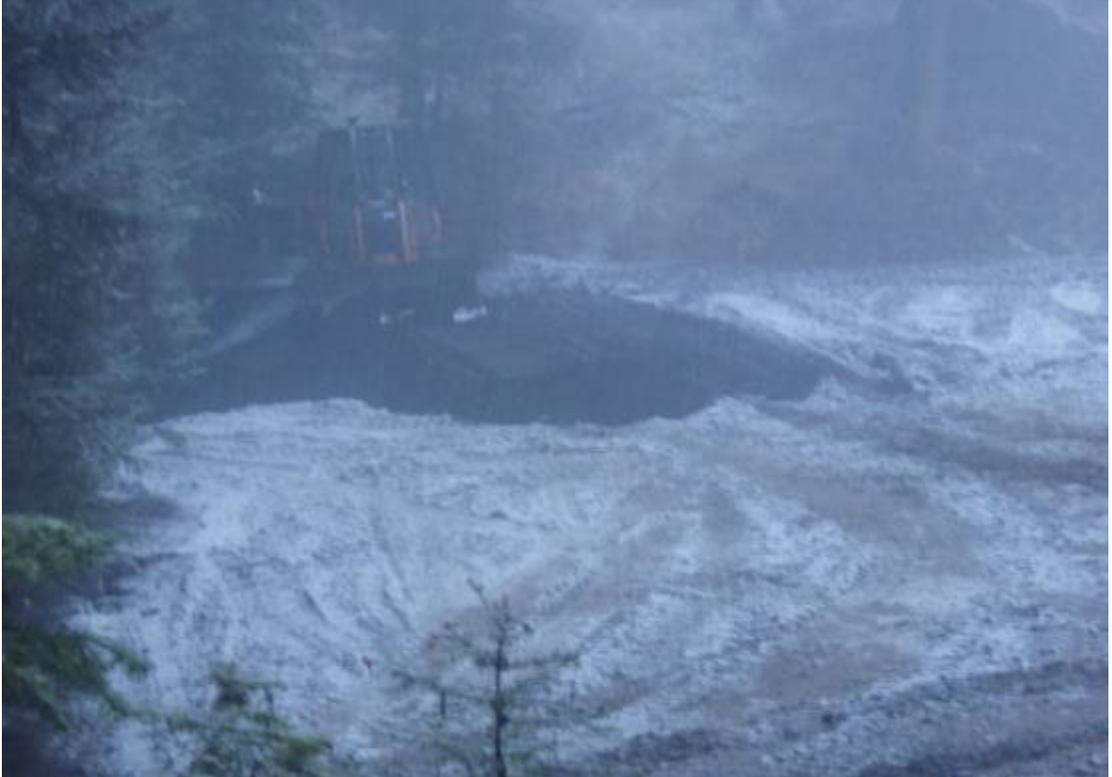
Client Name: United States Forest Service		Site Location: Kelly Camp Mine, Colville National Forest	Project No. 25697239
Photo No. 27	Date: October 29, 2010

Direction Photo Taken: North			
Description: Beginning peat moss placement on consolidated waste rock pile.

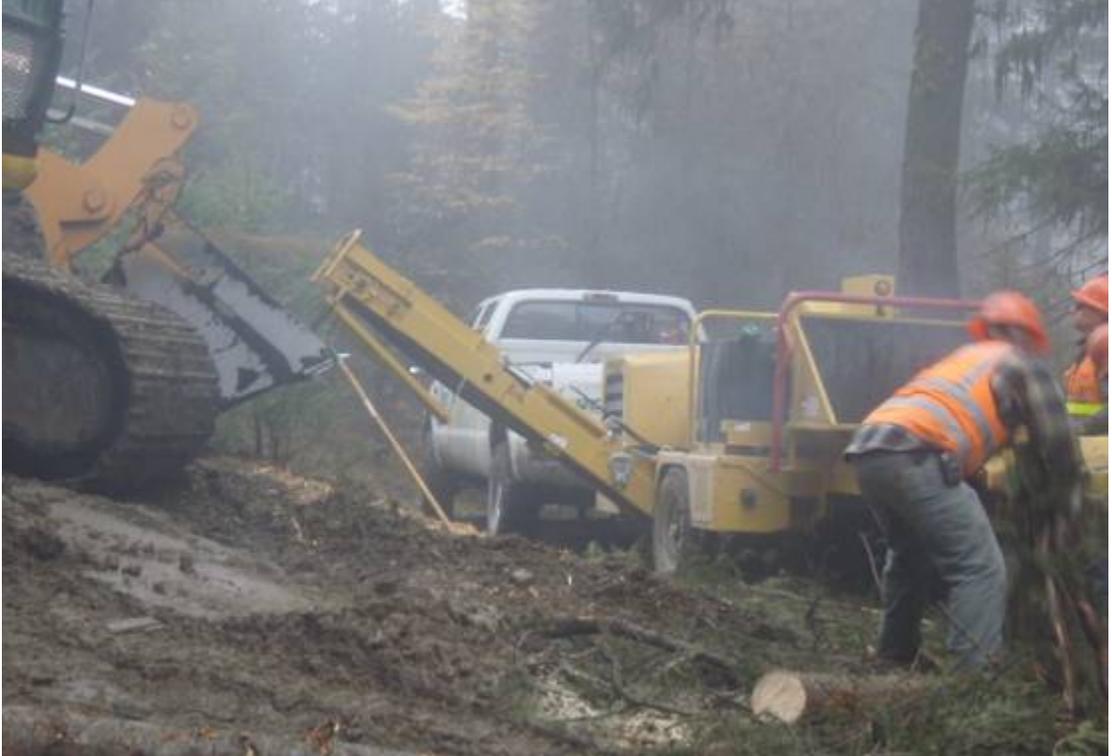
Photo No. 28	Date: October 29, 2010

Direction Photo Taken: Northeast			
Description: Shredding cleared vegetation stockpile.

- NRC began hauling peat moss from the Fill #1 borrow area to the UWRP and LWRP.
- Anchors were installed for the bat gate at the upper workings.
- Shredding of stockpiled vegetation began, with approximately ¾ of stockpile shredded by the end of October 29, 2010 resulting in approximately 8 loose cubic yards of mulch.

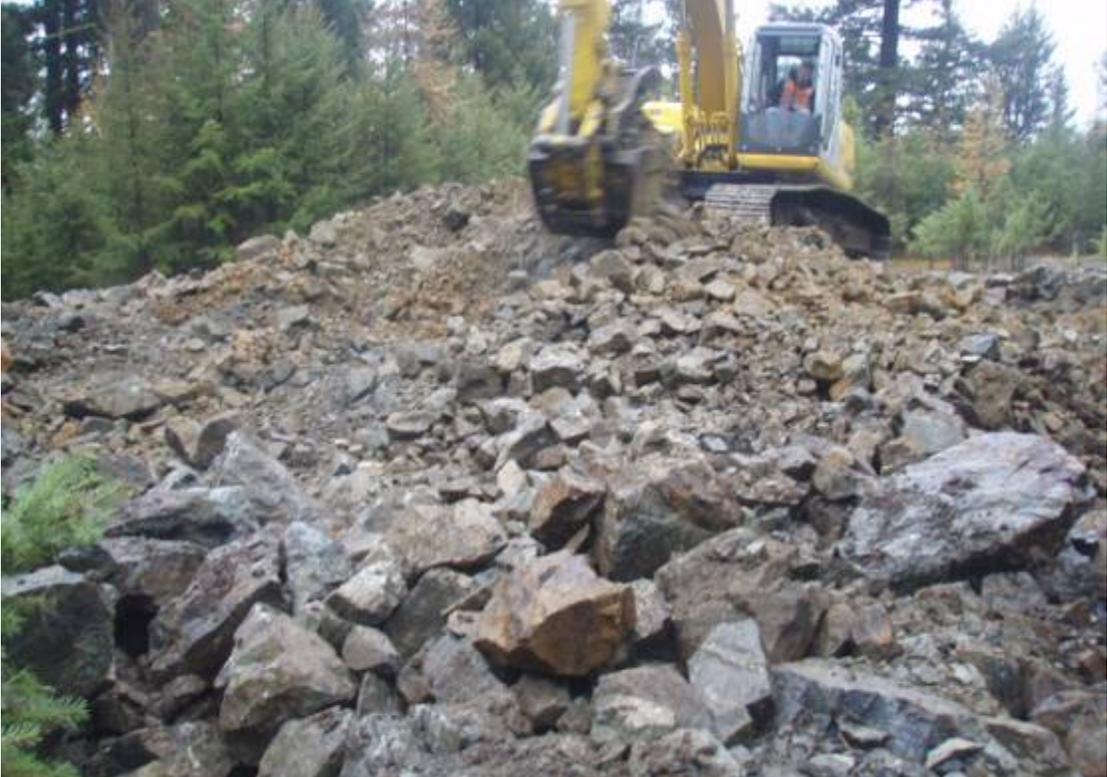
Client Name: United States Forest Service		Site Location: Kelly Camp Mine, Colville National Forest	Project No.: 25697239
Photo No.: 29	Date: November 1, 2010

Direction Photo Taken: South			
Description: Using excavator to level blast rock pile.
