REMOVAL ACTION REPORT
Kelly Camp Mine, Colville National
Forest

December 2010

Prepared for:
USDA Forest Service

Prepared by:
URS
111 S.W. Columbia, Suite 1500
Portland, Oregon 97201-5850
25697239

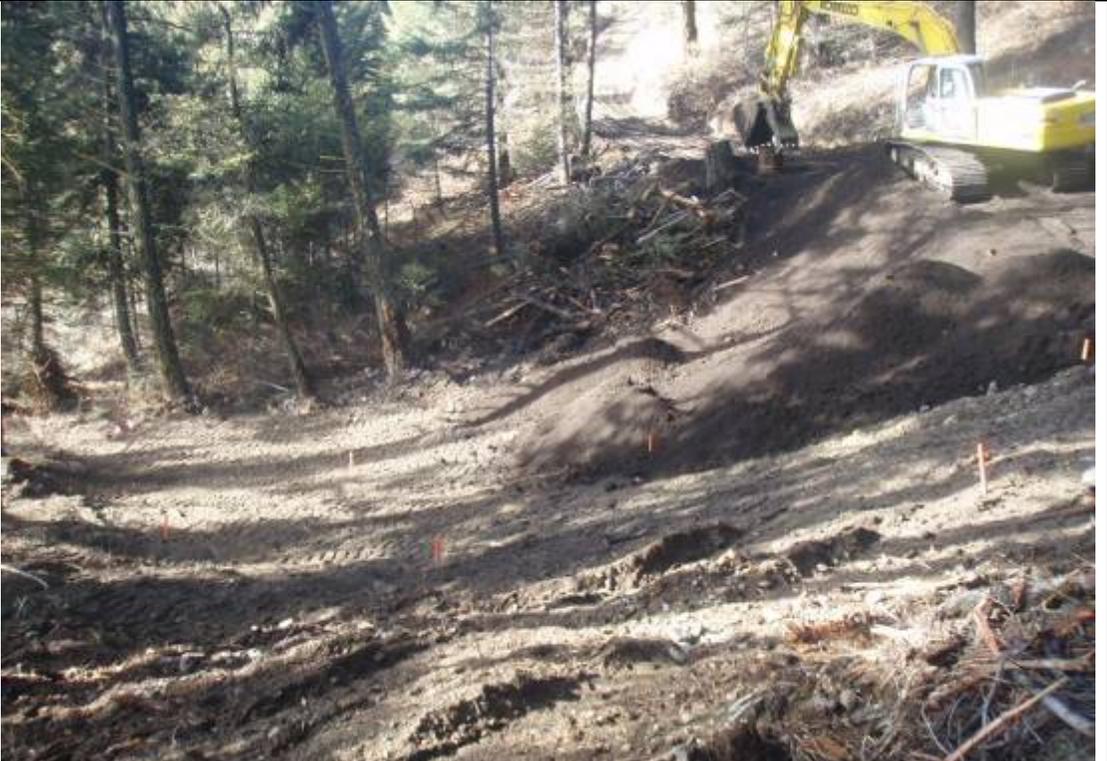
Photo No.: 30	Date: November 2, 2010

Direction Photo Taken: West			
Description: Placing compost on LWRP footprint.

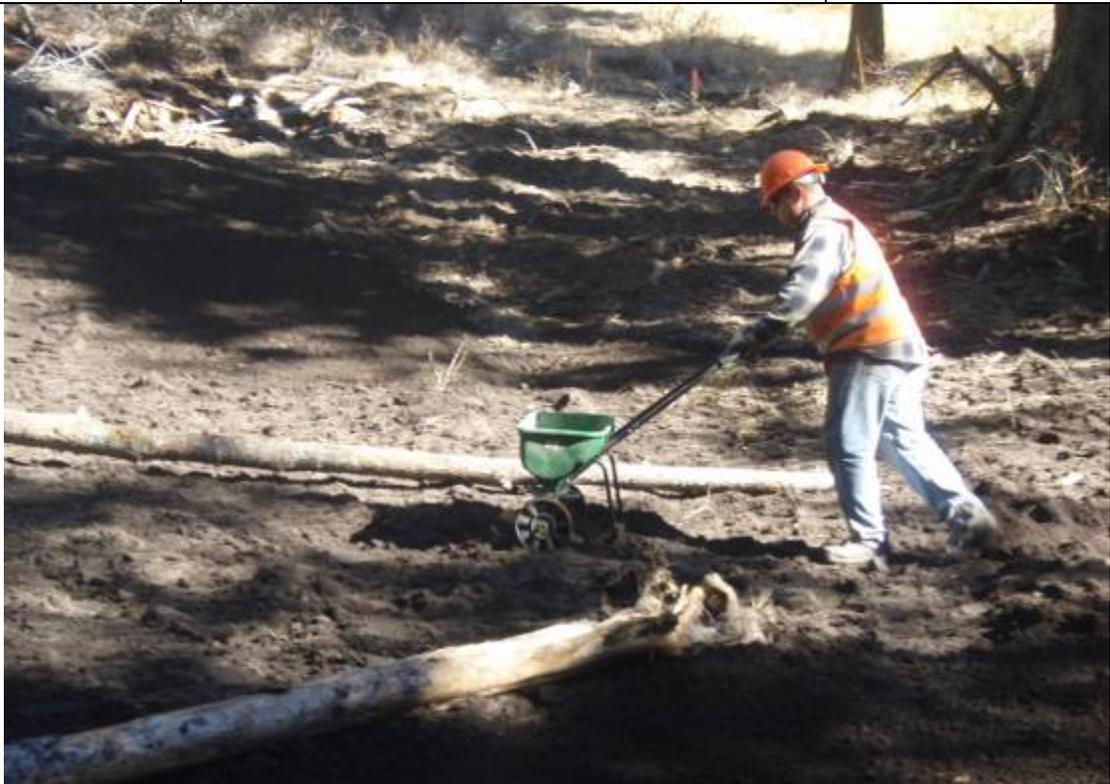
Description: Distributing seed at LWRP.

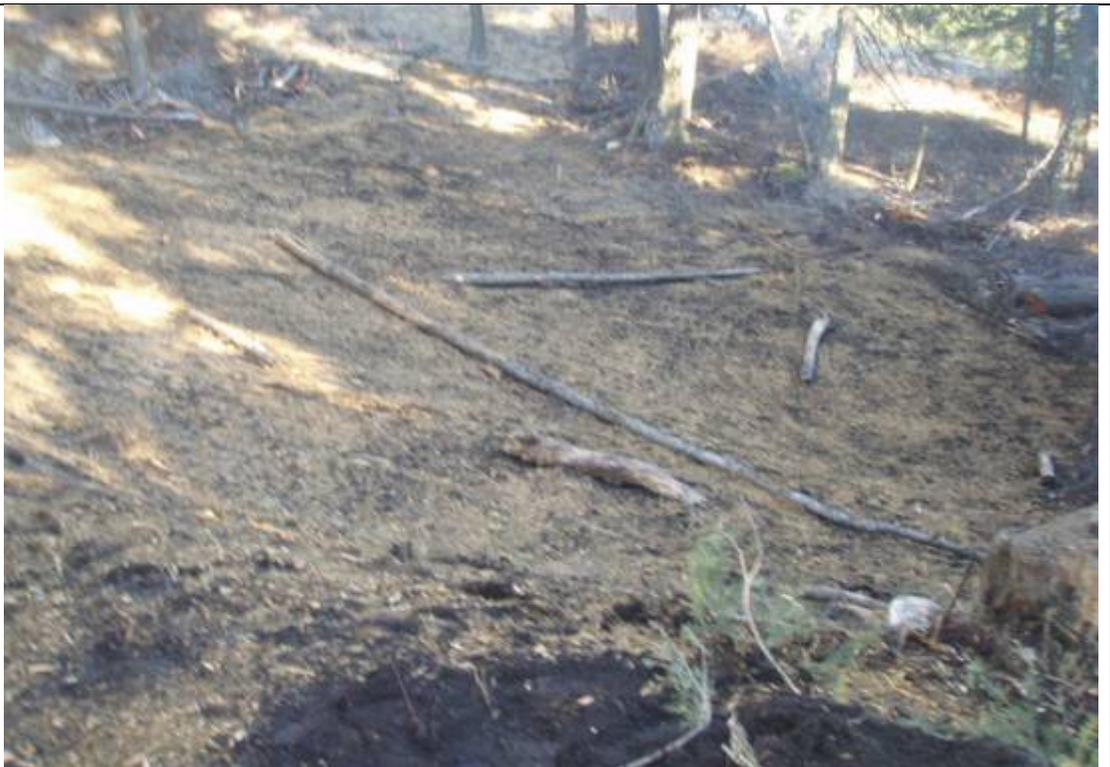
Photo No. 32	Date: November 3, 2010
------------------------	----------------------------------

Description: Completed restoration at LWRP footprint.

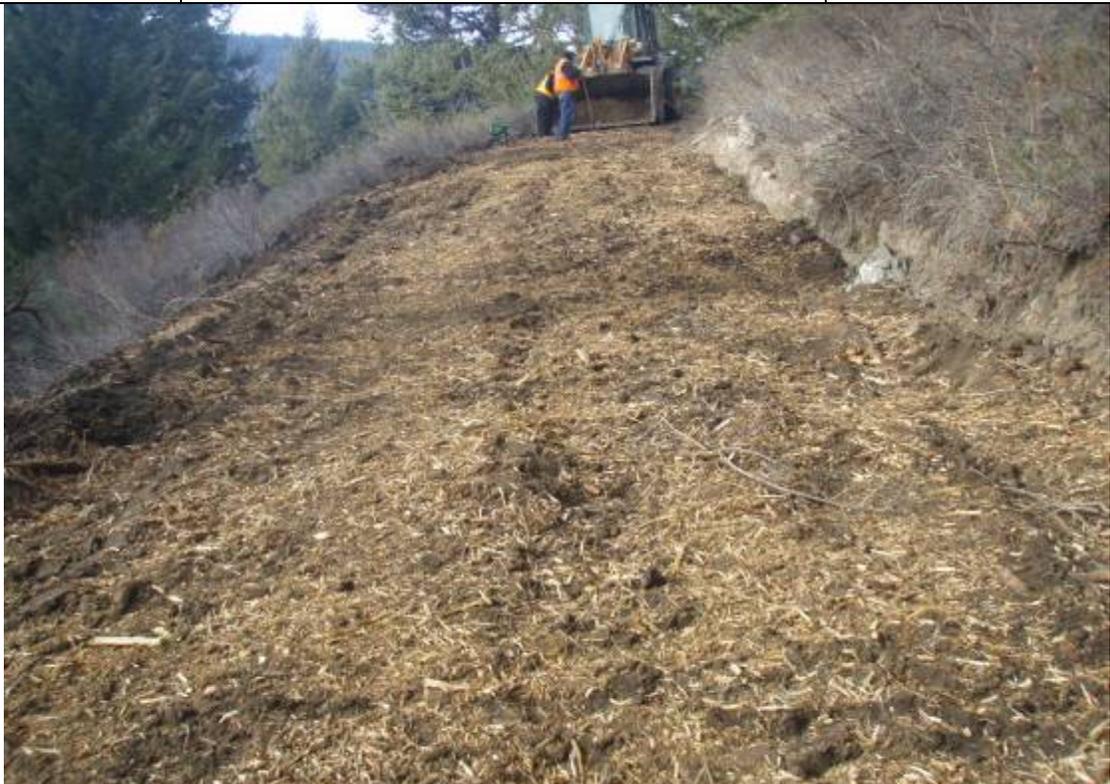
Description:
LWRP access road following ripping, seeding, raking and mulching. Note water bar installed at top of pictured road portion pictured.

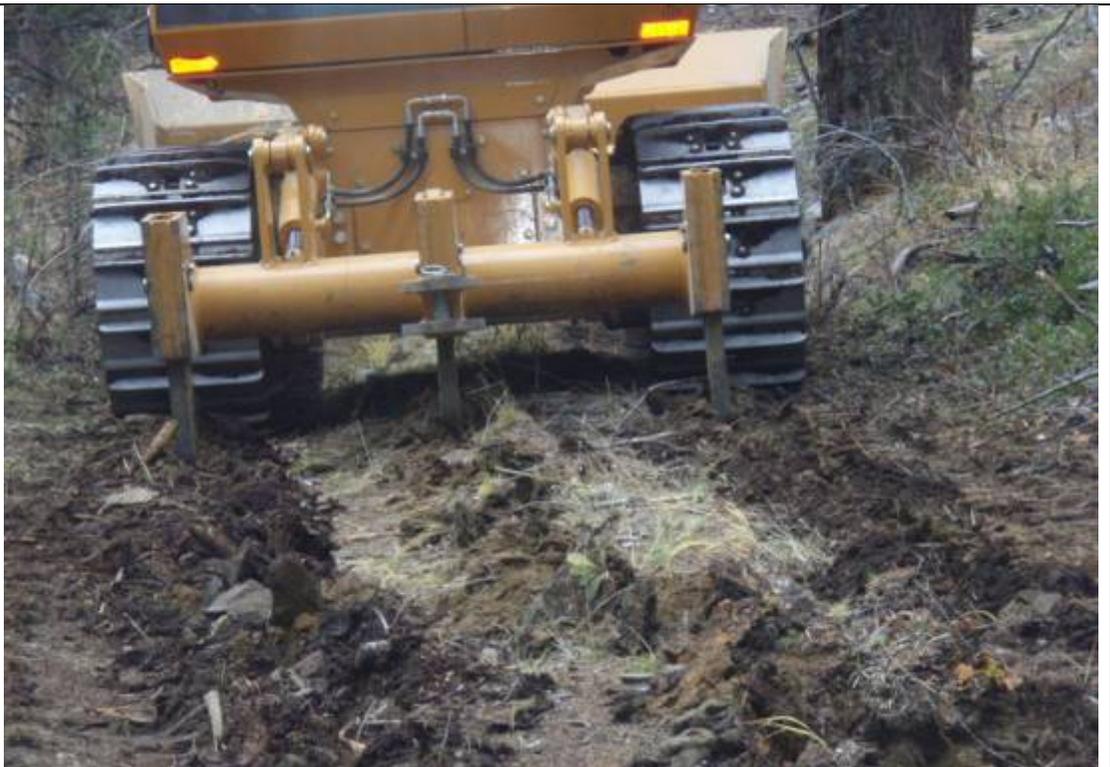
Photo No. 34	Date: November 5, 2010
------------------------	----------------------------------

Description:
Ripping access road to blast rock pile.

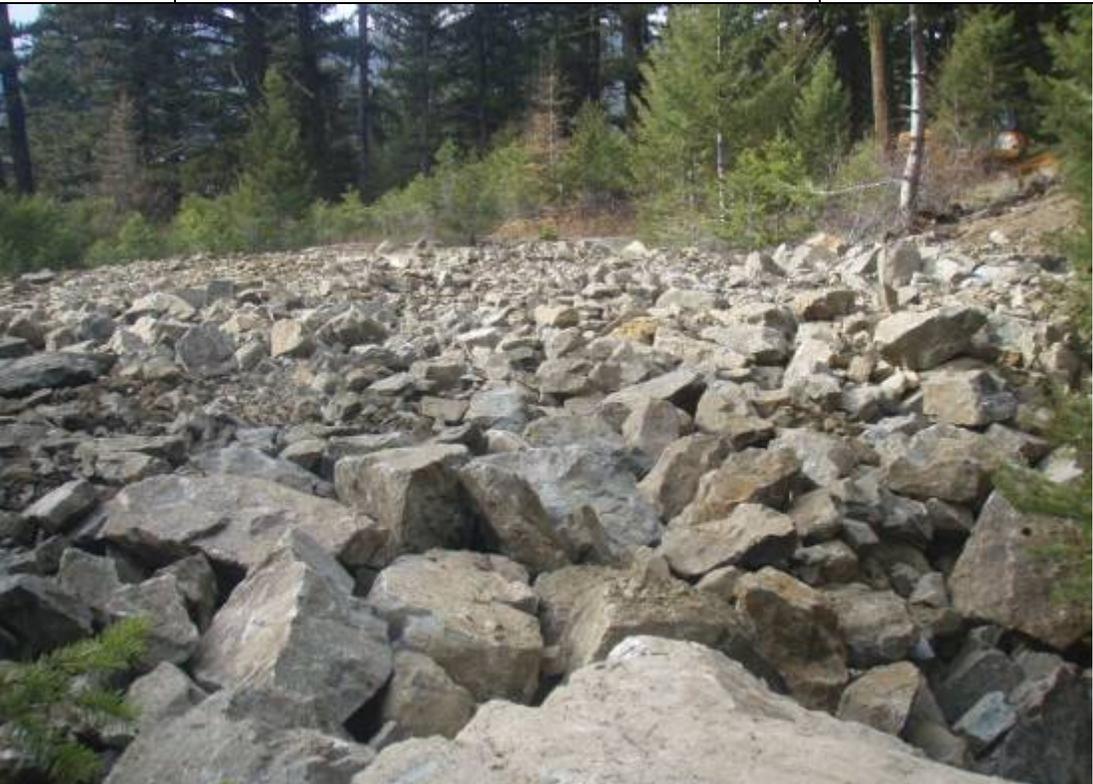
Client Name: United States Forest Service		Site Location: Kelly Camp Mine, Colville National Forest	Project No.: 25697239
Photo No.: 35	Date: November 5, 2010

Direction Photo Taken: West			
Description: Blast rock pile following leveling.

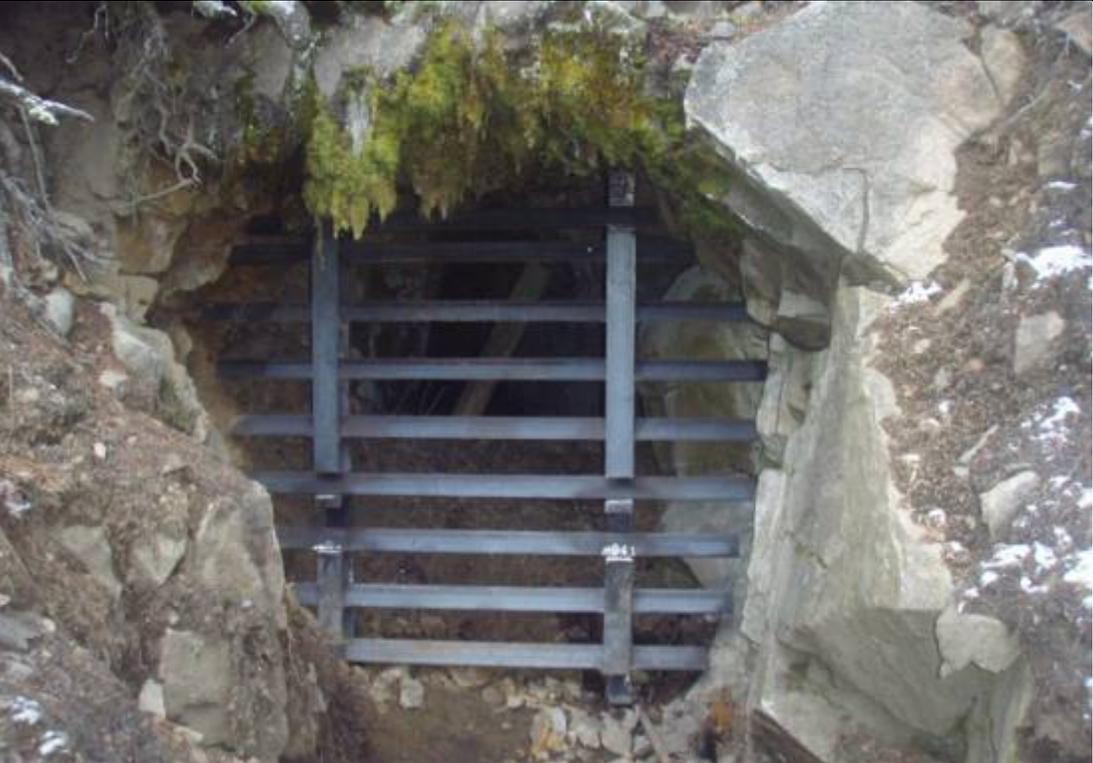
Photo No.: 36	Date: November 9, 2010

Direction Photo Taken: North		
Description: Finished gate at lower adit.

- Installation of the lower bat gate was completed.
- Additional loads of Bonaparte Lake peat moss material were received at borrow area Fill #1. Approximately 240 cubic yards were received during the week ending October 29, 2010. A total of 840 loose cubic yards were received at the Fill #1 borrow area during the RA.

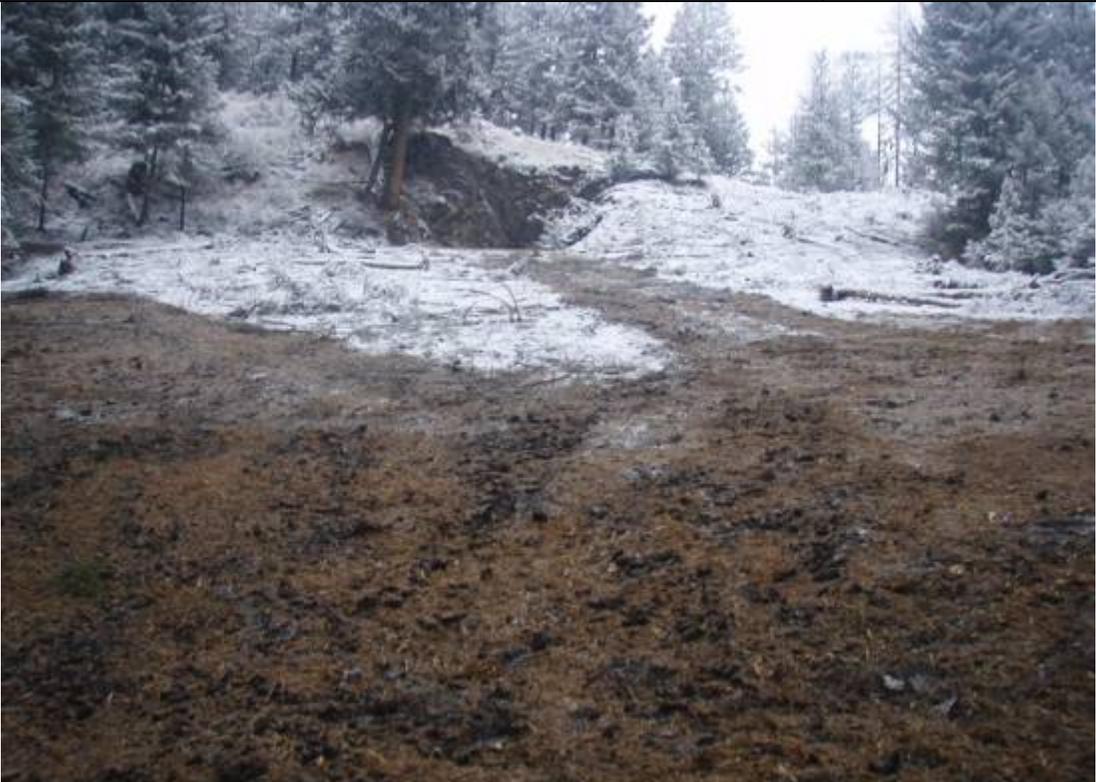
Client Name: United States Forest Service		Site Location: Kelly Camp Mine, Colville National Forest	Project No. 25697239
Photo No. 37	Date: November 9, 2010

Direction Photo Taken: Northe			
Description: Restoration of consolidated waste rock complete.

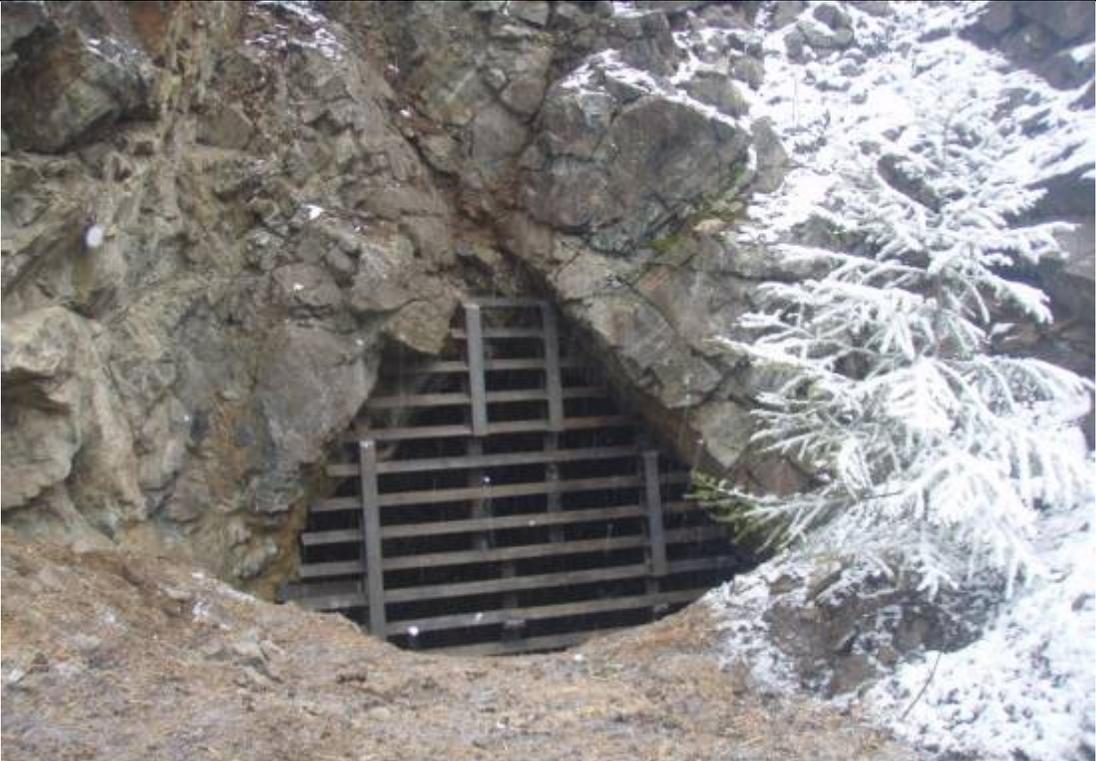
Photo No. 38	Date: November 9, 2010

Direction Photo Taken: North		
Description: Completed gate at UWRP.

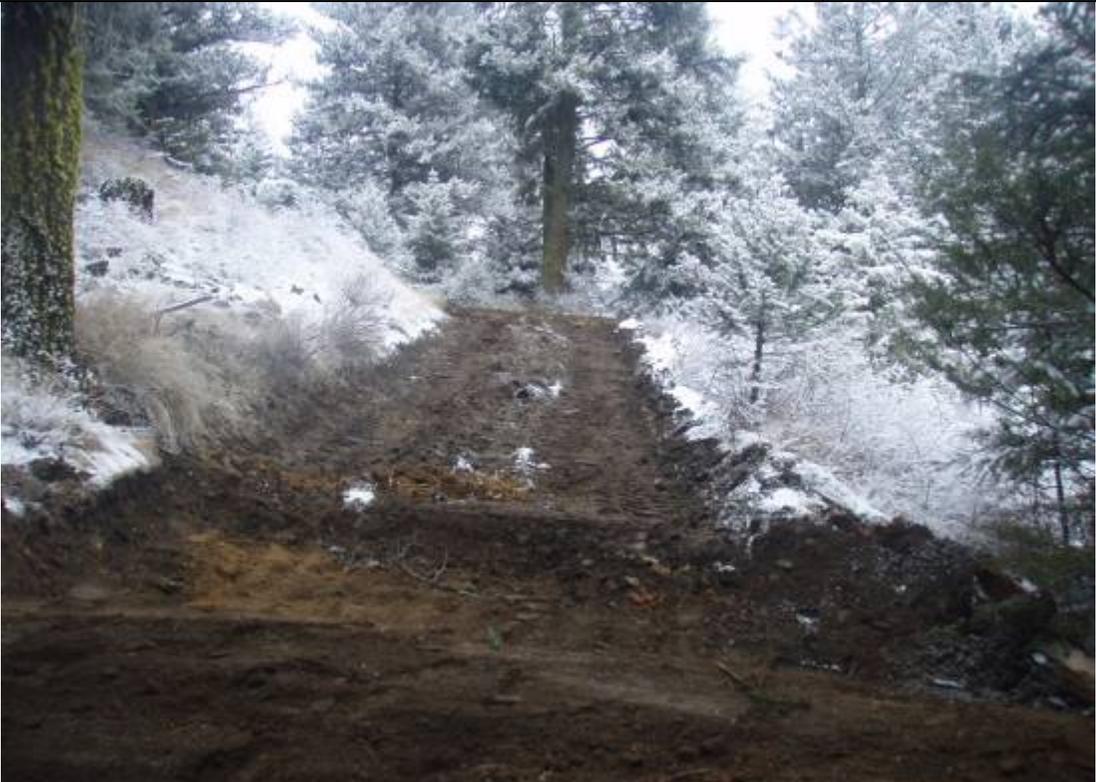
Client Name: United States Forest Service		Site Location: Kelly Camp Mine, Colville National Forest	Project No. 25697239
Photo No. 40	Date: November 9, 2010

Direction Photo Taken: East			
Description: Water bar installed on upper access road.

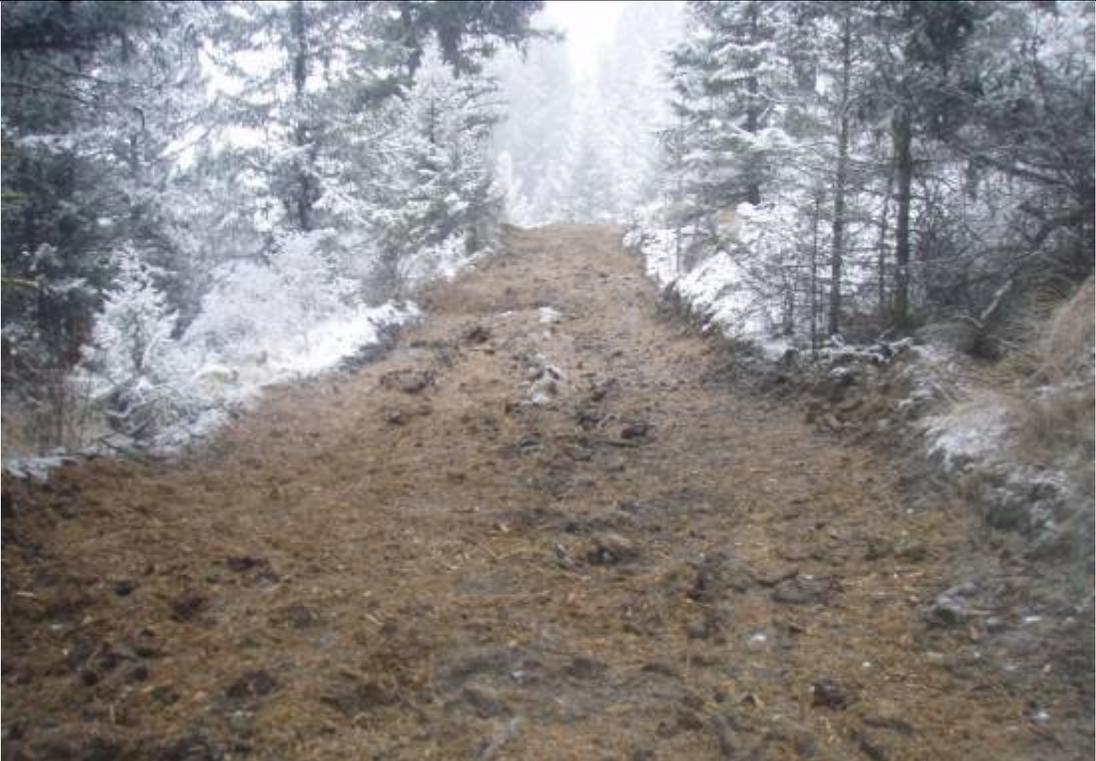
Photo No. 41	Date: November 5, 2010

Direction Photo Taken: South			
Description: Upper access road following ripping, water-barring, seeding, raking and mulching.

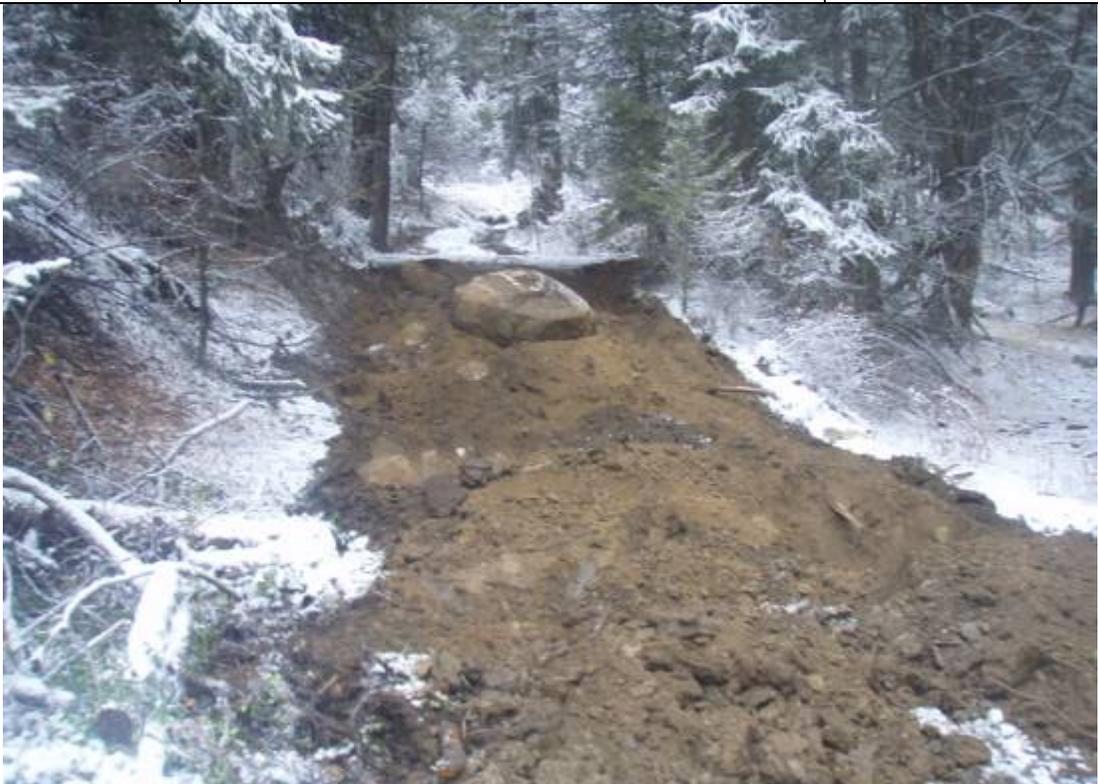
Client Name: United States Forest Service		Site Location: Kelly Camp Mine, Colville National Forest	Project No.: 25697239
Photo No.: 42	Date: November 9, 2010

Direction Photo Taken: North			
Description: Blockage of road up to blast rock pile.

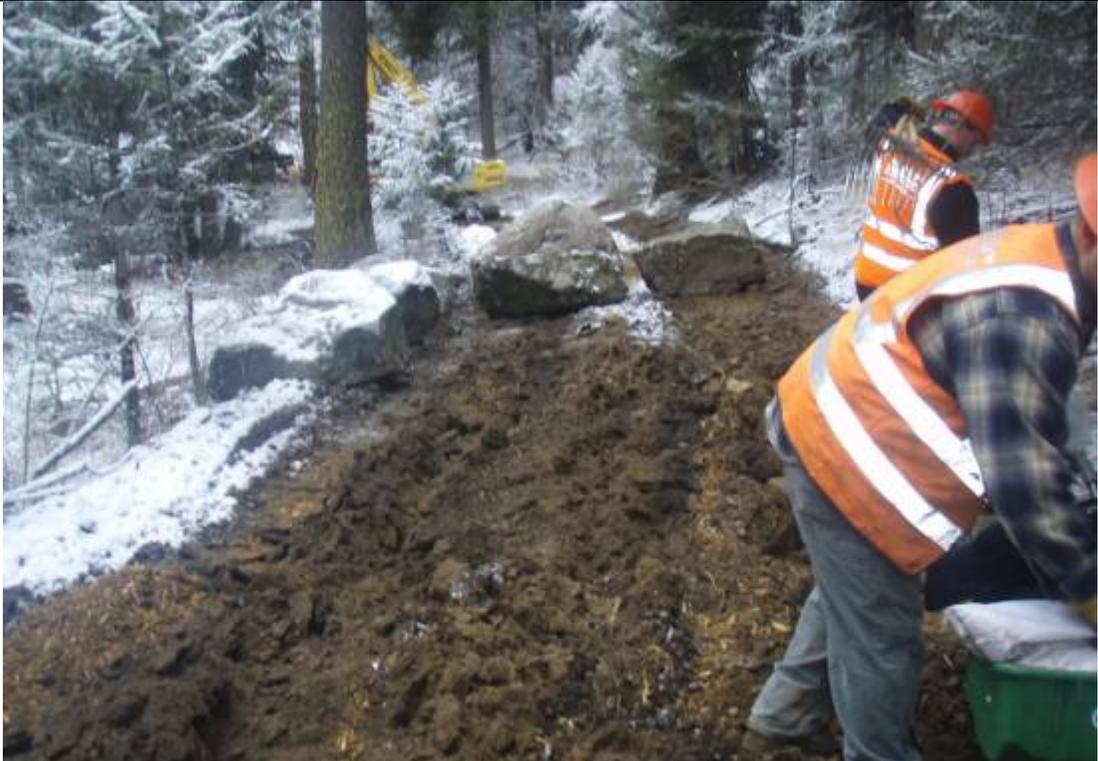
Photo No.: 43	Date: November 9, 2010

Direction Photo Taken: West			
Description: Boulders placed to block access roads to UWRP and LWRP.

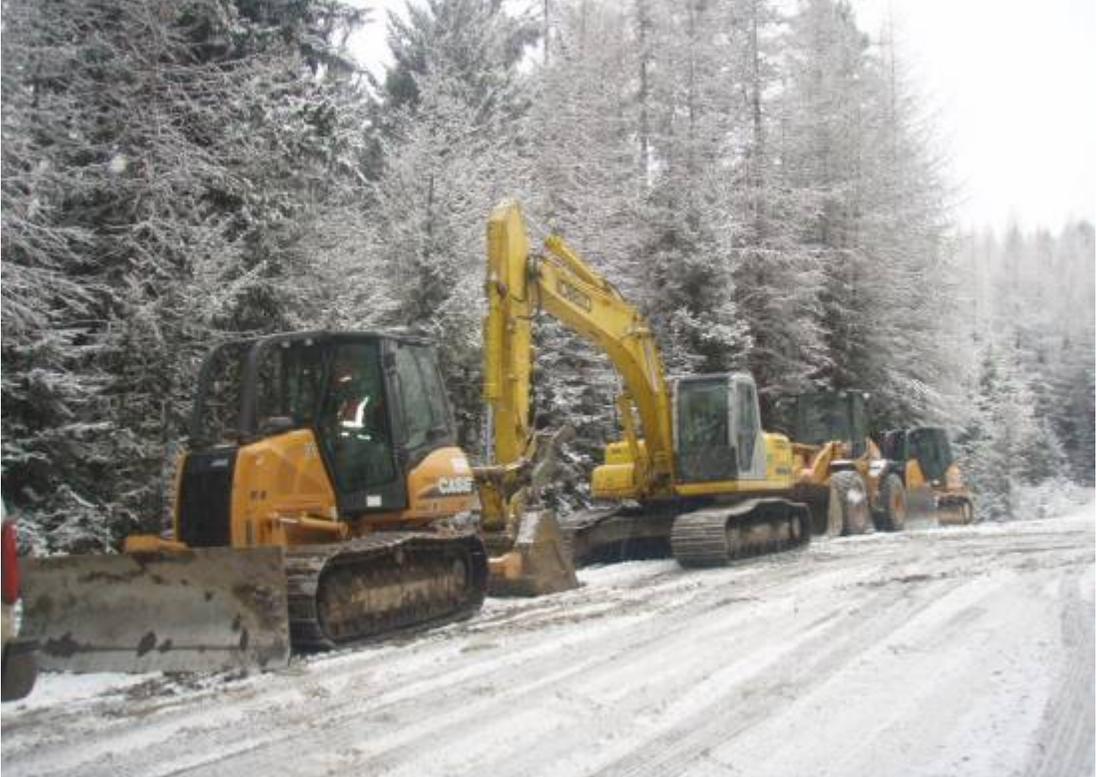
Client Name: United States Forest Service		Site Location: Kelly Camp Mine, Colville National Forest	Project No.: 25697239
Photo No.: 44	Date: November 9, 2010

Direction Photo Taken: West			
Description: Equipment staged for demobilization.

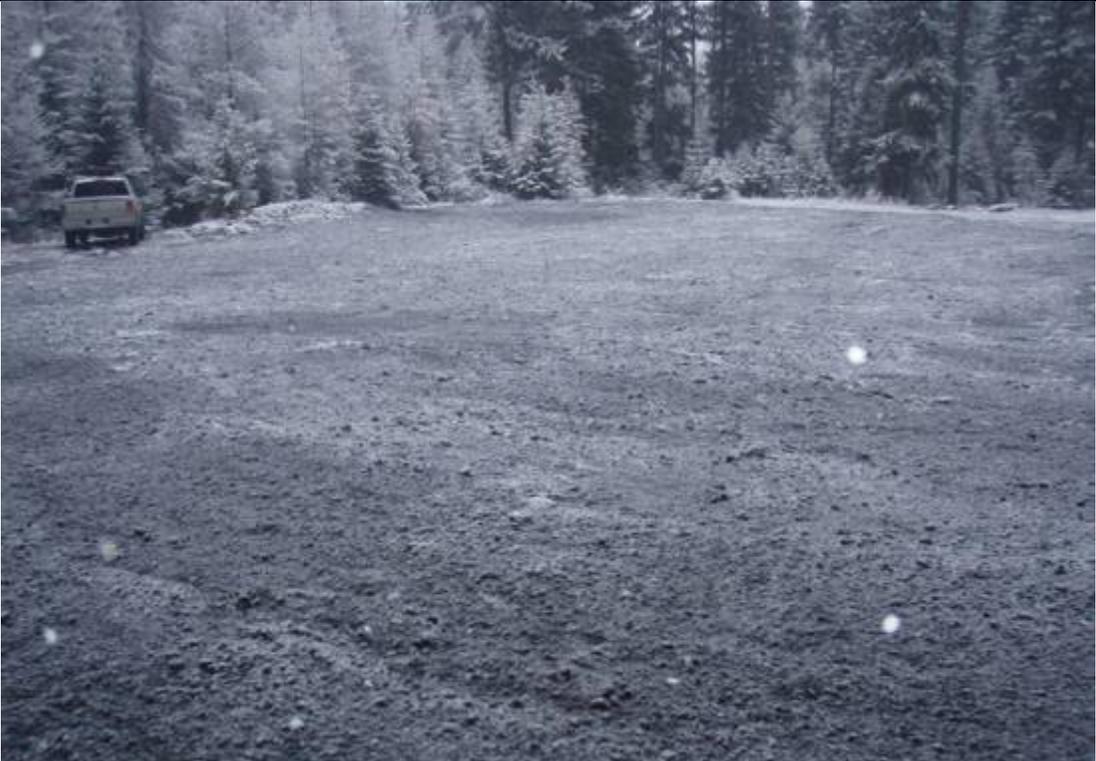
Photo No.: 45	Date: November 9, 2010

Direction Photo Taken: Southeast		
Description: Borrow area following restoration..

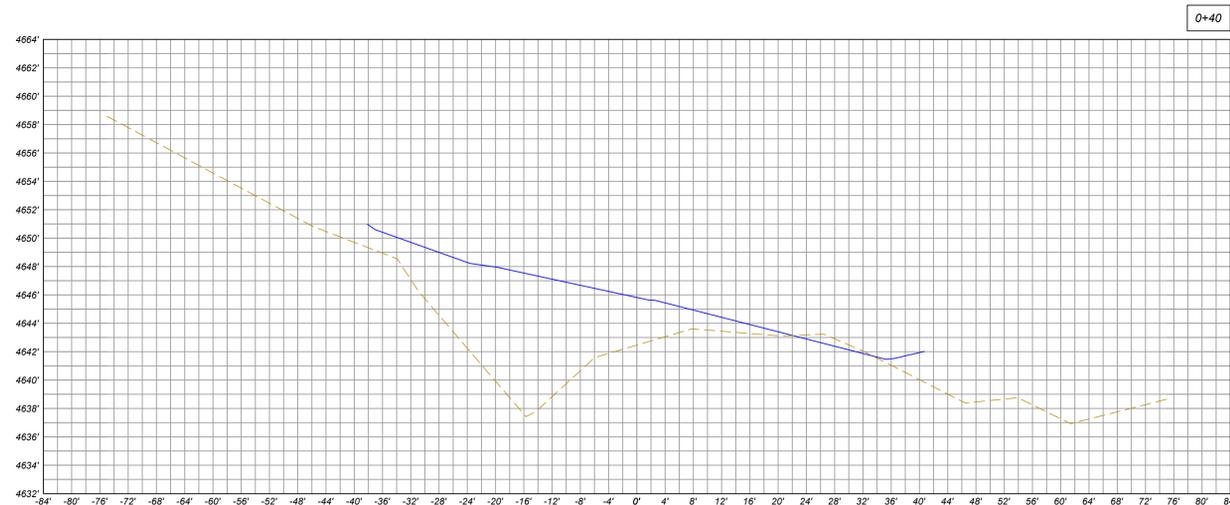
Topographic, Boundary and Volume Survey

NOTE:
 The volume tables shown herein indicate the cumulative volume totals, station by station, using the average cross-section area method of volume calculations. For comparison, the total cut and fill volumes computed using the composite method are listed below the respective table. The minor variation in volumes are due to the limited number of samplings when the average mean area method is used. With an increase in sampling, the volume totals would be closer to the volumes computed by the composite method.
 On the profile views shown on Sheets 2 and 3, the blue lines represent the comparison surface and the brown dashed lines the original ground surface which was provided by others. The left and right end points of the blue lines represent the horizontal limit of the comparative (finish ground) surface. The fact that the end points of the finish ground surface (blue lines) don't meet the original ground surface (brown lines) indicates that the peat moss fill areas were over ground that had been excavated after the original ground and before the finish ground survey was executed.
