19 April 2004
13890.20

**SUBJECT: Index Sportsmen's Club – Final Field Investigation Report
Mt. Baker-Snoqualmie National Forest**

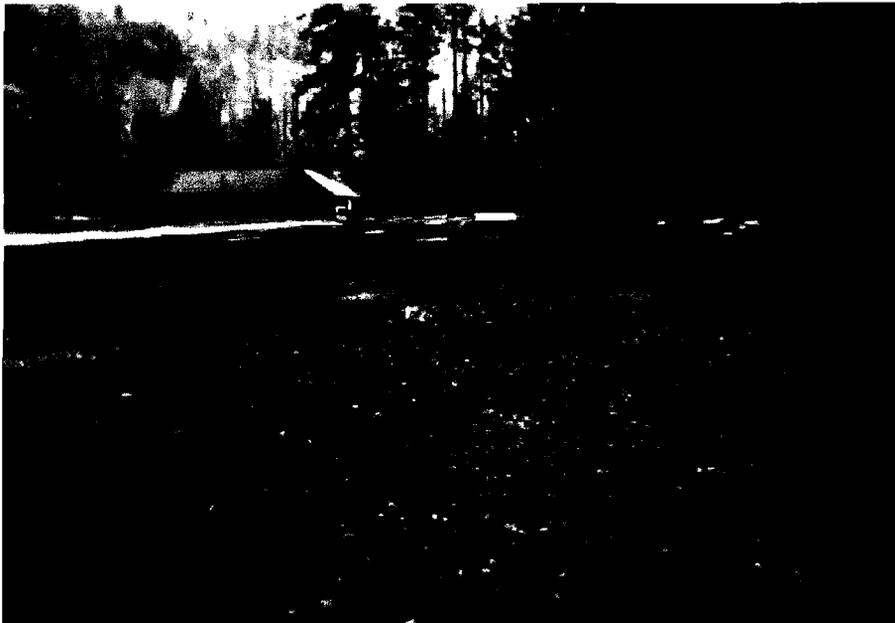
Photo 12 Date: 11/12/03 Looking south across the site and sampling location TA-06 (dirt pile). Note
Time: 1315 surface debris.

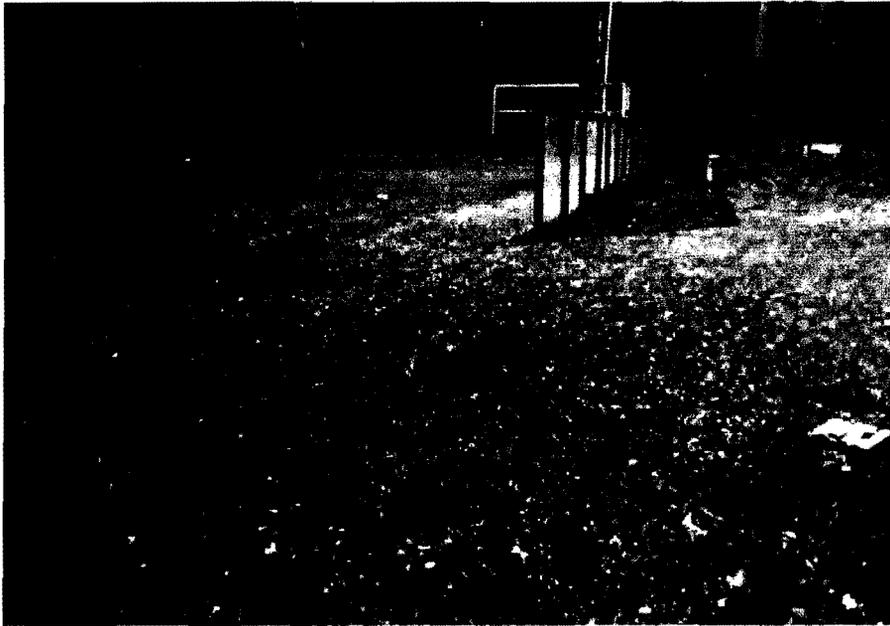
Photo 13 Date: 11/12/03 Looking north across sampling location TA-07 (dirt pile). Note debris on
Time: 1345 land surface.

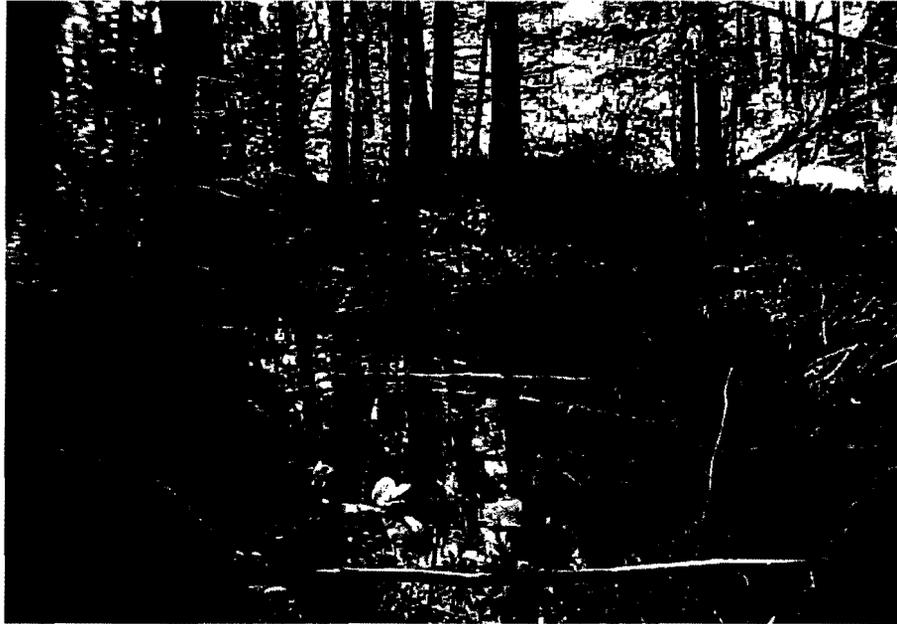
Photo 17

Surface water tends to pond in the wooded area north of the cleared range area. This is also the area where the vast majority of the shot accumulates. The high organic content of the soils in this area tends to cause a low soil pH. This, in turn, tends to cause accelerated degradation of the shot, with dissolved lead released to the environment. In addition, lead shot and dissolved lead can be moved by surface water runoff, causing it to concentrate in low, ponded areas. Although surface water was observed to flow from east to west in a discontinuous drainage along the railroad berm, the water ponded in several areas with no apparent outlet.

Date: 02/12/04 Ponded water in depression north of the site.
Time: 1217

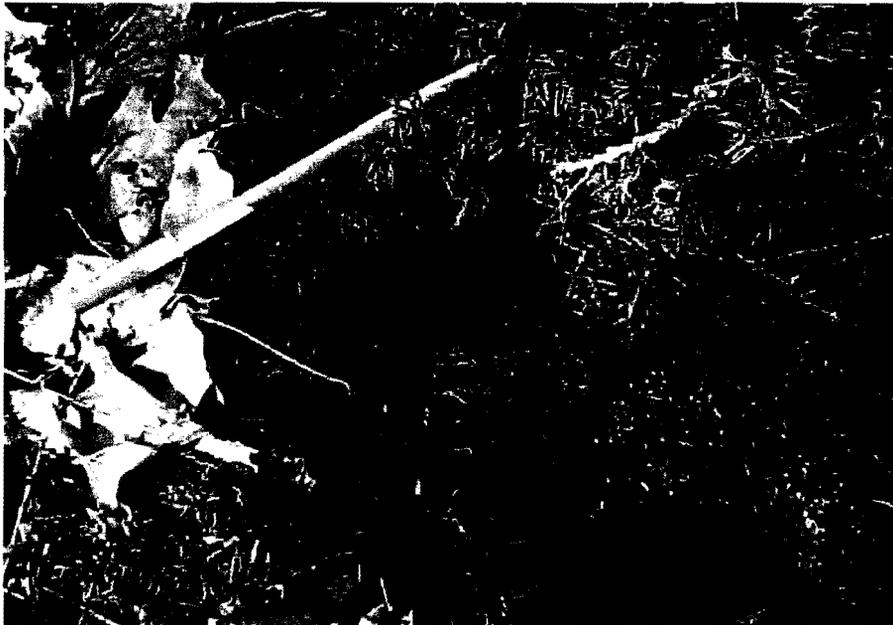
Photo 18

Surface soil samples from the wooded area, north of the cleared range area, were collected from locations with large amounts of visible shot. The shot was sieved out of the samples. Surface soil samples collected from this area contained elevated concentrations of lead (exceeding all of the comparison criteria). A couple of these samples also contained elevated concentrations of arsenic. The highest concentrations of lead and arsenic were detected in a surface soil sample collected from a depression which collects stormwater runoff from the site area (location TA-14; see Figure 2 and Photo 18). A large amount of shot was observed in soil throughout much of this depression. Shot observed on and near the

Date: 02/12/04 Abundant shot in soil just beneath the moss cover (cover is peeled back).
Time: 1220 Located in the depression north of about mid-site, near sampling location TA-14.

- Add lime to soil periodically to maintain a pH of approximately 7. Lime spreading is particularly important in heavily wooded areas where soil removal is difficult and where surface detritus tends to increase soil acidity.

- Add phosphate to soil to tie up lead. Phosphate addition is especially important in locations where there is a high potential for migration of lead to groundwater (i.e., low soil pH and shallow groundwater).

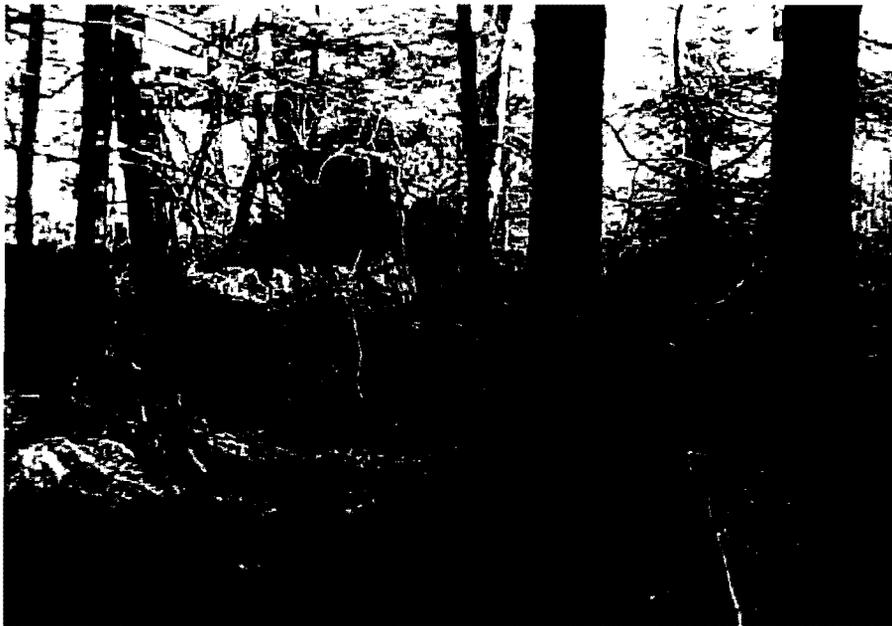
Photo 20 Date: 02/12/04 Looking across sampling location TA-14, toward the range (south). Note
Time: 1509 very dense vegetation.
