REMOVAL ACTION FINAL REPORT
Beth Lake Prospect, Okanogan and
Wenatchee National Forests

September 2009

Prepared for:
USDA Forest Service

Prepared by:
URS
111 S.W. Columbia, Suite 1500
Portland, Oregon 97201-5850
25696997

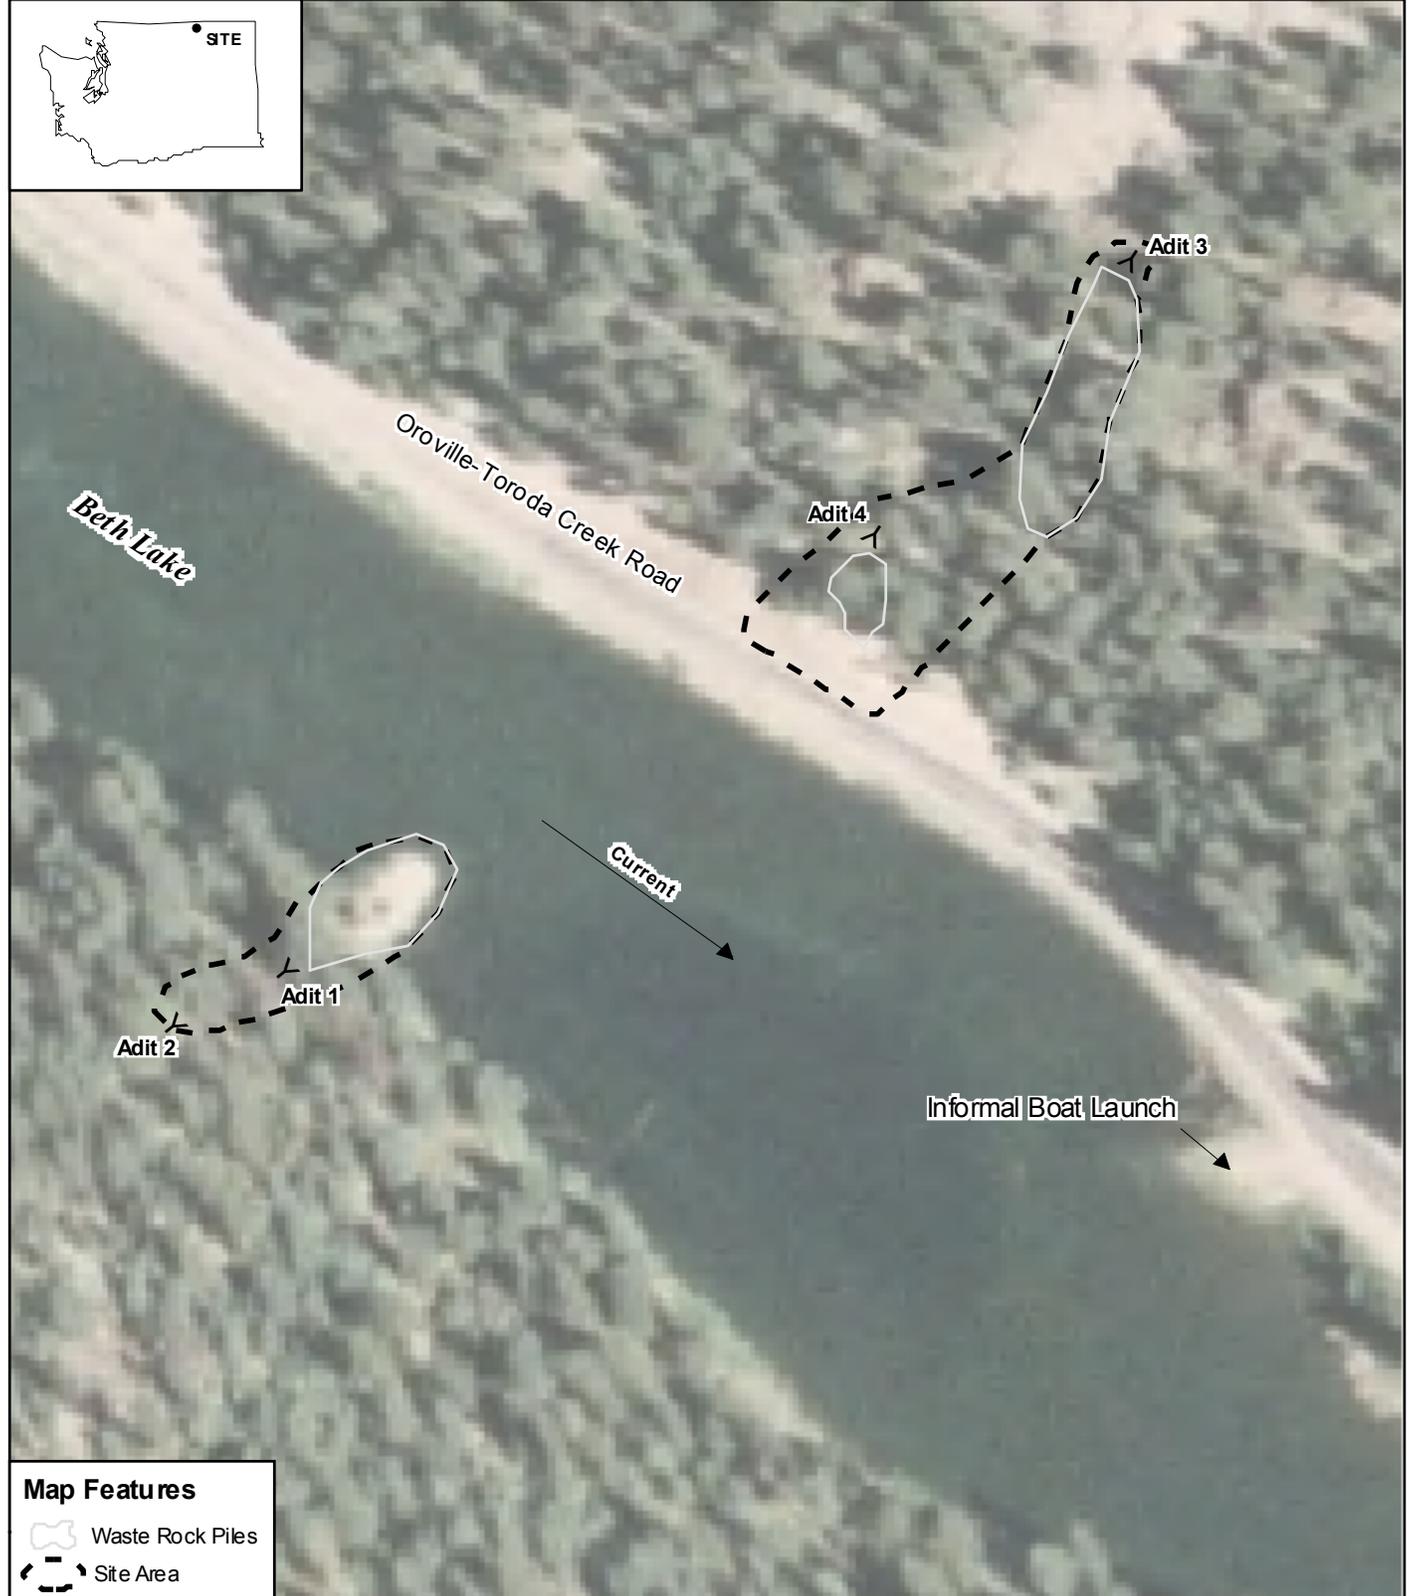
FIGURE 2

SITE AREA
UNITED STATES FOREST SERVICE
BETH LAKE PROSPECT - REMOVAL ACTION
CHESAW, WASHINGTON

There is an informal boat launch on the north side of Beth Lake and east of Adit 1 (Figure 2) that served as a staging area for aggregate cap rock and as the loading area for barge activities while transporting machinery and cover materials across the lake.

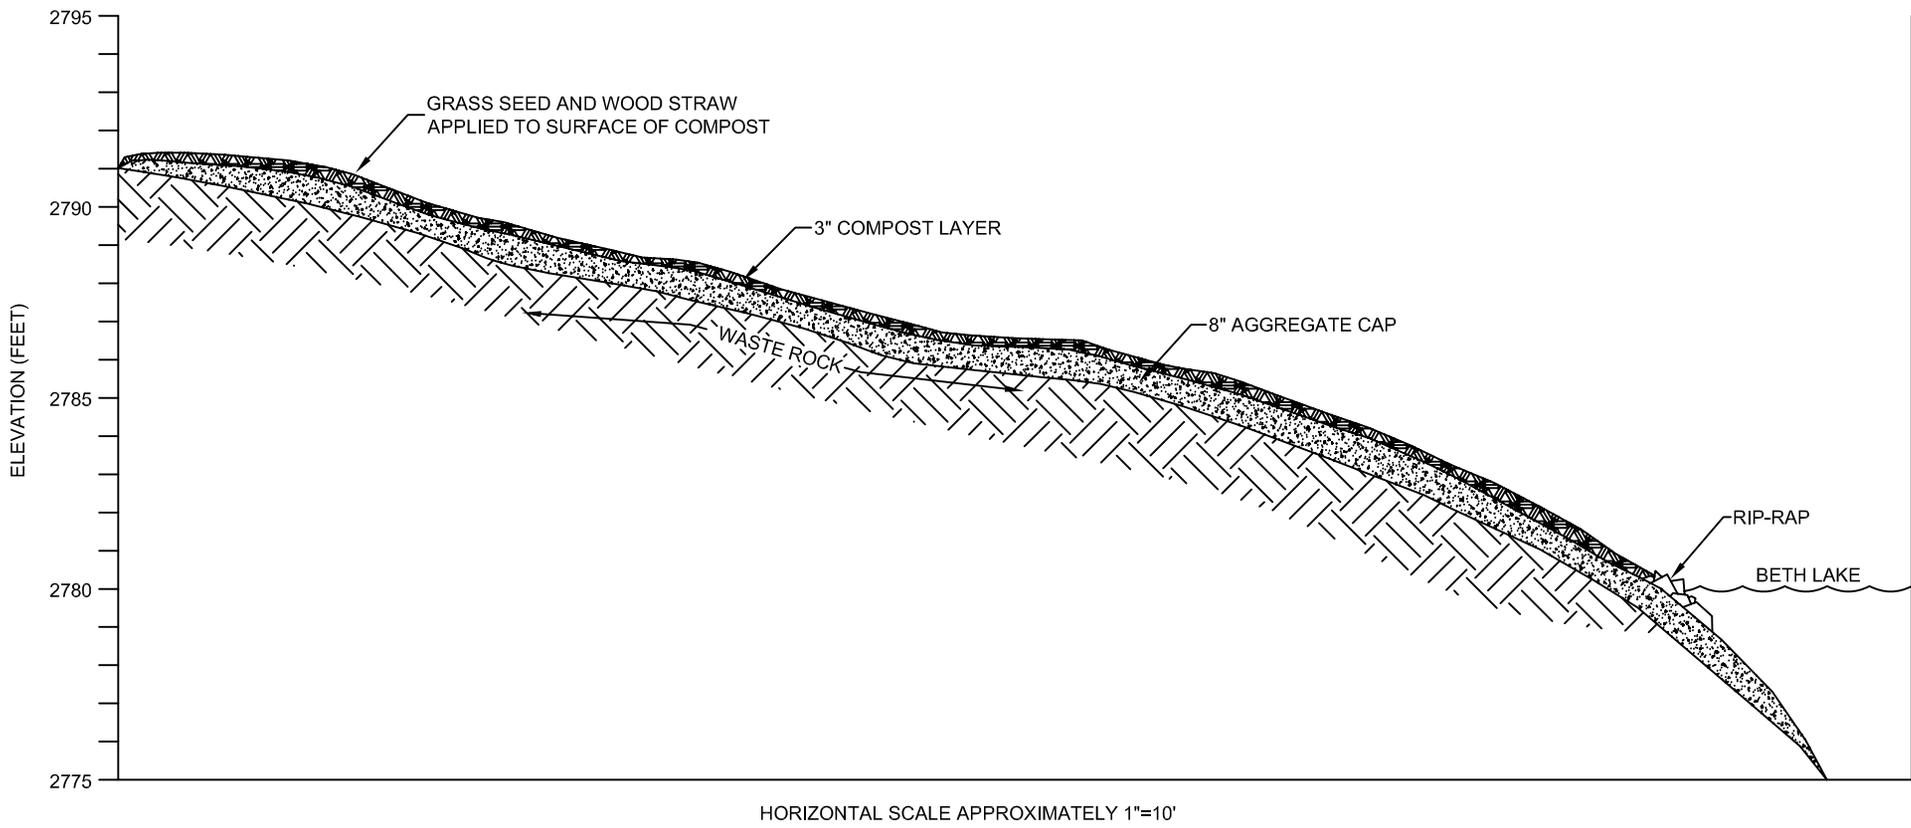
FIGURE 4

CROSS SECTION OF COMPLETED CAP

No post-construction topographic survey was conducted.
Contours on approximate 2' intervals.
Aggregate cap placed +/- 8 inches thick.
Compost placed +/- 3 inches thick.

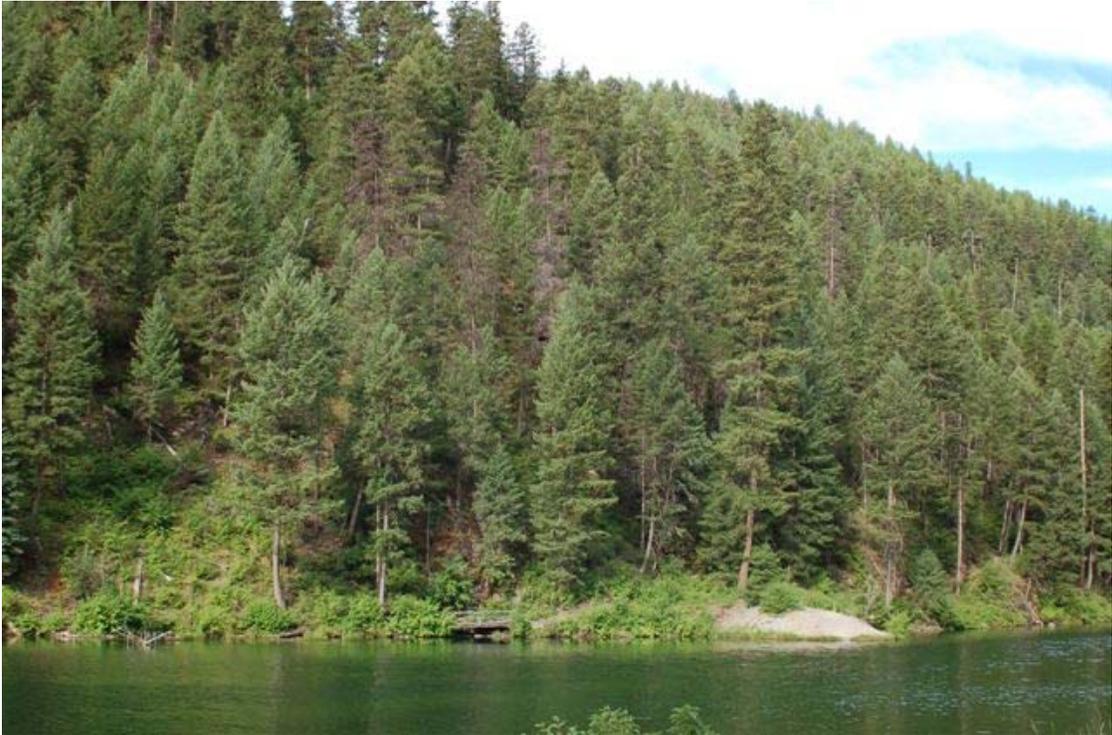
Client Name: United States Forest Service		Site Location: Beth Lake, Okanogan National Forest	Project No. 25696997
Photo No. 1	Date: July 22, 2008

Direction Photo Taken: West			
Description: Waste rock pile prior to Removal Action.

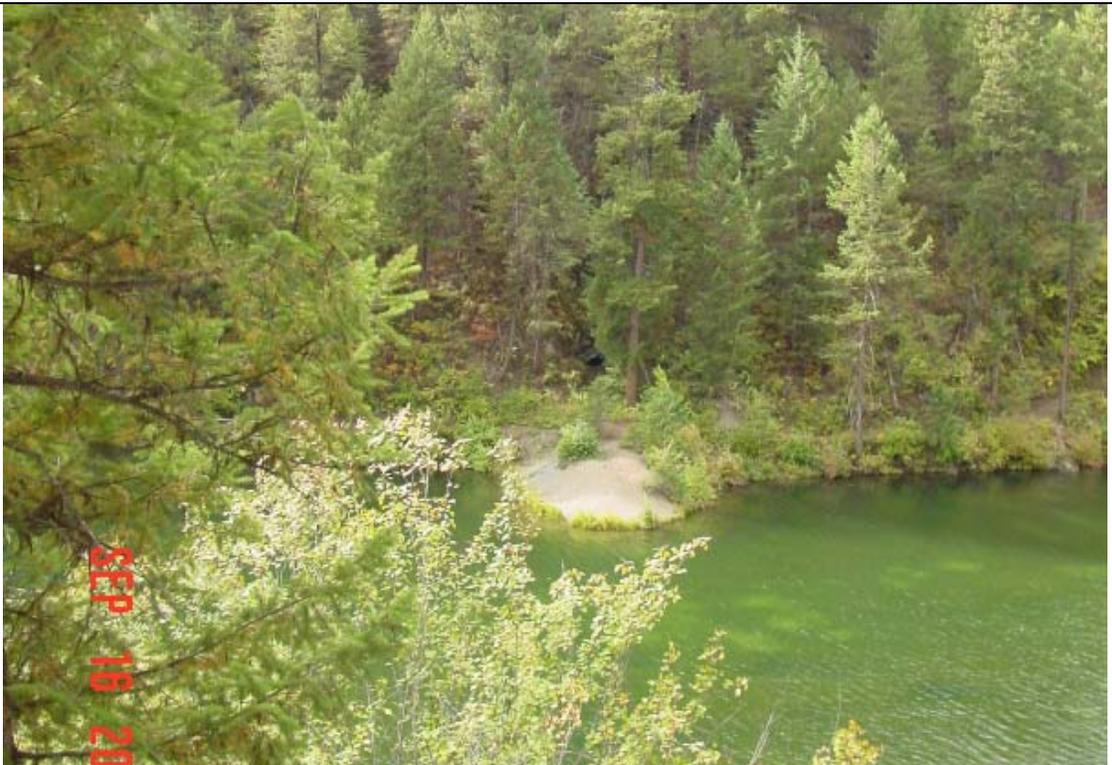
Photo No. 2	Date: September 16, 2004

Direction Photo Taken: Southwest			
Description: Waste rock pile prior to Removal Action.

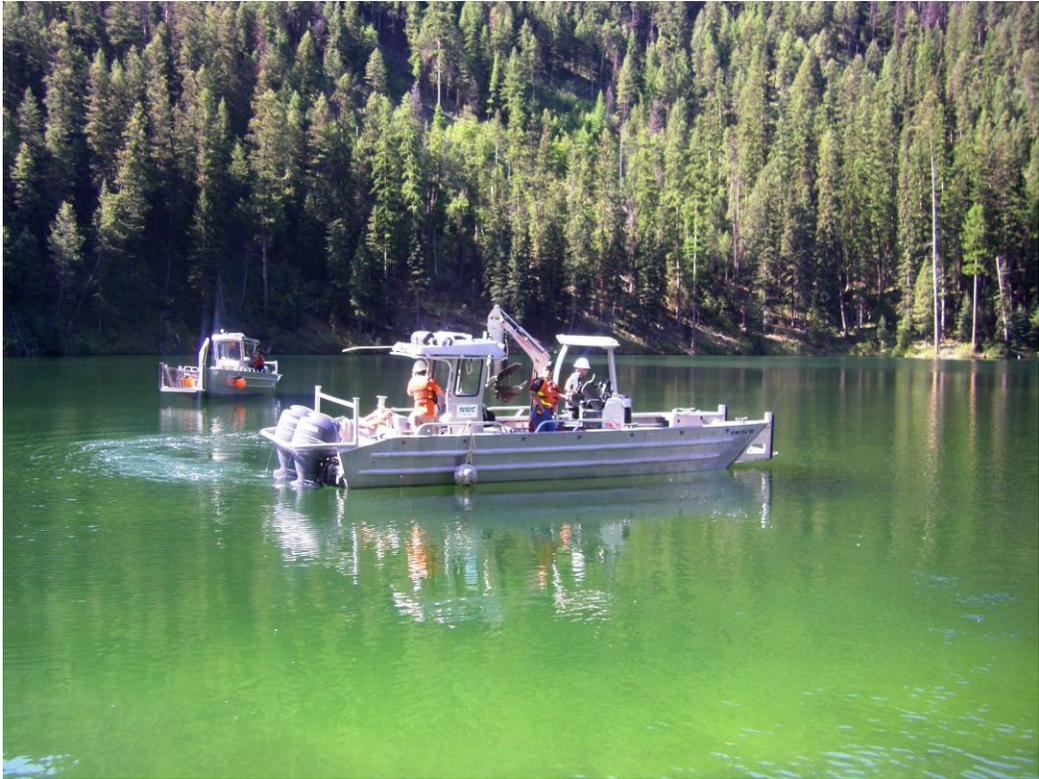
Client Name: United States Forest Service		Site Location: Beth Lake, Okanogan National Forest	Project No. 25696997
Photo No. 3	Date: June 1, 2009

Direction Photo Taken: South			
Description: Mobilizing equipment to site.

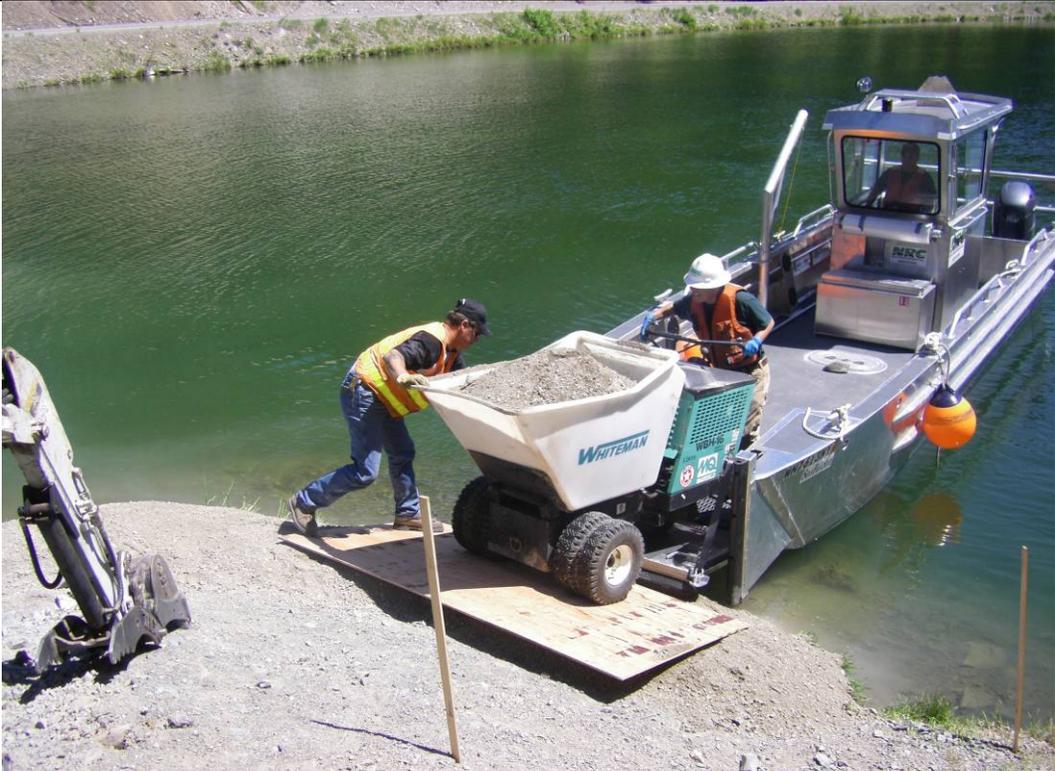
Photo No. 4	Date: June 2, 2009

Direction Photo Taken: North			
Description: Off-loading wheel barrow. Grade stake visible in foreground.

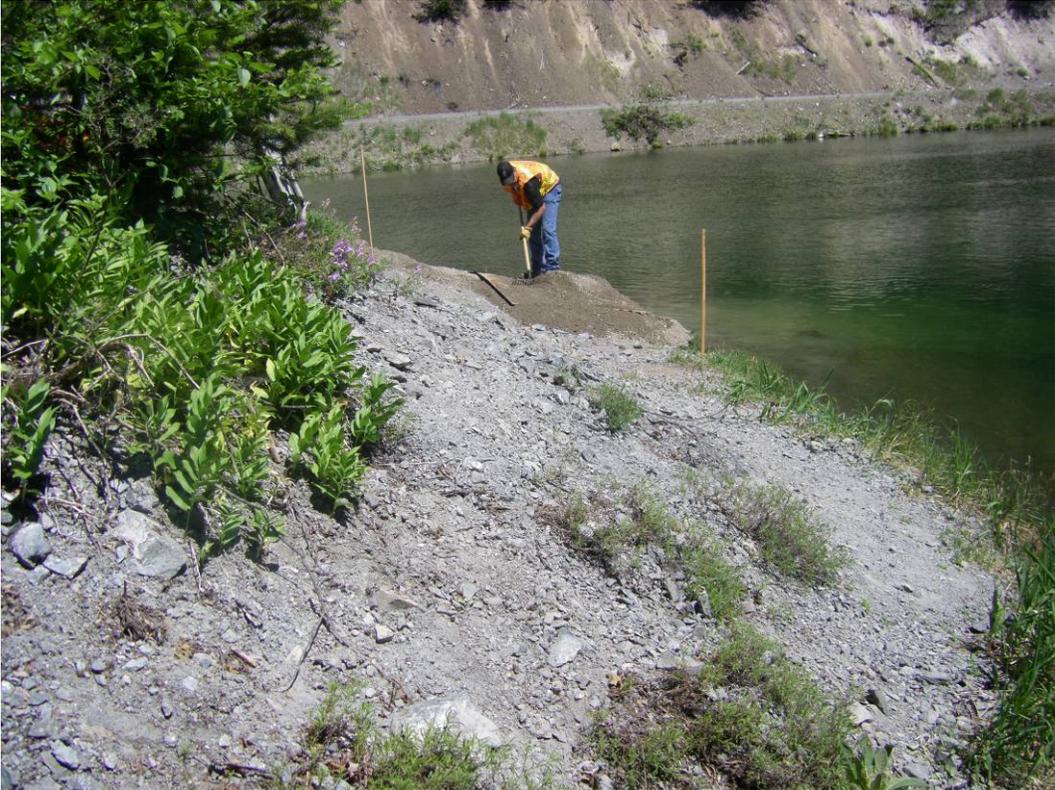
Client Name: United States Forest Service		Site Location: Beth Lake, Okanogan National Forest	Project No. 25696997
Photo No. 5	Date: June 2, 2009

Direction Photo Taken: North			
Description: Spreading aggregate cover by hand.

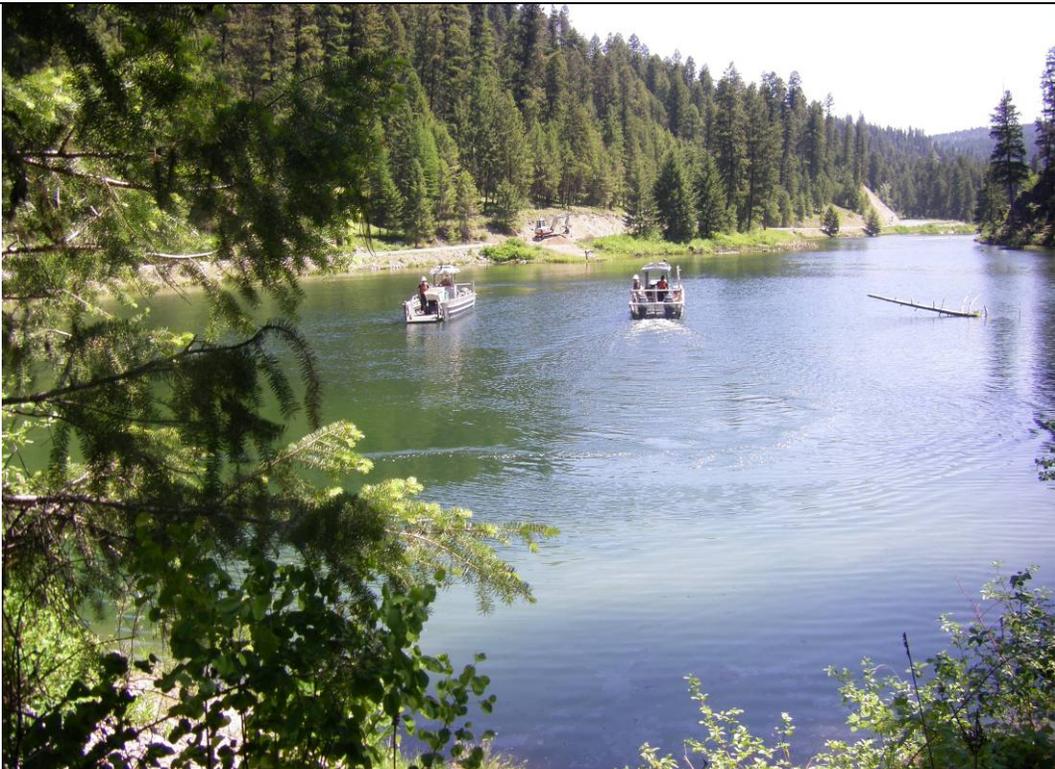
Photo No. 6	Date: June 2, 2009

Direction Photo Taken: East		
Description: View of boat ramp and cover staging area.

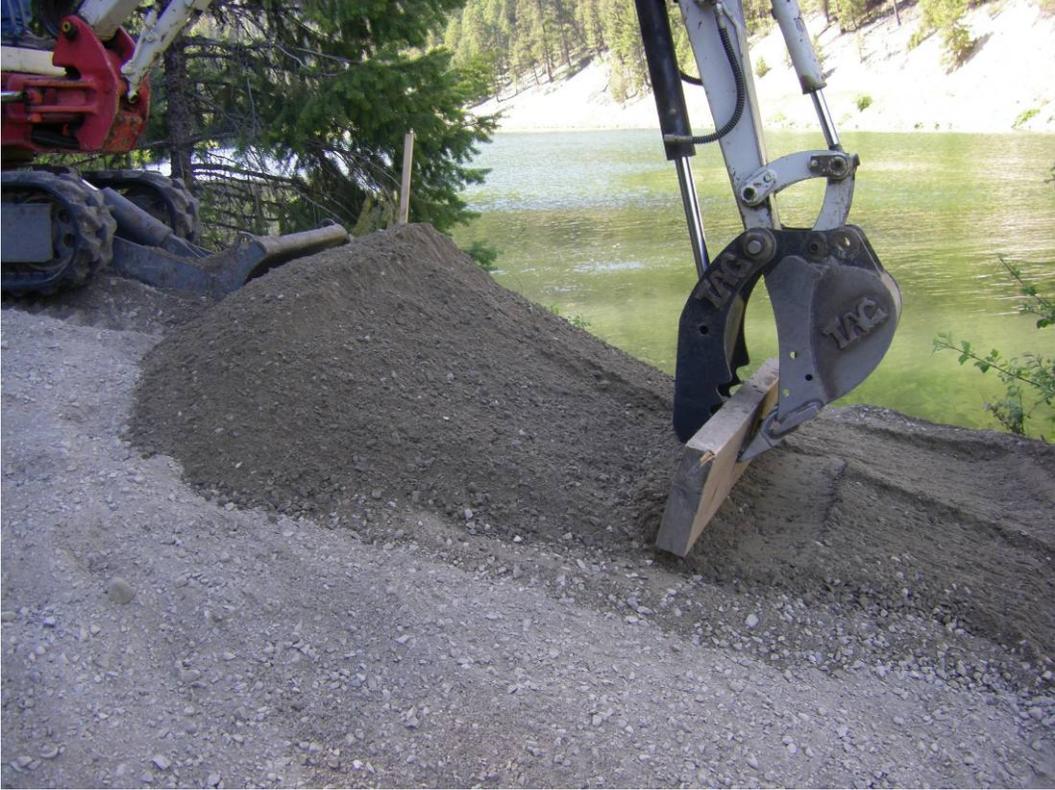
Client Name: United States Forest Service		Site Location: Beth Lake, Okanogan National Forest	Project No.: 25696997
Photo No.: 7	Date: June 3, 2009

Direction Photo Taken: Northwest			
Description: Spreading aggregate cover by machine.

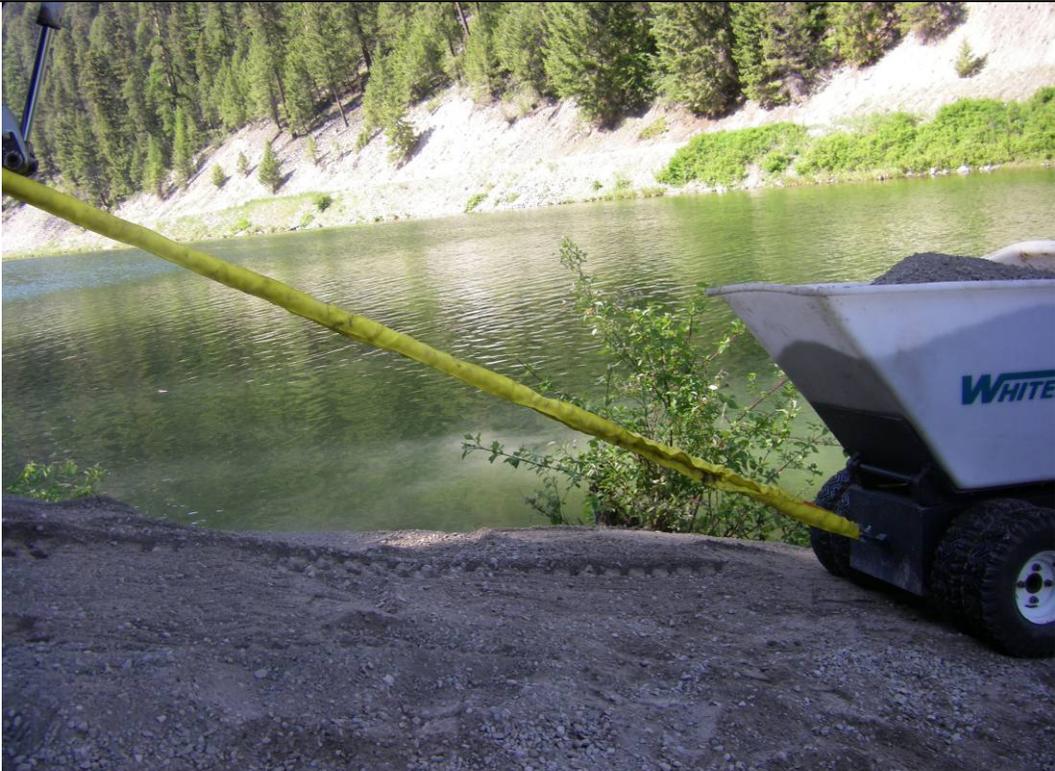
Photo No.: 8	Date: June 3, 2009

Direction Photo Taken: Northwest			
Description: Safety line on wheel barrow.

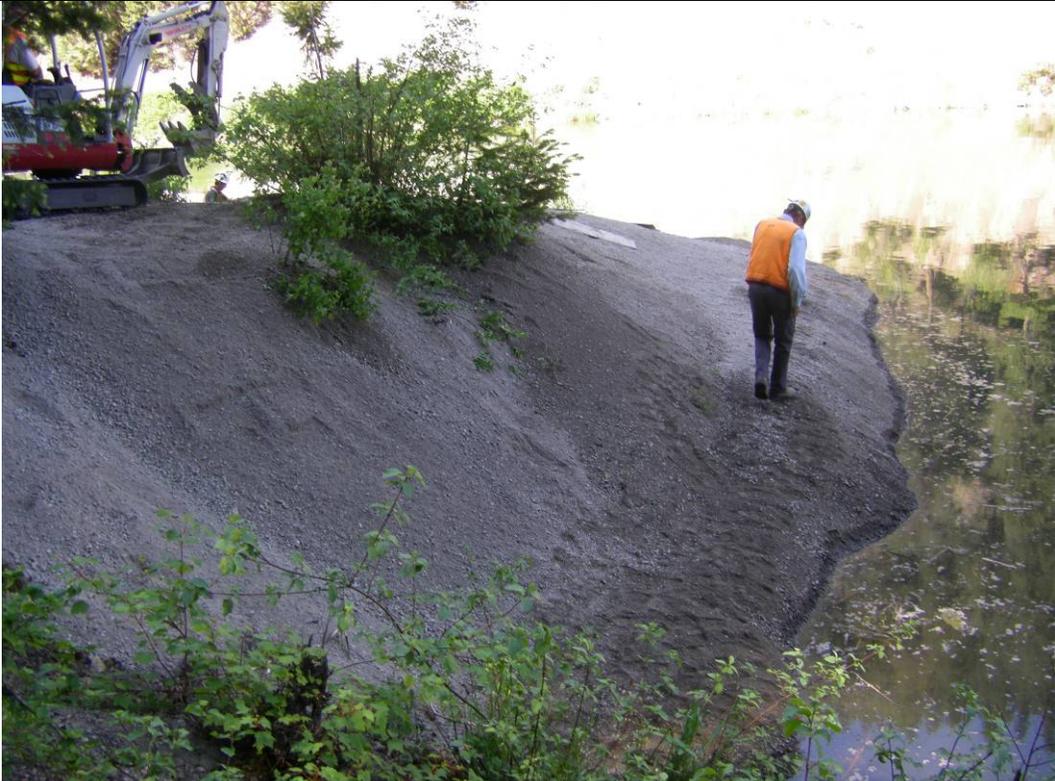
Client Name: United States Forest Service		Site Location: Beth Lake, Okanogan National Forest	Project No. 25696997
Photo No. 9	Date: June 3, 2009

Direction Photo Taken: Northeast			
Description: Inspecting the aggregate cover.

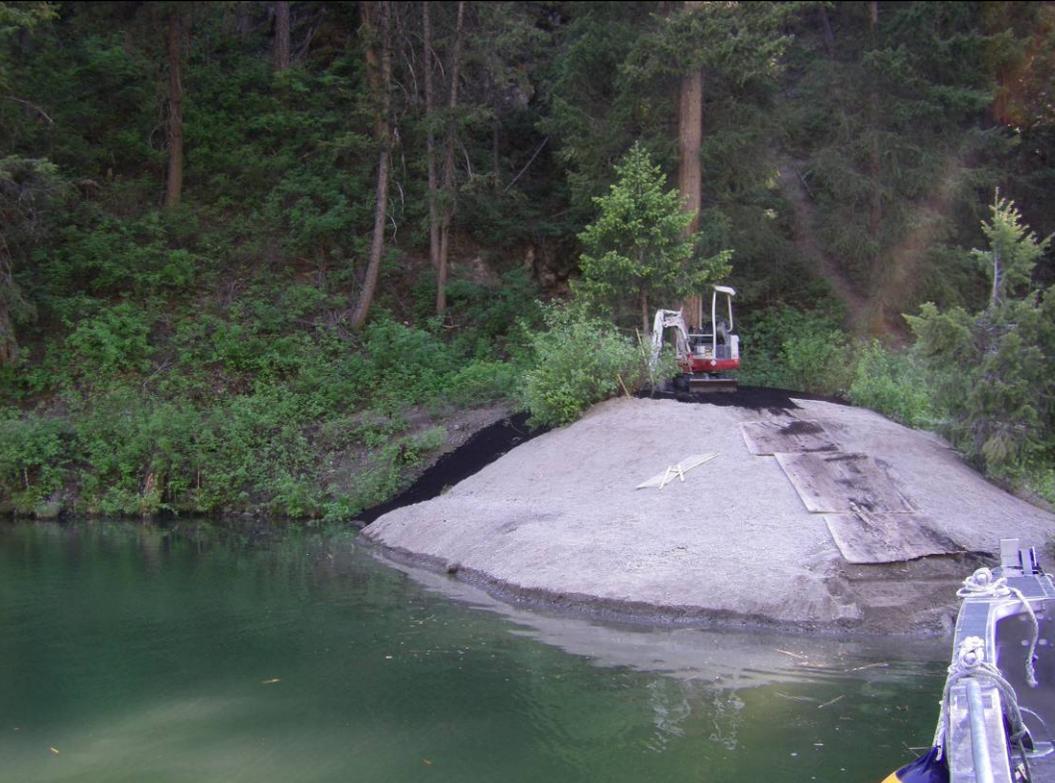
Photo No. 10	Date: June 3, 2009

Direction Photo Taken: Southwest			
Description: Placement of mulch.

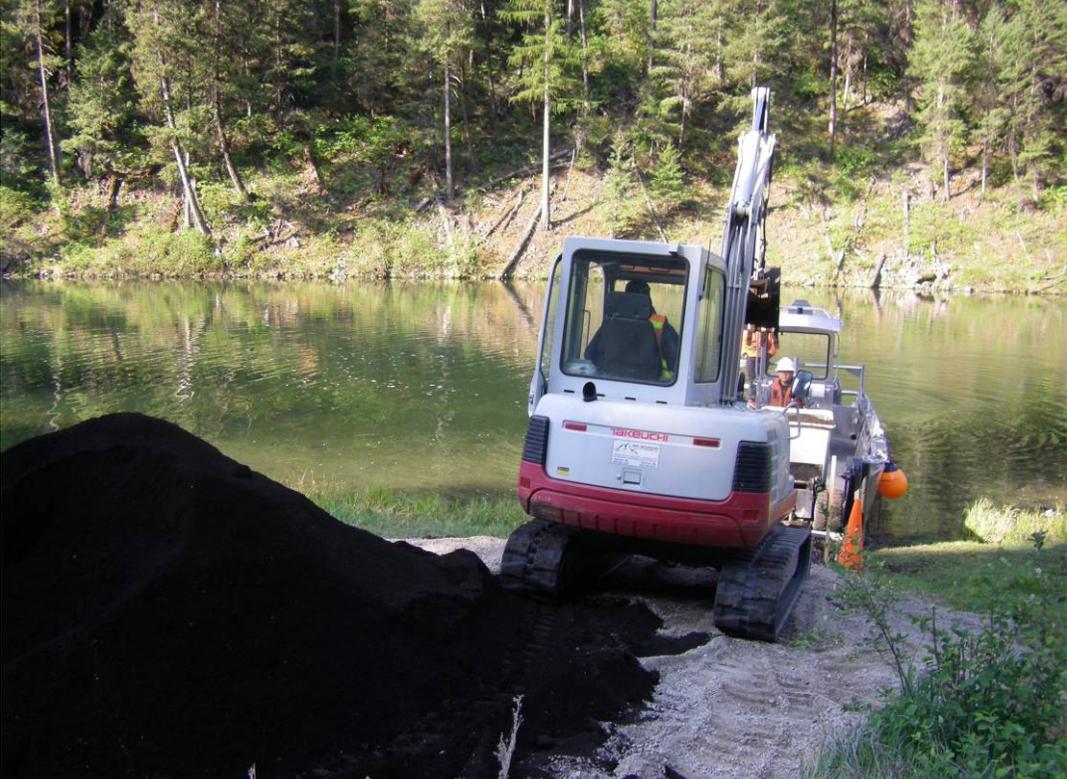
Client Name: United States Forest Service		Site Location: Beth Lake, Okanogan National Forest	Project No. 25696997
Photo No. 11	Date: June 4, 2009

Direction Photo Taken: Southwest			
Description: Loading mulch at boat ramp.

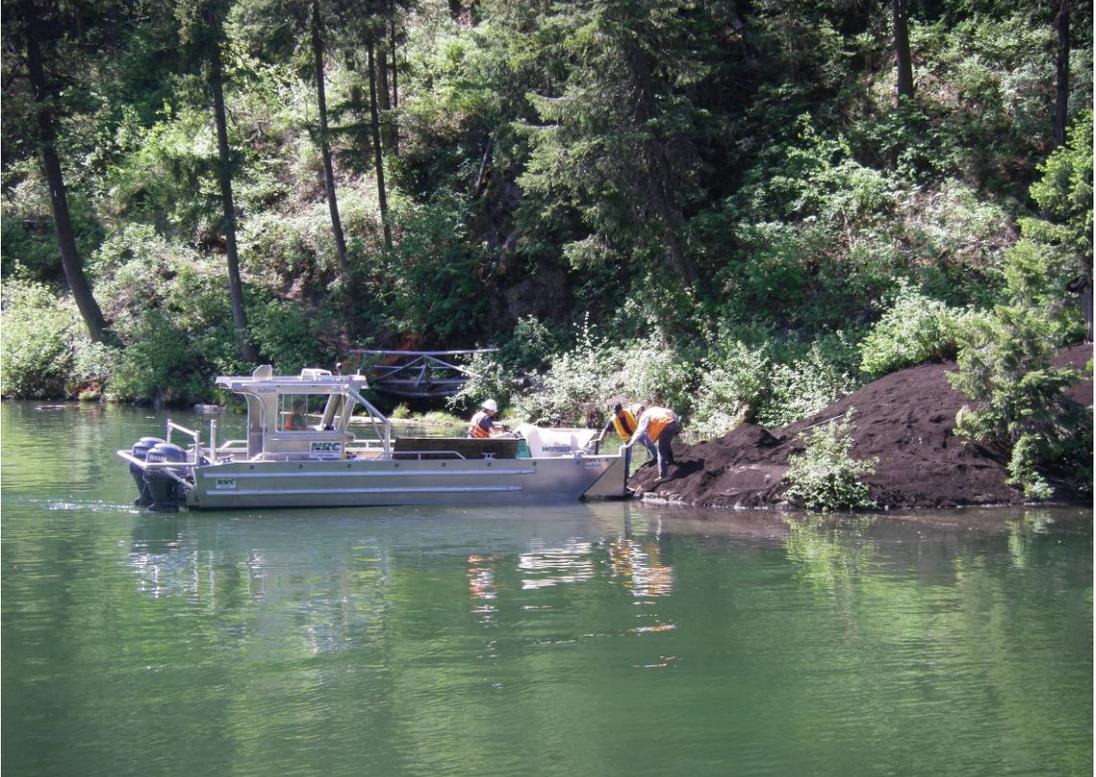
Photo No. 12	Date: June 4, 2009

Direction Photo Taken: South			
Description: Placing 'Rip Rap' at base to stabilize slope.

- URS and NRC observed that waves from the boats were causing minor erosion of the compost along the shoreline of the waste rock pile.
 - As a value-added service, NRC recommended that several loads of coarse rip rap material stockpiled near the Beth Lake Campground boat launch be placed at the base of the waste rock pile, along the east and north shore.
 - The Forest Service approved, and NRC proceeded with placing the material to provide added protection from wave action.
- During day three, approximately one gallon of diesel fuel was released while NRC was refueling the excavator.
 - The incident was caused by a “burp” from the excavator’s fuel tank.
 - NRC used fuel absorbent diapers to capture much of the fuel. What fuel did reach the ground was intercepted by the compost.
 - NRC placed compost impacted with fuel in a plastic bag and disposed of it offsite as solid waste.

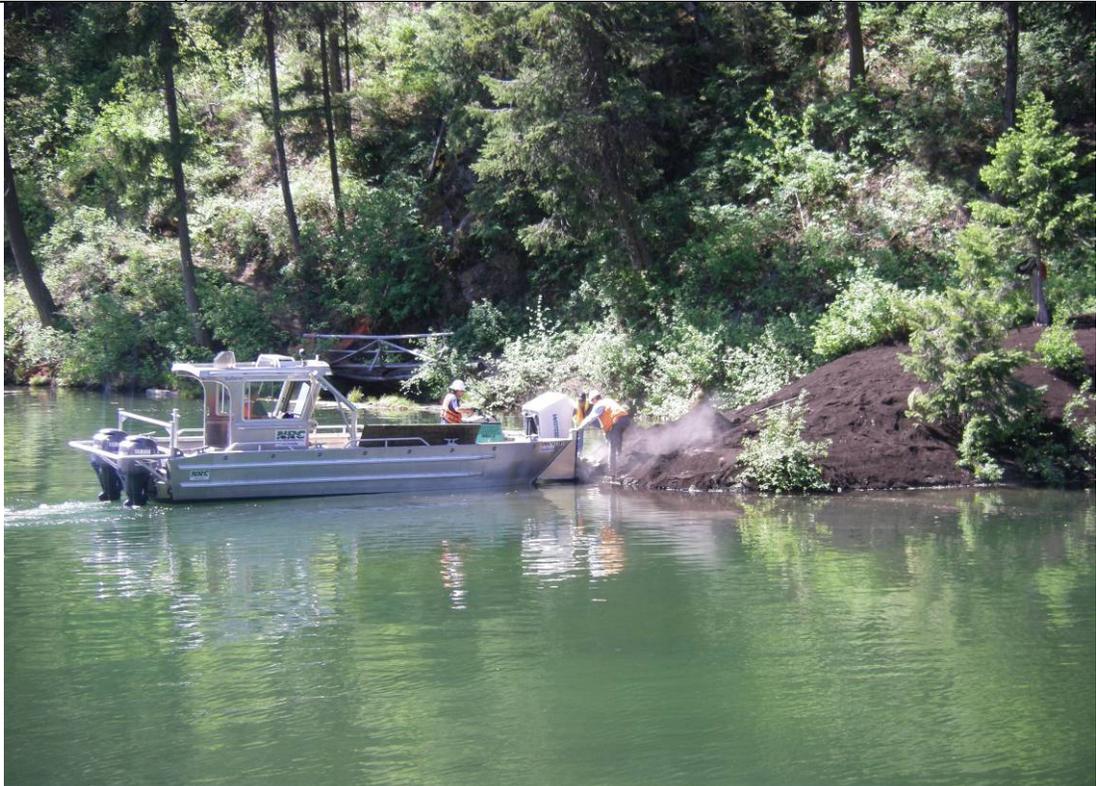
Client Name: United States Forest Service		Site Location: Beth Lake, Okanogan National Forest	Project No. 25696997
Photo No. 13	Date: June 4, 2009

Direction Photo Taken: South			
Description: Placing 'Rip Rap' at base to stabilize slope.

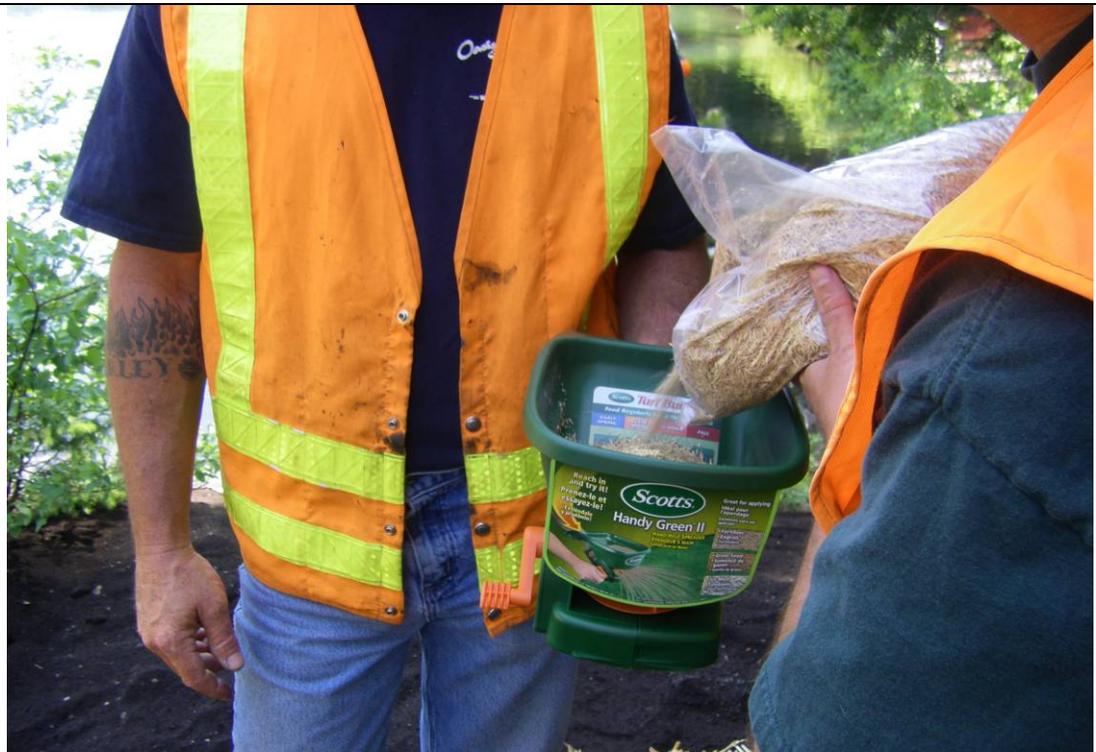
Photo No. 14	Date: June 4, 2009

Direction Photo Taken: North		
Description: Seed placement equipment.

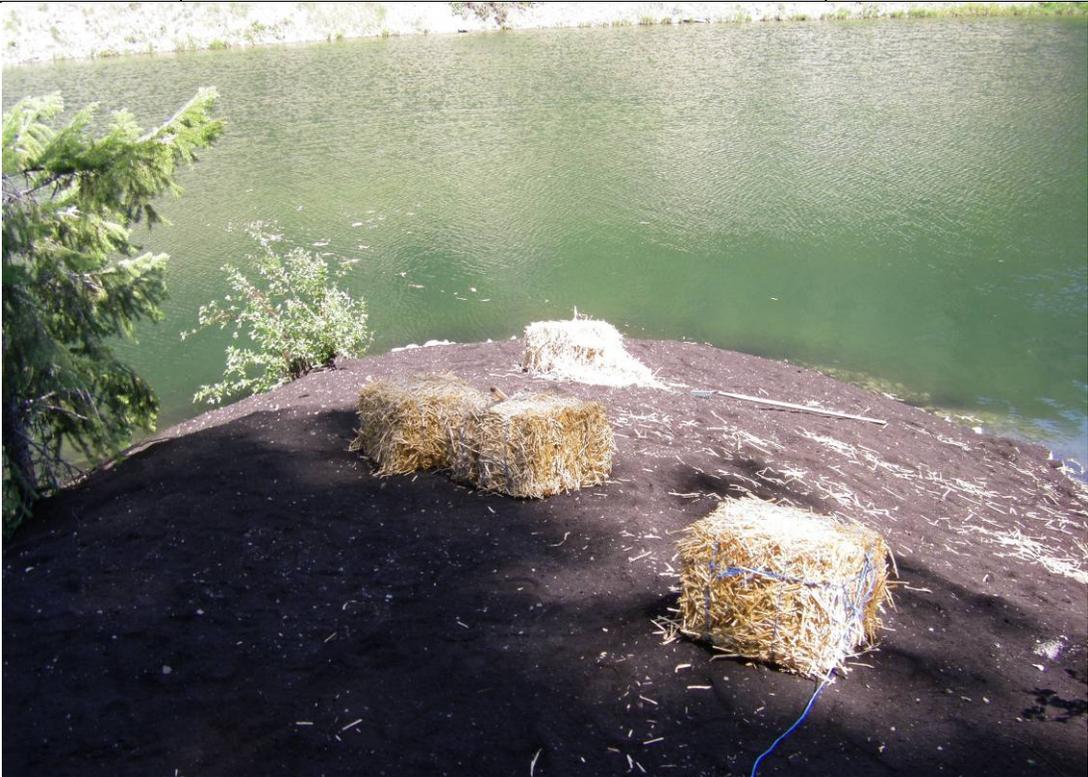
Client Name: United States Forest Service		Site Location: Beth Lake, Okanogan National Forest	Project No.: 25696997
Photo No.: 15	Date: June 4, 2009

Direction Photo Taken: North			
Description: 'Wood' straw bales.

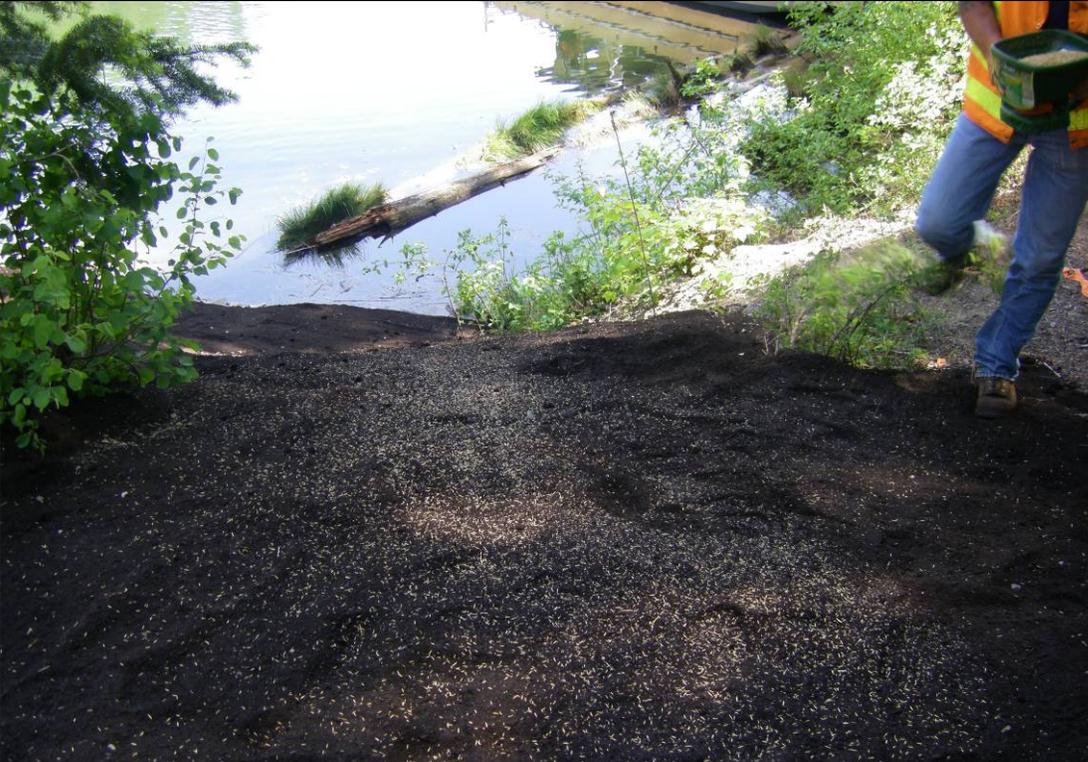
Photo No.: 16	Date: June 4, 2009

Direction Photo Taken: East		
Description: Grass seed prior to being raked into mulch.

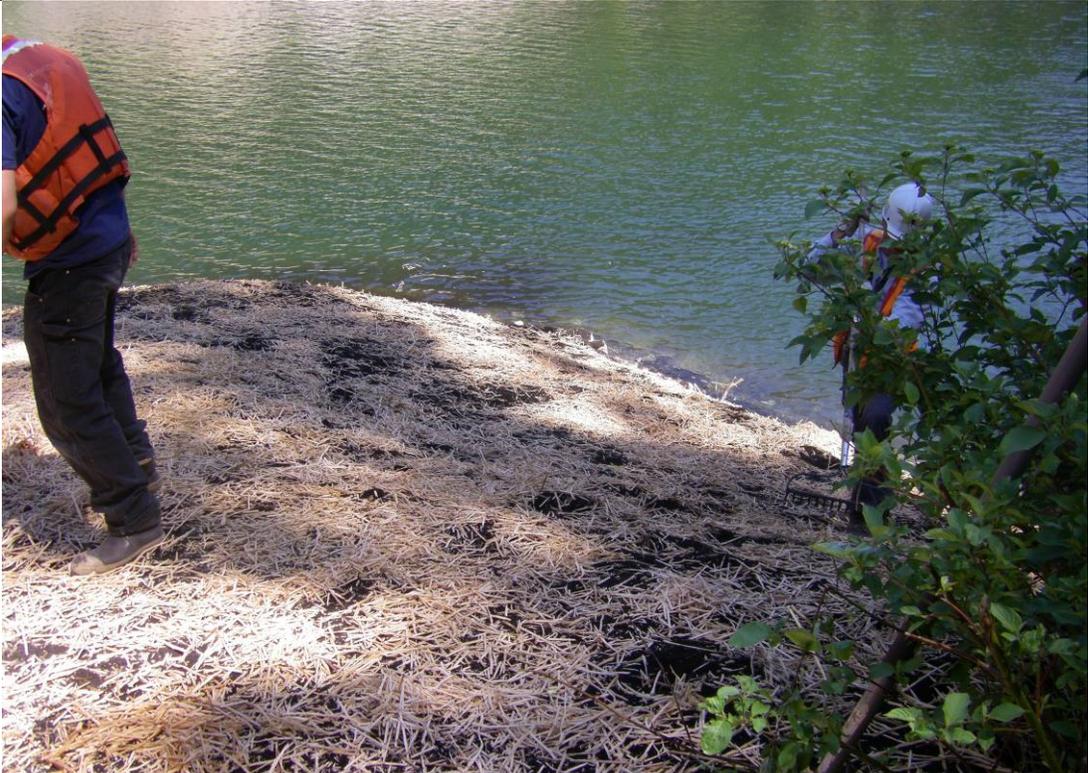
Client Name: United States Forest Service		Site Location: Beth Lake, Okanogan National Forest	Project No.: 25696997
Photo No.: 17	Date: June 4, 2009

Direction Photo Taken: Northeast			
Description: Placement of wood straw.

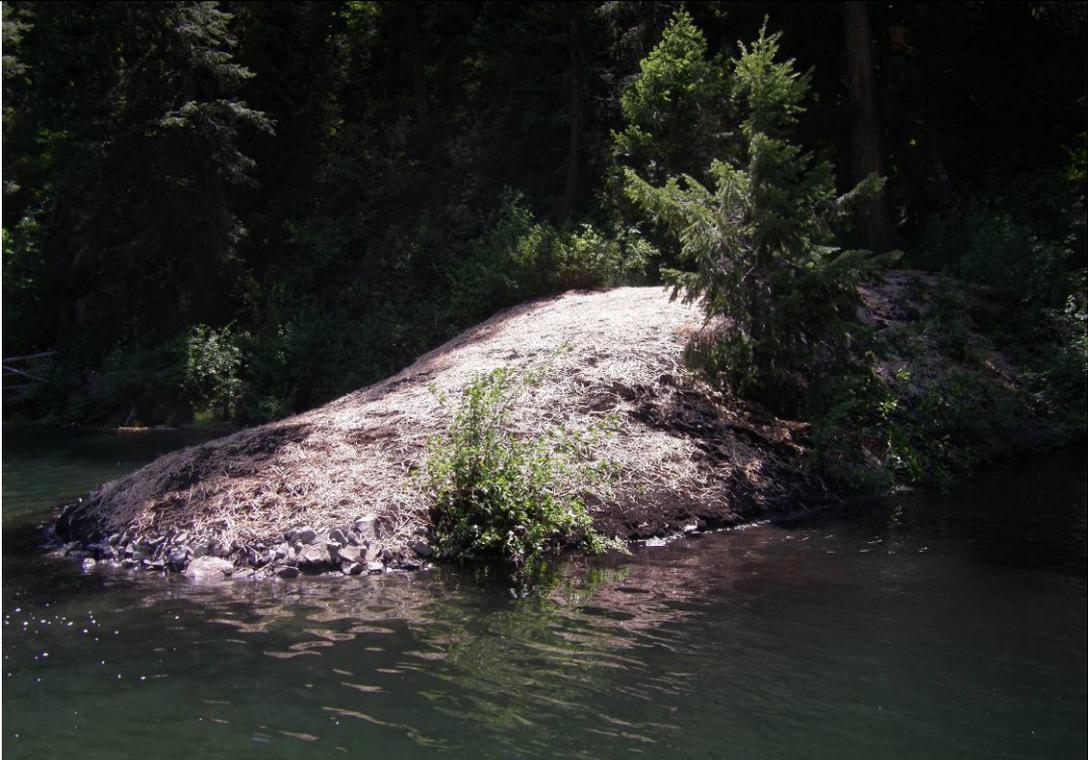
Photo No.: 18	Date: June 4, 2009

Direction Photo Taken: South		
Description: Finished product, west side.

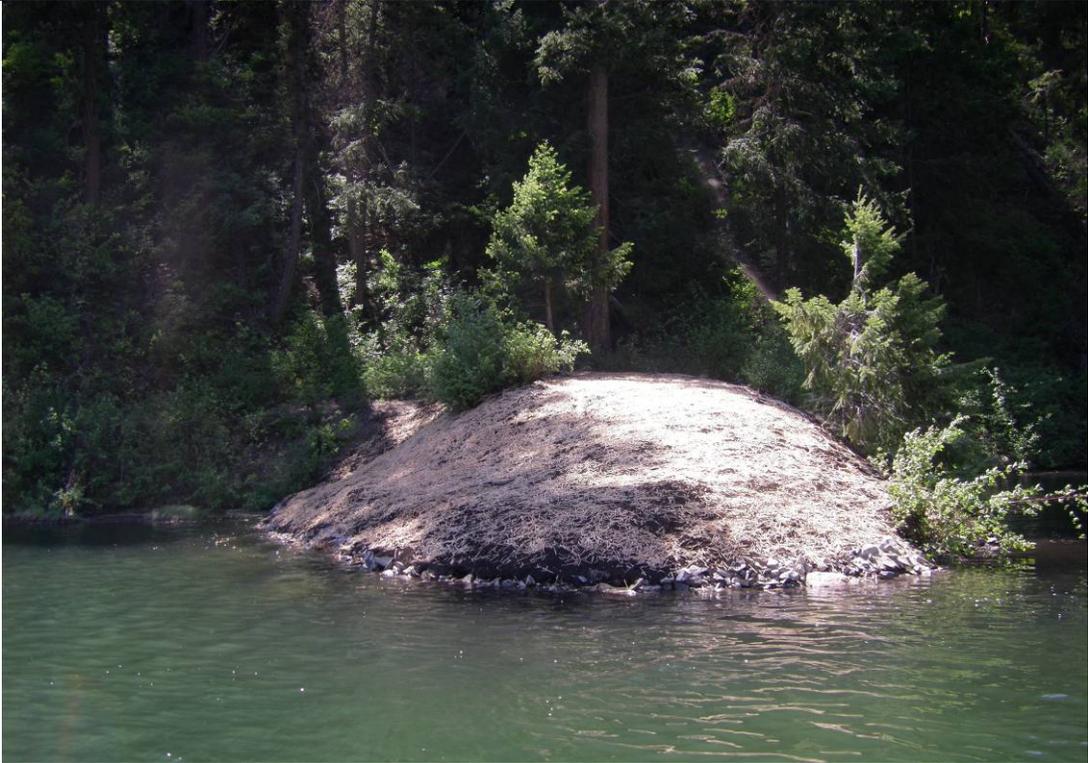
Client Name: United States Forest Service		Site Location: Beth Lake, Okanogan National Forest	Project No.: 25696997
Photo No.: 19	Date: June 4, 2009

Direction Photo Taken: Southwest			
Description: Finished product, north side.

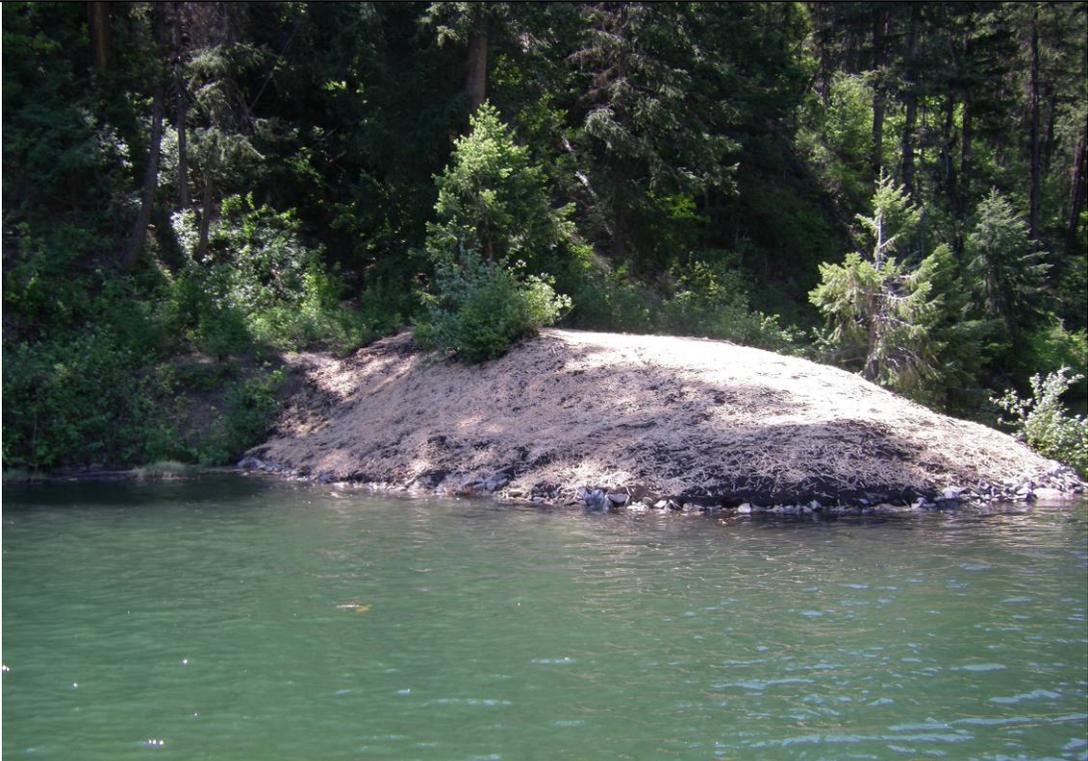
Photo No.: 20	Date: June 4, 2009

Direction Photo Taken: West			
Description: Finished product, east side.

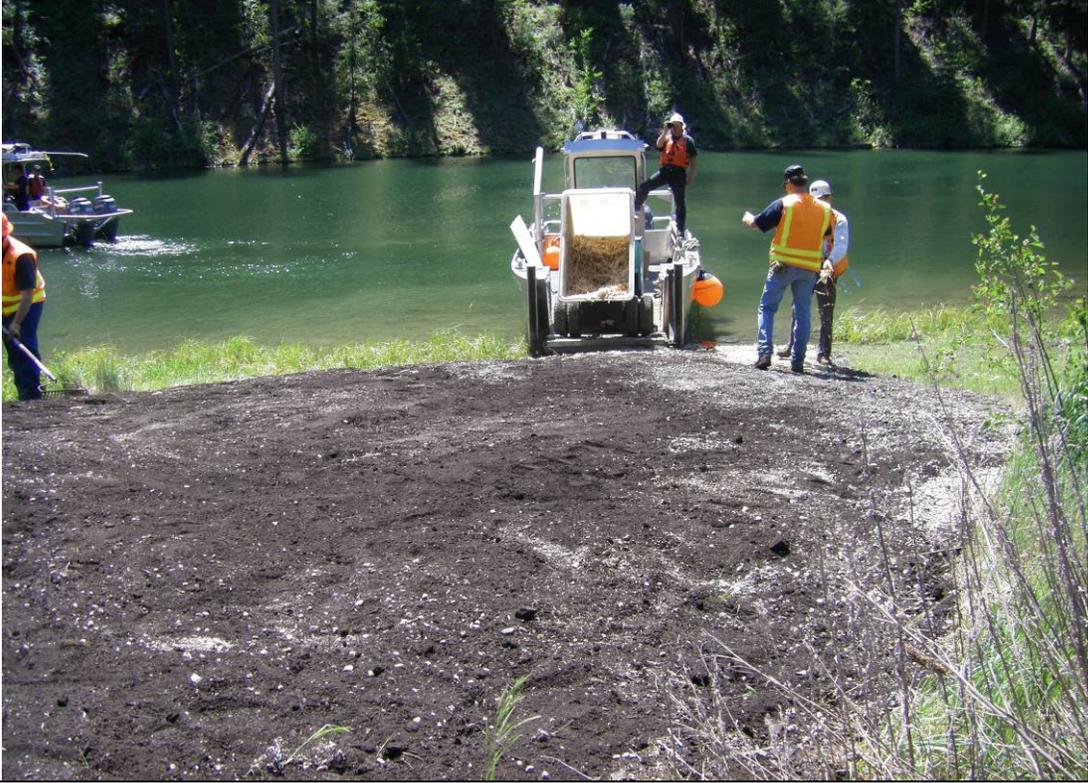
Client Name: United States Forest Service		Site Location: Beth Lake, Okanogan National Forest	Project No. 25696997
Photo No. 21	Date: June 4, 2009

Direction Photo Taken: Southwest			
Description: Boat ramp improvement.
