| <b>Project Name:</b><br>Sunchief Mill Site EE/CA | | <b>Site Location:</b><br>Tonto National Forest, Gila County, Arizona | <b>Project No.</b><br>12238.041.002 |

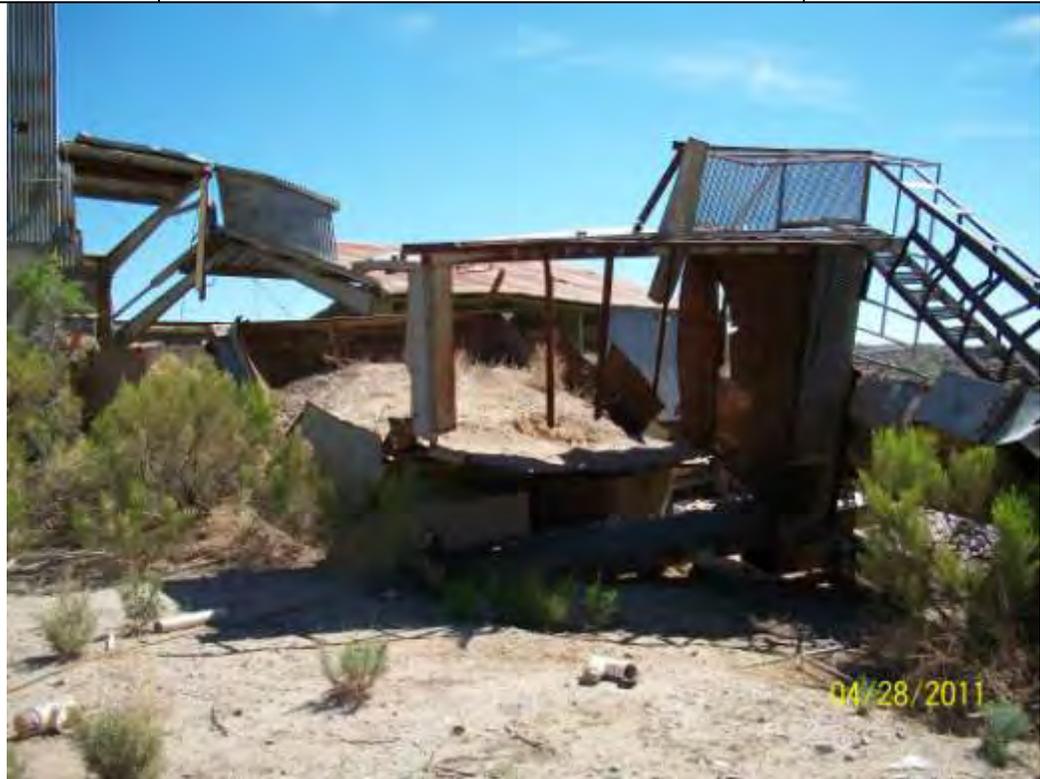
| <b>Photo No.</b><br><b>71</b> | <b>Date:</b><br>4-28-11 |

Concrete pad to south of mill building, ball mill/debris pictured left.

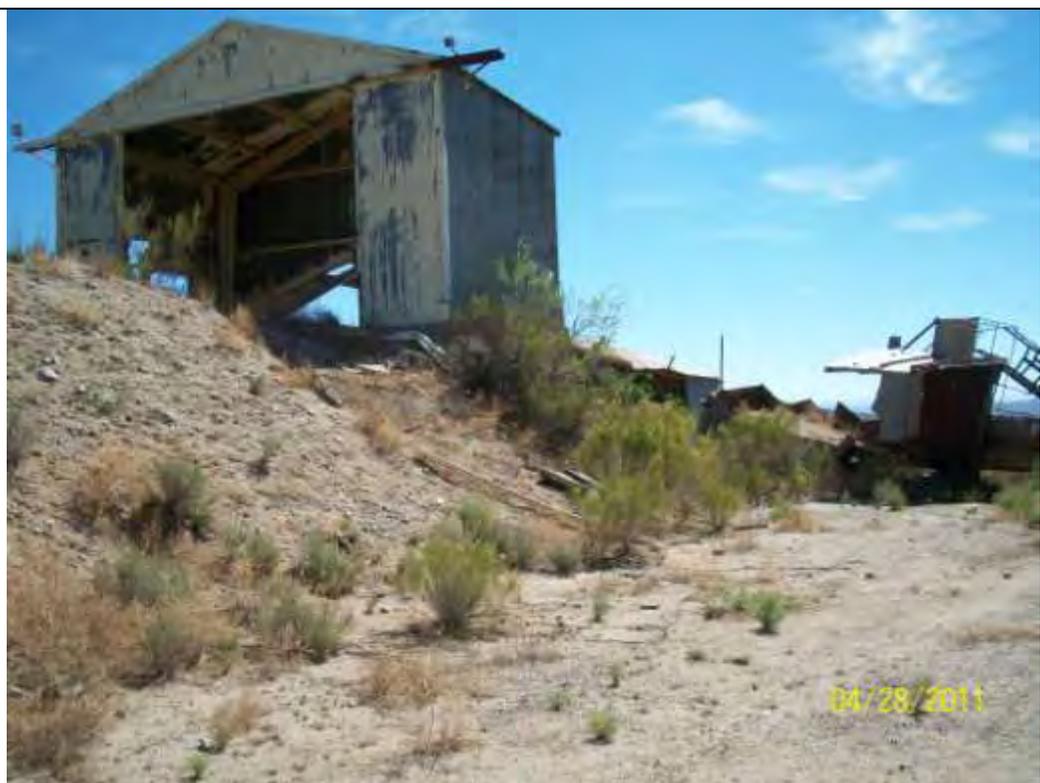
| <b>Photo No.</b><br><b>72</b> | <b>Date:</b><br>4-28-11 |

Ball/mill debris pictured at mill building.

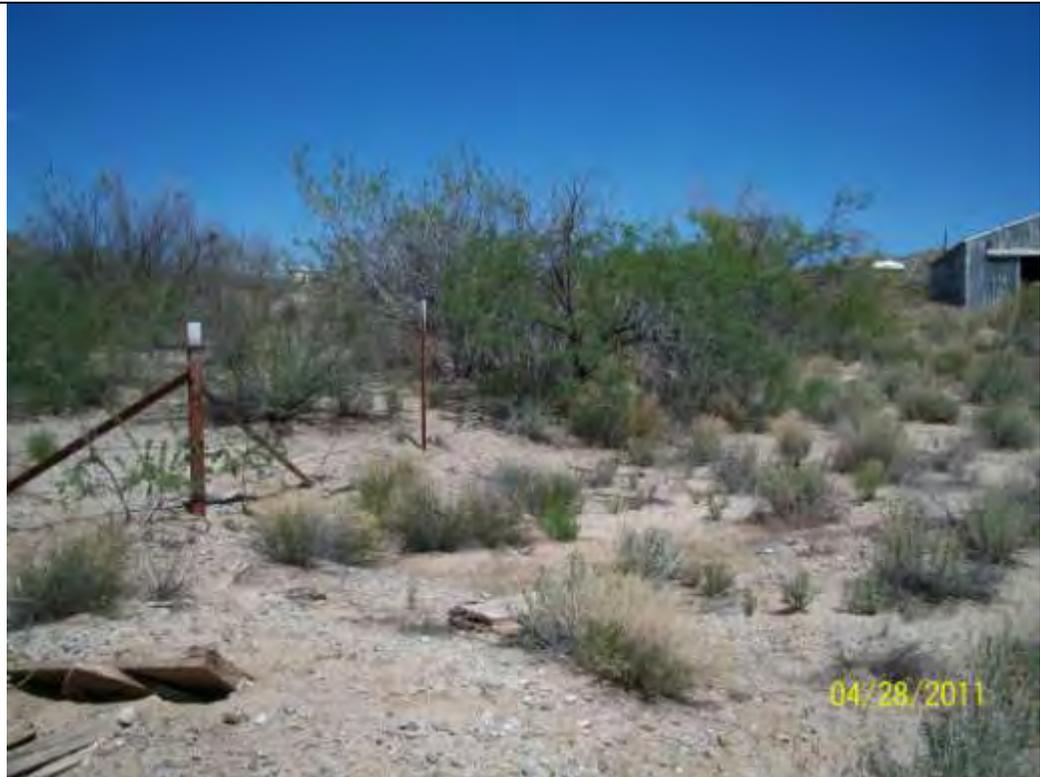
| <b>Photo No.</b><br><b>74</b> | <b>Date:</b><br>4-28-11 |

| <b>Description:</b><br><br>Fence transition shown from 6-foot chain link to 4-strand barbed-wire on west perimeter, just south of access gate (See Figure E1). |

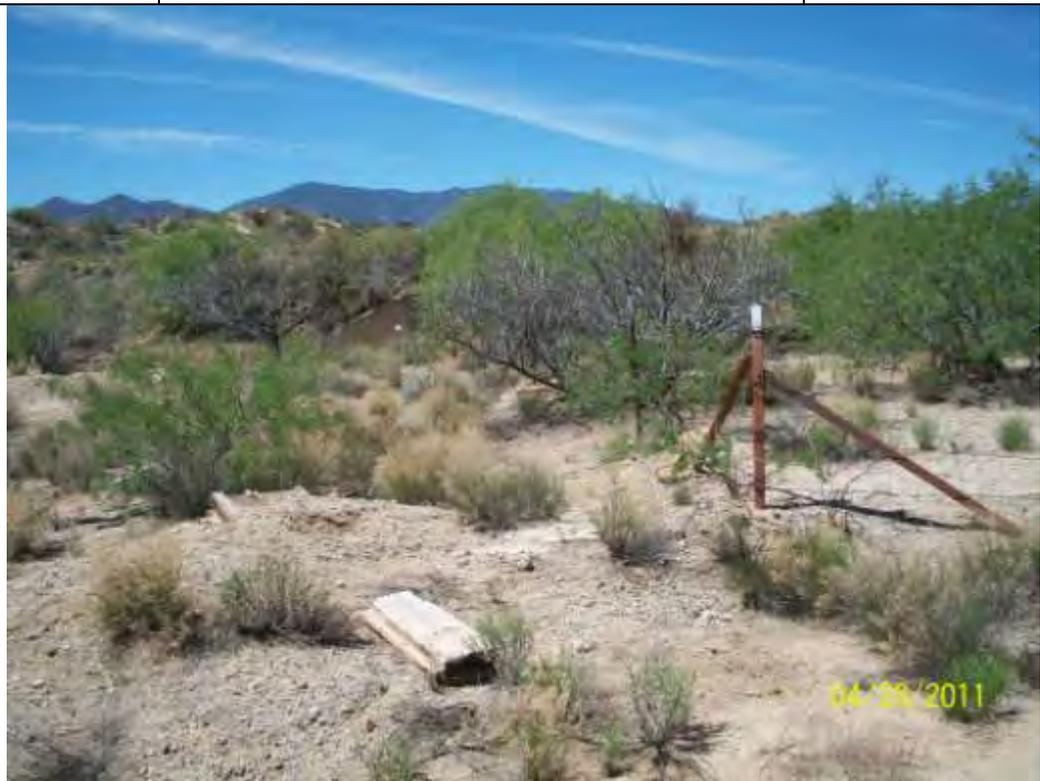
| <b>Photo No.</b><br><b>75</b> | <b>Date:</b><br>4-28-11 |

View of west fence; 4-strand barbed-wire fence (See Figure E1).

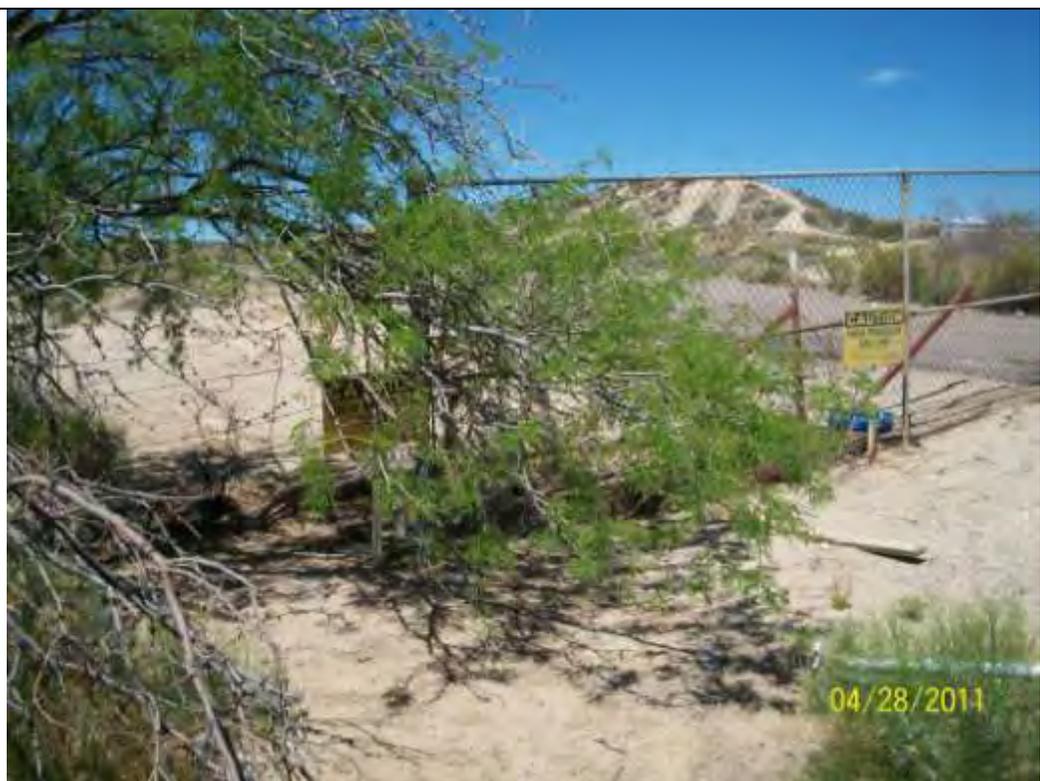
| <b>Photo No.</b><br><b>76</b> | <b>Date:</b><br>4-28-11 |

Fence transition shown from 6-foot chain link to 4-strand barbed-wire on west perimeter, just south of access gate (See Figure E1).

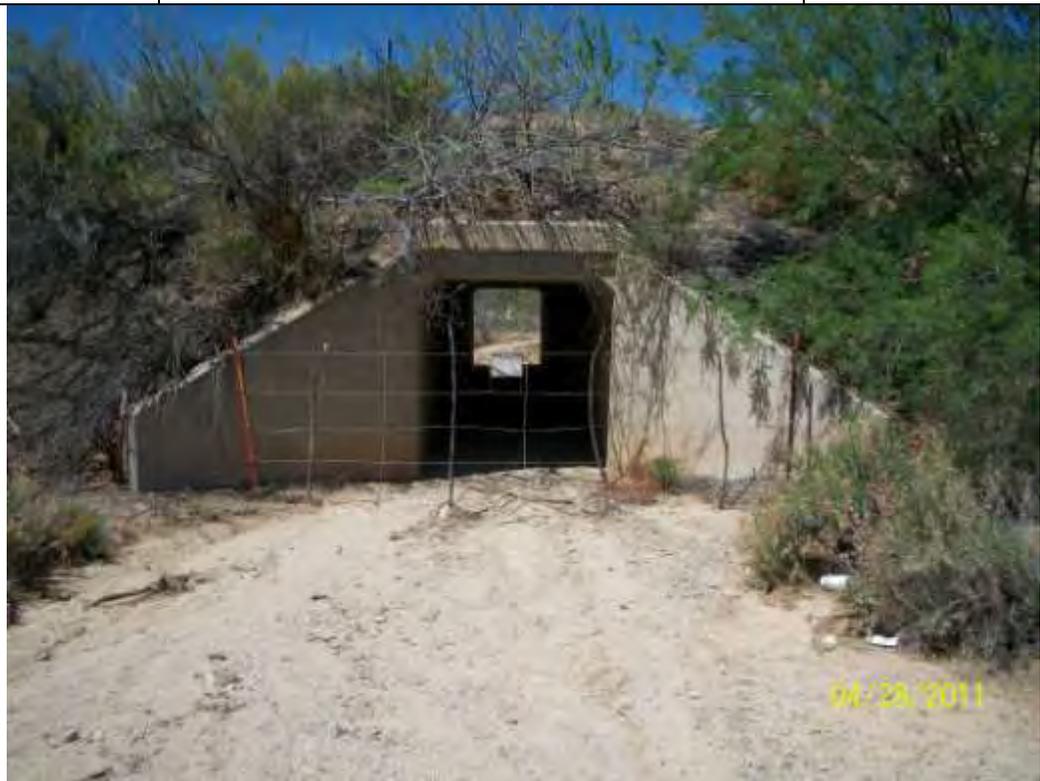
| <b>Photo No.</b><br><b>77</b> | <b>Date:</b><br>4-28-11 |

Box culvert on west side of site, ~6-foot x 5 foot opening (See Figure E1).

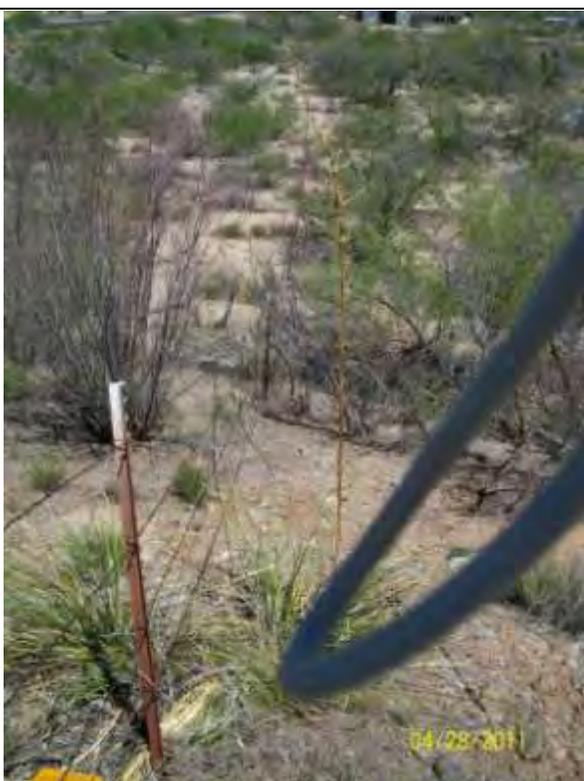
| <b>Photo No.</b><br><b>78</b> | <b>Date:</b><br>4-28-11 |

West fence line on hillside, looking downhill; 4-strand barbed-wire fence (See Figure E1).

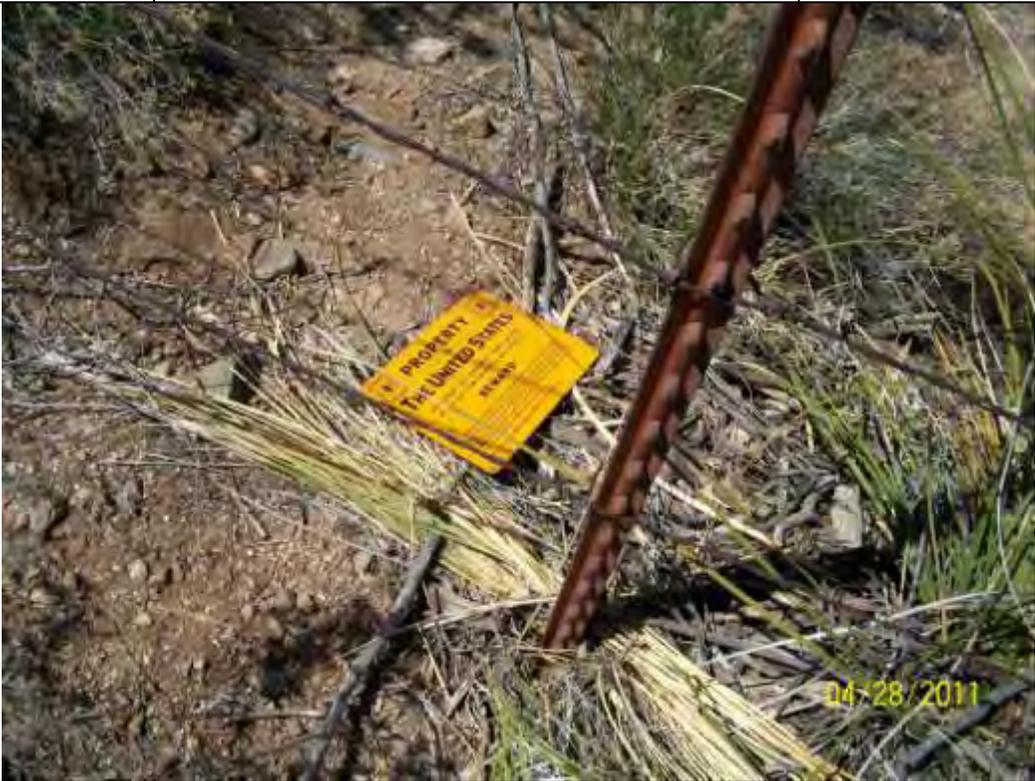
| <b>Photo No.</b><br><b>79</b> | <b>Date:</b><br>4-28-11 |

USFS sign has fallen off fence (See Figure E1).

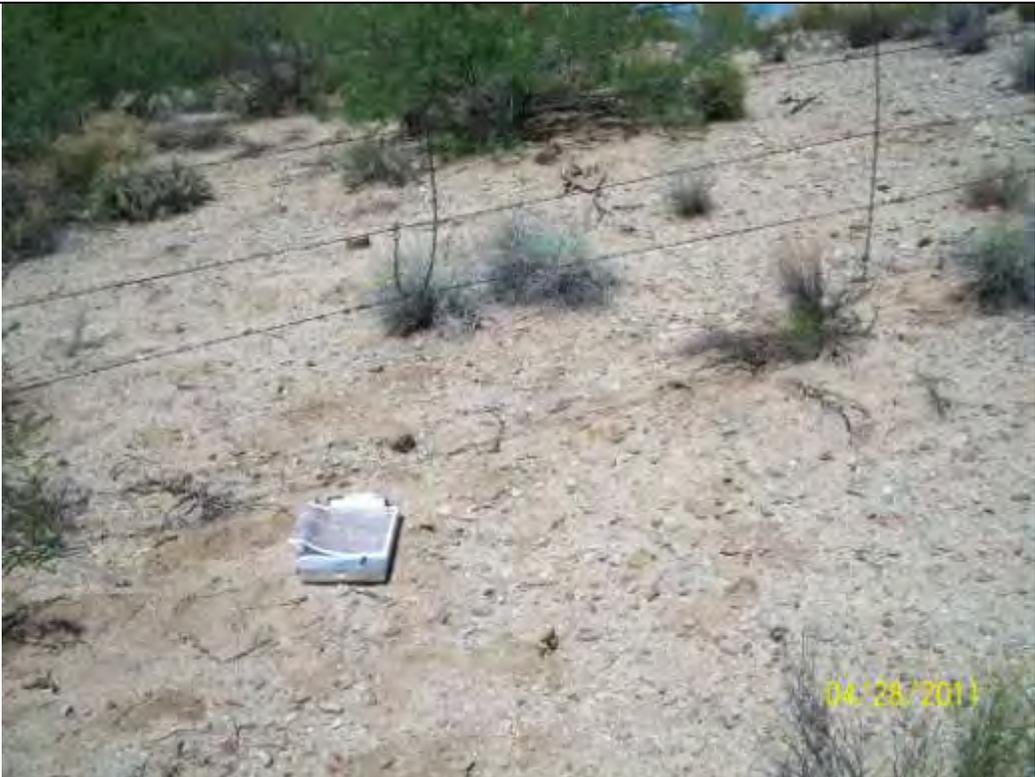
| <b>Photo No.</b><br><b>80</b> | <b>Date:</b><br>4-28-11 |

Large gaps under fence indicate fence has been disturbed to permit site access by unauthorized personnel (See Figure E1).

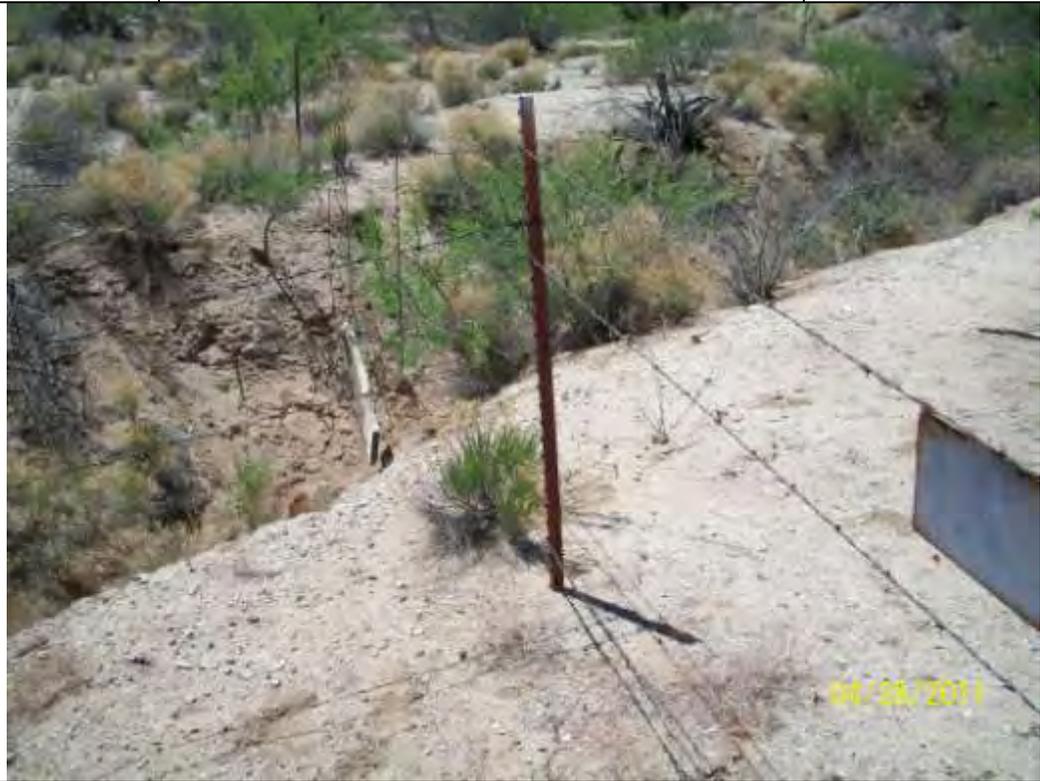
| <b>Photo No.</b><br><b>81</b> | <b>Date:</b><br>4-28-11 |

| <b>Description:</b><br><br>Southwest corner of fence post, fence continues across drainage (See Figure E1). |

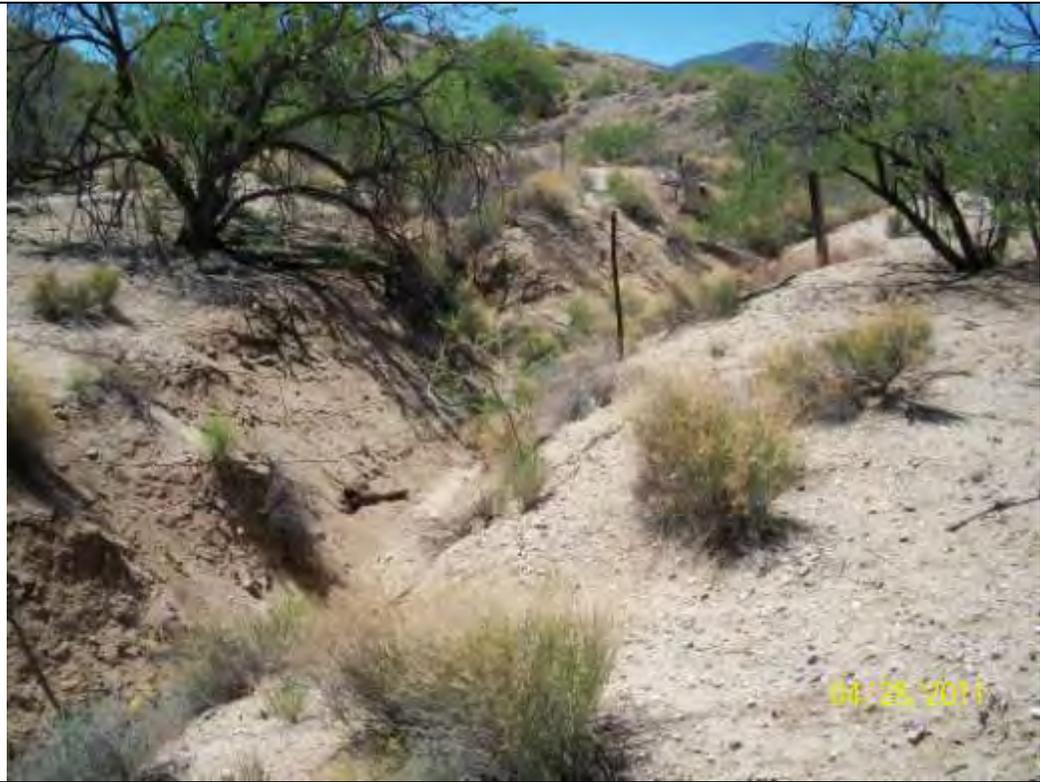
| <b>Photo No.</b><br><b>82</b> | <b>Date:</b><br>4-28-11 |

| <b>Description:</b><br><br>Site fence crosses drainage on the south side of the site (See Figure E1). |

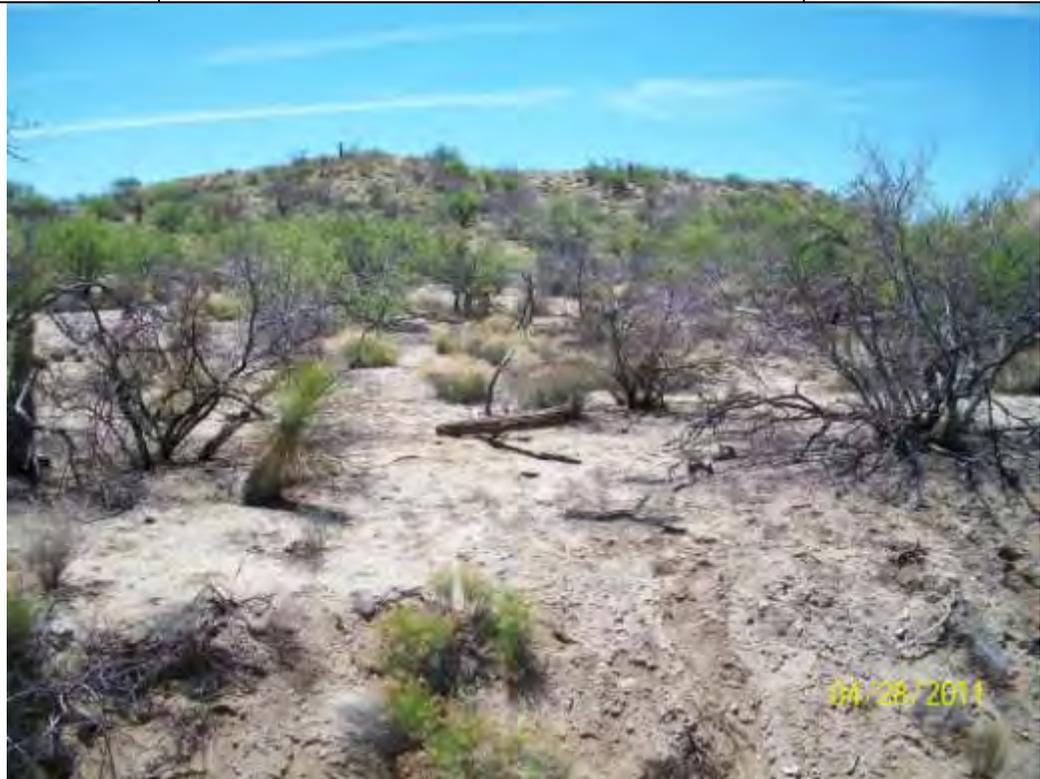
| <b>Photo No.</b><br><b>83</b> | <b>Date:</b><br>4-28-11 |

Log placed on top of area where site fence is down (See Figure E1).

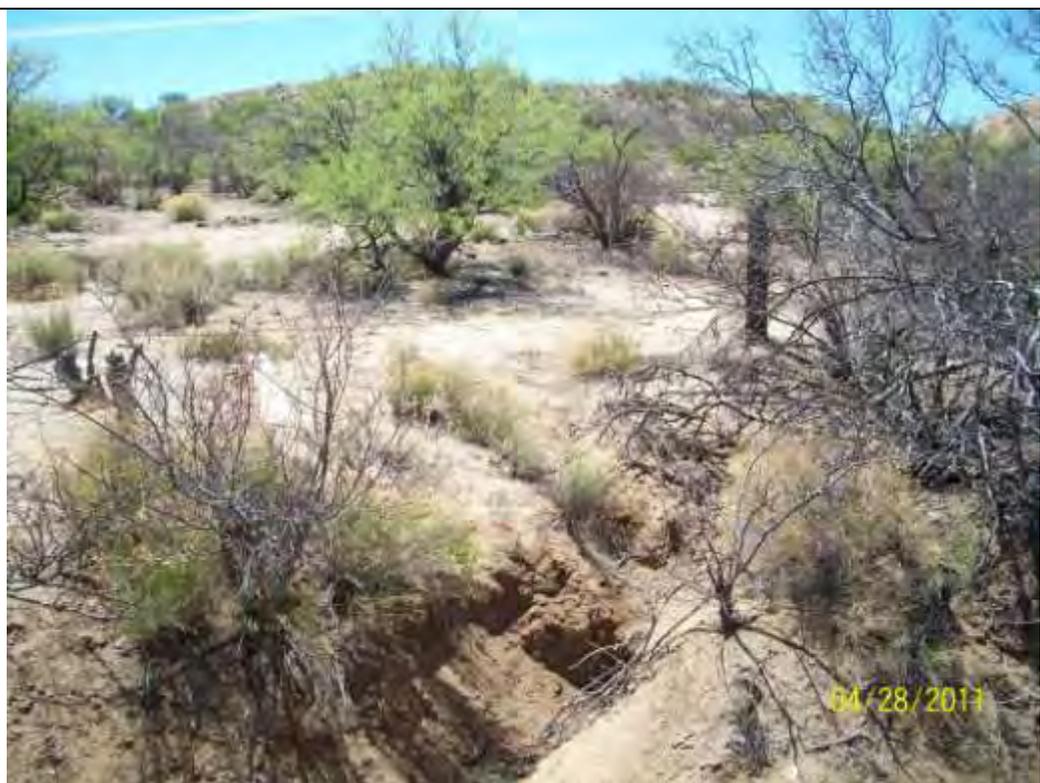
| <b>Photo No.</b><br><b>84</b> | <b>Date:</b><br>4-28-11 |

Site fence is down; fence strands twisted together (See Figure E1).

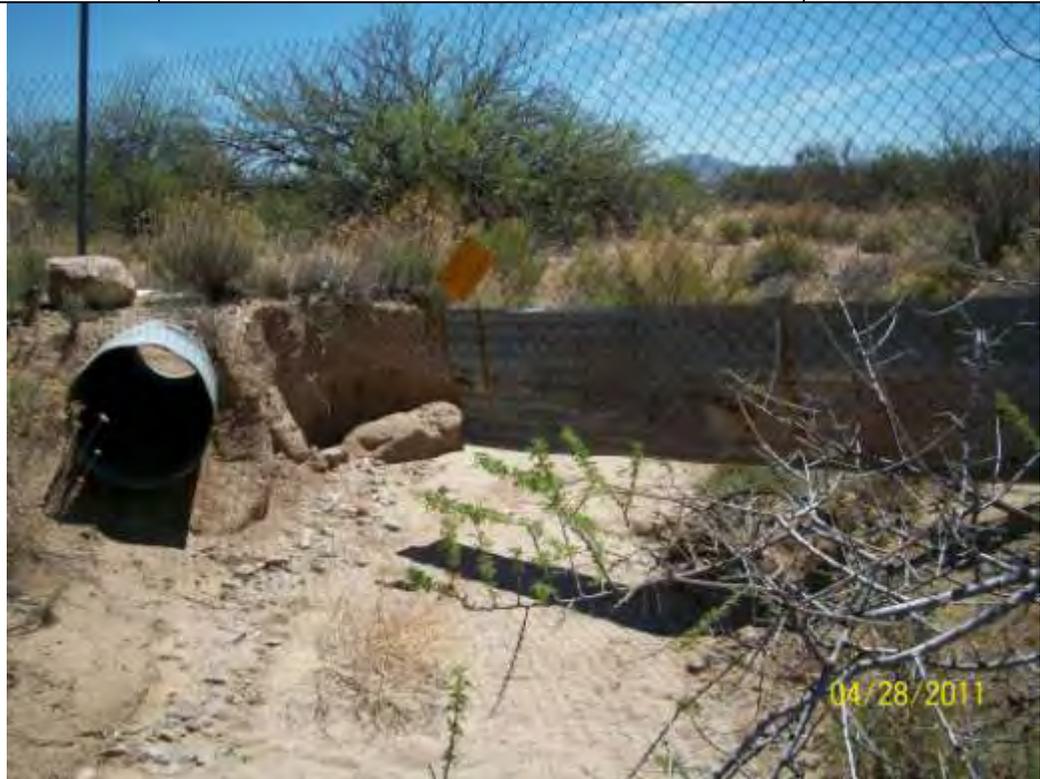
| <b>Photo No.</b><br><b>87</b> | <b>Date:</b><br>4-28-11 |

Fence spans drainage, and corrugated pipe (culvert is useless). Drainage opening is ~6 feet x 3 feet (See Figure E1).

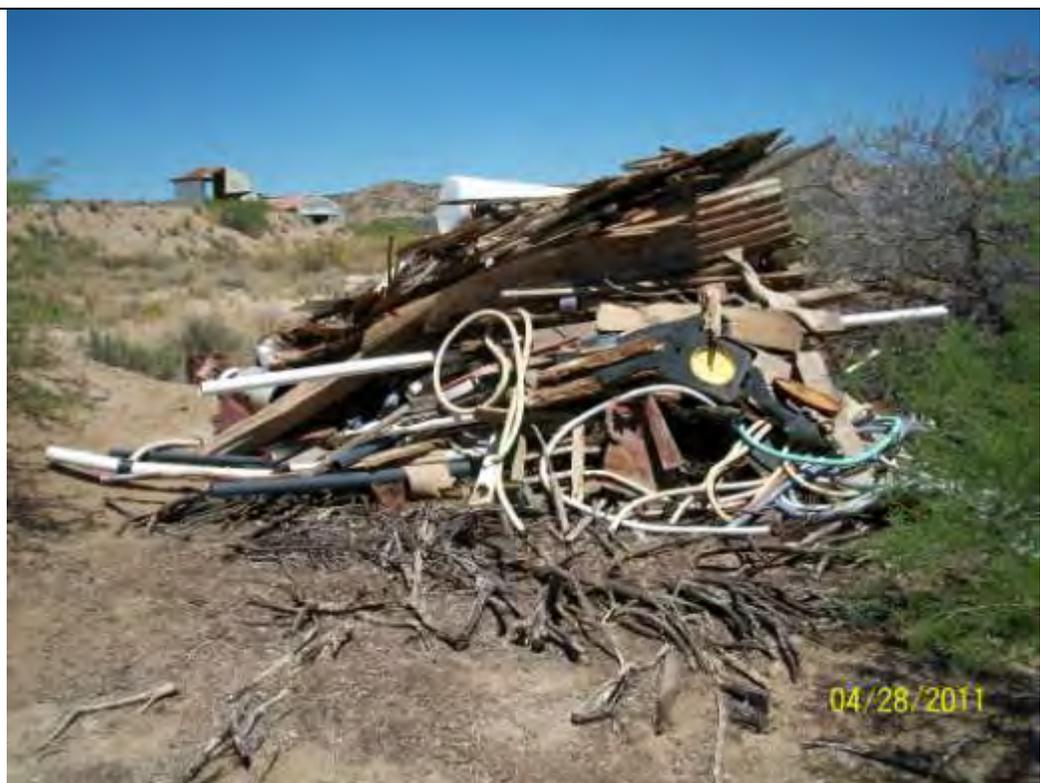
| <b>Photo No.</b><br><b>88</b> | <b>Date:</b><br>4-28-11 |

Debris pile on southeast corner of site.

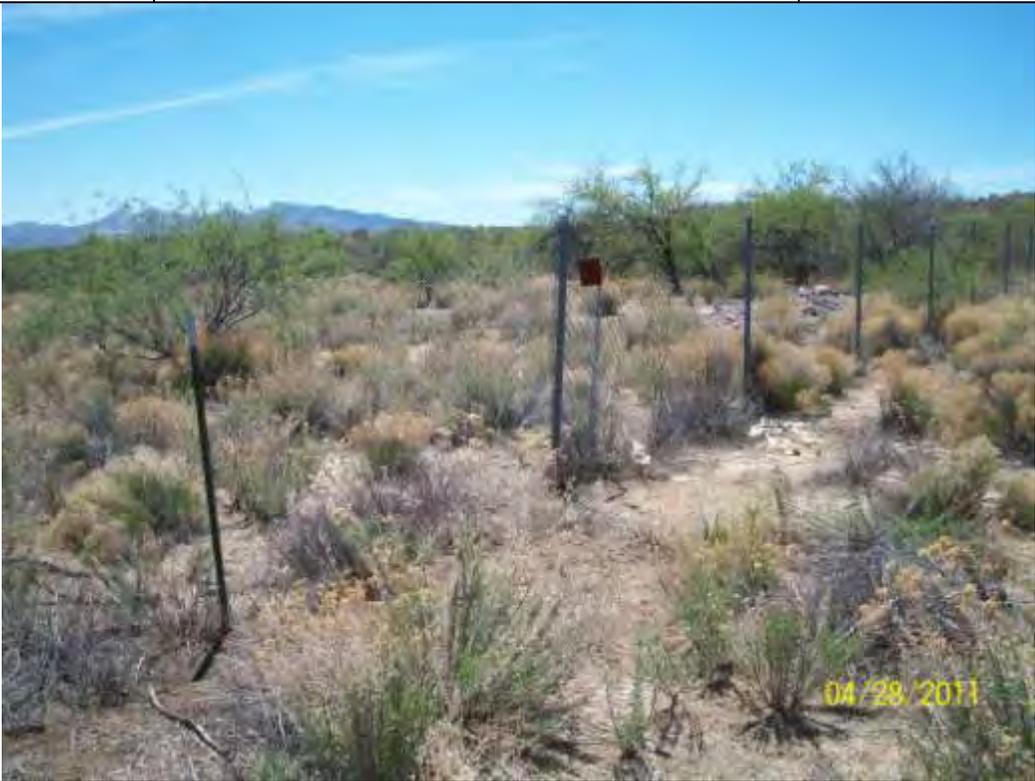
| <b>Photo No.</b><br><b>89</b> | <b>Date:</b><br>4-28-11 |

Fence transitions from steel tube posts to T-posts ~40 linear feet (See Figure E1).

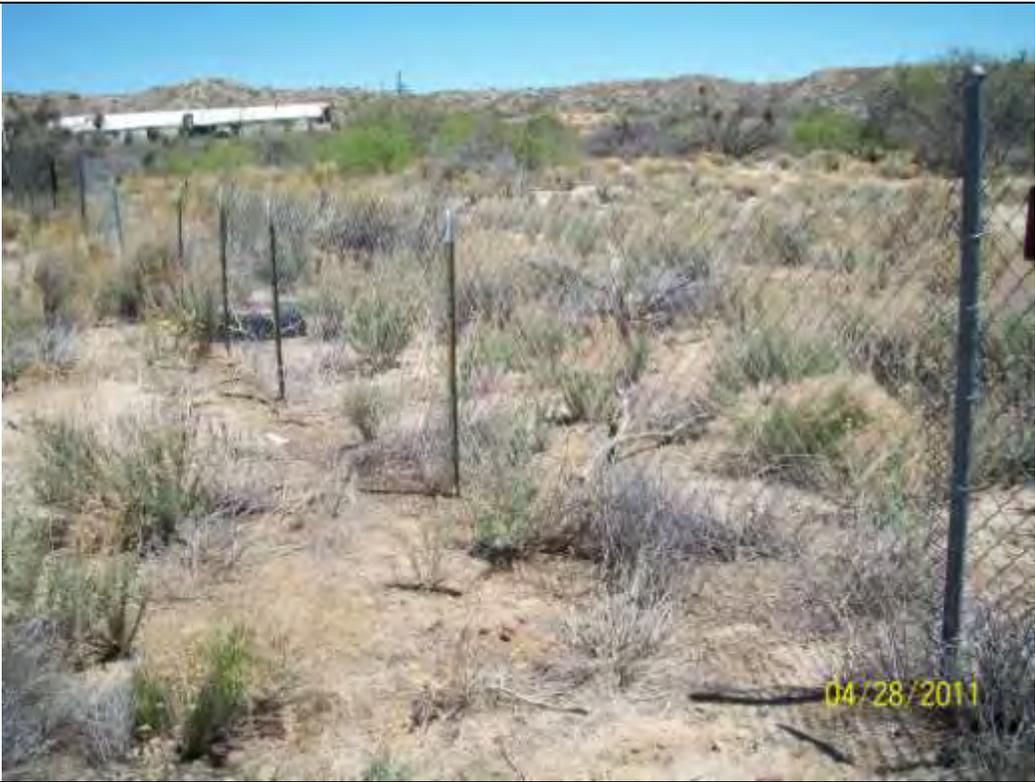
| <b>Photo No.</b><br><b>90</b> | <b>Date:</b><br>4-28-11 |

Fence transitions from steel tube posts to T-posts ~40 linear feet (See Figure E1).

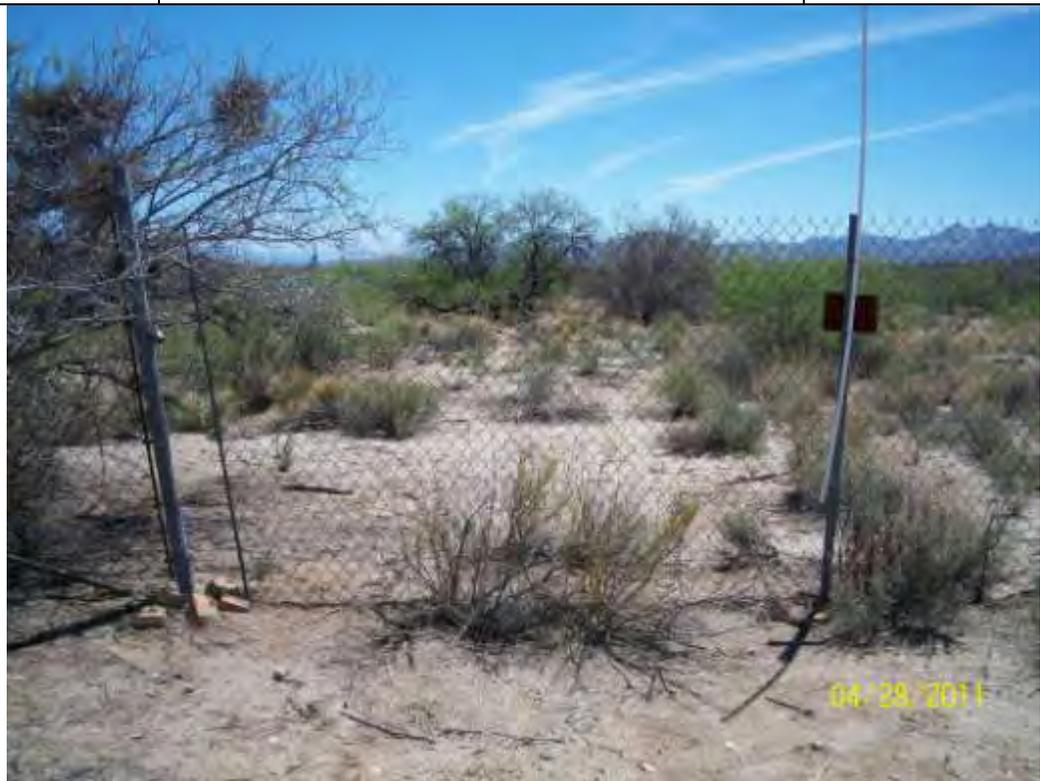
| <b>Photo No.</b><br><b>91</b> | <b>Date:</b><br>4-28-11 |

Fence is in disrepair; view of an ~10-foot unsecured section that is in need of repair (See Figure E1).

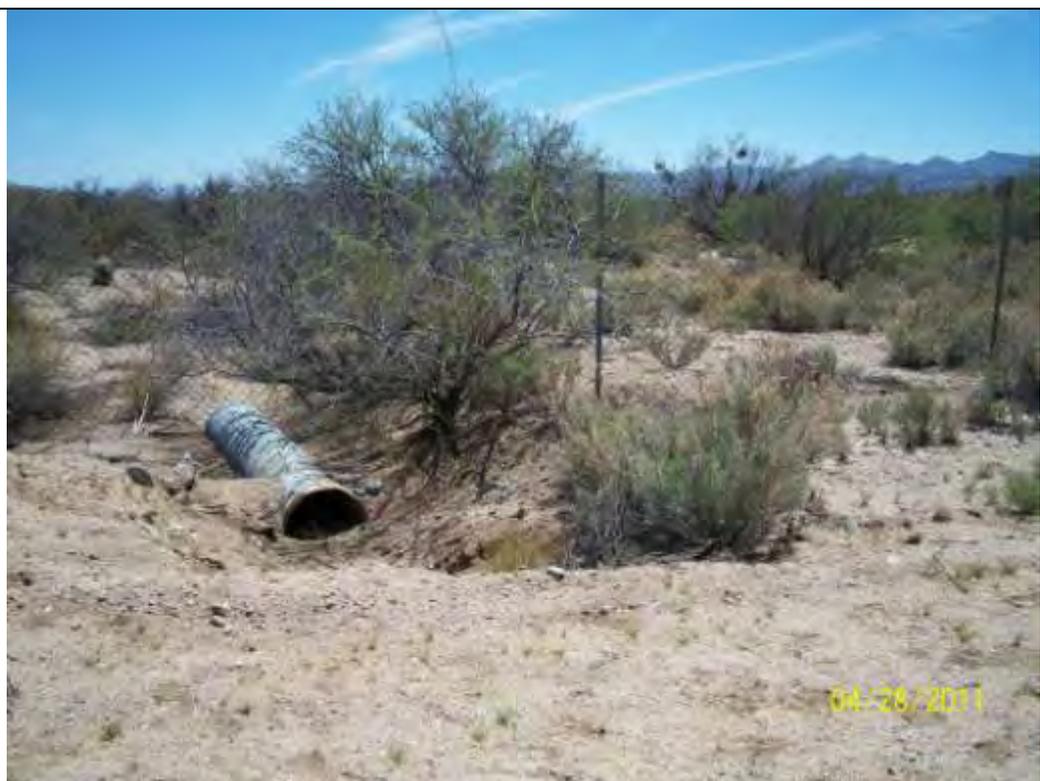
| <b>Photo No.</b><br><b>92</b> | <b>Date:</b><br>4-28-11 |

Fence spans what likely used to be drainage; corrugated pipe is useless. Fence needs extension or hole filled in (See Figure E1).

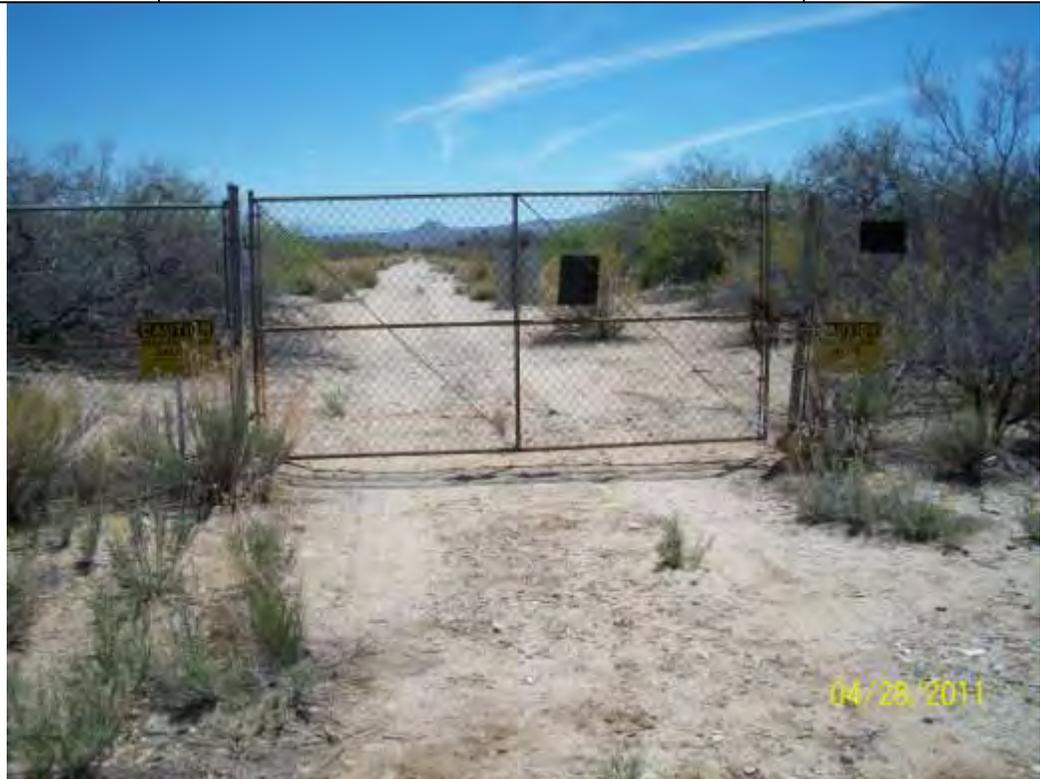
| <b>Photo No.</b><br><b>93</b> | <b>Date:</b><br>4-28-11 |

Gate for El Paso gas access (See Figure E1).

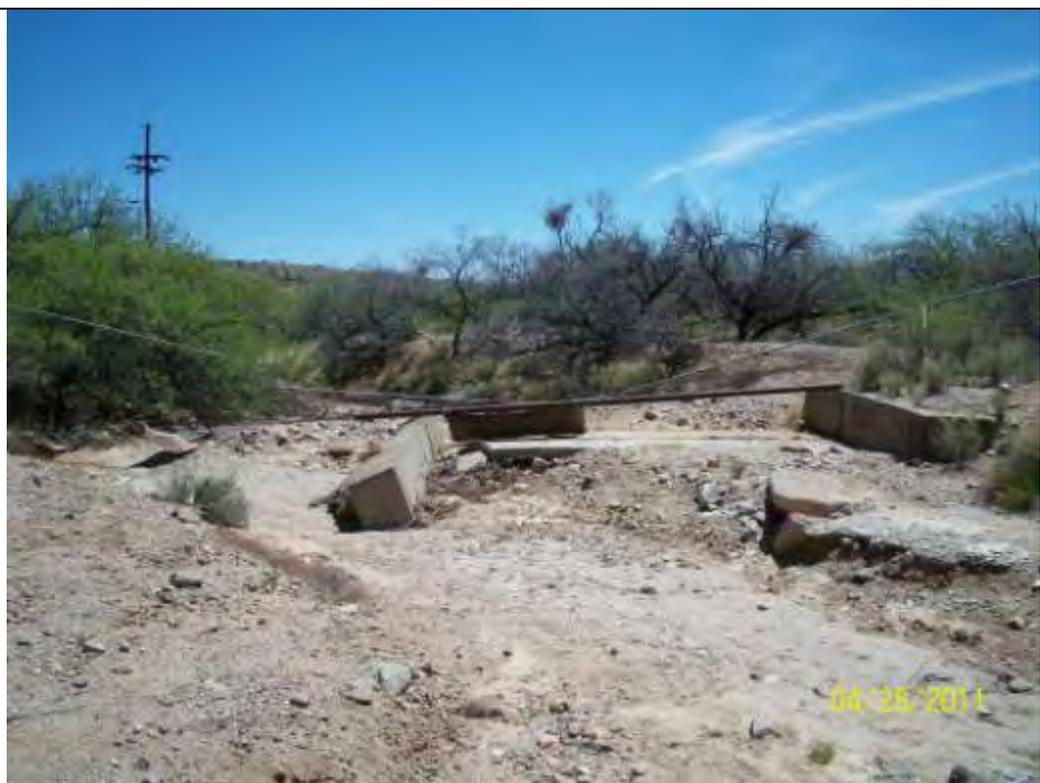
| <b>Photo No.</b><br><b>94</b> | <b>Date:</b><br>4-28-11 |

Fence spans concrete spillway on northeast corner of site, ~50 linear feet is in need of repair (See Figure E1).

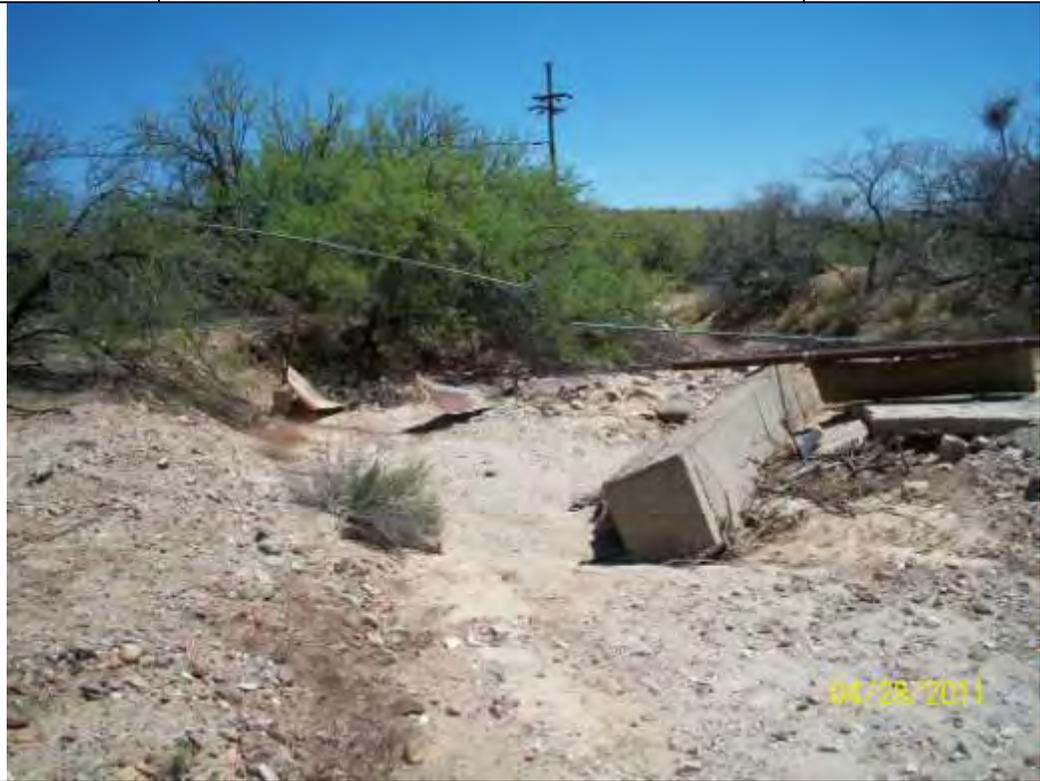
| <b>Photo No.</b><br><b>95</b> | <b>Date:</b><br>4-28-11 |

Fence spans concrete spillway on northeast corner of site, ~50 linear feet is in need of repair (See Figure E1).

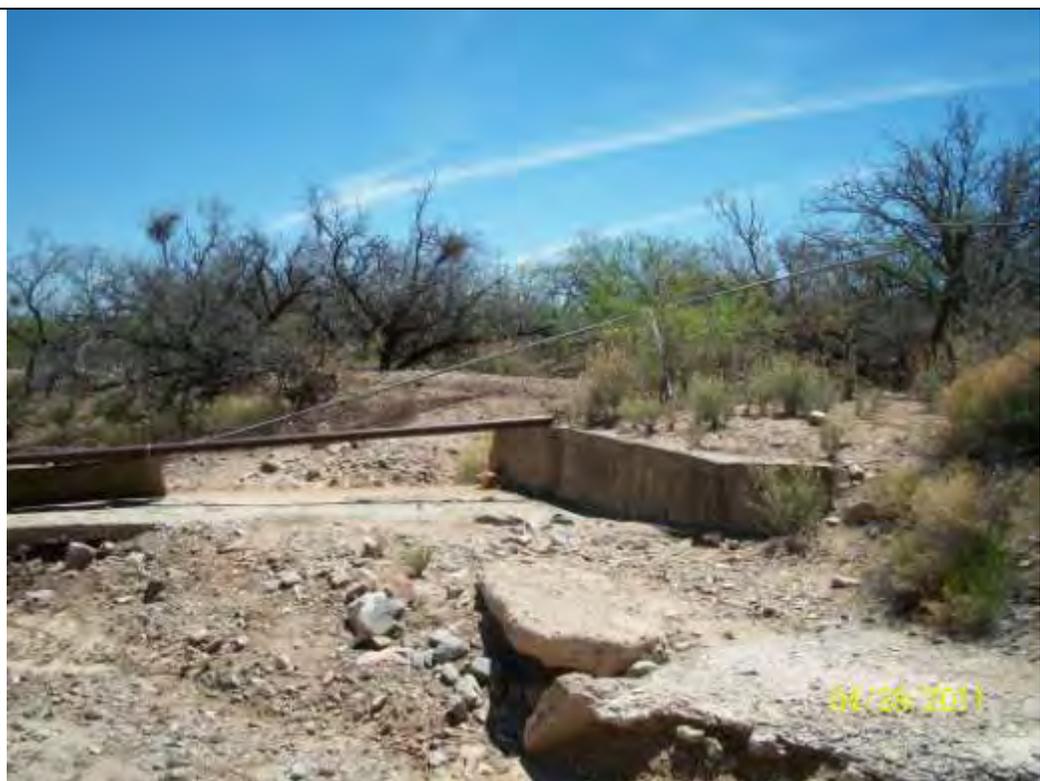
| <b>Photo No.</b><br><b>96</b> | <b>Date:</b><br>4-28-11 |

Fence spans concrete spillway on northeast corner of site, ~50 linear feet is in need of repair (See Figure E1).

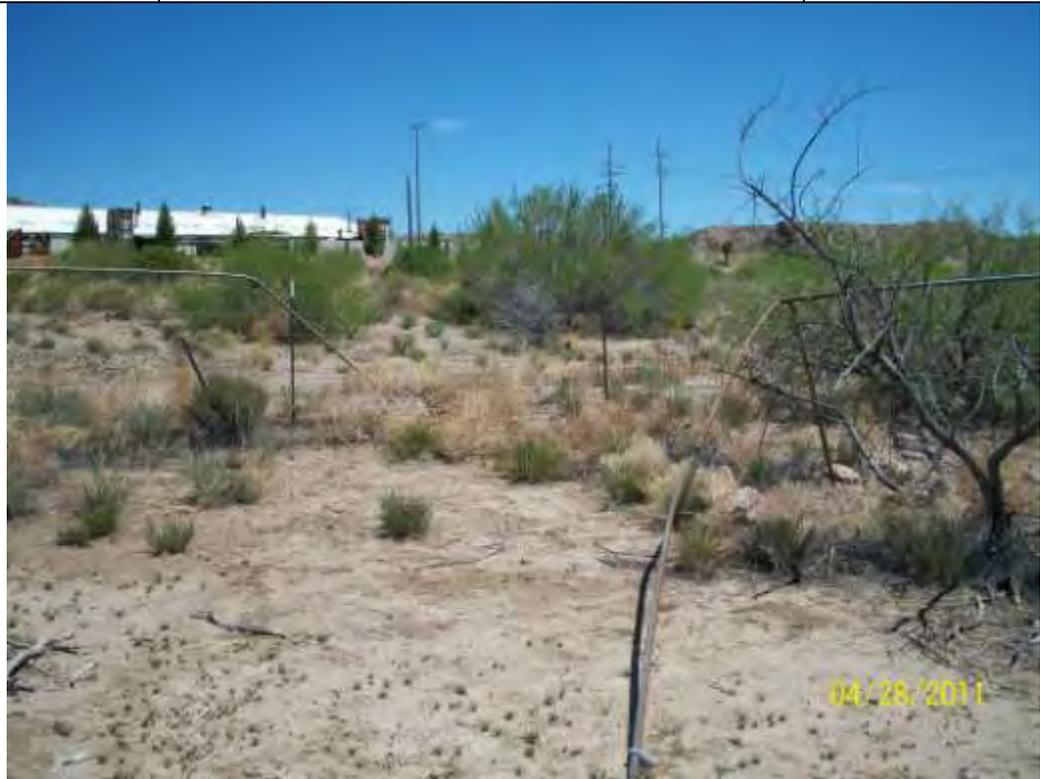
| <b>Photo No.</b><br><b>97</b> | <b>Date:</b><br>4-28-11 |

Northeast corner of fence needs new corner post and ~15 linear feet is in need of repairs (See Figure E1).

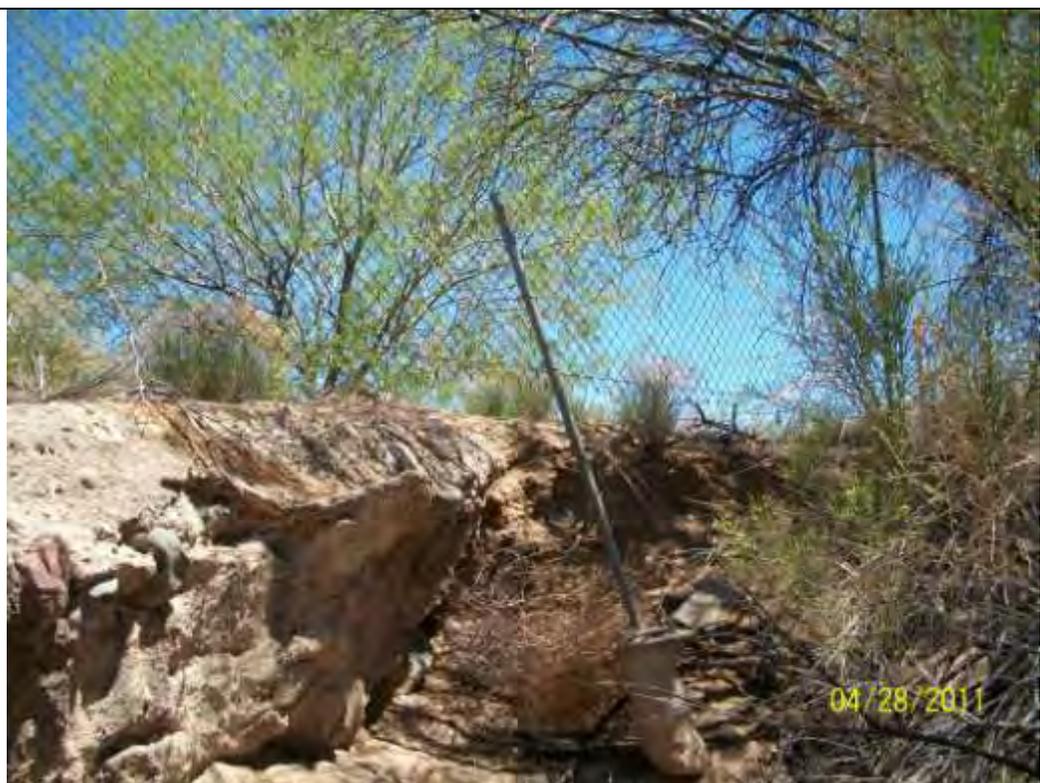
| <b>Photo No.</b><br><b>98</b> | <b>Date:</b><br>4-28-11 |

Fence spans drainage on northern site perimeter, fence extension needed into drainage and ~25 linear feet of repairs needed (See Figure E1).

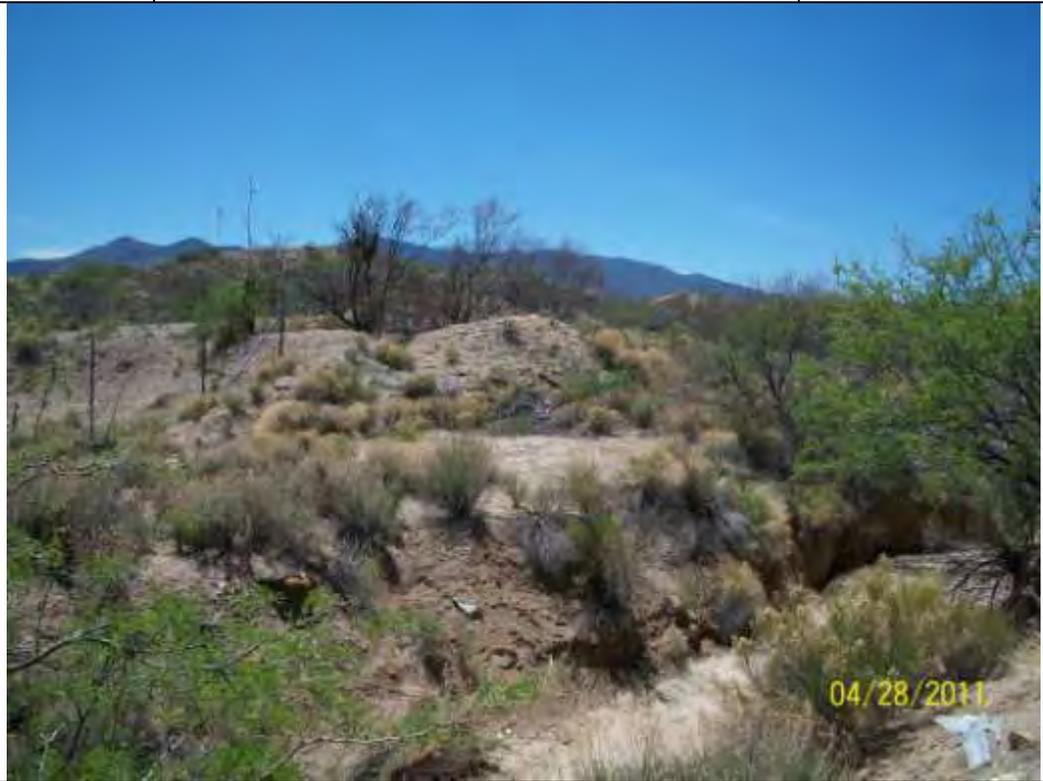
| <b>Photo No.</b><br><b>99</b> | <b>Date:</b><br>4-28-11 |

Picture of waste pile A: not sampled (See Figure 8 for location on Site).

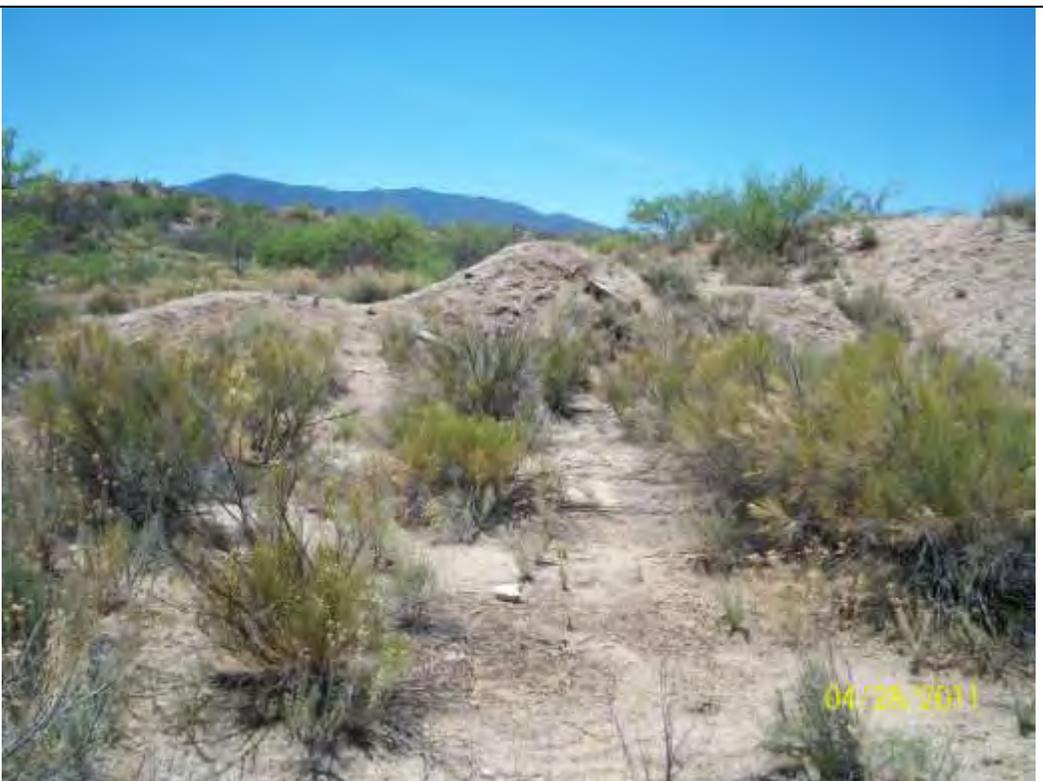
| <b>Photo No.</b><br><b>100</b> | <b>Date:</b><br>4-28-11 |

Picture of waste pile B; PA/SI sample SM-A4-WS-5 (See Figure 8 for location on Site).
