| <b>Project Name:</b><br>Sunchief Mill Site EE/CA | | <b>Site Location:</b><br>Tonto National Forest, Gila County, Arizona | <b>Project No.</b><br>12238.041.002 |

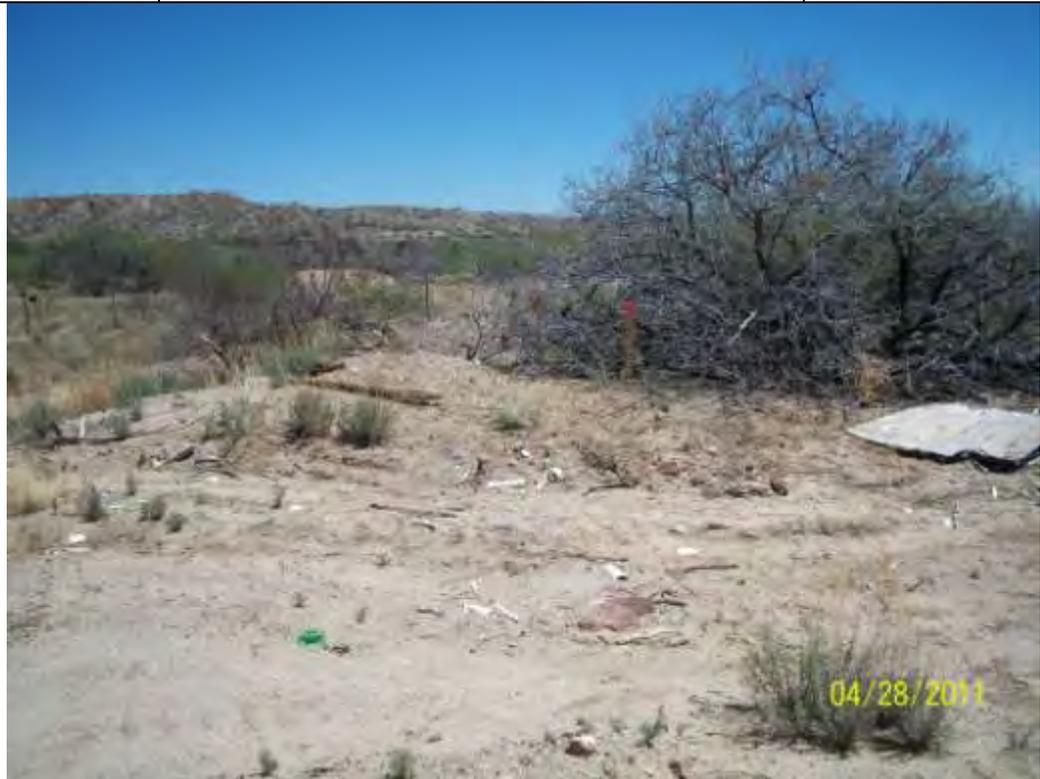
| <b>Photo No.</b><br><b>103</b> | <b>Date:</b><br>4-28-11 |

Picture of waste pile E; EE/CA A4-WS3E (See Figure 8 for location on Site).

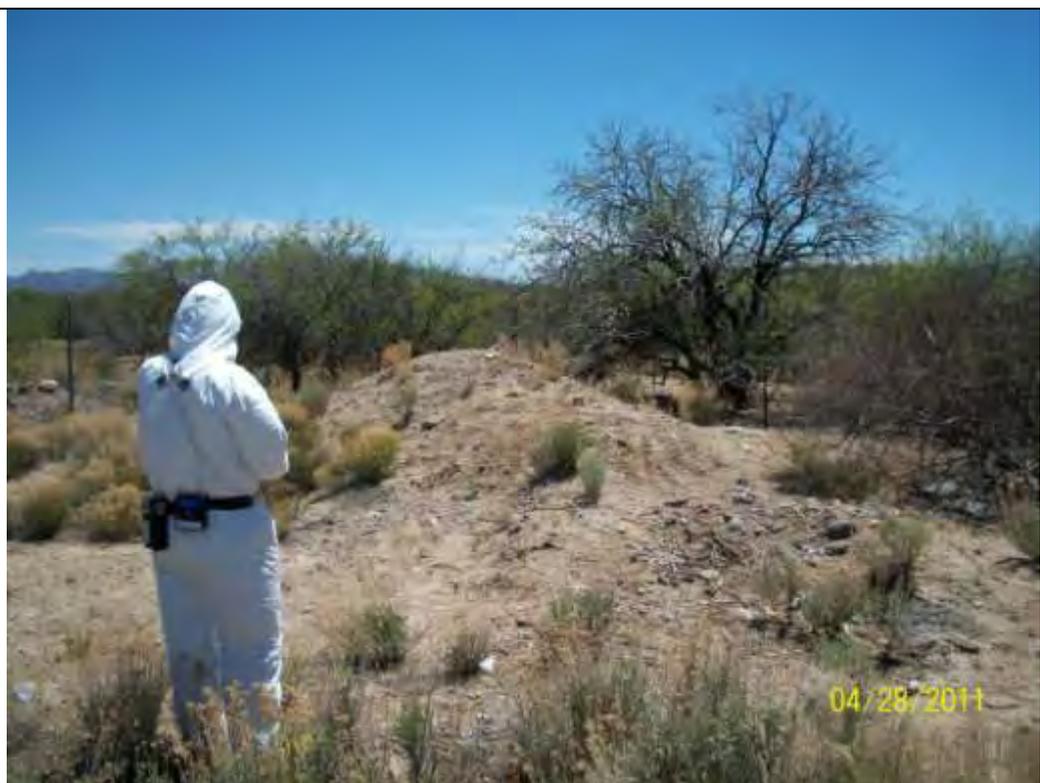
| <b>Photo No.</b><br><b>104</b> | <b>Date:</b><br>4-28-11 |

Picture of waste pile F; not sampled (See Figure 8 for location on Site).

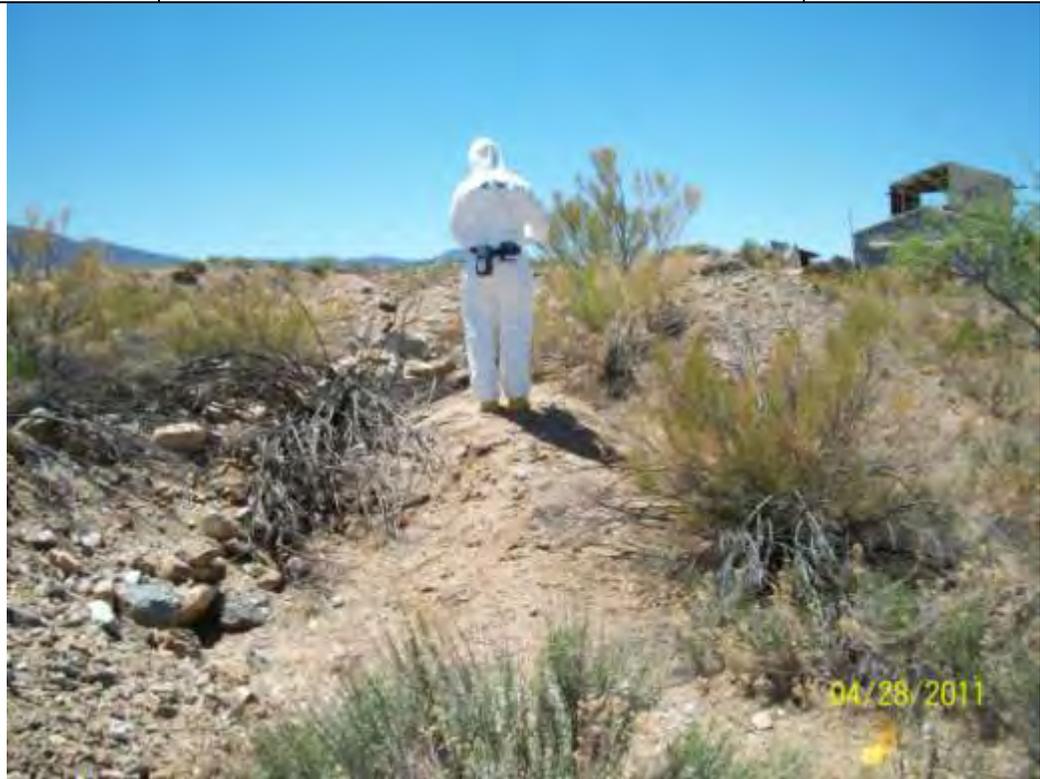
| <b>Photo No.</b><br><b>107</b> | <b>Date:</b><br>4-28-11 |

Picture of waste pile I; not sampled (See Figure 8 for location on Site).

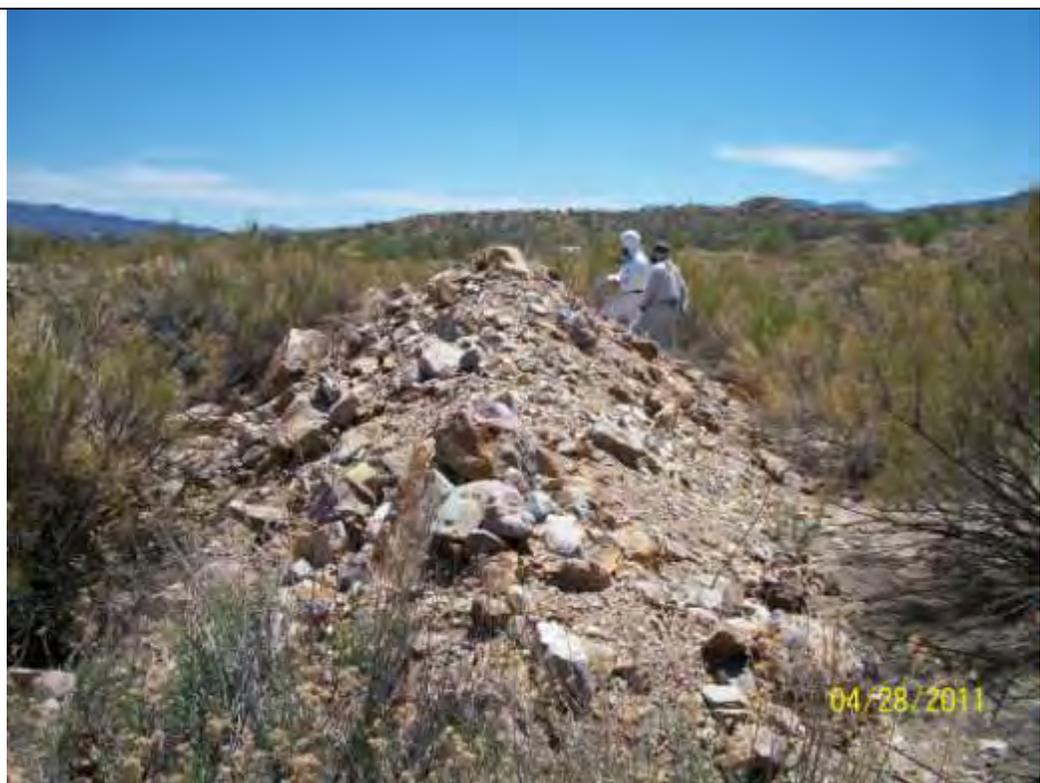
| <b>Photo No.</b><br><b>108</b> | <b>Date:</b><br>4-28-11 |

Picture of waste pile J; PA/SI SM-A4-WS-1 (arsenic 12mg/kg) (See Figure 8 for location on Site).

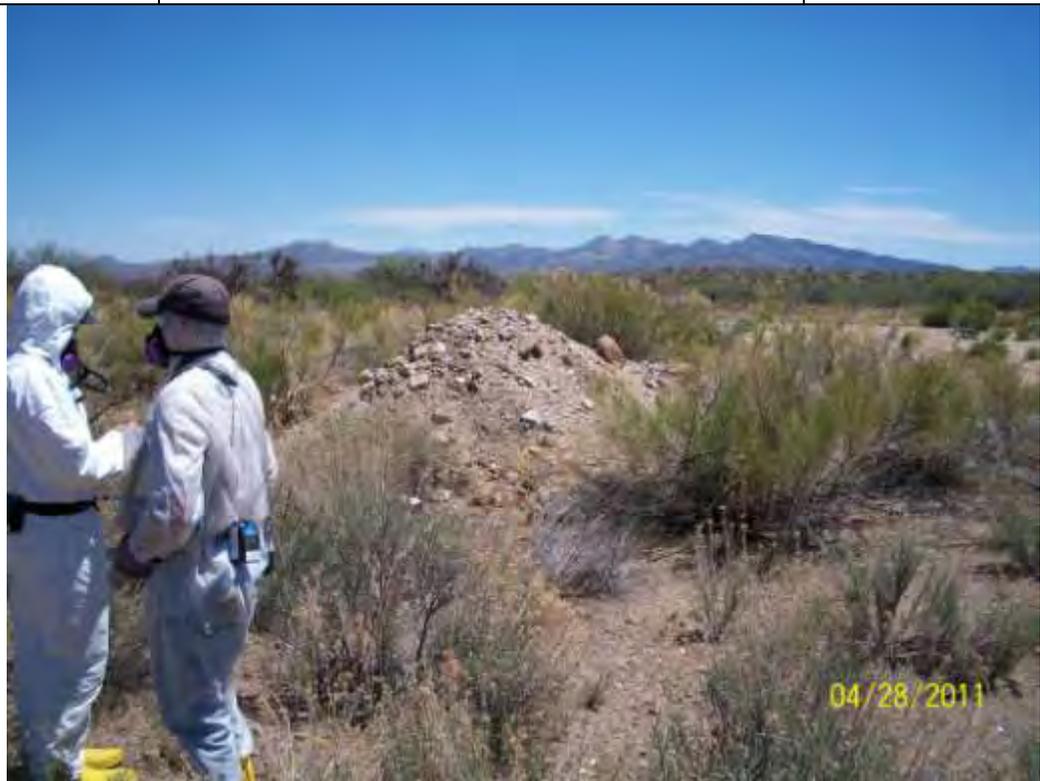
| <b>Photo No.</b><br><b>109</b> | <b>Date:</b><br>4-28-11 |

Picture of waste pile K; not sampled (See Figure 8 for location on Site).

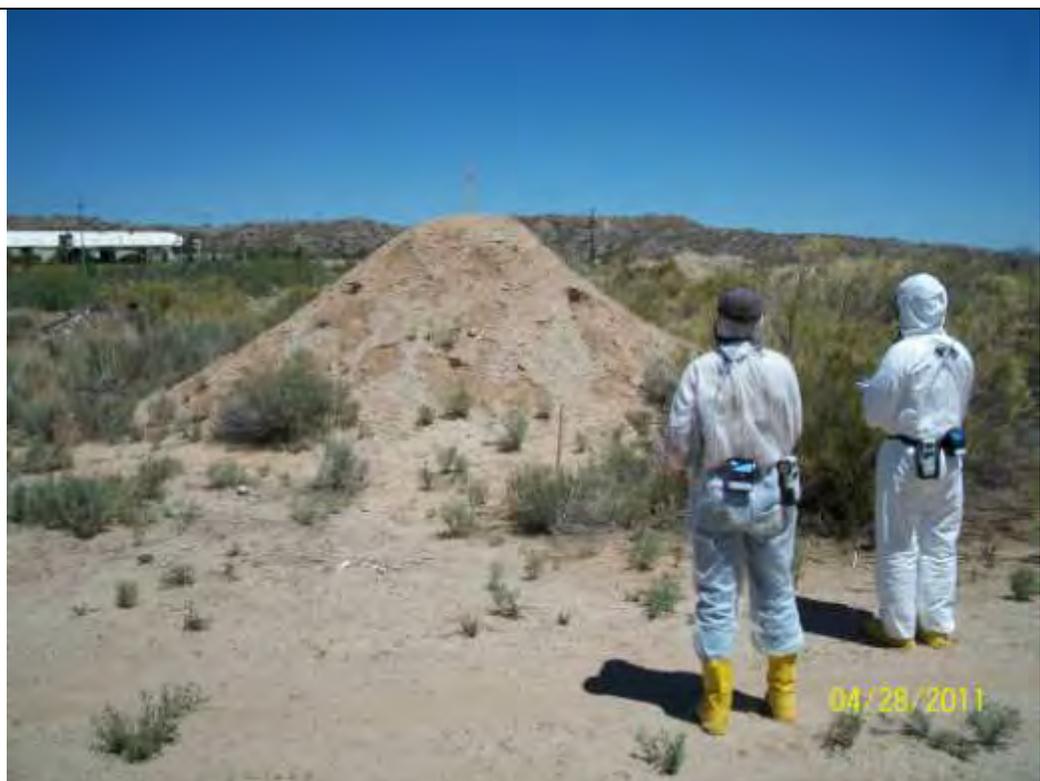
| <b>Photo No.</b><br><b>110</b> | <b>Date:</b><br>4-28-11 |

Picture of waste pile L EE/CA A4-WS1E (See Figure 8 for location on Site).

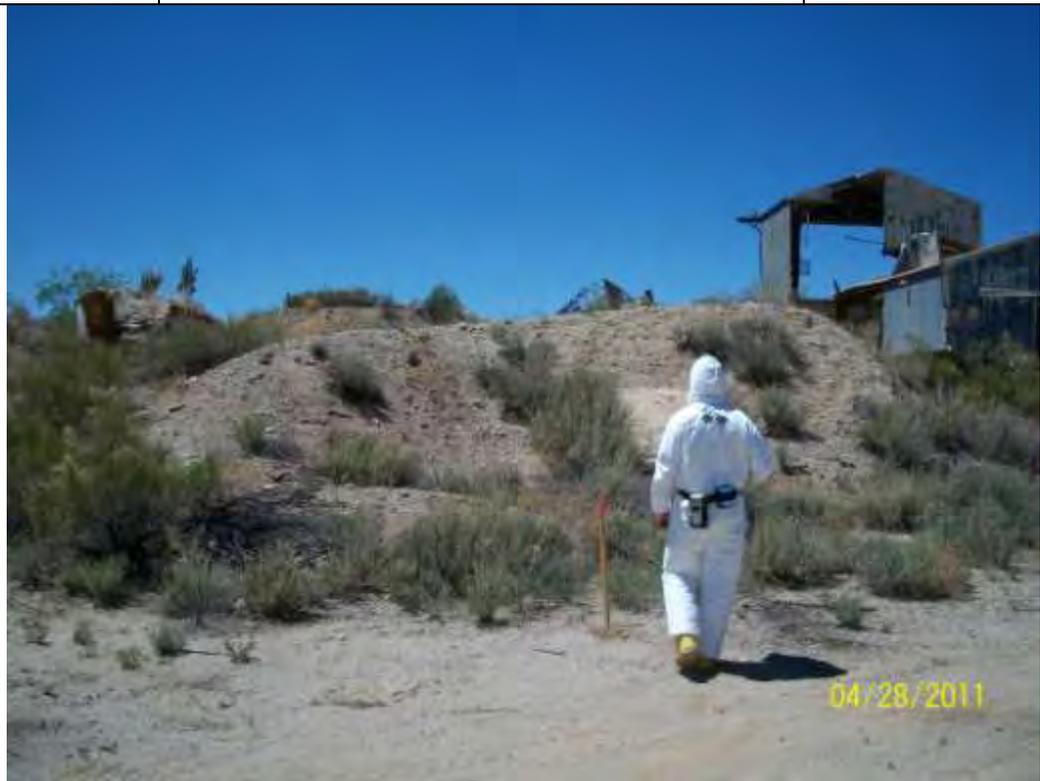
| <b>Photo No.</b><br><b>111</b> | <b>Date:</b><br>4-28-11 |

Picture of waste pile M; PA/SI SM-A3-WS-6 (See Figure 8 for location on Site).

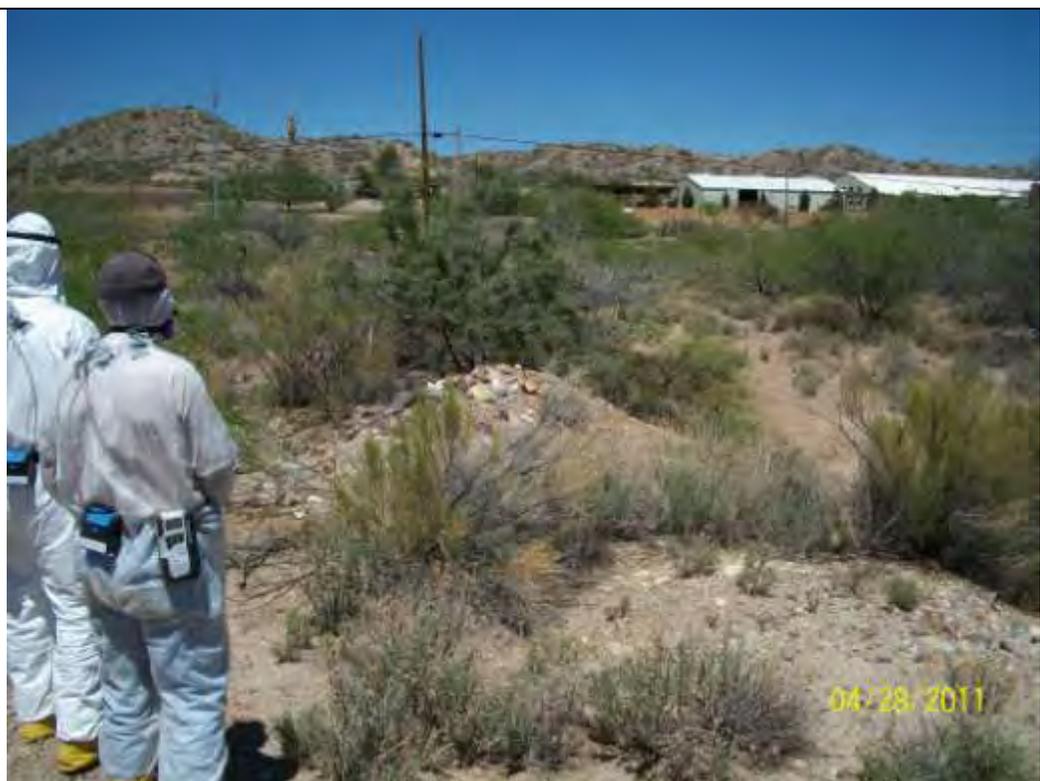
| <b>Photo No.</b><br><b>112</b> | <b>Date:</b><br>4-28-11 |

Picture of waste pile N; not (See Figure 8 for location on Site).

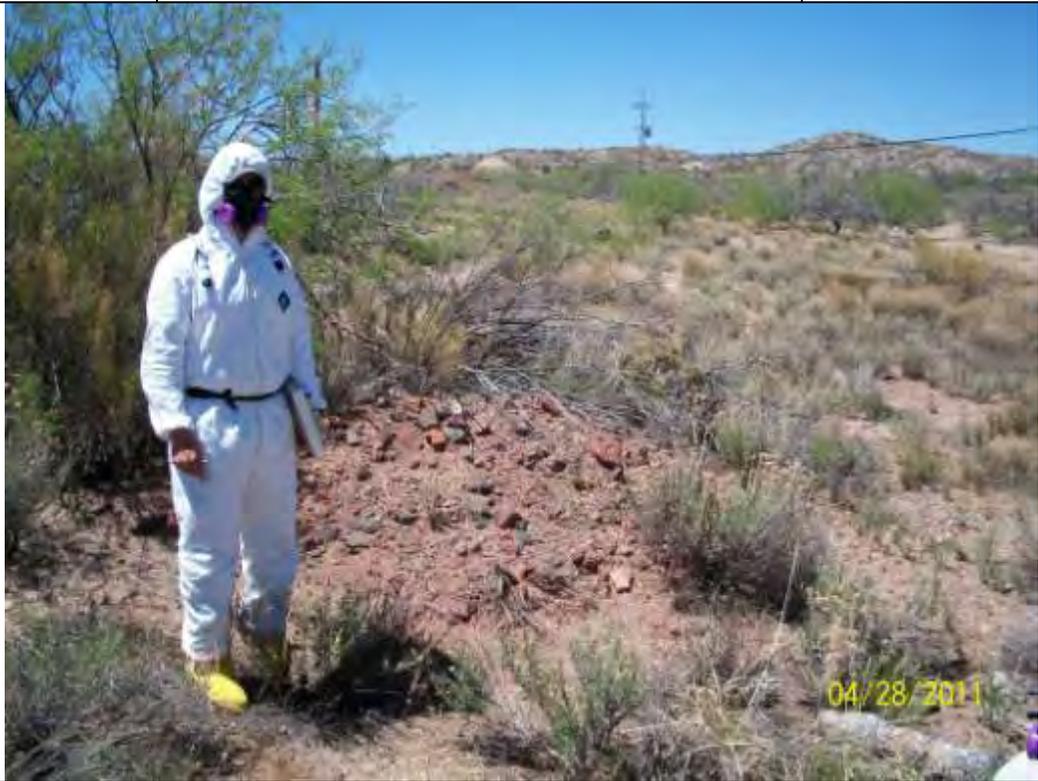
| <b>Photo No.</b><br><b>115</b> | <b>Date:</b><br>4-28-11 |

| <b>Description:</b><br><br>Picture of waste pile P; not sampled (See Figure 8 for location on Site). | |

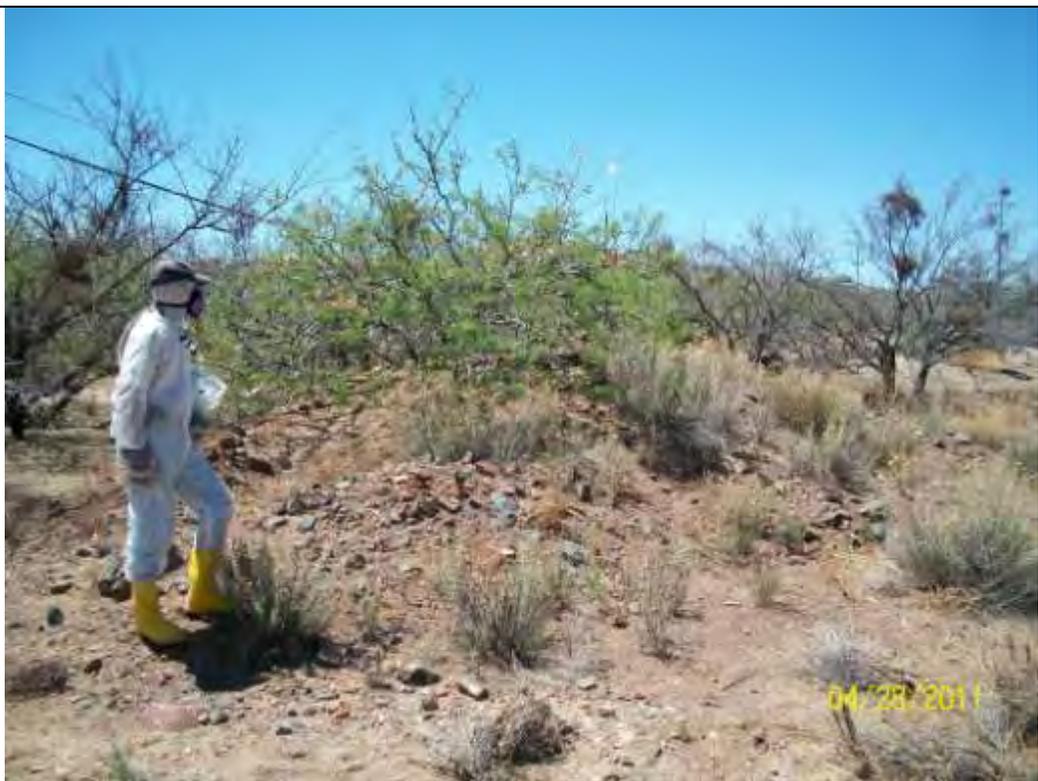
| <b>Photo No.</b><br><b>116</b> | <b>Date:</b><br>4-28-11 |

| <b>Description:</b><br><br>Picture of waste pile Q. EE/CA A2-WS4E (arsenic 18mg/kg) (See Figure 8 for location on Site). | |

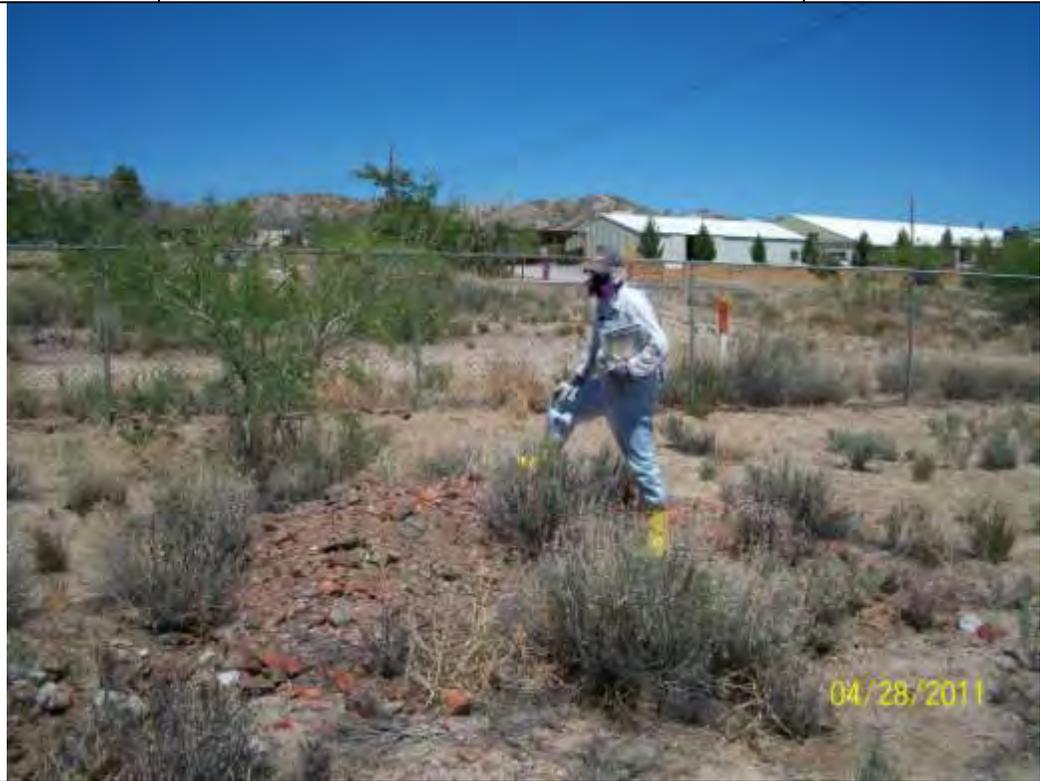
| <b>Photo No.</b><br><b>117</b> | <b>Date:</b><br>4-28-11 |

Picture of waste pile R;  
not sampled (See Figure 8  
for location on Site).

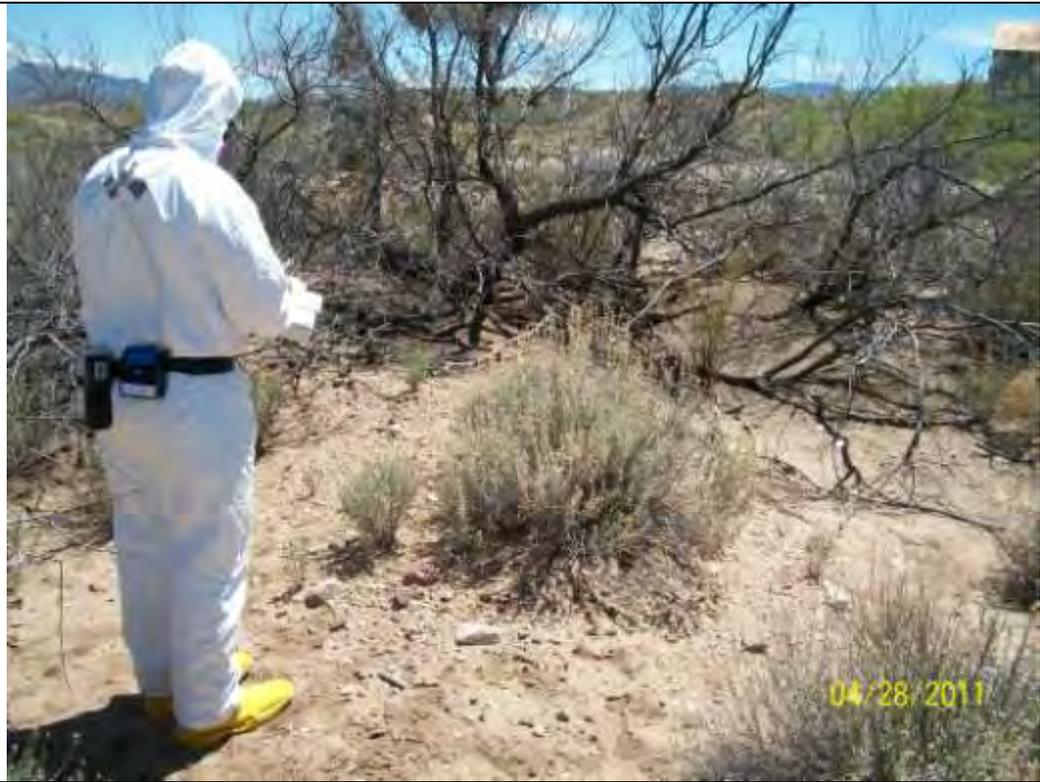
| <b>Photo No.</b><br><b>118</b> | <b>Date:</b><br>4-28-11 |

Picture of waste pile S;  
not sampled (See Figure 8  
for location on Site).

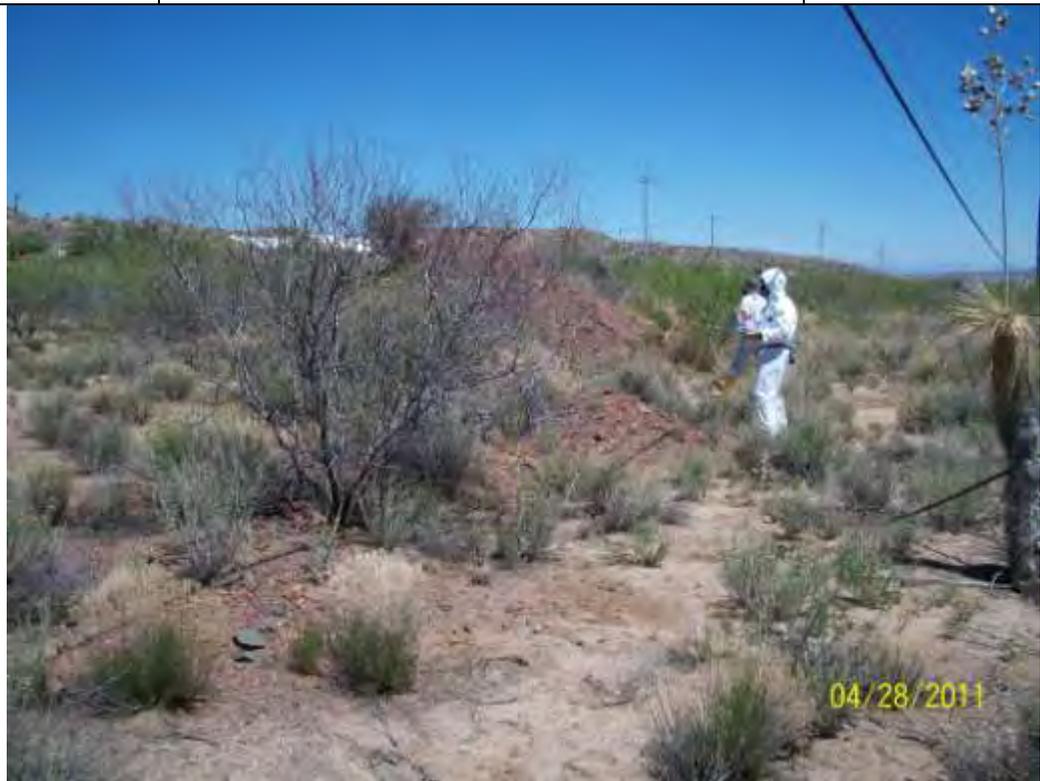
| <b>Photo No.</b><br><b>123</b> | <b>Date:</b><br>4-28-11 |

Picture of waste pile X; EE/CA A2-WS2E (arsenic 20 mg/kg) (See Figure 8 for location on Site).

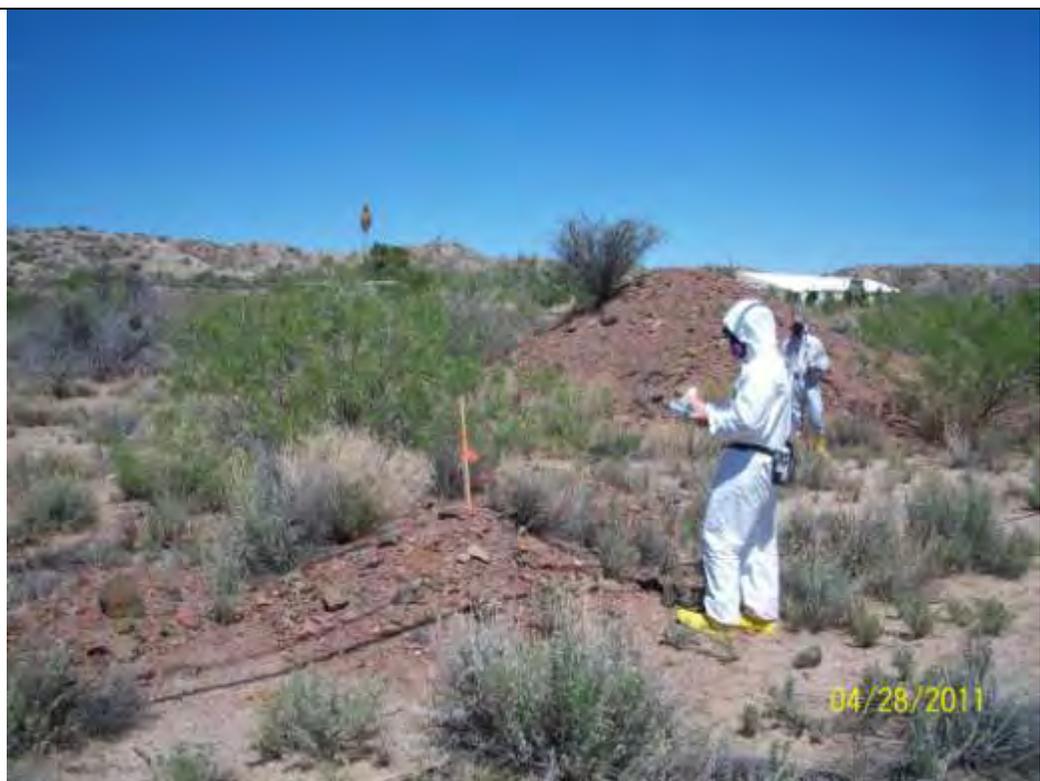
| <b>Photo No.</b><br><b>124</b> | <b>Date:</b><br>4-28-11 |

Picture of waste pile X; (See Figure 8 for location on Site).

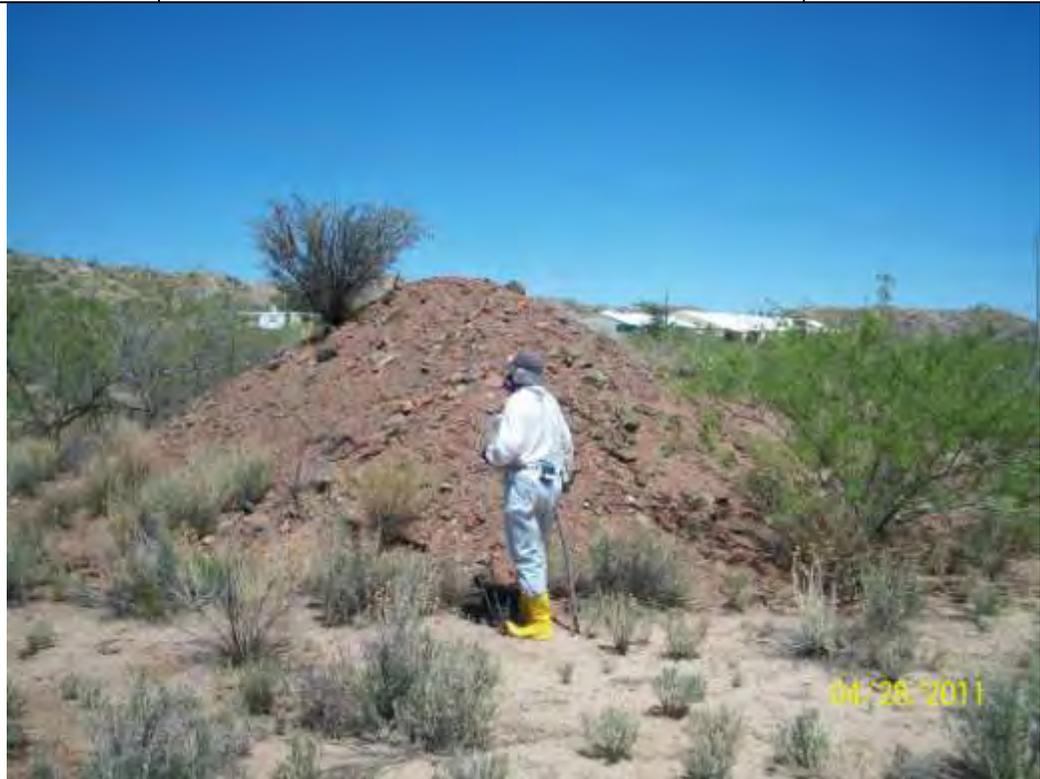
| <b>Photo No.</b><br><b>125</b> | <b>Date:</b><br>4-28-11 |

Picture of waste pile Y; PA/SI SM-A2-WS-4 (arsenic 29 mg/kg) (See Figure 8 for location on Site).

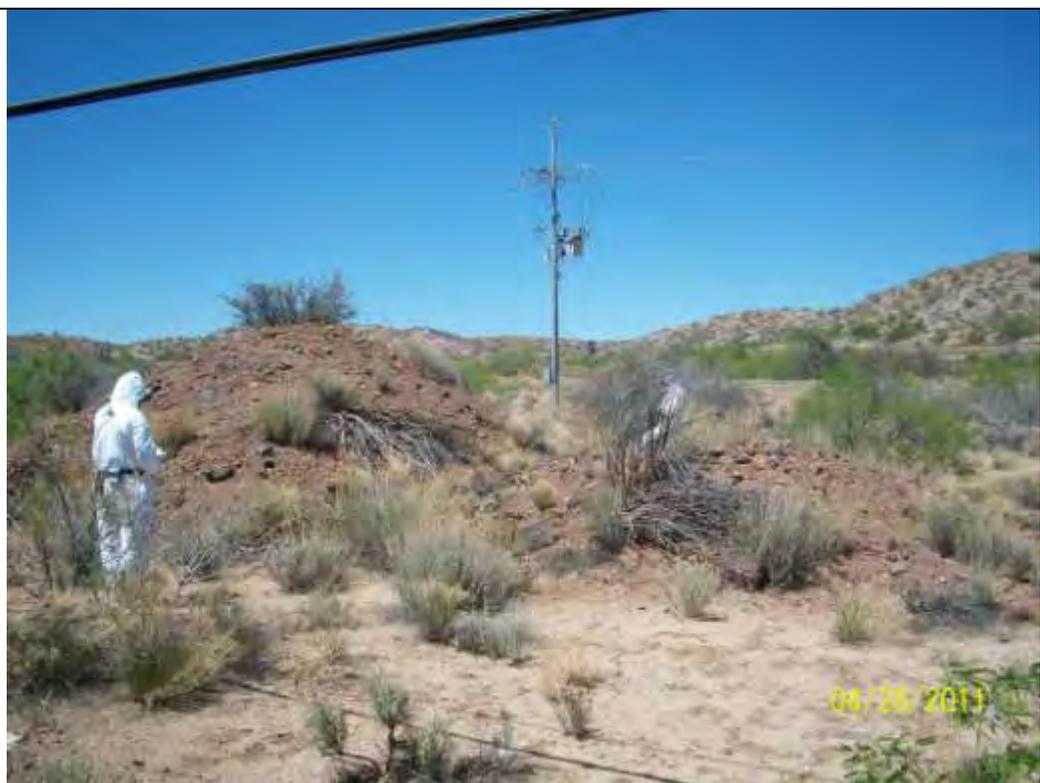
| <b>Photo No.</b><br><b>126</b> | <b>Date:</b><br>4-28-11 |

Picture of waste pile Y; (See Figure 8 for location on Site).

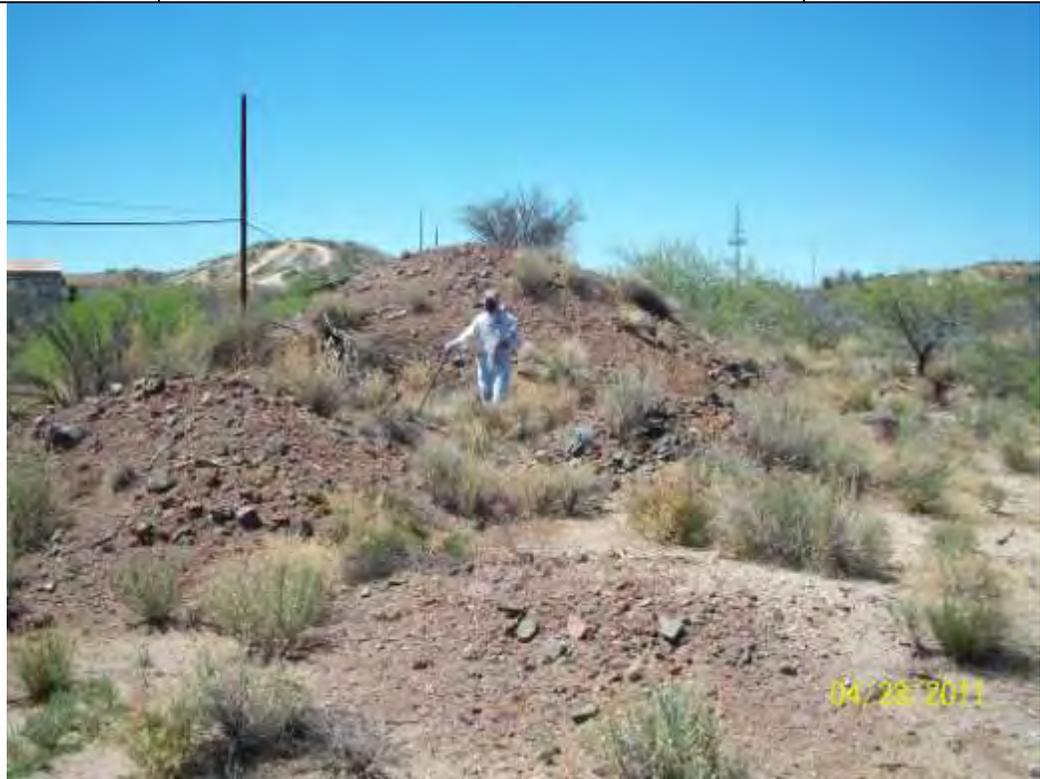
| <b>Photo No.</b><br><b>127</b> | <b>Date:</b><br>4-28-11 |

Picture of waste pile Y;  
(See Figure 8 for location on Site).

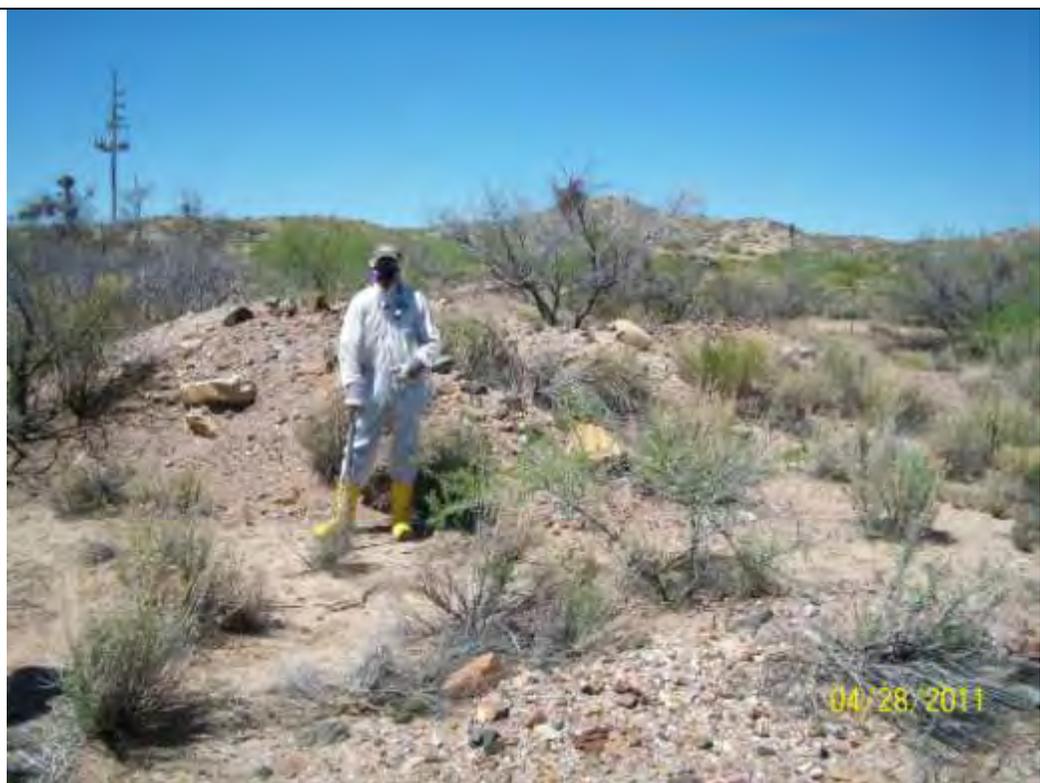
| <b>Photo No.</b><br><b>128</b> | <b>Date:</b><br>4-28-11 |

Picture of waste pile Z;  
PA/SI SM-A2-WS-1  
(arsenic 49 mg/kg, lead 1,500 mg/kg) (See Figure 8 for location on Site).

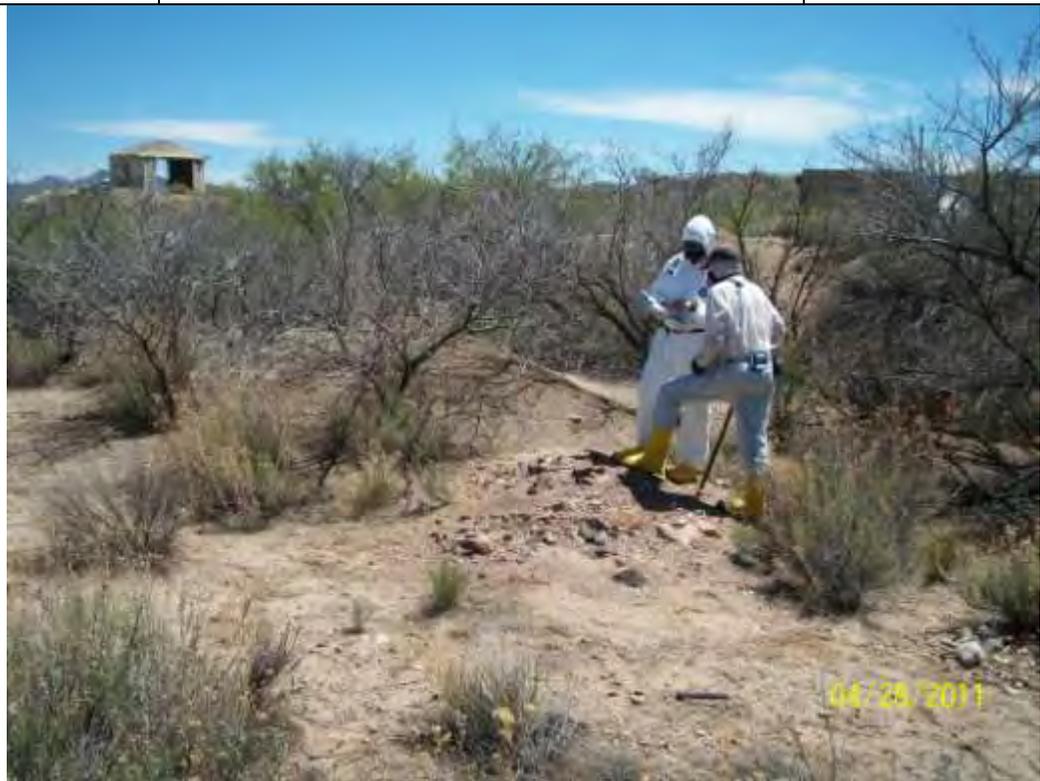
| <b>Photo No.</b><br><b>129</b> | <b>Date:</b><br>4-28-11 |

Picture of waste pile AA; PA/SI SM A2-WS-2 (arsenic 28 mg/kg) (See Figure 8 for location on Site).

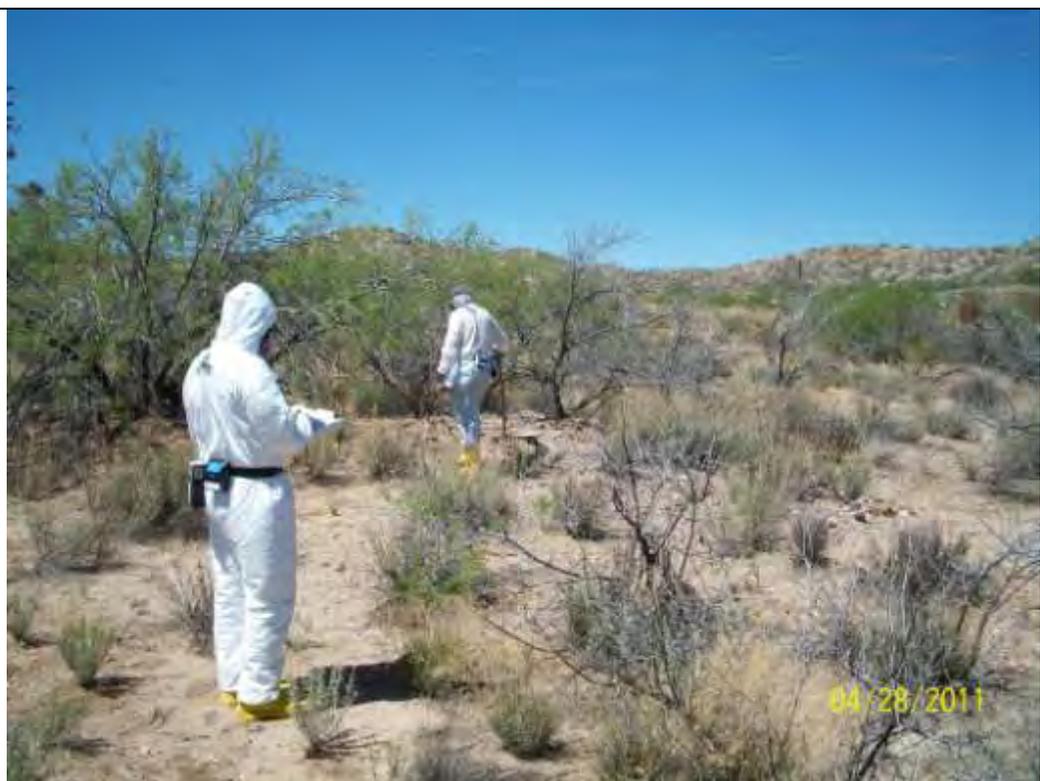
| <b>Photo No.</b><br><b>130</b> | <b>Date:</b><br>4-28-11 |

Picture of waste pile BB, not sampled (See Figure 8 for location on Site).

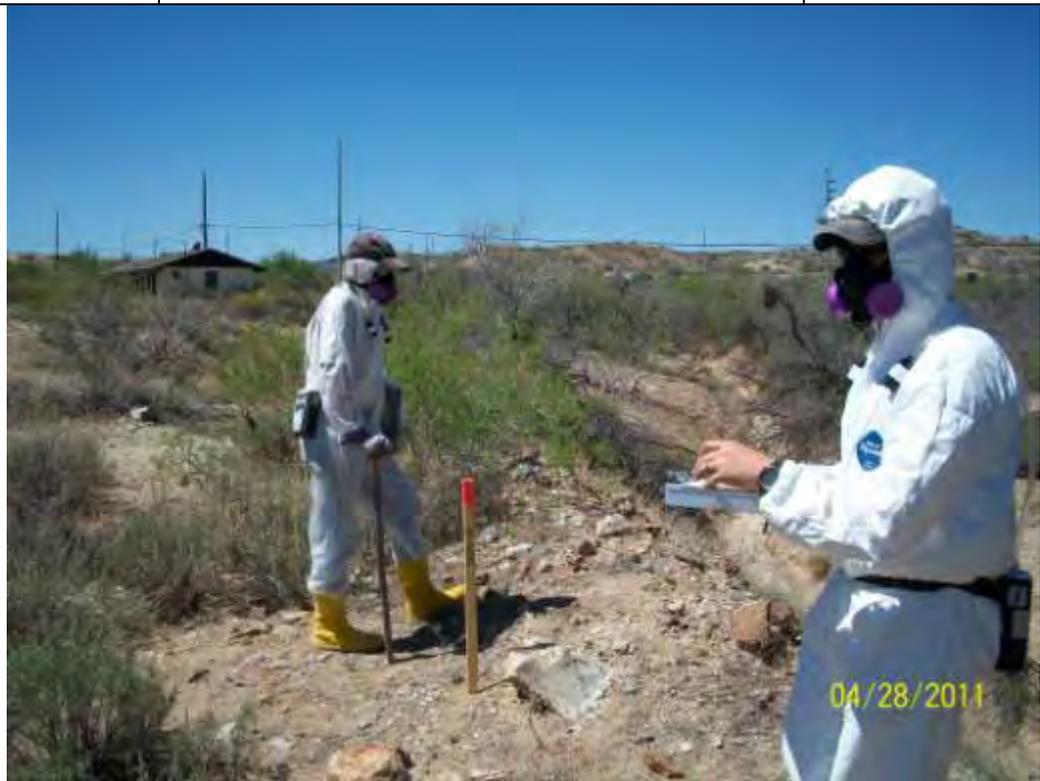
| <b>Photo No.</b><br><b>131</b> | <b>Date:</b><br>4-28-11 |

Picture of waste pile CC; EE/CA A1-WS1E (no exceedances) (See Figure 8 for location on Site).

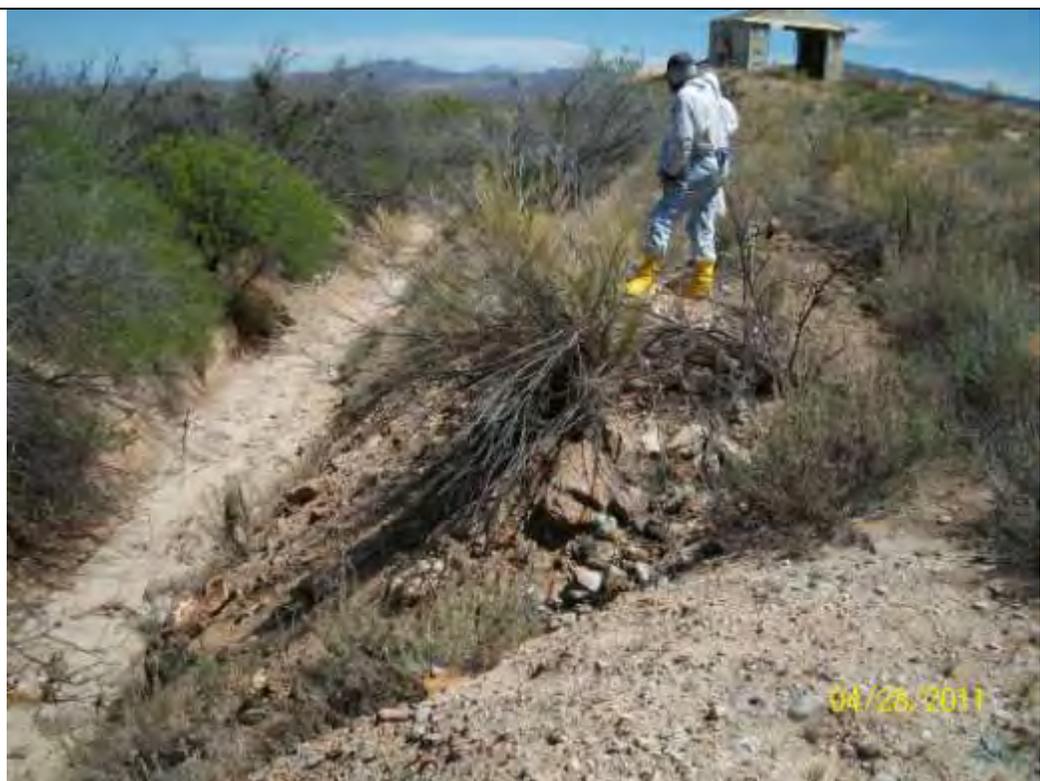
| <b>Photo No.</b><br><b>132</b> | <b>Date:</b><br>4-28-11 |

Picture of waste pile DD; PA/SI A1-WS-9 (arsenic 28 mg/kg, copper 58,000 mg/kg, lead 1,800 mg/kg) (See Figure 8 for location on Site).

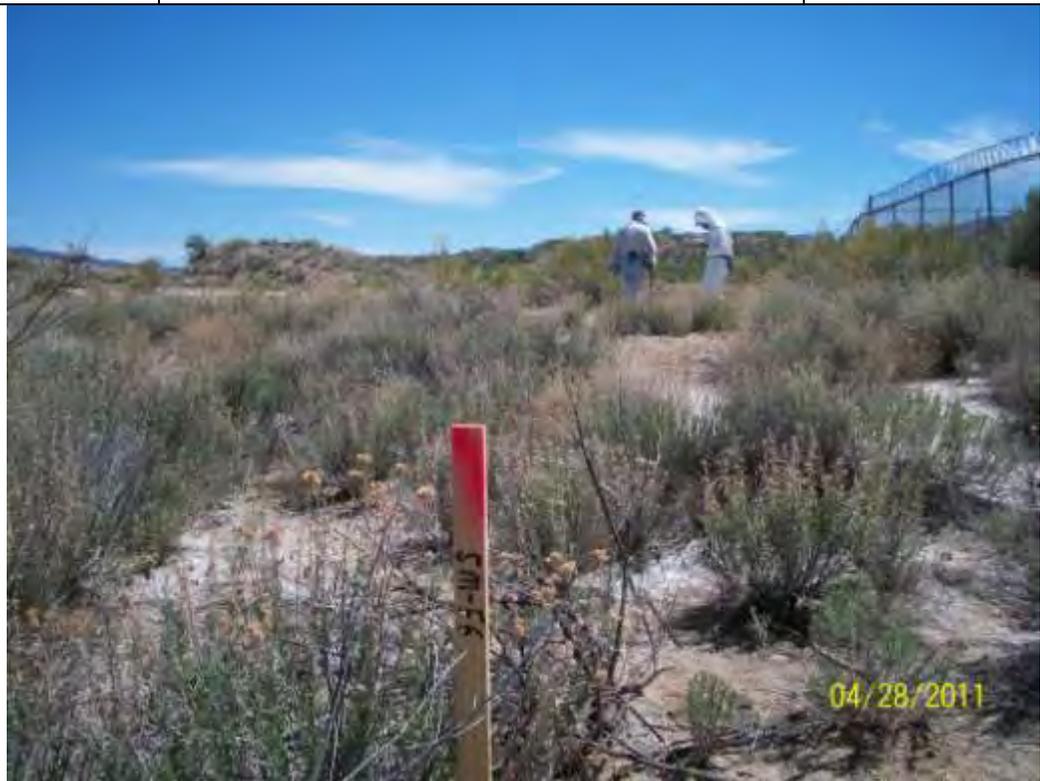
| <b>Photo No.</b><br><b>133</b> | <b>Date:</b><br>4-28-11 |

Picture of waste pile EE; PA/SI SM-A1-3 (arsenic 56 mg/kg, chromium 84 mg/kg, lead 1,800 mg/kg) (See Figure 8 for location on Site).

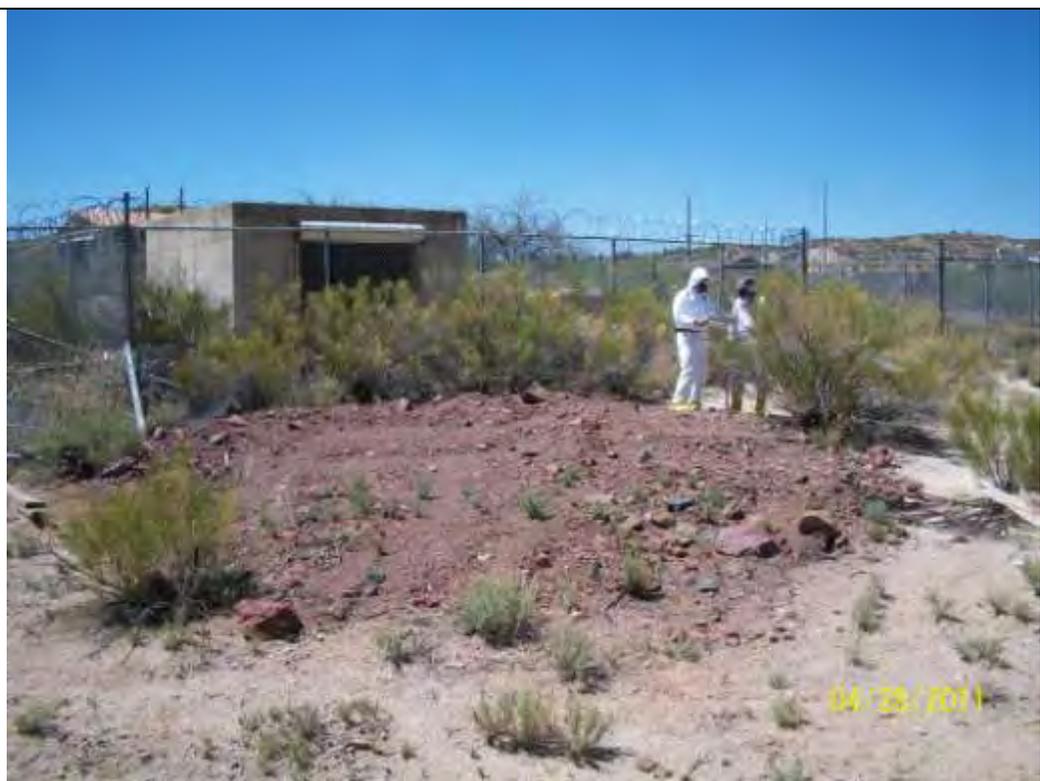
| <b>Photo No.</b><br><b>134</b> | <b>Date:</b><br>4-28-11 |

Picture of waste pile FF (See Figure 8 for location on Site).
