Uinta-Wasatch-Cache National Forest

State of the Forest Report for Wasatch-Cache Planning Area Fiscal Year 2011

September 2011

Resource Monitoring

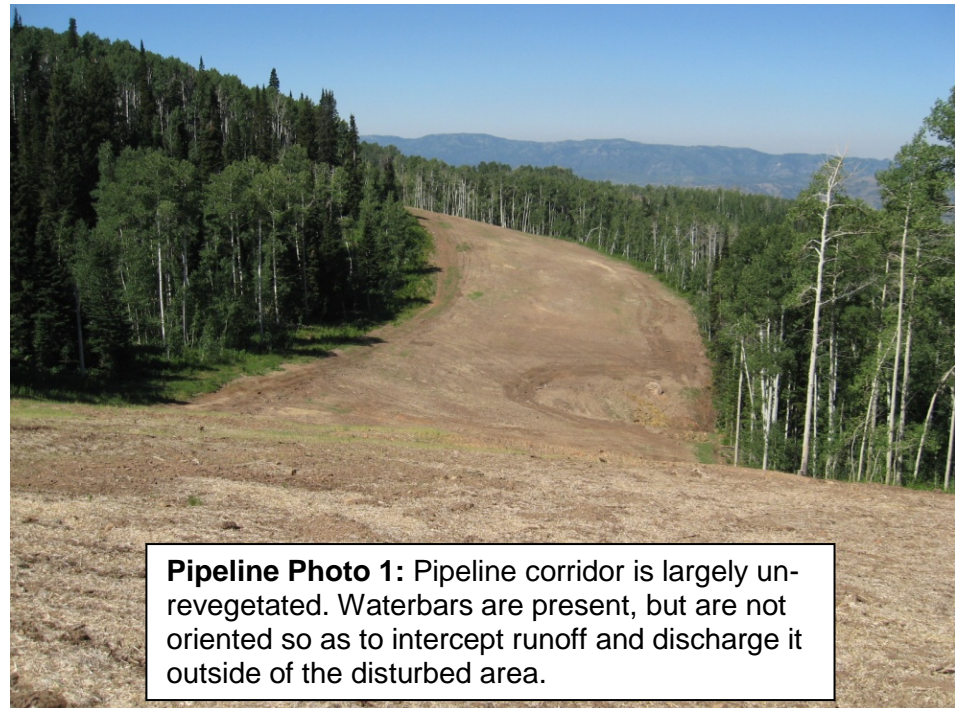
Pipeline Photo 1: Pipeline corridor is largely un-revegetated. Waterbars are present, but are not oriented so as to intercept runoff and discharge it outside of the disturbed area.

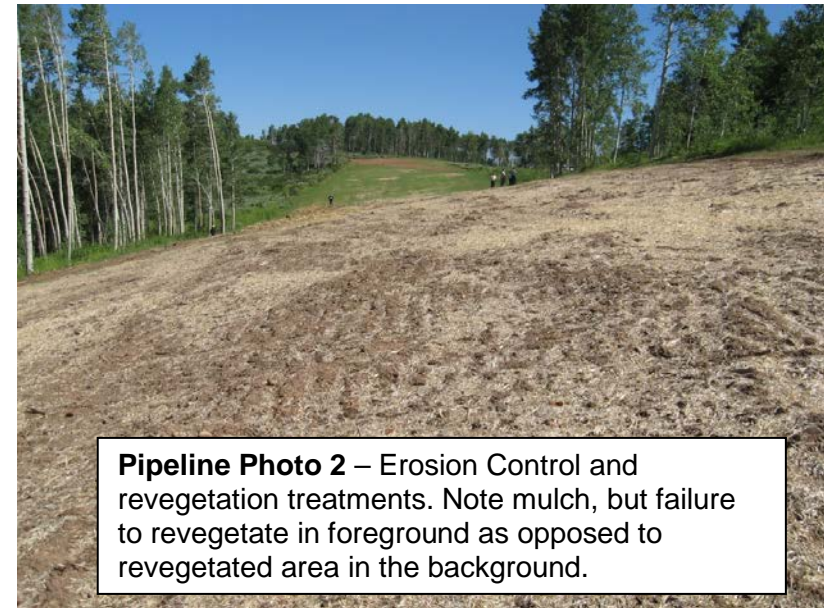
- *The disturbed areas were seeded with native seed.*
- *The seeding was successful in some areas, and not in others (see **Pipeline Photo 2**). The areas lacking adequate vegetative cover will need to be reseeded.*

Pipeline Photo 2 – Erosion Control and revegetation treatments. Note mulch, but failure to revegetate in foreground as opposed to revegetated area in the background.

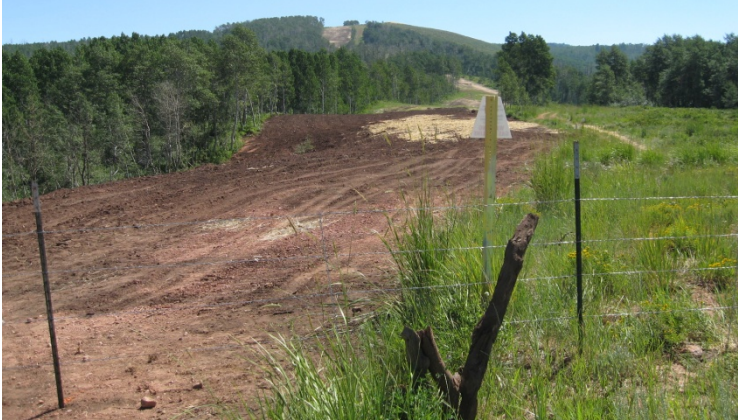
- b. *There are no ATV structures in place except for a wire fence that was recently installed; this could impact successful reclamation if not addressed. (see **Pipeline Photo 3** and **4**)*

Pipeline Photo 3: New wire fence. Note adjacent road with no barriers to discourage or prevent illegal ATV use on the pipeline.

- a. *Many trees were removed for the road and pipeline corridor. Some of these could have been kept onsite and put back within the corridor to hinder ATV traffic and provide additional erosion control.*

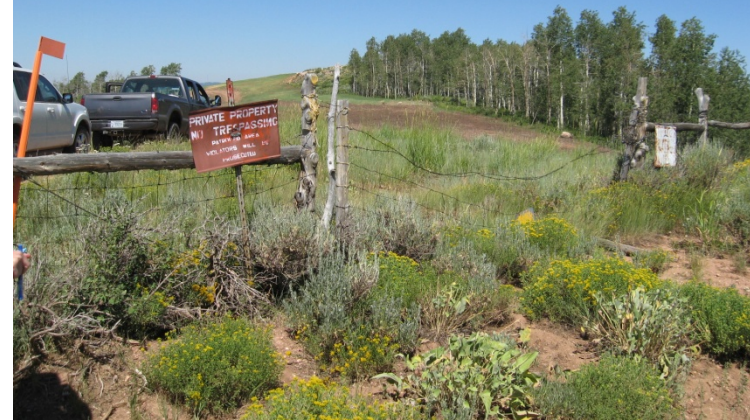
Pipeline Photo 4: Forest boundary fence and gate with road directly adjacent to pipeline. Note lack of barriers to discourage illegal ATV use.

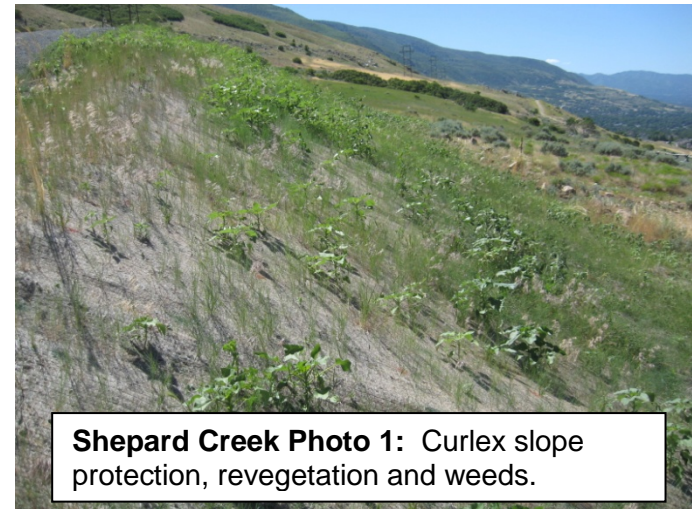
- *Records reviewed by the monitoring team did not indicate whether this requirement had been complied with or not. However, the monitoring team did observe weeds in the area revegetated (see Shepard Creek Photo 1). However, the entire hill side has weed infestations and these could be the source of the weeds found within the disturbed area. Additional weed treatments in the area would be beneficial.*

Shepard Creek Photo 1: Curlex slope protection, revegetation and weeds.

- *There are some weeds present; however the entire hillside has weed infestations. Additional weed treatments in the area would be beneficial.*
- *The seed appears to be applied at sufficient quantity (40 lb/acre). However, it appears that a wrong or contaminated seed mix was used. No forbs are present and there is a very high percentage of annual ryegrass and sunflowers. At this time reseeding is likely not successful because of the curlex blanket. However, a possible corrective action could be to reseed in a couple of years when curlex blanket has broken down or shrubs/sagebrush could hand-planted. This would also benefit deer as this is good winter range.*

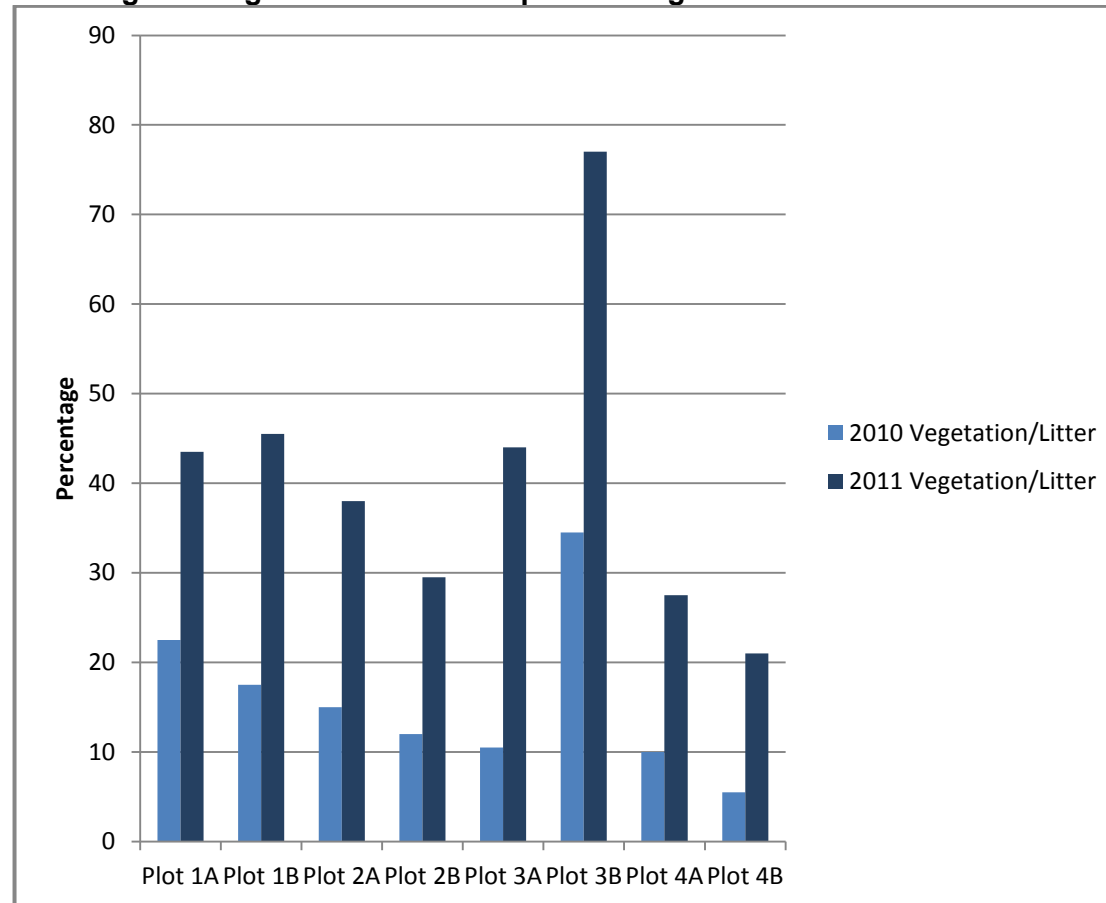
This monitoring study found that growth in the growing season after the fire (2010) was higher in all the seeded plots than in the non-seeded plots. During the second growing season (2011) growth percentages increase in all plots indicating the return of vegetation to the area. Monitoring show that vegetation and litter returned more fully in the second growing season than the first (see the following figure and photos), and that in the seeded plots plant species diversity was much higher than in the unseeded control plots.

Big Pole Figure 1: Increase of percent vegetation from 2010 to 2011.

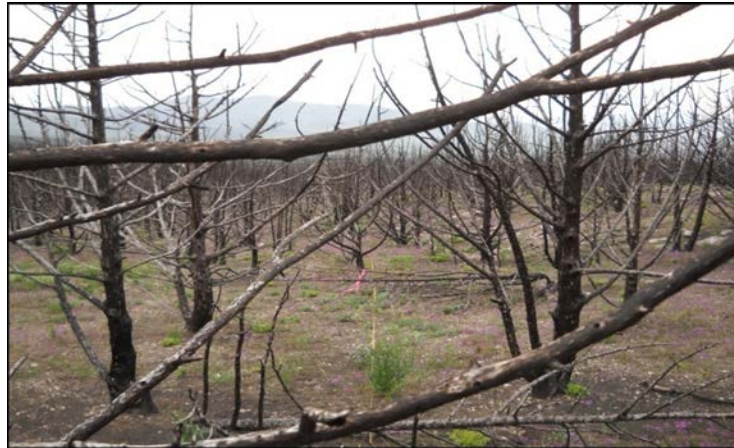
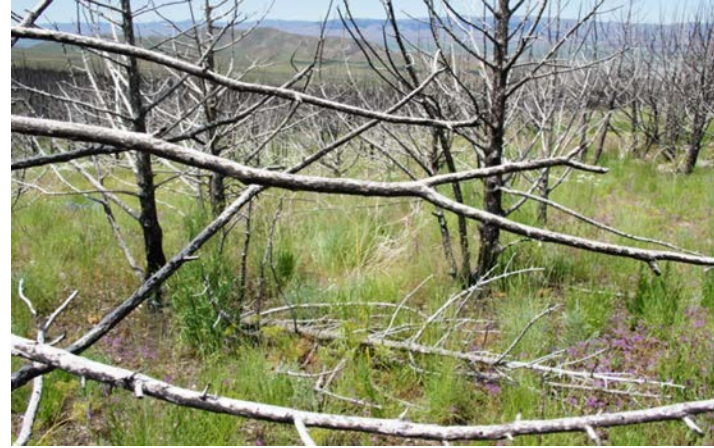
Big Pole Plot 1A Belt 1 226 deg. 17 June 2010

Big Pole Plot 1A Belt 1 226 deg. 20 June 2011

Big Pole Photos 1 and 2: Seeded plot (#1A) 1 year and 2 years following the burn and seeding. Note the increase in vegetation and ground cover in year 2. Photos of the other seeded plots look similar.

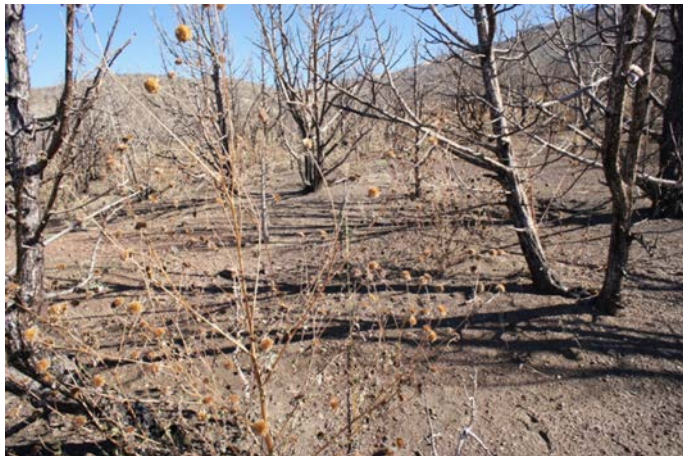
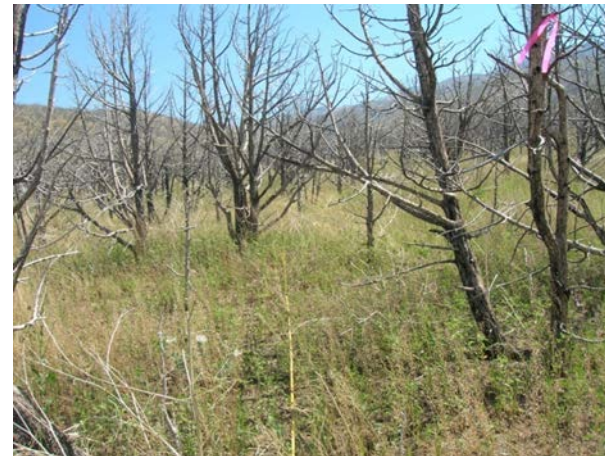
Big Pole Plot 4A Belt 2 38 deg. 2 Nov. 2010

Big Pole Plot 4A Belt 2 38 deg. 16 Aug. 2011

Big Pole Photos 3 and 4: Unseeded control plot (#4A) 1 year and 2 years following the burn and seeding. Note the increase in vegetation and ground cover.

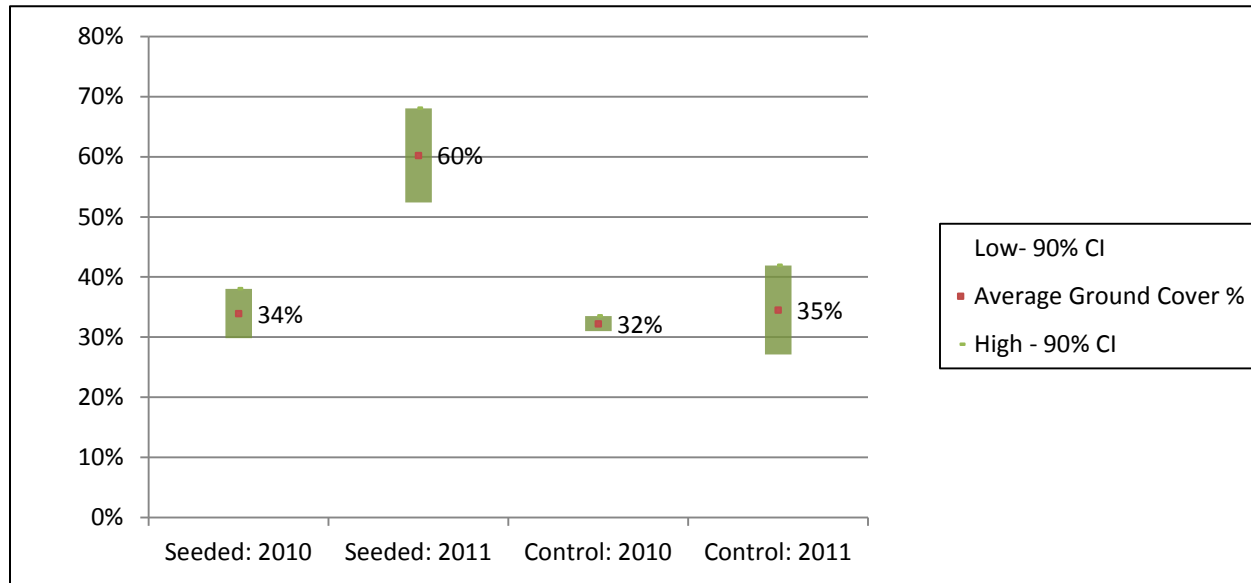
- *In the unseeded control plots this increase in vegetative cover did not result in a significant increase in ground cover. The data shows that while the vegetation/litter component increased (as illustrated above), the amount of exposed soil did not significantly decrease. The amount of rock/soil pavement did decrease suggesting that most of the increase in vegetation and litter "covered" rock/soil pavement. The data collected does not indicate why this might have occurred.*
- *Change in ground cover was also evaluated in the seeding effectiveness study. As can be seen in Figures 2 and 3, ground cover (vegetation/litter and rock/soil pavement) increased the 2nd year following the burn. This is consistent with many other studies. However, different than some similar studies, ground cover and vegetative cover were significantly higher in year 2 in the seeded plots than in the unseeded.*

Big Pole Figure 2: Percent Ground Cover 1 and 2 Years Post Burn, Seeded and Unseeded (90% Confidence Interval)

Big Pole Monitoring Summary: In general the seeding appeared to take (i.e., seeded species were established). However, it had not achieved one of its intended purposes (prevention of cheatgrass). The IDT recommends that for future restoration projects such as this, that seeding be considered to achieve other goals (accelerated ground cover recovery, enhancing species diversity and regrowth of desired species, etc.) but not be employed for this purpose.
