# Appendix A. Photographic Logs of Construction Progress in 2010 and 2011

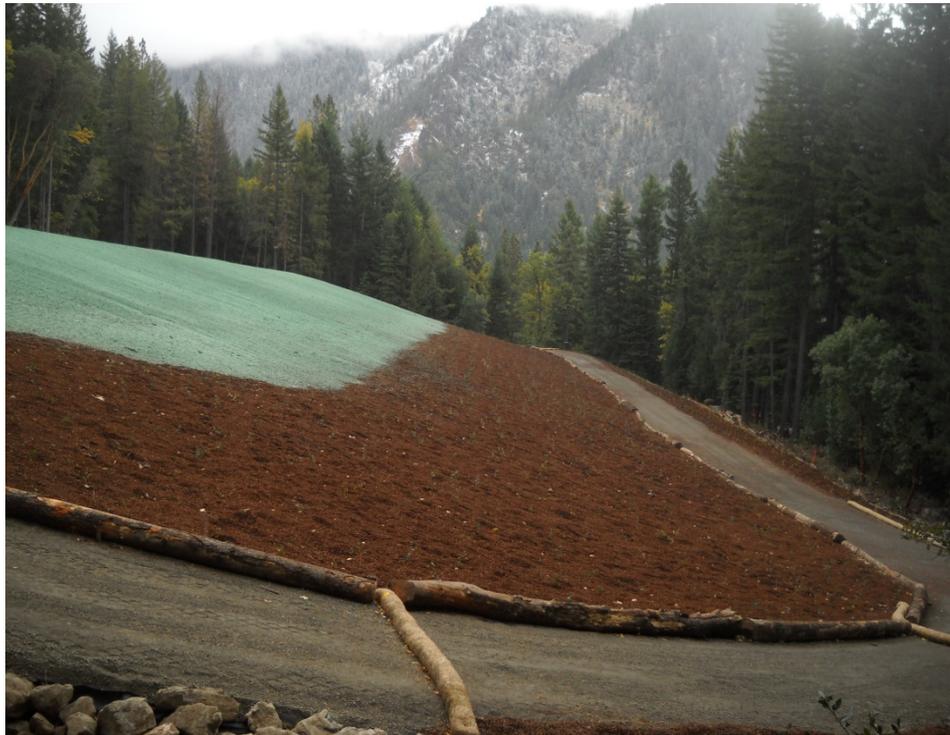
**USFS – Blue Ledge Mine Removal Project:**  
*Photograph A-1 - View of the completed Repository*

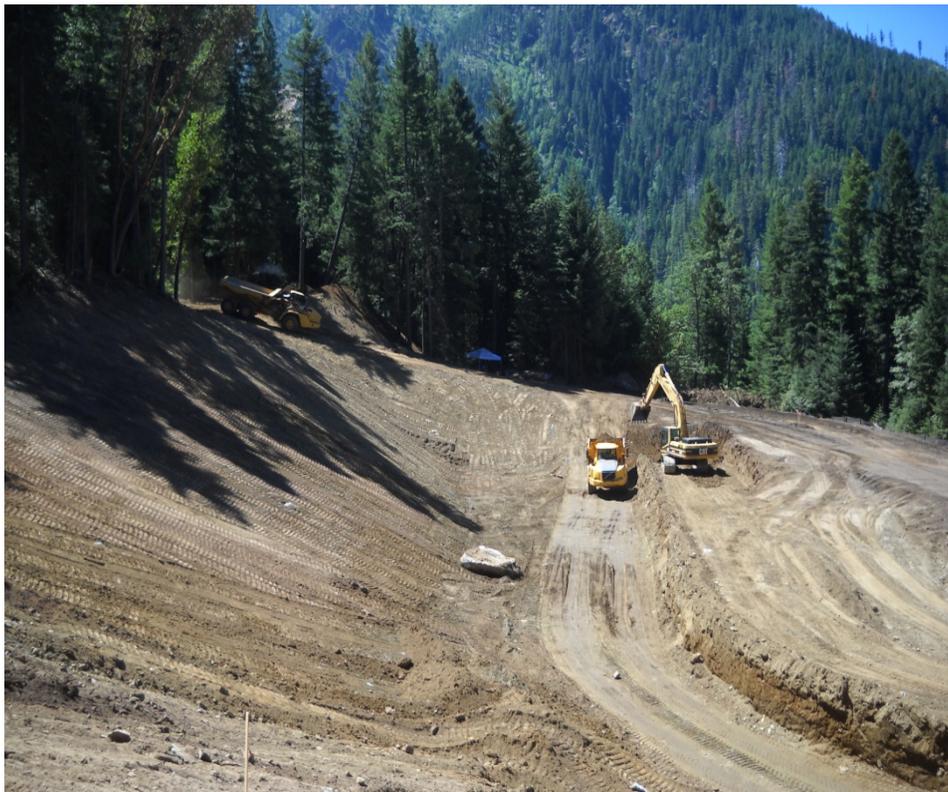
**USFS – Blue Ledge Mine Removal Project:**  
*Photograph A-2 - View of Repository subgrade excavation*

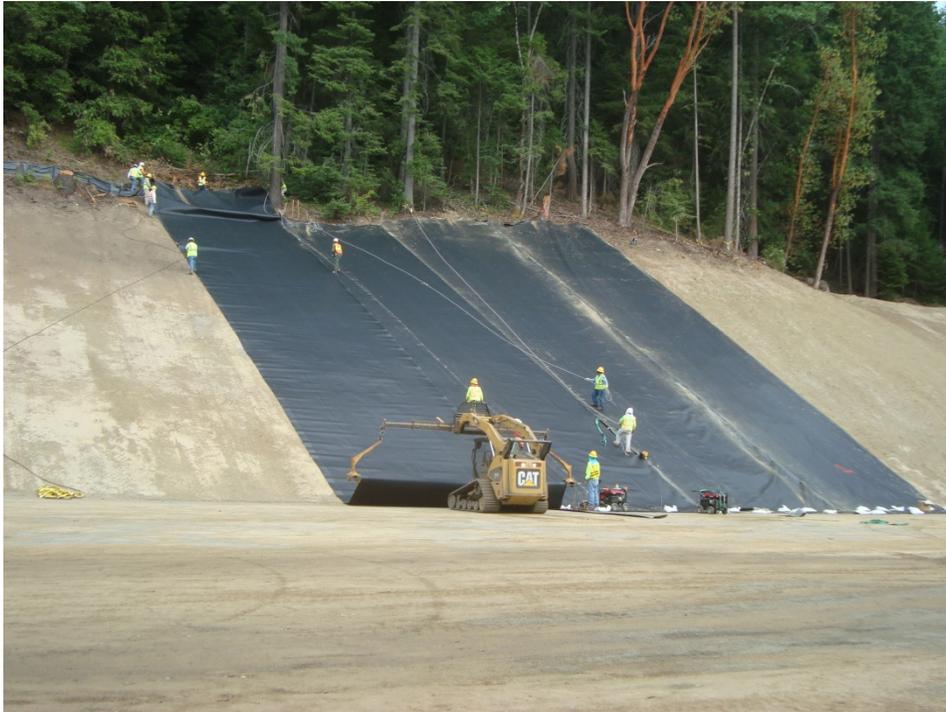
*Photograph A-3* - View of the 60 mil HDPE liner being installed on Repository subgrade slopes

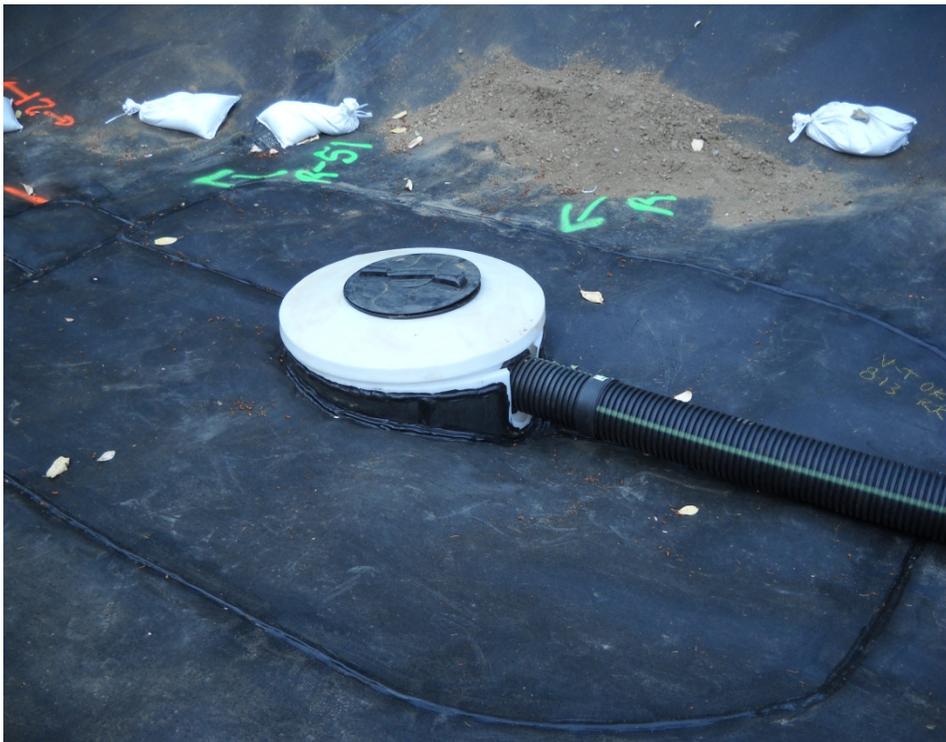
*Photograph A-4* - View of buried double contained leachate collection sump at the south end of the Repository

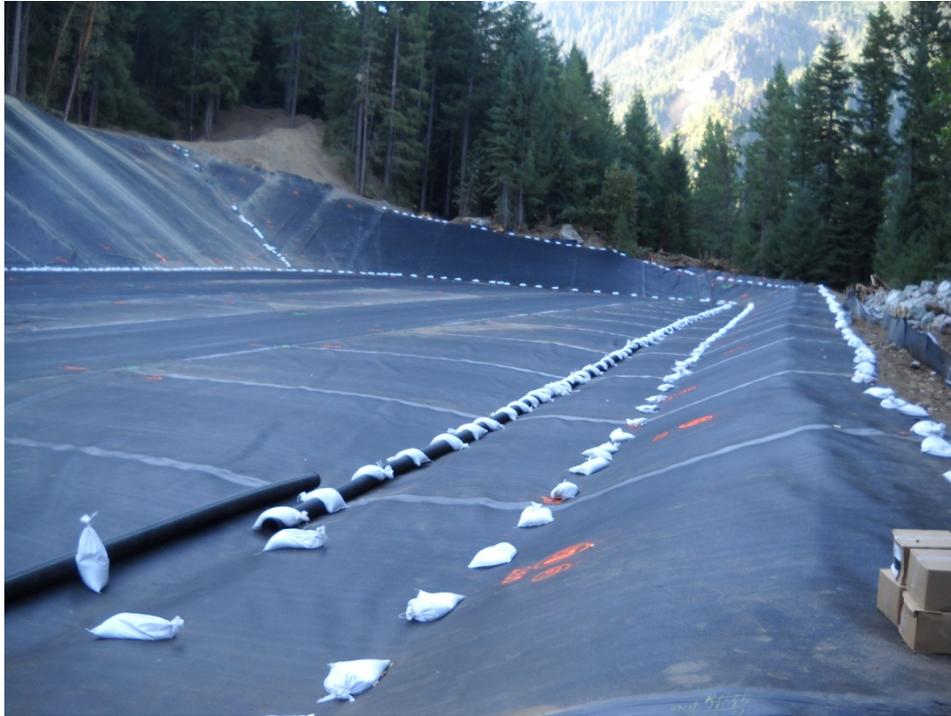
**USFS – Blue Ledge Mine Removal Project:**  
*Photograph A-5 - View of the Repository subgrade with 60 mil HDPE liner installed*

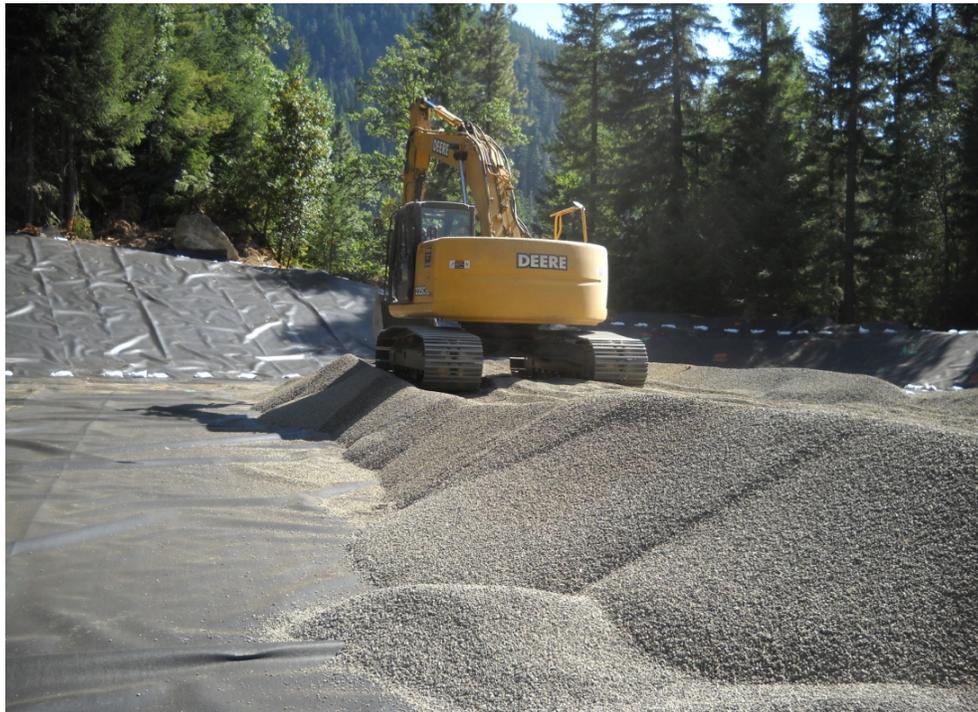
**USFS – Blue Ledge Mine Removal Project:**  
*Photograph A-6 - View of excavator spreading pea gravel to form the drainage layer on the Repository liner*

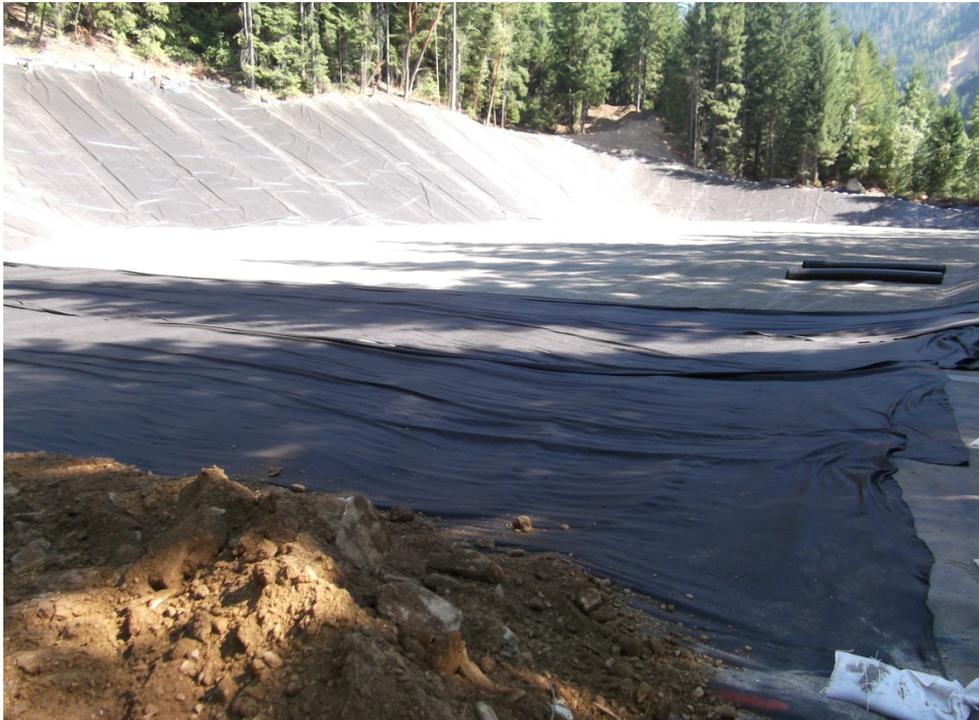
**USFS – Blue Ledge Mine Removal Project:**  
*Photograph A-7 - View of geotextile layer on top of pea gravel drainage layer*

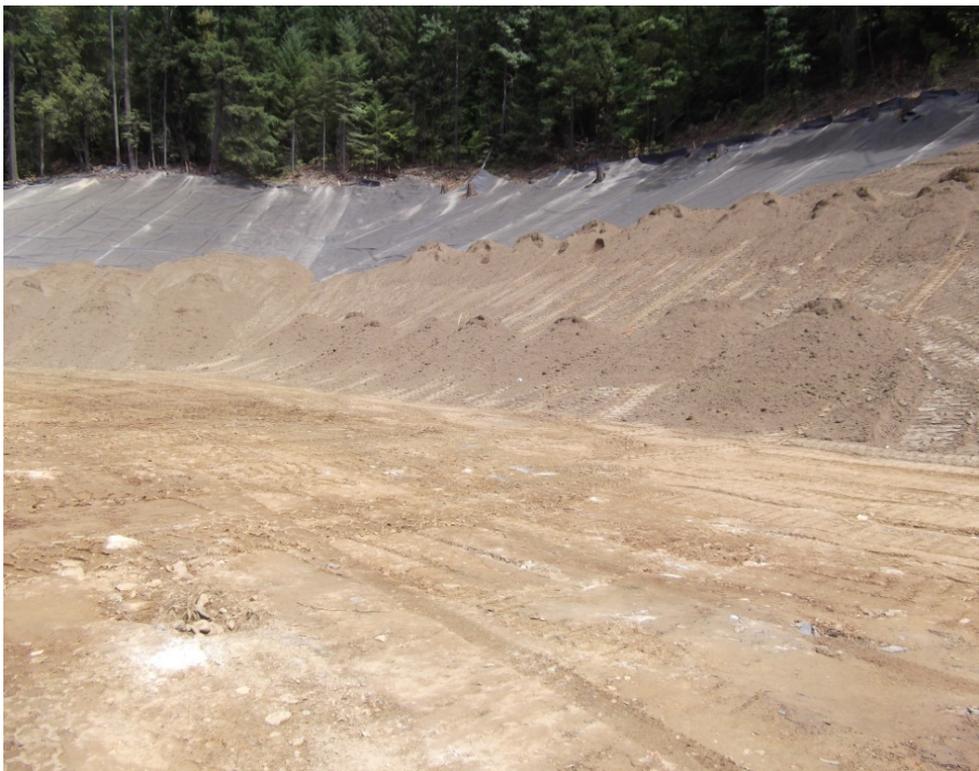
**USFS – Blue Ledge Mine Removal Project:**  
*Photograph A-8 - View of deposited waste rock material on Repository floor and 1-foot cushion layer on Repository slopes*

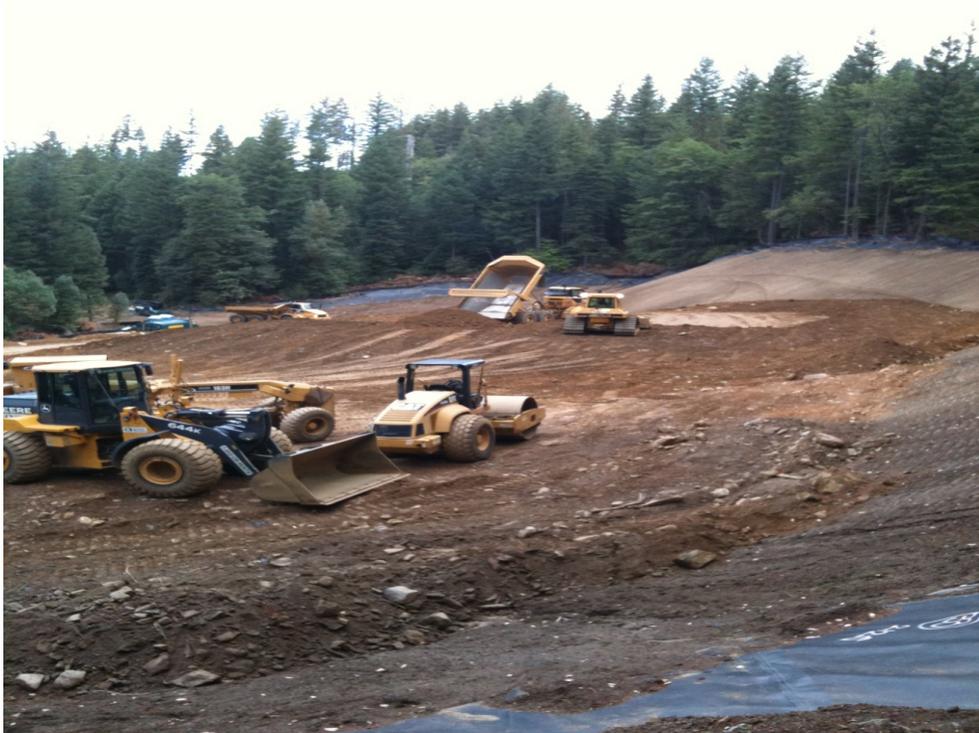
**USFS – Blue Ledge Mine Removal Project:**  
*Photograph A-9 - View of waste rock placement in Repository*

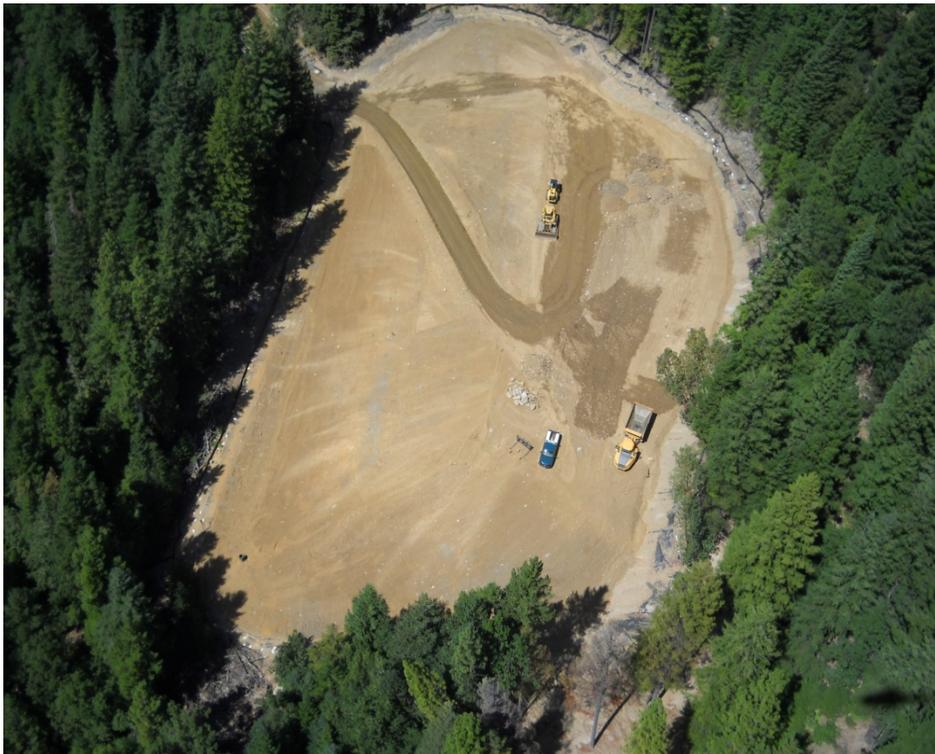
**USFS – Blue Ledge Mine Removal Project:**  
*Photograph A-10 -Aerial view of waste rock placement and grading in the Repository*

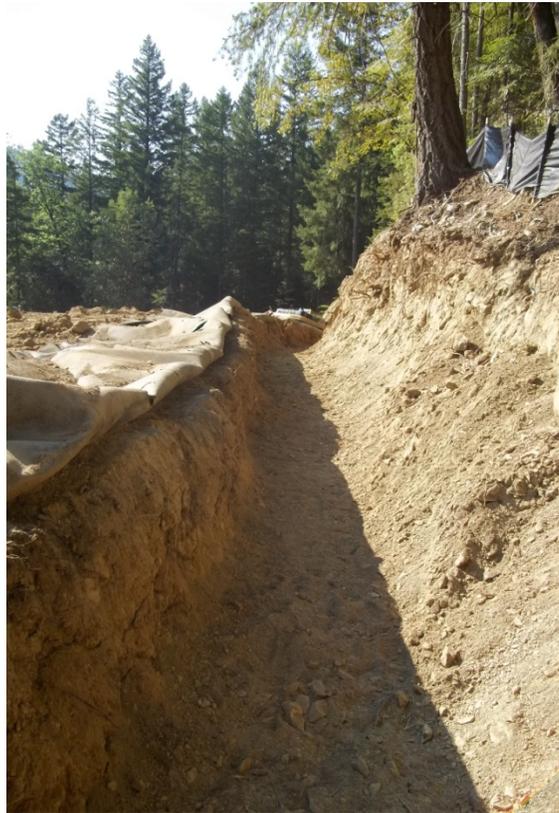
**USFS – Blue Ledge Mine Removal Project:**  
*Photograph A-11 - View of the anchor trench along the east side of the Repository*

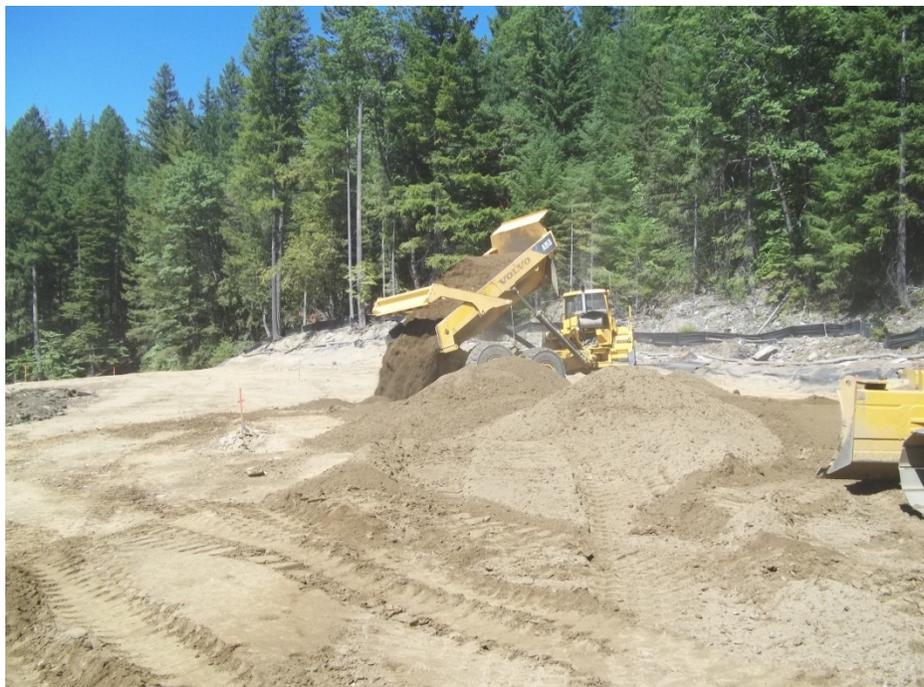
**USFS – Blue Ledge Mine Removal Project:**  
*Photograph A-12 - View of the cushion layer placement over waste rock on the top deck of the Repository.*

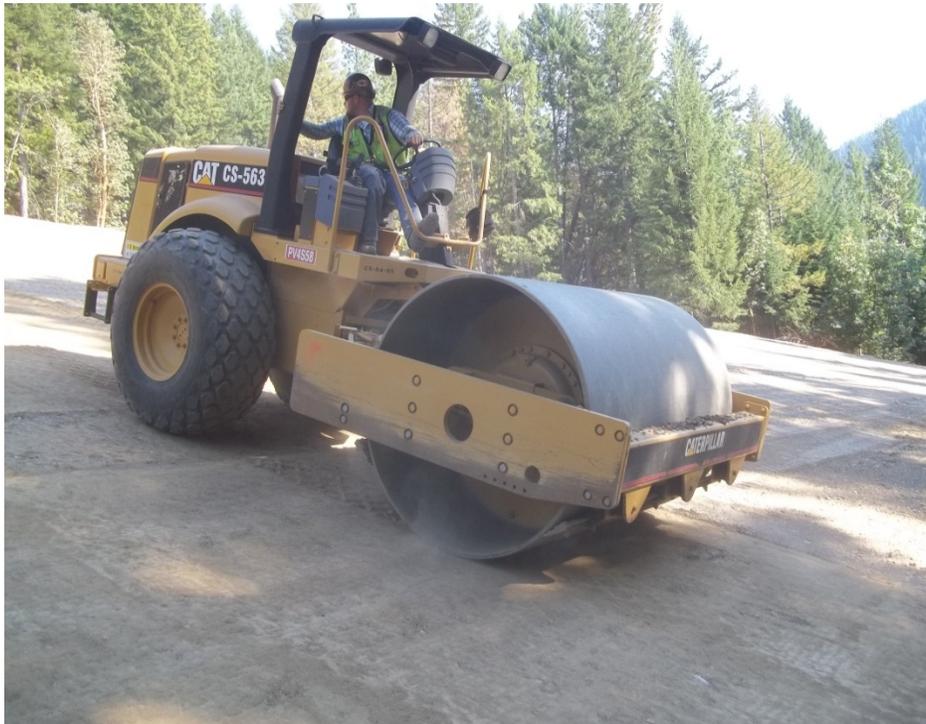
**USFS – Blue Ledge Mine Removal Project:**  
*Photograph A-13 - View of cushion layer compaction*

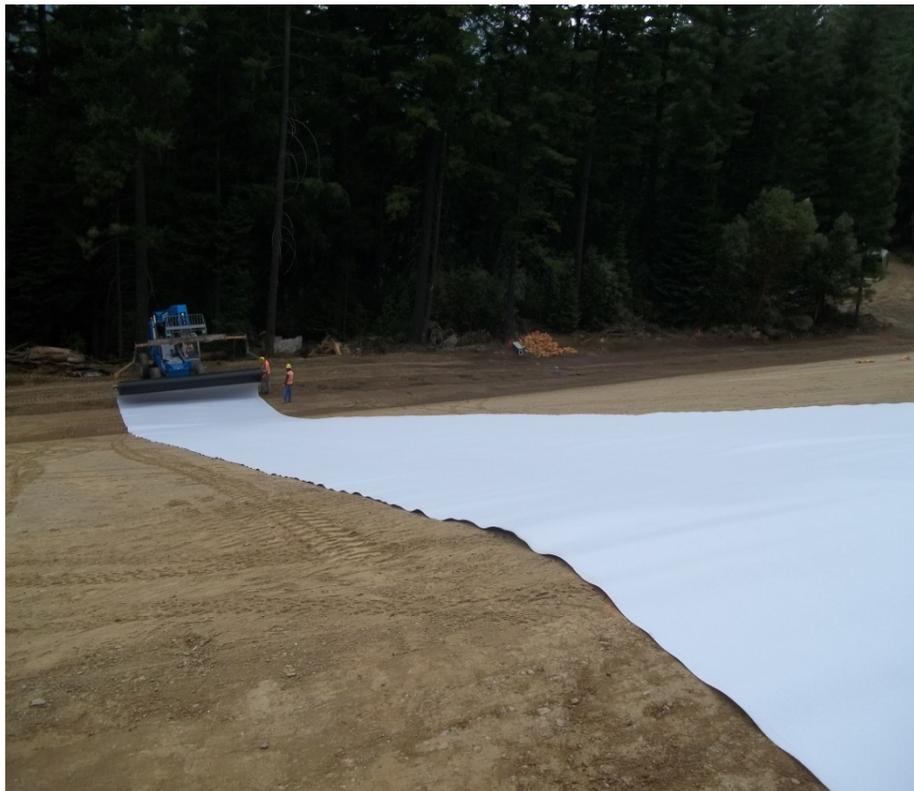
**USFS – Blue Ledge Mine Removal Project:**  
*Photograph A-14 - View of the 60 mil LLDPE cover being installed over the cushion layer*

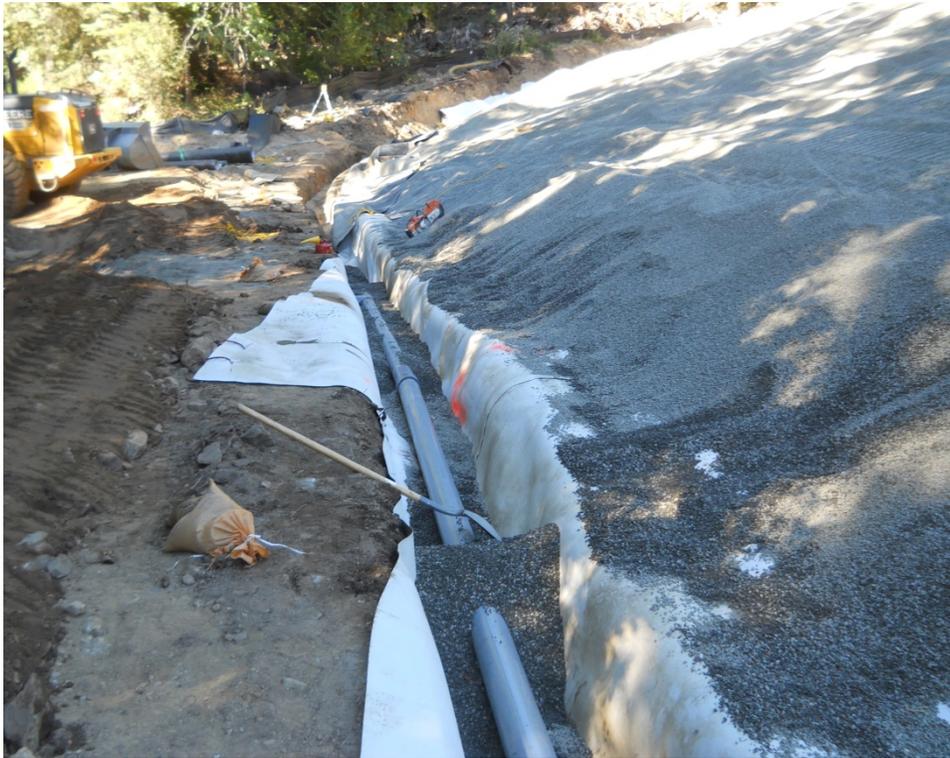
*Photograph A-15* - View of the perforated collection pipe and pea gravel installed in the anchor trench along the west side of the Repository

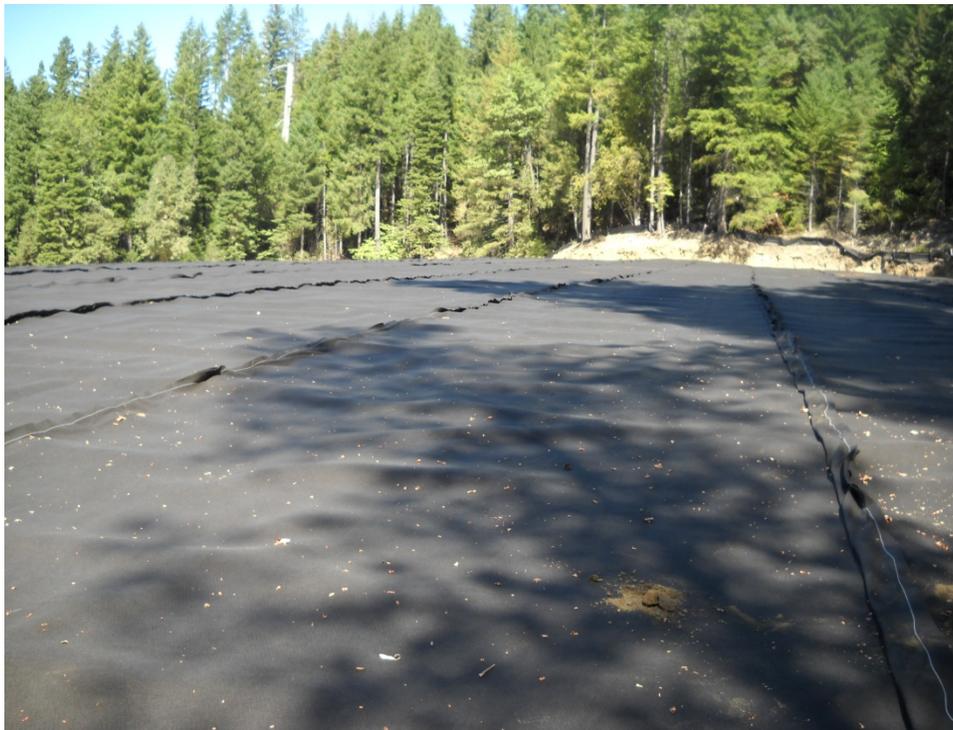
*Photograph A-16* - View of the geocomposite drainage layer placed on the top deck of the Repository

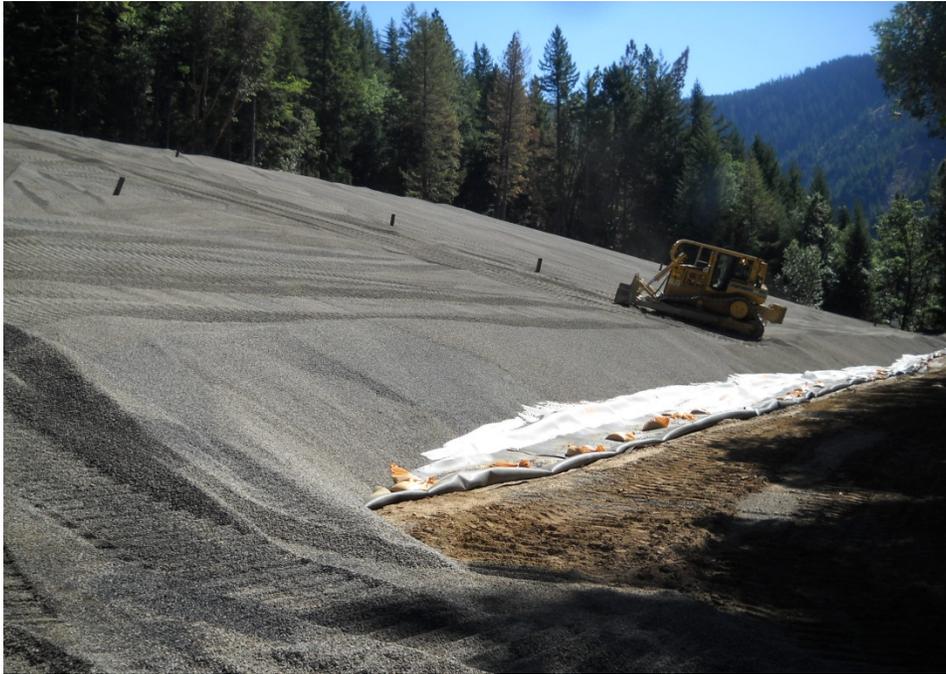
**USFS – Blue Ledge Mine Removal Project:**

*Photograph A-17* - View of the pea gravel placement along the slopes of the west side of the Repository

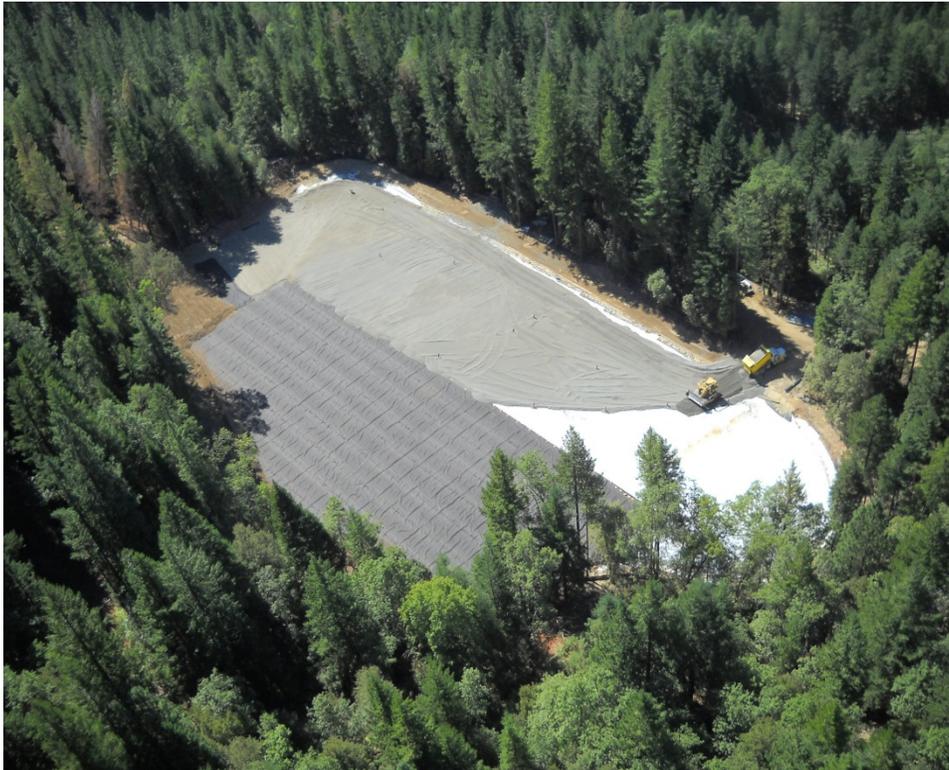
*Photograph A-18* - Aerial view of the pea gravel placement on the slopes of the Repository. Also shown are the installed geocomposite drainage material and 60 mil LLDPE cover.

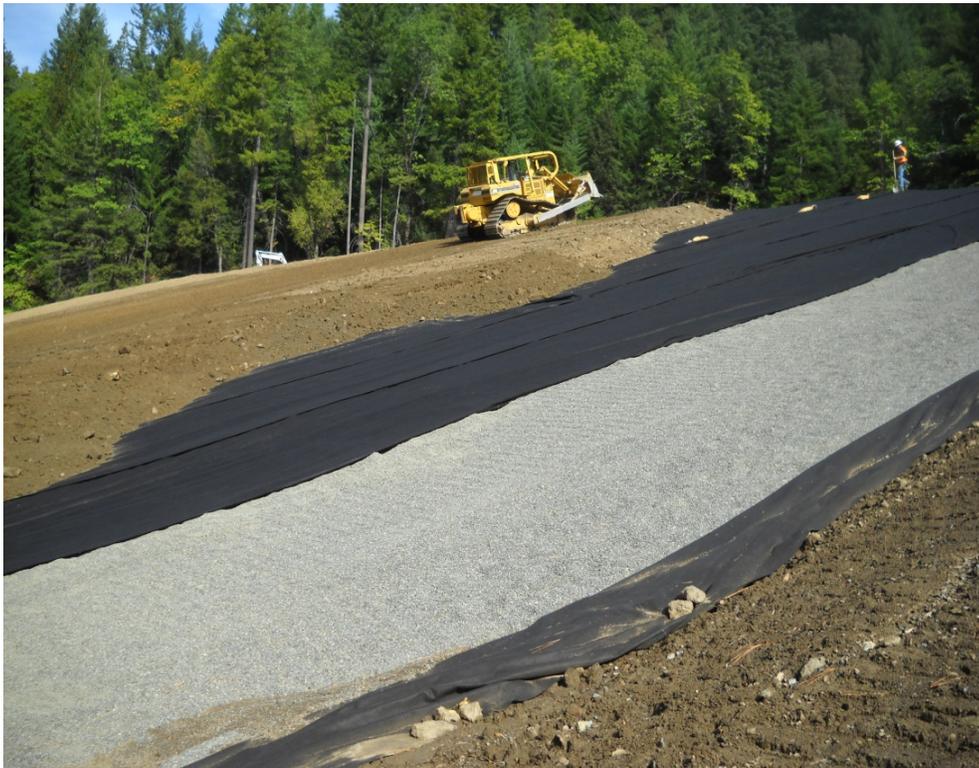
**USFS – Blue Ledge Mine Removal Project:**  
*Photograph A-19 - View of cover soil layered over geotextile and pea gravel*

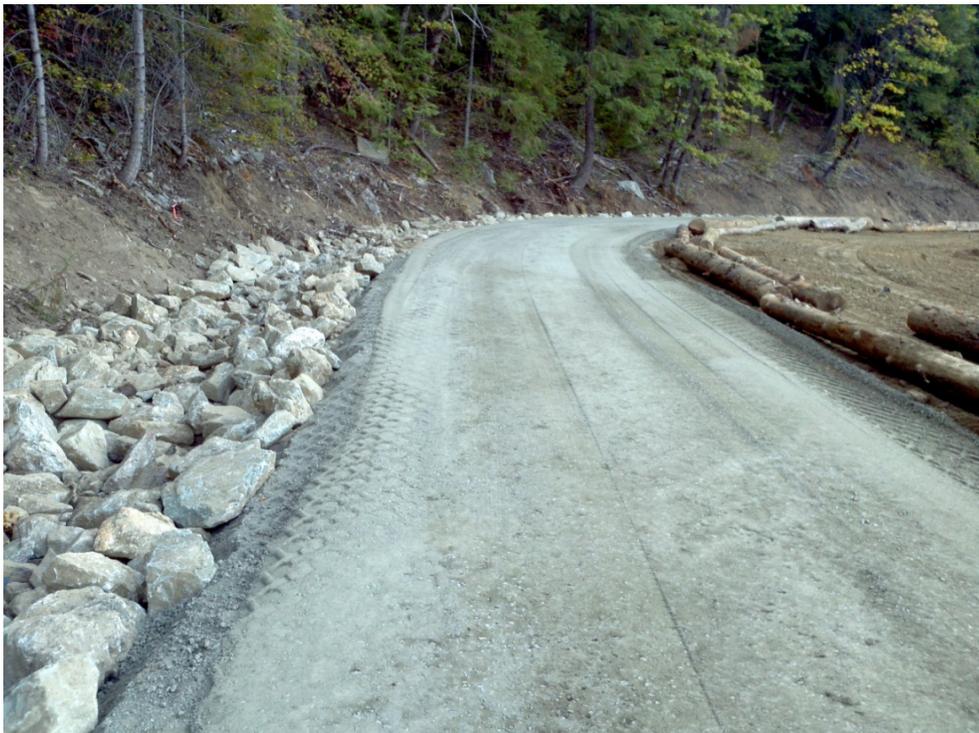
**USFS – Blue Ledge Mine Removal Project:**  
*Photograph A-20 - View of the Repository service road and storm water ditch*

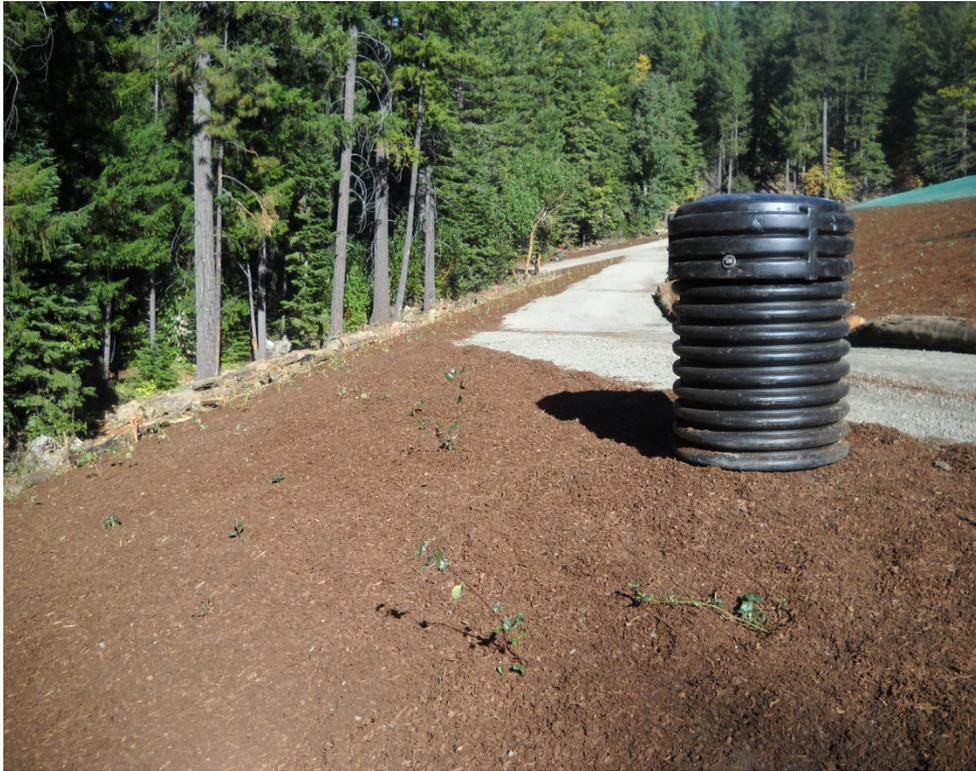
*Photograph A-21 - View of the Repository reclamation features and capped sump tank riser*

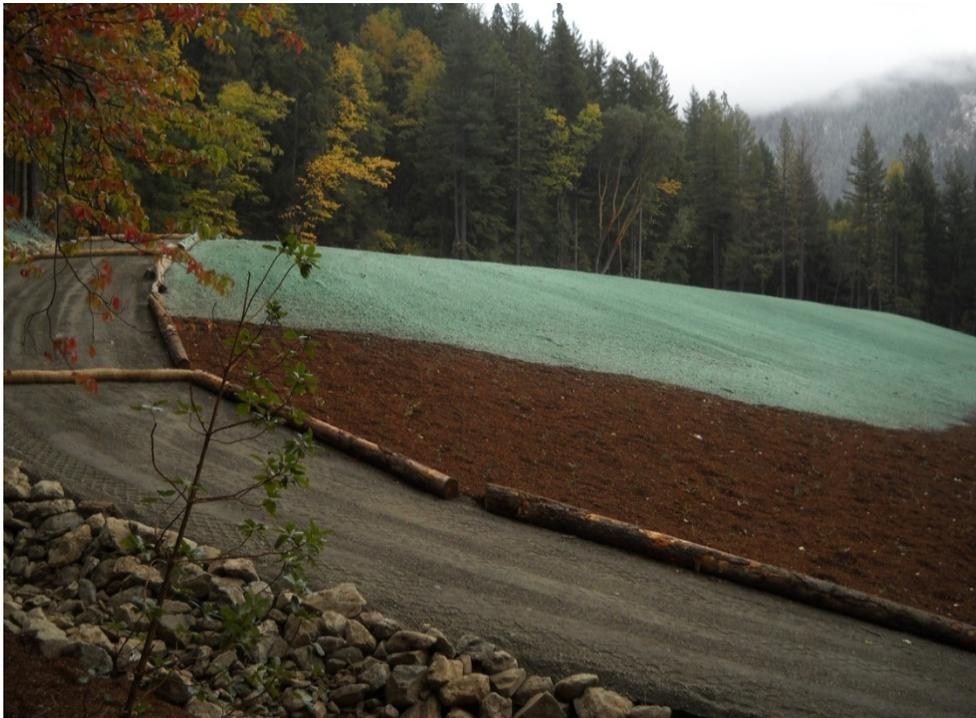
*Photograph A-22 - View of the Repository reclamation features*

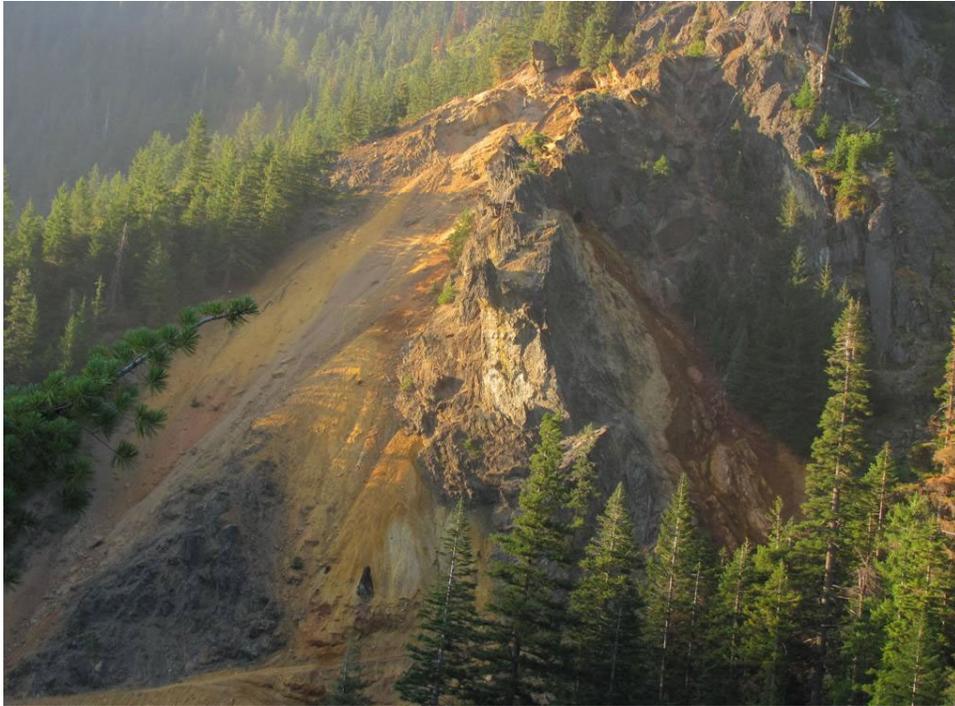
**USFS – Blue Ledge Mine Removal Project:**  
*Photograph A-23 - Original view of WRP-1*

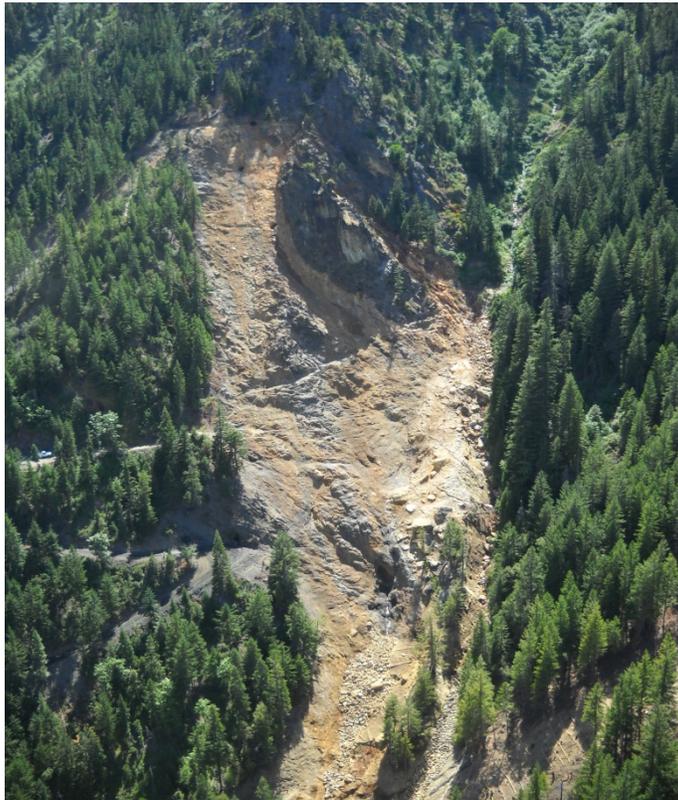
**USFS – Blue Ledge Mine Removal Project:**  
*Photograph A-24 - View of completed removal efforts on WRP-1*

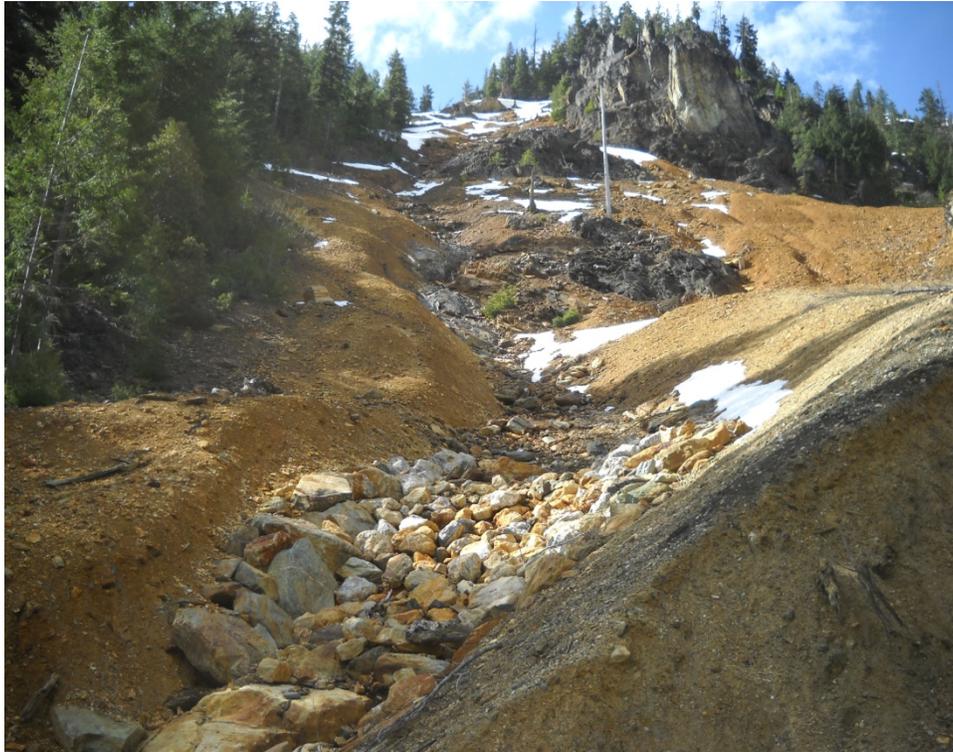
**USFS – Blue Ledge Mine Removal Project:**  
*Photograph A-25 - Original view of WRP-1*

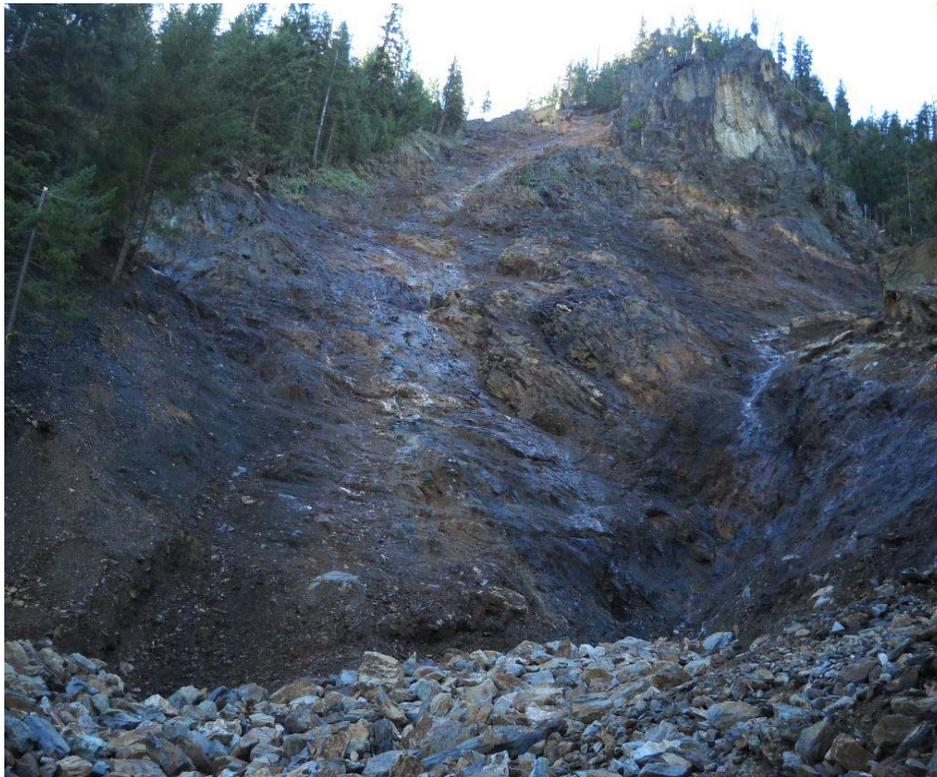
**USFS – Blue Ledge Mine Removal Project:**  
*Photograph A-26 - View of completed removal efforts on WRP-1*

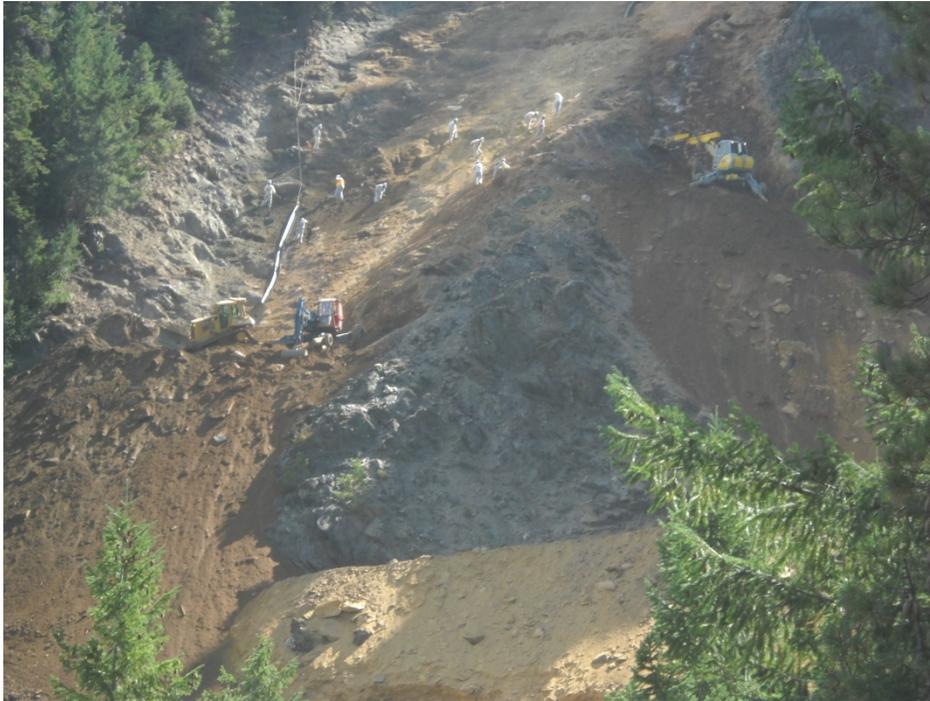
**USFS – Blue Ledge Mine Removal Project:**

*Photograph A-27 - View of waste rock removal and hand cleaning of WRP-1 during 2010 work season.*

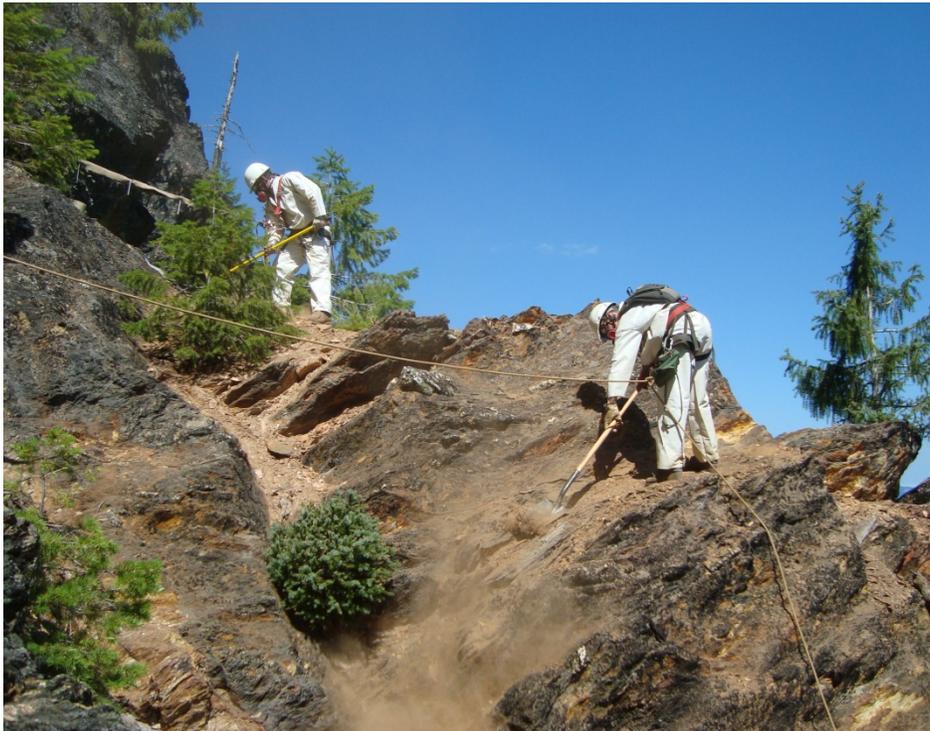
**USFS – Blue Ledge Mine Removal Project:**

*Photograph A-28 - View of hand cleaning waste rock on WRP-1 during 2010 work season.*

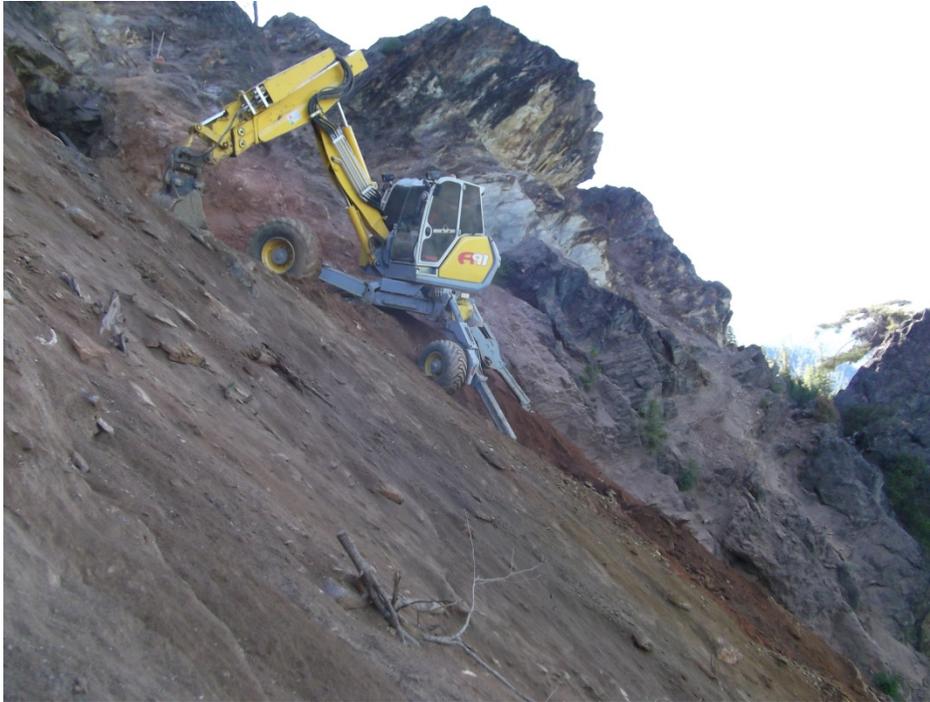
**USFS – Blue Ledge Mine Removal Project:**

*Photograph A-29 - View of spider excavator removing waste rock near vertical shaft on WRP-1 during 2010 work season.*

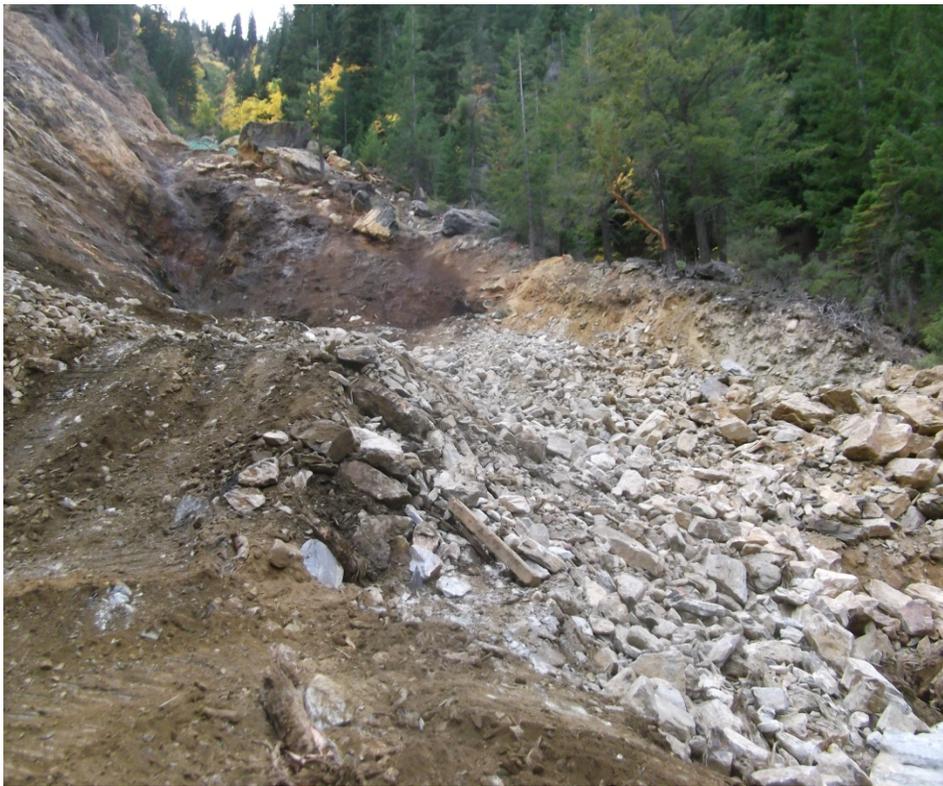
*Photograph A-30 - View of WRP-1 from haul road 3 prior to 2011 removal activities*

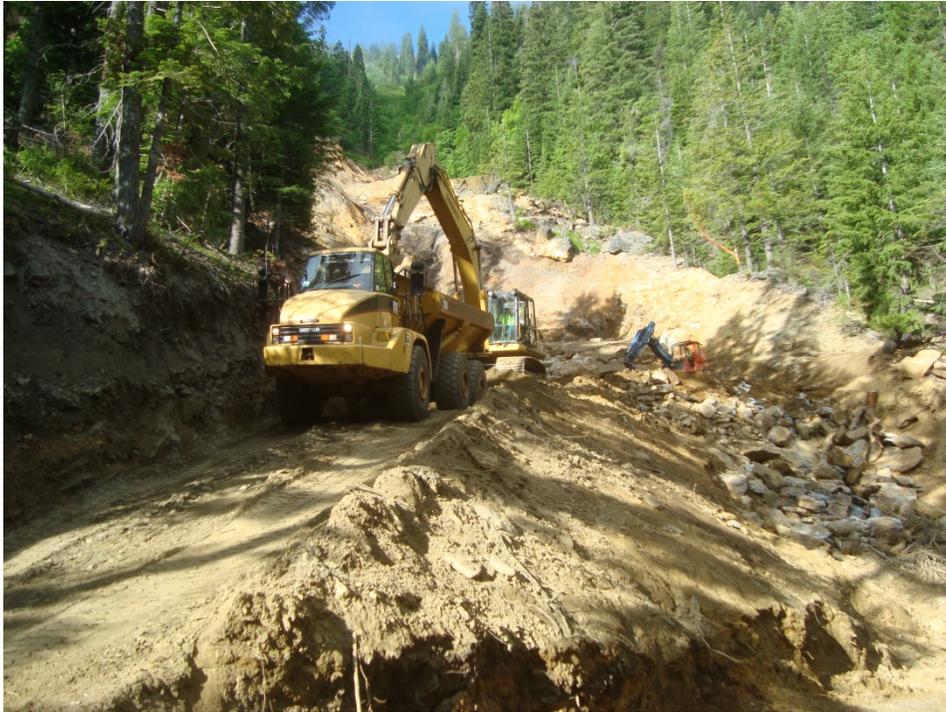
**USFS – Blue Ledge Mine Removal Project:**  
*Photograph A-31 - View of WRP-1 load out during 2011 removal activities*

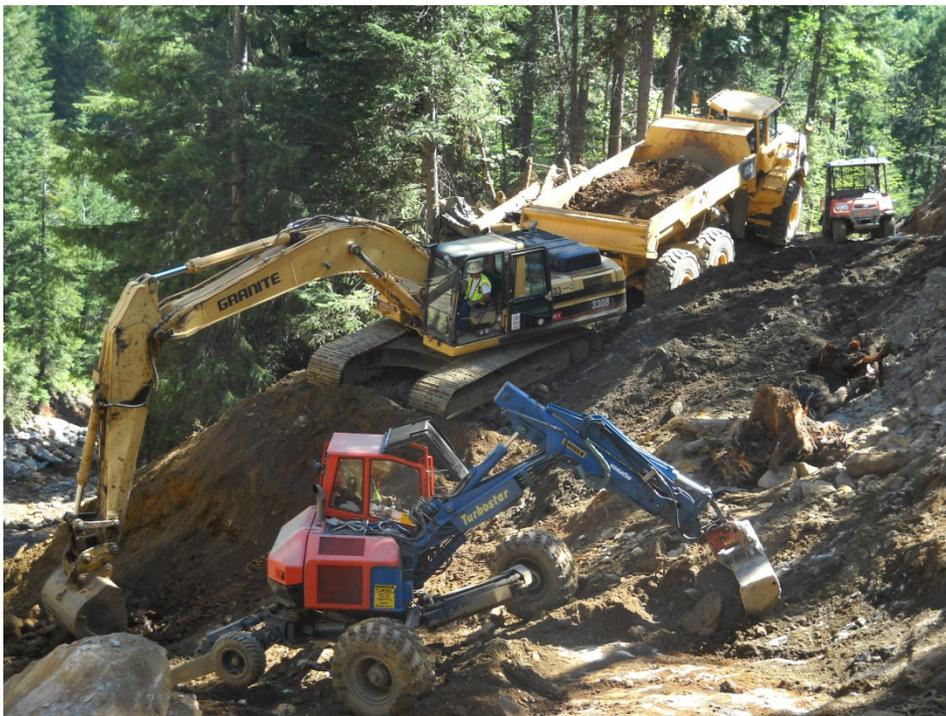
**USFS – Blue Ledge Mine Removal Project:**  
*Photograph A-32 - View of WRP-1 load out during 2011 removal activities*
