# Appendix A. Photographic Logs of Construction Progress in 2010 and 2011

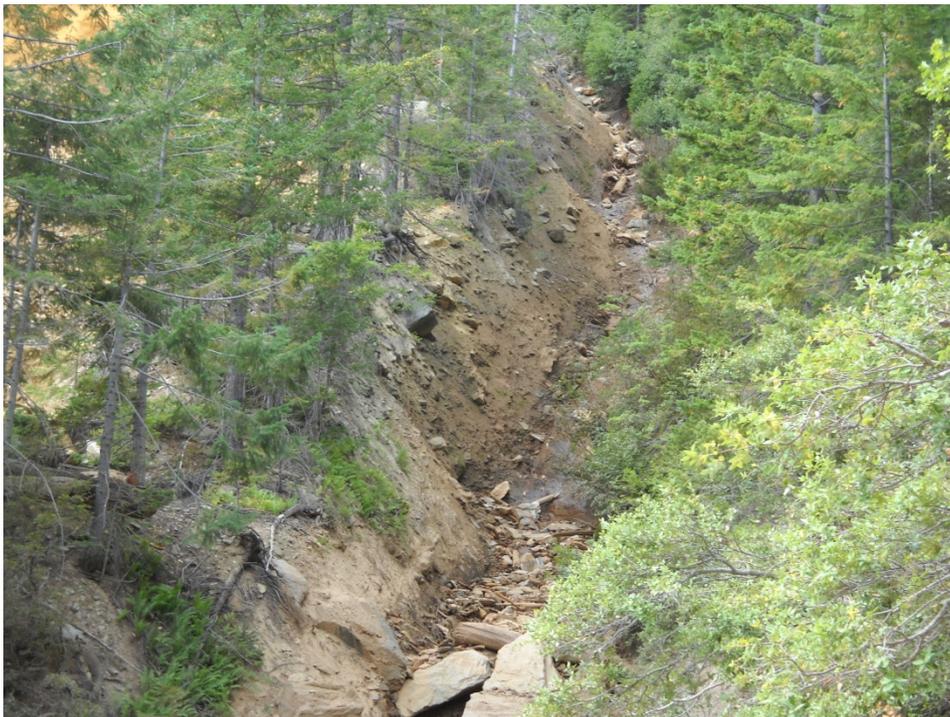
*Photograph A-34* - View of un-named tributary of Joe Creek at WRP-1 boundary where excavation was not performed

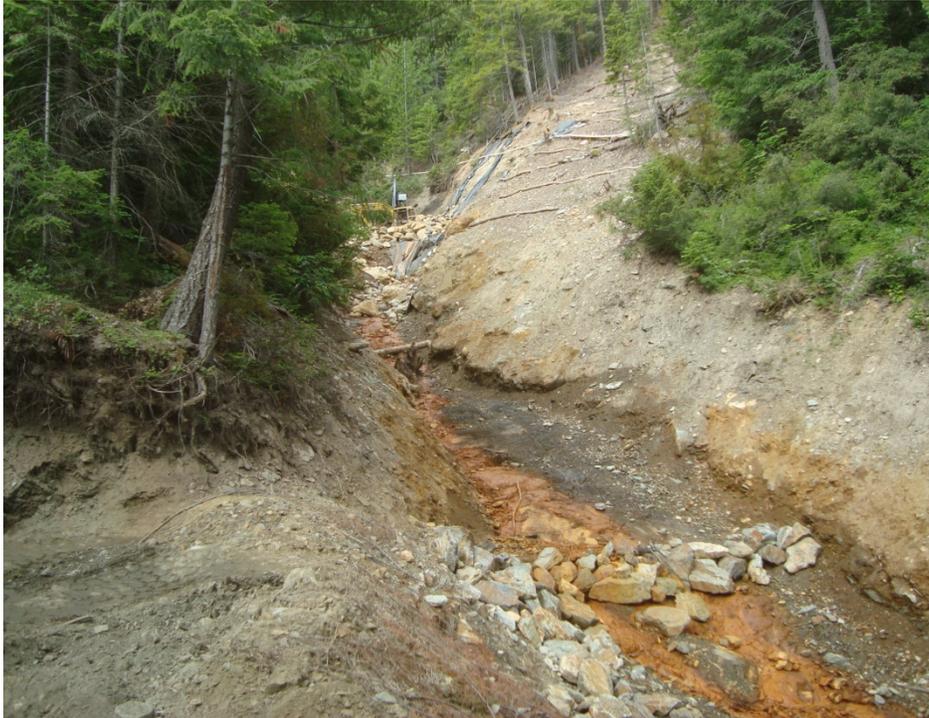
**USFS – Blue Ledge Mine Removal Project:**

*Photograph A-35 - View of WRP-1 creek channel from haul road 3 prior to rip rap placement*

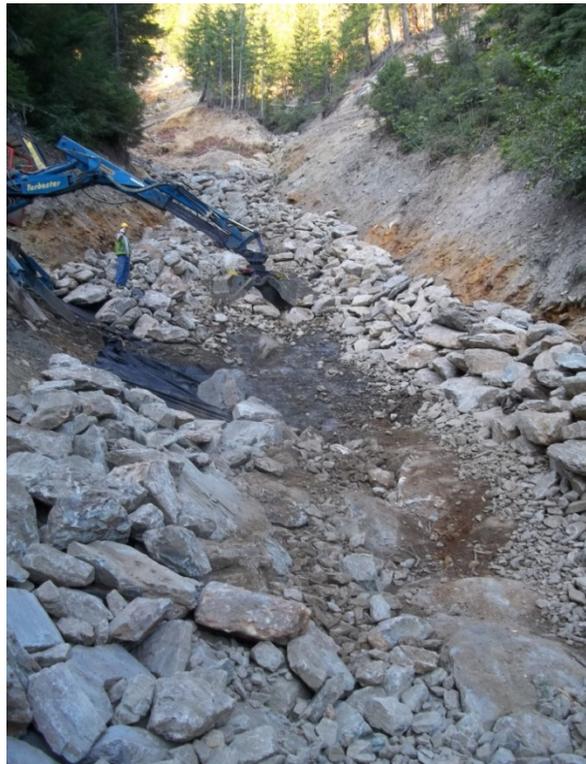
**USFS – Blue Ledge Mine Removal Project:**

*Photograph A-36 - View of spider excavator placing rip rap material along WRP-1 creek channel*

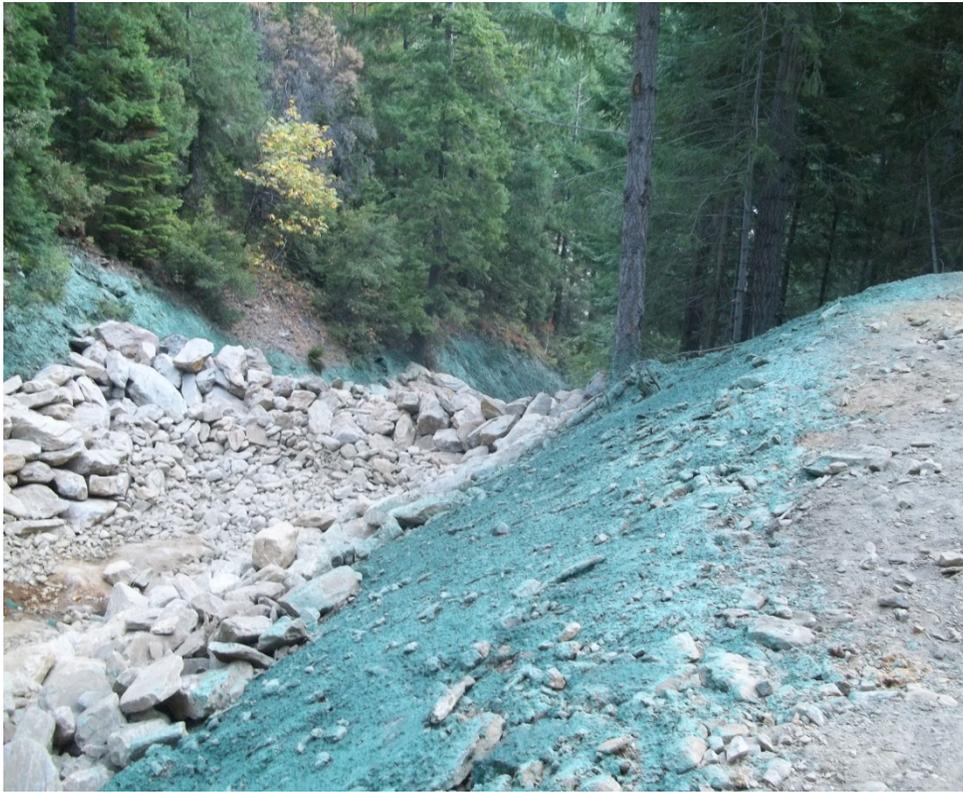
**USFS – Blue Ledge Mine Removal Project:**  
*Photograph A-37 - View of rock armored channel and reclamation features on WRP-1*

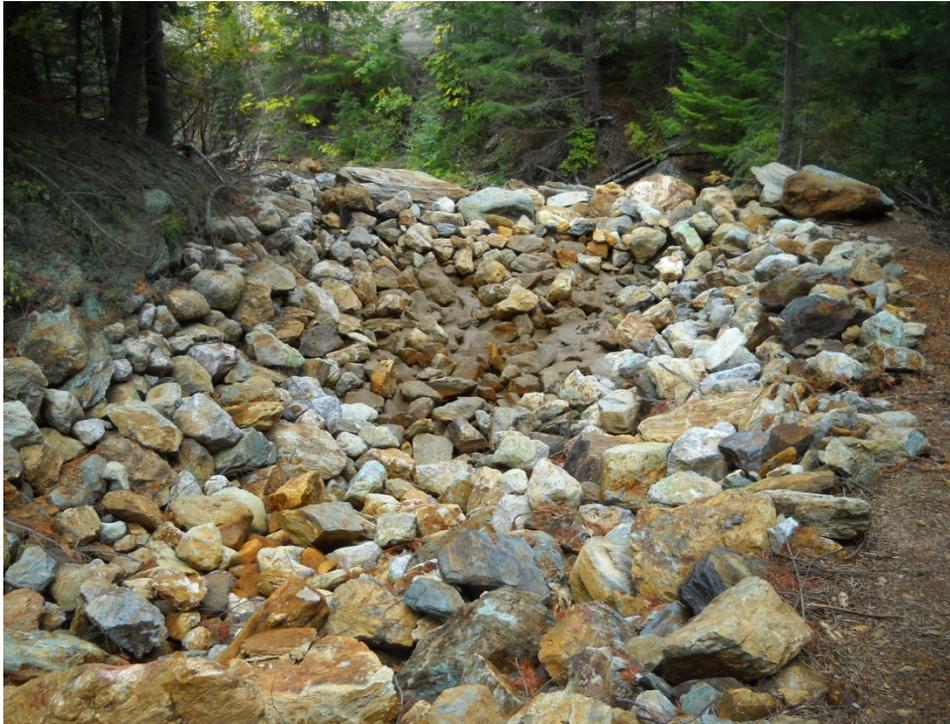
**USFS – Blue Ledge Mine Removal Project:**  
*Photograph A-39 - View of completed Sediment/pH Treatment Basin 1A on WRP-1*

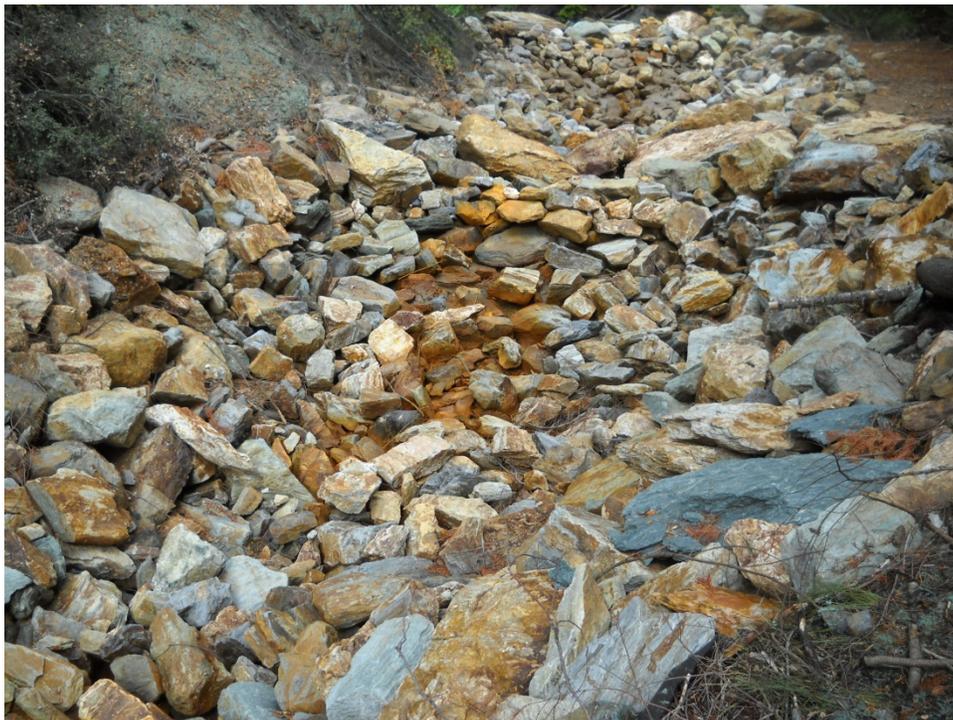
**USFS – Blue Ledge Mine Removal Project:**  
*Photograph A-40 - View of completed Sediment/pH Treatment Basin 1B on WRP-1*

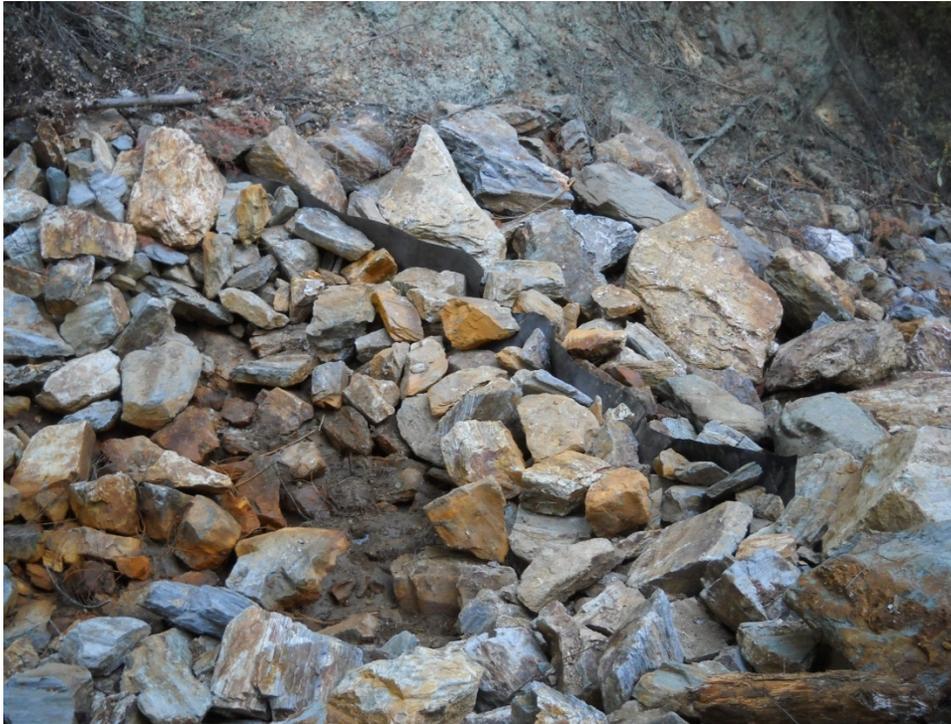
**USFS – Blue Ledge Mine Removal Project:**  
*Photograph A-41 - View of completed Sediment/pH Treatment Basin 1C on WRP-1*

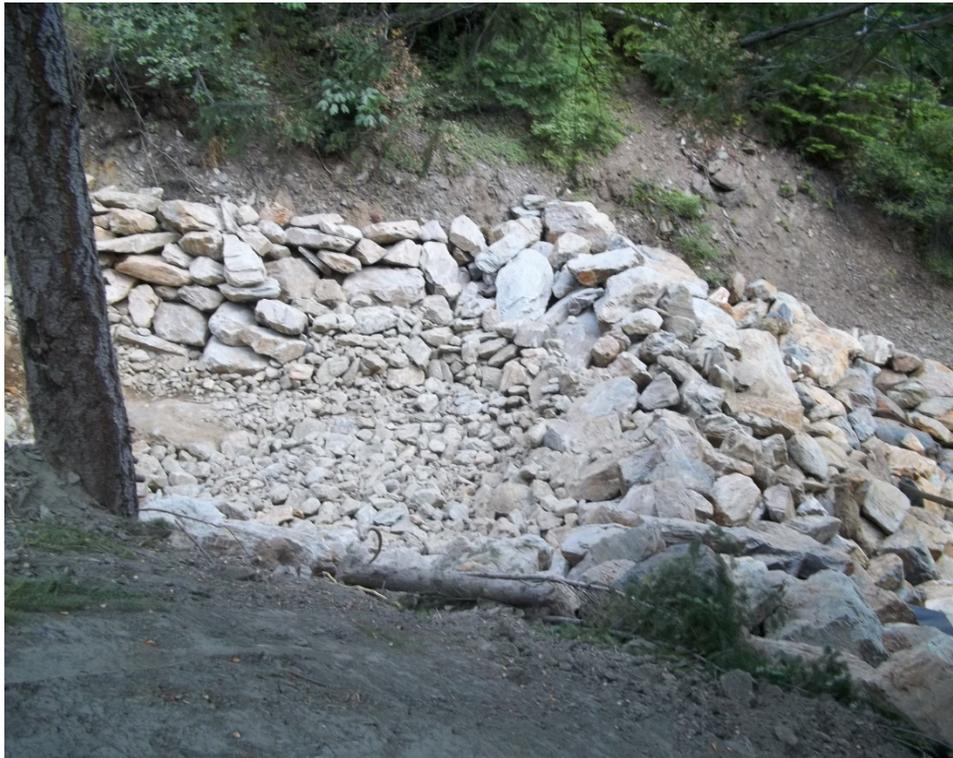
**USFS – Blue Ledge Mine Removal Project:**  
*Photograph A-42 - View of completed Sediment/pH Treatment Basin 1D on WRP-1*

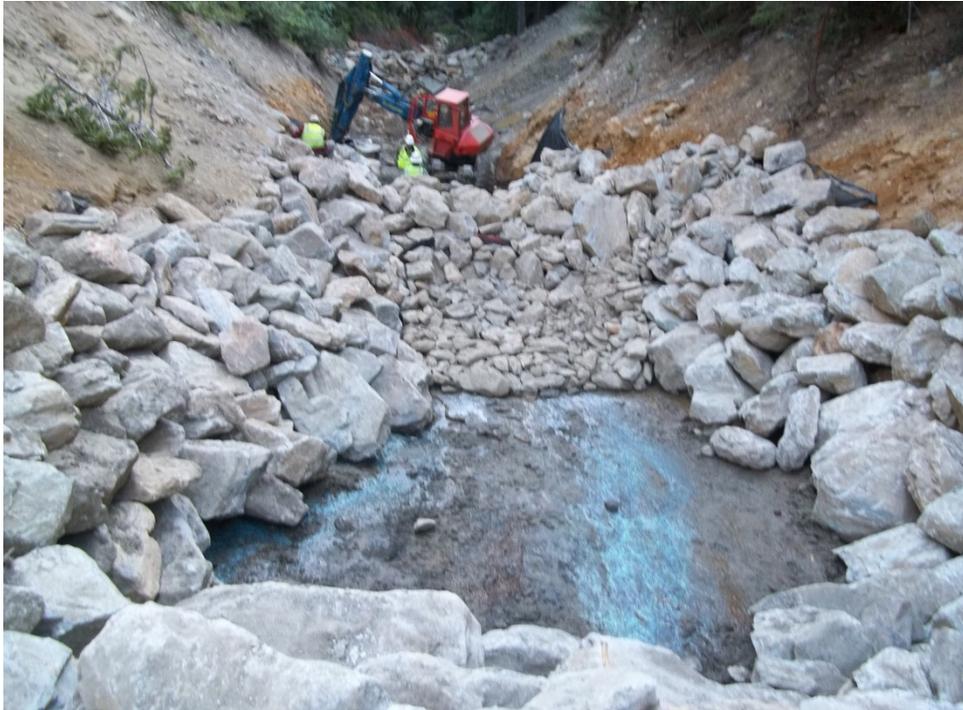
**USFS – Blue Ledge Mine Removal Project:**

*Photograph A-43 - View of completed Sediment/pH Basin 1E on WRP-1*

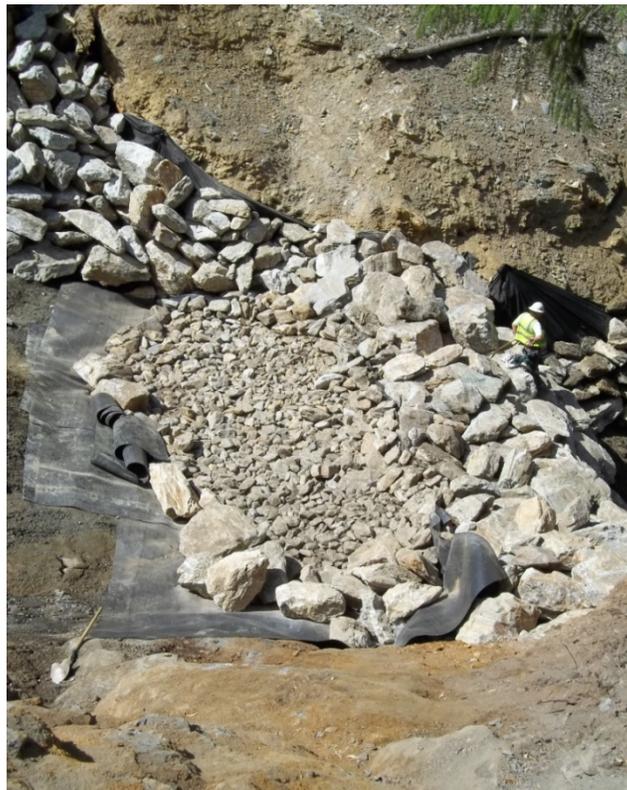
**USFS – Blue Ledge Mine Removal Project:**

*Photograph A-44 - View of completed Sediment/pH Treatment Basin 1F on WRP-1*

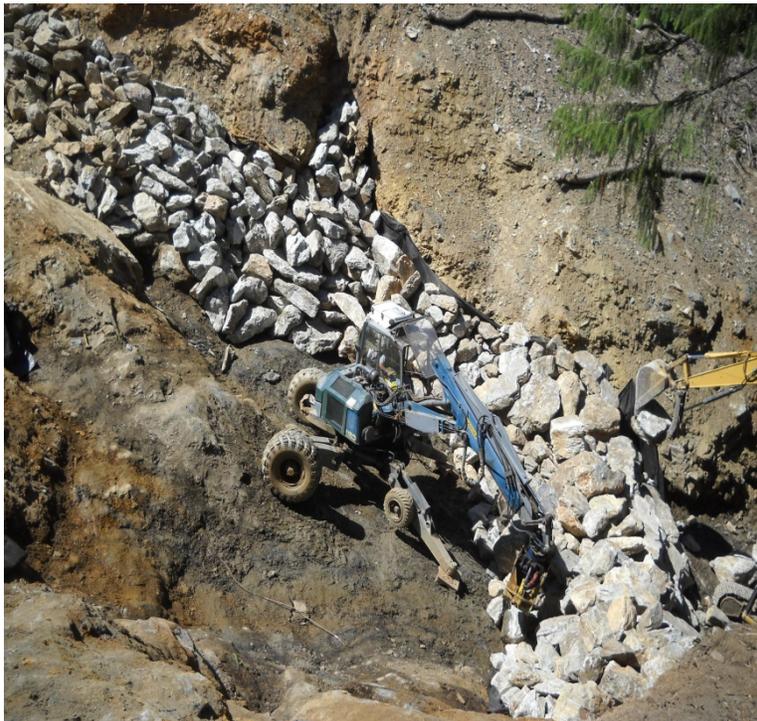
*Photograph A-45* -- View of WRP-1 area where large boulders (background) with underlying waste rock unsafe to remove

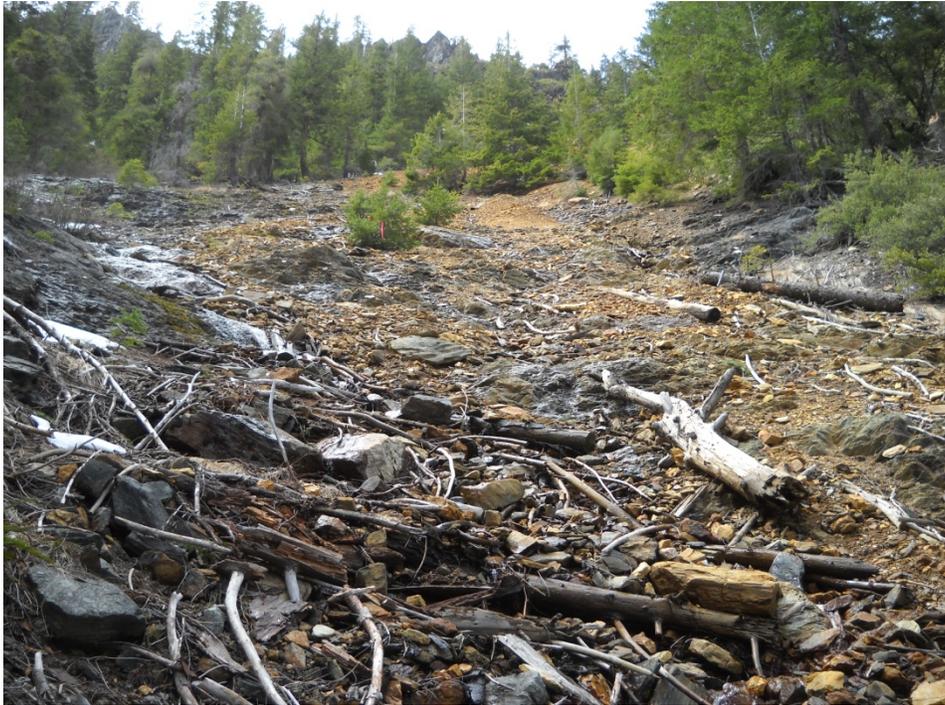
**USFS – Blue Ledge Mine Removal Project:**  
*Photograph A-47 - Original view of WRP-2*

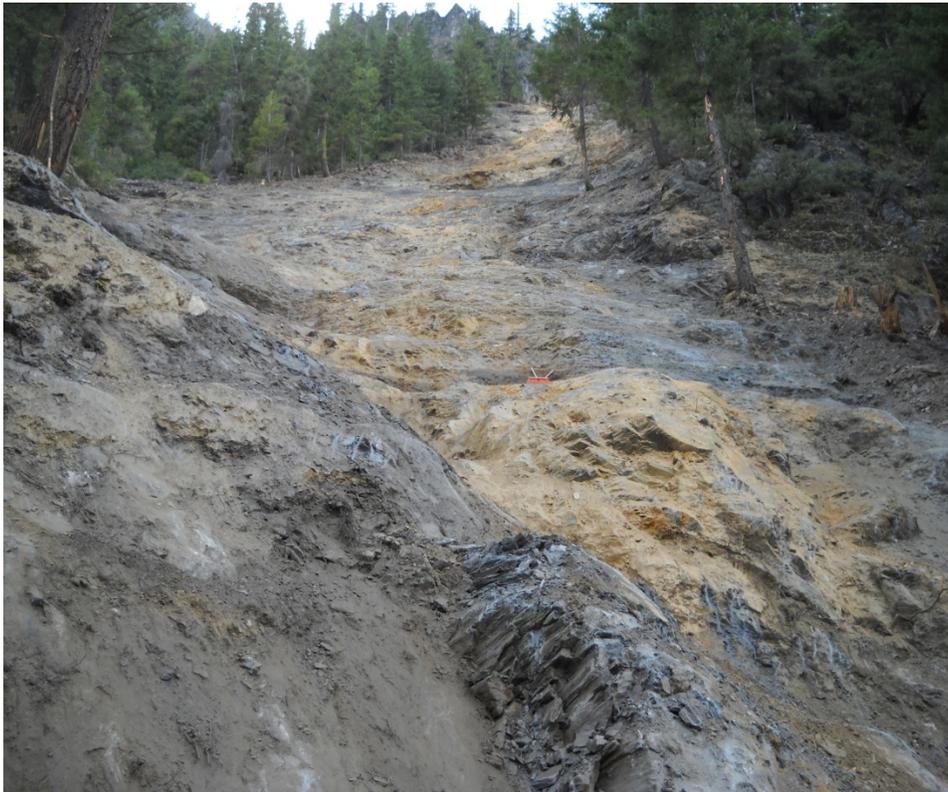
**USFS – Blue Ledge Mine Removal Project:**  
*Photograph A-48 - View of completed removal efforts on WRP-2*

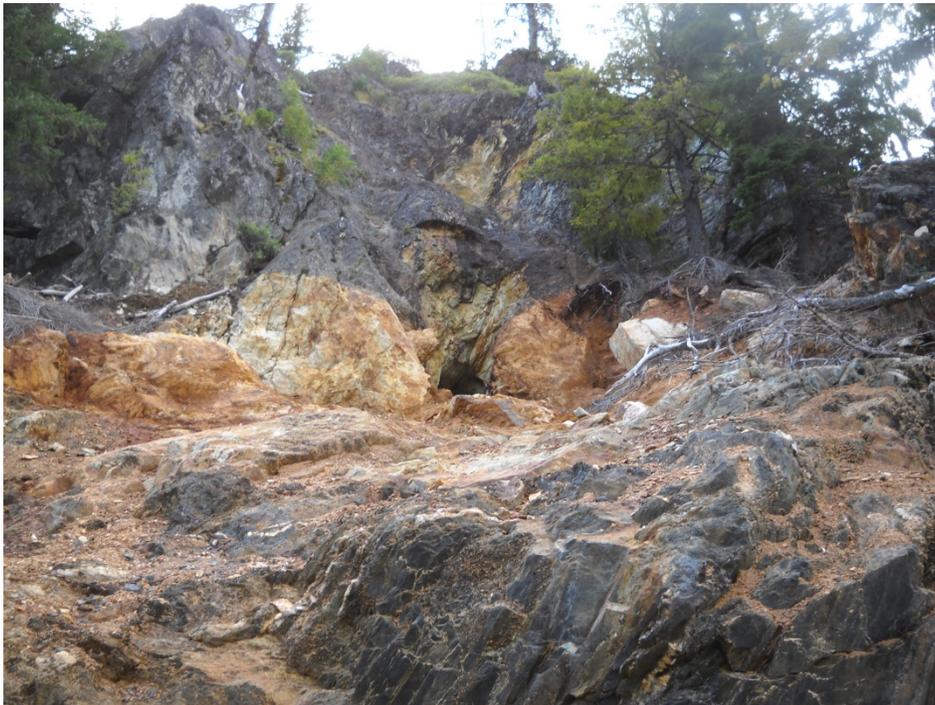
**USFS – Blue Ledge Mine Removal Project:**

*Photograph A-49* - View of upper WRP-2 area below adits A2 and A2S where safety concerns due to boulders prevented further hand excavation of residual waste rock

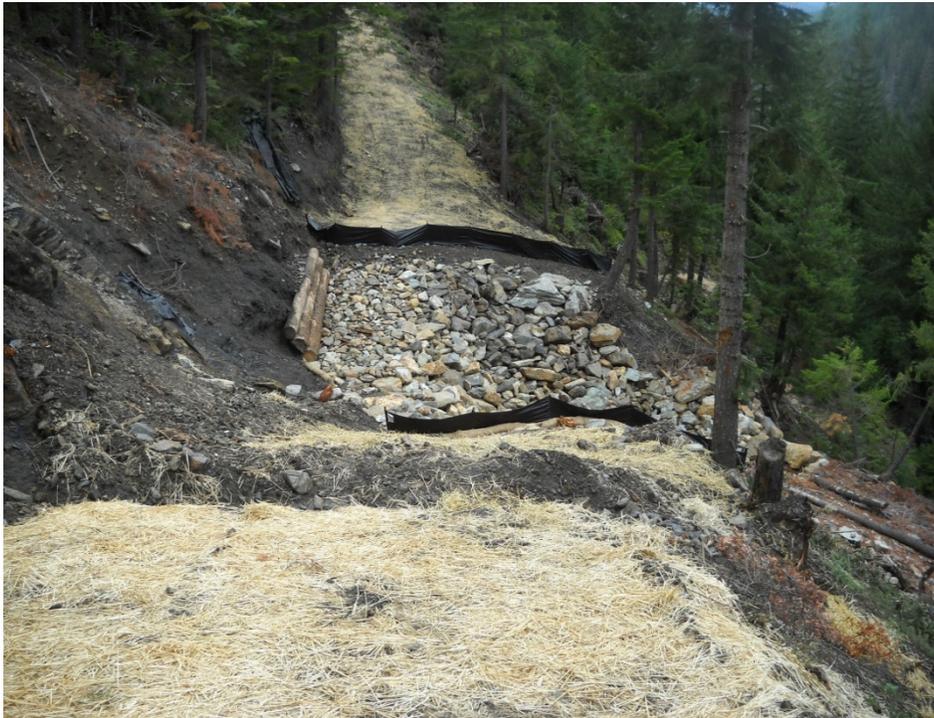
**USFS – Blue Ledge Mine Removal Project:**

*Photograph A-51 - View of completed Sediment/pH Treatment Basin 2B on WRP-2*

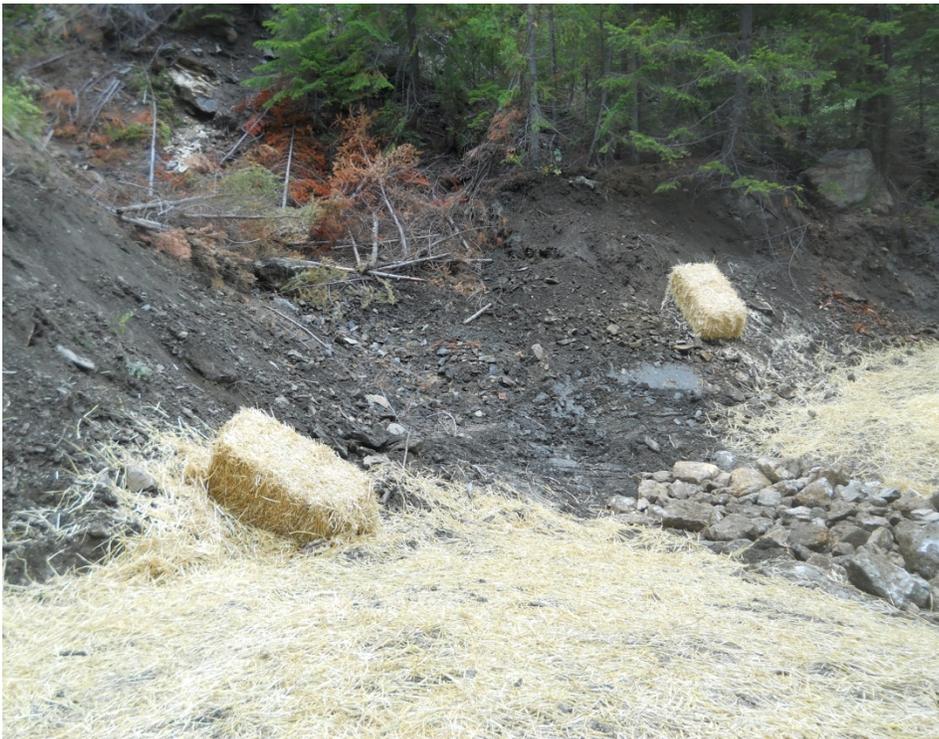
**USFS – Blue Ledge Mine Removal Project:**

*Photograph A-52 - View of reclamation features being installed above Sediment/pH Treatment Basin 2A on WRP-2*

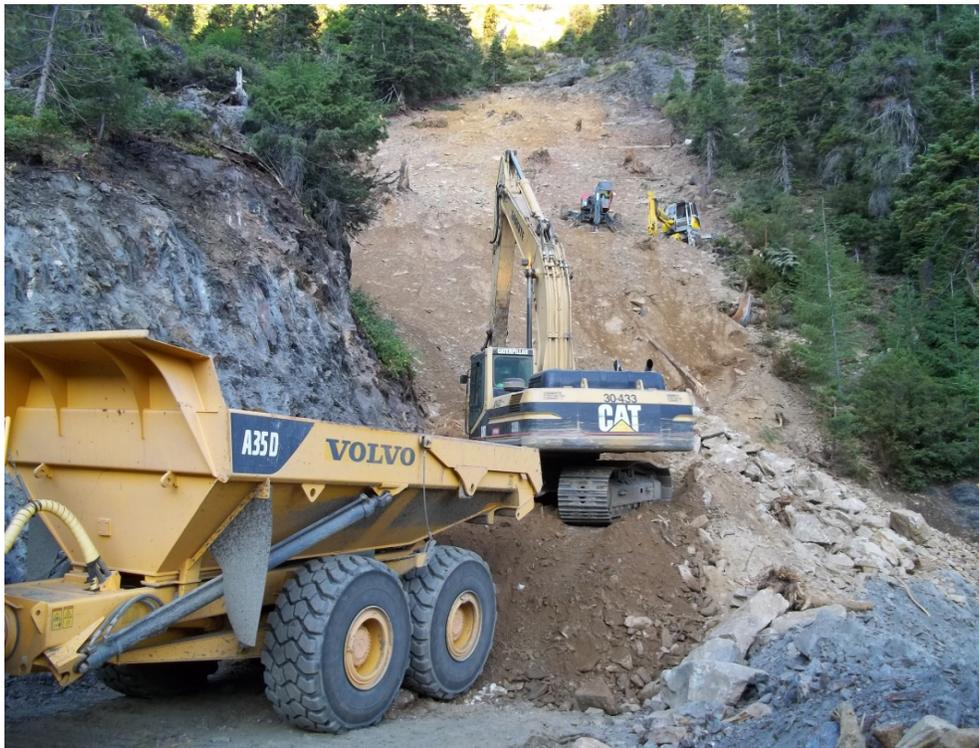
**USFS – Blue Ledge Mine Removal Project:**

*Photograph A-56 - View of waste rock removal and load-out from WRP-3*

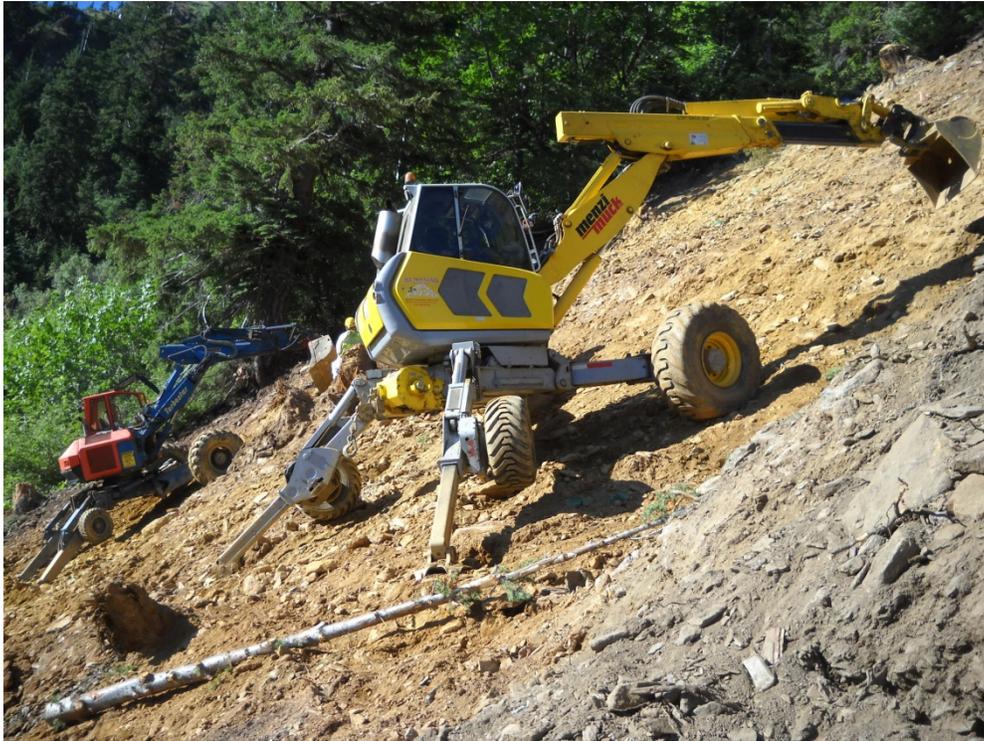
**USFS – Blue Ledge Mine Removal Project:**  
*Photograph A-57 - View of spider excavators on WRP-3*

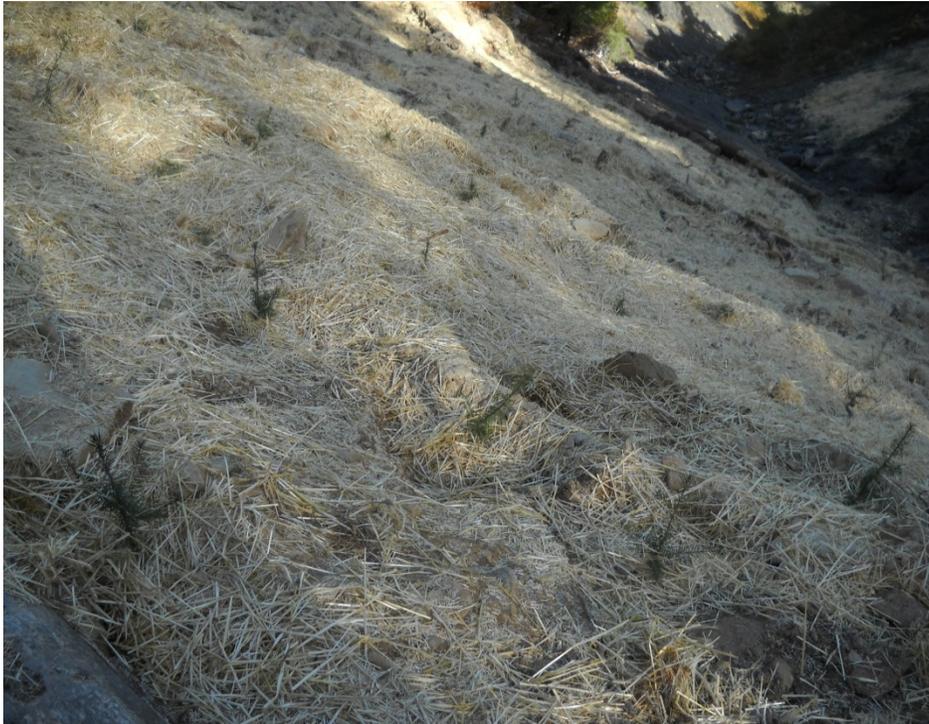
**USFS – Blue Ledge Mine Removal Project:**  
*Photograph A-59 - View of trees and shrubs planted on WRP-3*

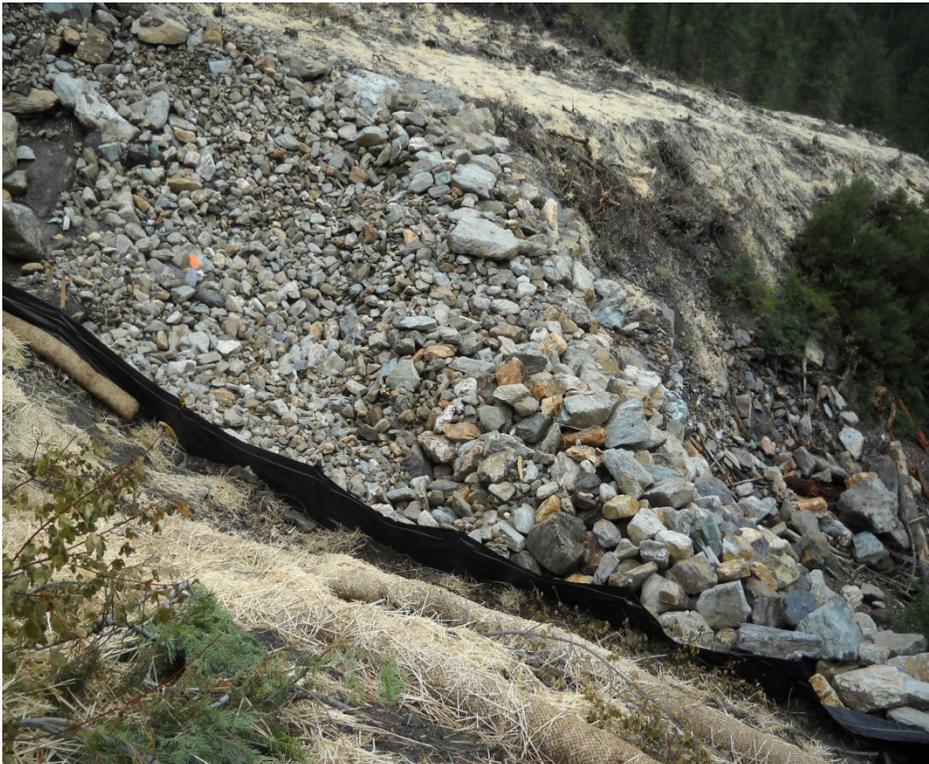
**USFS – Blue Ledge Mine Removal Project:**  
*Photograph A-60 - View of completed Sediment/pH Treatment Basin 3 on WRP-3*

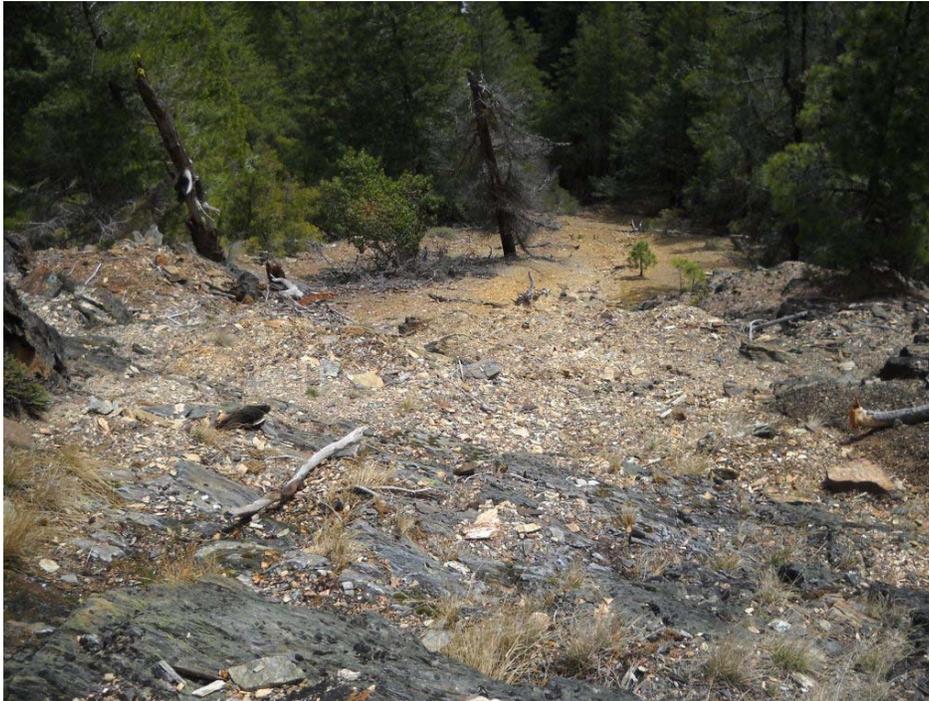
**USFS – Blue Ledge Mine Removal Project:**  
*Photograph A-61 - Original view of WRP- 4*

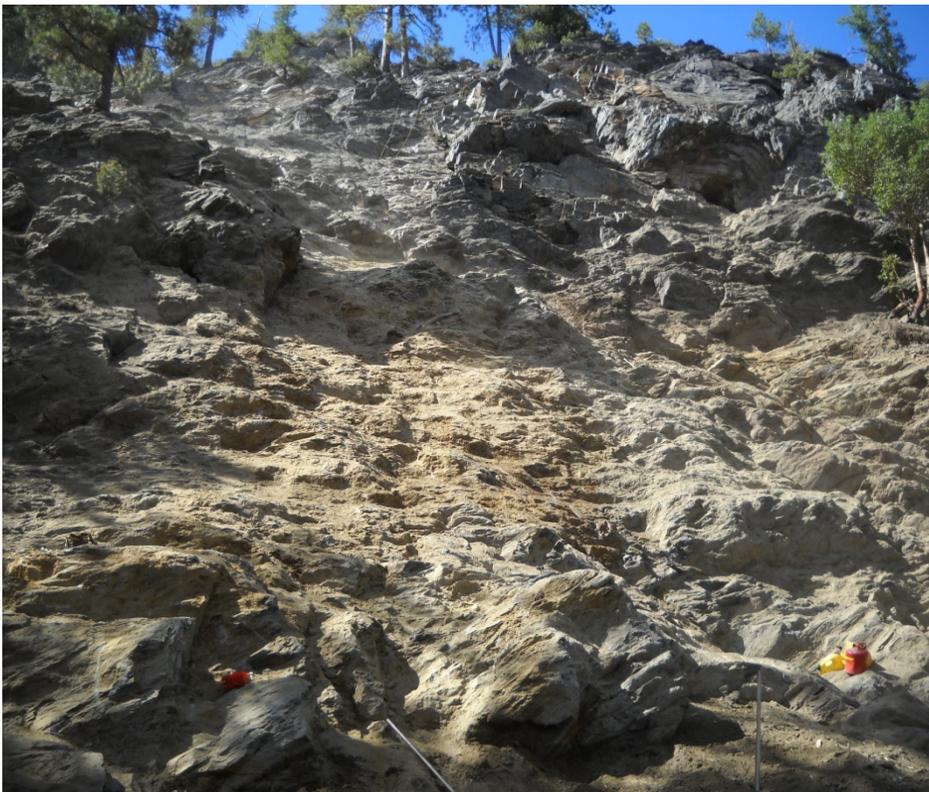
**USFS – Blue Ledge Mine Removal Project:**  
*Photograph A-62 - View of completed removal activities on WRP- 4*

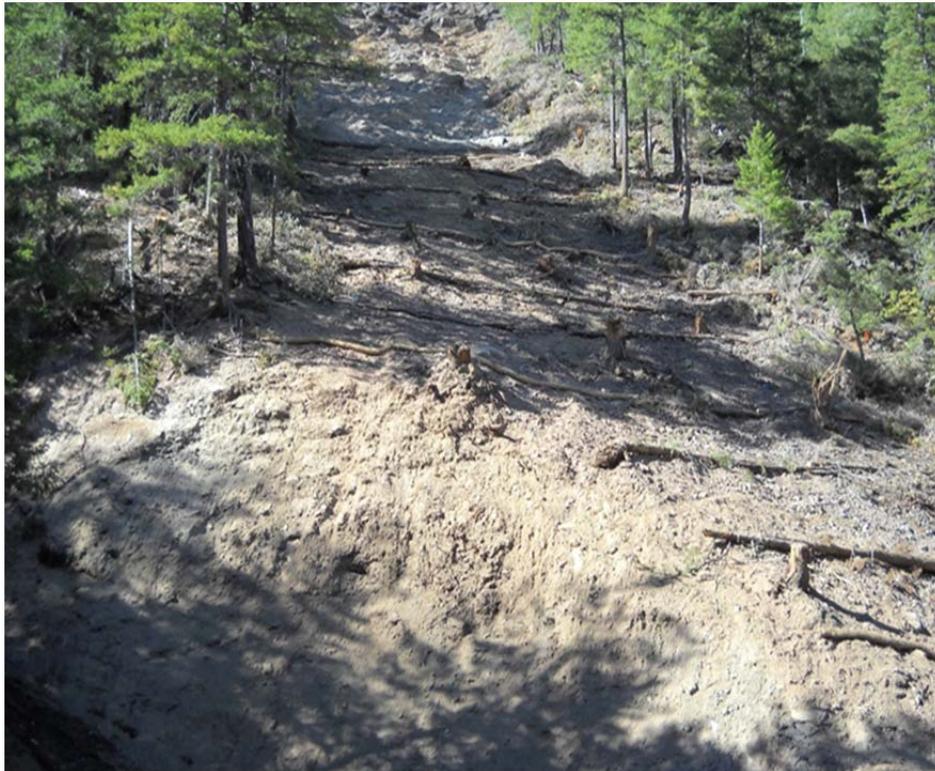
**USFS – Blue Ledge Mine Removal Project:**  
*Photograph A-63 - View of the base of WRP-4*

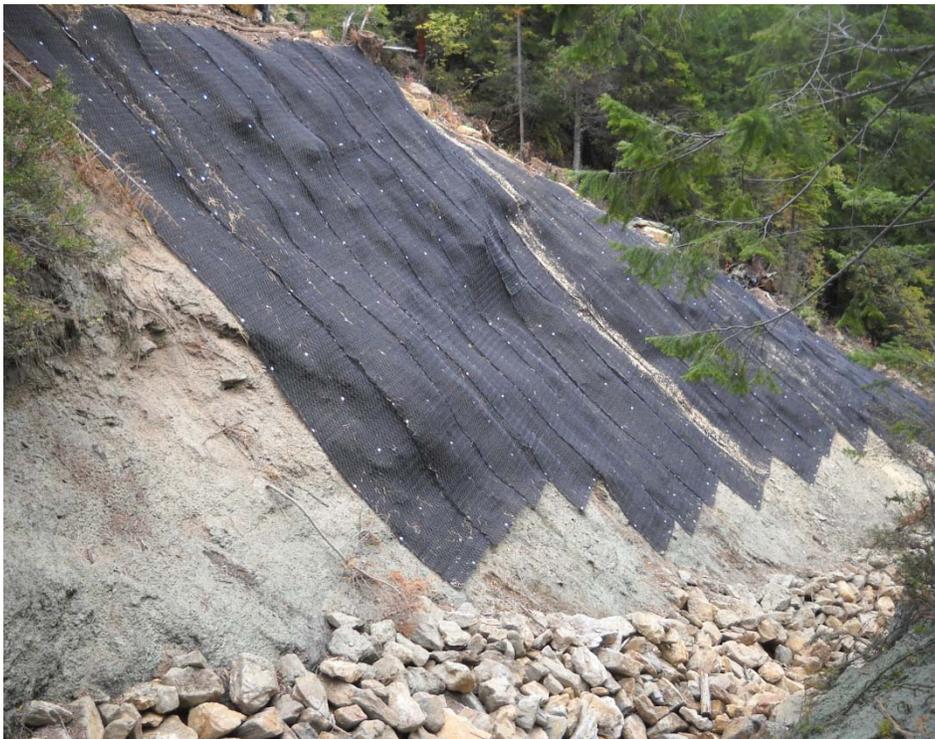
**USFS – Blue Ledge Mine Removal Project:**  
*Photograph A-64 - View of reinforced erosion control fabric at bottom of WRP-4*

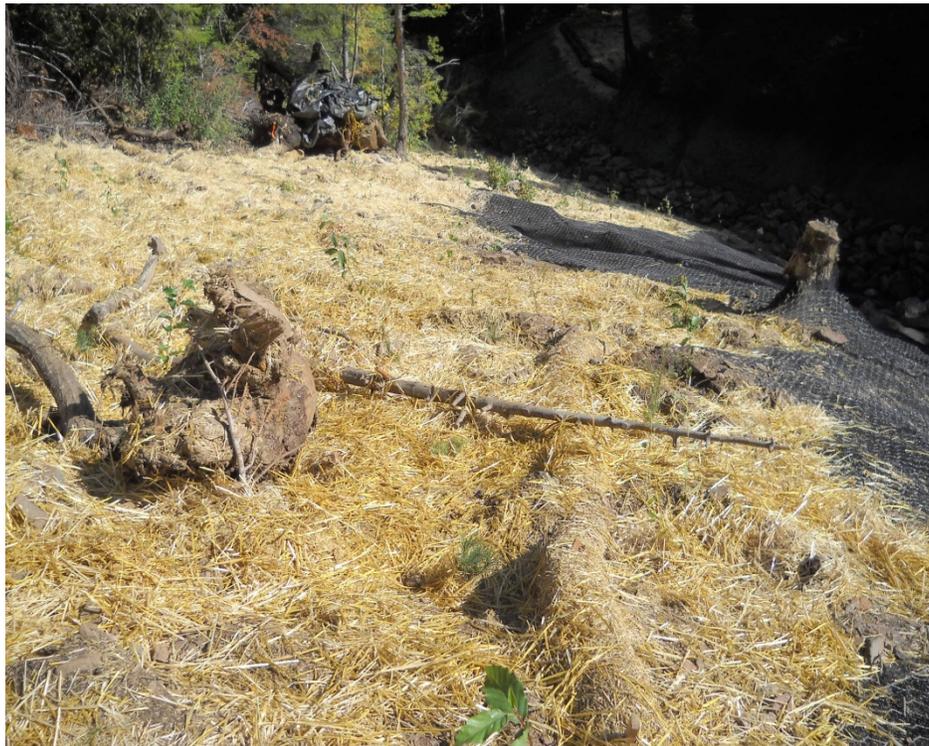
**USFS – Blue Ledge Mine Removal Project:**  
*Photograph A-66 - View of trees and shrubs planted on WRP-4*

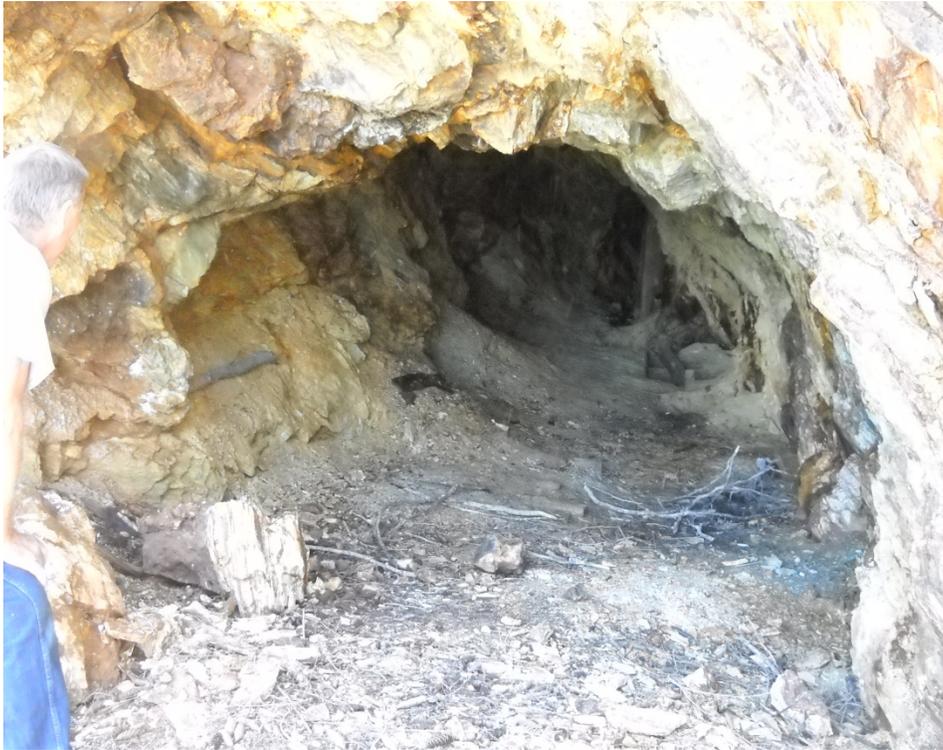
**USFS – Blue Ledge Mine Removal Project:**  
*Photograph A-67 - View of adit A1S on the top of WRP-1 prior to adit gate installation*

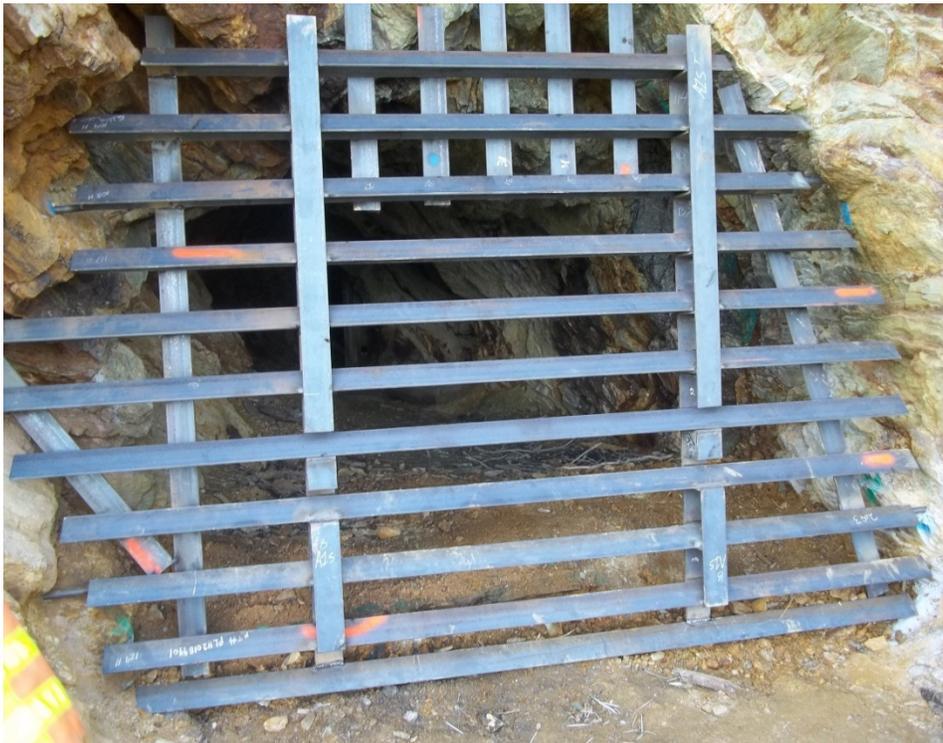
**USFS – Blue Ledge Mine Removal Project:**  
*Photograph A-68 - View of adit A1S on the top of WRP-1 with typical adit gate installed*

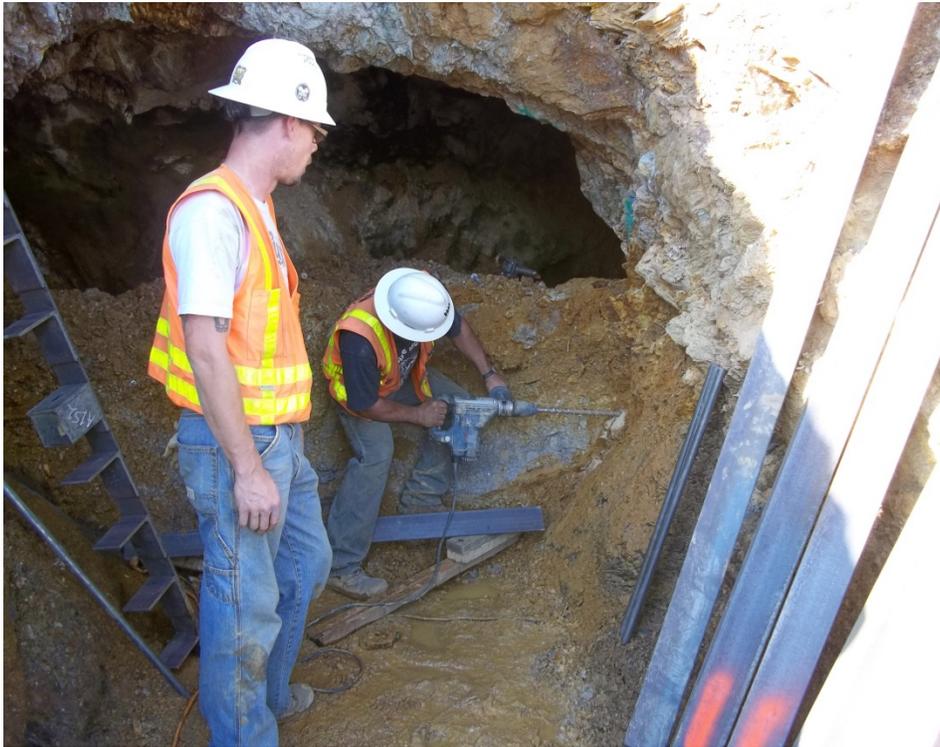
**USFS – Blue Ledge Mine Removal Project:**  
*Photograph A-69 - View of steel adit gate anchor pin drilling operations at adit A1S3*

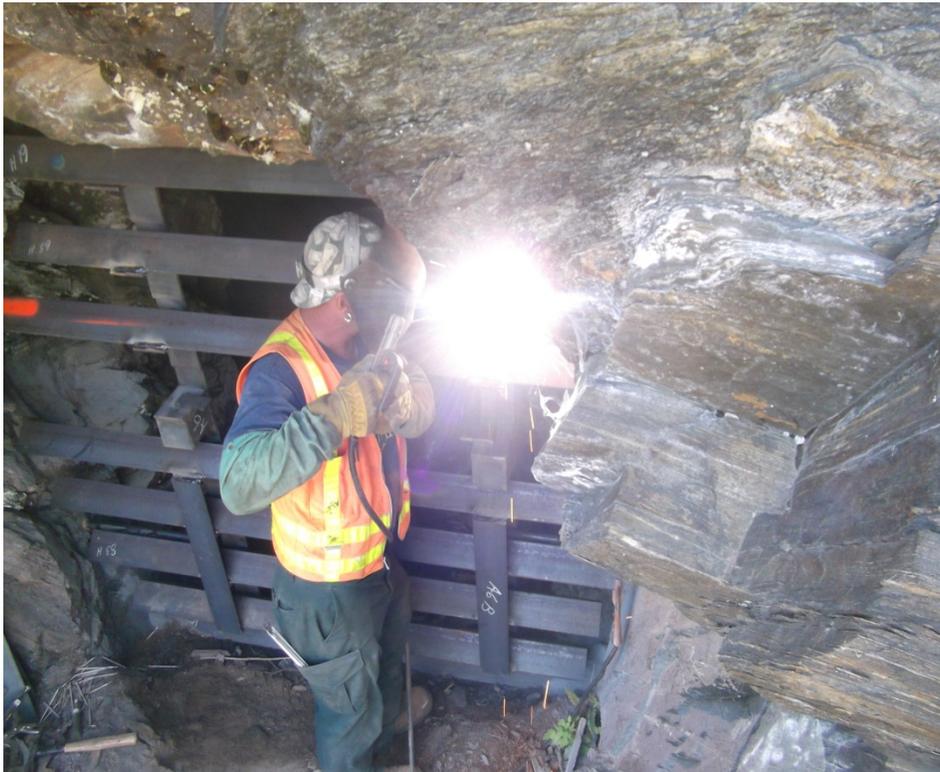
**USFS – Blue Ledge Mine Removal Project:**  
*Photograph A-70 - View of steel adit gate welding operations at adit A6*

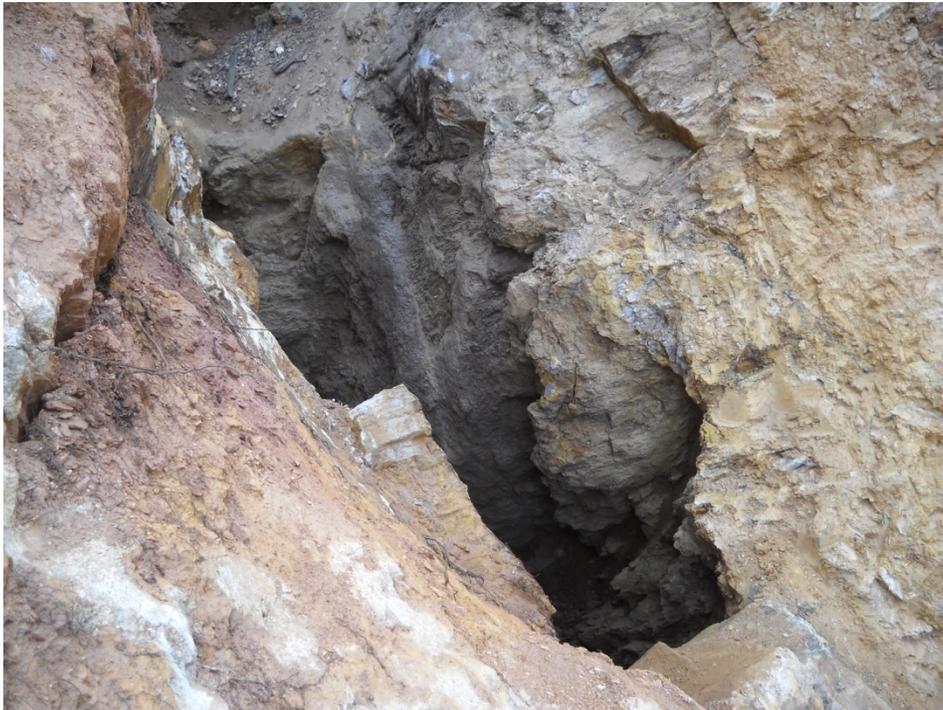
**USFS – Blue Ledge Mine Removal Project:**  
*Photograph A-71 - View of vertical shaft on WRP-1 prior to PUF application*

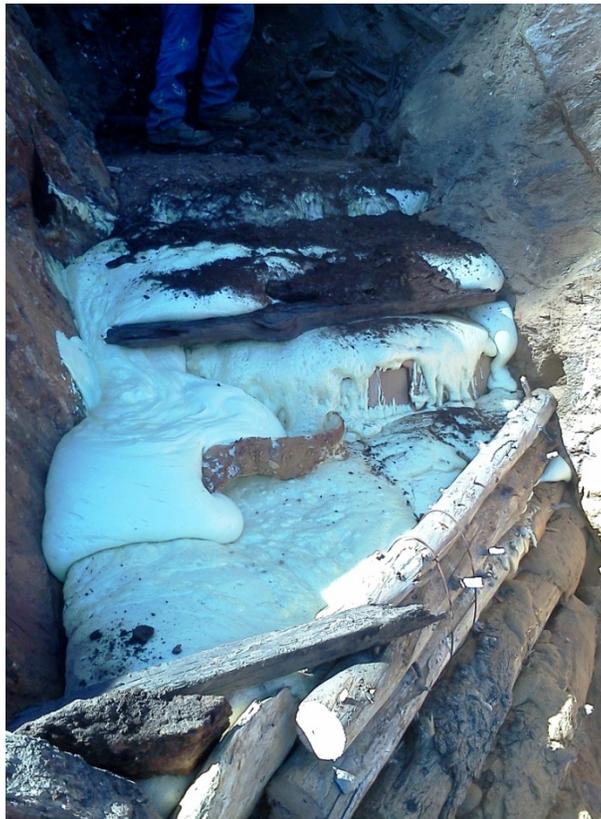
**USFS – Blue Ledge Mine Removal Project:**  
*Photograph A-72 - View of vertical shaft on WRP-1 with PUF application*

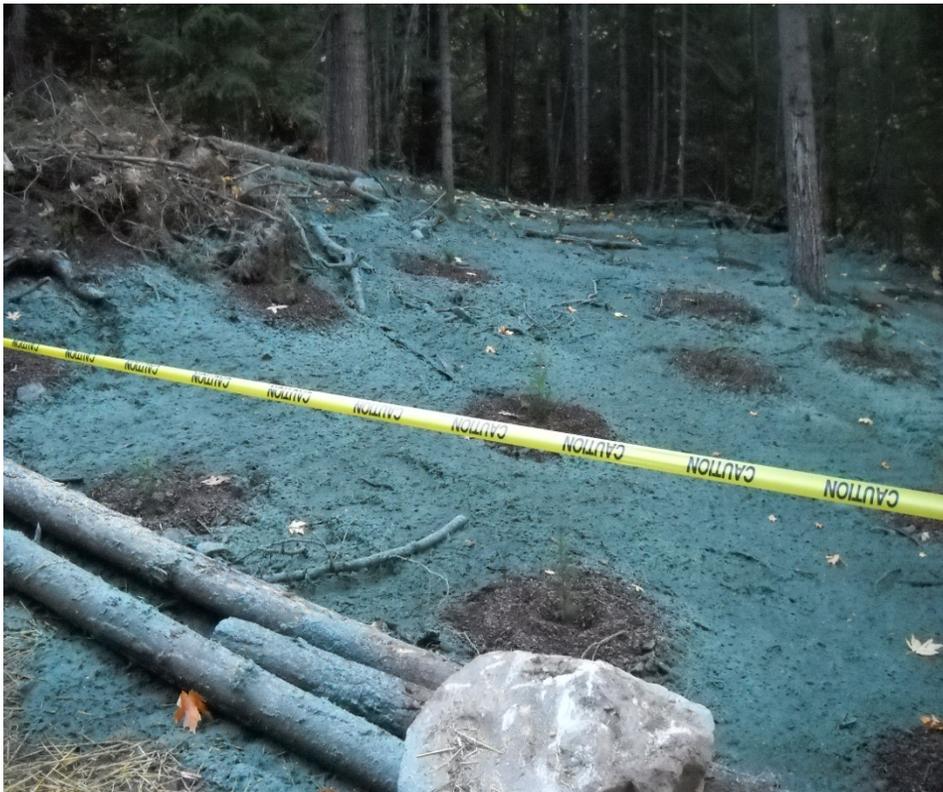
**USFS – Blue Ledge Mine Removal Project:**  
*Photograph A-74 - View of Rock Stockpile area with reclamation features installed*
