# Appendix A. Photographic Logs of Construction Progress in 2010 and 2011

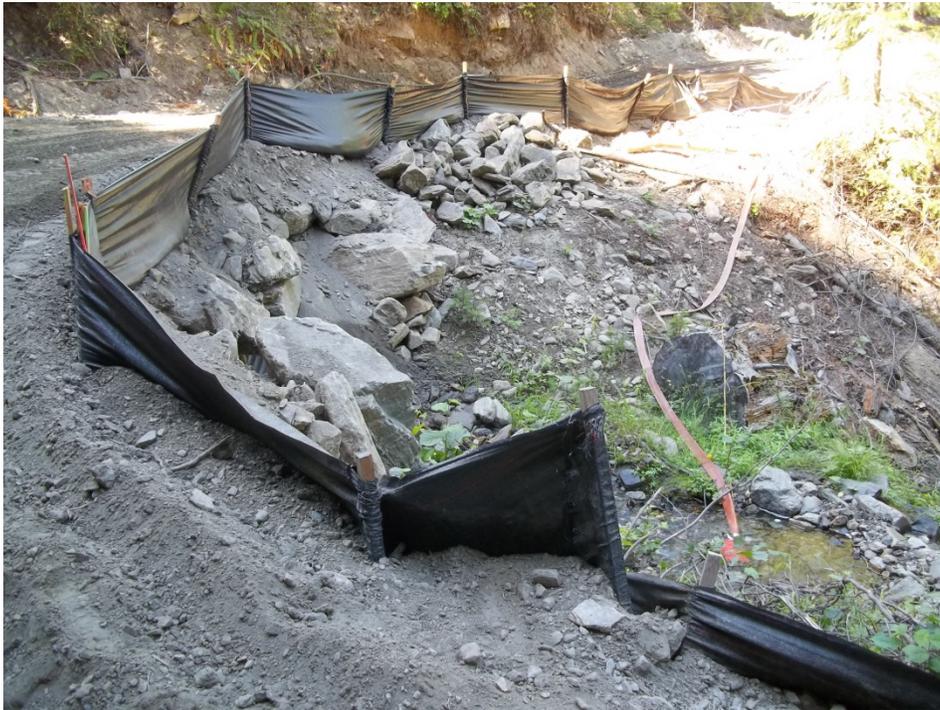
**USFS – Blue Ledge Mine Removal Project:**  
*Photograph A-75 - View of HR-1 creek crossing during removal activities*

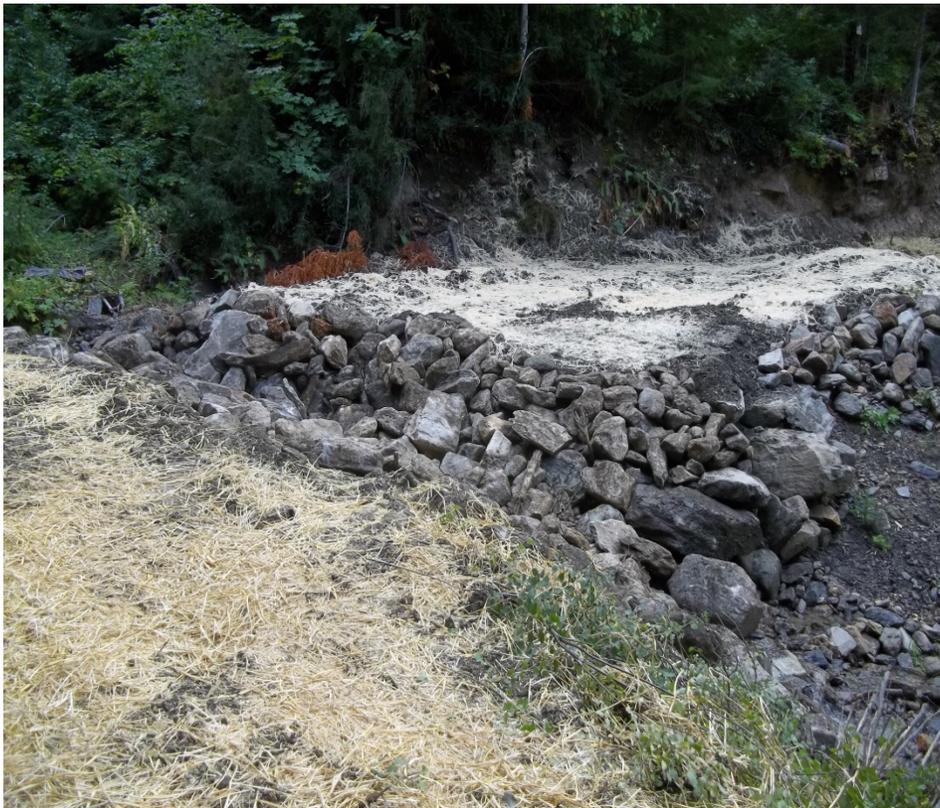
**USFS – Blue Ledge Mine Removal Project:**  
*Photograph A-76 - View of HR-1 creek crossing with completed winterization features*

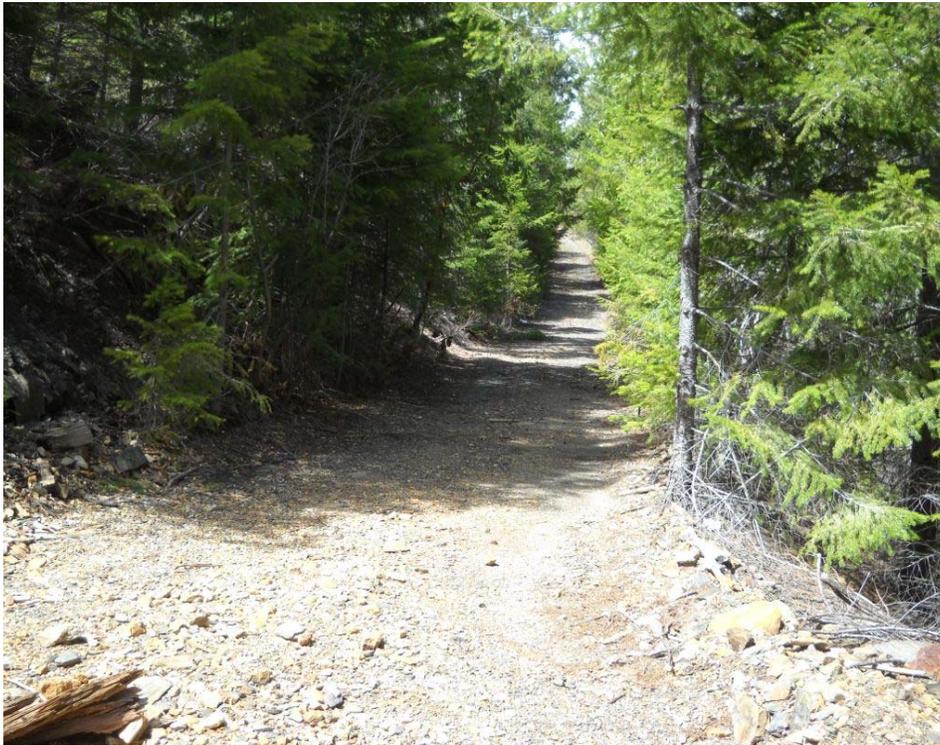
**USFS – Blue Ledge Mine Removal Project:**  
*Photograph A-77 - Original view of HR-1*

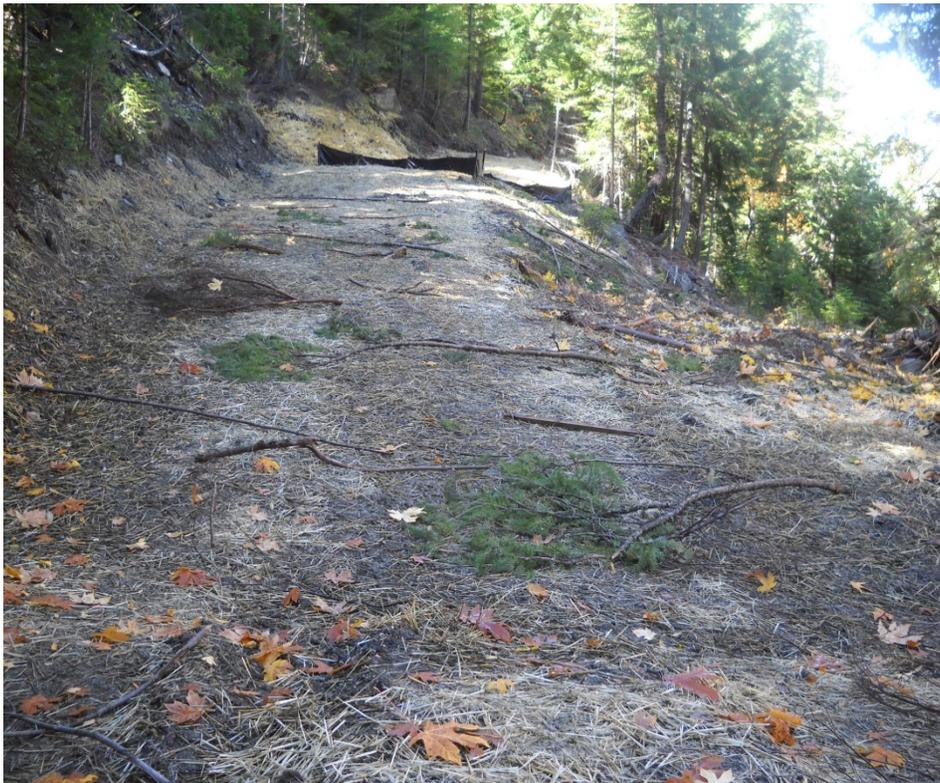
**USFS – Blue Ledge Mine Removal Project:**  
*Photograph A-78 - View of winterized HR-1*

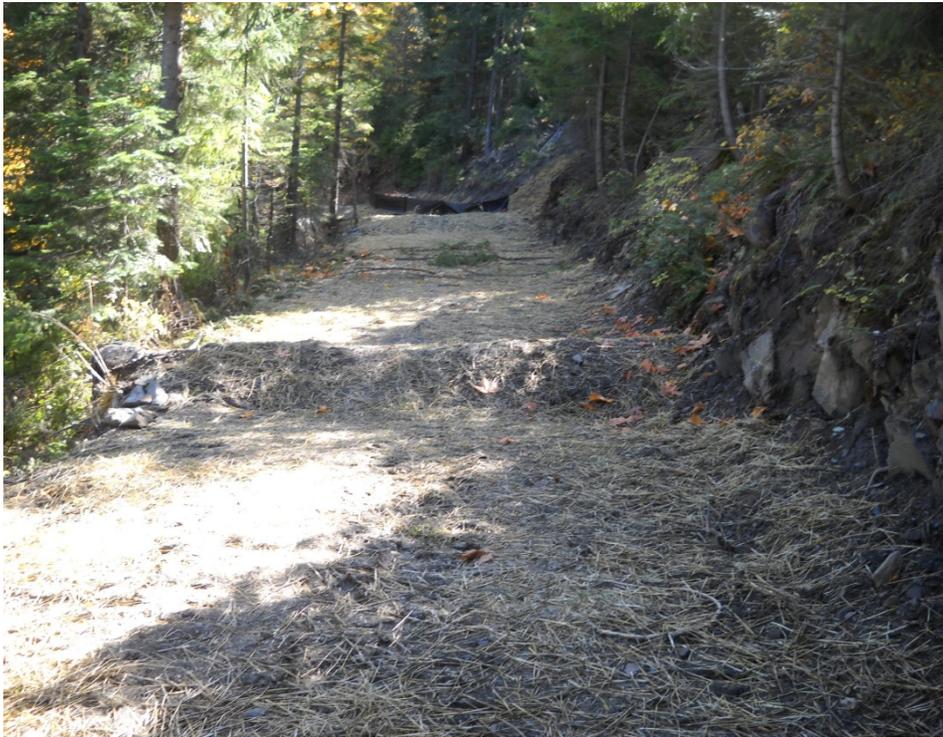
**USFS – Blue Ledge Mine Removal Project:**  
*Photograph A-79 - View of water bar on winterized HR-1*

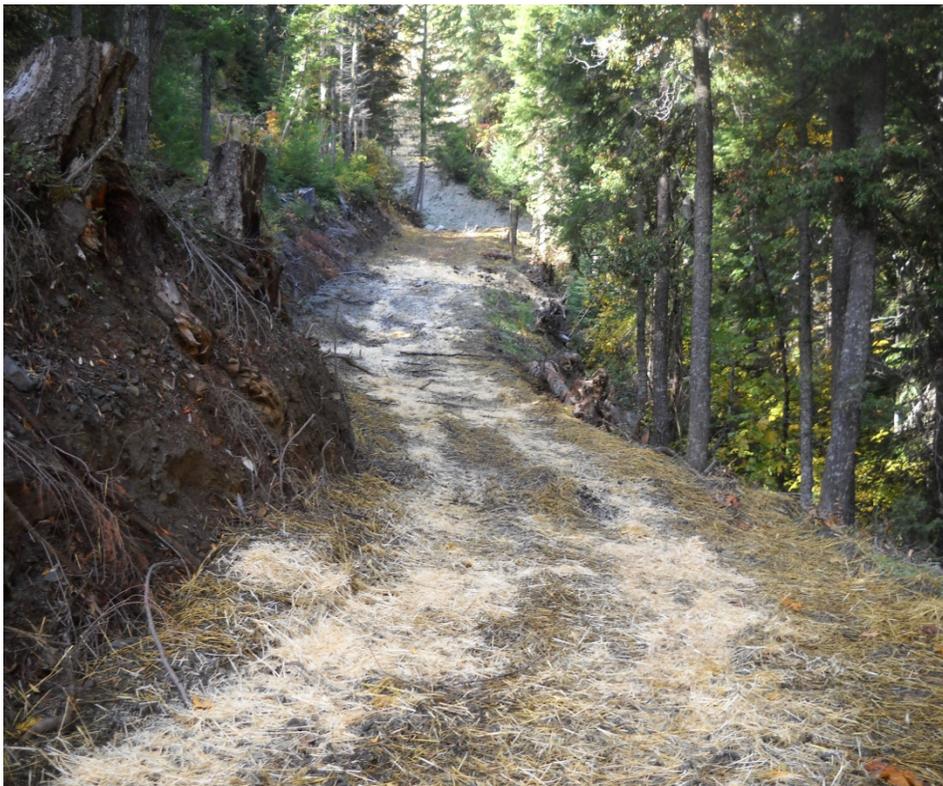
**USFS – Blue Ledge Mine Removal Project:**  
*Photograph A-80 – View of winterized HR-3*

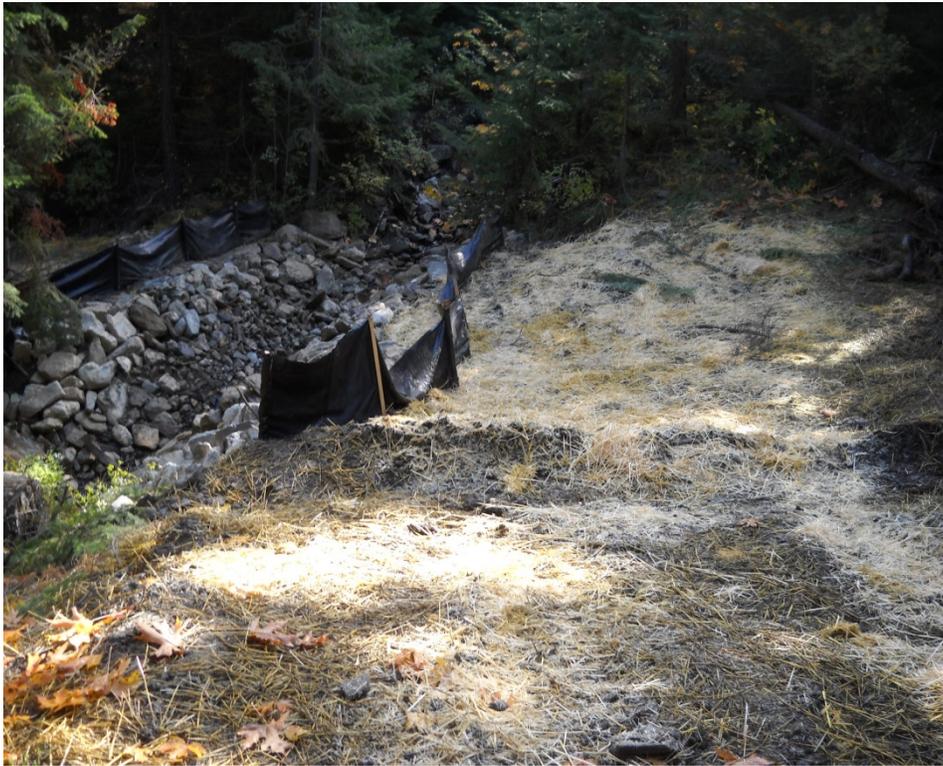
**USFS – Blue Ledge Mine Removal Project:**  
*Photograph A-81* -- View of HR-3 creek crossing with completed winterization features

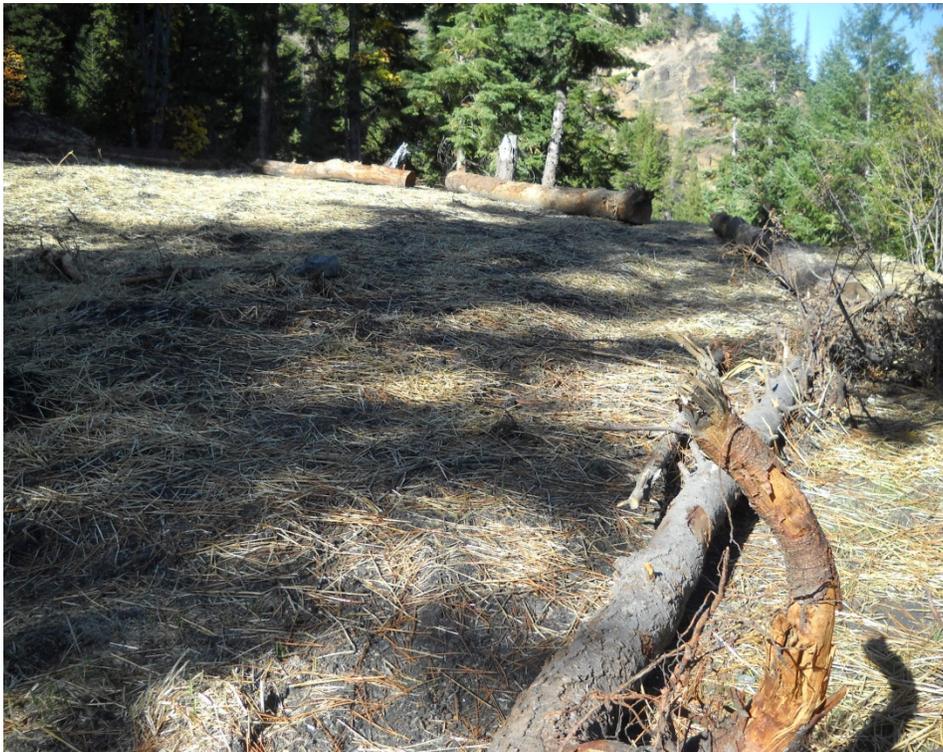
**USFS – Blue Ledge Mine Removal Project:**  
*Photograph A-82* - View of winterized miner's trail parking area

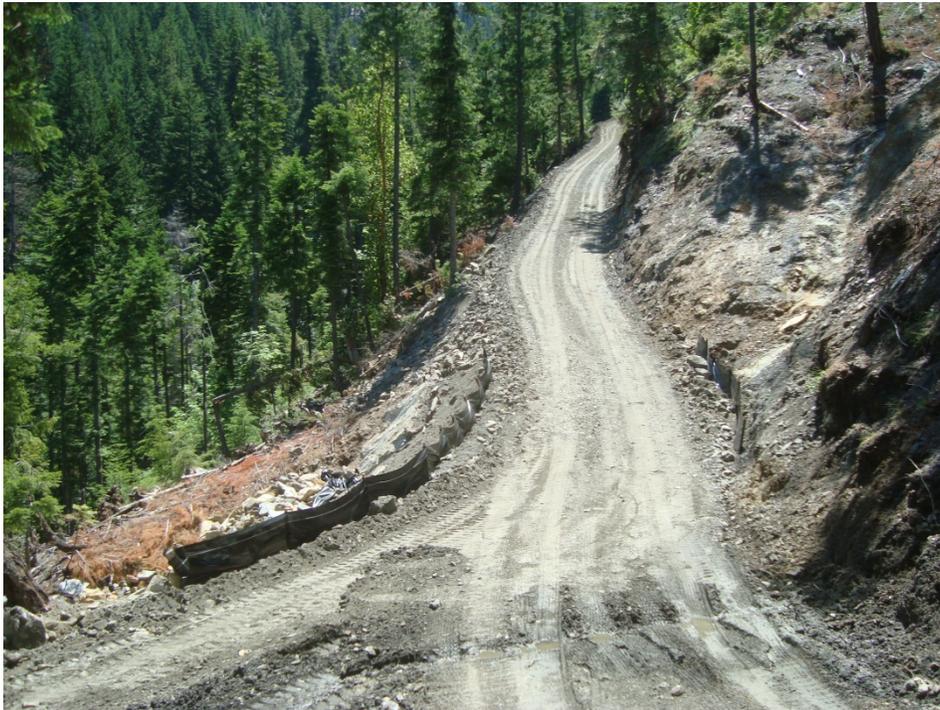
**USFS – Blue Ledge Mine Removal Project:**  
*Photograph A-83 - View of HR-4 during removal efforts*

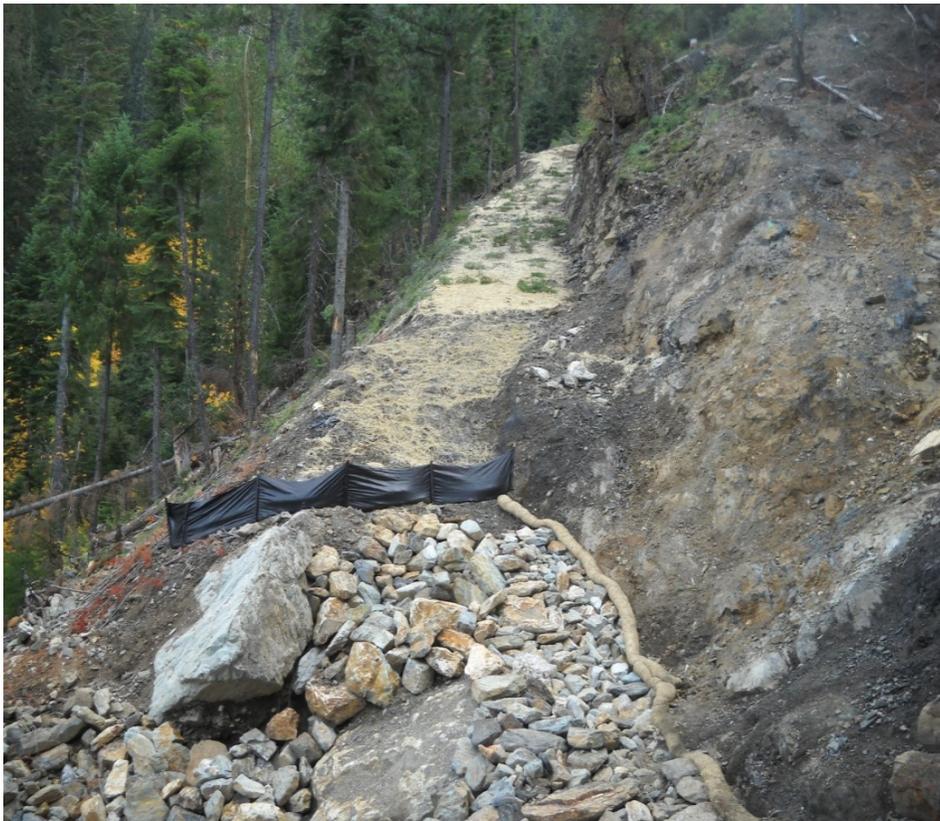
**USFS – Blue Ledge Mine Removal Project:**  
*Photograph A-84 - View of winterized HR-4 and reclamation features installed above Sediment/pH Treatment Basin 2B*

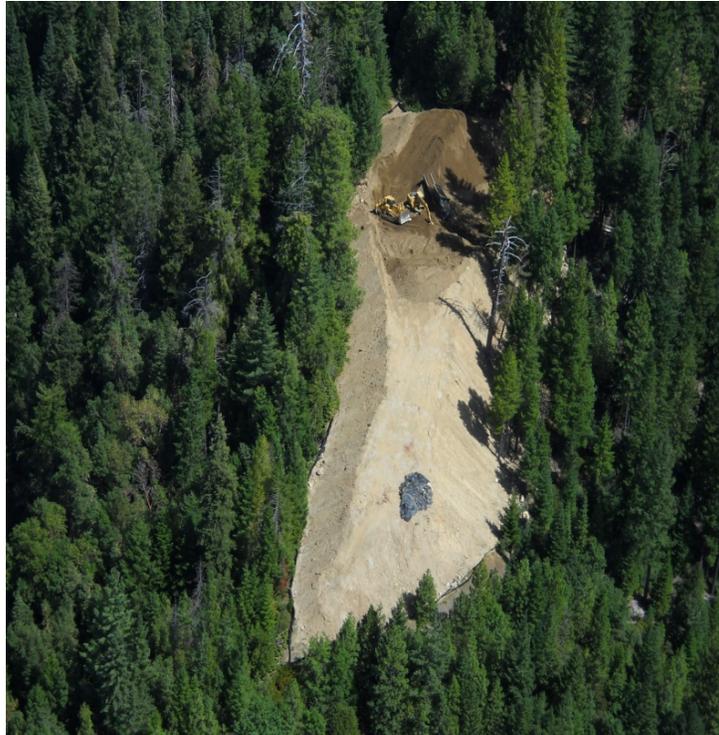
*Photograph A-85* - Aerial view of North Storage area with excavated material from the repository

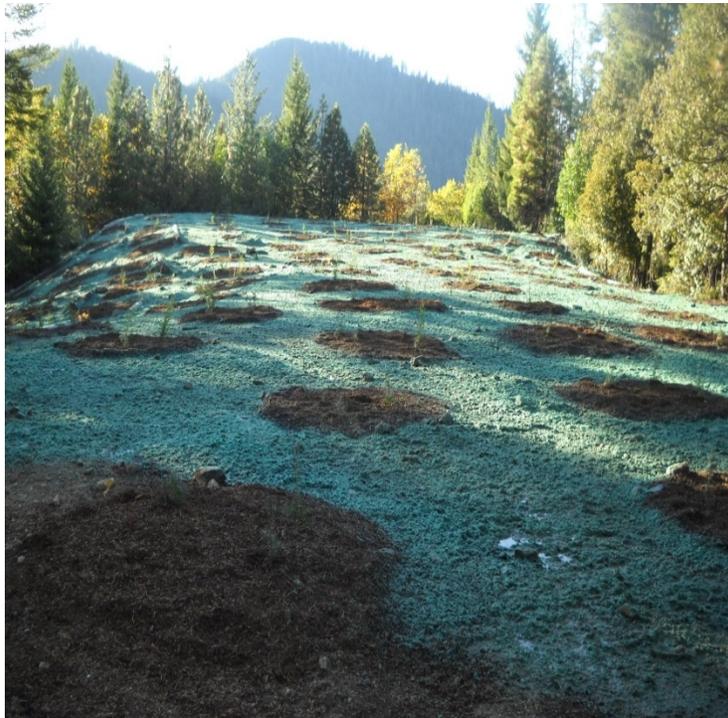
*Photograph A-86* - View of North Storage area with reclamation features installed

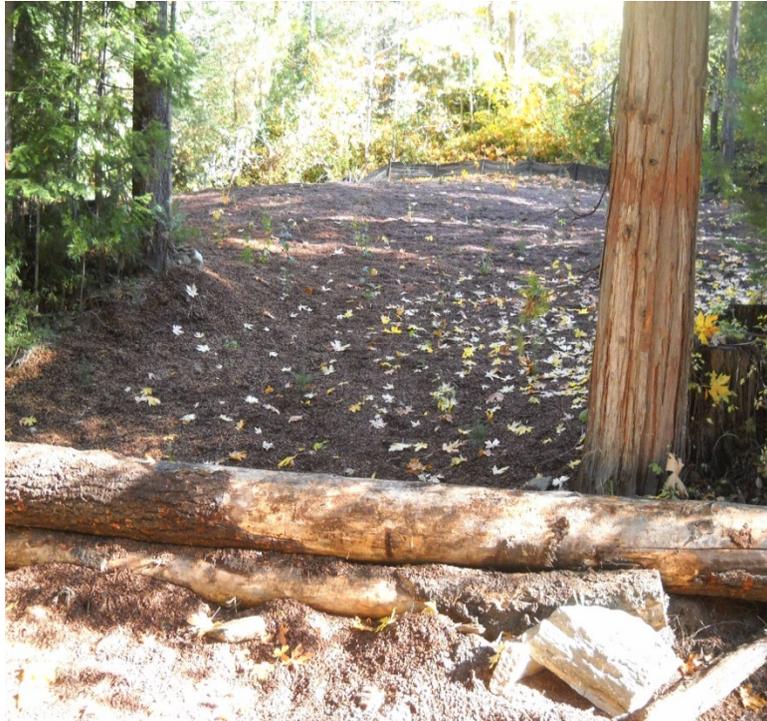
**USFS – Blue Ledge Mine Removal Project:**  
*Photograph A-87 - View of reclamation features installed at the South Storage area*

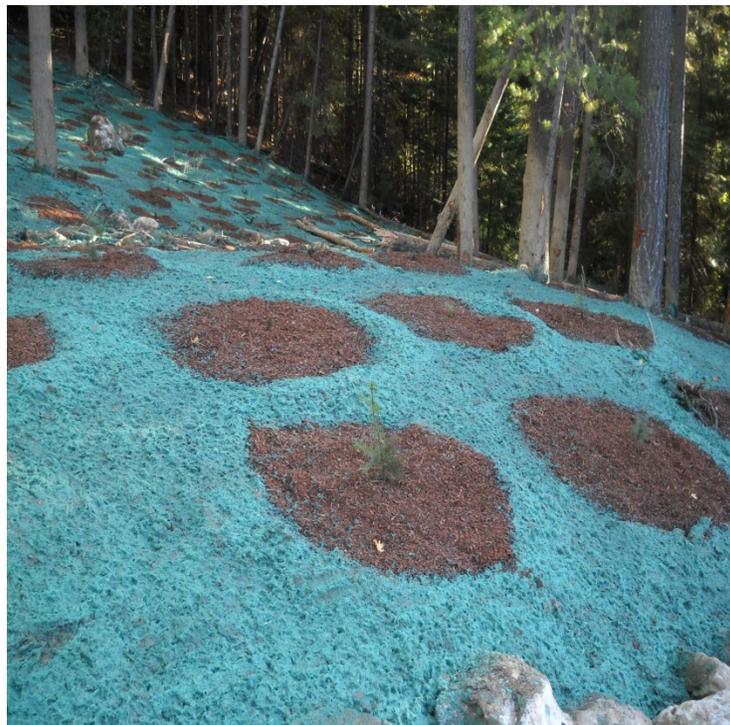
**USFS – Blue Ledge Mine Removal Project:**  
*Photograph A-88 - View of the Repository South Stockpile area with reclamation features installed*

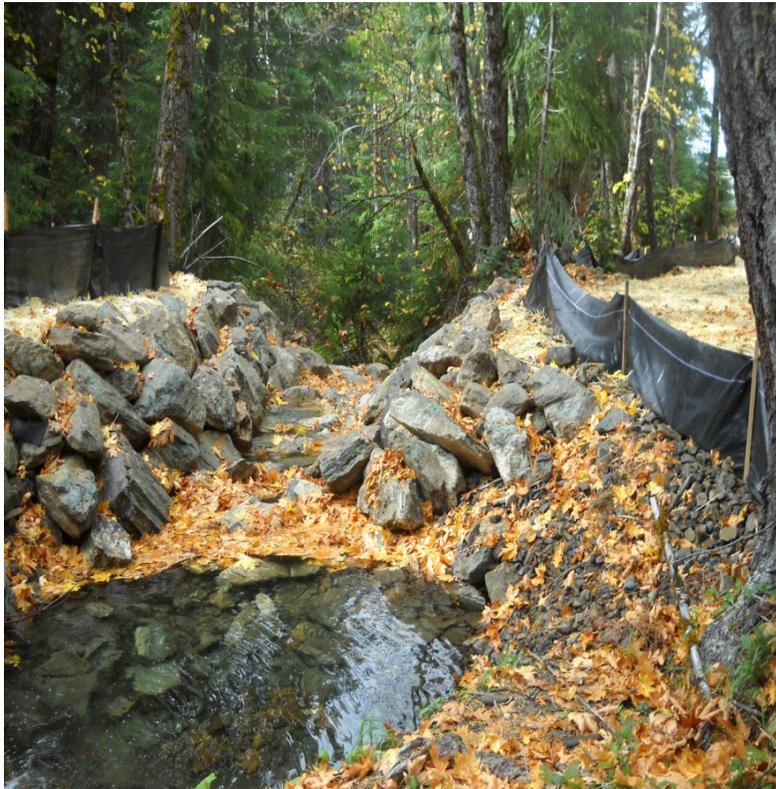
**USFS – Blue Ledge Mine Removal Project:**  
*Photograph A-89 - View of winterized Joe Creek crossing at start of HR-1*

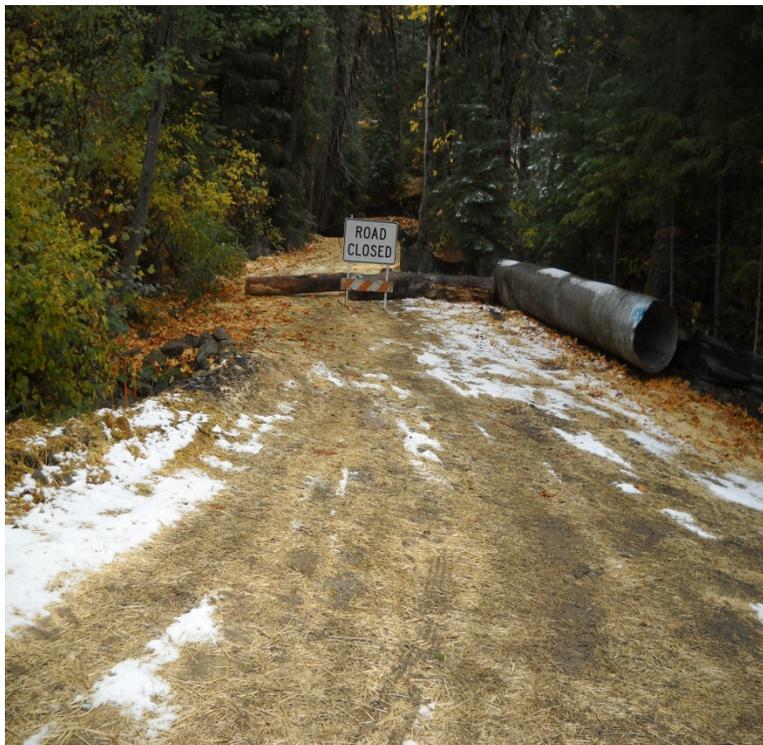
**USFS – Blue Ledge Mine Removal Project:**  
*Photograph A-90 - View of HR-1 road closure from Forest Service Road 1060*
