FOREST-WIDE COLLABORATIVE TRAILS ASSESSMENT

CHATTAHOOCHEE-OCONEE
NATIONAL FOREST

CONASAUGA RANGER DISTRICT

JANUARY- MAY, 2012
CONTRACT #: AG-435H-S-12-0001

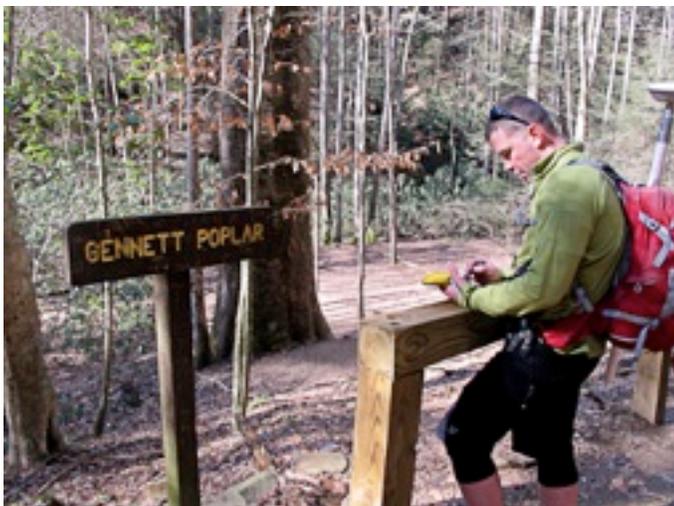
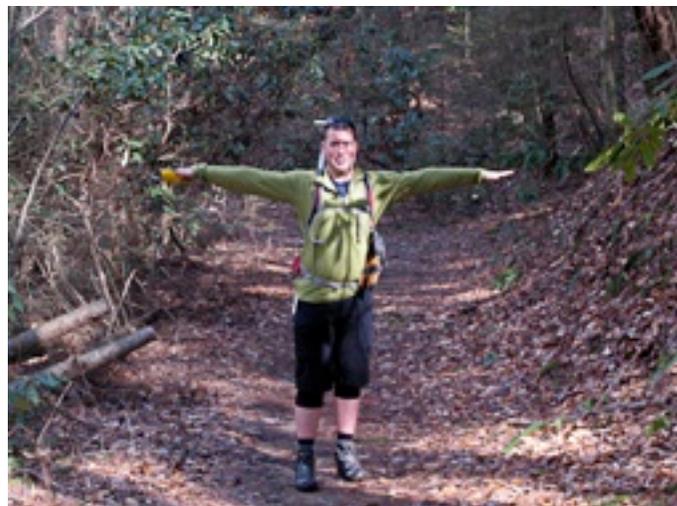
Left: Gennett Poplar location provides mid-trail destination. Right: old road bed provides trail corridor. This requires more intensive water management maintenance extending the full width of the corridor

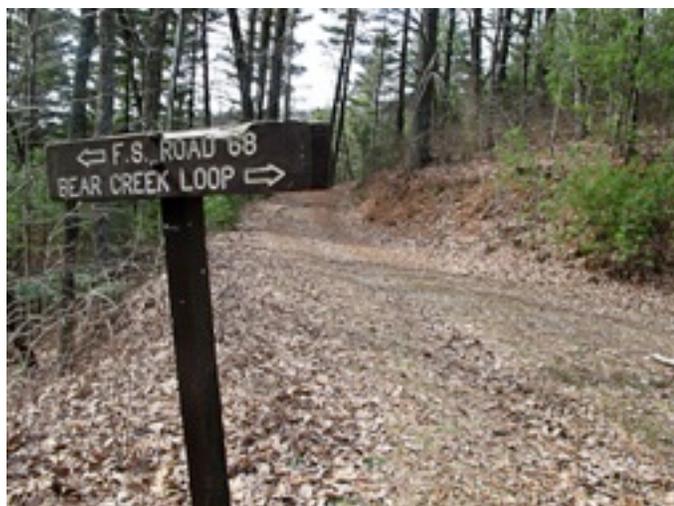
Above Left and Right: Trail is shared in part with FDR 68 and above switchback at Bear Creek has gravel surface and road-style dips with narrow drains, often not outsloped enough or with wide enough drains making them prone to filling.

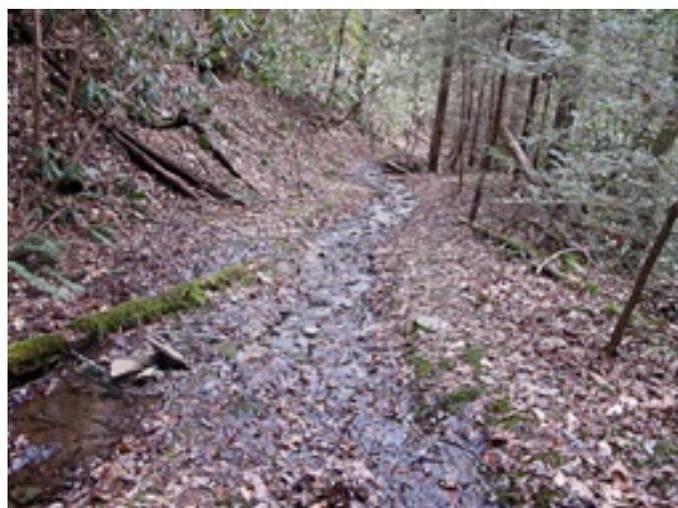
Left: Very steep old road bed from ridge to Bear Creek crossing on southeast portion of trail has many locations where drainage is not provided and tread erosion and persistently wet conditions are present.

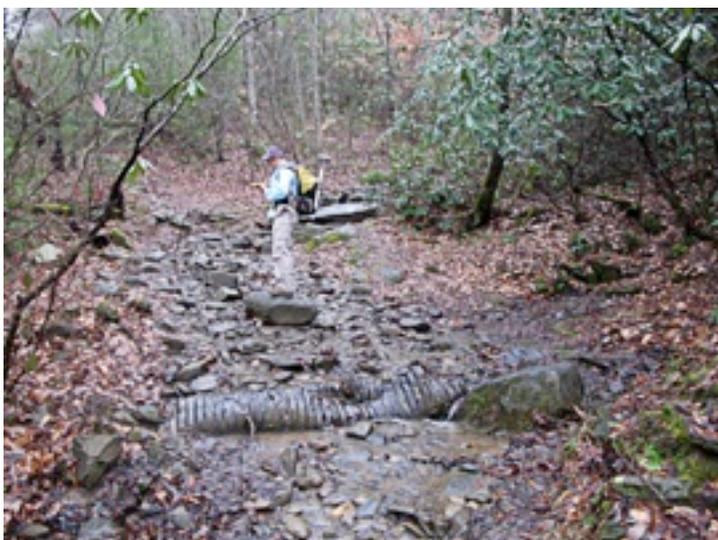
Above: Exposed culvert- erosion present in many locations due to stream diversion to trail during flow events

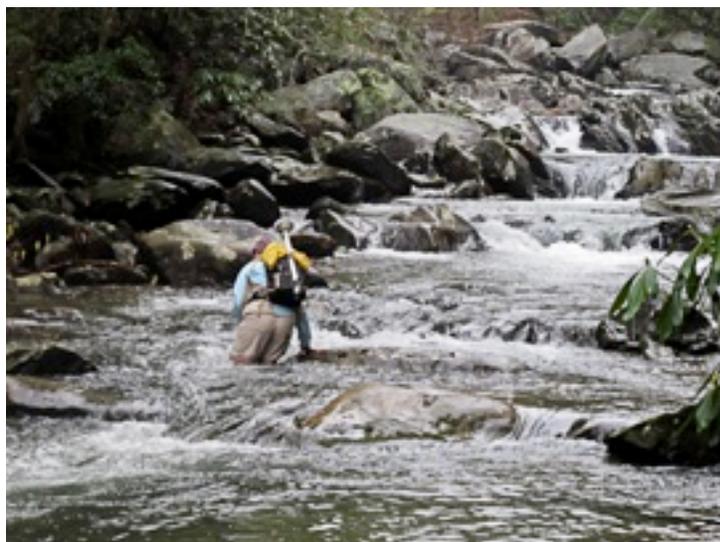
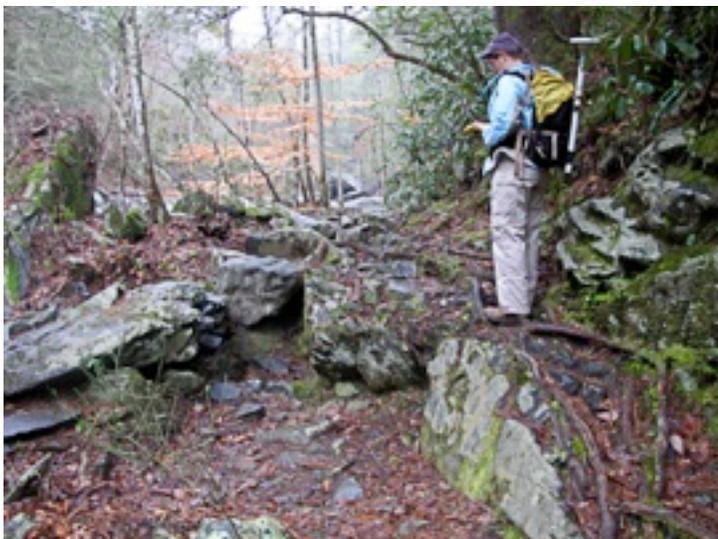
Right: First stream crossing from Trailhead, very deep

Below: Large rock obstacles near Trailhead

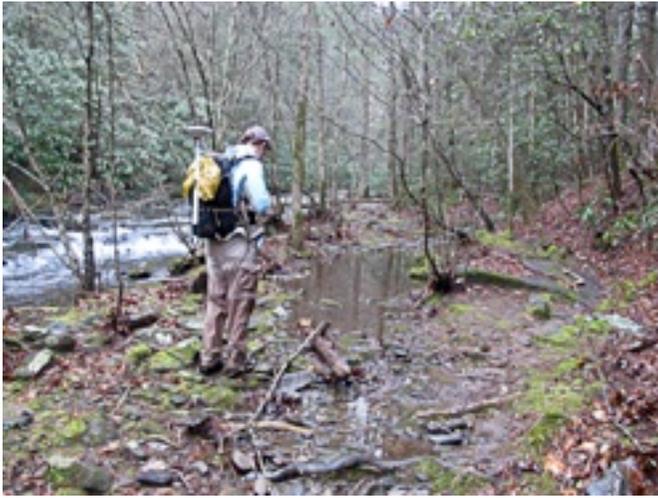
Above and Right: Stream diverted to trail during moderate flow, causing erosion, persistently wet trail conditions, and potential sedimentation to Emery Creek

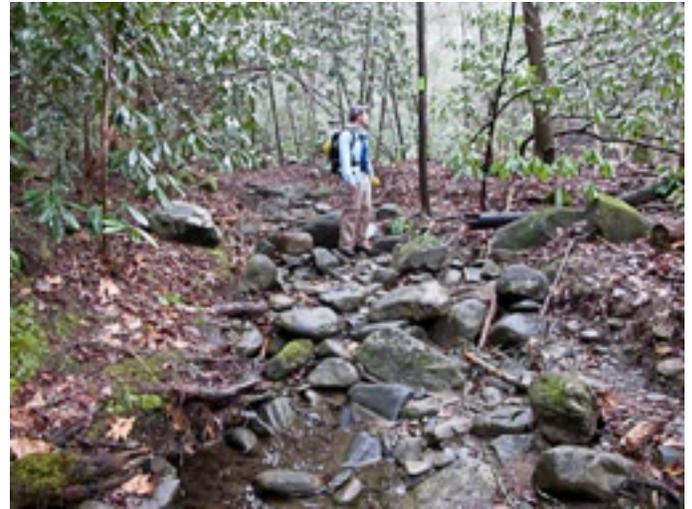
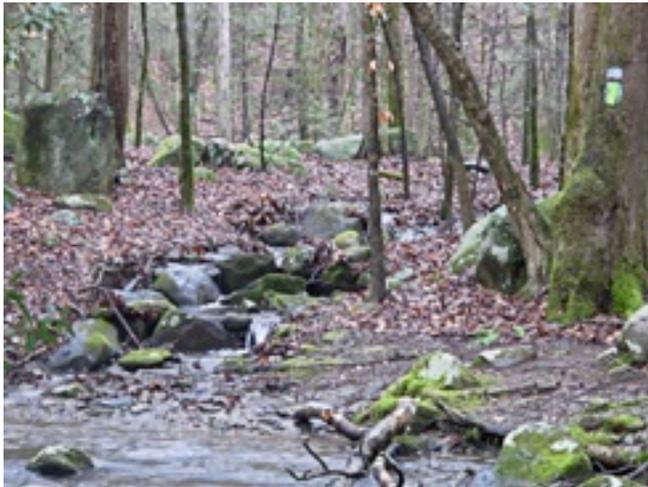
Above: Trail located in channel of intermittent side drainage

Right: Trail entrance at Trailhead parking area. Lack of signage and fencing make determination of trail location difficult. Fall line social trails to Creek in multiple

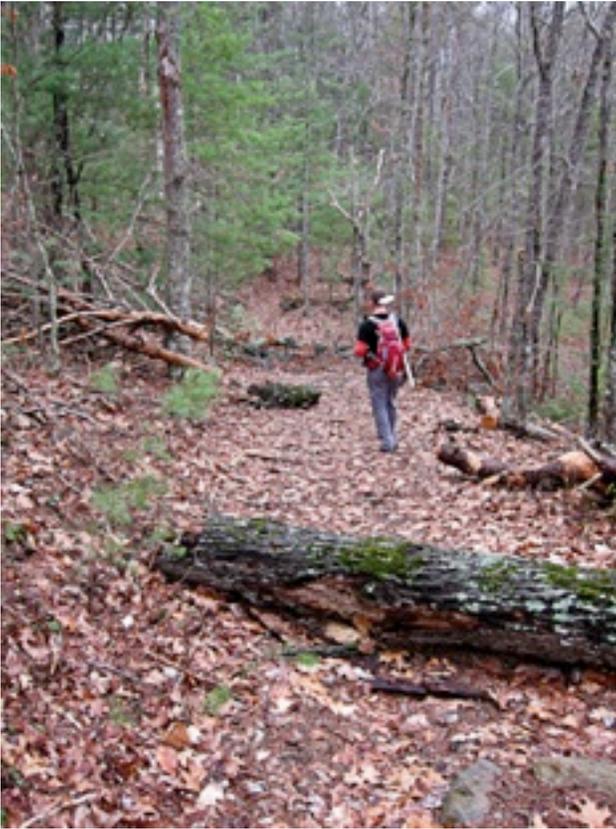
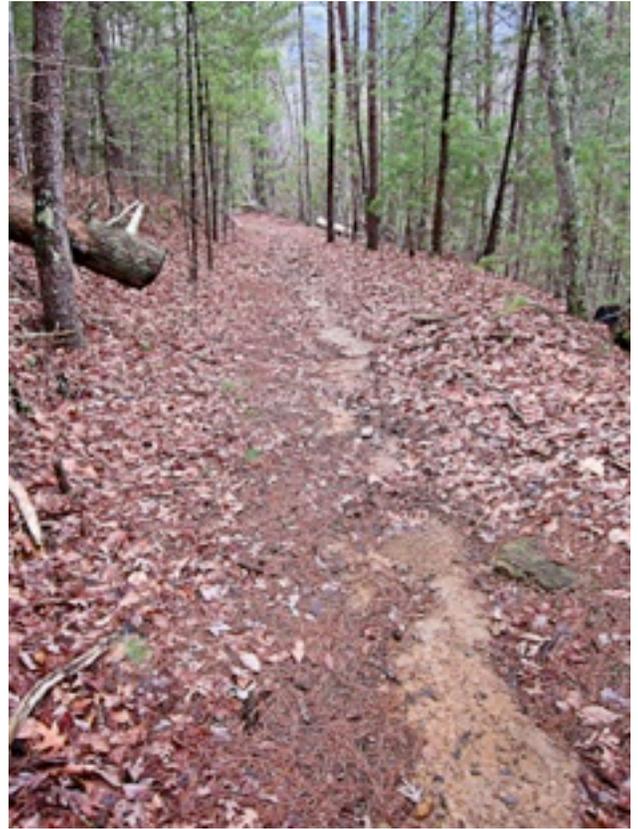
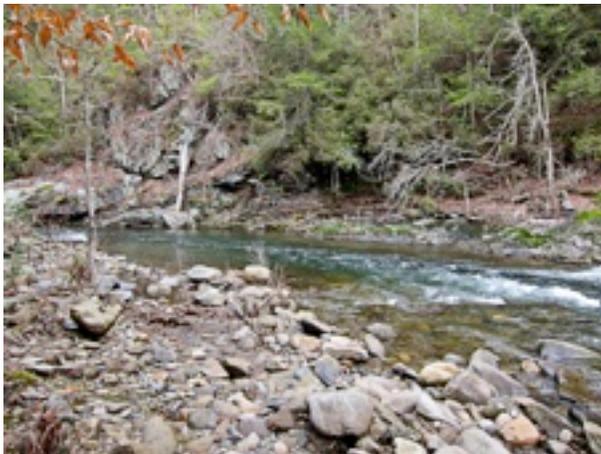
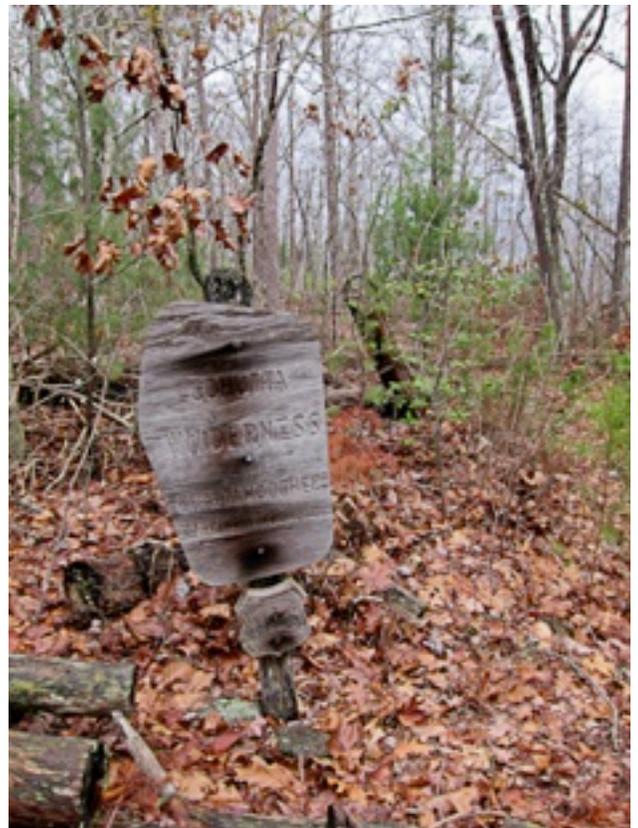
Above Left and Right: The upper portion of the trail is on an old road bed. Water runs freely along the tread removing organic litter and soil.

Left and Above: The lower portion of the trail is in the stream draw and at 60%+ grade

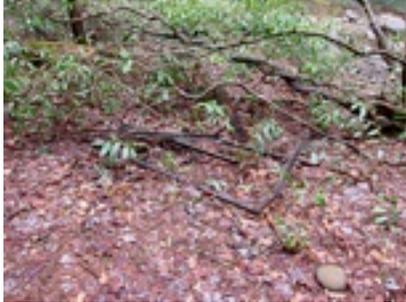
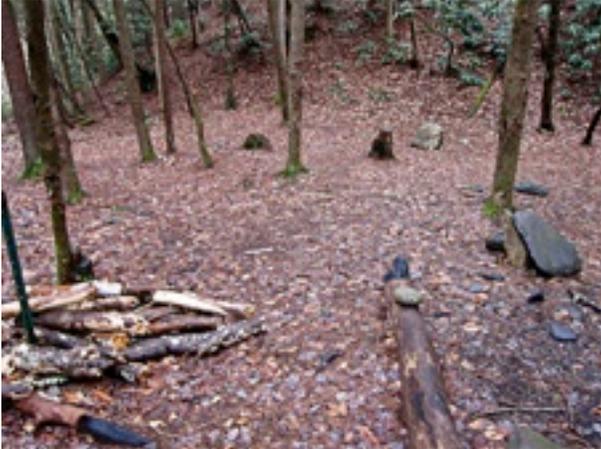
Right and Below: Bedframes at the campsite. Metal signage and wood pile at the campsite

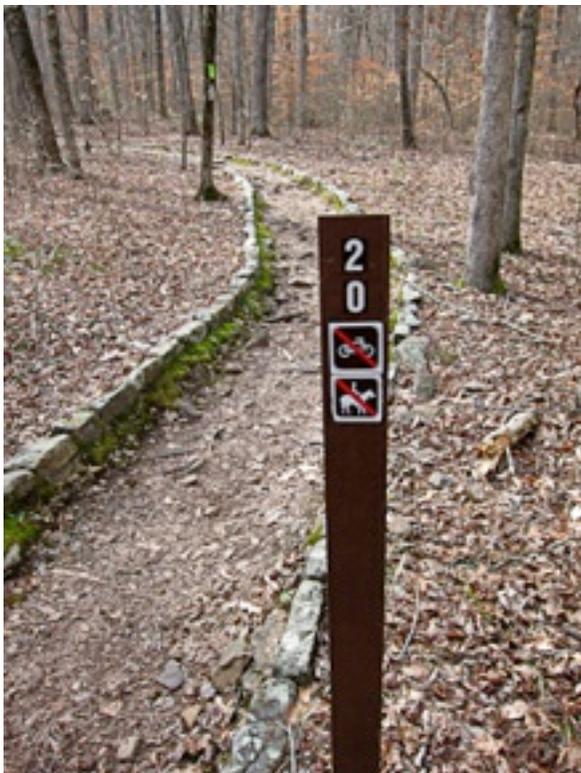
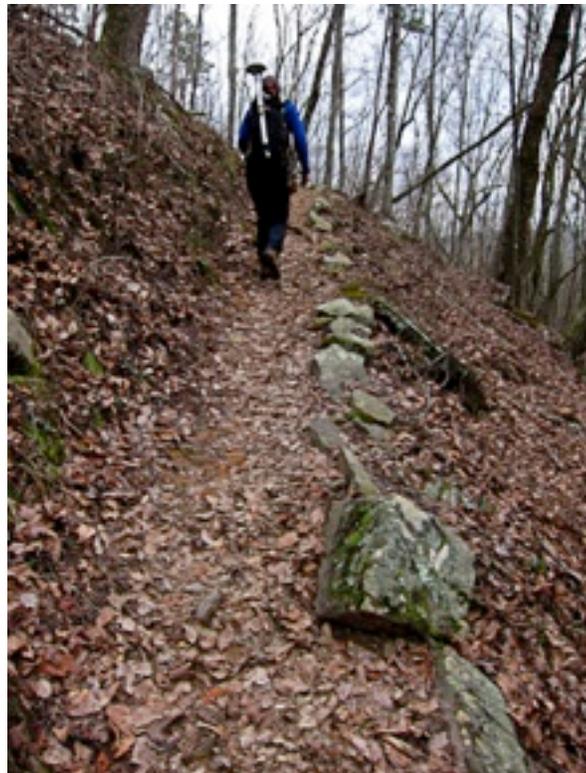
Above Left: Keown Falls trails starts with a narrow rock lined tread, making water management difficult.

Above Right: Steep grades take visitors up to the overlook from the stream valley.

Priorities	<p>High- Improve signage</p> <p>High- Downgrade trail to Class 3</p> <p>High- Reconstruct trail to meet Class 3 design parameters with improved and widened tread, relocations to decrease grade, and more durable structures</p> <p>Medium- Improve steps to overlook</p> <p>Medium- Consider decommissioning loop portion of trail to best use resources</p>

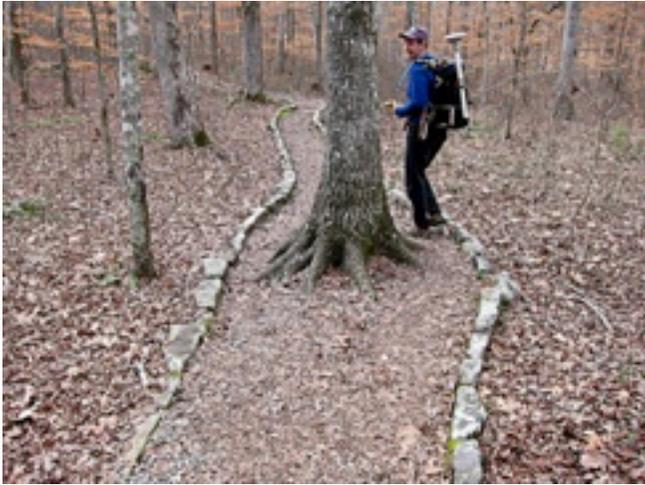
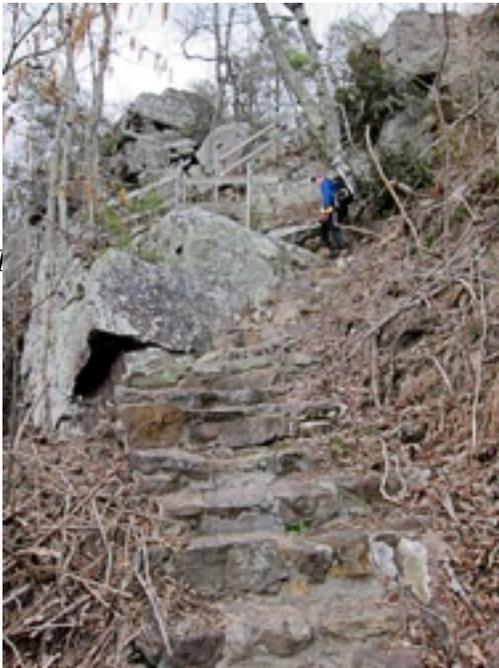
Clockwise from upper left: A tree in the middle of the rock lined trail. 2-way traffic challenging

Switchback issues on Keown Falls trail- shortcutting and erosion present on all turns.

Foundation "re-use" and a brand new viewing platform atop Keown Falls.

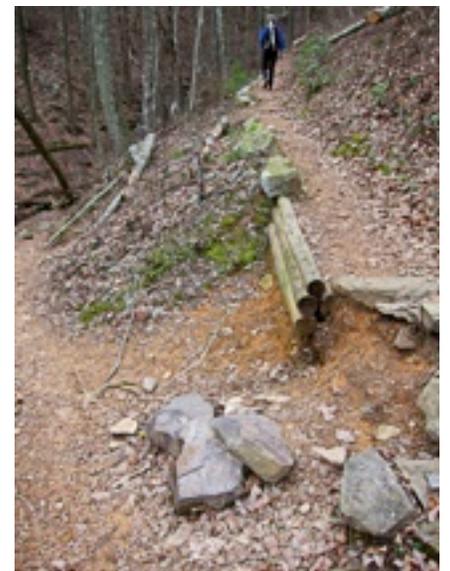
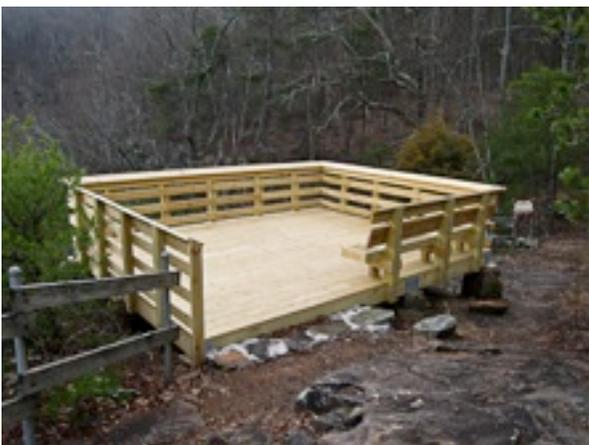
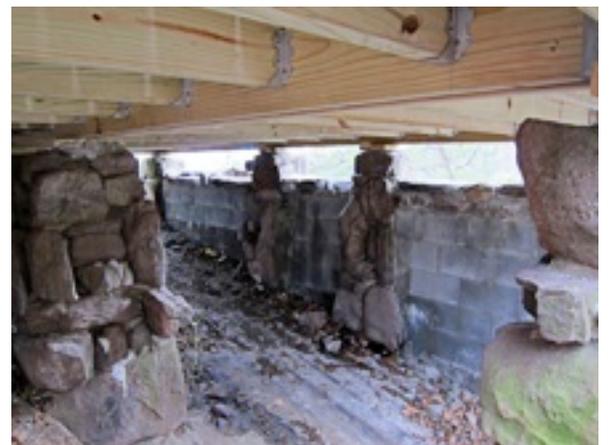
Steep and irregular steps meet visitors at the top of the trail.

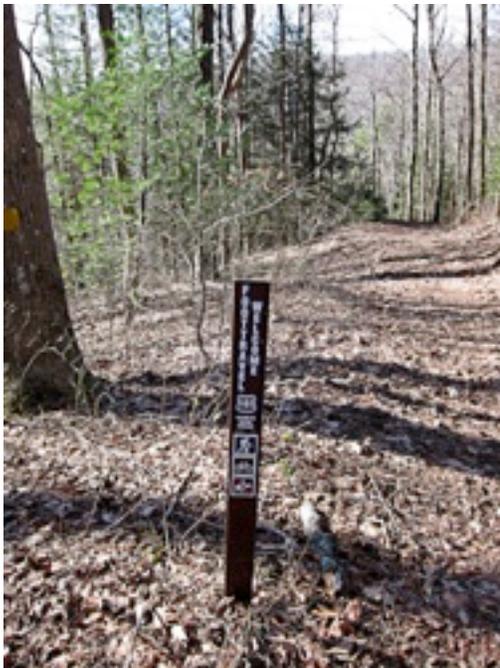
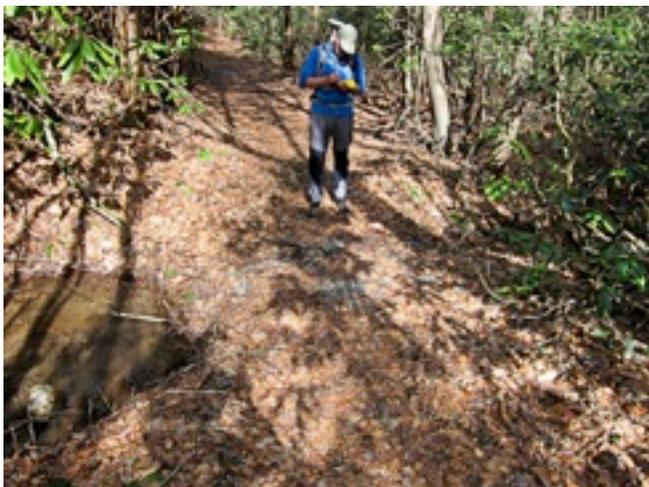
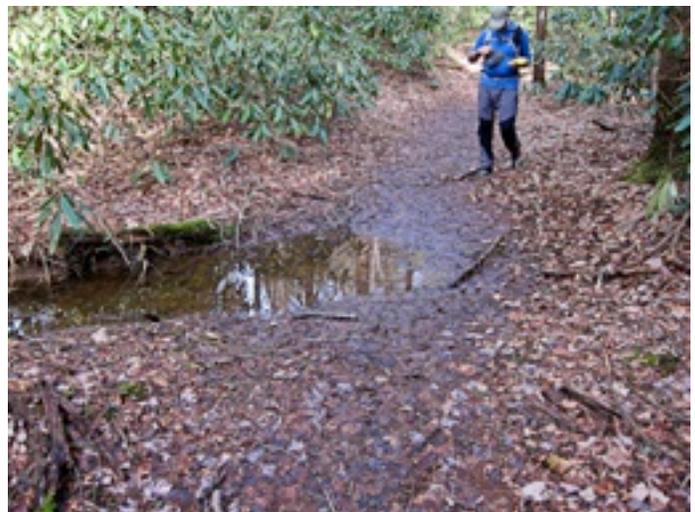
Top Left and Right: Mountaintown Creek trail is located almost entirely on an old road bed.

Above Left: The upper section has steep grades, yet ample water management and the tread is in good shape.

Above Right: After the initial steep descent, the trail parallels the creek. Leadoff ditches have riprap and sediment traps to capture any loose sediments during rain events

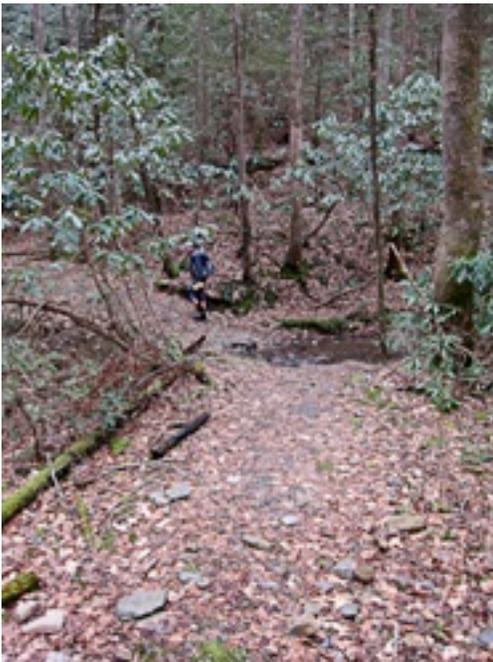
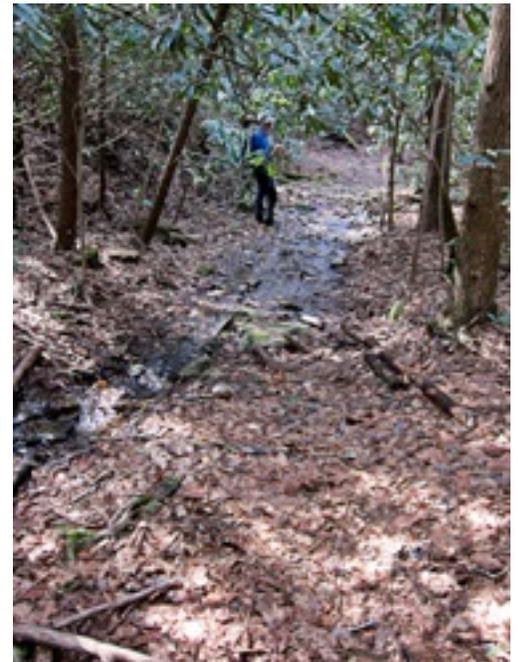
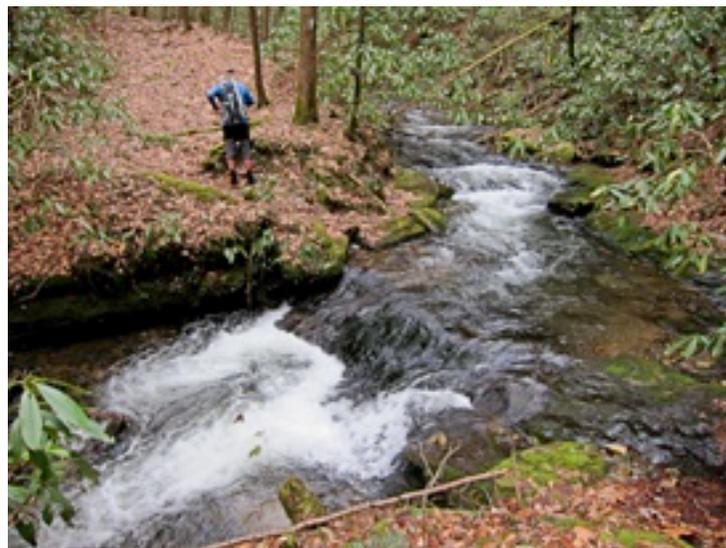
Above: Recent maintenance has provided hardened crossings at most stream fords.

Left and Right: The trails shows little evidence of use. Side drainages complicate water management in the gorge section of the trail.

Below: Stream crossing locations best at riffle areas where water volume and power is dispersed

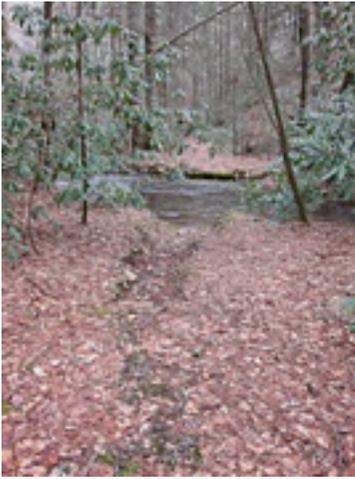
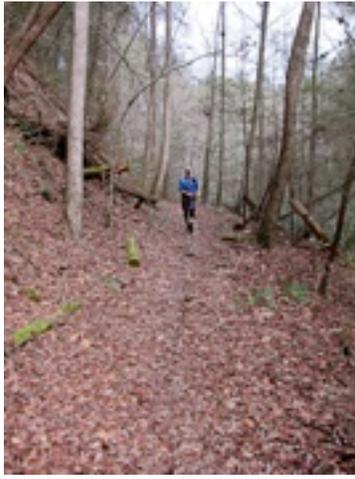
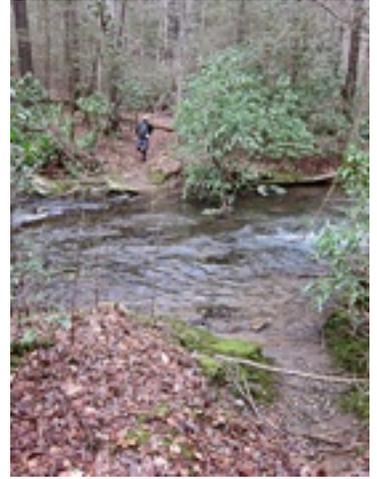
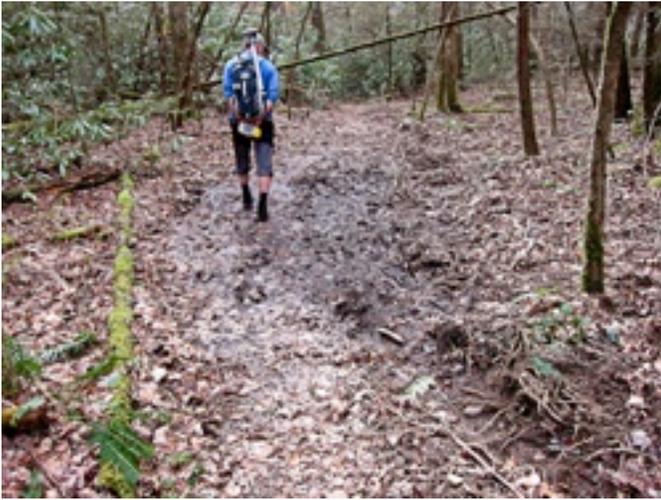
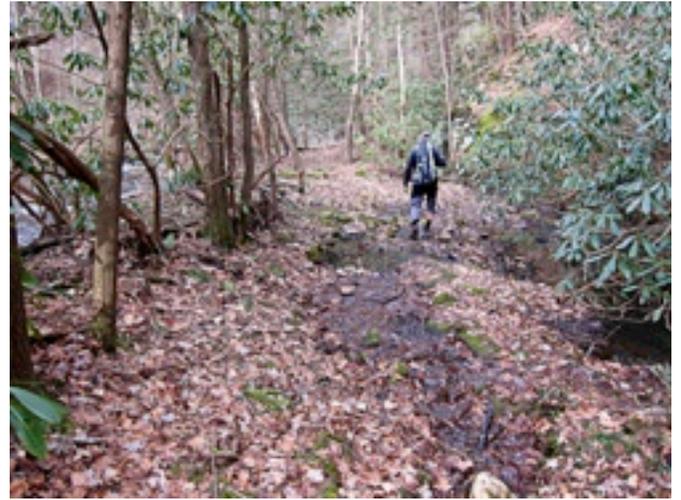
Below the junction with Pinhoti trail, trail conditions drop off rapidly. Crossings are wider on this section and lack armored approaches. Muddy conditions are present and downed trees are prevalent across the trail corridor, and active sediment deposition in the creek was observed

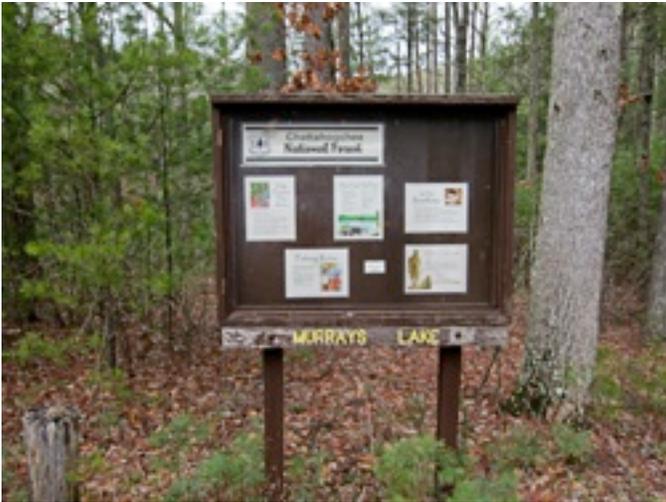
Above Left: Trailhead kiosk

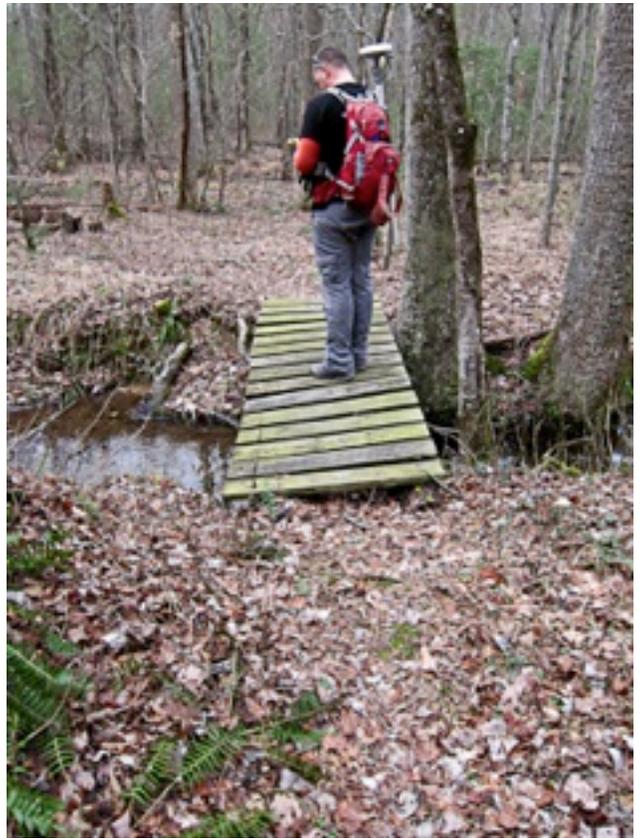
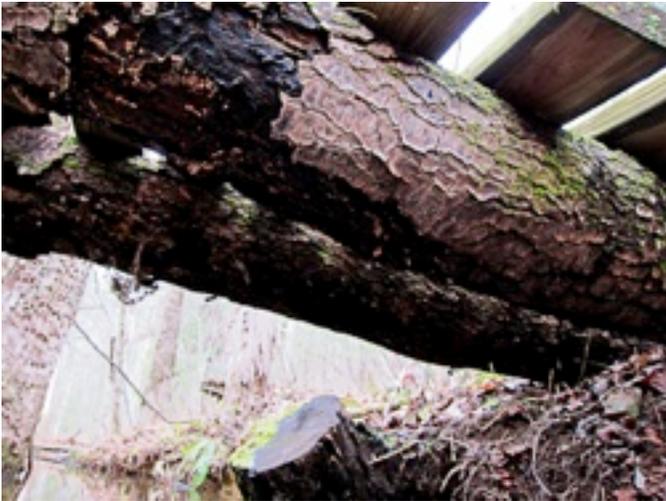
Above and Left: Deteriorating bridge conditions and lack of sufficient engineering

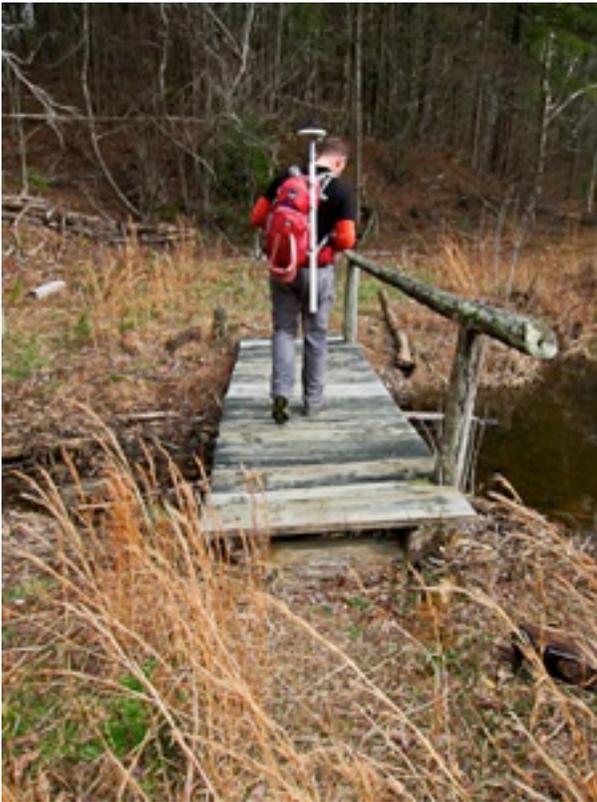
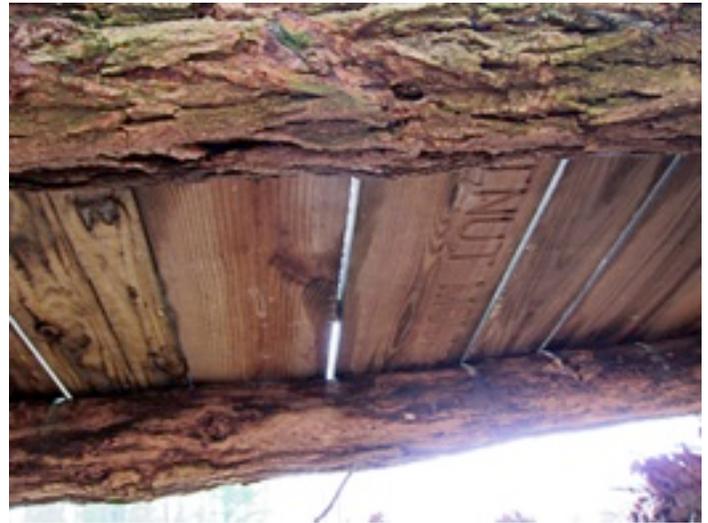
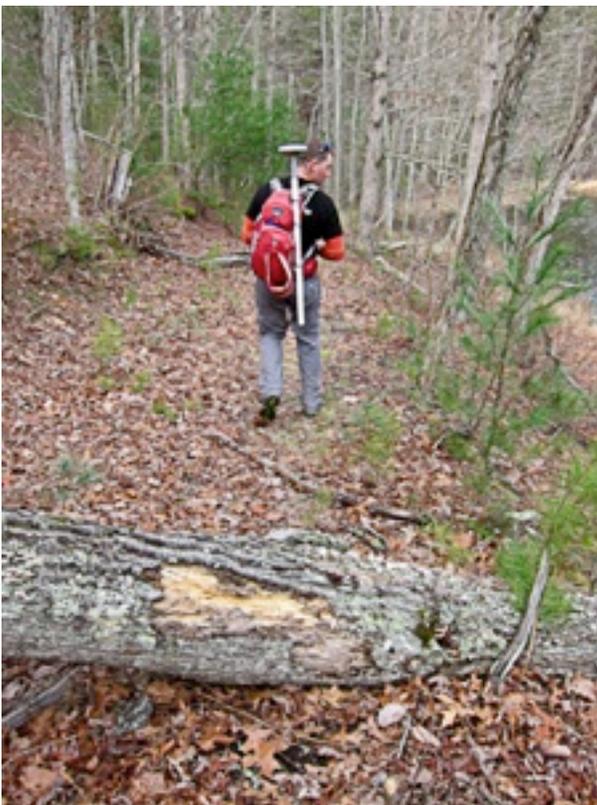
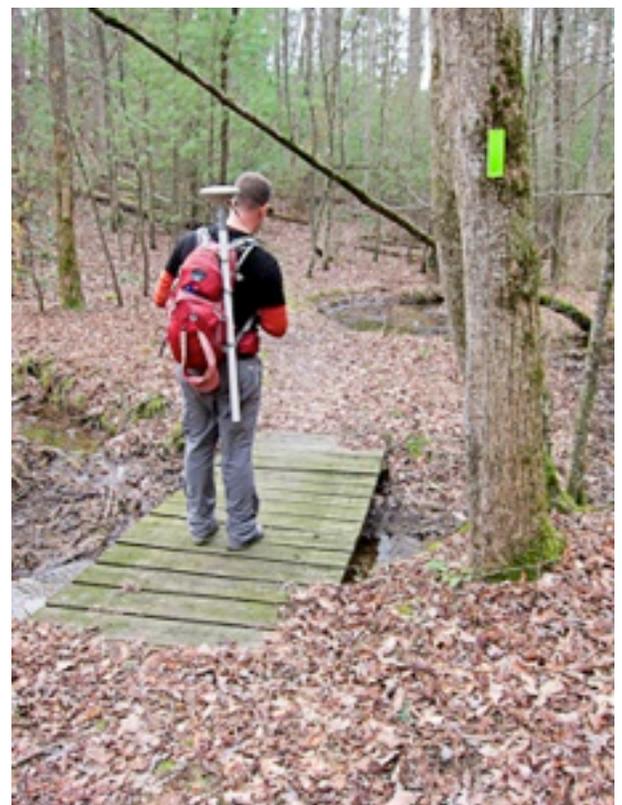
Additional bridges along the trail route that are in need of repair/removal and higher level of engineering. Trail seems to see little use, with many downed trees across the trail corridor and hazard trees capable of falling in the near future

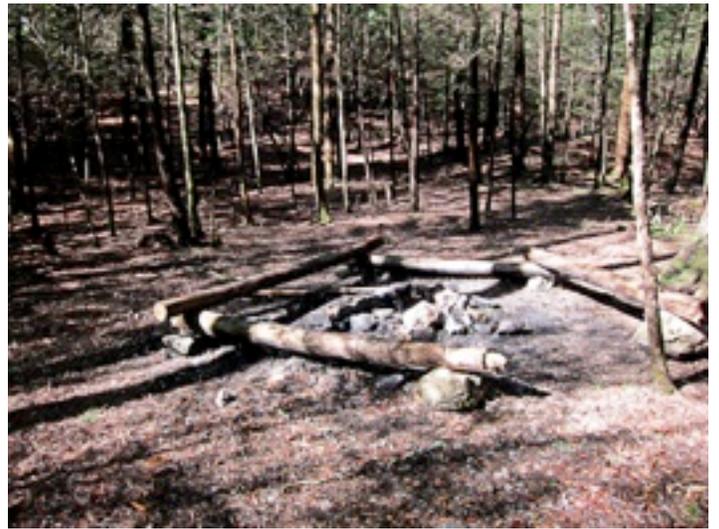
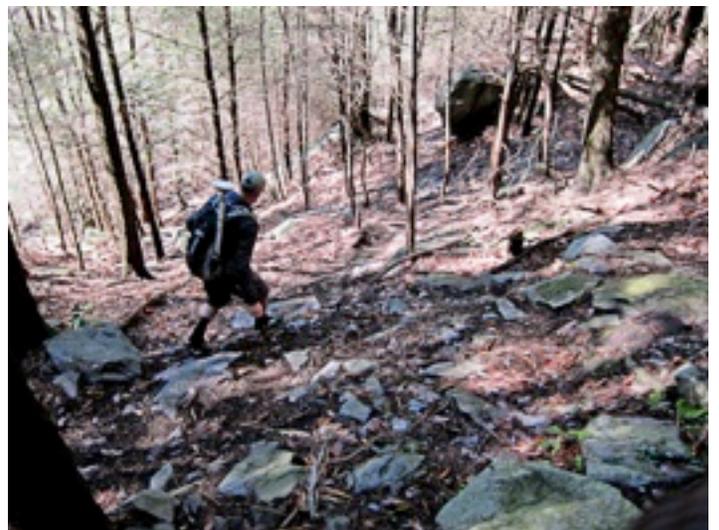
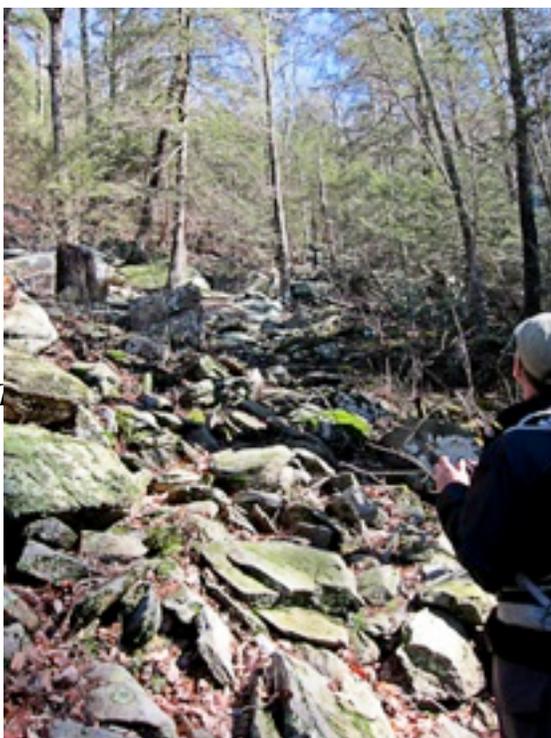
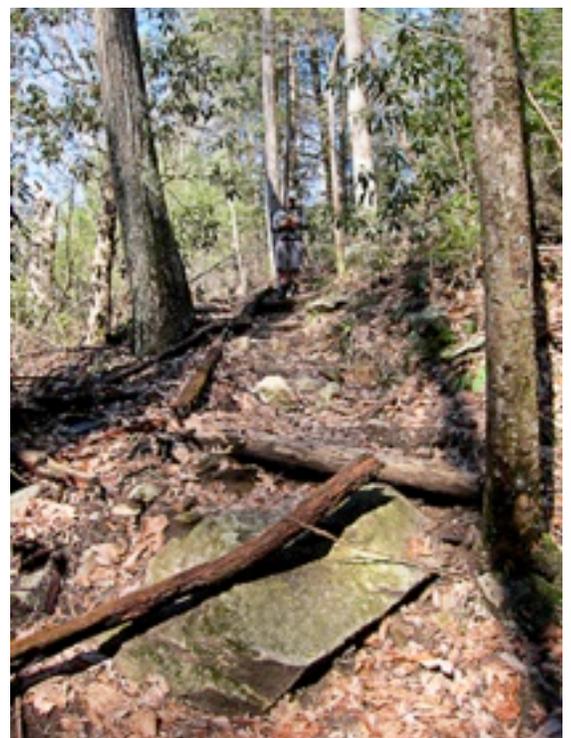
Below and Right: Below the falls, the trail steepens and becomes a rock scramble

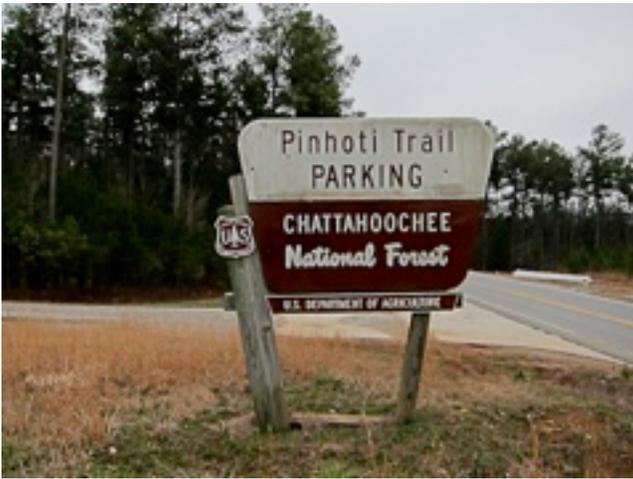
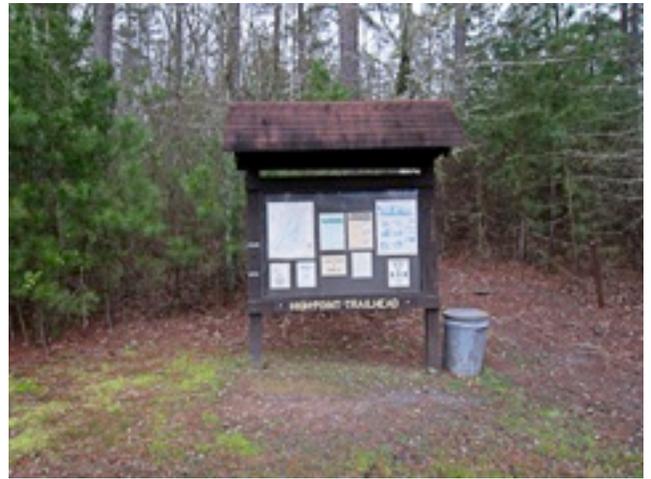
Above Left and Right: Pinhoti Trailhead and Kiosk

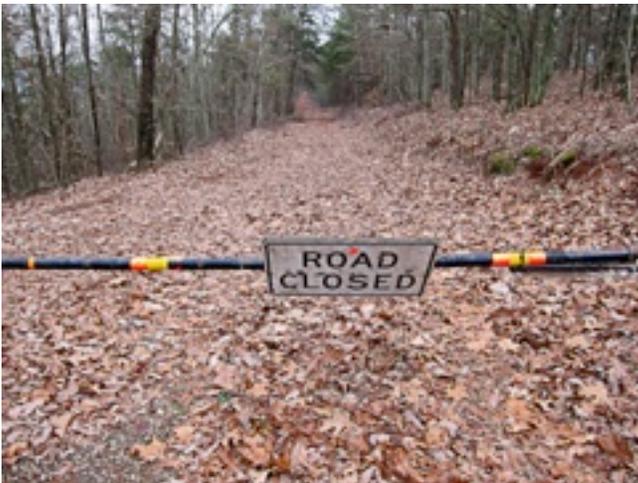
Left: Much of the Pinhoti is co-located with existing Forest roads

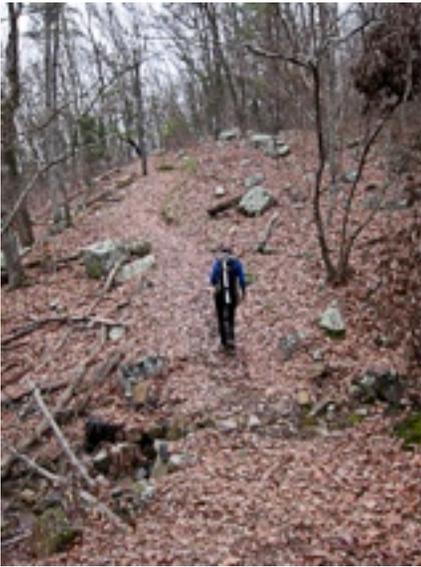
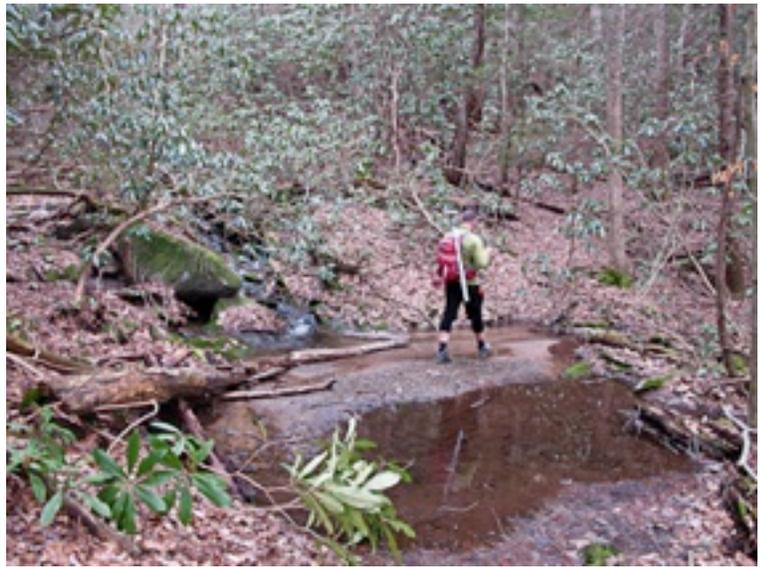
Above and Below Left: Many non-road sections of the trail exceed sustainable grades and have little actual trail construction

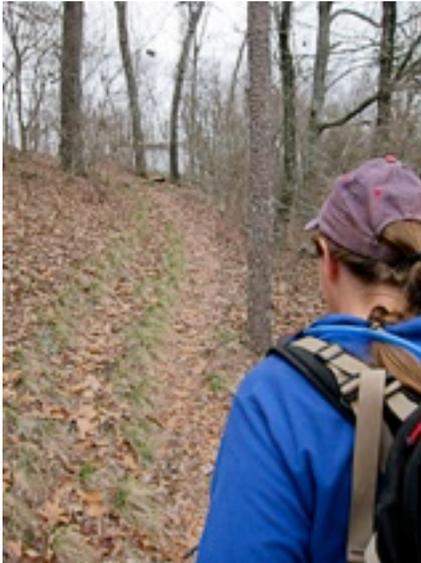
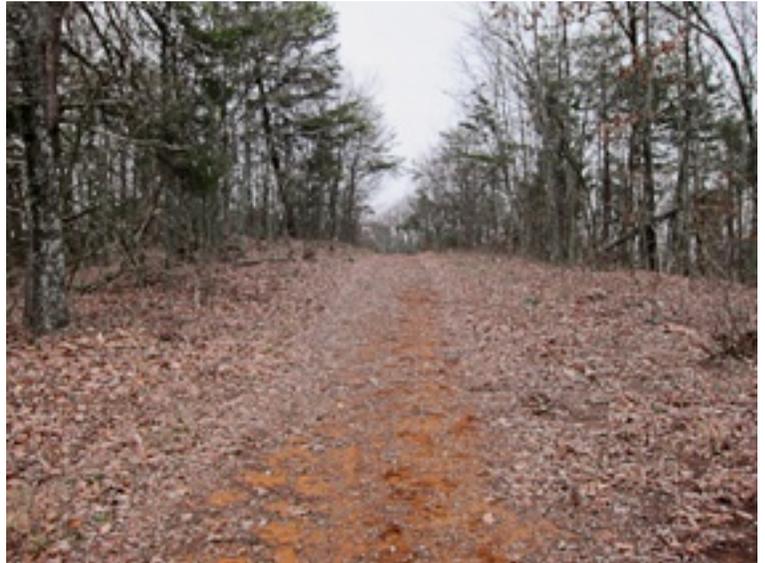
Above Right and Below: The large amount of road-based mileage that is linear in nature detracts from potentially very scenic and enjoyable trail

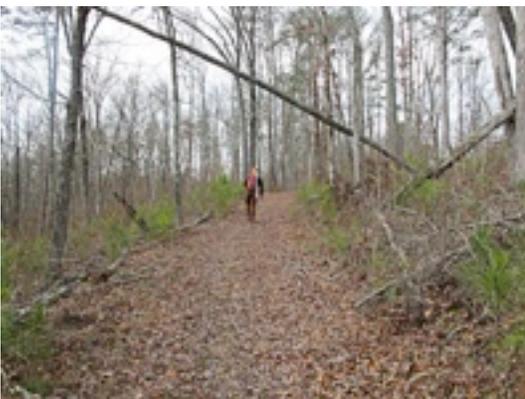
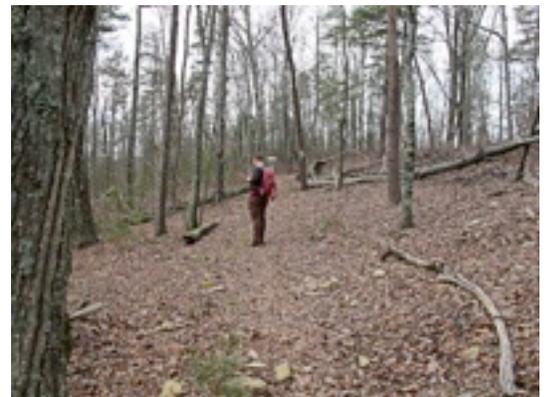
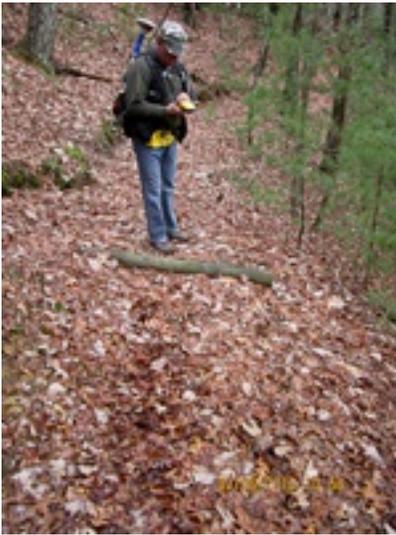
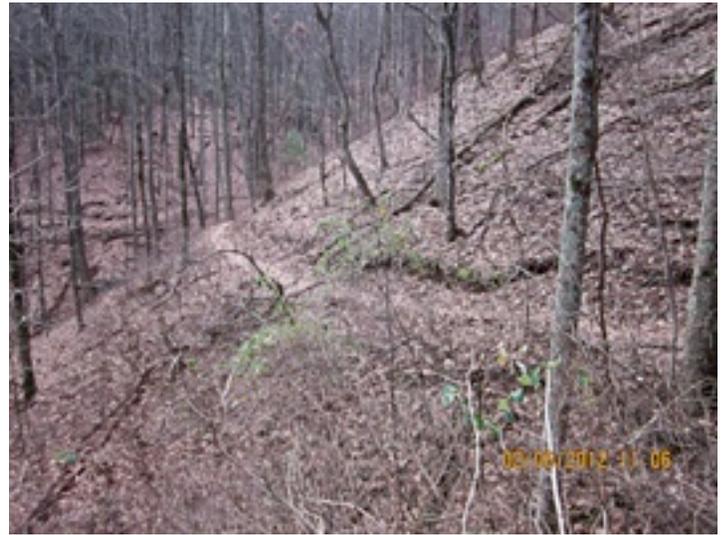
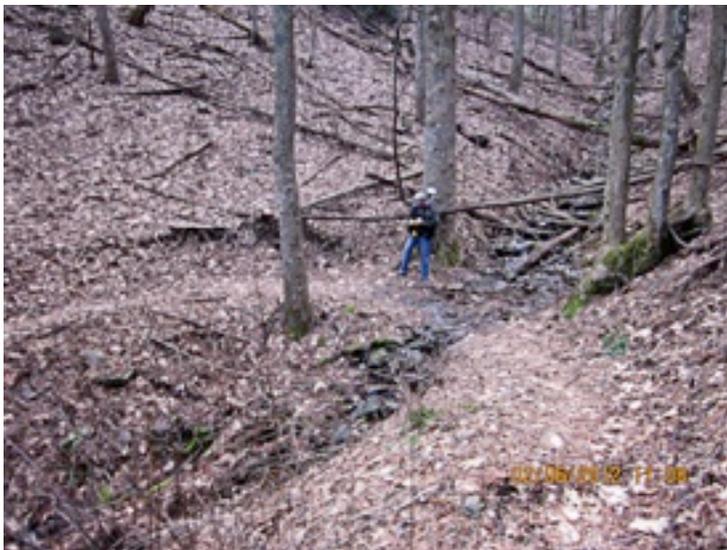
Clockwise from Above: Countour section of trail sustainably routed through a drainage. Trail users route around the left of the water bar, allowing drainage to continue down the trail tread. Contour section of trail in a steep sidehill location manages trail users, water, and provides an intimate recreational experience. Trail routed above a large tree provides a visual “anchor” that adds interest and confines the trail to a narrow corridor. Road-based portion of the Pinhoti that provides a stark contrast in recreation quality relative to the other photos on this section of the trail.

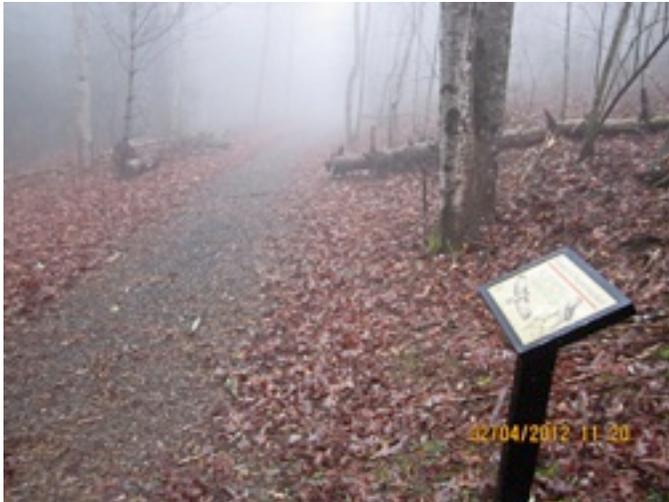
Above: Trail begins on old road bed before narrowing down to 24" tread

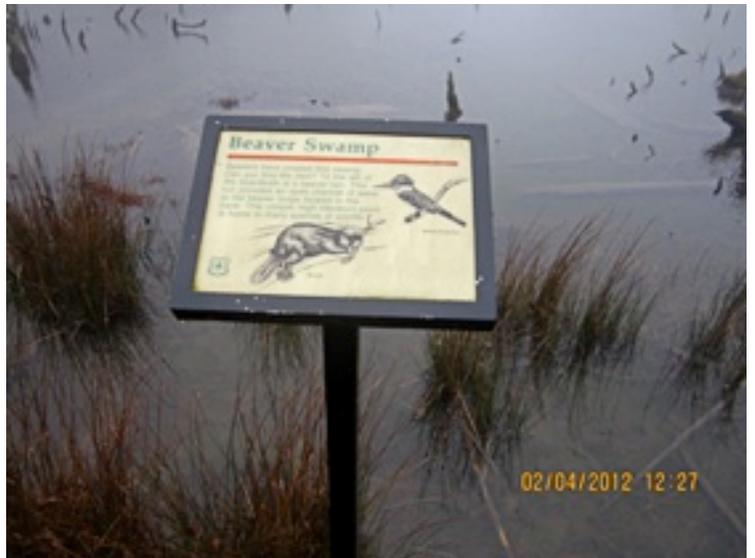
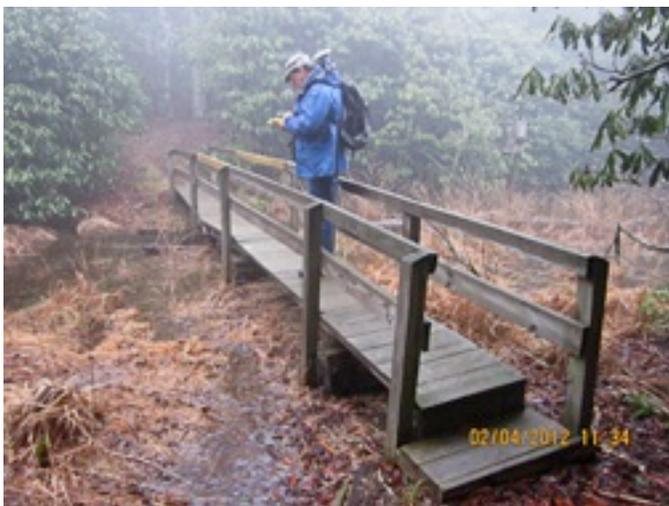
Below: One of many bridges present along trail route

Top Left: Failing bridge

Left: Large, deep hole near on trail near bridge posed hazardous condition

Priorities	High- bridges and wood structures are under-designed and -built (too narrow, need more handrail etc) and many are currently failing, creating significant risk management concerns that need to be addressed immediately Medium- Make accessibility improvements in tread and structure width, and tread firmness
