FOREST-WIDE COLLABORATIVE TRAILS ASSESSMENT

CHATTAHOOCHEE-OCONEE
NATIONAL FOREST

CONASAUGA RANGER DISTRICT

JANUARY- MAY, 2012
CONTRACT #: AG-435H-S-12-0001

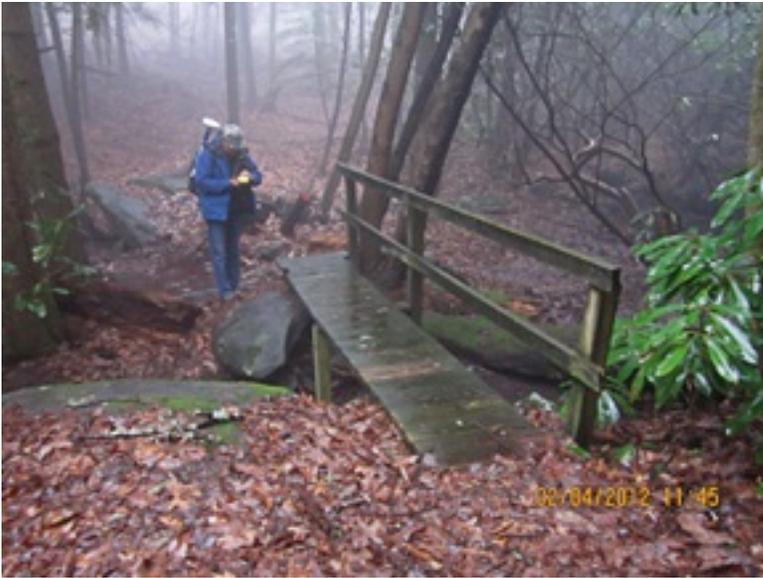
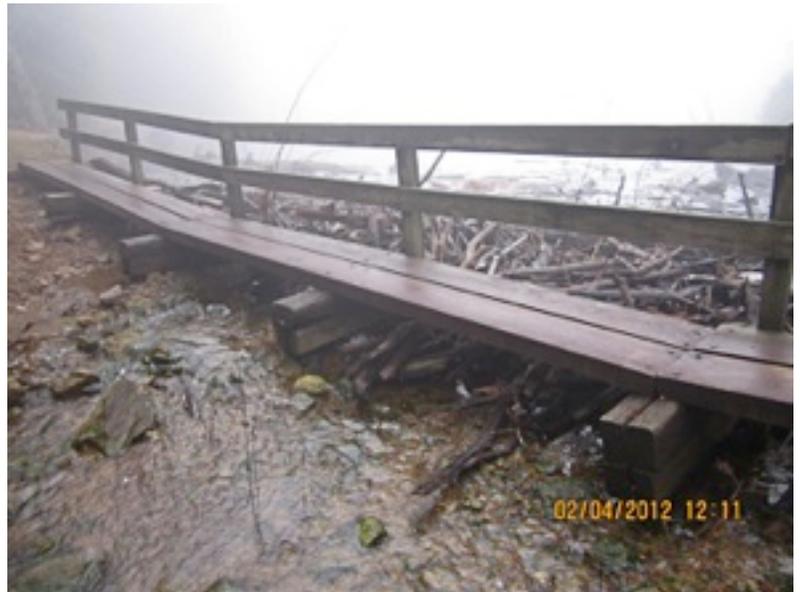
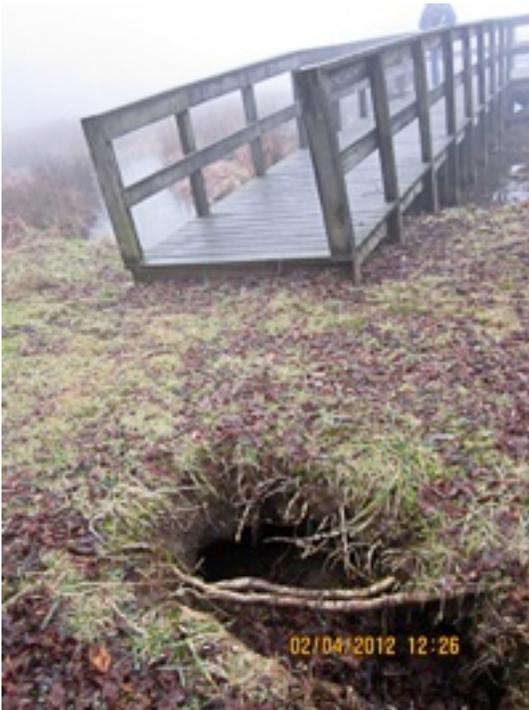
Top Left: Failing bridge

Above: Bridge forming dam with upstream vegetation pile

Left: Large, deep hole near on trail near bridge posed hazardous condition

Priorities	High- bridges and wood structures are under-designed and -built (too narrow, need more handrail etc) and many are currently failing, creating significant risk management concerns that need to be addressed immediately Medium- Make accessibility improvements in tread and structure width, and tread firmness

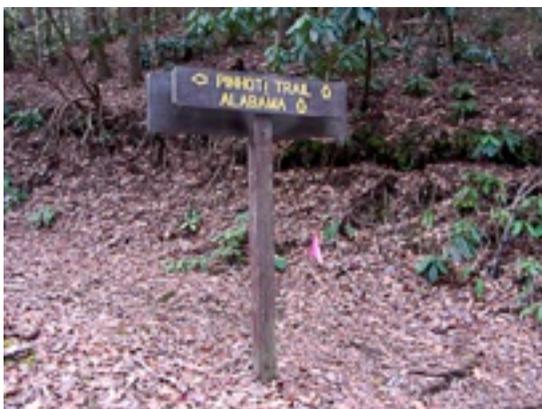
Right: Signage directing trail users to Alabama

Below Right: Stream crossing is not hardened and drainage is not controlled from upstream. Incised old road bed gathers water and directs it to the creek

Below Left: Trail condition under-developed for equestrian use and intersection at stream crossing increases probability of vegetation trampling and sedimentation

Priorities	<p>High- Move trail entrance to junction with FDR 126 on north end, directly connect trail to picnic area on south end, sign intersections along route.</p> <p>High- Institute consistent maintenance of water management and stream crossings</p> <p>High- Maintenance and/or relocations should meet equestrian design parameters and built to withstand that use.</p>

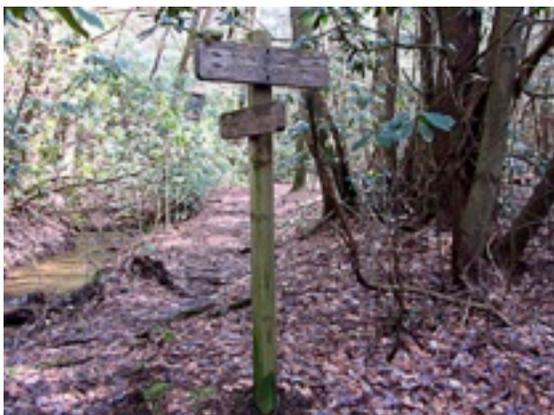
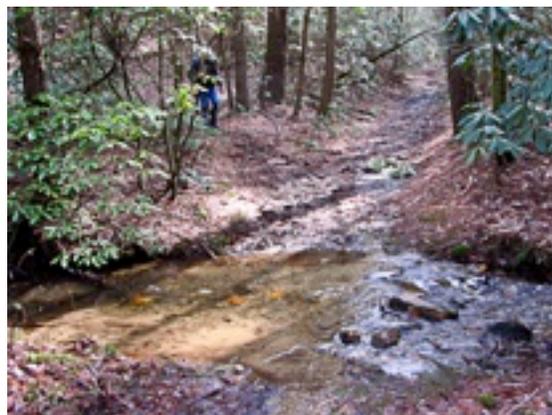
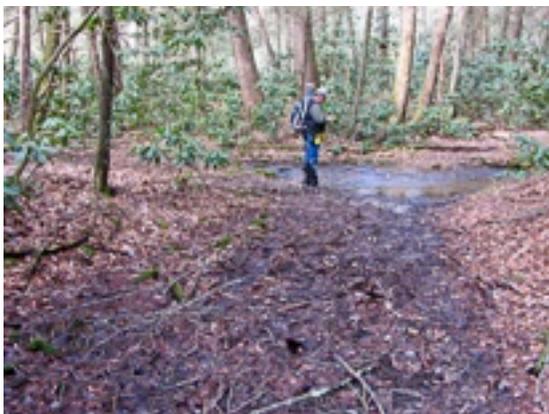
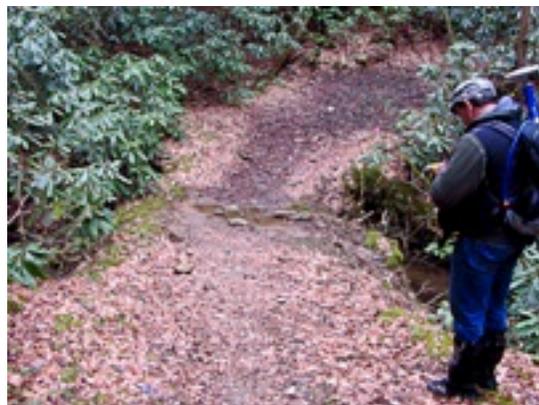
Above Left and Right and Left: Unmanaged drainage leading to flowing water. Lower crossing is hardened at entrance but drainage is not managed leading to crossing

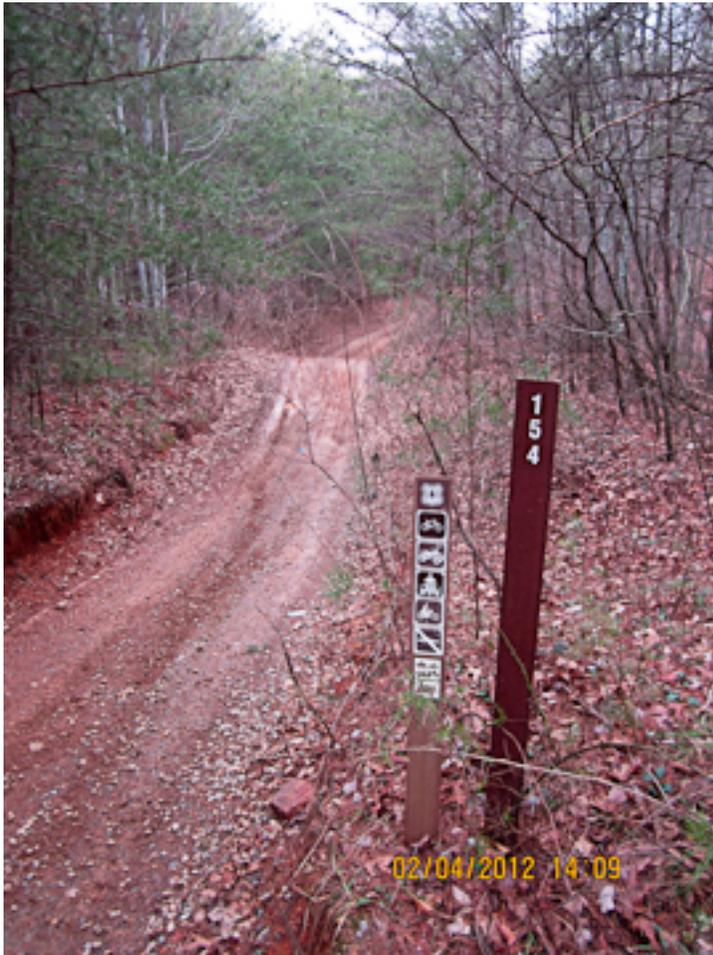
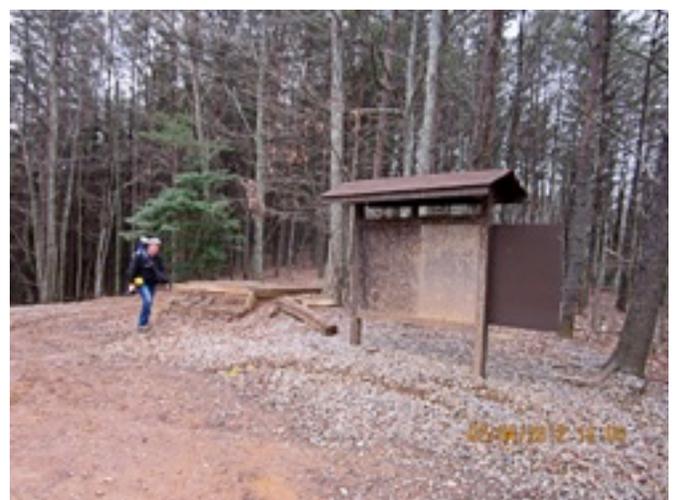
Above: Warning signage for trail difficulty

Below: Trailhead facility with loading ramp and empty kiosk

Clockwise from above: Dip attempts on fall-line trail require increasingly deep excavation upon successive events. Switchback deterioration due to lack of ohv-specific design and construction methods. Side-by-side use demonstrating trail width. Relatively rolling contour road/trail has much greater probability for maintenance success. Regulatory sign restricting atv use on old road that lacks width restrictors.
