# **BIG CREEK WATERSHED ASSESSMENT REPORT**

Prepared for:  
**North Coast Regional Water Quality Control Board**  
**5550 Skylane Blvd., Suite A**  
**Santa Rosa, CA 95403**

Prepared by:  
**The Watershed Research and Training Center**  
**P.O. Box 356**  
**Hayfork, CA 96041**

**July 2008**

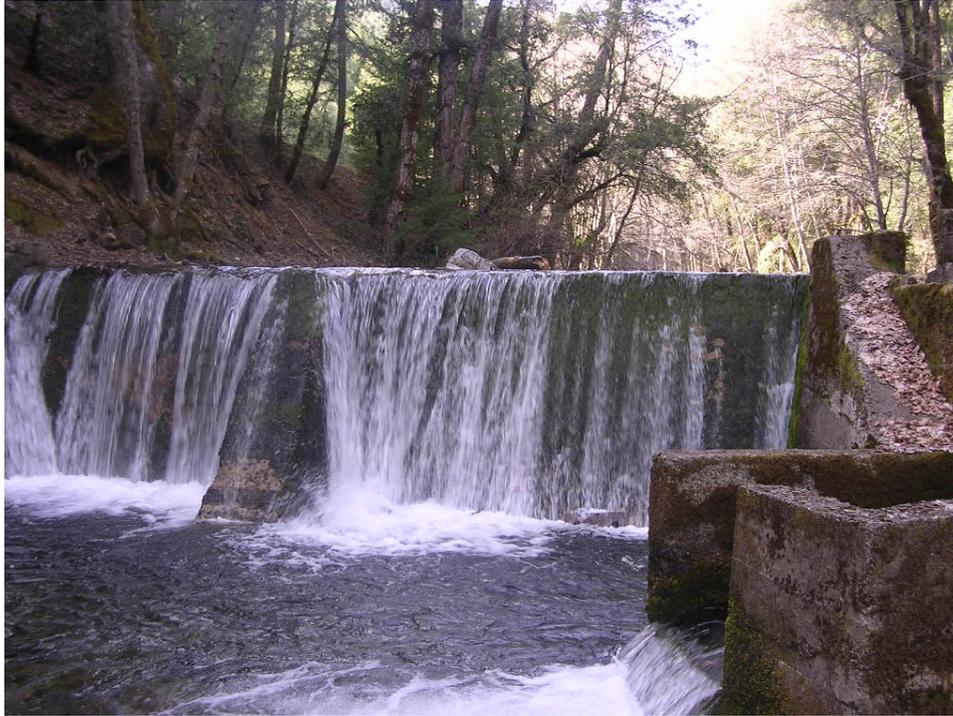
Photo 2-1 Concrete diversion dam along main stem Big Creek. Diversion supplies municipal water supply for town of Hayfork and agricultural irrigation.

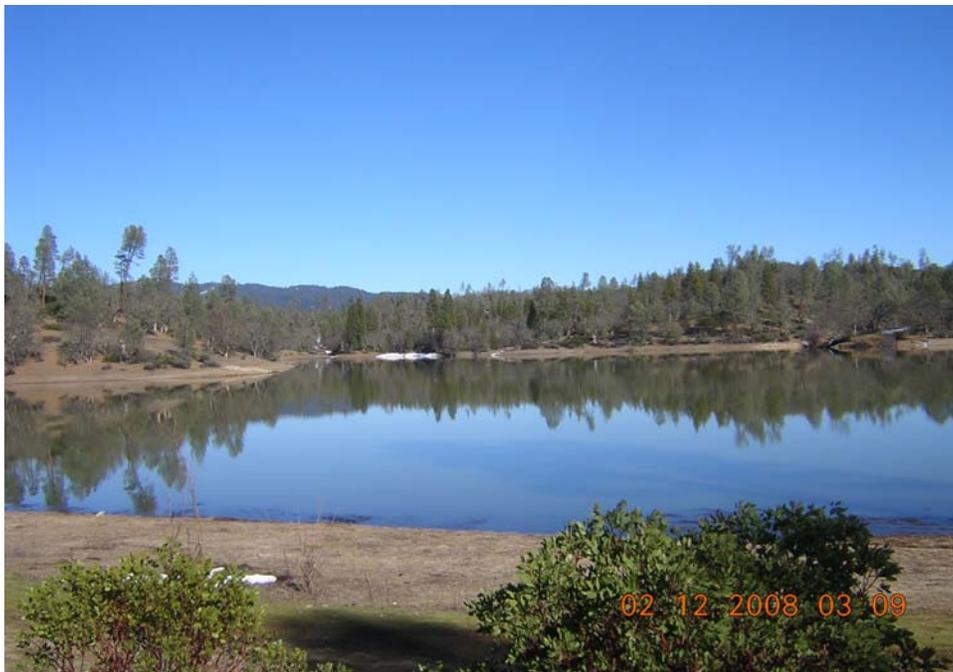
Photo 2-2 Ewing Reservoir located approximately one mile north of the community of Hayfork, California. The reservoir provides 820 acre-feet of water storage for approximately 2,450 users.

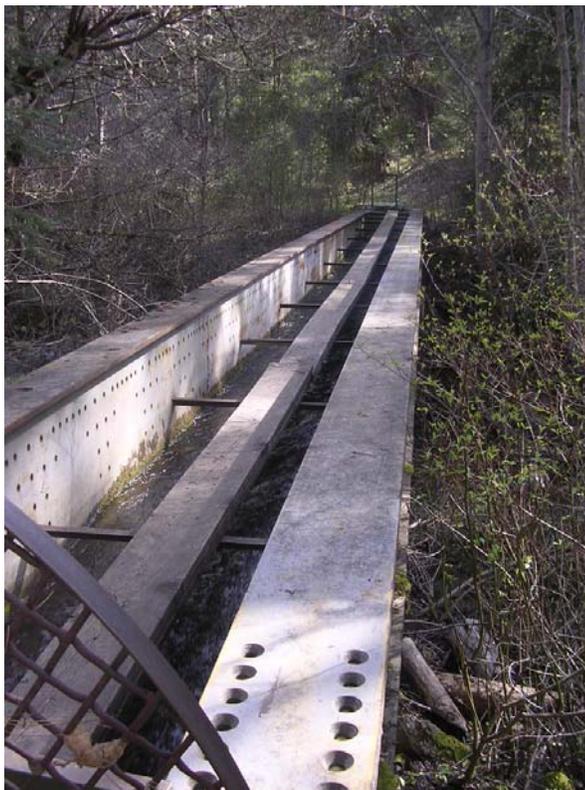
Photo 2-3 Water flume over Big Creek that delivers water from diversion site to Ewing Reservoir 2.5 miles to the southwest.

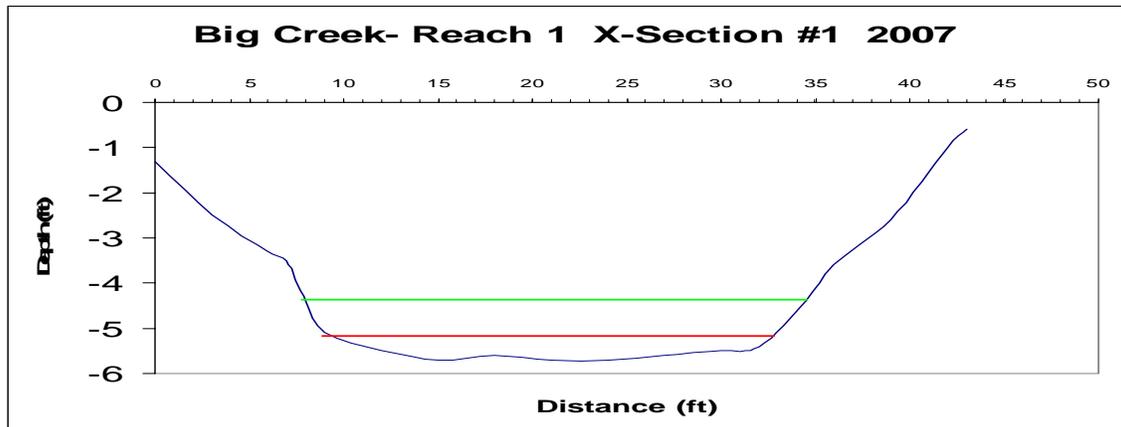
Figure 5-6.

**Figures 5-6 and 5-7** are the three permanent cross sections placed in Big Creek. Stakes were placed on both banks, at equal height, above the flood plain. Readings were taken from left bank, looking downstream, to right bank at appropriate intervals to characterize the stream. Waters edge (red) and bank full (green) are noted.

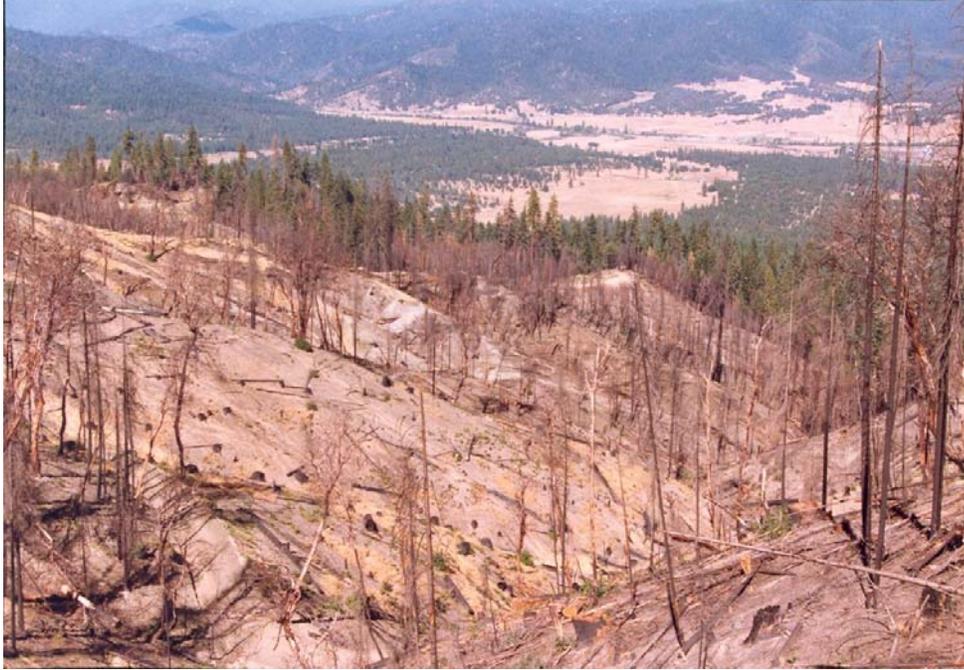
Photo 6-1. Mixed-conifer forest burned by high severity fire in 1987.  
Community of Hayfork can be seen top right of photo.  
(Image courtesy of Dick and Lonnie Jessee)

Wildfire poses a significant risk to human health and property. Historic fires in 1987 threatened the community of Hayfork and surrounding private property (Photo 6-1 and 6-2). More recently, the Hyampom Fire (2001) burned hundreds of acres and threatened to destroy homes to the north of Hayfork. Wildfires in neighboring communities of Trinity County, including the Lowden Fire (1999) in Lewiston, California and the Oregon Fire (2001) near Weaverville, California have seen wildfire destroy millions of dollars worth of private property, including timber resources. These losses are both economic and

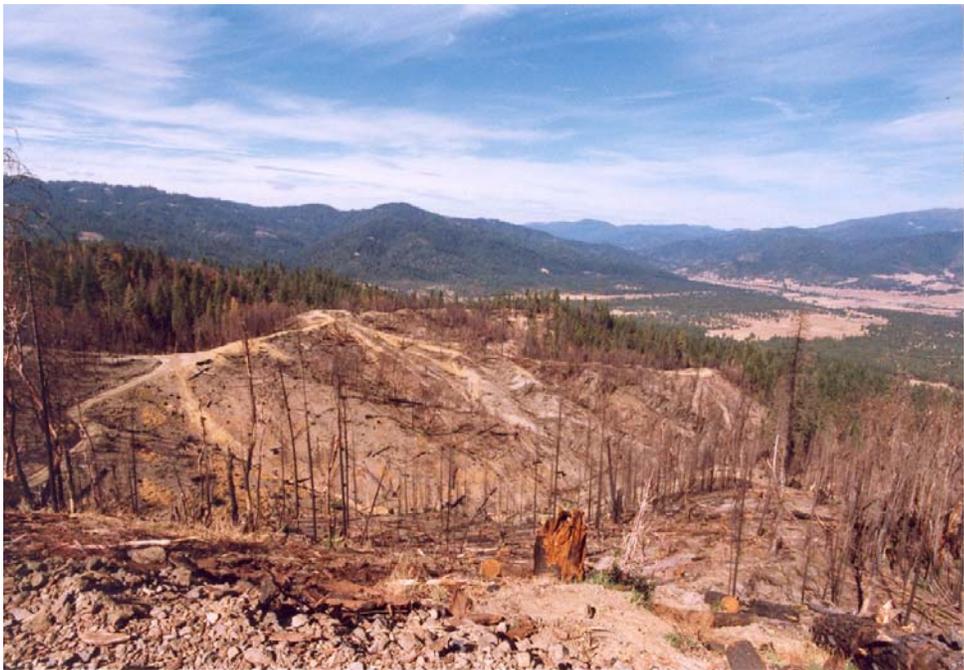
Photo 6-2. Areas that experienced intense, high severity fire may have contributed large amounts of sediment to tributary streams of Hayfork Creek. (Image courtesy of Dick and Lonnie Jessee)

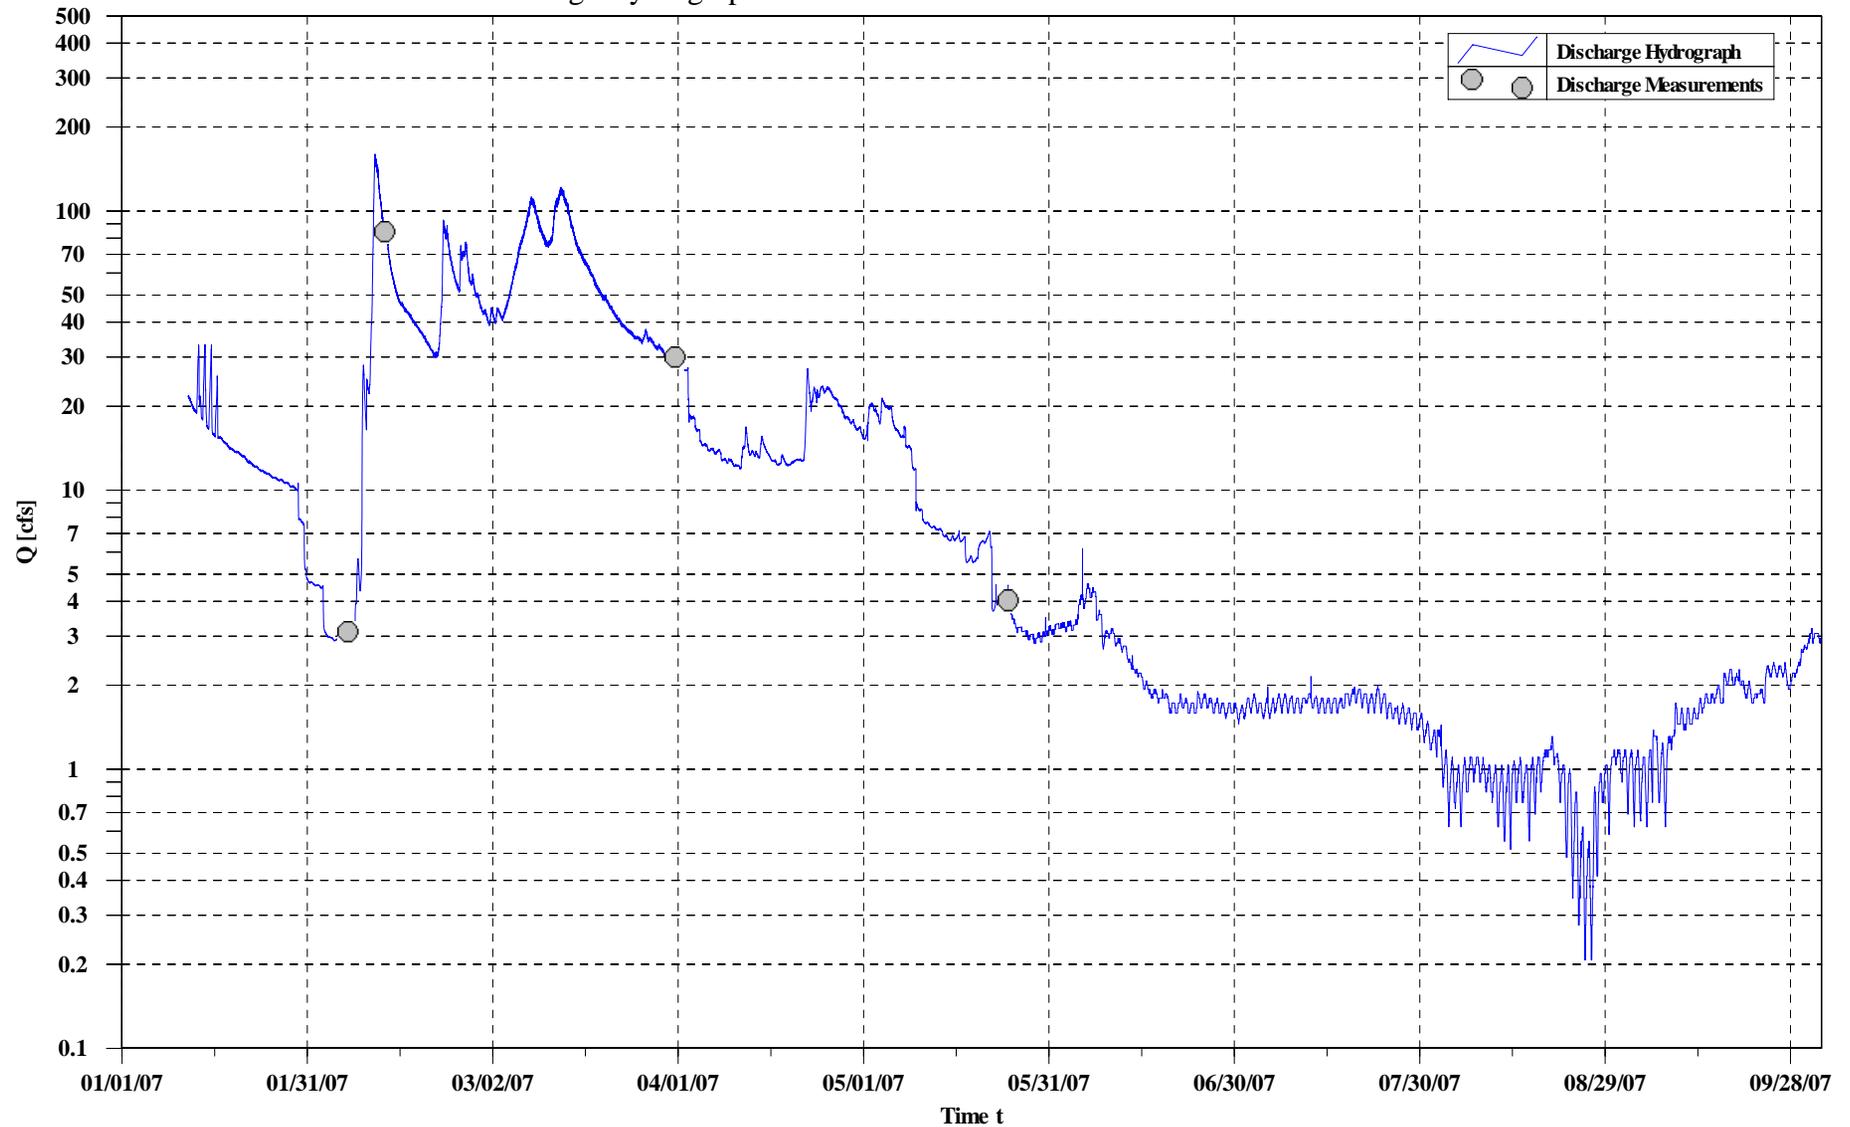
**BIG CREEK AT HWY 3 NR HAYFORK, CA – 11528440**  
 Discharge Hydrograph with Measurements – Partial Water Year 2007
