11-PA-11090700-044

Assessment and Management of Eurasian Watermilfoil on Crooked Lake and Duck Lake

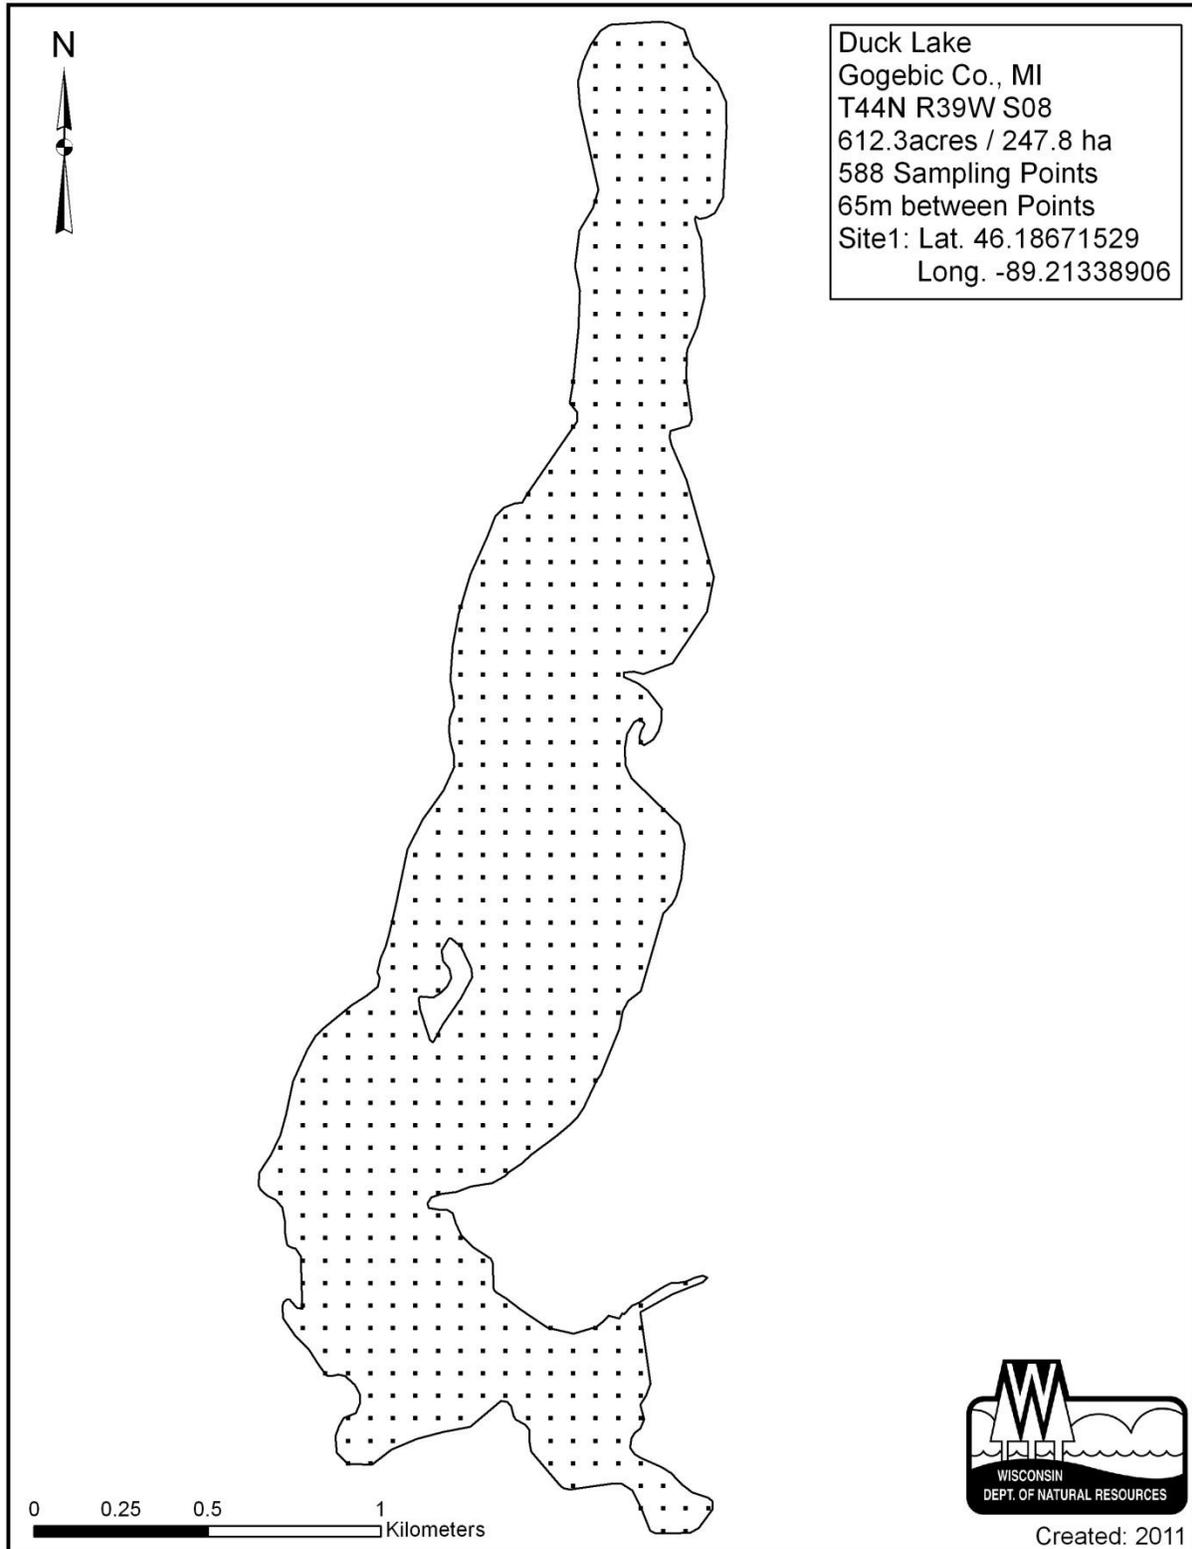
Figure 1: Duck Lake sampling grid

Specifically this survey followed the state of Wisconsin's Aquatic Plant monitoring and point intercept surveying protocol (<http://www.uwsp.edu/cnr/uwexplakes/ecology/APM/PI-Protocol-2010.pdf>). Crooked Lake had a total of 839 sampling points with a resolution of 55 meters, whereas Duck Lake had a total of 588 sampling points with a resolution of 65 meters (Figures: 1 & 2). On Duck Lake a Crestliner 1860 modified "v" hull boat was used equipped a Lowerance depth finder, Garmin 78CSx handheld GPS, a surveying throw rake on a 30 foot rope and a 15 foot surveying rod. On Crooked Lake a Sylvan 1436 Jon boat was used with a Motorguide

The GPS was used to navigate the boat to each sampling site, once the site was reached the depth was recorded. The depth determined whether the site was shallower or deeper than the maximum rooting depth of aquatic vegetation for that particular lake. If it was shallower than the maximum rooting depth, a rake was dropped to collect a aquatic plant sample and determine the sediment type. The aquatic plant sample was given a overall relative abundance rating and each species on the rake was identified and given an individual abundance rating. This procedure was repeated for each sampling point. In addition to systematically sampling at each point, additional efforts were made in between sampling points scanning and searching for EWM and other aquatic invasive species. On Duck Lake, emphasis was also placed on visually checking each EWM buoy placed in the water. On Crooked Lake additional visual observations were made around previous EWM locations, treatment areas and the channel from the first bay to the second bay. Because of this extended searching, efforts were made to time the surveys during calmer periods of wind and no precipitation.

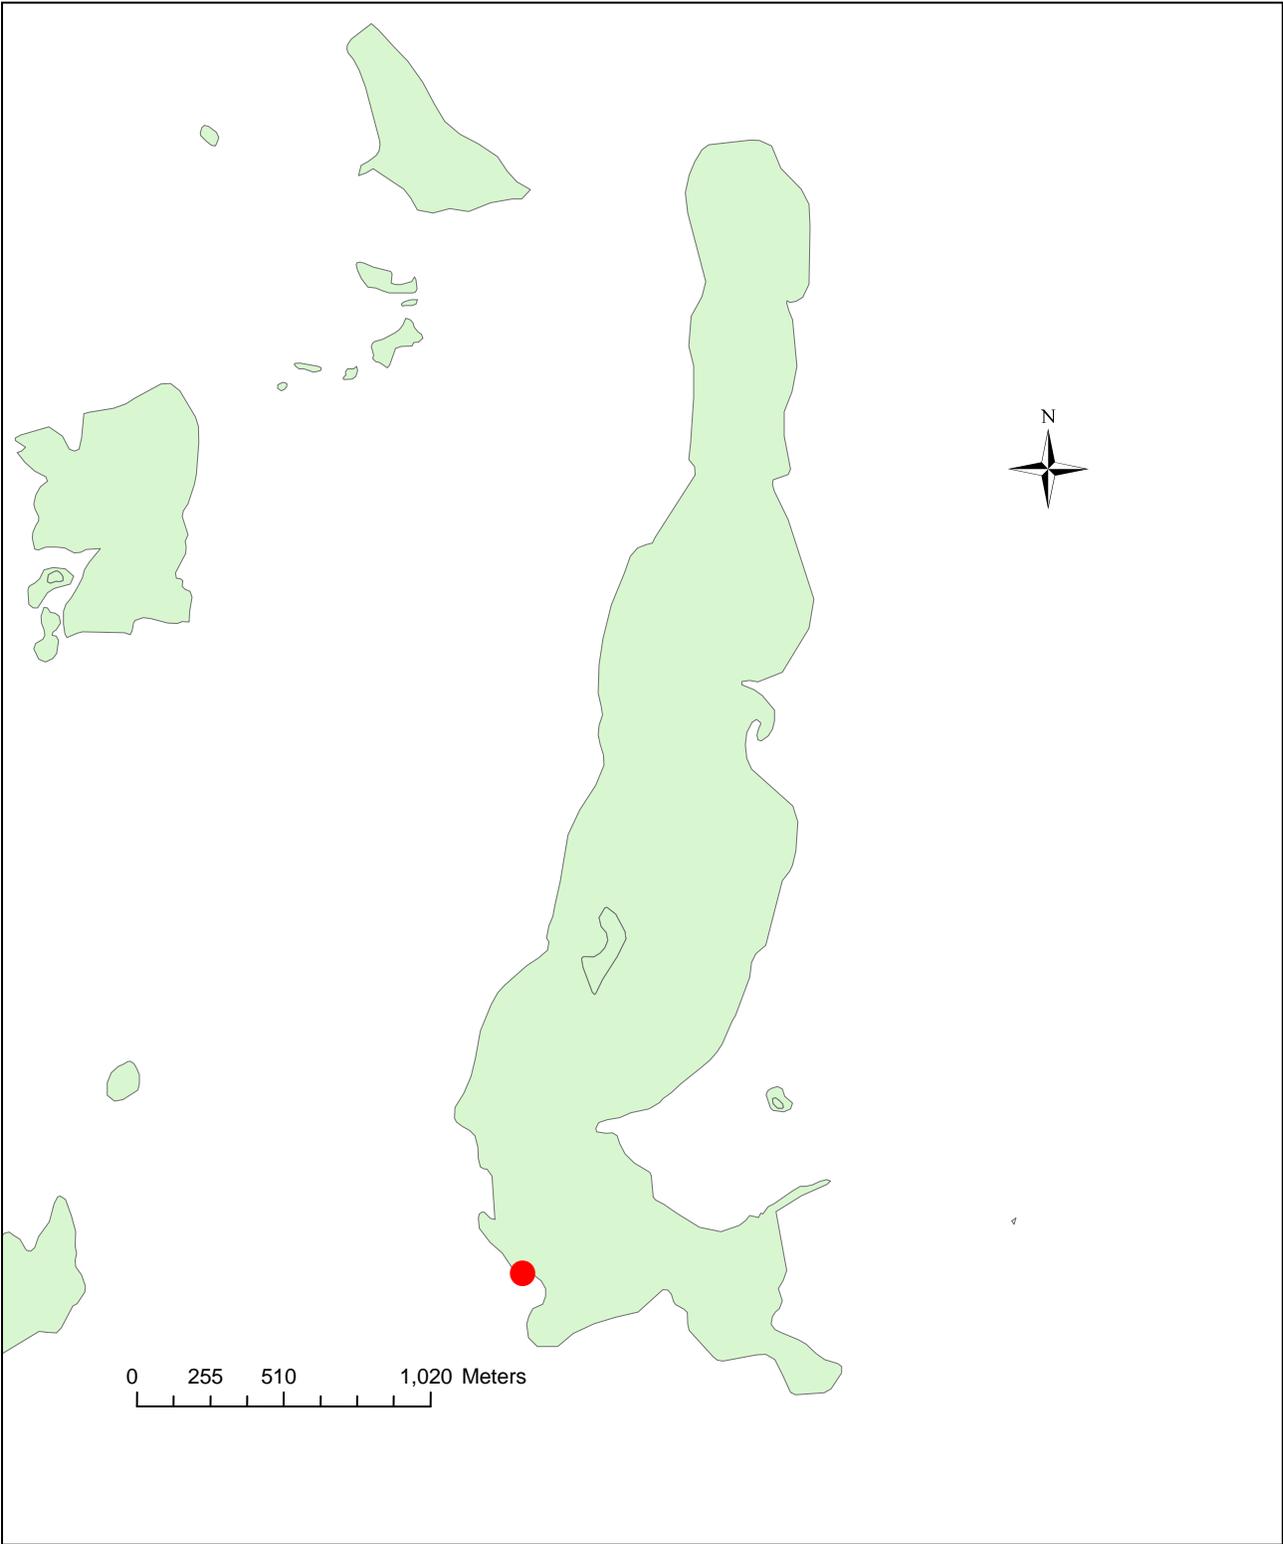
Figure 4: EWM observed, Duck Lake 2001

A total of 571 points were sampled on Duck Lake. Of these sampling points, 181 points had vegetation (Table: 1). No EWM was found on the sampling rake and only one visual observation of EWM was made near sampling point 50 (Figure: 4).

During the time of this survey, the Duck Lake EWM dive team had been actively searching and hand pulling EWM. The majority of these locations were in shallow water, where the bottom is readily visible under ideal weather conditions. In addition a contracted biologist from the ISCCW conducted a whole lake meander type survey looking for EWM. Most of these survey techniques are designed for shallow water (less than 10-12 feet deep) so it is very crucial to occasionally inspect areas of the lake where vegetation can still grow.

Based on the maximum rooted depth of vegetation recorded during the survey, 63% of Duck Lake has the potential to sustain aquatic plant life, including EWM. Given that the majority of this region is at the southern end and southwest side of the lake, extra attentions needs to continue within these particular regions. Periodic checks of deeper water adjacent to EWM already identified with an underwater camera and or sampling grid as done in this survey is also recommended.

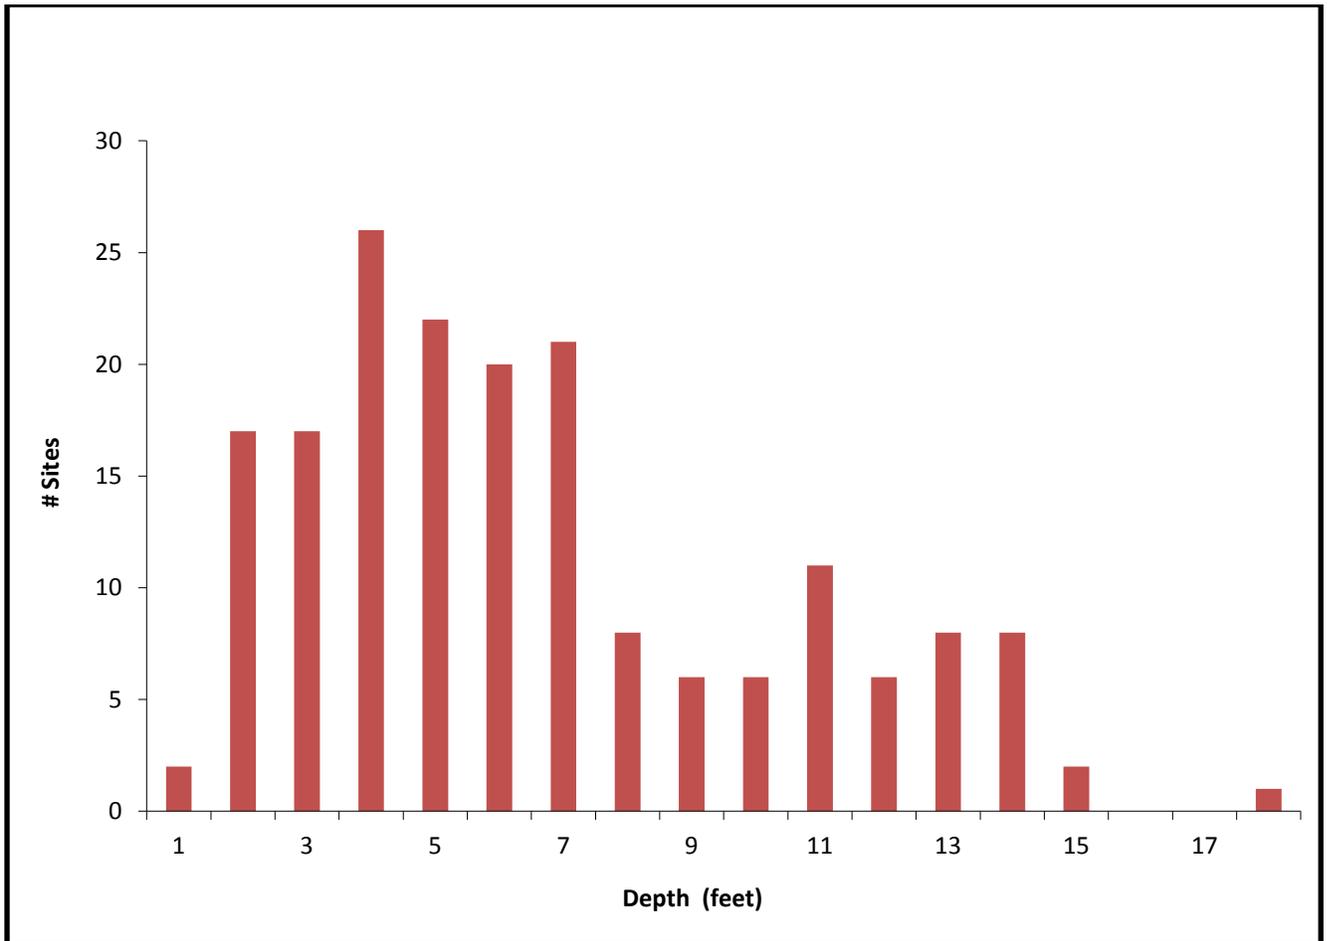
Figure 5: Maximum depth of plant colonization, Duck Lake 2011

The maximum rooting depth of vegetation during the survey was 18 feet, which is approximately 63% of the surface area of Duck Lake (Figures: 5 & 6). Of the sites sampled, 59% had a muck substrate, 15% a rock substrate and 26% a sand substrate (Figure: 7). The average depth of Duck Lake based on the survey is 14 feet with a maximum depth of 29 feet. The three most abundance plant species found in Duck Lake are *Potamogeton robbinsii*, *Vallisneria americana* and *Potamogeton amplifolius* at 26.70%, 15.34% and 14.49% respectfully (Figure: 8). Three species with a Coefficient of Conservatism of 10 were documented (Figures: 9, 10 & 11). Of these species *Potamogeton vaseyi* is considered threatened in the State of Michigan (<http://web4.msue.msu.edu/mnfi/data/specialplants.cfm>). The average Coefficient of Conservatism for Duck Lake is 7.37 with a Floristic Quality Index of 36.12.

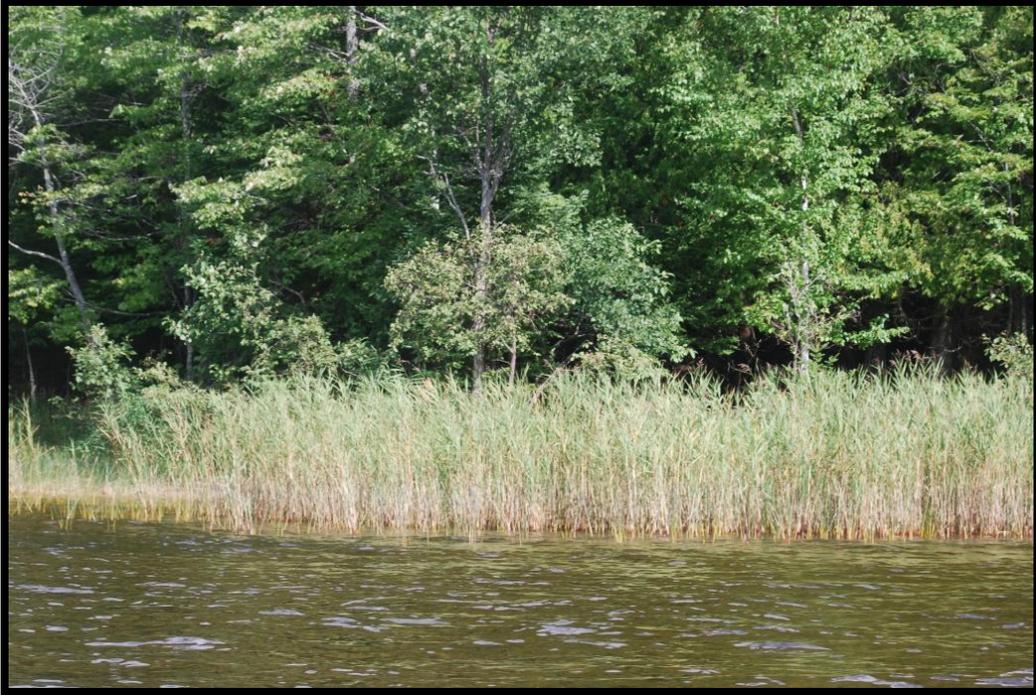
In 2002 the ERDC conducted a vegetation assessment on Duck Lake. The only potentially aggressive plant species that was recorded at that time was *Phragmites australis*. *Phragmites* was not sampled during the 2011 survey, however it was recorded near several sampling points (Figure: 12). This plant has the potential to become an aggressive shoreline colonizer, displacing native vegetation by creating monotypic stands. In addition to *Phragmites*, reed canary grass was also observed during the survey (Figure: 13). This plant was not recorded during the 2002 ERDC survey. As with *Phragmites*, reed canary grass can potentially displace native vegetation.

Phragmites in Duck Lake

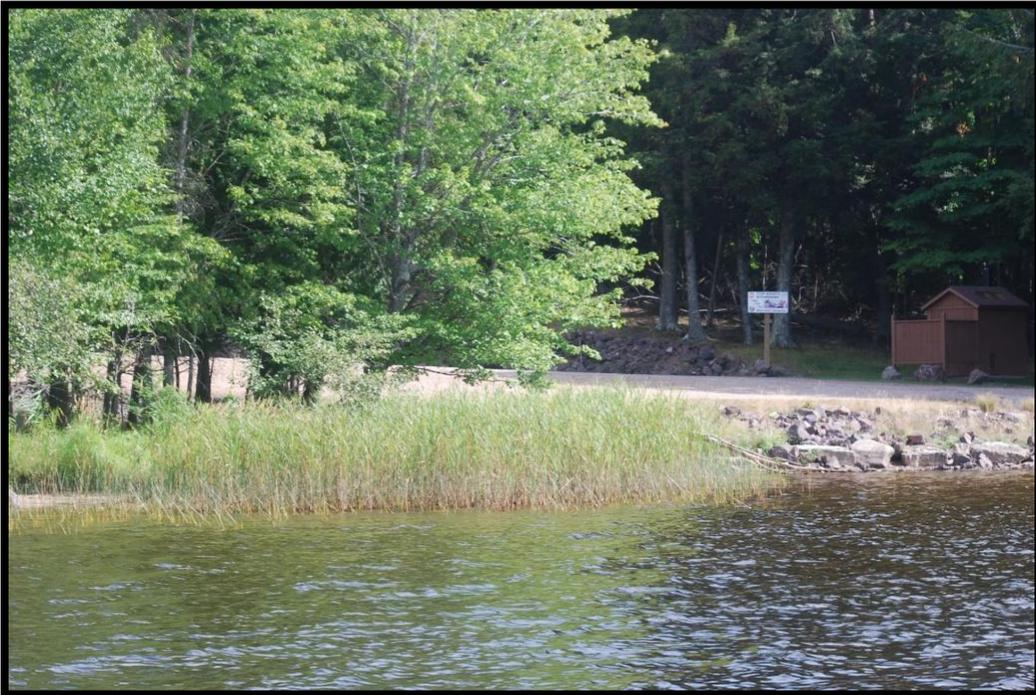
Phragmites near the boat launch, Duck Lake

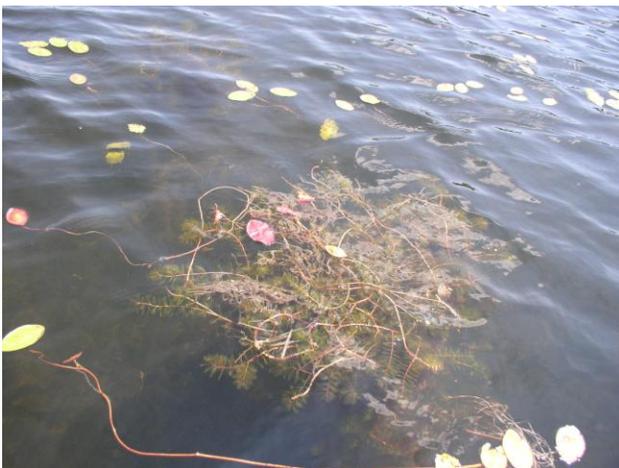
In 2005 the first infestation of EWM was discovered in the southwest bay of Duck Lake. Since then, EWM has spread to many areas throughout the lake at varying densities. The Duck Lake Homeowners Association has worked vigilantly since 2005 to keep EWM at low densities and reduce the probability of spread internally but also externally to other lakes. The two primary management tools used are seasonal herbicide treatments and a ongoing seasonal hand pulling/diving program. In 2011 alone approximately 380 hours of volunteer time was dedicated to EWM management.

Initial EWM found in 2005

The Duck Lake riparian owners are very active in the management of EWM. The shoreline is split up into segments and each segment is assigned to a riparian owner. The owner who is assigned that segment is then tasked with the job of patrolling their segment in search of EWM. If EWM is found during a patrol, a GPS waypoint is marked and a yellow foam buoy with a piece of blue ribbon on top is placed in the water near the plant. Once a few locations of EWM have been identified, a scuba diving crew is assembled and a modified pontoon boat specifically made for hand pulling EWM is taken out for the divers to hand pull the plants. As the divers hand pull the plants, there are people on the boat using pool skimming nets to collect any fragments that were not captured by the divers. Once the plant or plants have been pulled, the immediate area is scoured for additional plants not visible from the water's surface and the piece of ribbon is pulled off the top of the buoy signaling that the site has been pulled. The area will be periodically checked to make sure no new EWM arises.

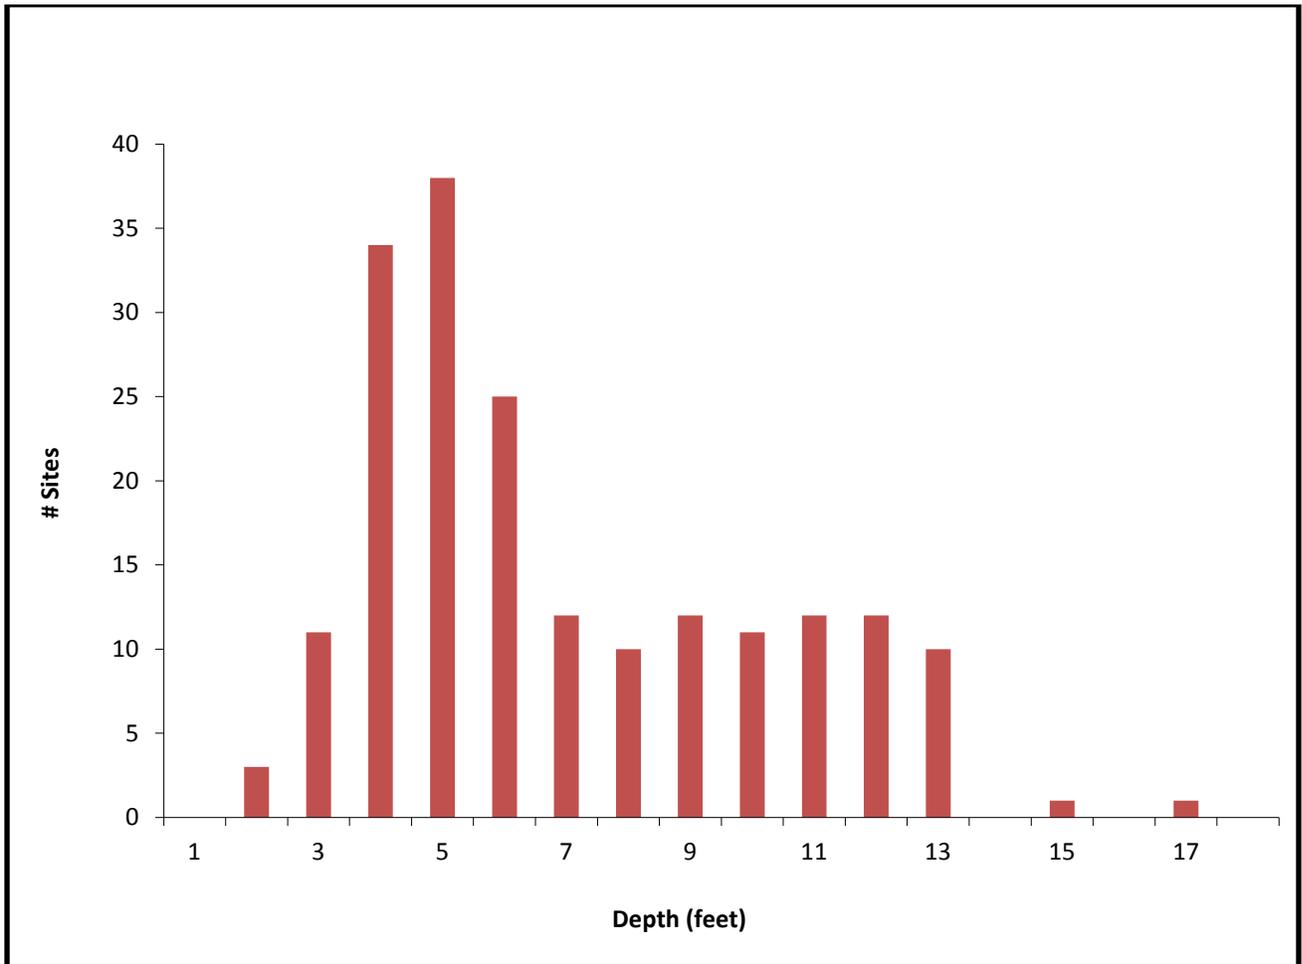
Figure 15: Maximum depth of plant colonization, Crooked Lake 2011

The maximum rooting depth of vegetation during the survey was 17 feet, which is approximately 57% of the surface area of Crooked Lake (Figure: 15 & 16). Of the sites sampled, 75% have a muck substrate, 18% a rock substrate and 8% a sand substrate (Figure: 17). The three most abundance plant species found in Crooked Lake are *Potamogeton robbinsii*, *Potamogeton zosteriformis* and *Elodea canadensis* at 31.22%, 15.61% and 14.02% respectfully (Figure: 17). The average Coefficient of Conservatism of Crooked Lake is 6.36 with a Floristic Quality Index of 27.76.

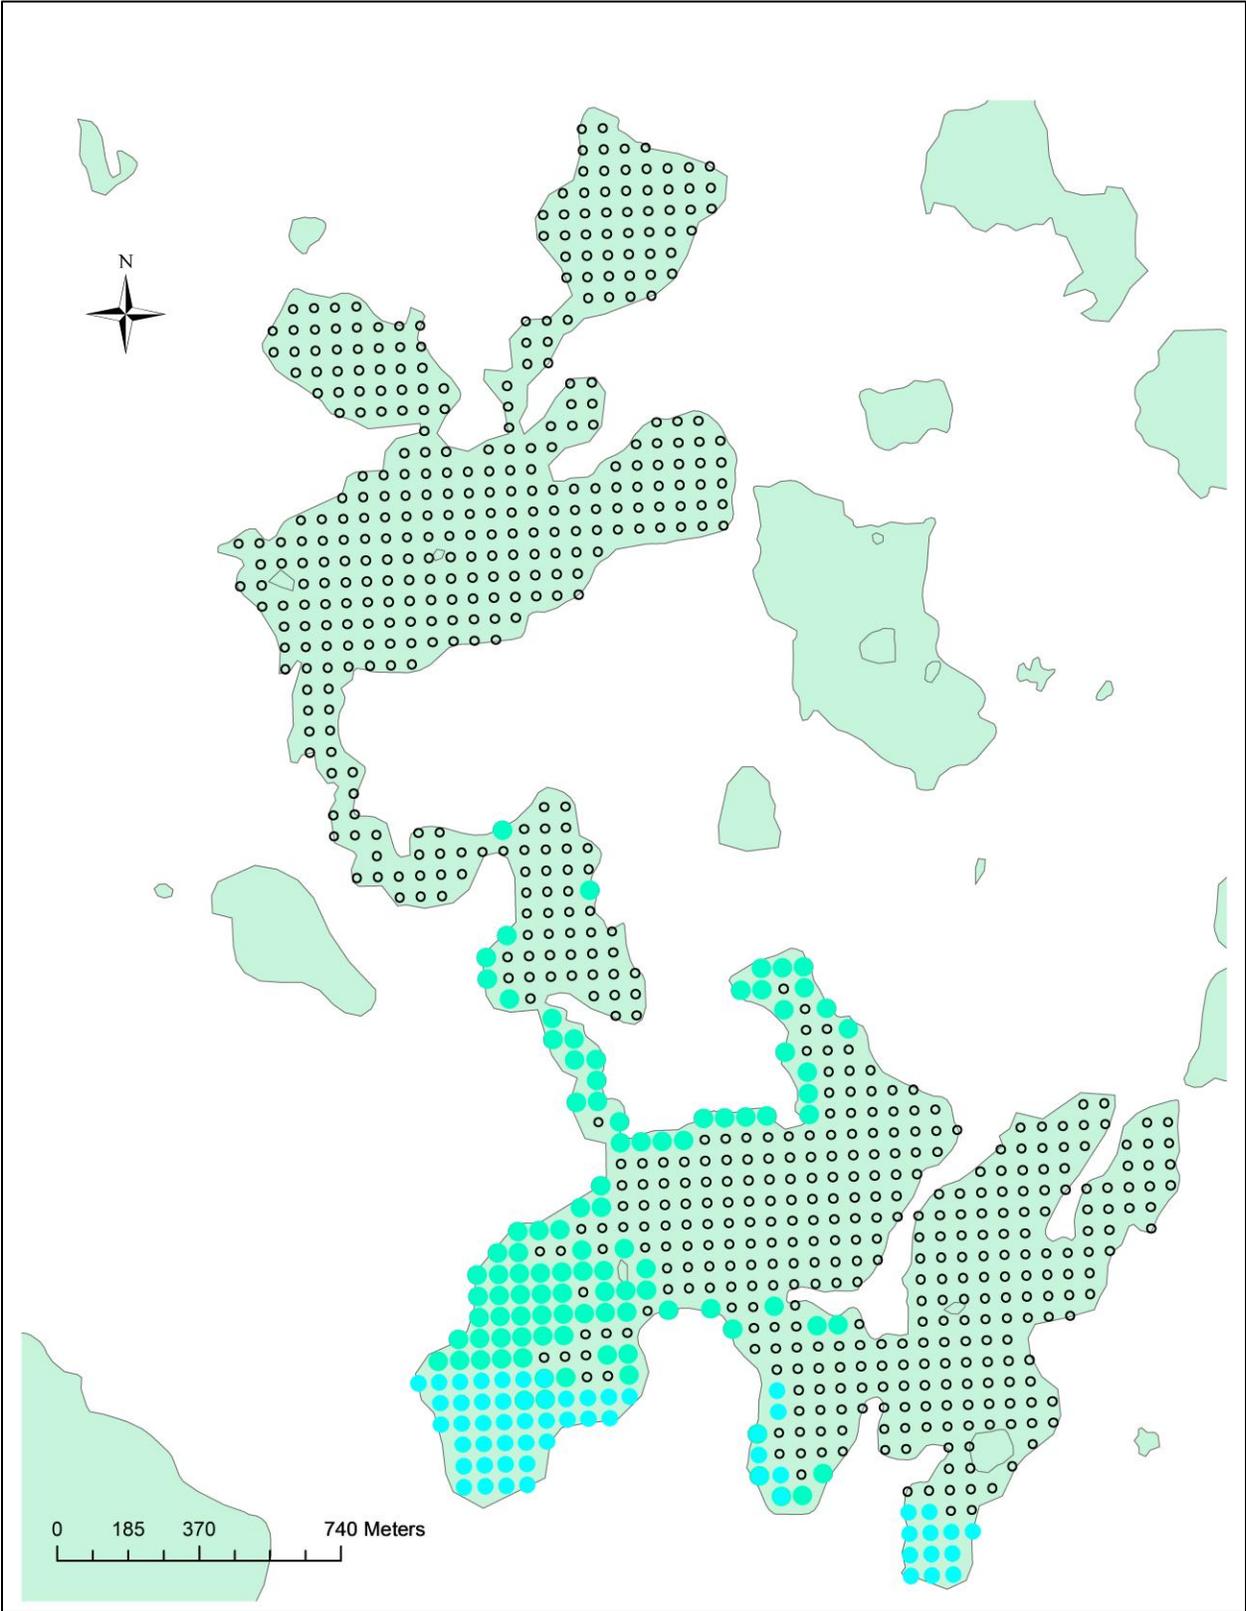
Figure 19: Location of wild rice, Crooked Lake 2011

Zizania palustris was found at 12.17% of the sample sites, however this percentage is an underestimate of the total spatial distribution of *Z. palustris*. Some sites were inaccessible due to dense plant growth including *Z. palustris*. Figure 19 represents the total observed visual distribution of *Z. palustris* based on the sampling grid.

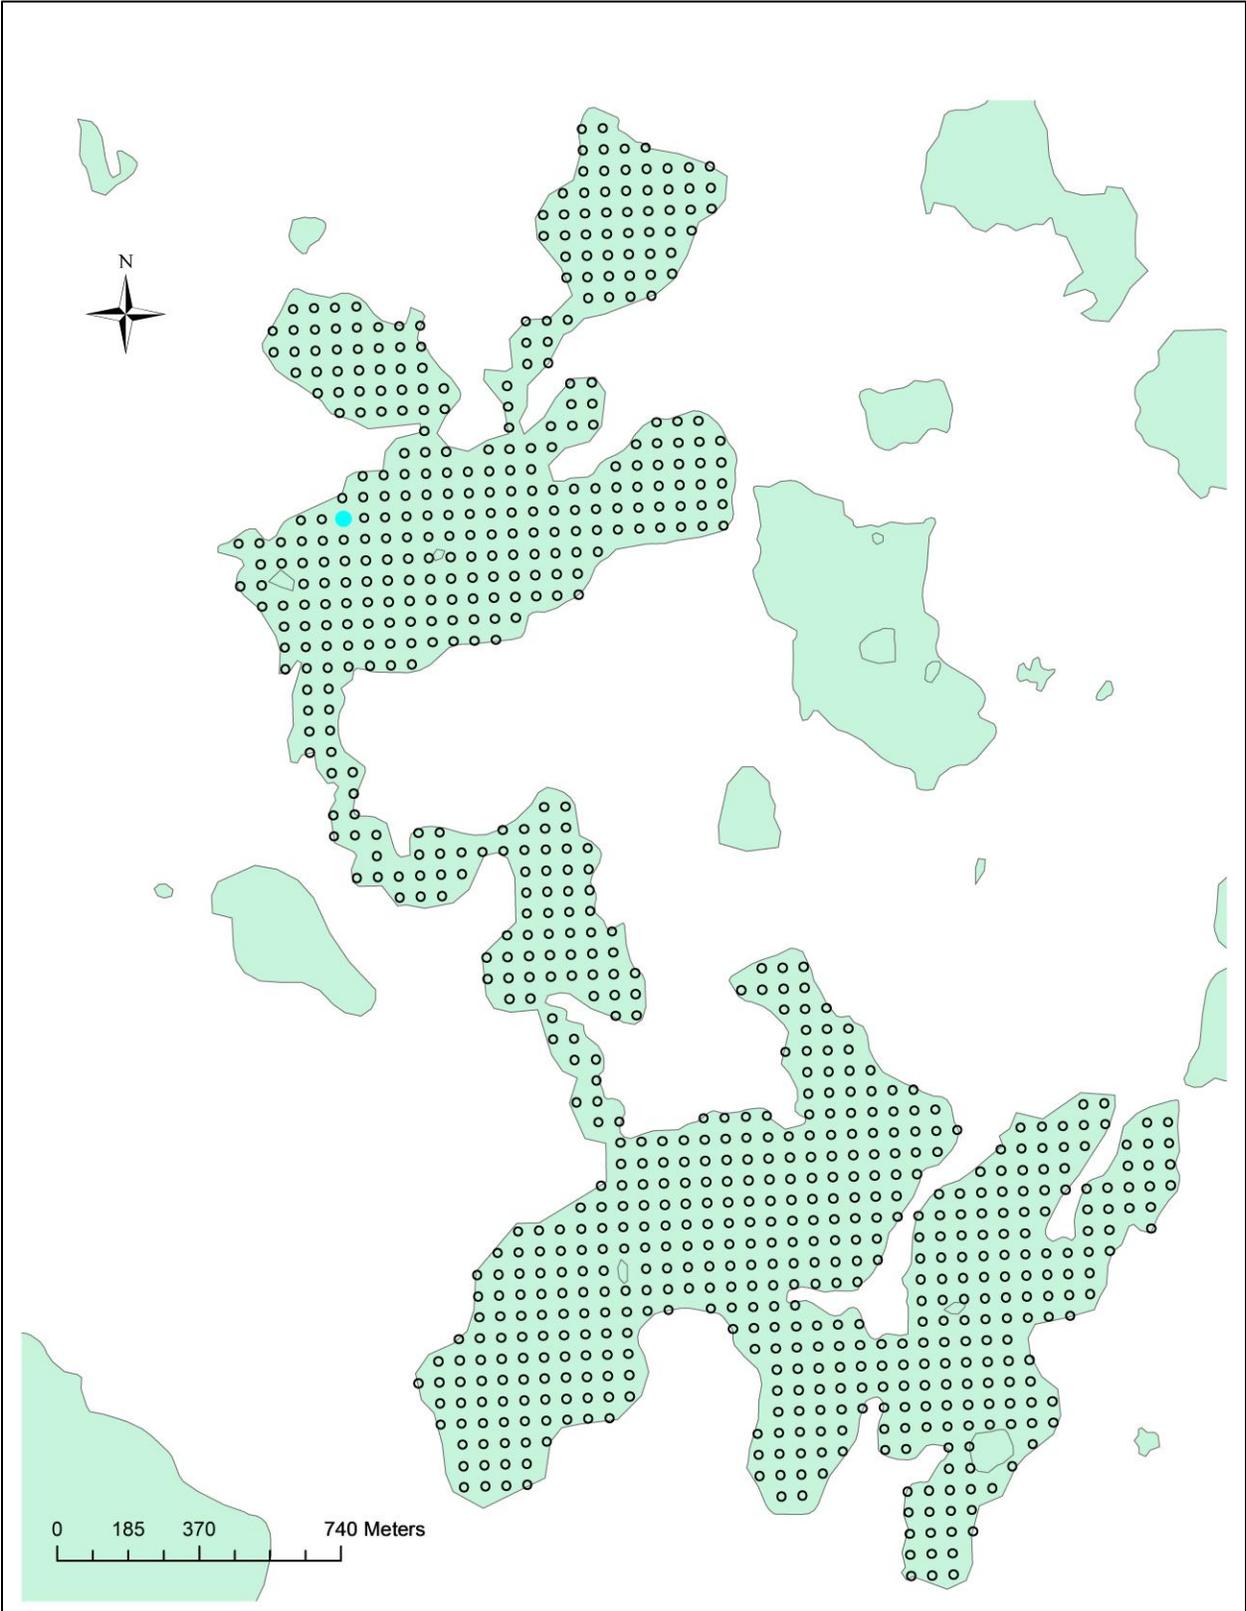
Figure 20: Location of reed canary grass, Crooked Lake 2011

In 2002 the ERDC conducted a vegetation assessment on Crooked Lake. The only invasive plant that was recorded at this time was EWM. Reed canary grass, a potentially aggressive plant species was recorded during the 2011 survey (Figure: 20). This plant has the potential to become an aggressive shoreline colonizer, displacing native vegetation creating monotypic stands.

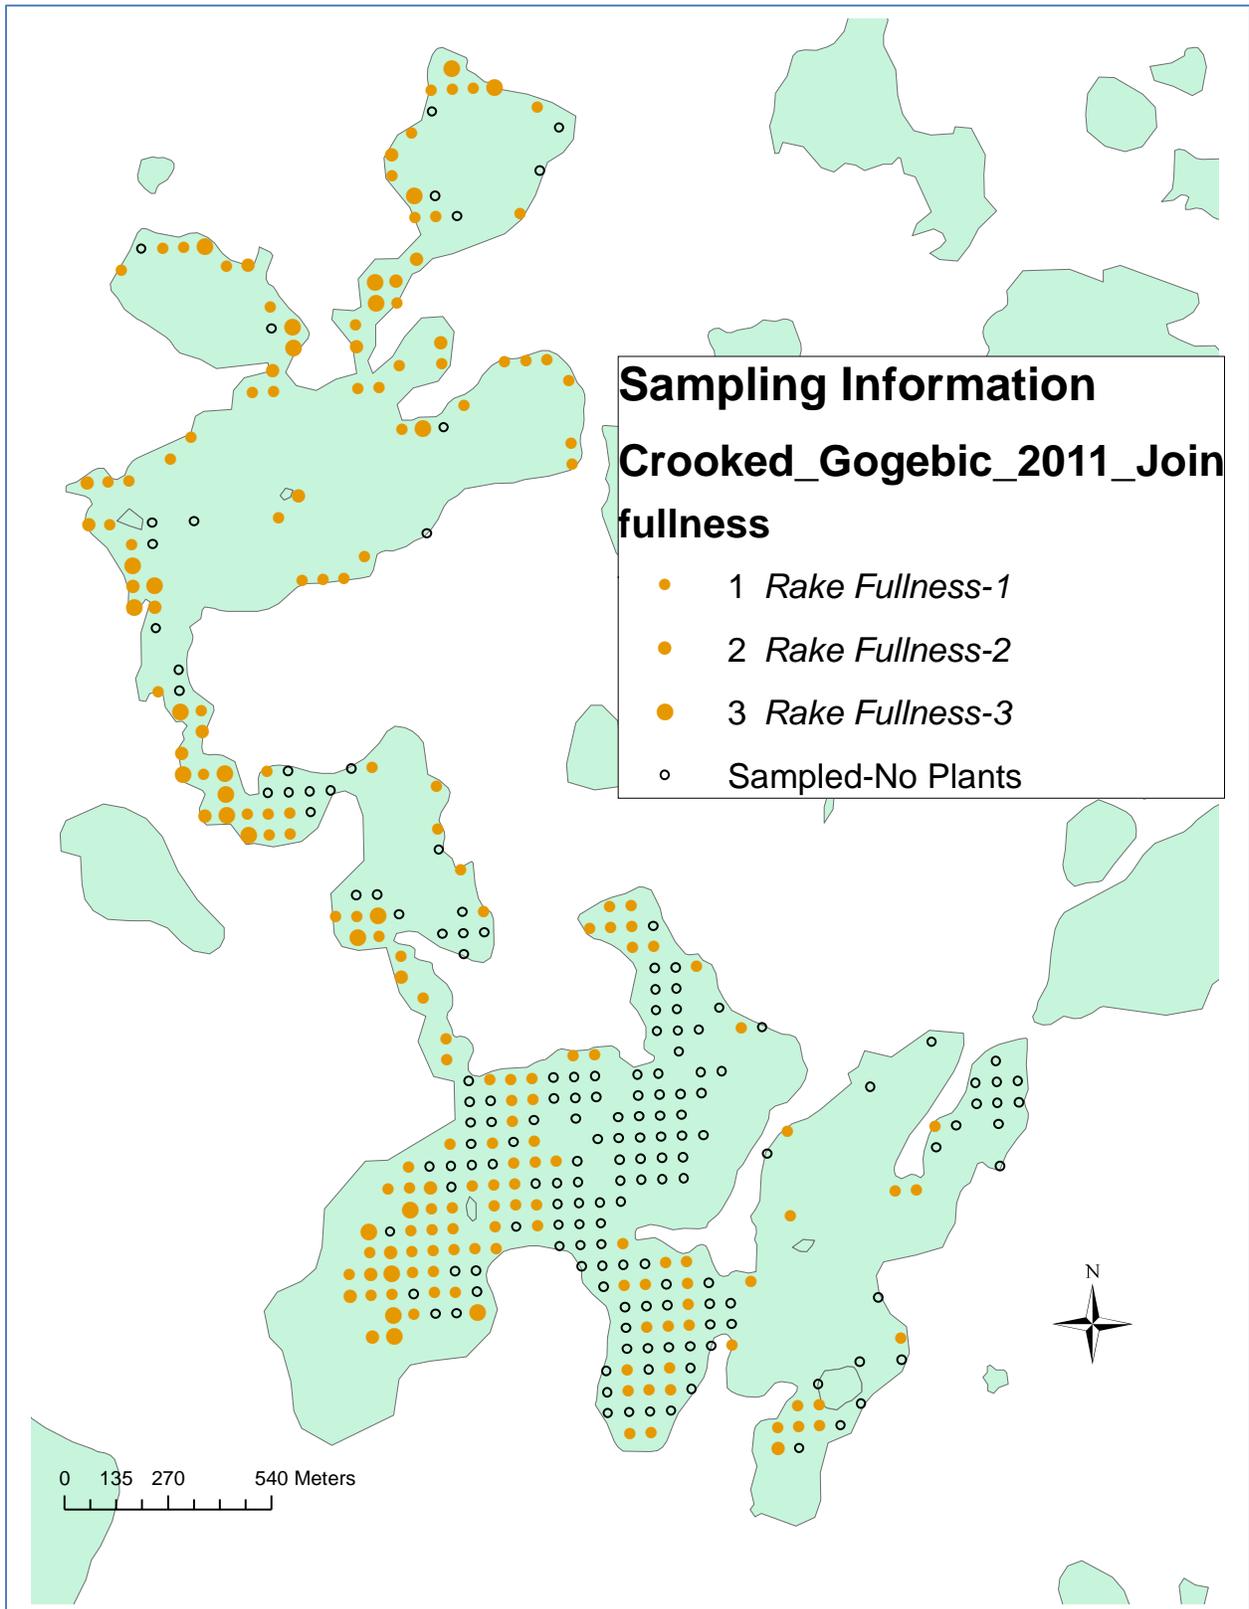
Figure 21: Location of aquatic plants sampled, Crooked Lake, 2011

Crooked Lake is a unique system with expansive bays connected by narrow channels. To this date, the first bay (bay farthest to the north) is the only area on the lake to have an infestation of EWM. This year two areas of the first bay of Crooked Lake had a herbicide treatment using granular 2,4-D. The ISCCW contract biologist who has visited the first bay of Crooked Lake annually since 2005 conducted a meaner survey in 2011 and did not find any EWM plants within the treatments area nor any other areas within the first bay. In addition to the work completed by the ISCCW, Ottawa National Forest personnel frequents the first bay of Crooked Lake annually either searching for EWM plants or diving for known EWM plants. Their post treatment survey also revealed no EWM present within the treatment areas.

The primary means of internal spread of EWM past the first bay of Crooked Lake would have to either occur by human transport or EWM fragments from established plants moving through the channel from the first bay to the second. It is plausible that if there is the first internal spread of EWM outside of the first bay, it could begin along the channel between the first and second bay. Based on the information collected during the survey, this area is shallow, supports aquatic vegetation and has a organic substrate, making it a likely colonization candidate for EWM (Figure: 21). An additional area of concern is the fourth bay of Crooked Lake where the majority of the current wild rice beds exists. This area is relatively shallower than the maximum depth of colonization and has a organic substrate. Based on the vegetative survey, even though a great portion of this bay is at and shallower than the maximum rooting depth, there is currently large portions of this bay void of vegetation. This open canvass holds prime conditions for the potential establishment of EWM. Future monitoring work should include an extensive search of the channel between the first and second bay, the shallow regions reaching into second bay adjacent to the channel and periodical checks of the fourth bay.
