Florida National Scenic Trail – Ocala National Forest

Maintenance Assessment for Volunteer Work Season 2011-2012

July, 2011

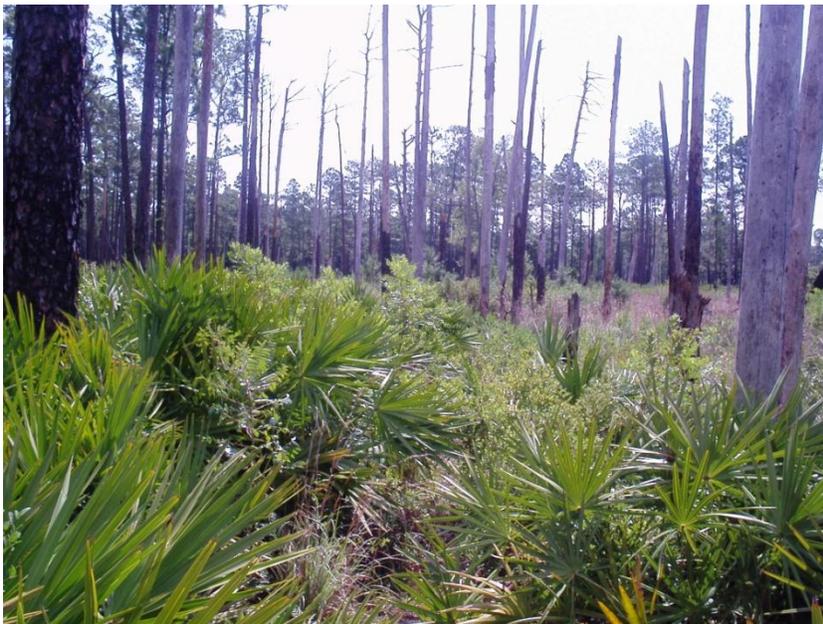
Figure 1

Notice that the trail is totally overgrown by palmettos and other vegetation. There is no visible trail tread or corridor. Extensive work is needed on these sections.

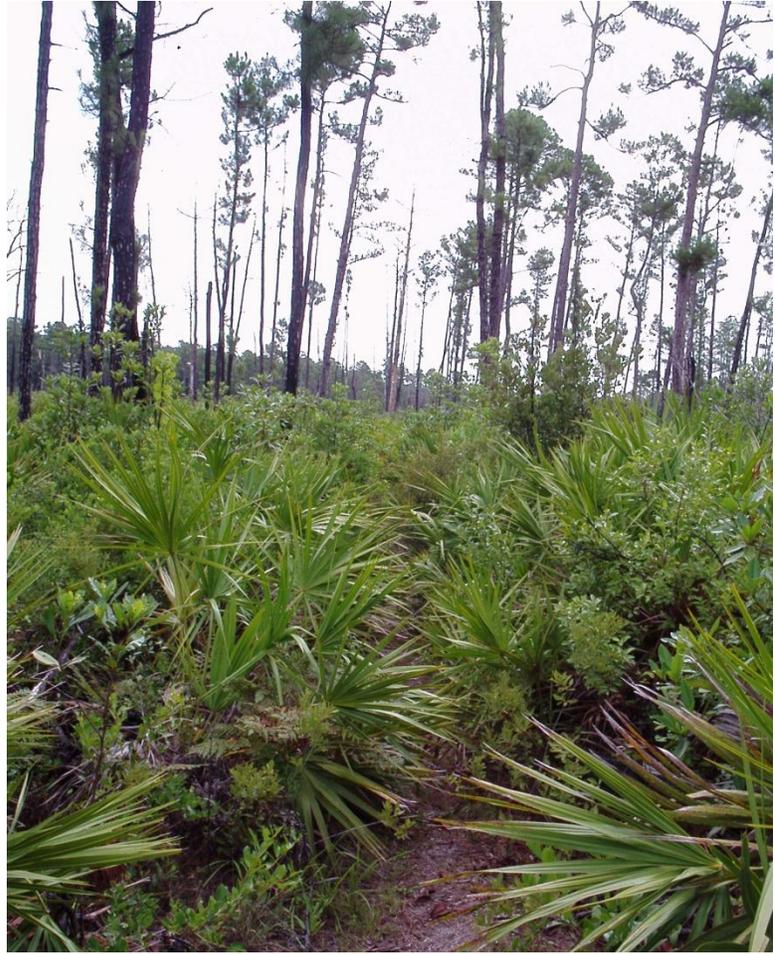
Figure 2

Again notice the trail is totally overgrown by palmettos. The trail tread can barely be seen by the hiker.

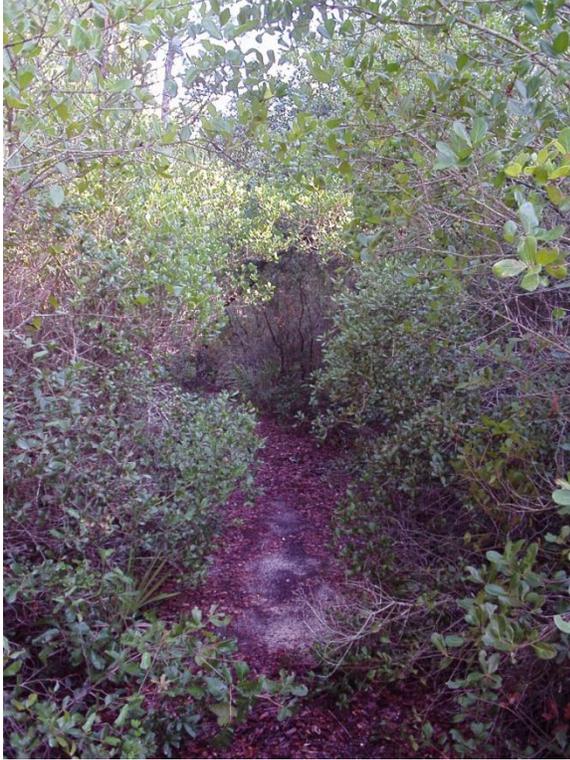
Figure 3

Notice the trail corridor is close to 2' or under. This scrub oak grows very quickly, especially with the rainy season upon us.

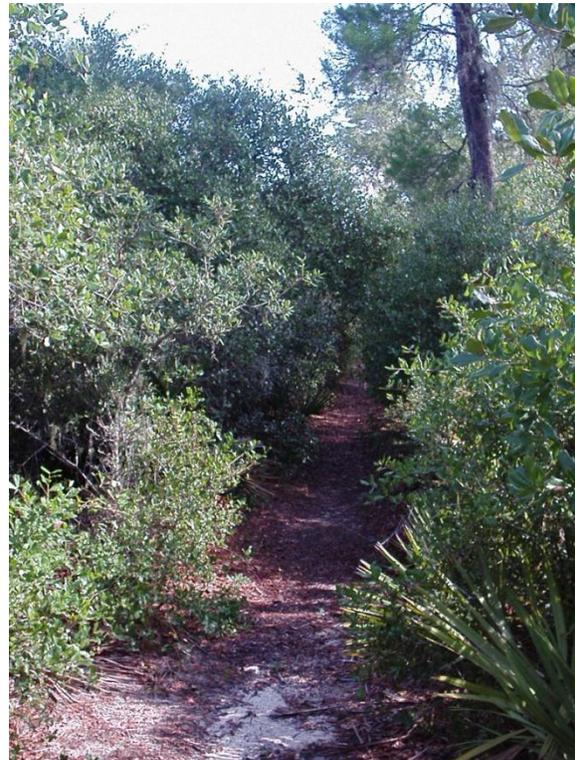
Figure 4

Again notice the trail corridor is being encroached by the scrub oak and is less than 2'. Here the trail tread is around 1'.

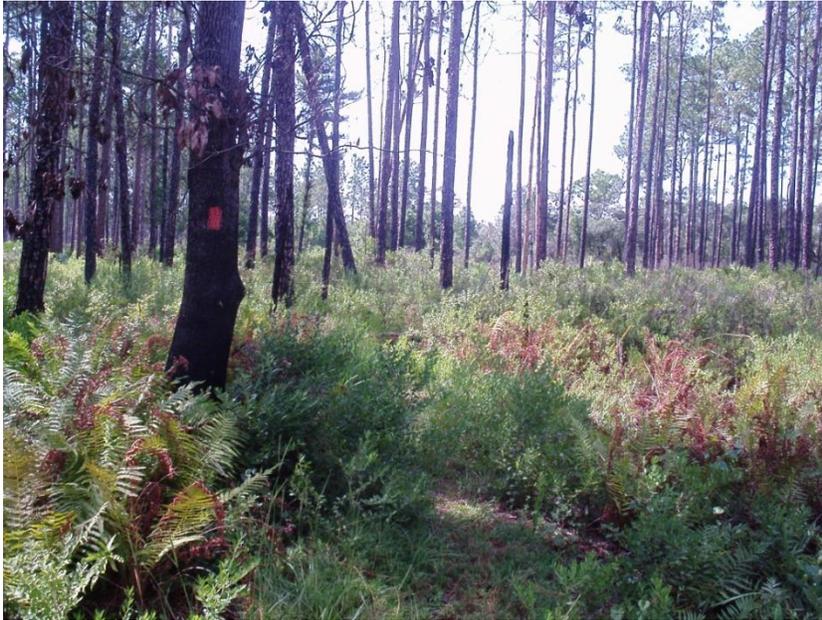
Figure 5

Notice the trail tread width is below 12” and the trail corridor width is below 48” with ferns on the edges of the trail. This will need mowing.

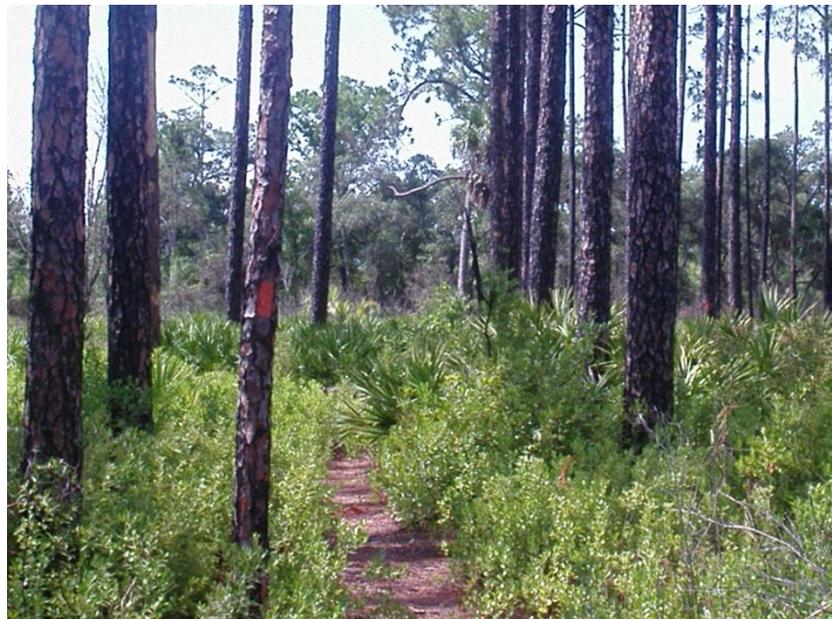
Figure 6

Notice the trail tread width is around 12” and the trail corridor width is again less than 48” with gallberry and palmettos on the edges of the trail. This will also need mowing and trimming.

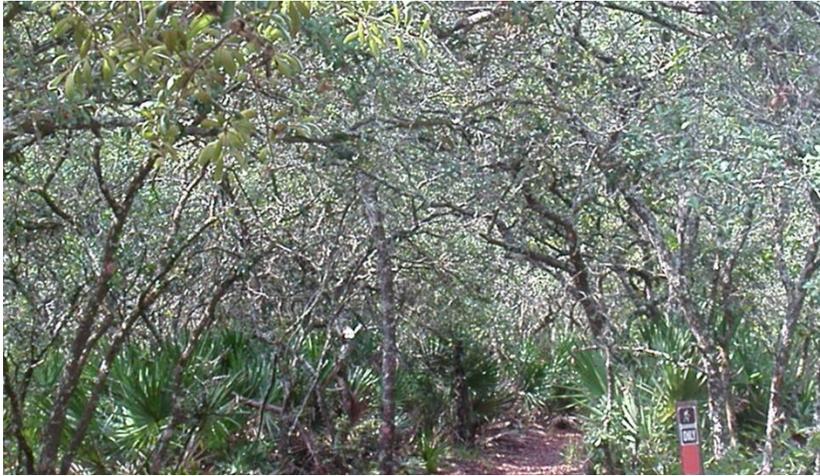
Figure 7

Notice the trail tread width is over 18" and the trail corridor width is over 48" with sand live oaks and palmettos on the edge of the trail

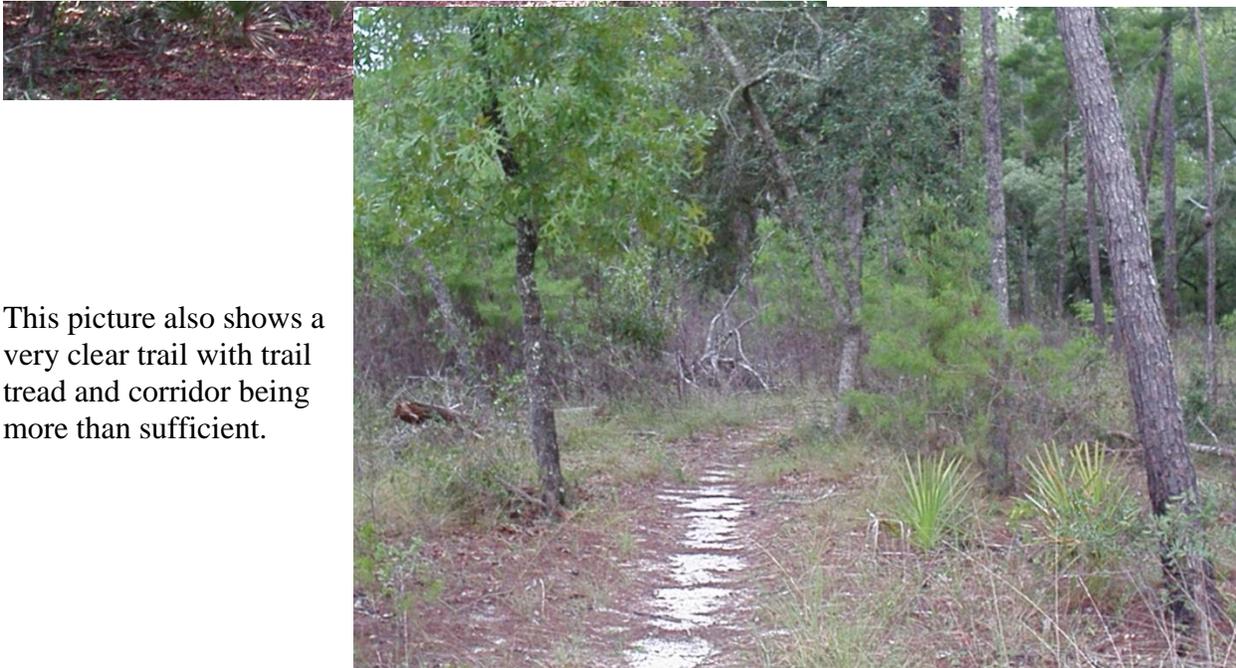
Figure 8

This picture also shows a very clear trail with trail tread and corridor being more than sufficient.

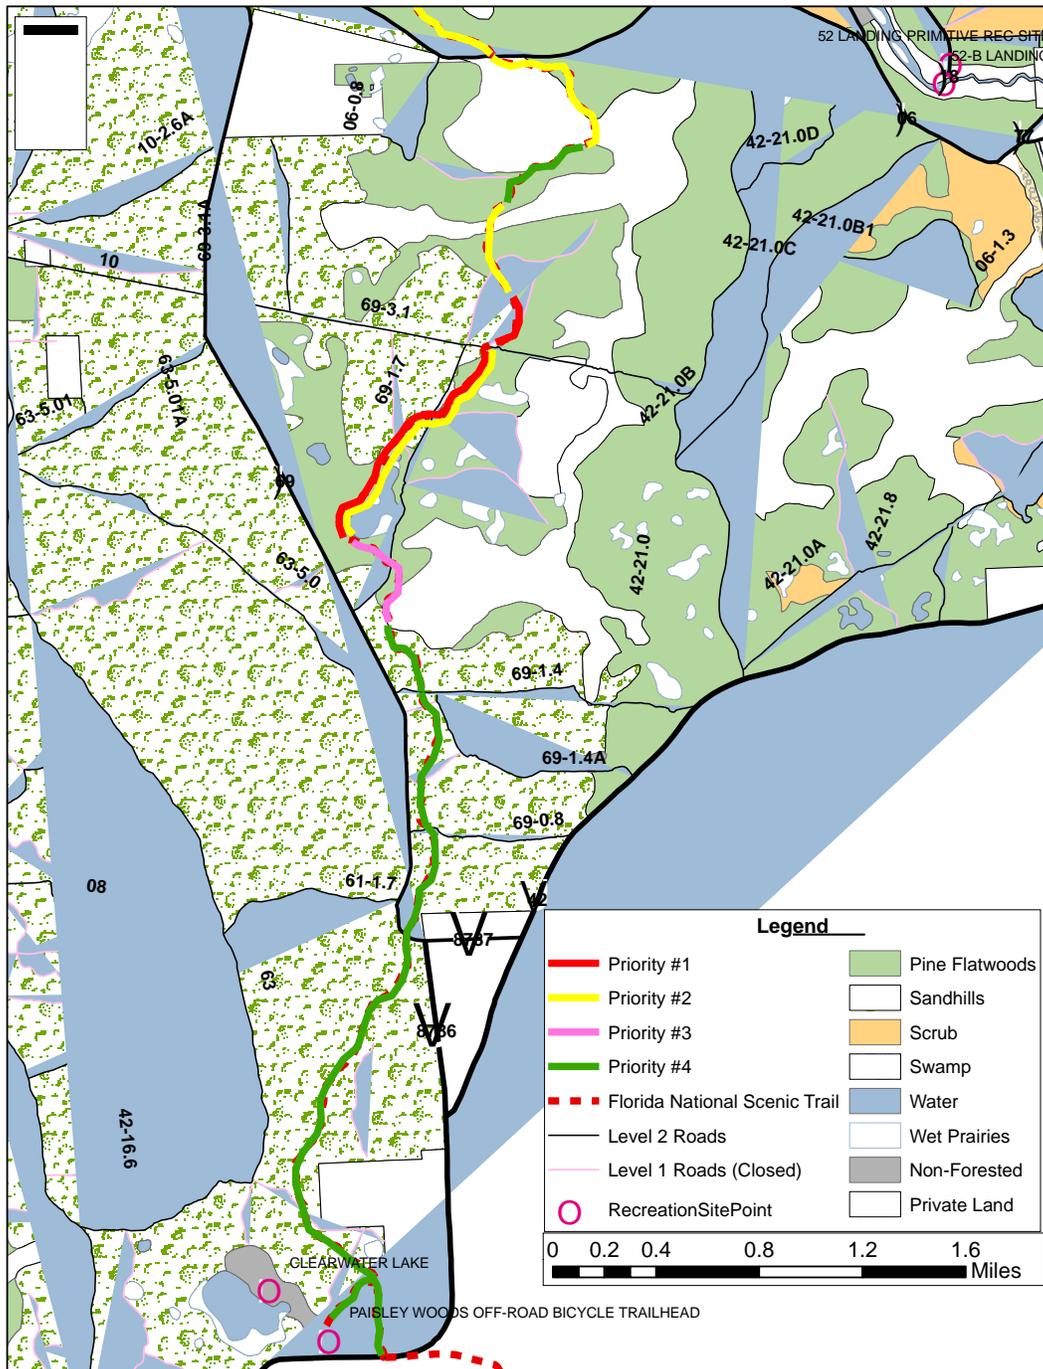
Section of trail from SR-42 to FR 06: Refer to Figure 9 for this description. The trail enters the forest through sandhill vegetation which usually requires little if any maintenance. The trail becomes rough upon entering the flatwoods vegetation just north of FR 69-1.4. The worst parts are about 1 mile south (mixture of priority #'s 1 and 2) and a ¼ mile north of FR 69-3.1.

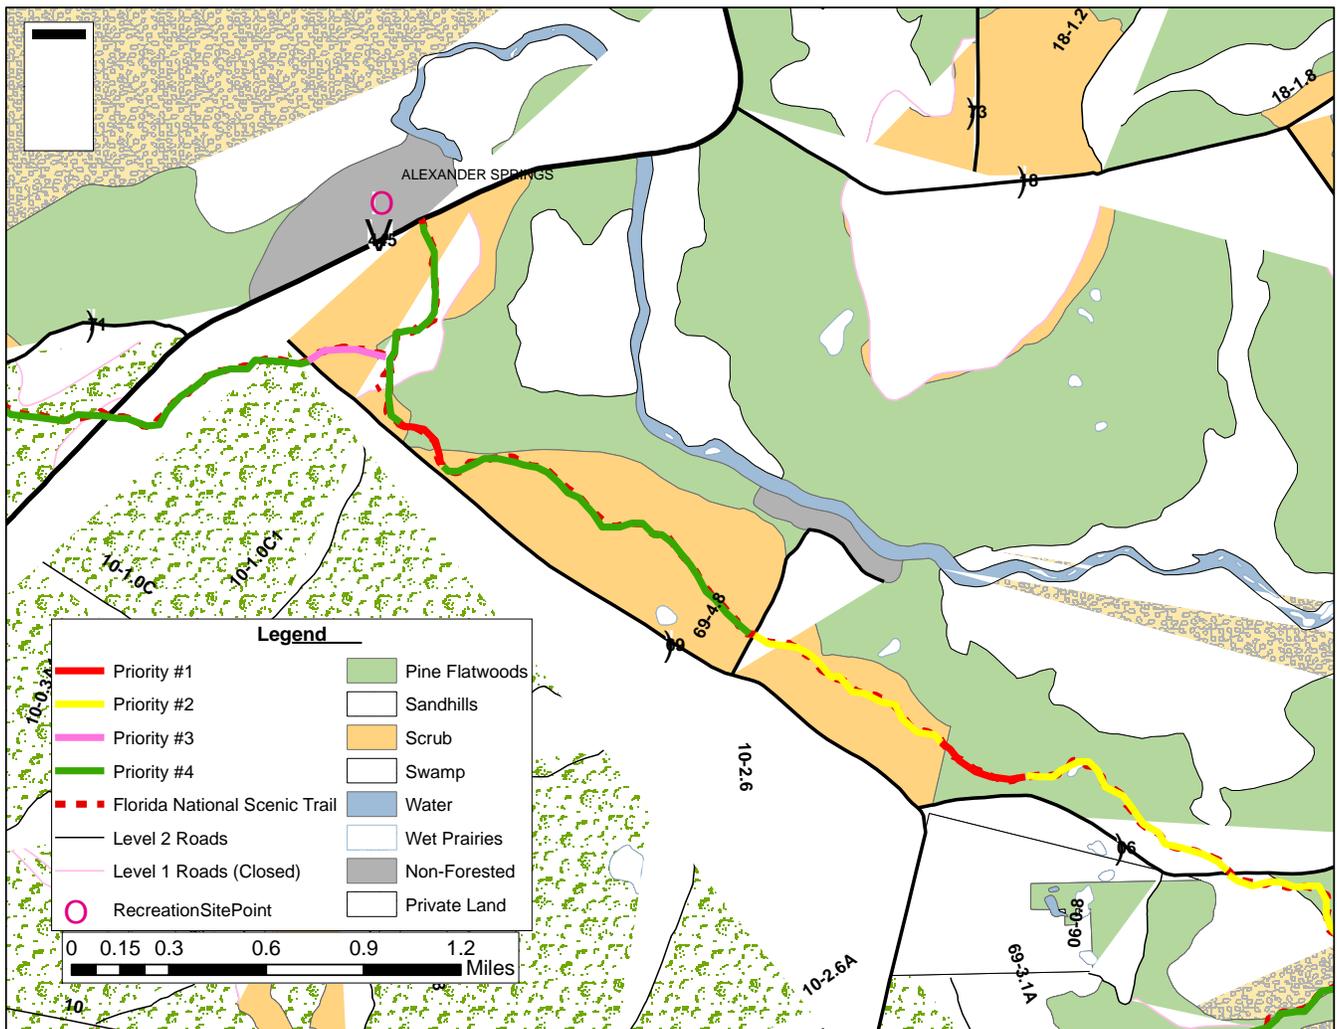
Section of trail from FR 06 to CR 445: Refer to Figure 10 for this description. From FR 06 to FR 69-4.8 there are priority #'s 1 and 2. The priority #1 subsection in the middle was in very poor condition. You can see this subsection goes through both scrub and flatwoods vegetation. Going north of FR 69-4.8 you come to more sandhill vegetation (the map shows it's in scrub but it actually isn't) so the trail is in good condition. Approaching the flatwoods vegetation the trail becomes very poor once again. This priority #1 subsection runs over the dilapidated puncheon and is overgrown and ridden with fallen trees. The rest of this section is of priority #4 besides the priority #3 subsection connecting to FR 69.

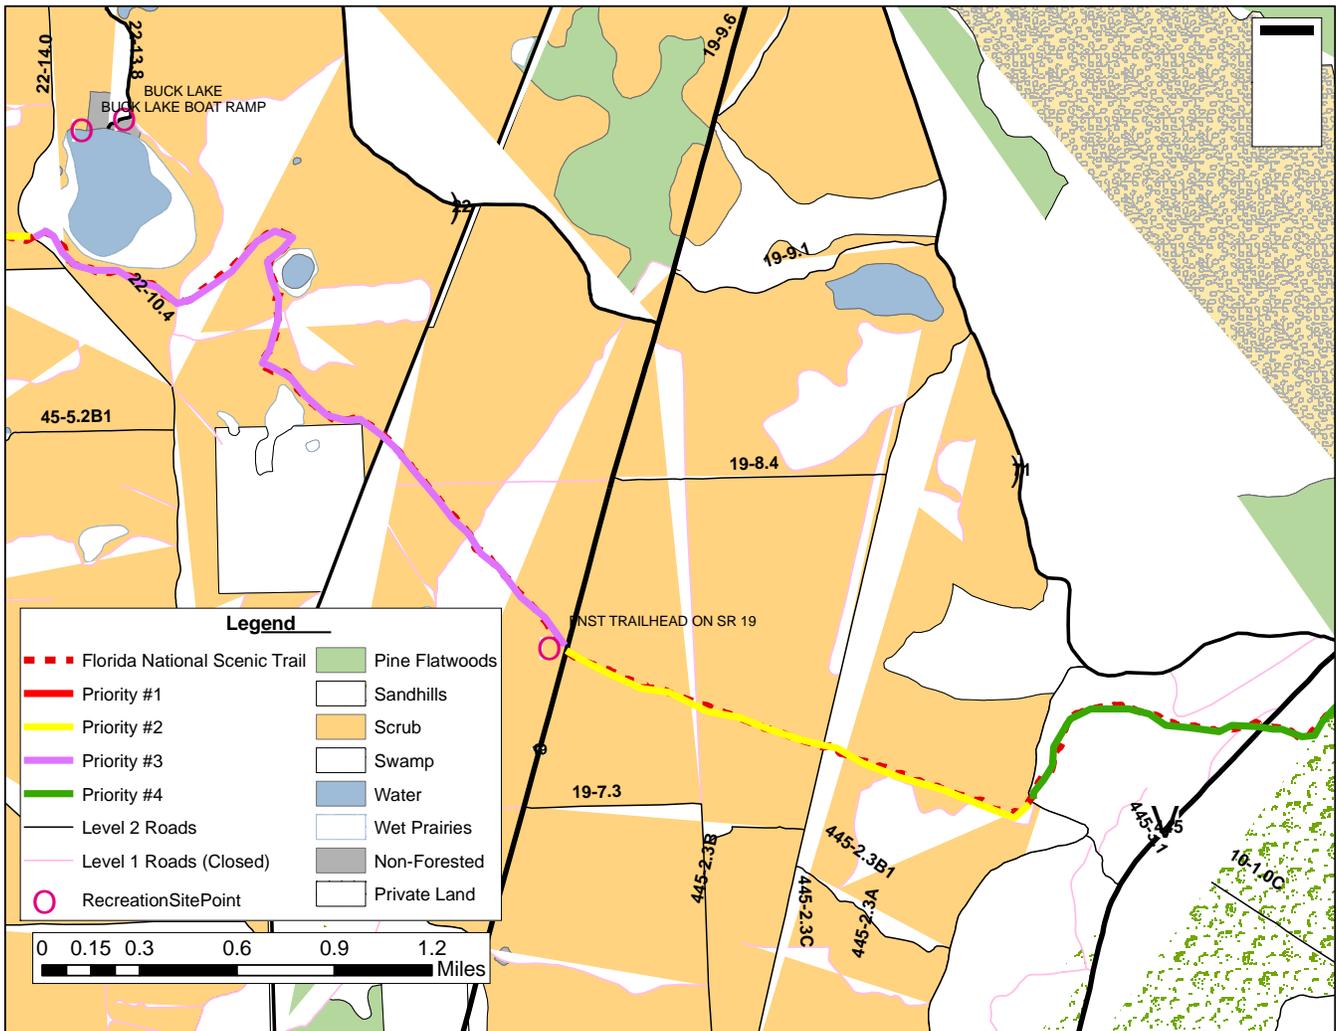
Section of trail from CR 445 to FR 22-13.8 (just west of Buck Lake): Refer to Figure 11 for this description. This section of trail starts off going through sandhill vegetation and makes its way through scrub vegetation. The subsection of trail east of SR 19 that runs through scrub needs attention. The subsection of trail that runs west of SR 19 all the way to FR 22-13.8 was in decent shape.

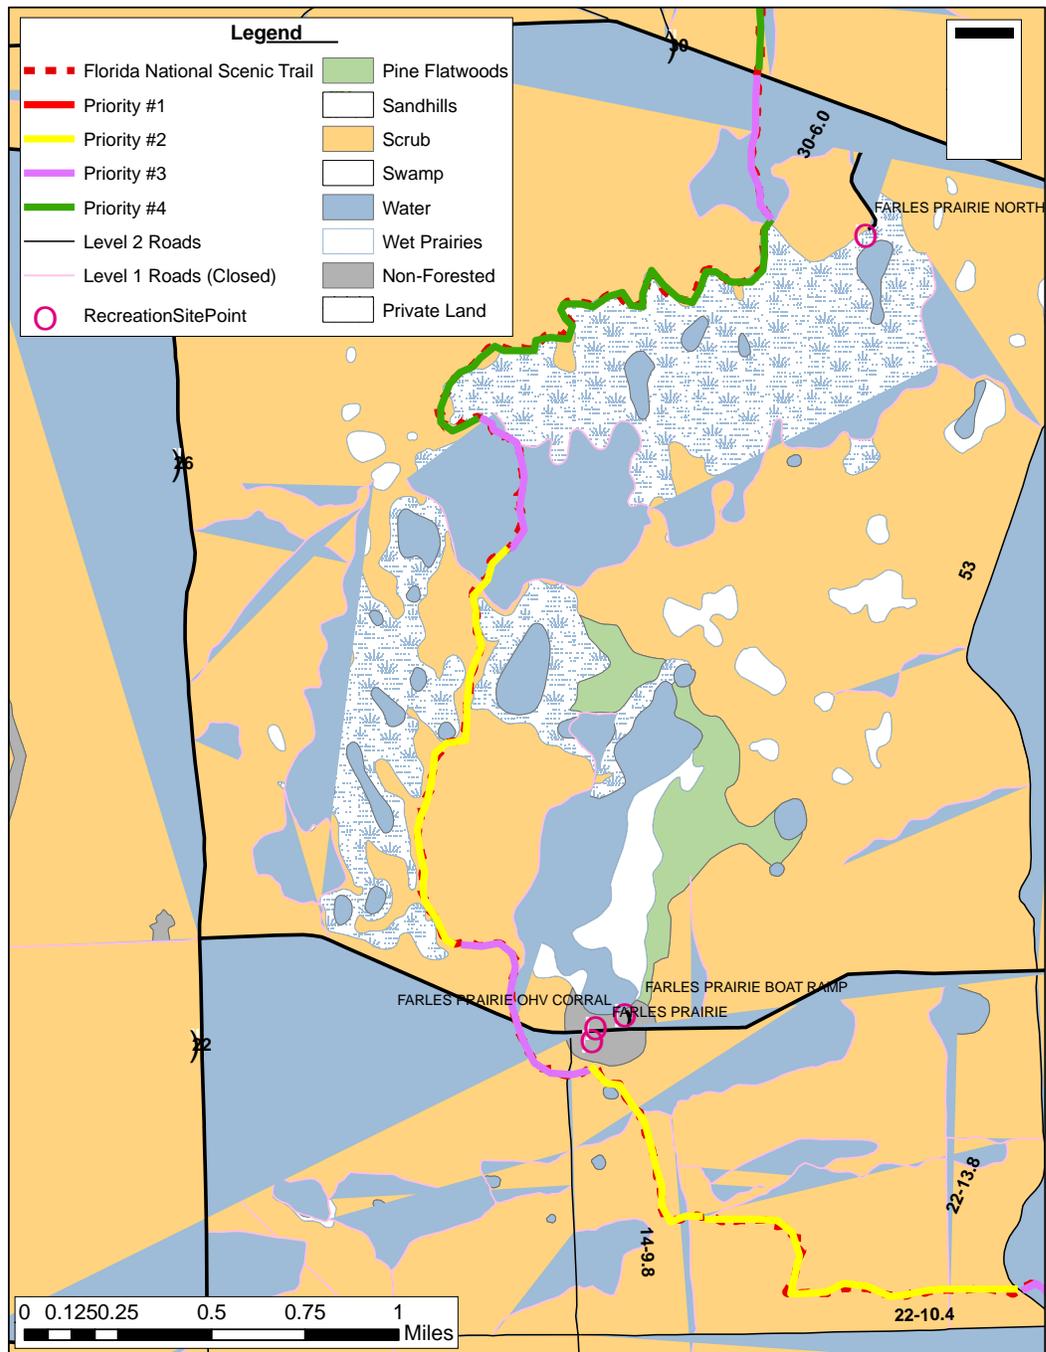
Section of trail from FR 22-13.8 to FR 30: Refer to Figure 12 for this description. The first subsection is of priority #2 because not only does it need trimming but it also runs through two older sand pine stands so blow-downs are common. The third subsection is of priority #2 because the trail runs through a stand of dead pines, which are constantly falling onto the trail. The stretch of priority #4 trail running along the wet prairies is wide open and needs little maintenance.

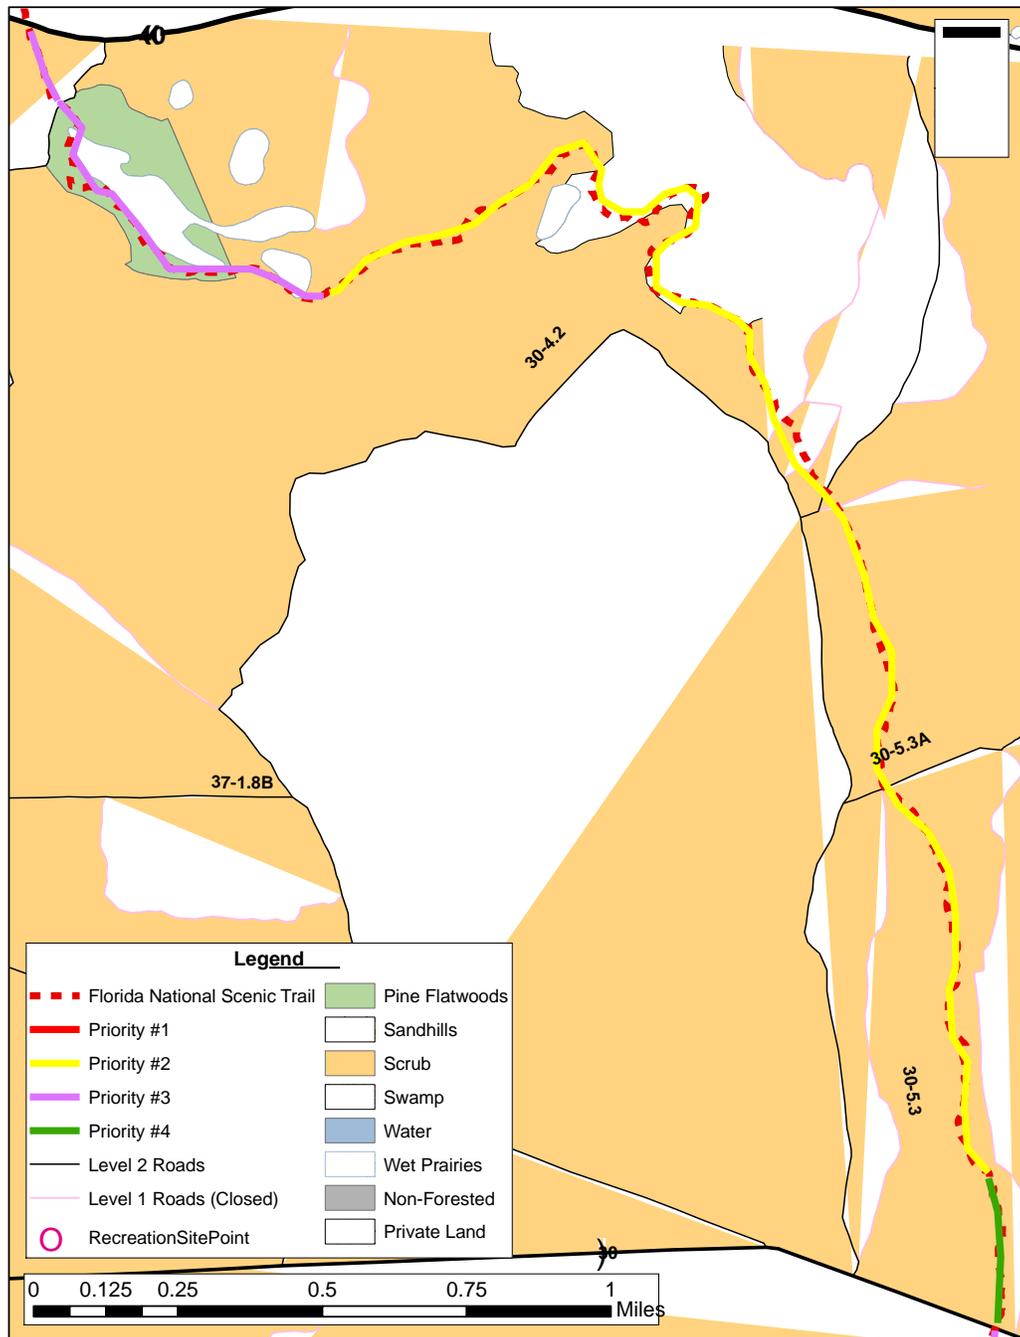
Section of trail from FR 30 to SR 40: Refer to Figure 13 for this description. Most of this section runs through overgrown scrub habitat. The trail is being encroached by scrub oak. The short subsection just north of FR30 was cleared by a brush-cutter. Most of the rest of this section runs through flatwoods and needs some attention.

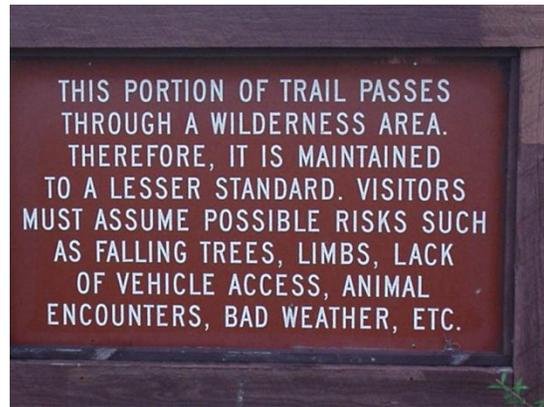
Section of trail from SR 40 to FR 46 (through Juniper Prairie Wilderness): Refer to Figures 14 and 15 for this description. As you can see from Figure 14 (photo taken heading south, when first entering the northern portion of Juniper Wilderness), the standard of maintenance is less stringent than the rest of the FNST. Regardless of the lesser standard, the current condition of the

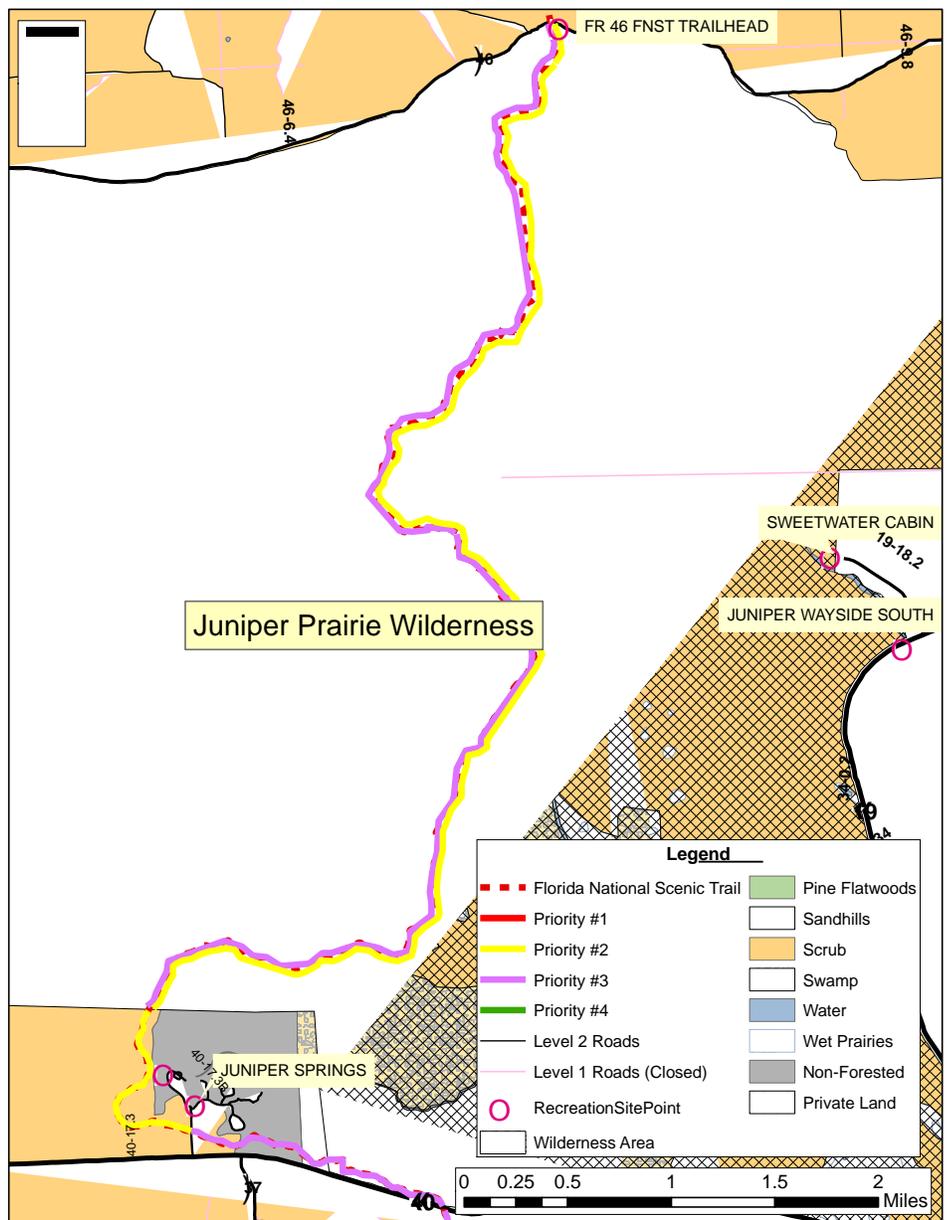
Figure 15

trail is represented in Figure 15. First entering the wilderness from SR 40, the trail is mostly priority #3 with a few palmettos jutting into the trail. Upon heading west from FR 40-17.3 (Juniper Recreation Area access road) to the southwestern boundary of the wilderness, the trail is grown in and needs maintenance. The trail through the wilderness is a consistent mixture of priority level #'s 2 and 3.

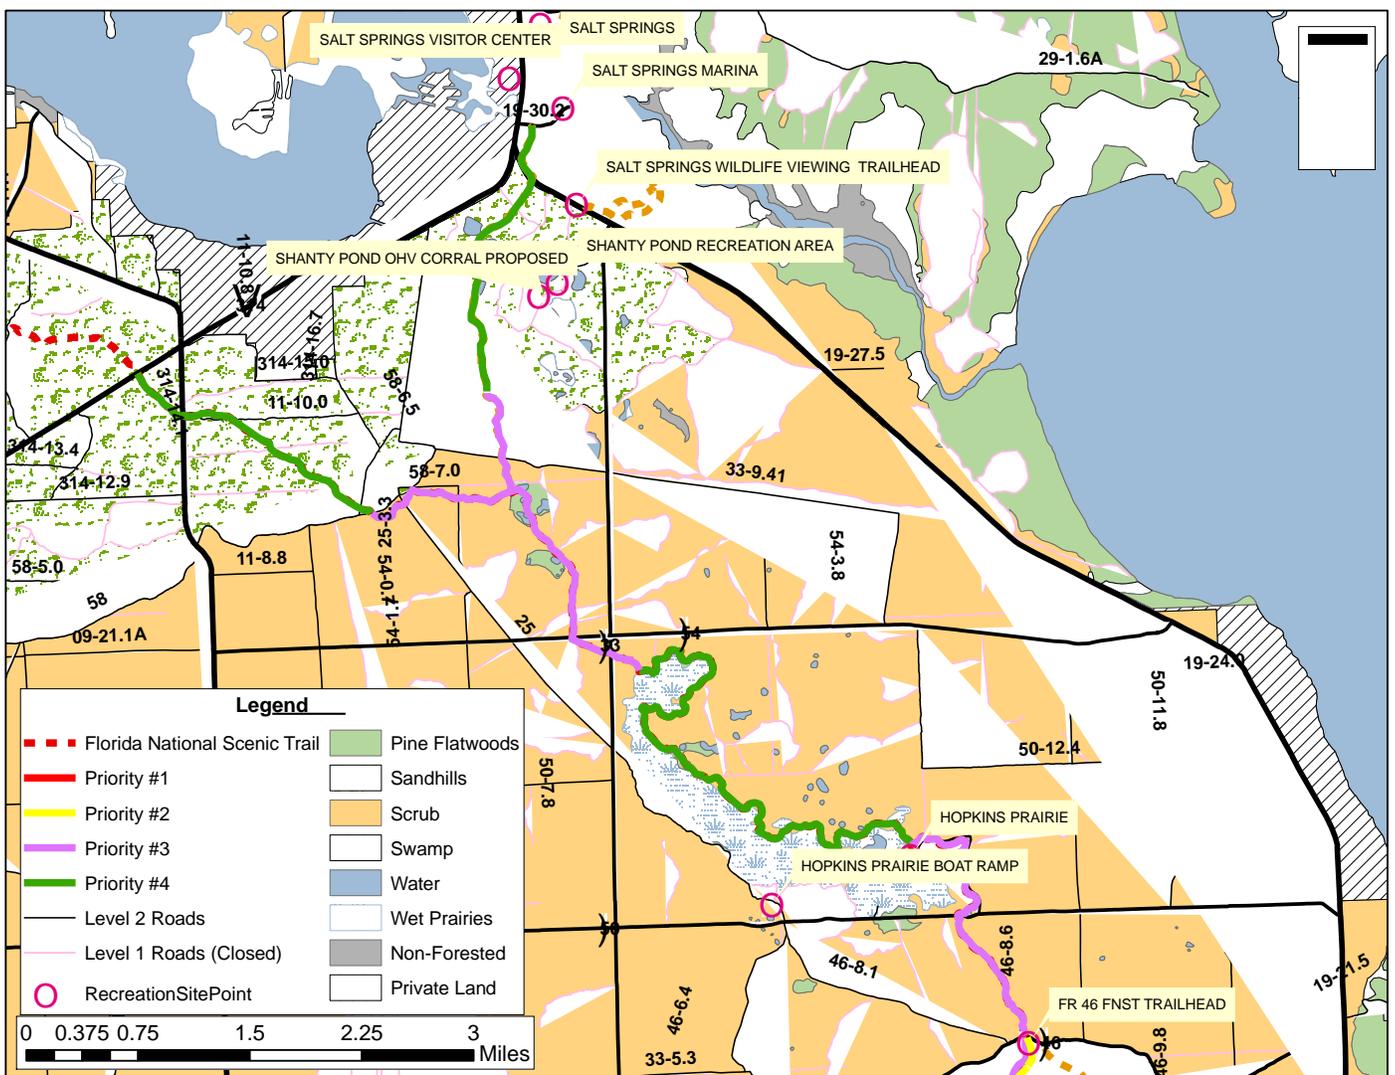
Section of trail from FR 46 to Salt Springs Marina and CR 314: Refer to Figure 16 for this description. The first subsection goes from FR 46 to Hopkins Prairie Campground. It runs mostly through scrub habitat and will need some attention. The second section runs along Hopkins Prairie and is very wide open. The only issue with this section is fallen trees. The third subsection has priority level #3 and splits to the west and north towards Salt Springs. This section is also through scrub and will eventually need some attention. The rest of this trail section goes through sandhill habitat and is of low priority.

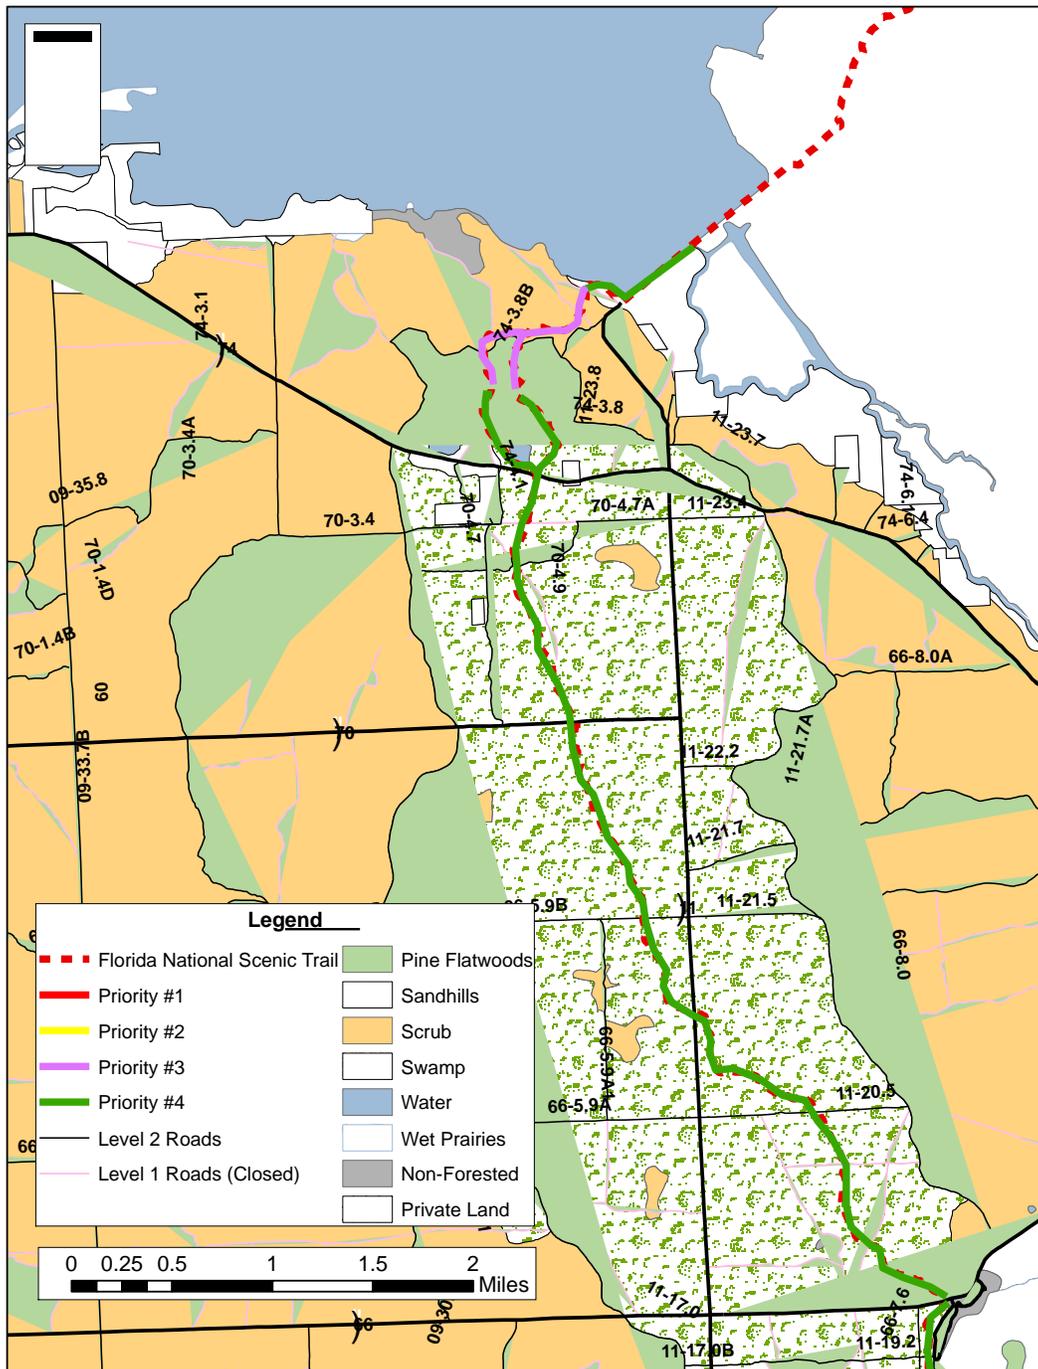
Section from FR 66 to the edge of the northern part of the forest: Refer to Figure 18 for this description. This section is very straight forward and needs little maintenance. The only subsection that could use some maintenance is the northern subsection that runs through some scrub habitat. This subsection is of priority level #3.
