Technical Memorandum  
April 2012 Site Inspection Report  
Blue Ledge Mine  
Rogue River-Siskiyou National Forest

Engineering/Remediation Resources Group, Inc. (ERRG) is submitting this technical memorandum summarizing the April 22, 2012 site inspection of the Blue Ledge Mine site. ERRG performed the site inspection in coordination with operations, maintenance, and monitoring (O&M) requirements for the Blue Ledge Mine site under the U.S. Department of Agriculture Forest Service (Forest Service) Contract No. GS-10F-0294R, Delivery Order No. AG-0489-D-10-0126. For a full list of elements inspected, please see the attached site inspection checklist ([Enclosure 1](#)), overall site plan ([Enclosure 2](#)), and photographic log ([Enclosure 3](#)).

# **Enclosure 1.      April 2012 Blue Ledge Mine Inspection Checklist**

# **Enclosure 3.      April 2012 Site Inspection Photographic Log**

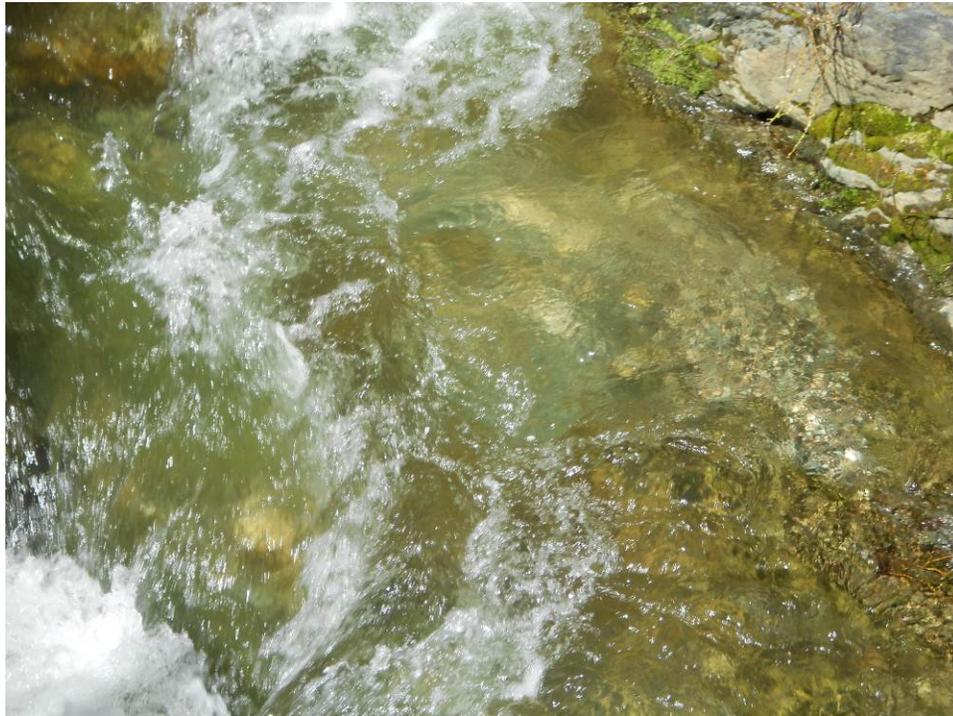
**Photograph 1: Joe Creek at Joe Creek Bridge.**  
Blue Ledge Mine, Rogue River - Siskiyou National Forest, CA  
Photographed by: Randall West (ERRG)

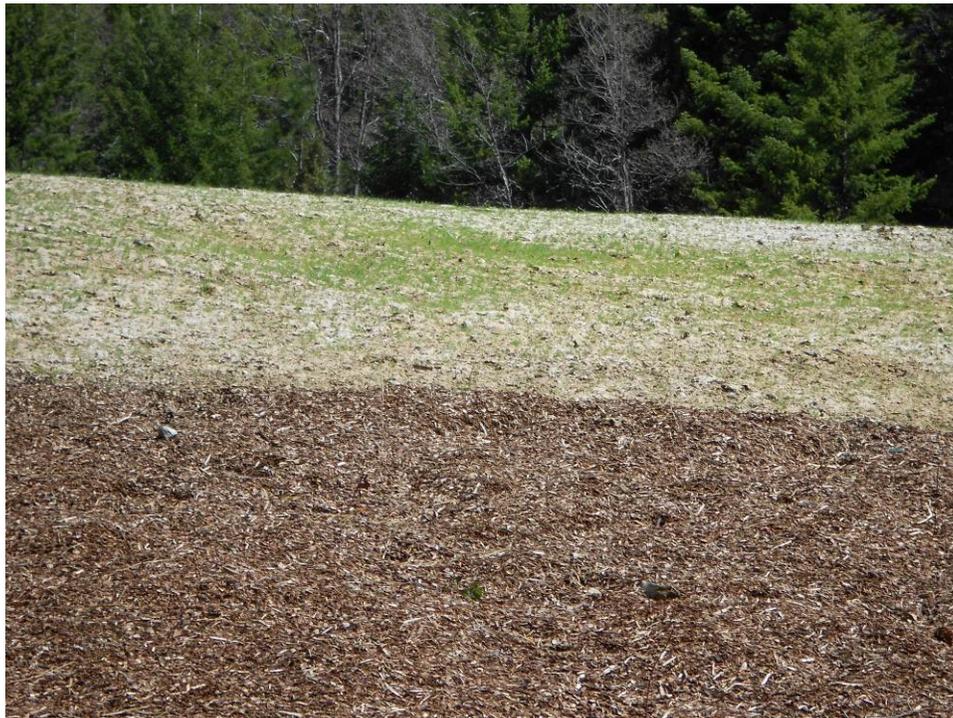
**Photograph 2: Repository hydroseed and reclamation plantings.**  
Blue Ledge Mine, Rogue River - Siskiyou National Forest, CA  
Photographed by: Randall West (ERRG)

Comments: Need to apply Big Game Repellant to shrubs and trees on repository and repository stockpile area.

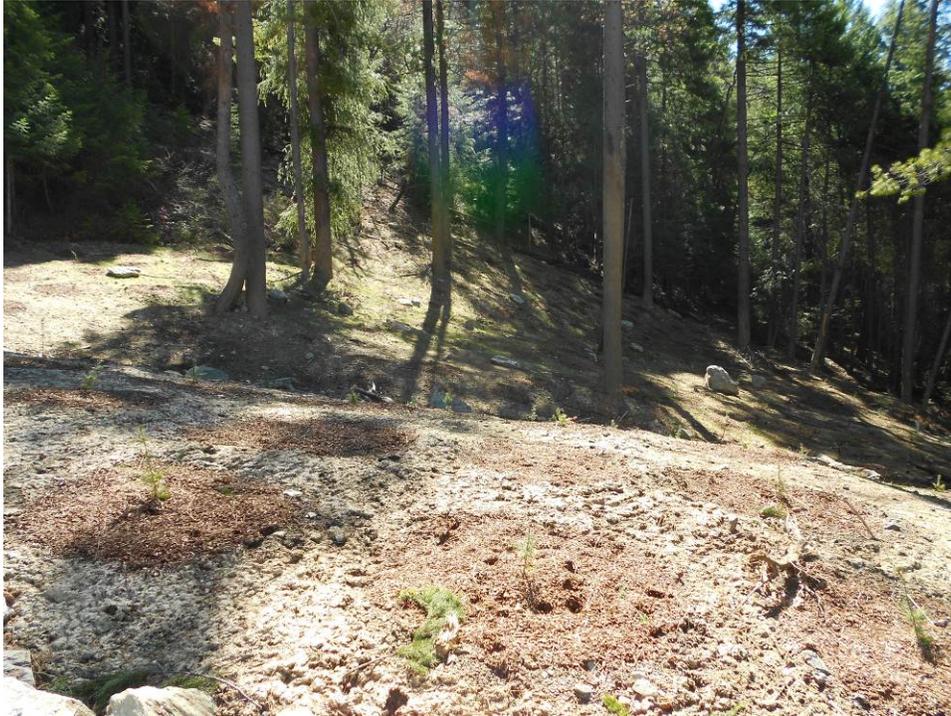
Photograph 3: **Repository stockpile with hydroseed and reclamation plantings.**  
Blue Ledge Mine, Rogue River - Siskiyou National Forest, CA  
Photographed by: Randall West (ERRG)

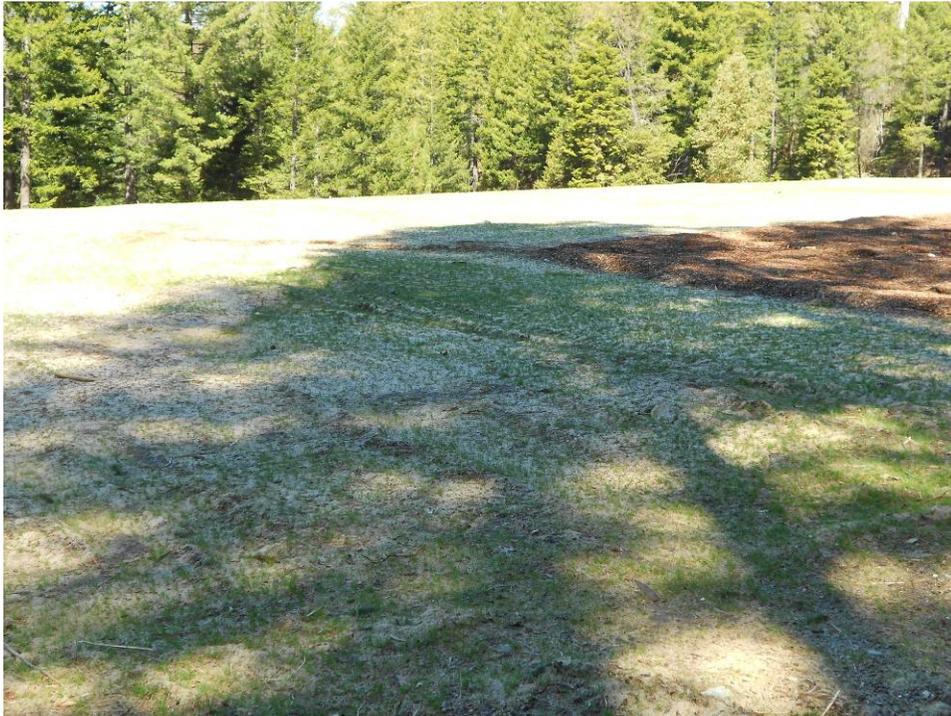
Photograph 4: **Repository hydroseed and reclamation planting.**  
Blue Ledge Mine, Rogue River - Siskiyou National Forest, CA  
Photographed by: Randall West (ERRG)

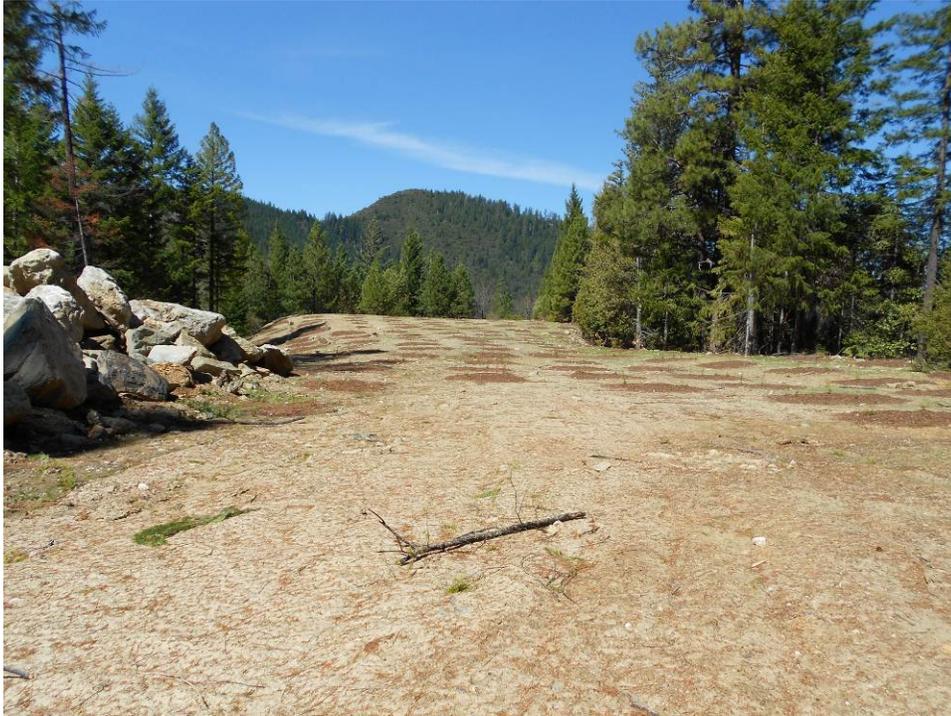
Photograph 5: **North stockpile with hydroseed and reclamation planting.**  
Blue Ledge Mine, Rogue River - Siskiyou National Forest, CA  
Photographed by: Randall West (ERRG)

Comments: Apply Big Game Repellent to reduce further Browsing.

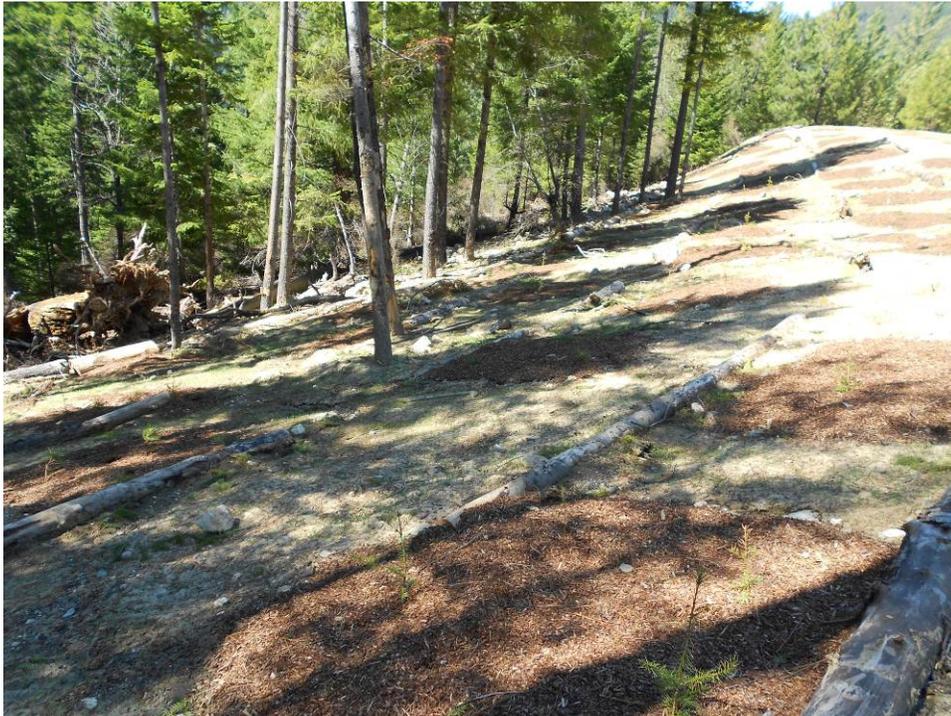
Photograph 6: **Reclamation plantings at north stockpile.**  
Blue Ledge Mine, Rogue River - Siskiyou National Forest, CA  
Photographed by: Randall West (ERRG)

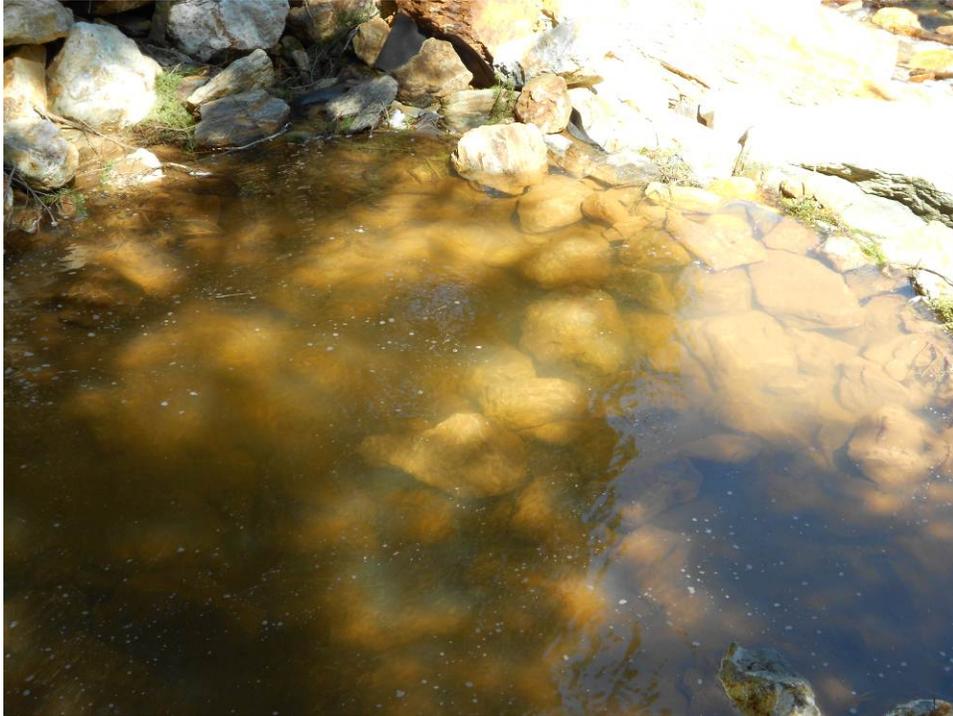
The stockpile areas and WRP 2, 3, and 4 had minimal erosion, while a significant amount of sediment had eroded from WRP 1. All of the sediment, however, was captured in sediment basins 1F through 1A, and in the riprap above the sediment basins. No evidence was observed that sediment had entered Joe Creek. Sediment and debris were also observed in sediment treatment basins 2A and 2B. Sediment treatment basin 3 did not have significant sediment accumulation.

Photograph 7: **Water in sediment treatment basin 1A at bottom of WRP 1.**  
Blue Ledge Mine, Rogue River - Siskiyou National Forest, CA  
Photographed by: Randall West (ERRG)

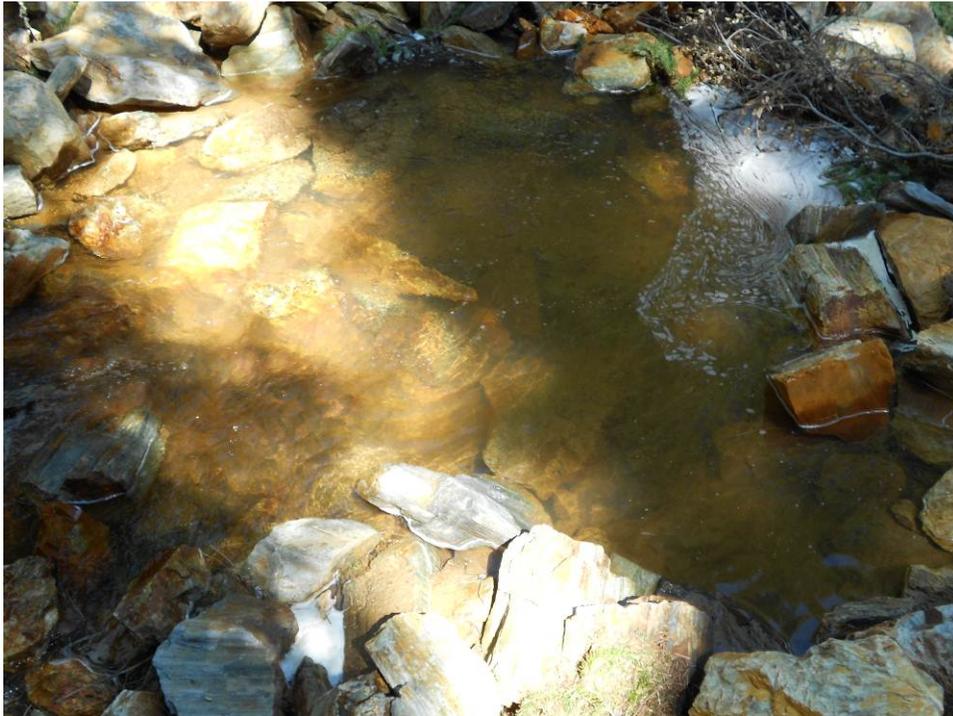
Water depth water is leaking around liner at 1B, not  
Spilling over liner. (Water ~1 foot deep).

Photograph 8: **Water in sediment treatment basin 1B at bottom of WRP 1.**  
Blue Ledge Mine, Rogue River - Siskiyou National Forest, CA  
Photographed by: Randall West (ERRG)

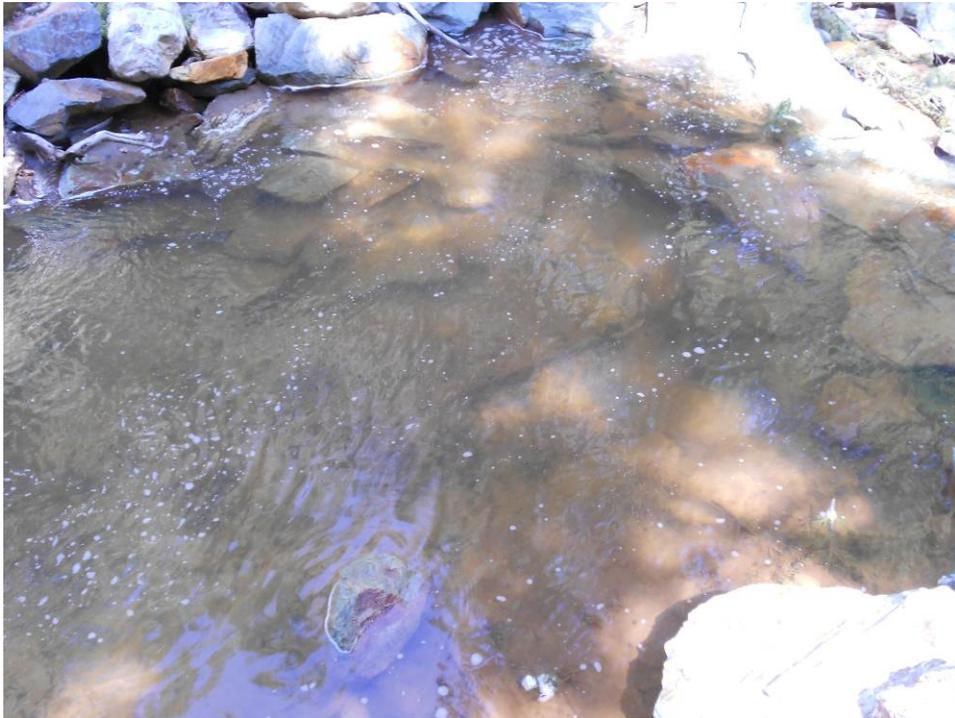
Photograph 9: **Water in sediment treatment basin 1C at bottom of WRP 1.**  
Blue Ledge Mine, Rogue River - Siskiyou National Forest, CA  
Photographed by: Randall West (ERRG)

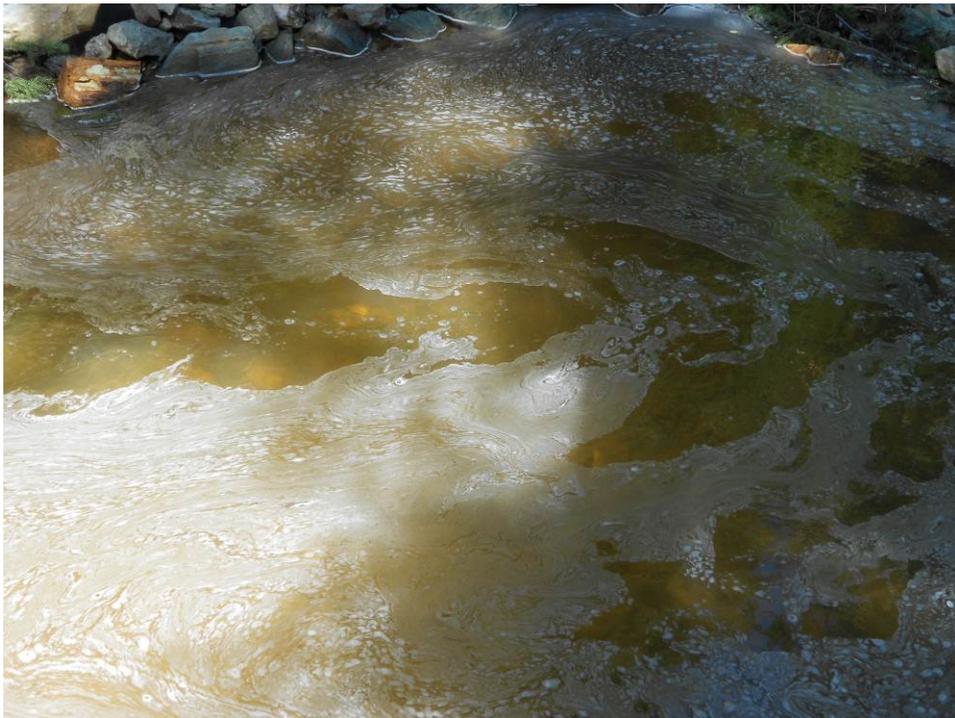
Photograph 10: **Water in sediment treatment basin 1D at bottom of WRP 1.**  
Blue Ledge Mine, Rogue River - Siskiyou National Forest, CA  
Photographed by: Randall West (ERRG)

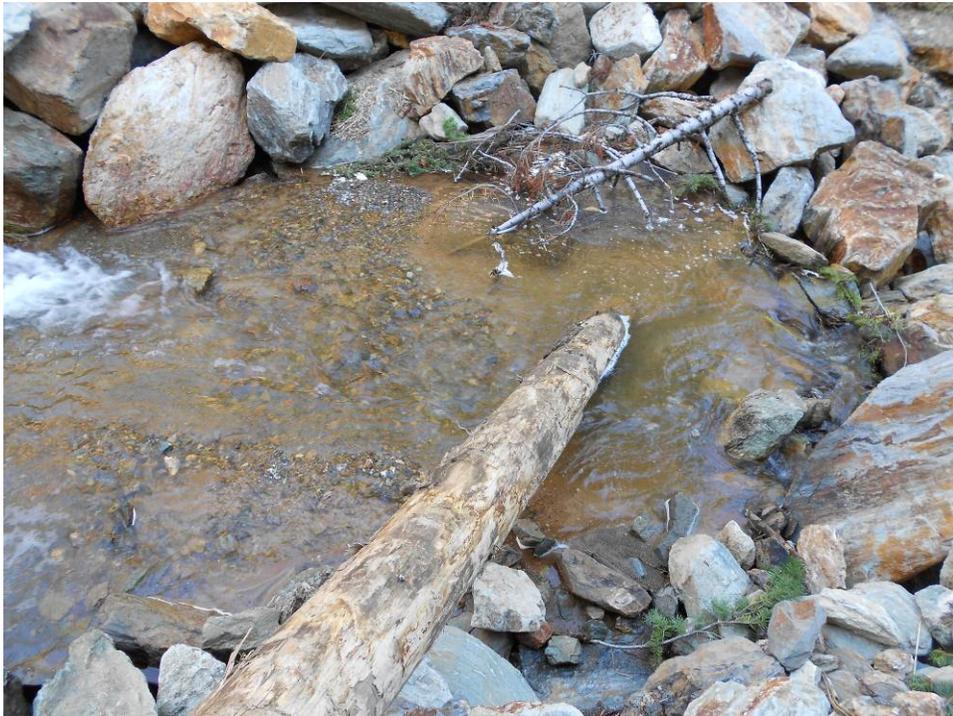
Photograph 11: **Water in sediment/ treatment basin 1E bottom of WRP 1.**  
Blue Ledge Mine, Rogue River - Siskiyou National Forest, CA  
Photographed by: Randall West (ERRG)

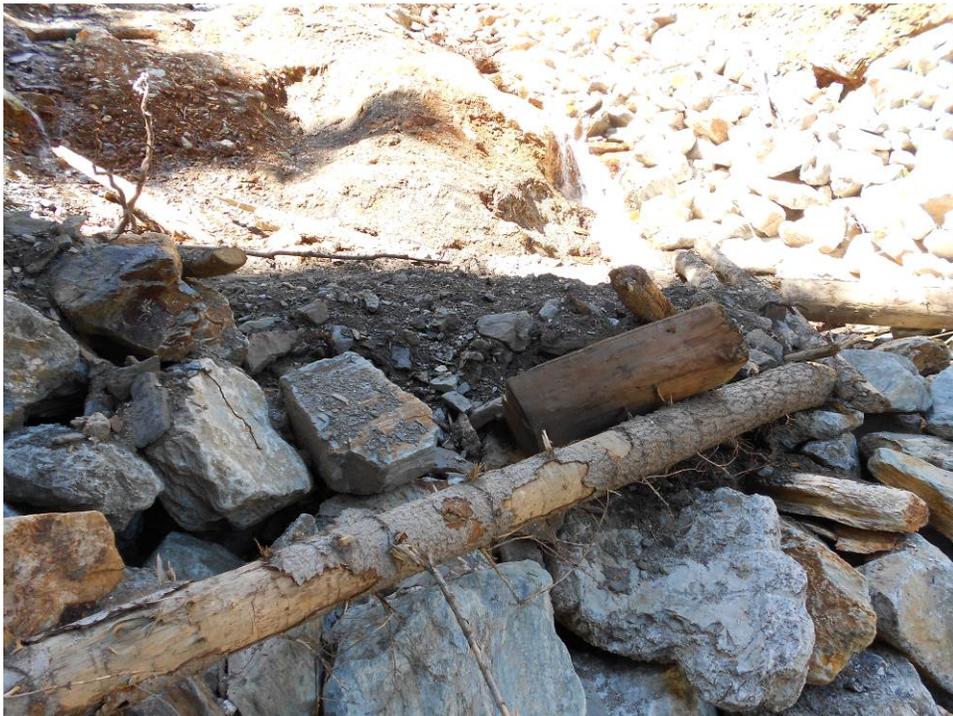
Photograph 12: **Debris in sediment/treatment basin 1F bottom of WRP 1.**  
Blue Ledge Mine, Rogue River - Siskiyou National Forest, CA  
Photographed by: Randall West (ERRG)

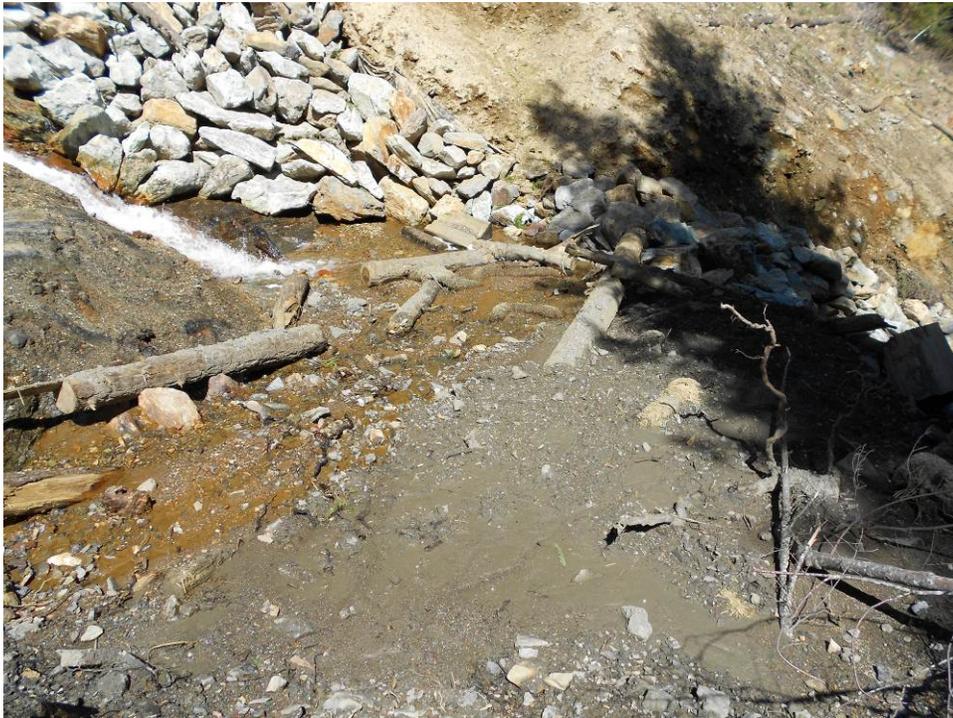
Photograph 13: **Water in sediment/treatment basin 1F bottom of WRP 1.**  
Blue Ledge Mine, Rogue River - Siskiyou National Forest, CA  
Photographed by: Randall West (ERRG)

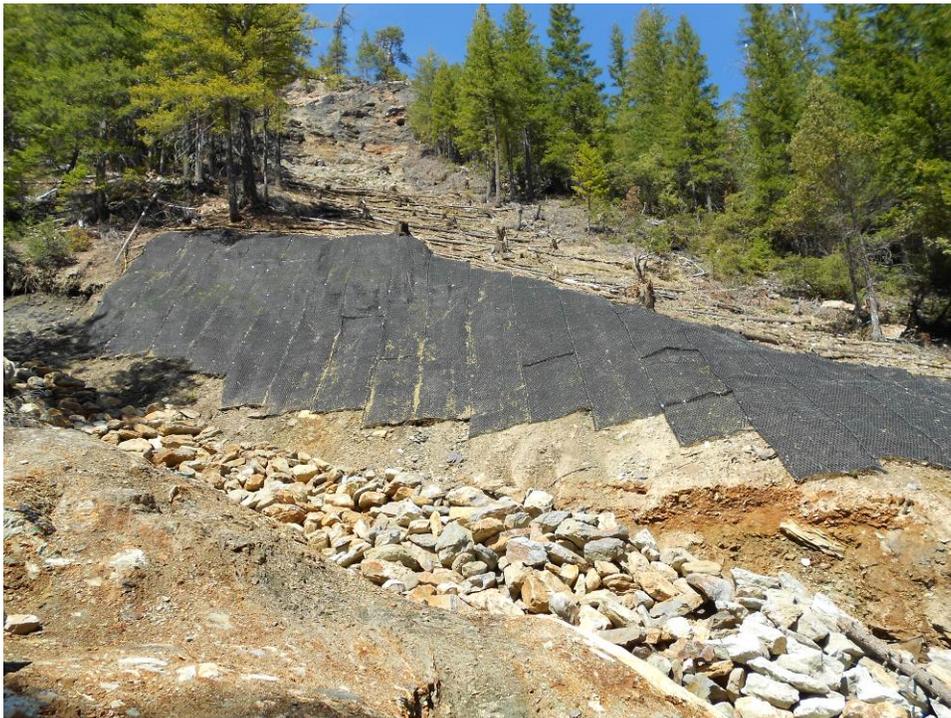
Photograph 14: **Erosion control fabric at base of WRP 4; rock-lined channel in lower part of photograph.**  
Blue Ledge Mine, Rogue River - Siskiyou National Forest, CA  
Photographed by: Randall West (ERRG)

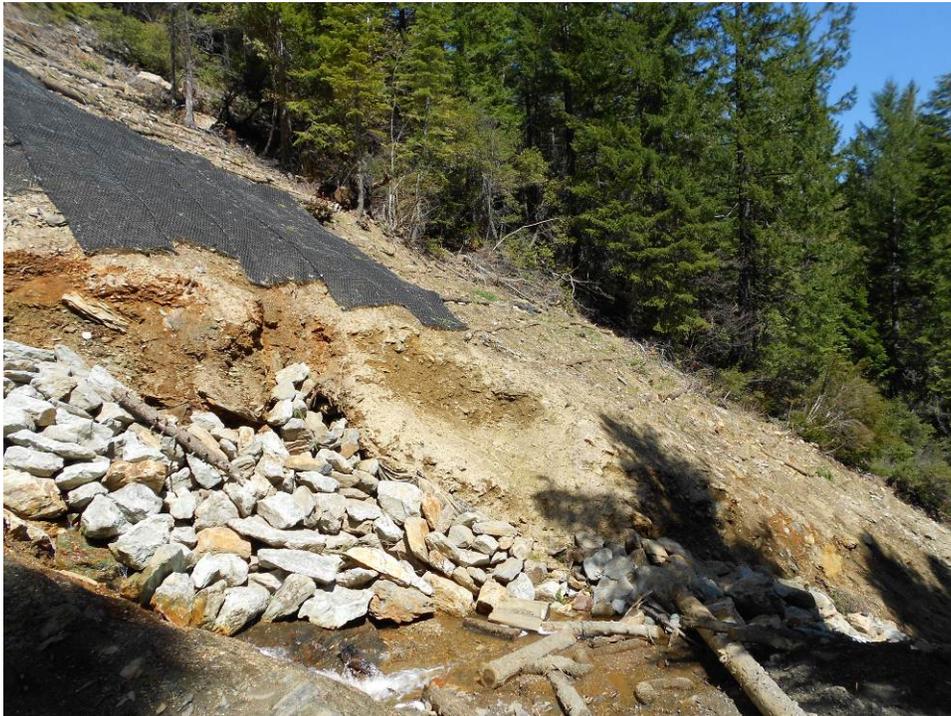
Photograph 15: **Erosion control fabric at base of WRP 4; sediment treatment basin 1F in lower part of photograph.**

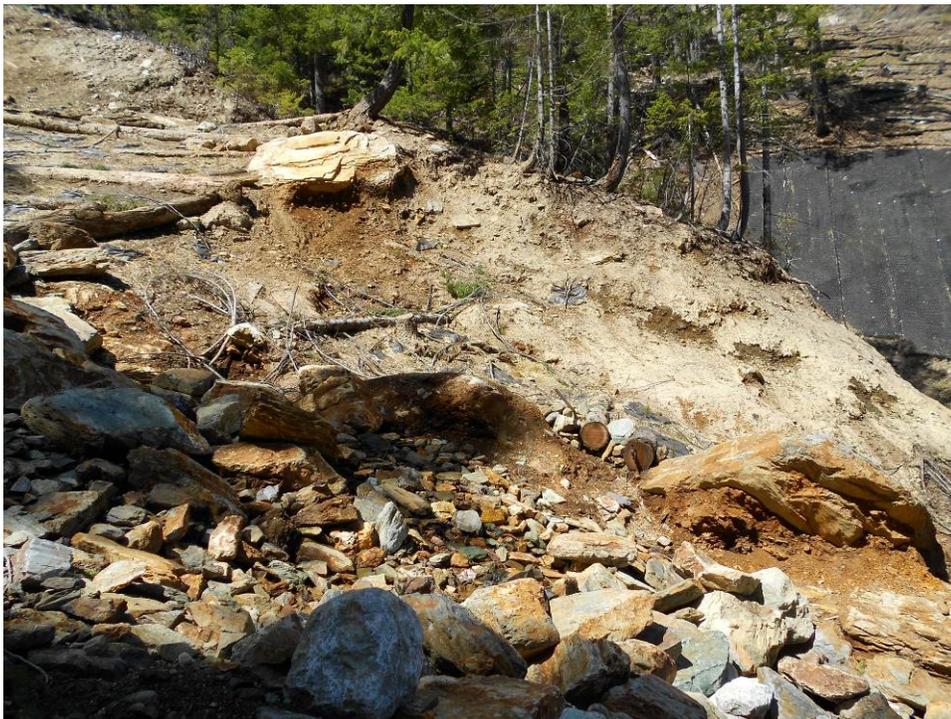
Photograph 16: **Hydroseeded slope at base of WRP 1; reclamation area just uphill from hydroseeded slope.**

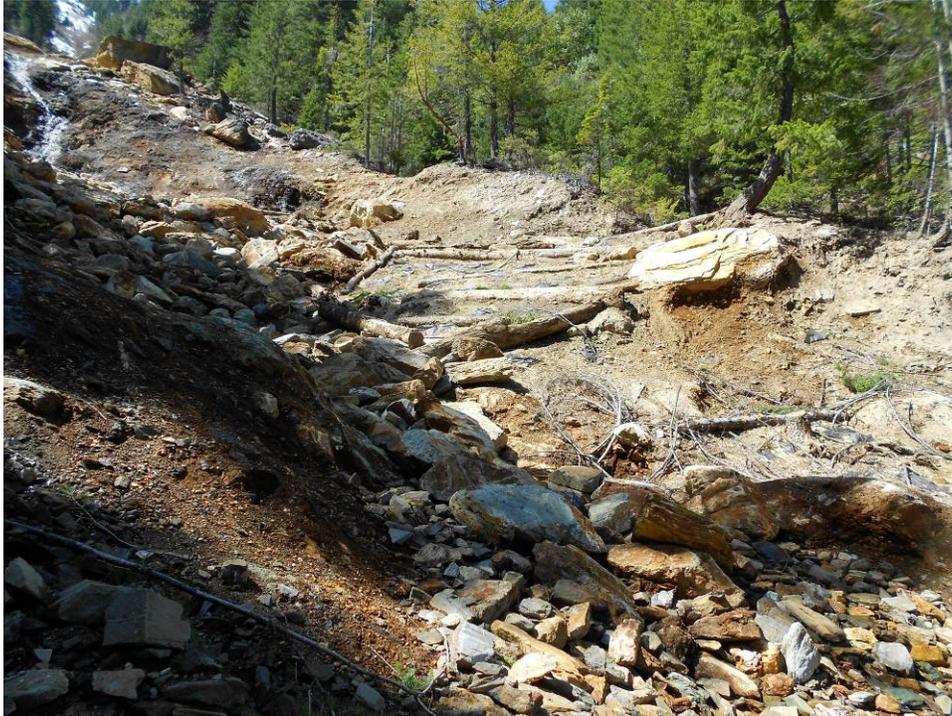
Photograph 17: **Reclamation area and rip rap channel on WRP 1.**  
Blue Ledge Mine, Rogue River - Siskiyou National Forest, CA  
Photographed by: Randall West (ERRG)

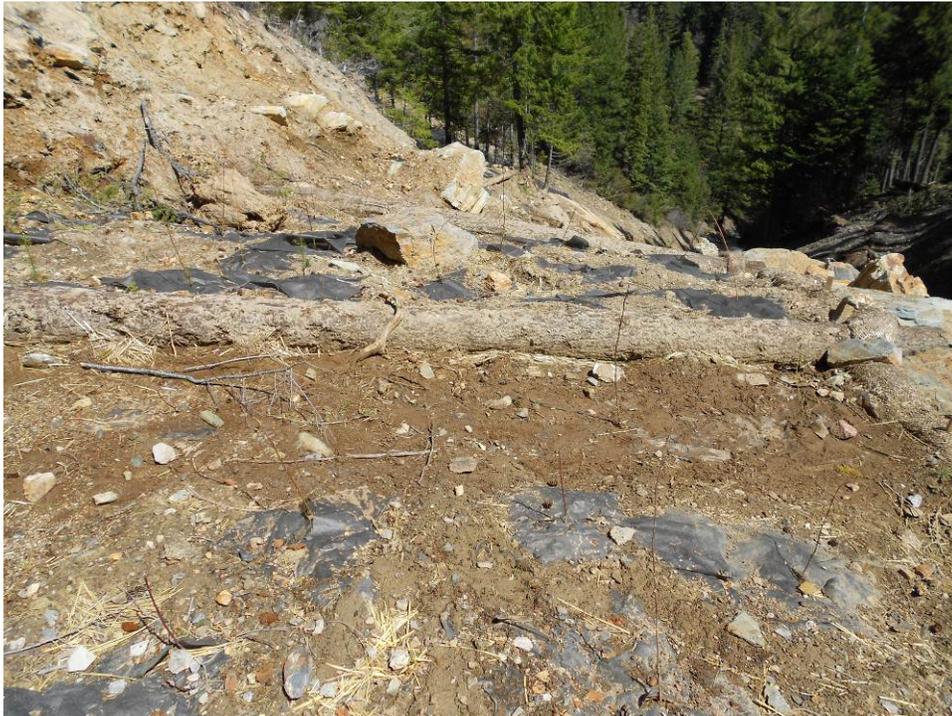
Photograph 18: **Log wattles and reclamation plantings on WRP 1.**  
Blue Ledge Mine, Rogue River - Siskiyou National Forest, CA  
Photographed by: Randall West (ERRG)

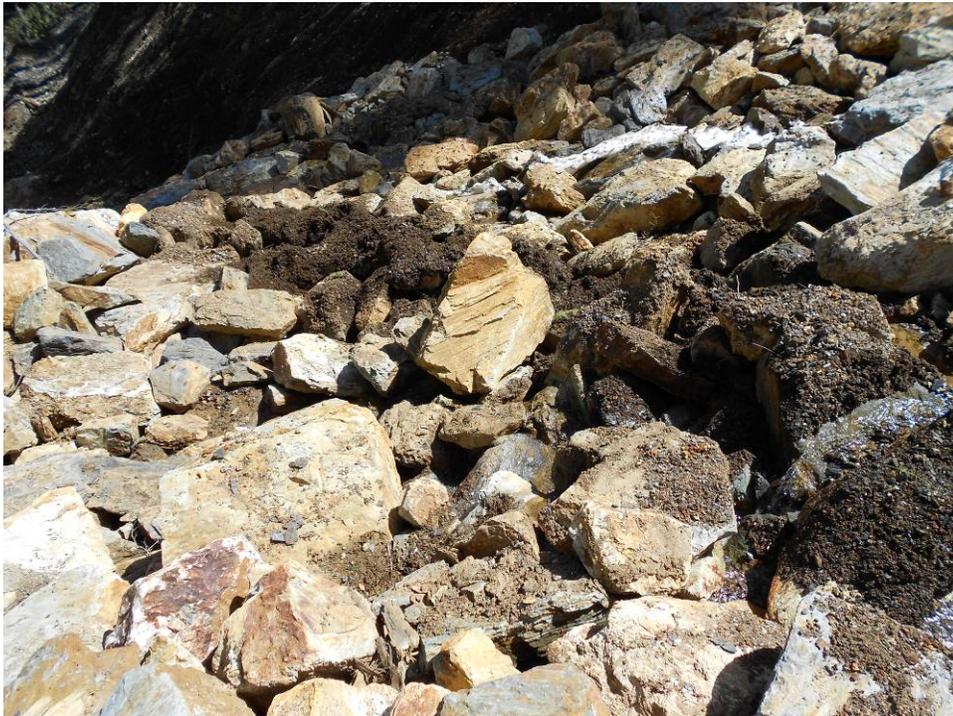
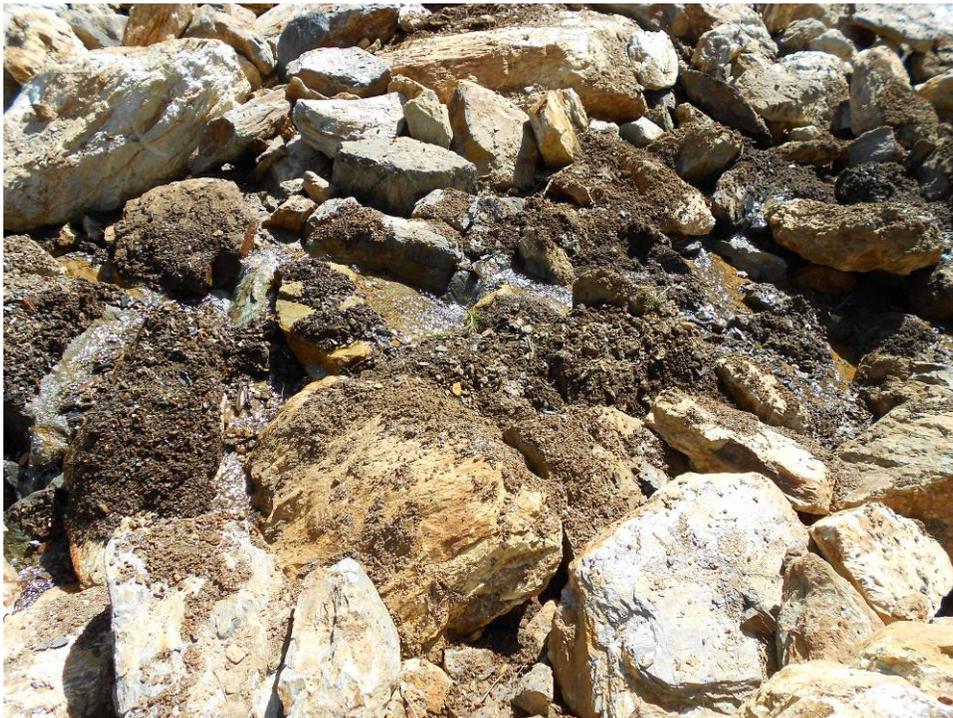
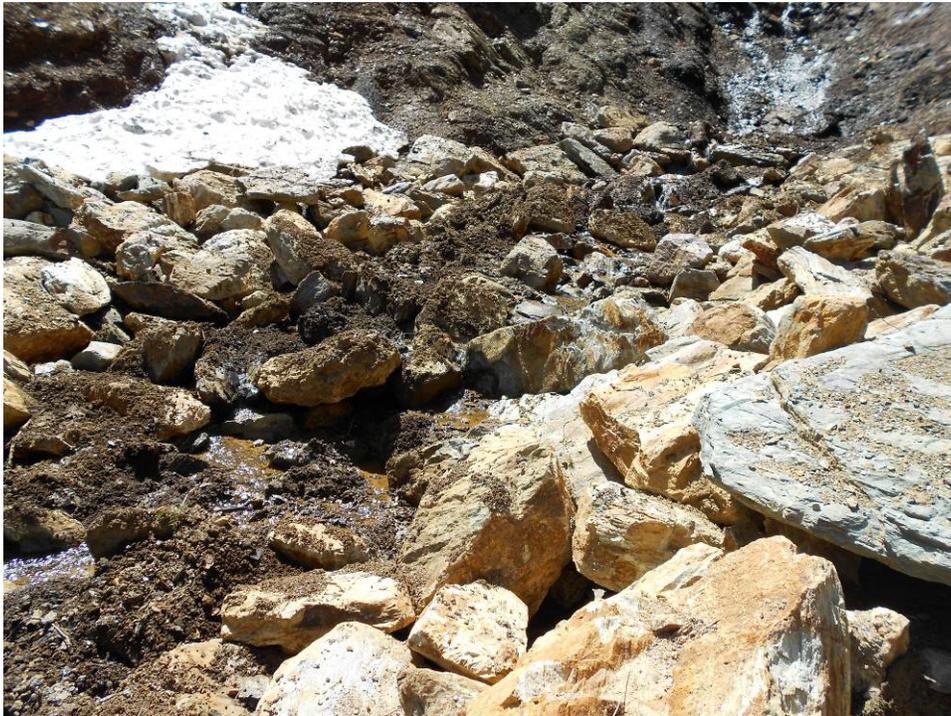
Photograph 19: **Winter debris deposited on riprap channel at base of WRP 1.**  
Blue Ledge Mine, Rogue River - Siskiyou National Forest, CA  
Photographed by: Randall West (ERRG)

Photograph 20: **Winter debris deposited on riprap channel at base of WRP 1.**  
Blue Ledge Mine, Rogue River - Siskiyou National Forest, CA  
Photographed by: Randall West (ERRG)

Photograph 21: **Winter debris deposited on riprap channel at base of WRP 1.**  
Blue Ledge Mine, Rogue River - Siskiyou National Forest, CA  
Photographed by: Randall West (ERRG)

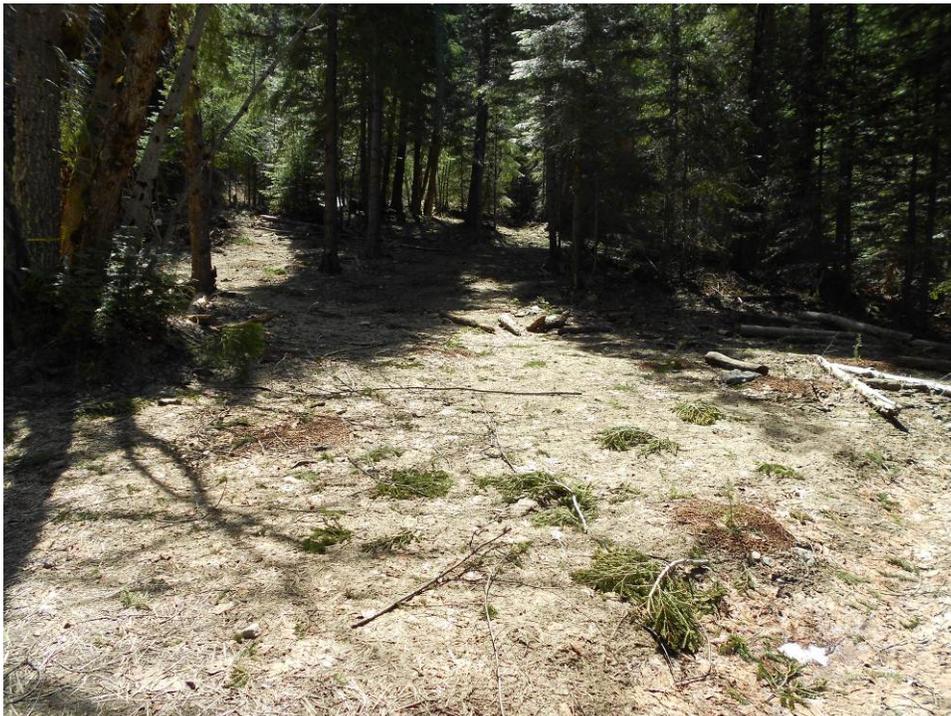
Photograph 22: **Rock Stockpile reclamation area along haul road 1.**  
Blue Ledge Mine, Rogue River - Siskiyou National Forest, CA  
Photographed by: Randall West (ERRG)

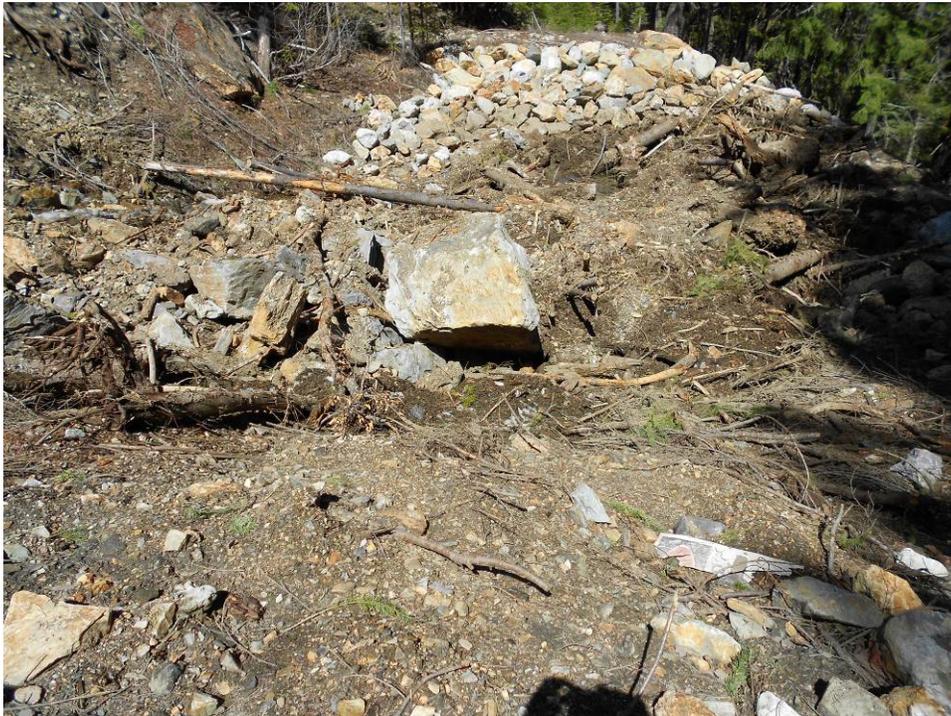
**Photograph 23: Rock and soil slide into sediment treatment basin 2A at bottom of WRP 2.**

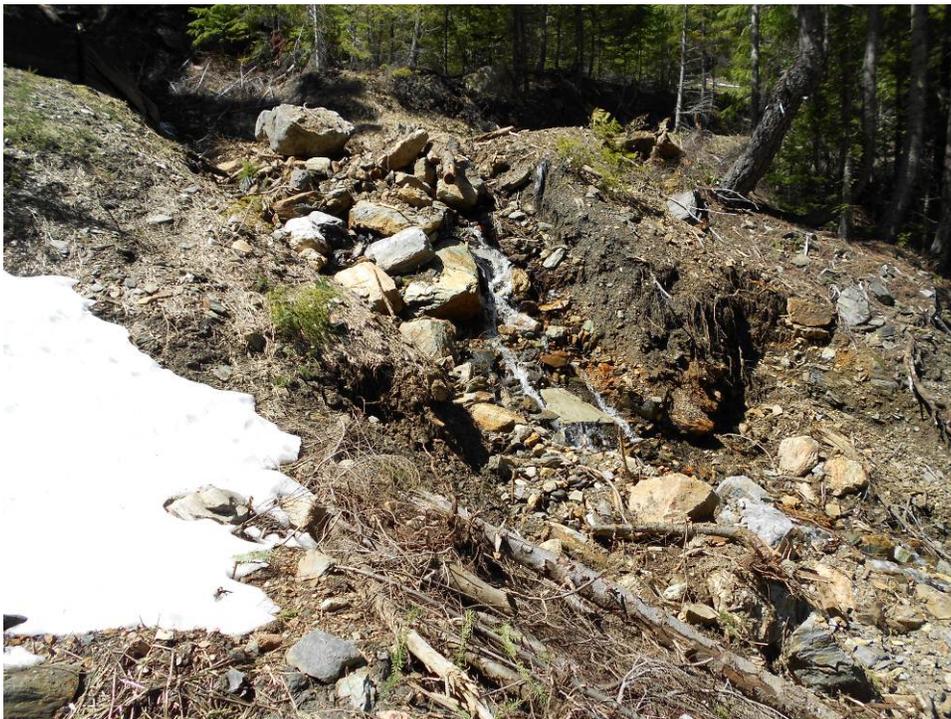
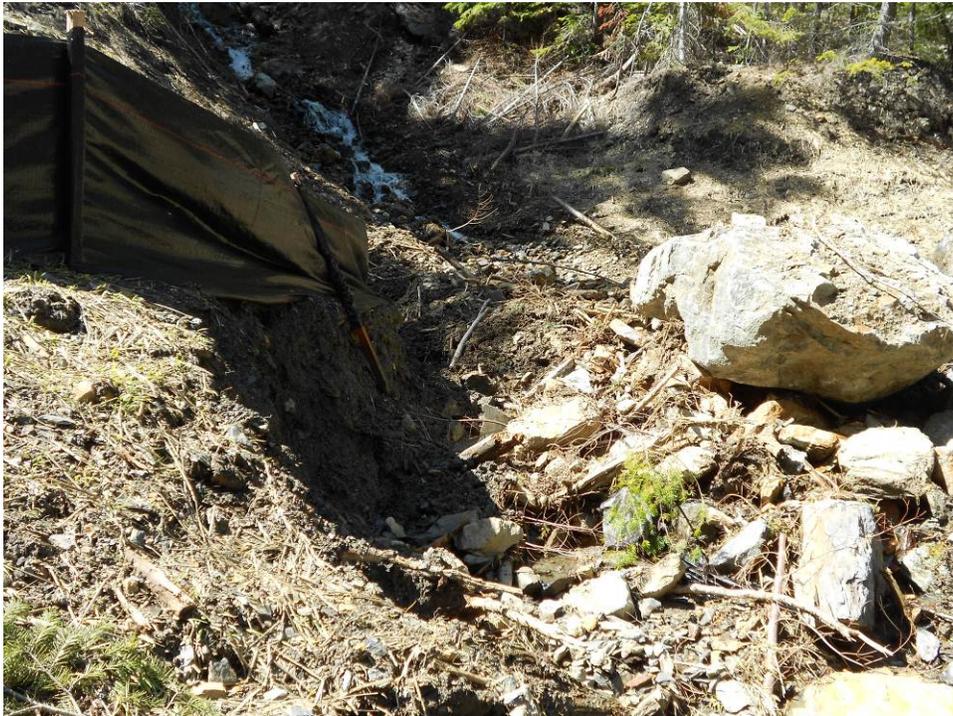
**Photograph 24: Haul Road 1 washed out above sediment basin 2A.**

Photograph 25: **Haul Road 1 washed out above sediment basin 2A.**  
Blue Ledge Mine, Rogue River - Siskiyou National Forest, CA  
Photographed by: Randall West (ERRG)

Some erosion was observed on Forest Road 1060 and haul roads (as previously documented during the SWPPP inspections) and will require maintenance over the summer. Some culverts will be cleared by hand during May maintenance activities. Road condition was similar to that observed during the last SWPPP inspection. Overall, the roads are in very good shape.

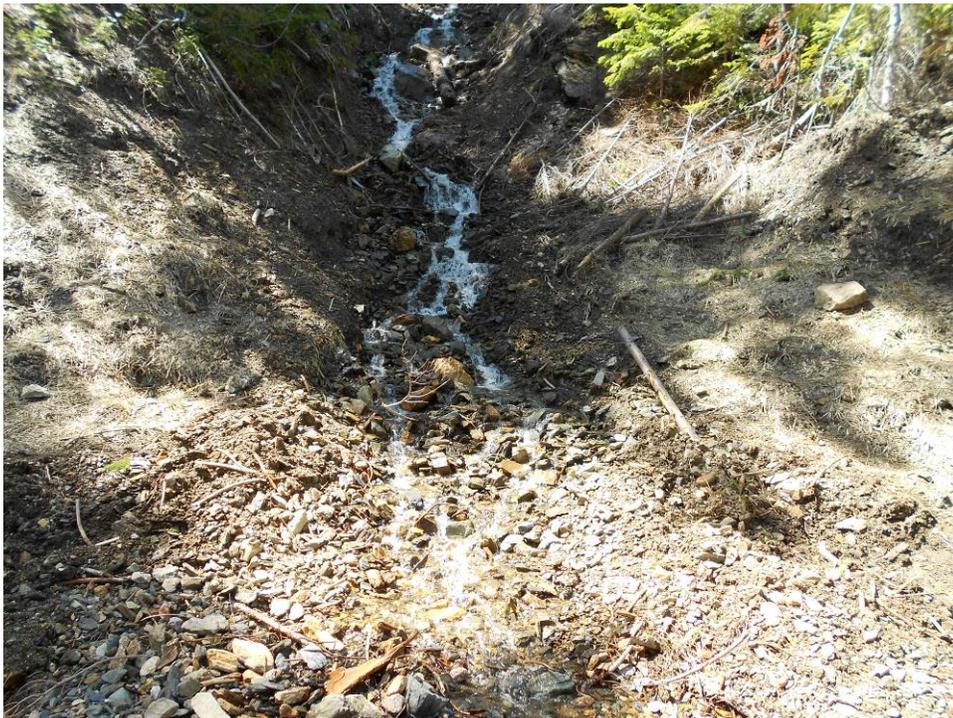
Photograph 26: **Stream flow downhill from sediment basin 2B to Haul Road 1 crossing above sediment basin 2A at WRP 2.**  
Blue Ledge Mine, Rogue River - Siskiyou National Forest, CA  
Photographed by: Randall West (ERRG)

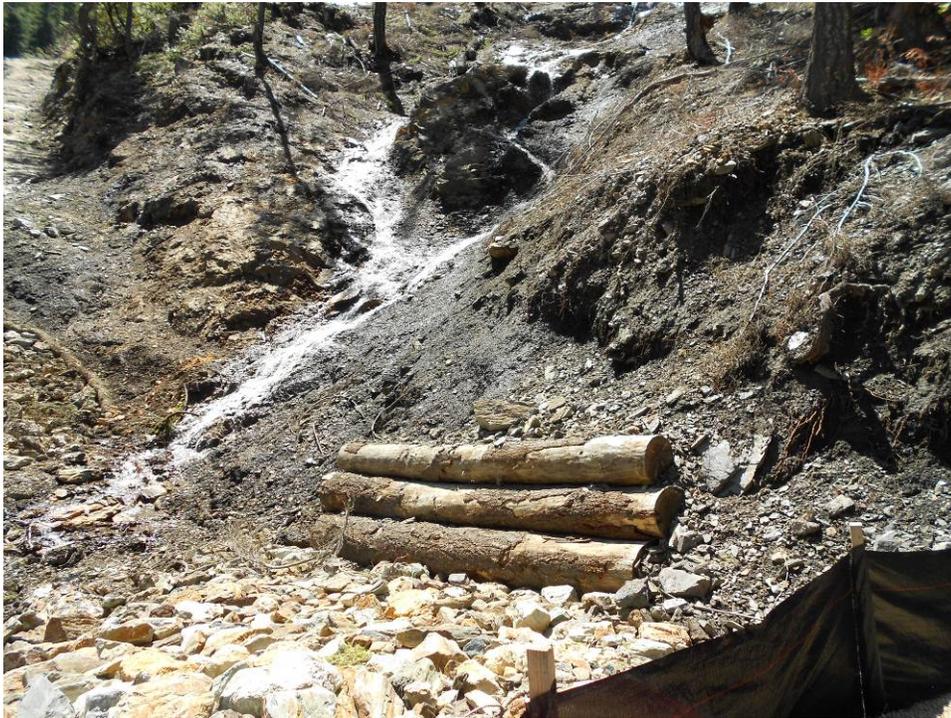
Photograph 27: **Haul road 4 crossing upslope from sediment basin 2B at WRP 2.**  
Blue Ledge Mine, Rogue River - Siskiyou National Forest, CA  
Photographed by: Randall West (ERRG)

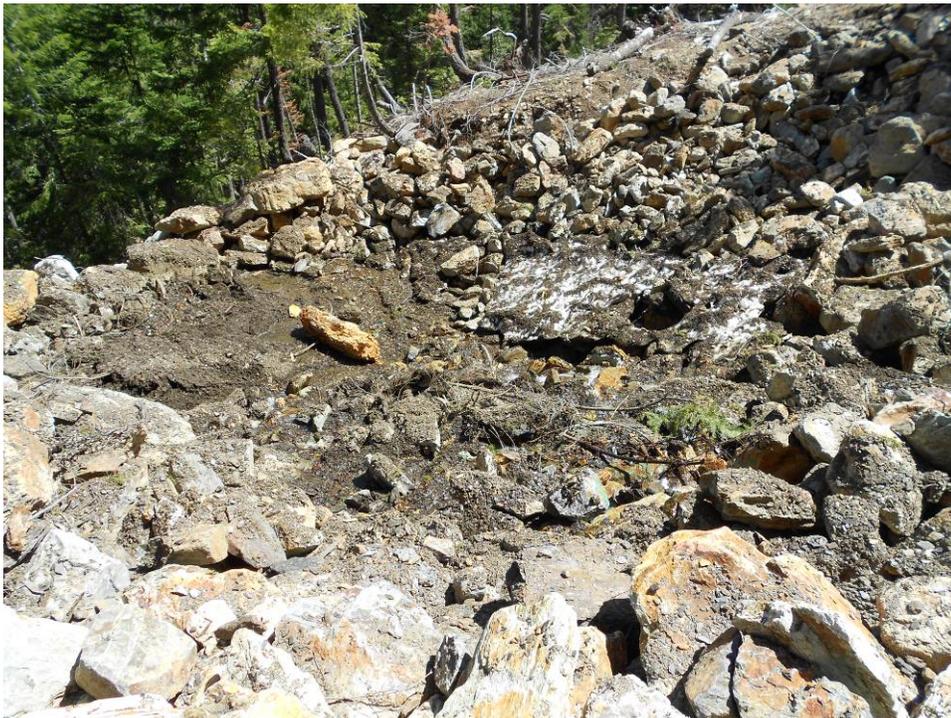
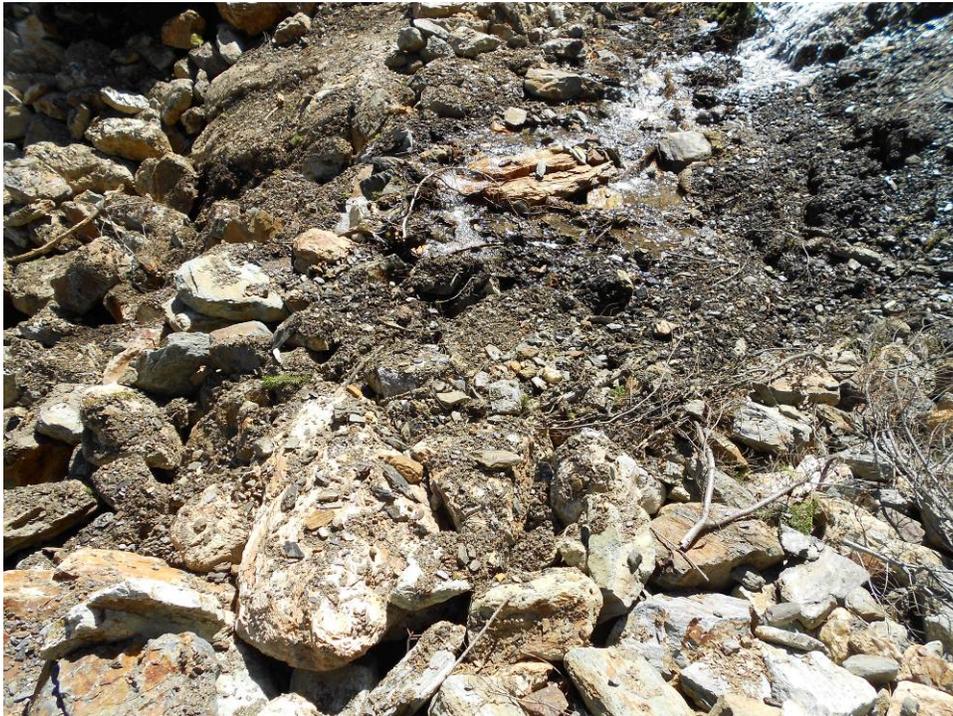
Photograph 28: **Sediment in sediment treatment basin 2B at WRP 2.**  
Blue Ledge Mine, Rogue River - Siskiyou National Forest, CA  
Photographed by: Randall West (ERRG)

Photograph 29: **Sediment in 2B sediment treatment basin at WRP 2.**  
Blue Ledge Mine, Rogue River - Siskiyou National Forest, CA  
Photographed by: Randall West (ERRG)

The pH and amount of accumulated sediment in the treatment and sediment basins were not assessed during this site inspection because a later site visit was planned, but did not occur due to weather. The pH and accumulated sediment measurements are not required as a part of the O&M Plan, but ERRG will track these site conditions to help facilitate planned maintenance activities. The pH and amount of accumulated sediment will be measured during the May site inspection as part of the biannual sampling event. An evaluation of limestone fouling will be made during clean out of the accumulated sediment in August 2012, when water runoff is at the annual minimum flow.

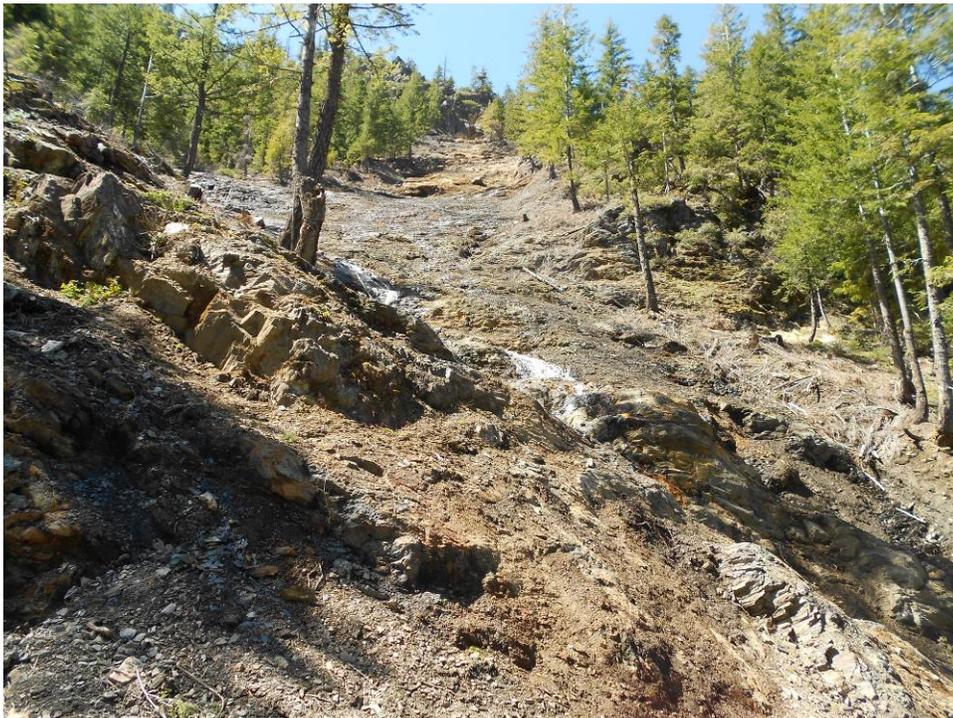
Photograph 30: **WRP 2 looking up from Haul Road 4.**  
Blue Ledge Mine, Rogue River - Siskiyou National Forest, CA  
Photographed by: Randall West (ERRG)
