Technical Memorandum  
April 2012 Site Inspection Report  
Blue Ledge Mine  
Rogue River-Siskiyou National Forest

Engineering/Remediation Resources Group, Inc. (ERRG) is submitting this technical memorandum summarizing the April 22, 2012 site inspection of the Blue Ledge Mine site. ERRG performed the site inspection in coordination with operations, maintenance, and monitoring (O&M) requirements for the Blue Ledge Mine site under the U.S. Department of Agriculture Forest Service (Forest Service) Contract No. GS-10F-0294R, Delivery Order No. AG-0489-D-10-0126. For a full list of elements inspected, please see the attached site inspection checklist ([Enclosure 1](#)), overall site plan ([Enclosure 2](#)), and photographic log ([Enclosure 3](#)).

# **Enclosure 1.      April 2012 Blue Ledge Mine Inspection Checklist**

# **Enclosure 3.      April 2012 Site Inspection Photographic Log**

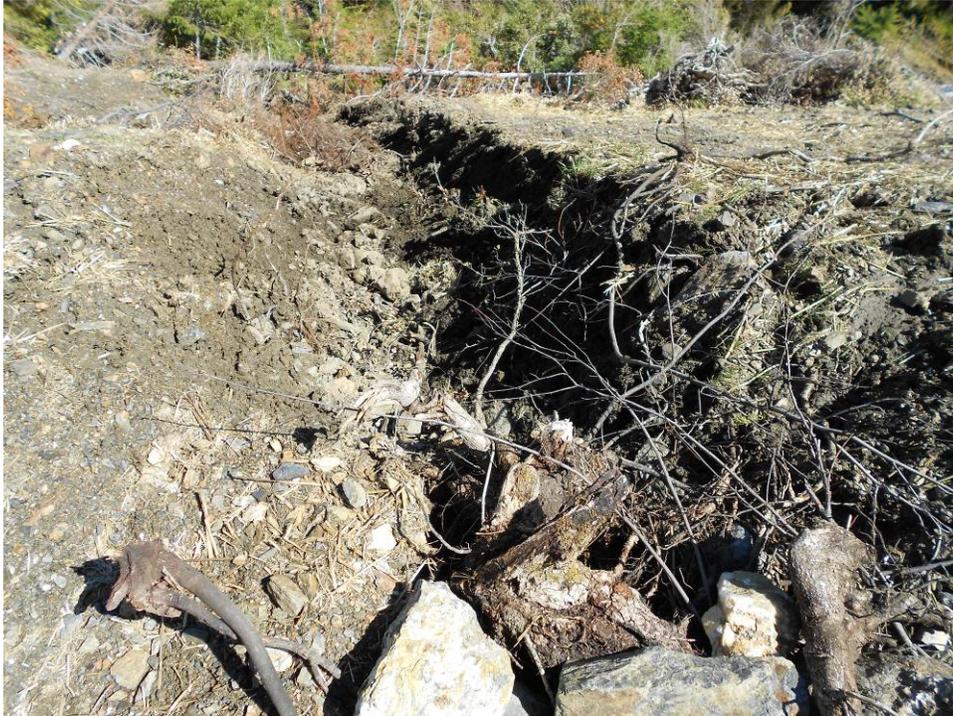
Comments: Several rills have developed over the winter that will require repair during the summer maintenance period. The rill by the water bar is the largest of the rills.

Photograph 31: **Erosion rill downslope of water bar along Haul Road 4.**  
Blue Ledge Mine, Rogue River - Siskiyou National Forest, CA  
Photographed by: Randall West (ERRG)

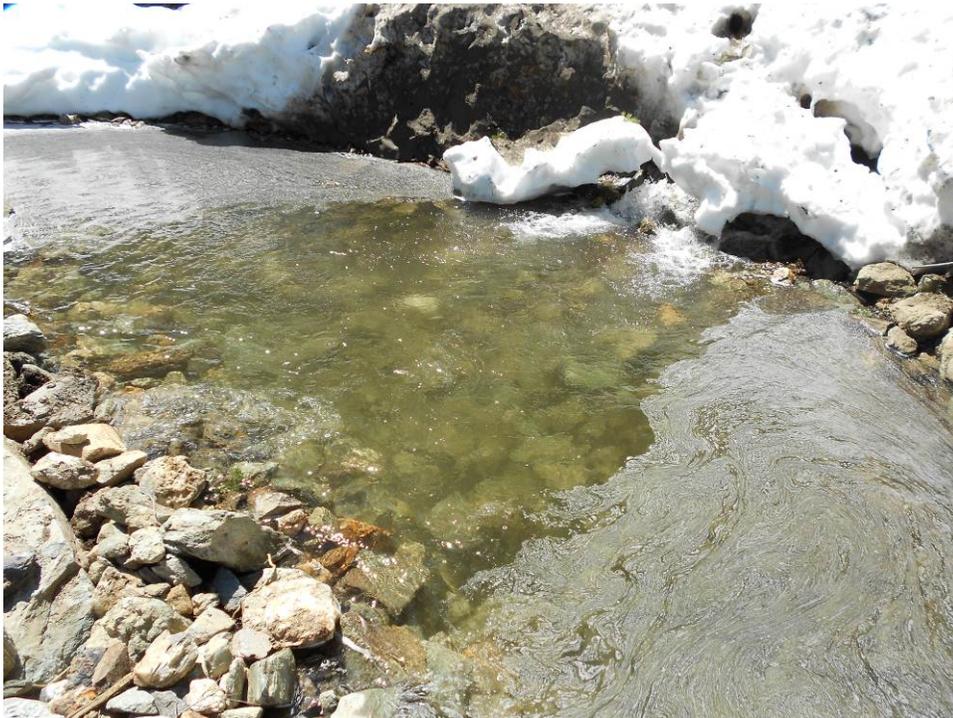
Photograph 32: **Water in sediment treatment basin 3 at WRP 3.**  
Blue Ledge Mine, Rogue River - Siskiyou National Forest, CA  
Photographed by: Randall West (ERRG)

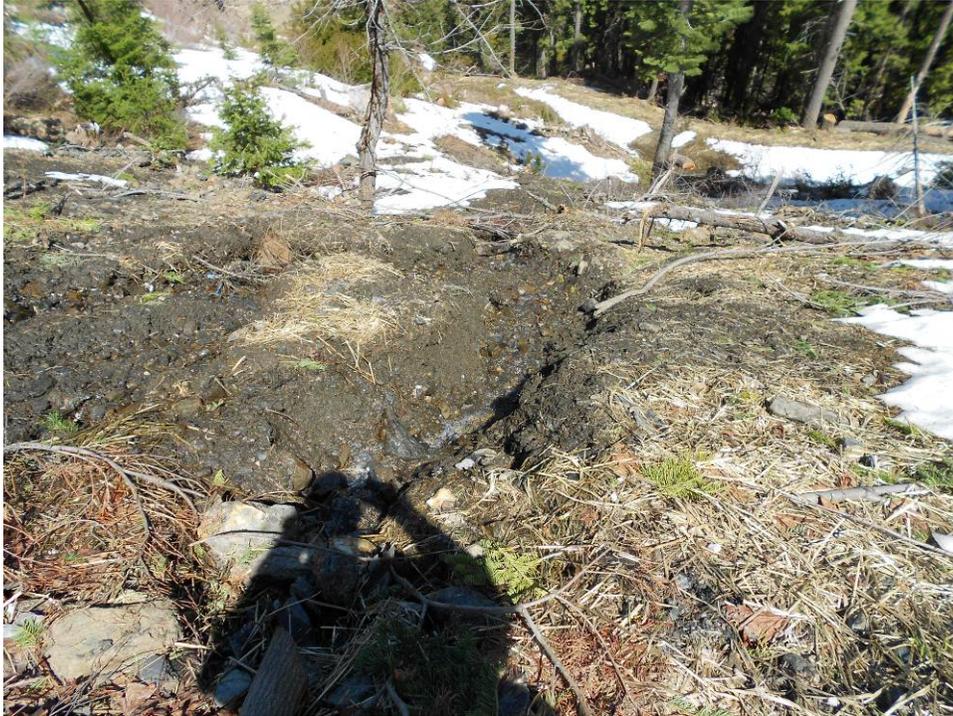
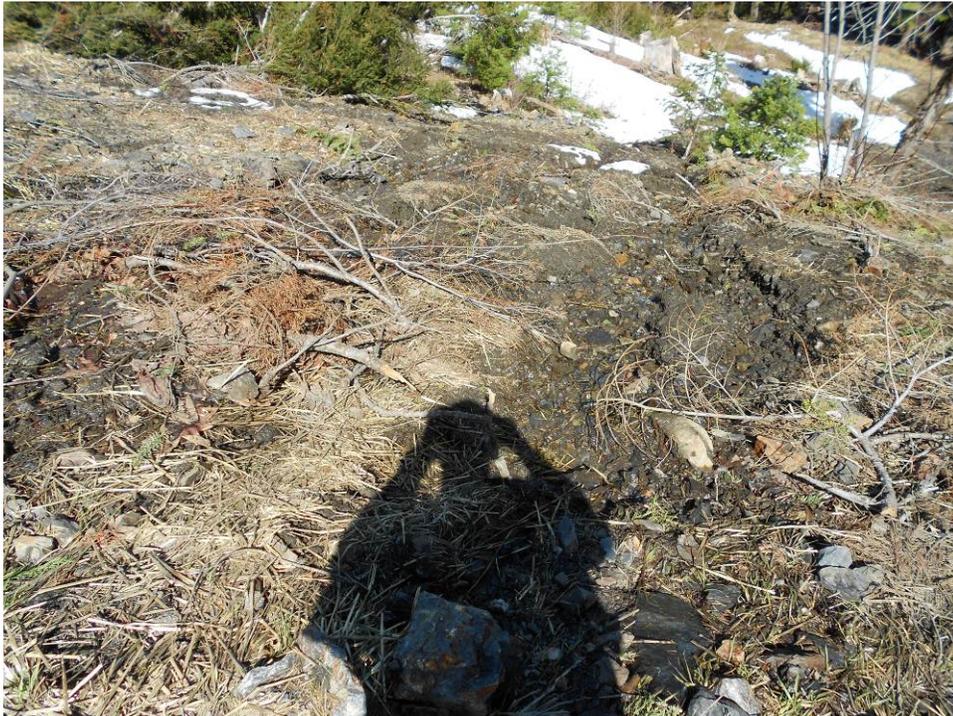
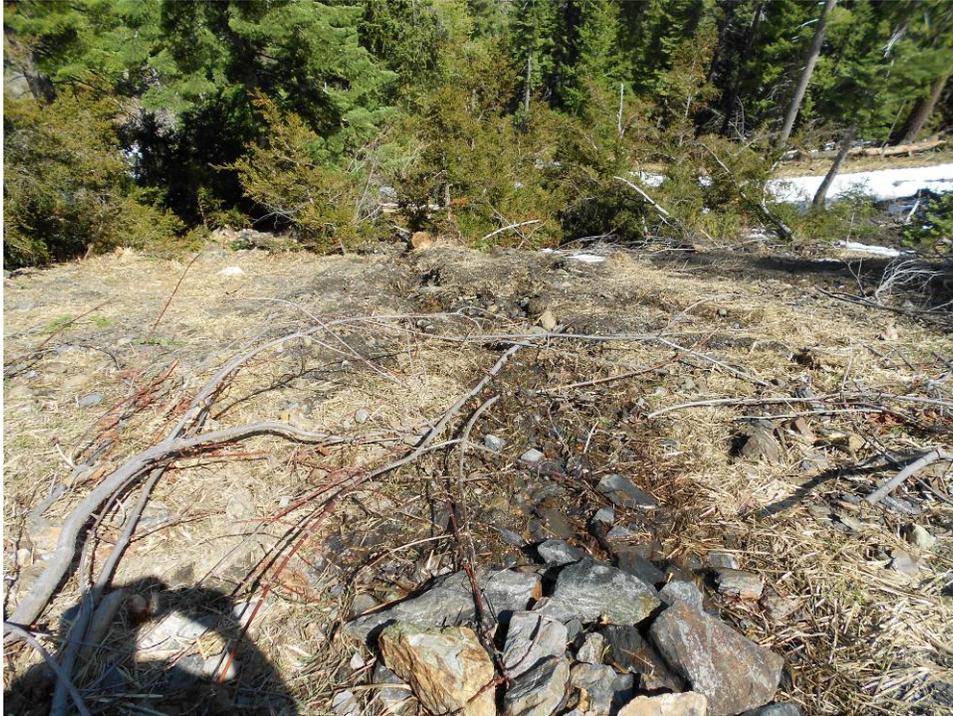
Photograph 33: **Erosion on slope along Haul Road 4.**  
Blue Ledge Mine, Rogue River - Siskiyou National Forest, CA  
Photographed by: Randall West (ERRG)

Photograph 34: **Erosion on slope along Haul Road 4.**  
Blue Ledge Mine, Rogue River - Siskiyou National Forest, CA  
Photographed by: Randall West (ERRG)

Photograph 35: **Erosion on slope along Haul Road 4.**  
Blue Ledge Mine, Rogue River - Siskiyou National Forest, CA  
Photographed by: Randall West (ERRG)

Comments: Silt fence need maintenance at crossings. Erosion of side banks will also require repair. (see above inspection item 3.)

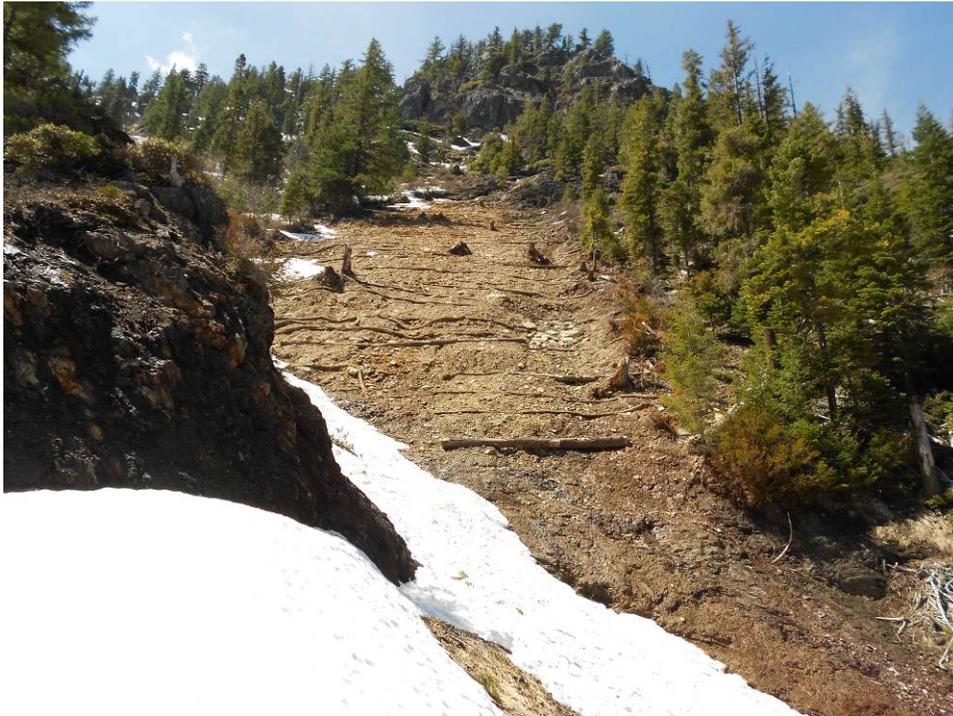
Comments: Some wattles require repair

Photograph 36: **WRP 3 showing straw and log wattles.**  
Blue Ledge Mine, Rogue River - Siskiyou National Forest, CA  
Photographed by: Randall West (ERRG)

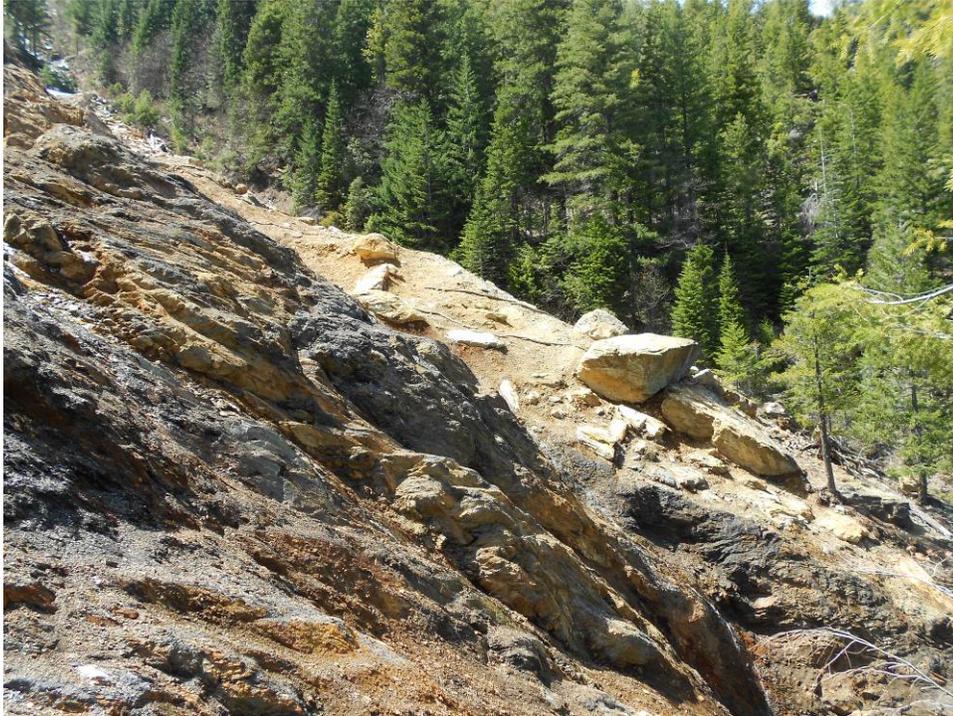
Photograph 37: **WRP 1 showing erosion controls on ridge.**  
Blue Ledge Mine, Rogue River - Siskiyou National Forest, CA  
Photographed by: Randall West (ERRG)

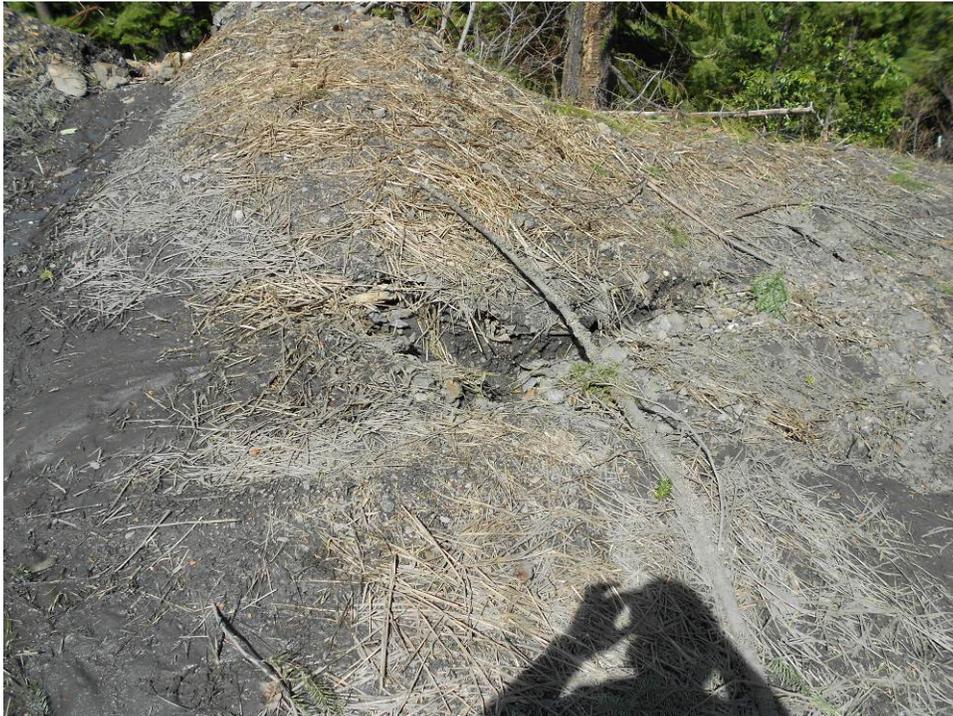
Photograph 38: **Erosion rill on Haul Road 3.**  
Blue Ledge Mine, Rogue River - Siskiyou National Forest, CA  
Photographed by: Randall West (ERRG)

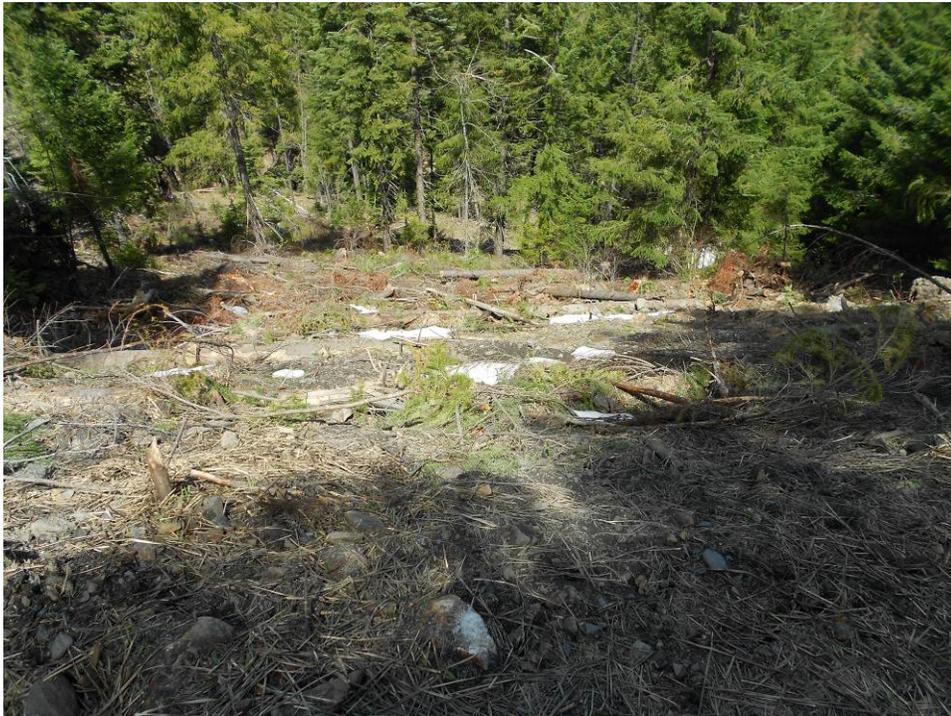
Photograph 39: **Haul truck accident site; no obvious erosion.**  
Blue Ledge Mine, Rogue River - Siskiyou National Forest, CA  
Photographed by: Randall West (ERRG)
