Engineering/Remediation
Resources Group, Inc.
616 First Ave, Suite 300
Seattle, WA 98104

Technical Memorandum
May 2012 Site Inspection Report
Blue Ledge Mine
Rogue River-Siskiyou National Forest

Enclosure 1 – May 2012 Blue Ledge Mine Inspection Checklist
Enclosure 2 – Site Map
Enclosure 3 – May 2012 Site Inspection Photographic Log

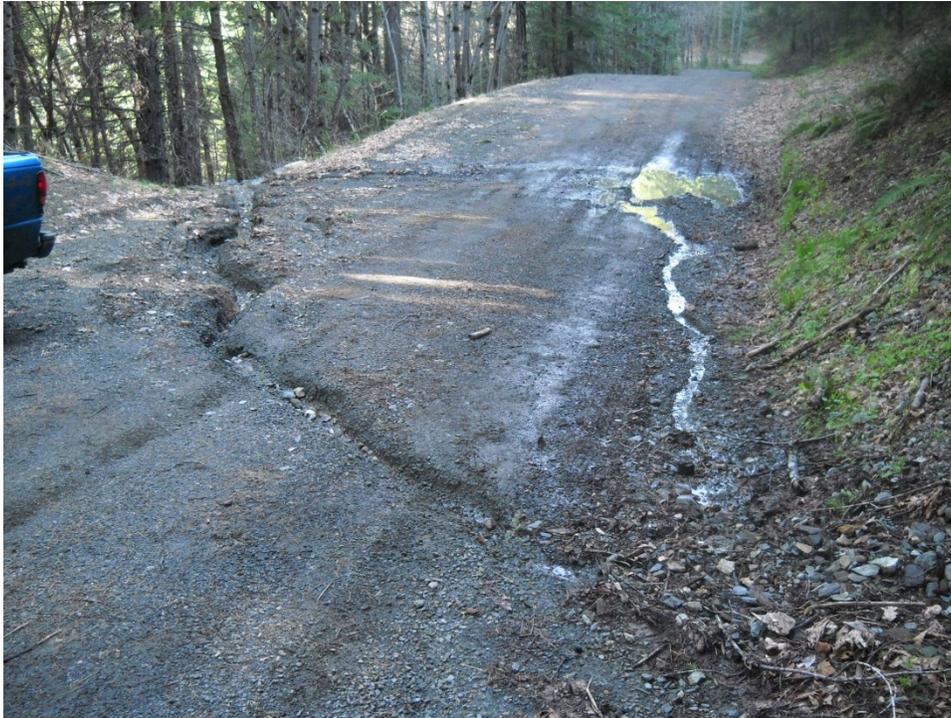
Comments: Excessive erosion has not occurred. Several rills have developed over the winter that will require repair during the summer maintenance period. The rill by the water bar is the largest of the rills. _____

Photograph 1: Erosion on FS Road 1060.

Some erosion was observed on the incoming Forest Road 1060 and haul roads (as previously documented during past inspections) and will require maintenance over the summer. Road condition was similar to that observed during the April inspection. Overall, the roads are in very good shape, except for small areas that require some maintenance.

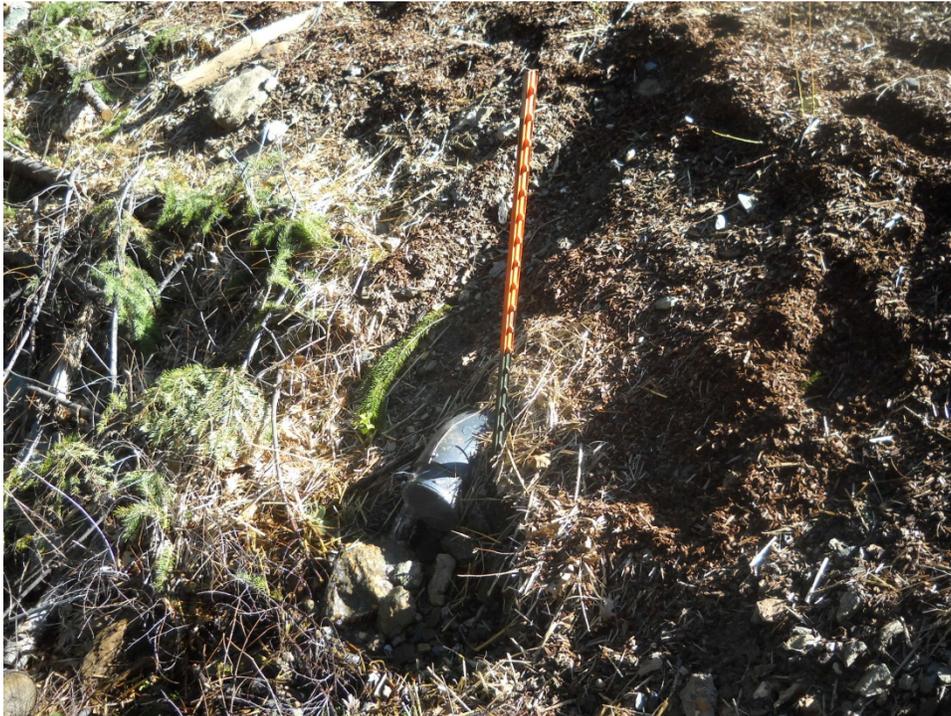
The repository was in good shape with minimal erosion. Most of the repository's drain outlets were discovered to be covered by soil that eroded from the repository bank below the access road. The drains were dry, so it appears that they were able to drain stormwater that infiltrates the repository cover layer. All other drain outlets were uncovered to provide complete inspection of all drain outlets. No additional erosion had occurred since the April inspection. The repository stockpile area and north storage area were both in good shape with minimal erosion.

Photograph 2: Repository underdrain outflow at base of repository.

Comments: Expose pipe drain outlets.

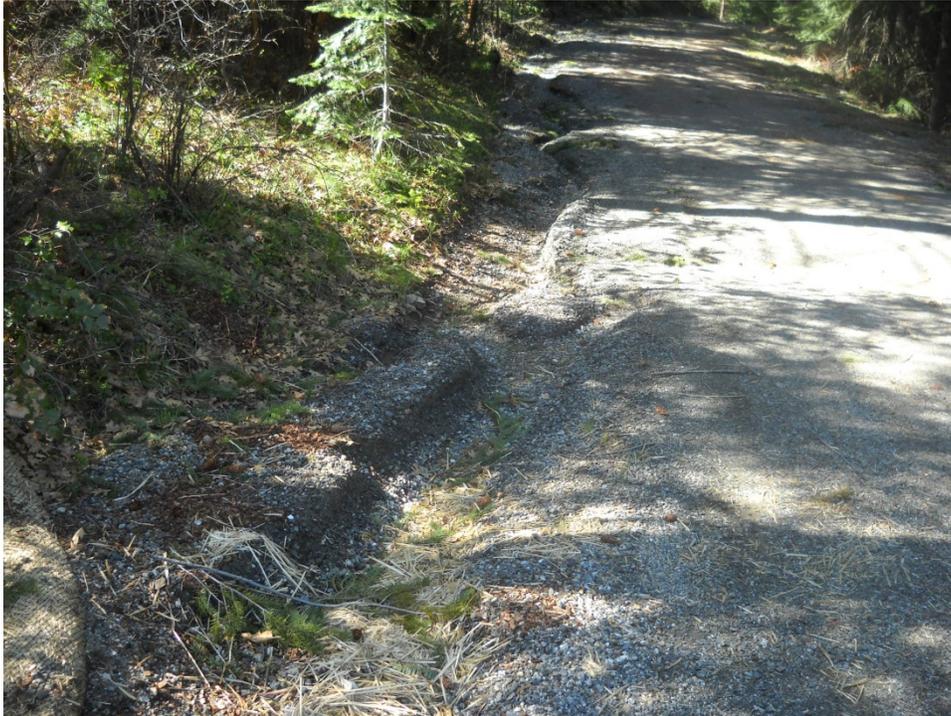
Comments: Excessive erosion has not occurred. Rills have developed on the road by the rock stockpile that will require maintenance.

Photograph 3: **Erosion along repository access road.**
Blue Ledge Mine, Rogue River - Siskiyou National Forest, CA
Photographed by: Brian Wetzsteon (ERRG)

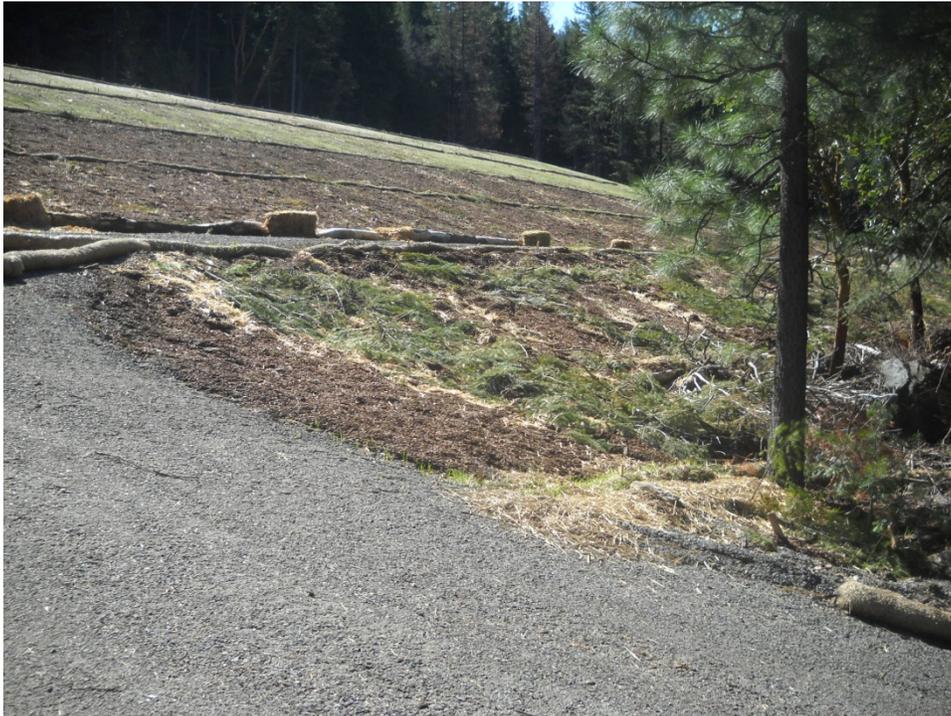
Photograph 4: **Repository access road. Top of slope is hydroseeded, lower portions are planted and covered with bark mulch.**
Blue Ledge Mine, Rogue River - Siskiyou National Forest, CA
Photographed by: Brian Wetzsteon (ERRG)

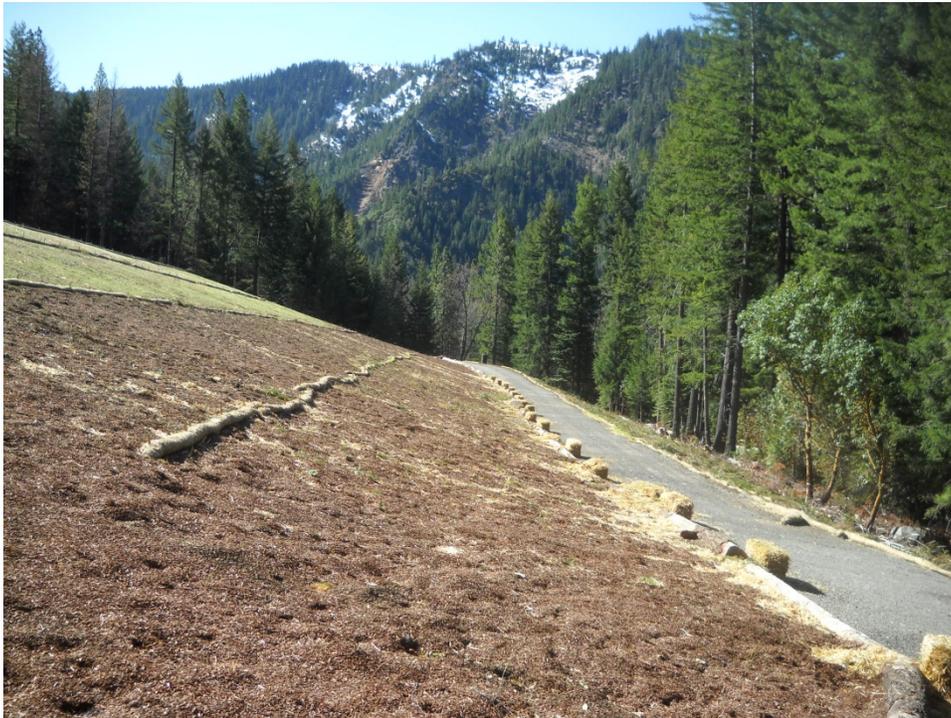
Photograph 5: **Slope of repository showing straw wattles on hillside with log wattles and straw bales at base.**

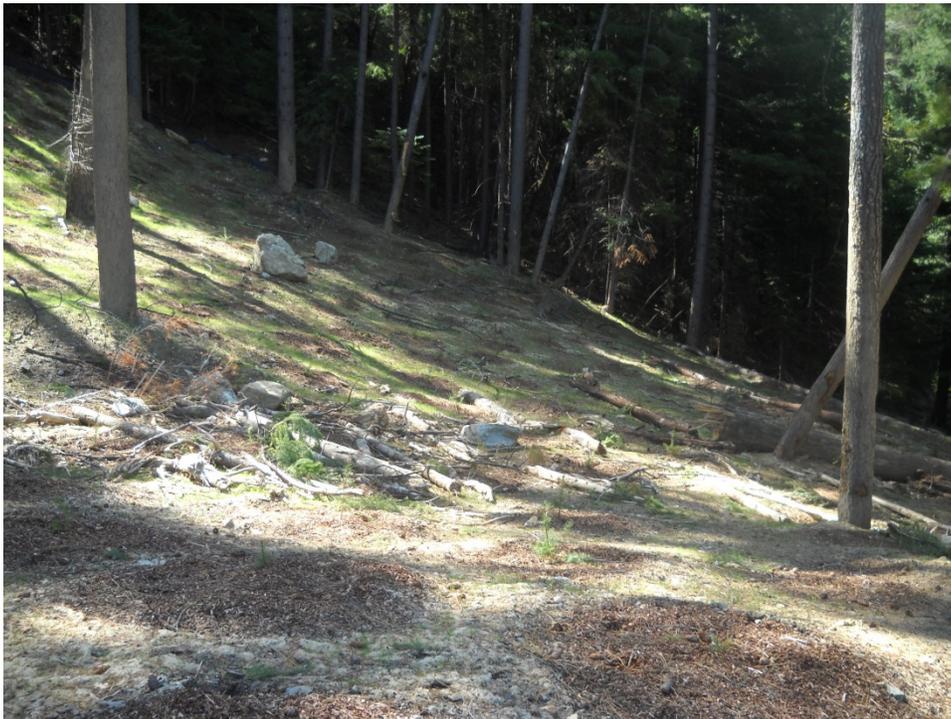
Photograph 6: **Repository stockpile reclamation area.**

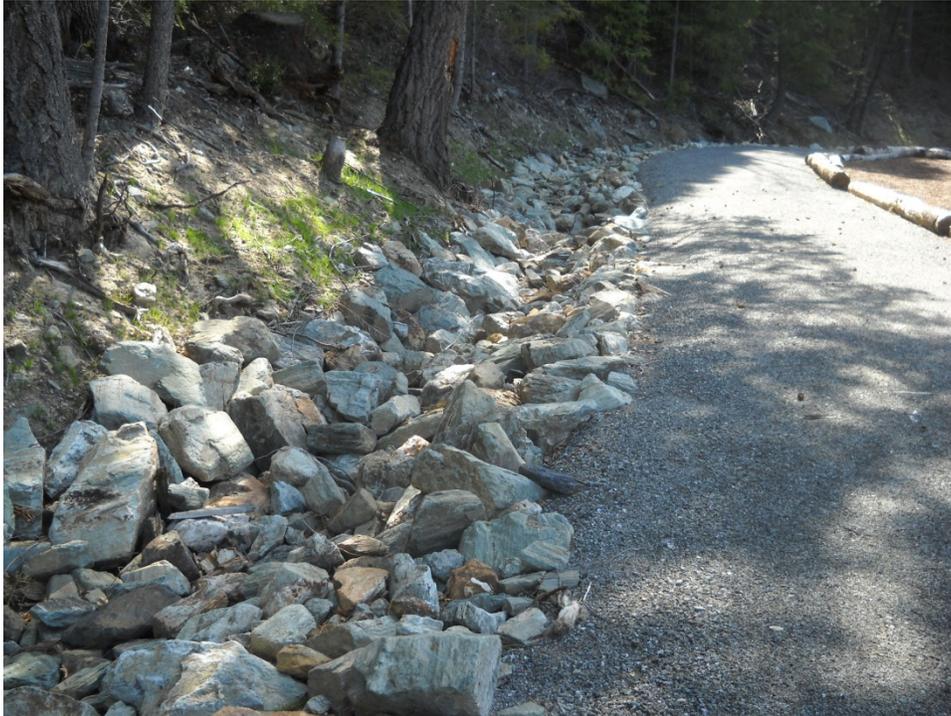
Photograph 7: **V-ditch along top of repository access road.**
Blue Ledge Mine, Rogue River - Siskiyou National Forest, CA
Photographed by: Brian Wetzsteon (ERRG)

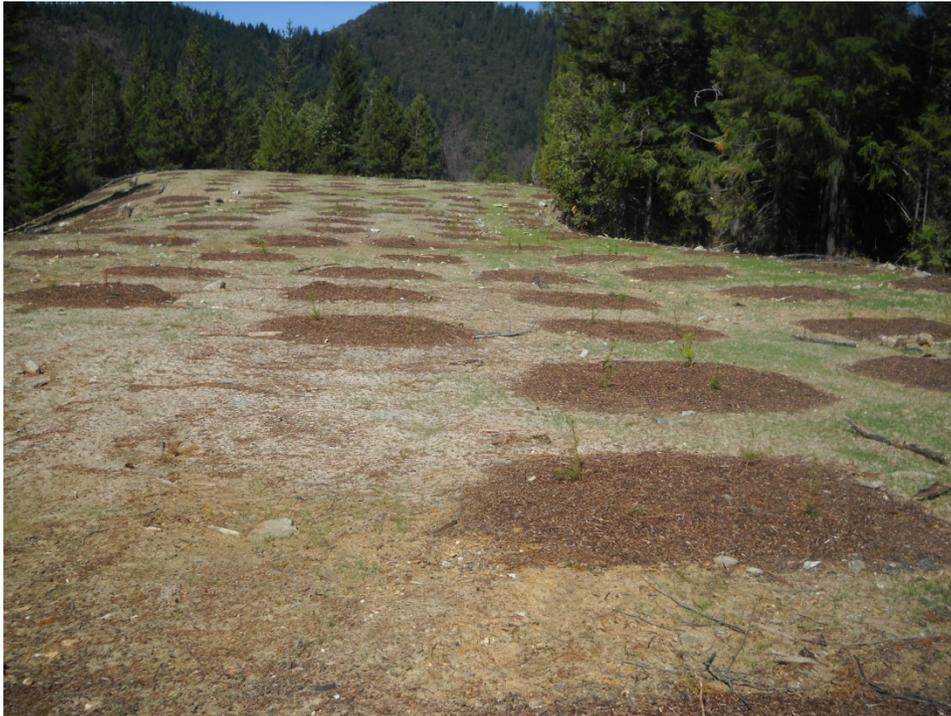
Photograph 8: **North stockpile reclamation area.**
Blue Ledge Mine, Rogue River - Siskiyou National Forest, CA
Photographed by: Brian Wetzsteon (ERRG)

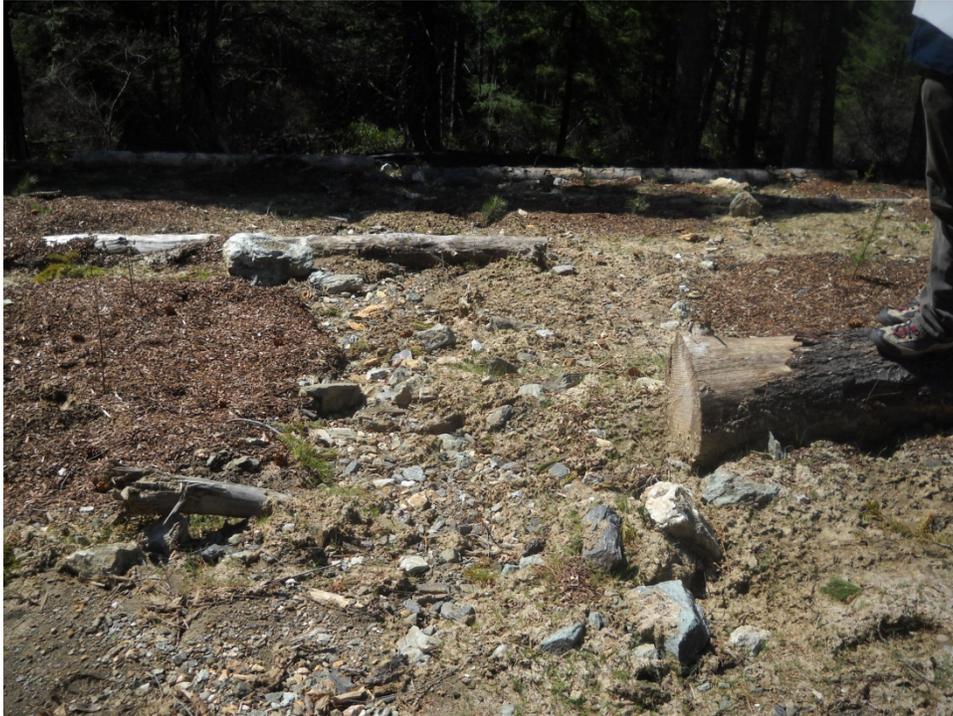
Photograph 9: **Erosion at north stockpile area.**
Blue Ledge Mine, Rogue River - Siskiyou National Forest, CA
Photographed by: Brian Wetzsteon (ERRG)

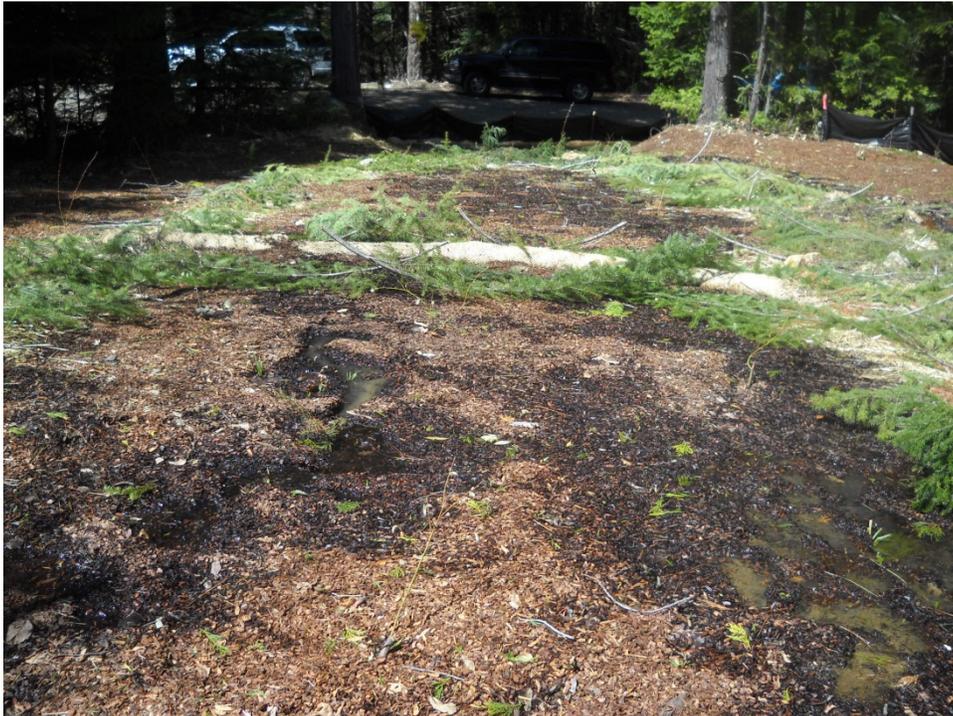
Photograph 10: **Spring water runoff through rock stockpile area.**
Blue Ledge Mine, Rogue River - Siskiyou National Forest, CA
Photographed by: Brian Wetzsteon (ERRG)

Comments: Place slash on rills on west slope. _____

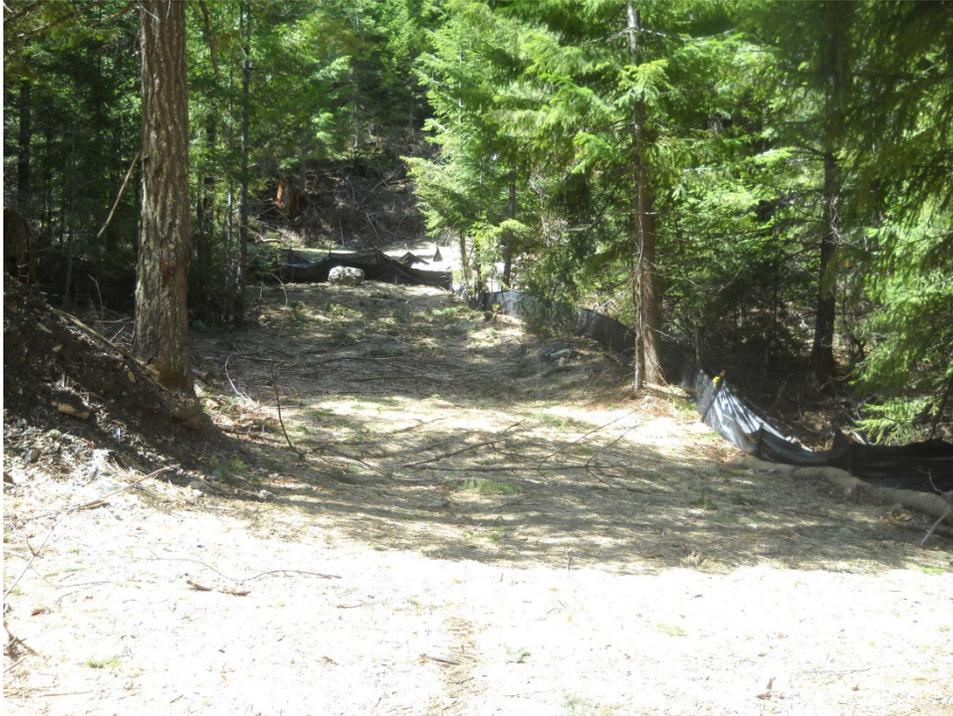
Photograph 11: **Erosion control measures on access road leading to sediment basins under waste rock pile 1.**
Blue Ledge Mine, Rogue River - Siskiyou National Forest, CA
Photographed by: Brian Wetzsteon (ERRG) Date: May 1, 2012

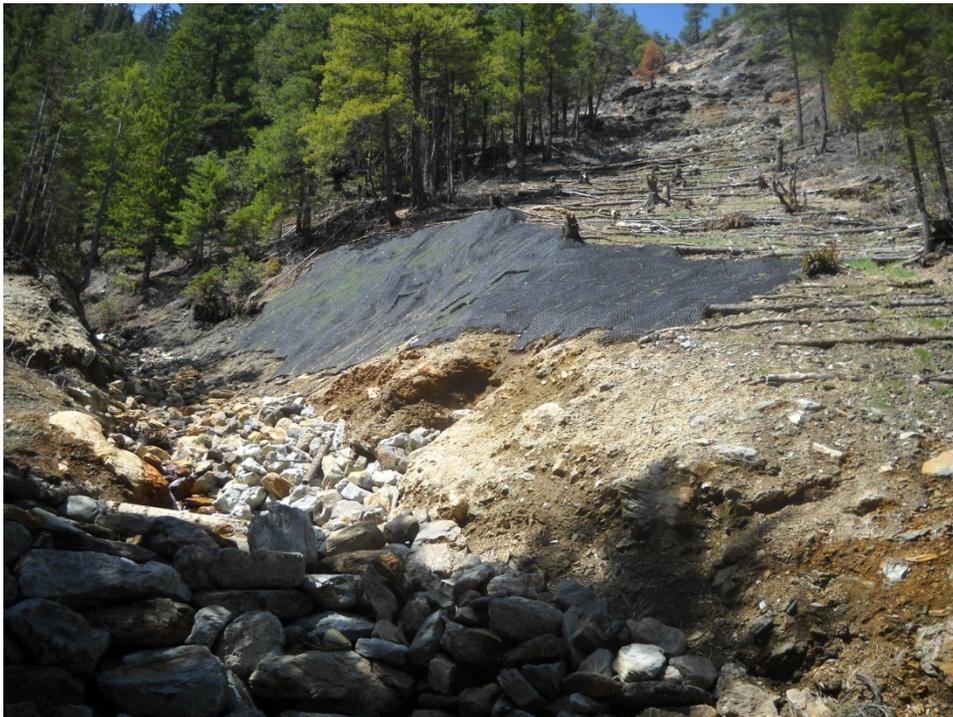
Photograph 12: **Erosion control fabric and log wattle on waste rock pile 4.**
Blue Ledge Mine, Rogue River - Siskiyou National Forest, CA
Photographed by: Brian Wetzsteon (ERRG) Date: May 1, 2012

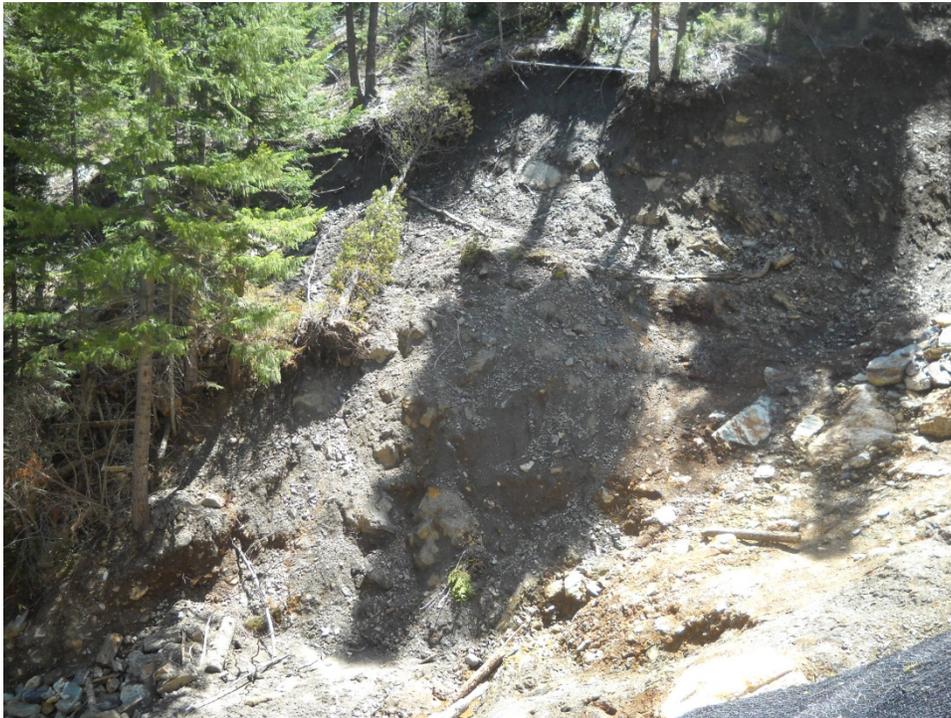
The stockpile and storage areas and WRPs 2, 3, and 4 had minimal erosion, while a significant amount of sediment had eroded from the side of haul road 3 in WRP 1 as previously noted in the April inspection. All of the sediment, however, was captured in sediment basins 1E and 1F. No evidence was observed that sediment had entered Joe Creek. Sediment and debris were also observed in sediment treatment basins 2A and 2B. Sediment treatment basin 3 did not have significant sediment accumulation. Sediment will be removed from all basins in August 2012.

Photograph 13: Portion of hillside under waste rock pile 1 that slid into sediment basin 1F.

No immediate maintenance or further action is recommended based on the findings of this site inspection. Maintenance that requires heavy equipment will be performed in August 2012 in conjunction with removal of sediment from the sediment treatment basins. Repair and maintenance of minor erosion noted above will be performed during subsequent site inspections.

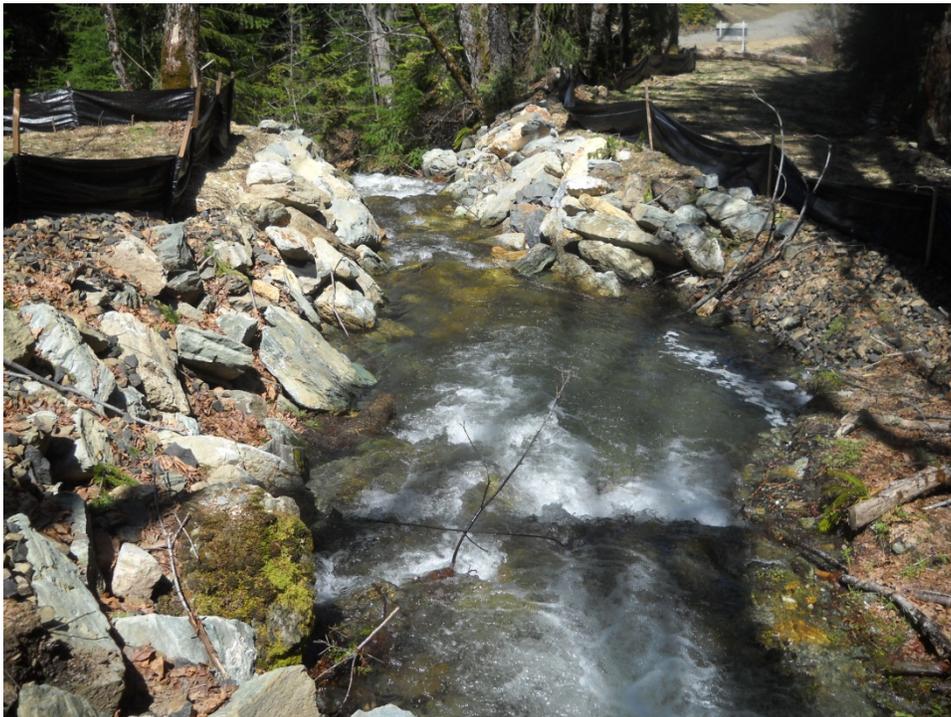
Photograph 14: Joe Creek at former first creek crossing.
Blue Ledge Mine, Rogue River - Siskiyou National Forest, CA
Photographed by: Brian Wetzsteon (ERRG)

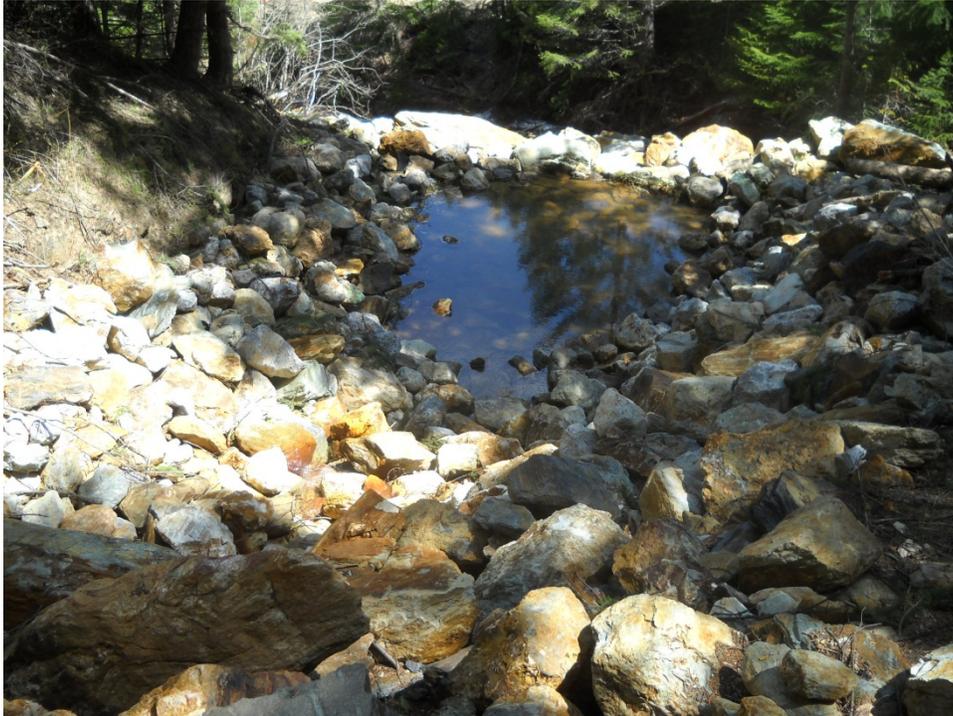
Photograph 15: **Sediment basin 1A, looking downhill.**
Blue Ledge Mine, Rogue River - Siskiyou National Forest, CA
Photographed by: Brian Wetzsteon (ERRG)

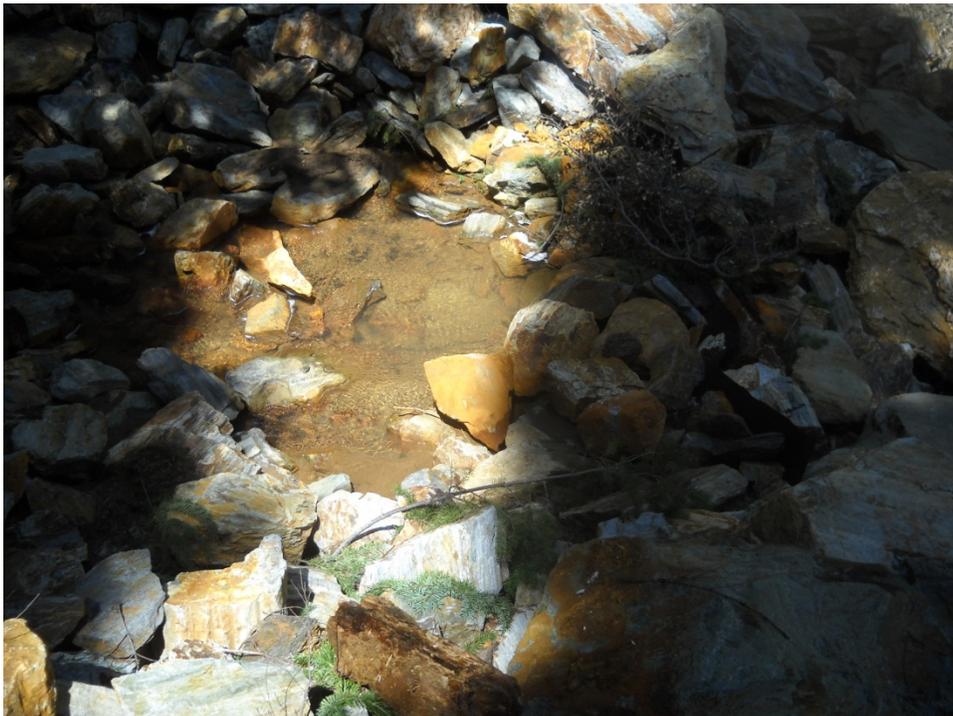
Water depth: Water is leaking around liner at 1B, not spilling over liner (water ~1 foot deep).

Photograph 16: **Sediment basin 1B.**
Blue Ledge Mine, Rogue River - Siskiyou National Forest, CA
Photographed by: Brian Wetzsteon (ERRG)

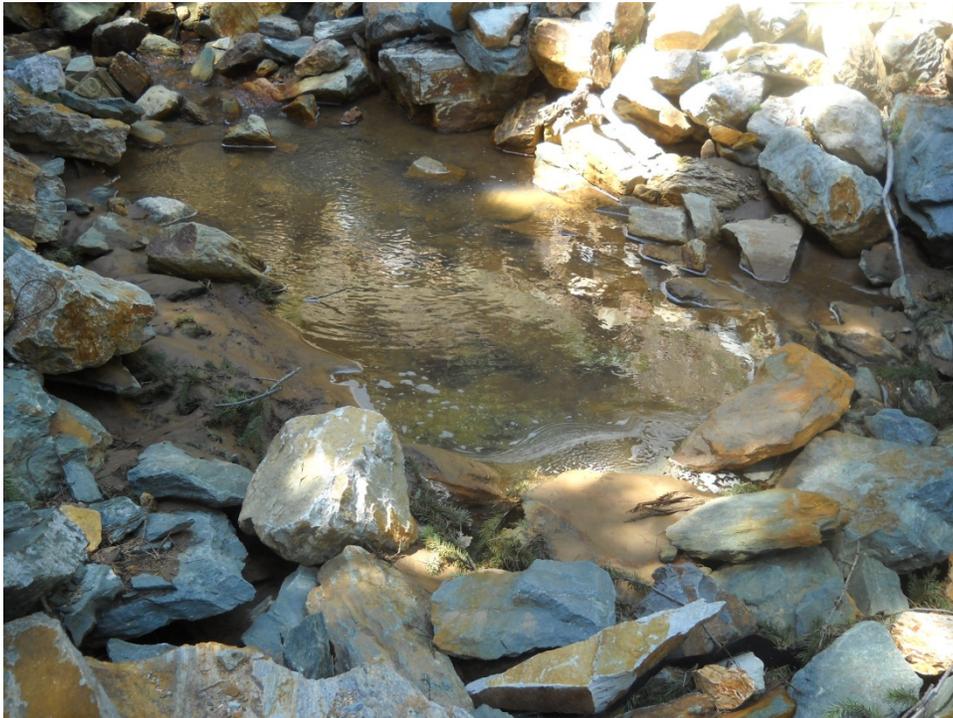
Photograph 17: **Sediment basin 1C.**
Blue Ledge Mine, Rogue River - Siskiyou National Forest, CA
Photographed by: Brian Wetzsteon (ERRG)

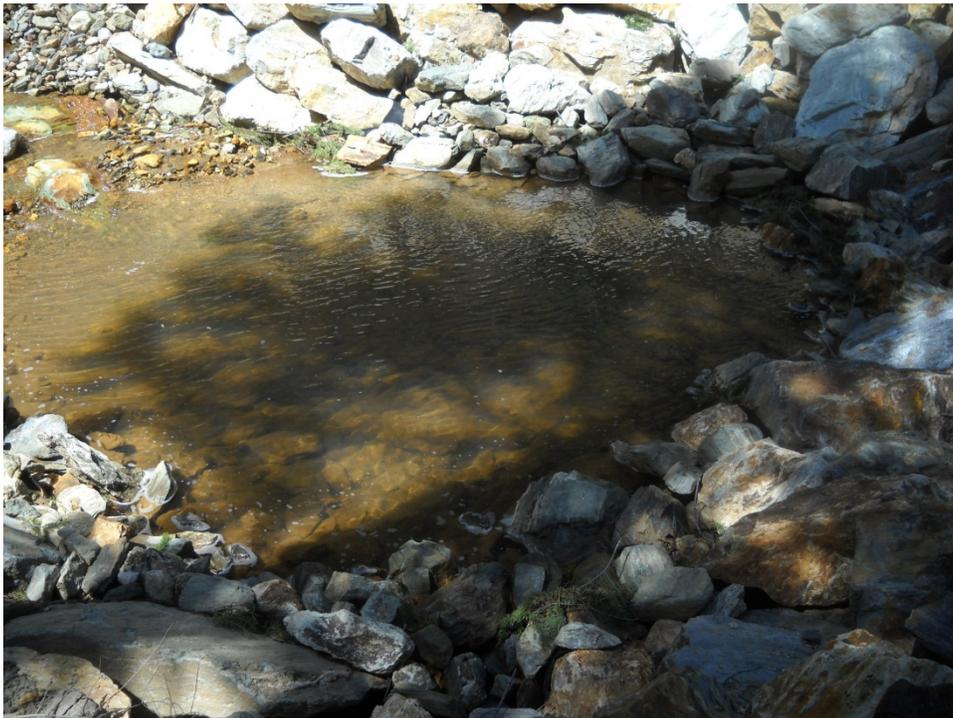
Photograph 18: **Sediment basin 1D.**
Blue Ledge Mine, Rogue River - Siskiyou National Forest, CA
Photographed by: Brian Wetzsteon (ERRG)

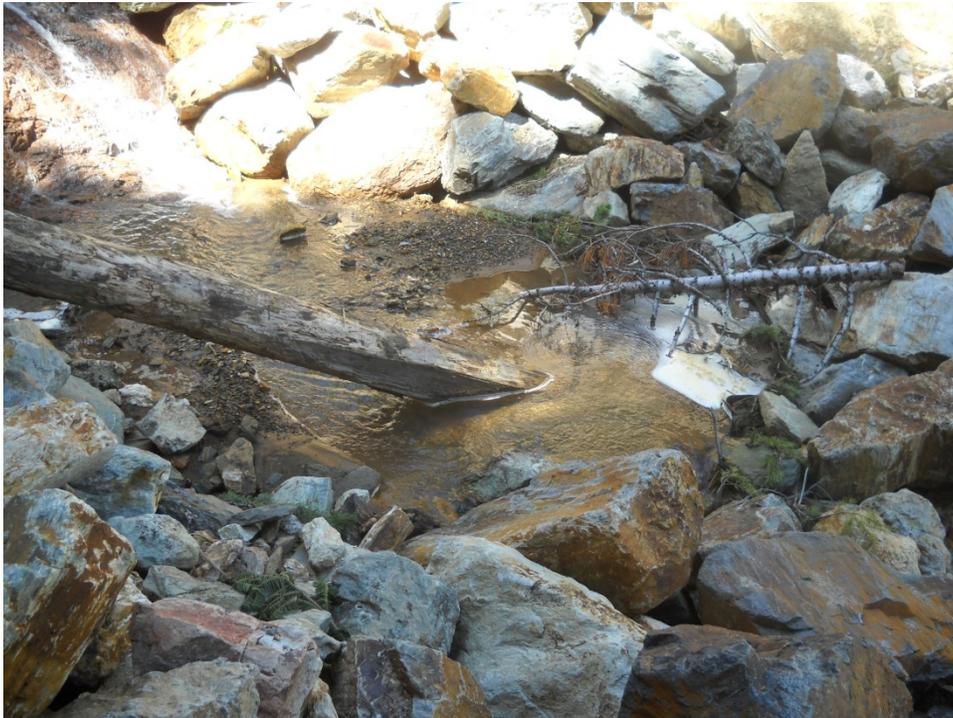
Photograph 19: **Sediment basin 1E.**
Blue Ledge Mine, Rogue River - Siskiyou National Forest, CA
Photographed by: Brian Wetzsteon (ERRG)

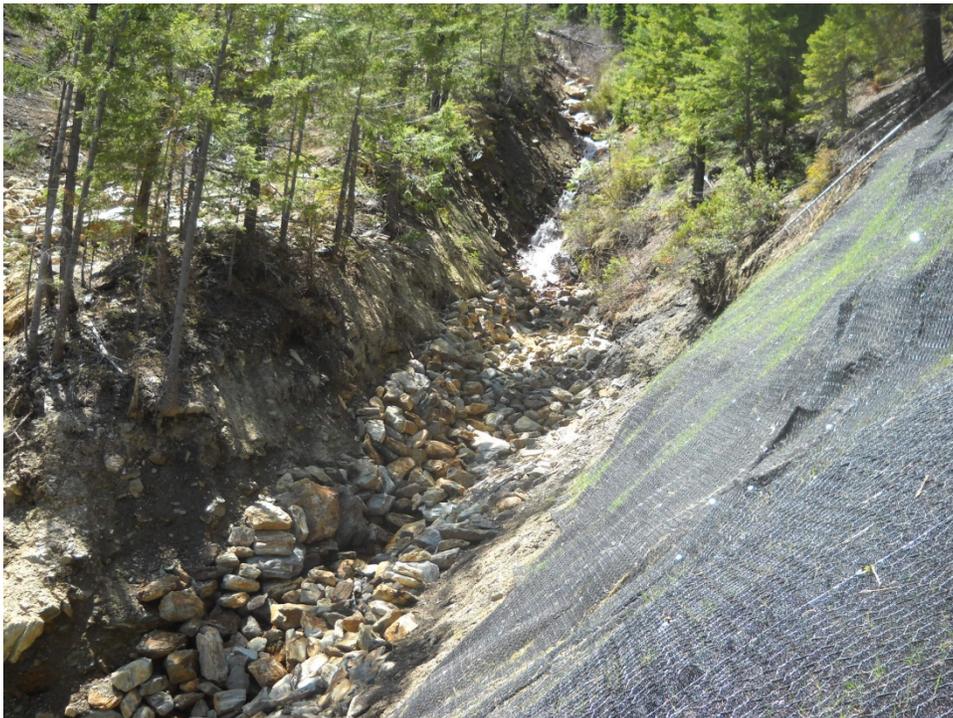
Photograph 20: **Armored stream channel below waste rock pile 4, looking uphill.**
Blue Ledge Mine, Rogue River - Siskiyou National Forest, CA
Photographed by: Brian Wetzsteon (ERRG)

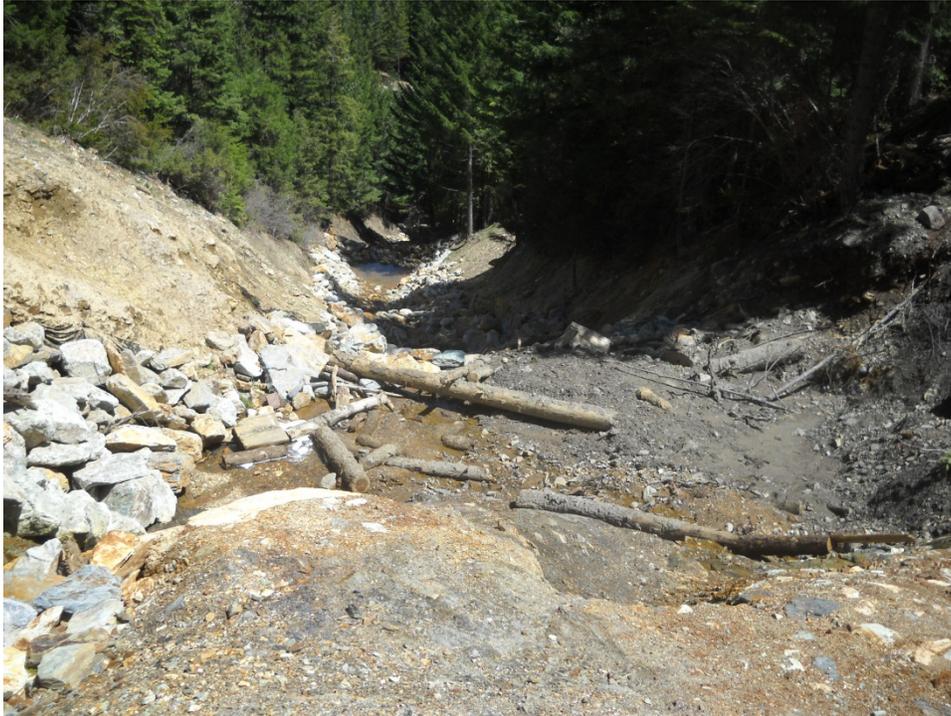
Photograph 21: **Sediment basin 1F.**
Blue Ledge Mine, Rogue River - Siskiyou National Forest, CA
Photographed by: Brian Wetzsteon (ERRG)

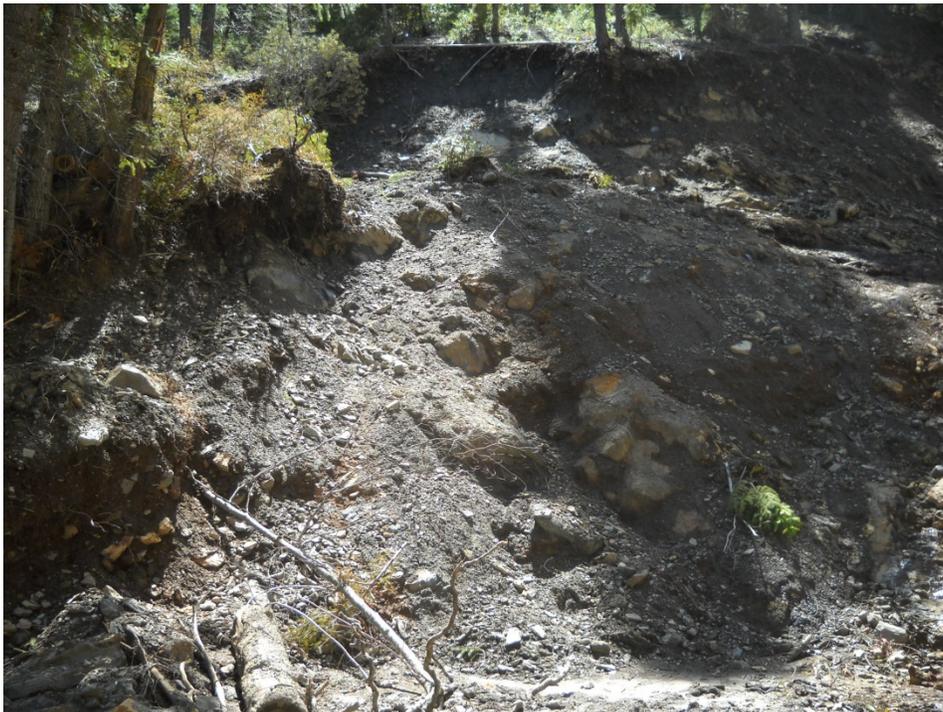
Photograph 22: **Landslide above Sediment Basin 1F.**
Blue Ledge Mine, Rogue River - Siskiyou National Forest, CA
Photographed by: Brian Wetzsteon (ERRG)
