Technical Memorandum
July 2012 Site Inspection Report
Blue Ledge Mine
Rogue River-Siskiyou National Forest

**Blue Ledge Mine Removal Project
Siskiyou County, California
Operation, Maintenance, and Monitoring Period**

Enclosure 3. July 2012 Inspection Photographic Log

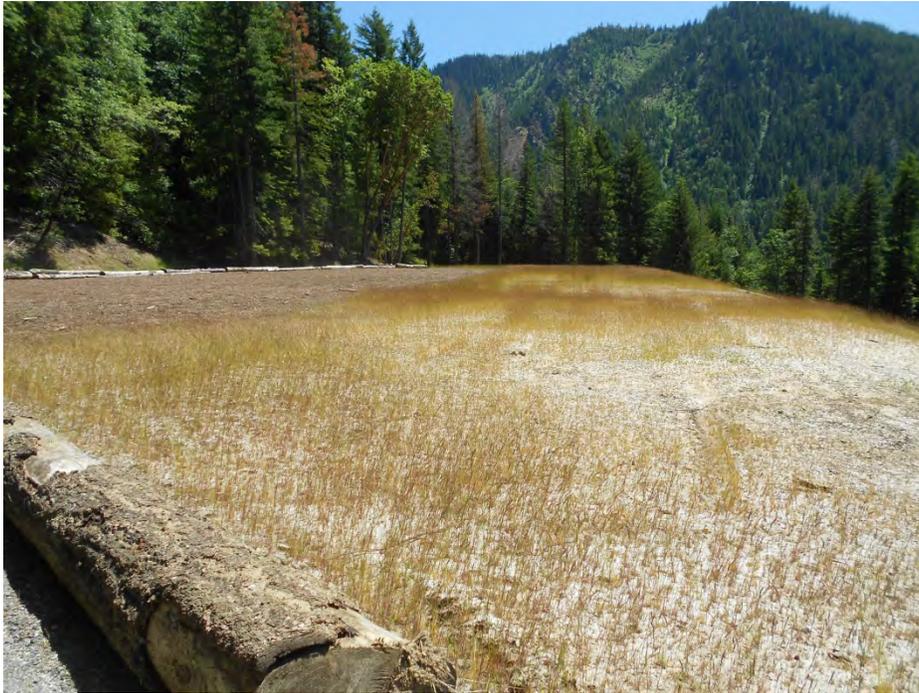
Photograph 1: Top of Repository looking south
Blue Ledge Mine, Rogue River - Siskiyou National Forest, CA
Photographed by: Randall West (ERRG)

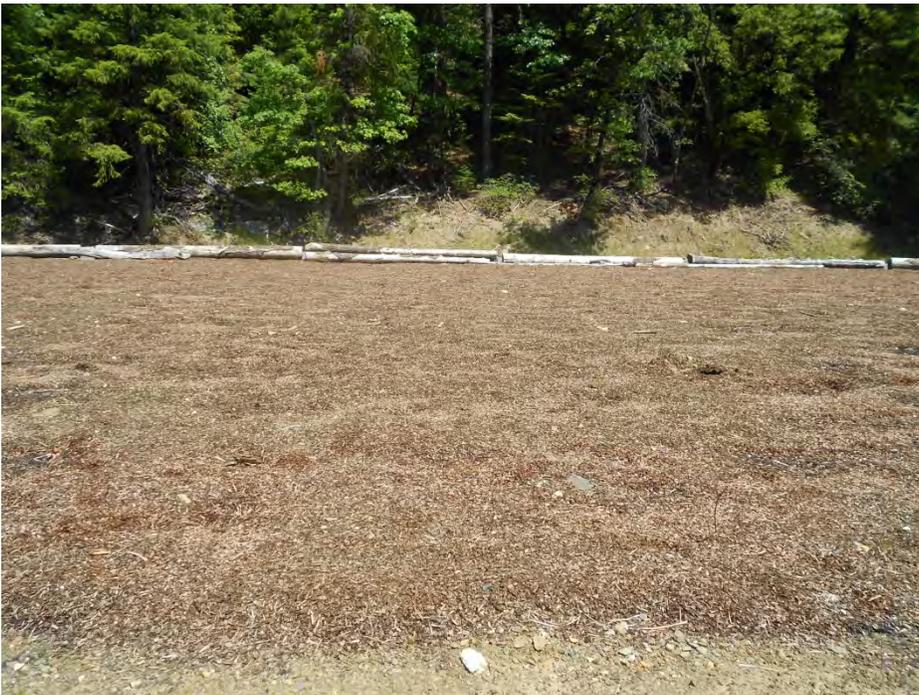
A large percentage of shrubs on the repository have died since the June 2012 inspection. At the date of the July inspection, approximately 90 percent of plantings on the top of the repository and 60 percent of the plantings on the side slope of the repository have died. Soil conditions under the bark mulch were drier, but the soil was still moist. As noted in the June 2012 Inspection Report, saturated conditions on the top layer of soil are likely causing the high mortality rates of plants on the repository. A site visit is scheduled for July 17, 2012, to evaluate the condition of soil on the repository to propose alternate plans for planting on the repository. Results of the July 17 site visit will be summarized in the August 2012 Site Inspection Report. In June 2012, additional grass seed was broadcast ([Enclosure 4](#)) on the bare areas that existed primarily on the top of the repository ([Enclosure 2](#)). Areas on the repository where the grass seed was broadcast have shown an increased growth.

Comments: Approximately 90% of plants on top of the repository and 60% of plants on the slope of the repository out of the 4,992 plants have died.

Photograph 2: Top of Repository, mulched planting area (note no growing shrubs)

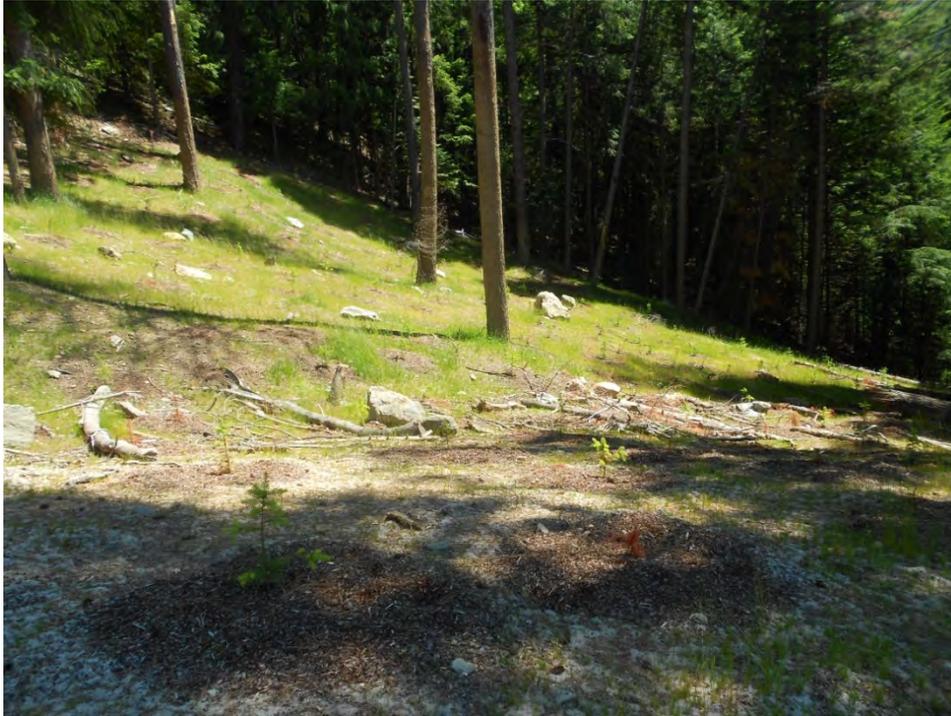
Photograph 3: Repository Stockpile looking south. Area typically shaded.
Blue Ledge Mine, Rogue River - Siskiyou National Forest, CA
Photographed by: Randall West (ERRG)

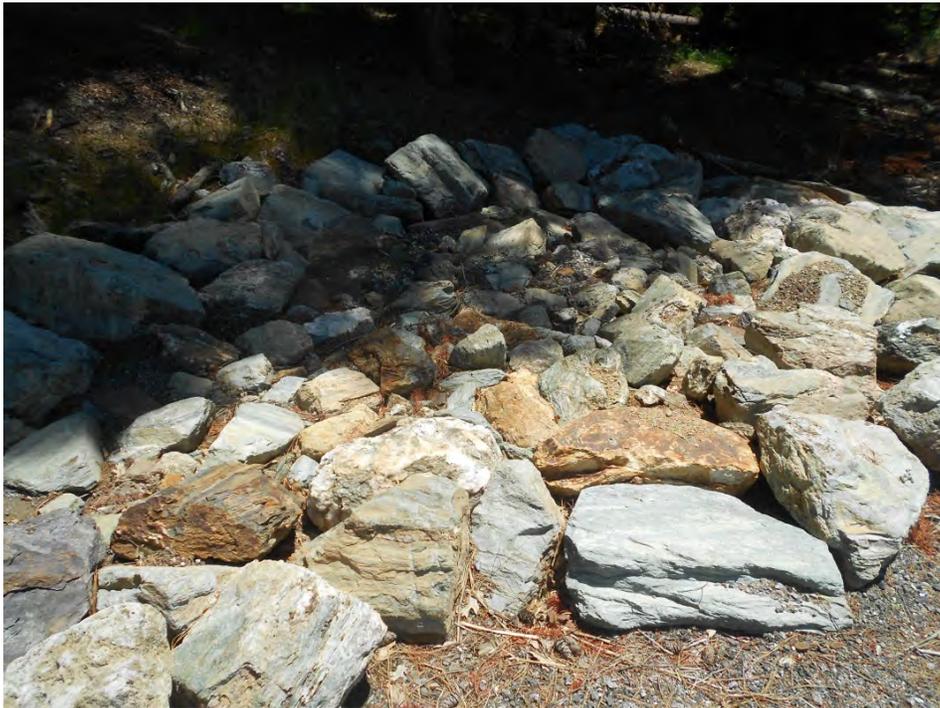
Photograph 4: Repository stormwater drainage ditch.
Blue Ledge Mine, Rogue River - Siskiyou National Forest, CA
Photographed by: Randall West (ERRG)

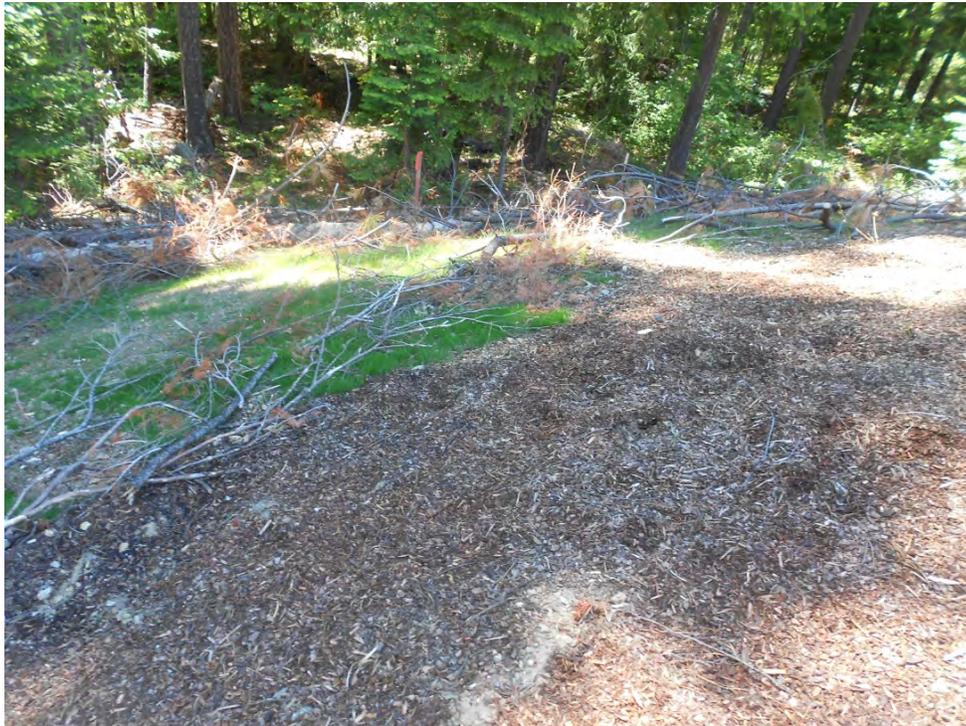
Comments: All drains were clear, no damage occurred to any screen, and no blockage of any drains.

Photograph 5: Repository slope below access road. Anchor Trench Drain located at Orange Flag

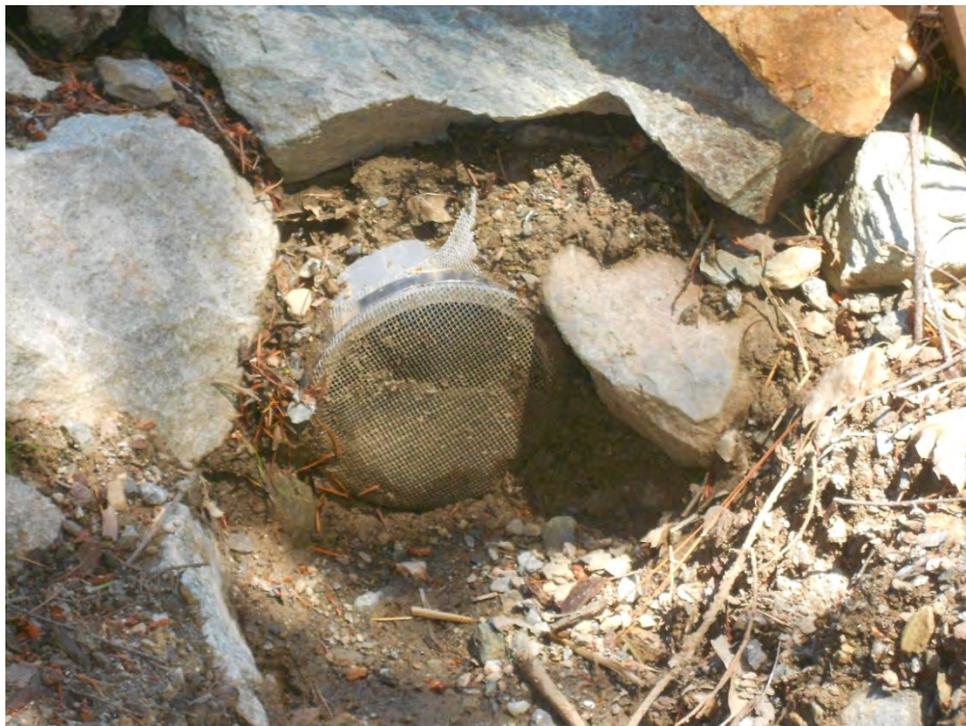
Photograph 6: Anchor trench drain outlet uncovered during May maintenance.

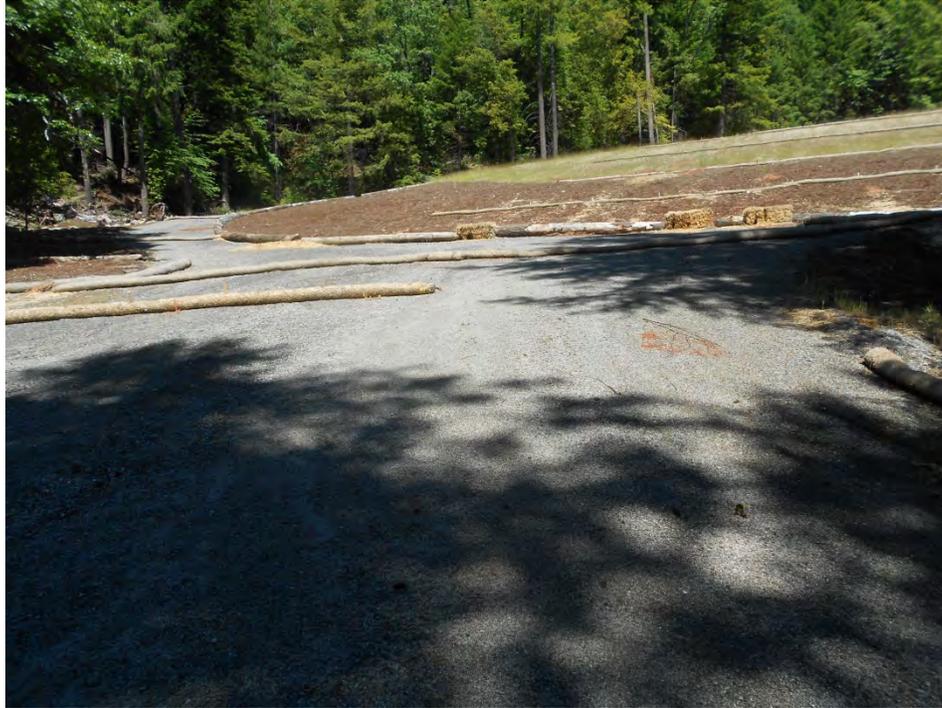
Comments: No additional or excessive erosion has occurred. Any evidence of erosion has occurred will be repaired during the summer work sessions or prior to next rain whichever comes first.

Photograph 7: Repository Access Road
Blue Ledge Mine, Rogue River - Siskiyou National Forest, CA
Photographed by: Randall West (ERRG)

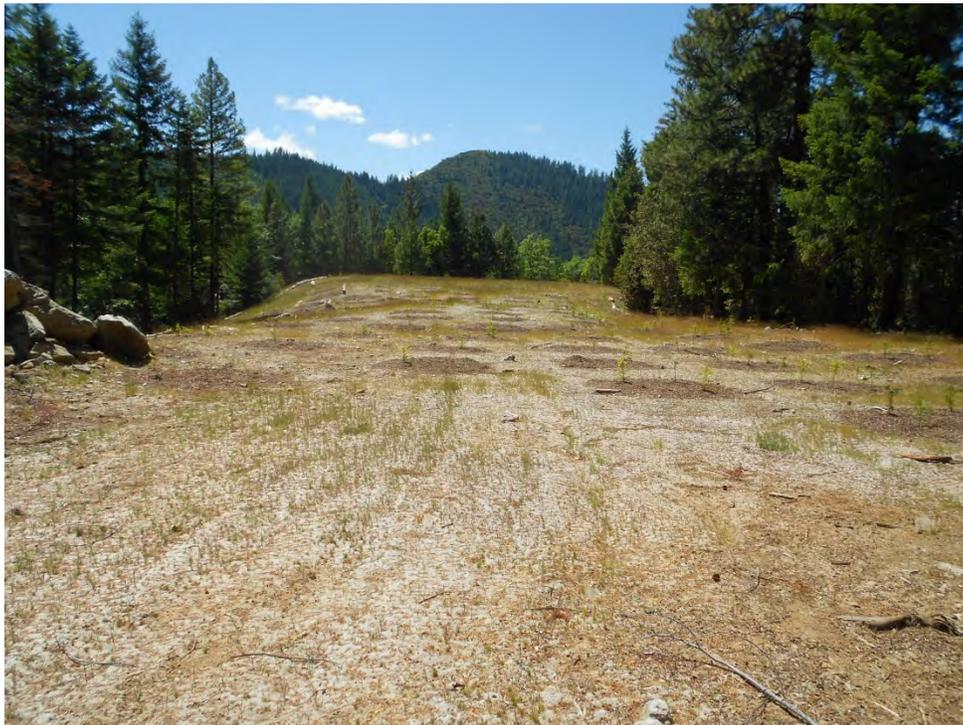
Comments: Approximately 100 out of 1,366 plants have died.

Photograph 8: North Storage Area looking north.
Blue Ledge Mine, Rogue River - Siskiyou National Forest, CA
Photographed by: Randall West (ERRG)

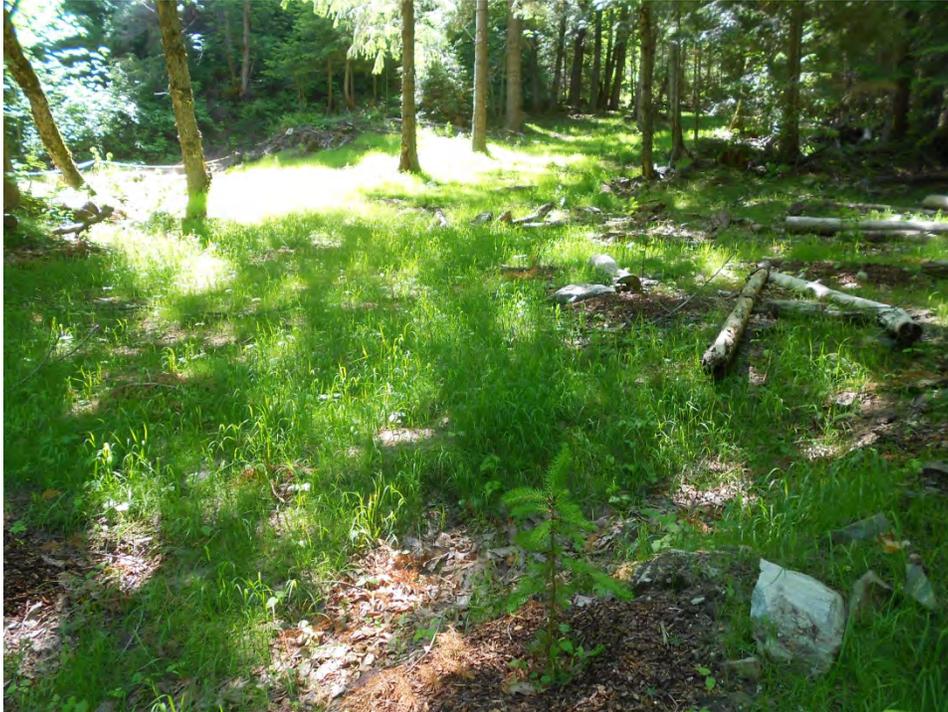
Comments: No BMP maintenance required after adding slash to slope.

Photograph 9: Rock Stockpile Area.

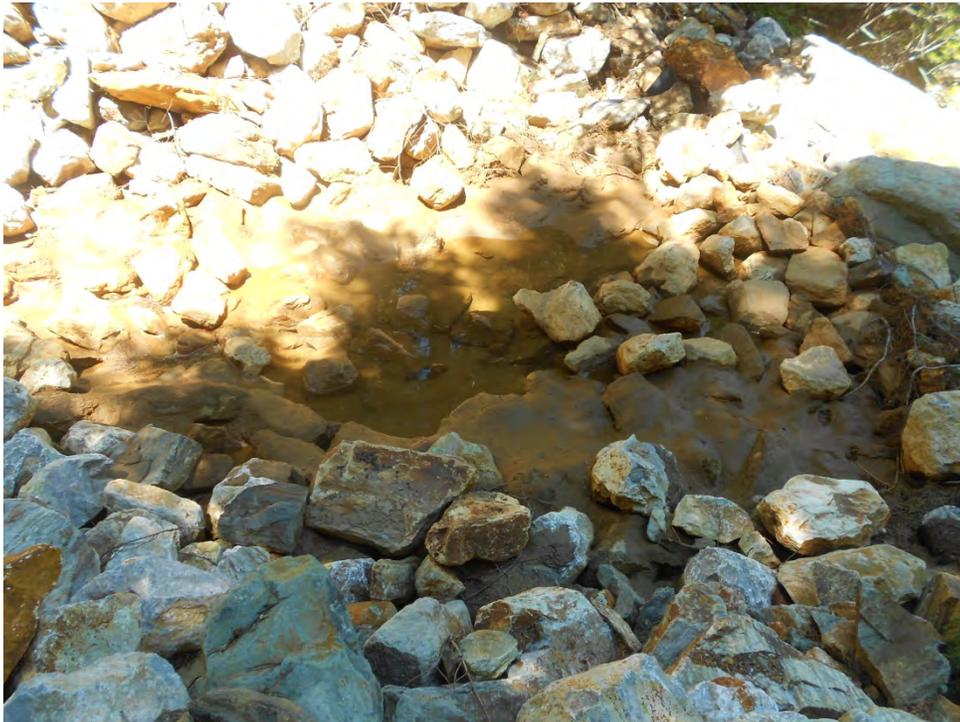
Photograph 10: Sediment/pH Treatment Basin 1A

Sediment Basins #1A-F				
Restore liner dam to raise water elevation at basins 1B and 1C. Water currently leaks around the edge or seam of liner.				
Clean out sediments and debris.				
WRP#4				
Repair any straw wattles that have come loose.	6/8/12		Y	Rw
Haul Roads				
Culvert inlet and outlet cleanout on HR1 just below #2 creek crossing.	6/2/12		Y	Rw
Repair silt fence at creek crossings	6/2/12		Y	Rw
Spread out dirt sluff at bypass road intersection and put grass seed on it.			Y	Rw
Fix water bars that have sediment or have been overtopped and created rills. Fix rocks at outlets. Clean out sediment as needed to maintain function.	6/2/12			
Install new water bar near toe of slope beyond sluff at Adit 5 so it drains to WRP1.

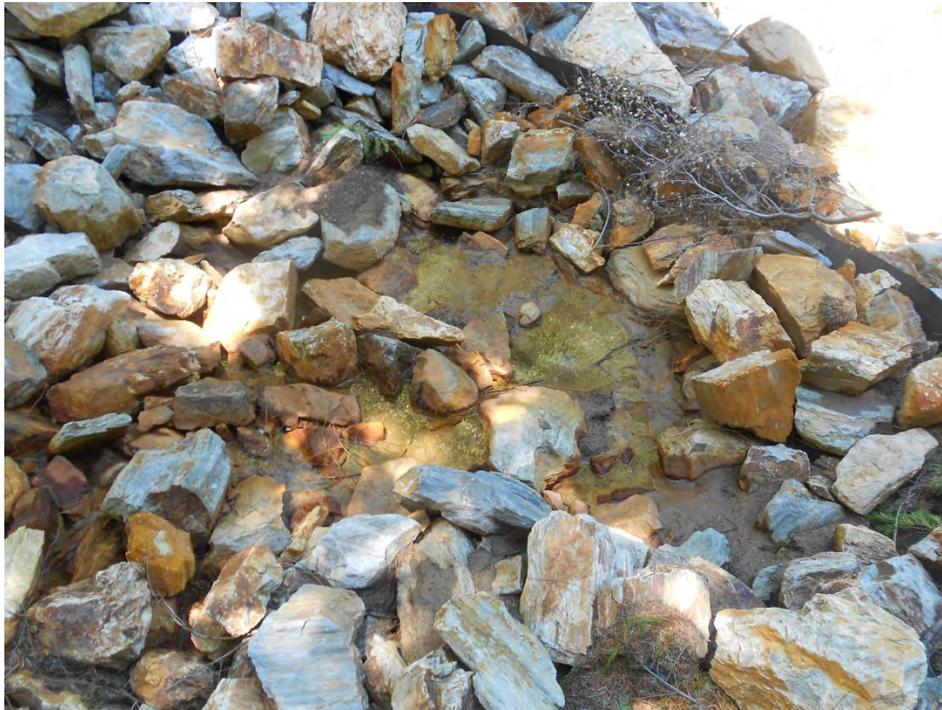
Photograph 11: Sediment/pH Treatment Basin 1B.
Blue Ledge Mine, Rogue River - Siskiyou National Forest, CA
Photographed by: Randall West (ERRG)

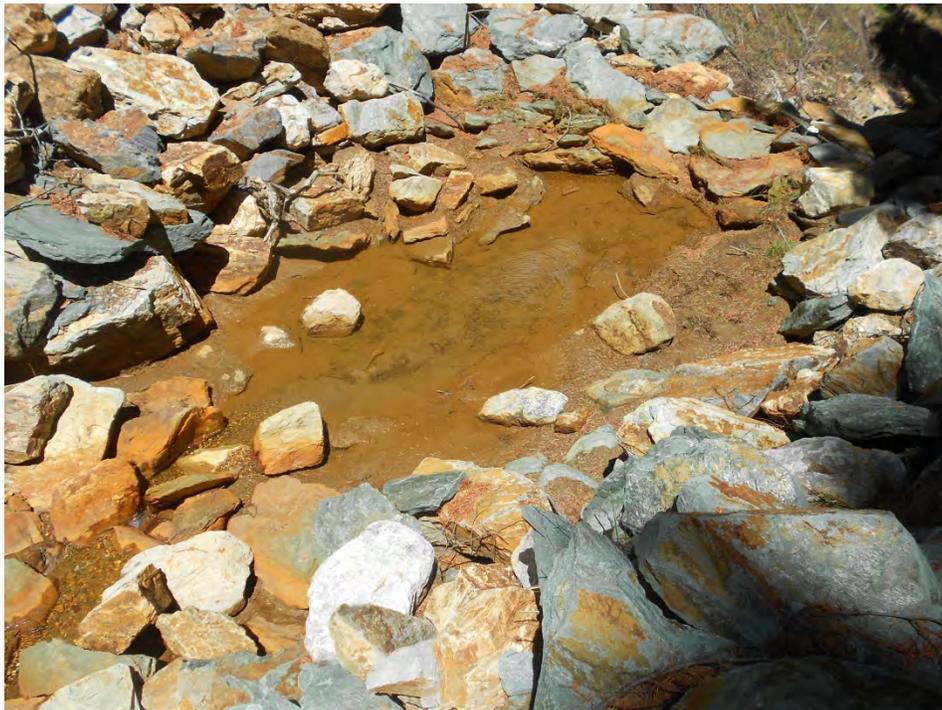
Photograph 12: Sediment/pH Treatment Basin 1C.
Blue Ledge Mine, Rogue River - Siskiyou National Forest, CA
Photographed by: Randall West (ERRG)

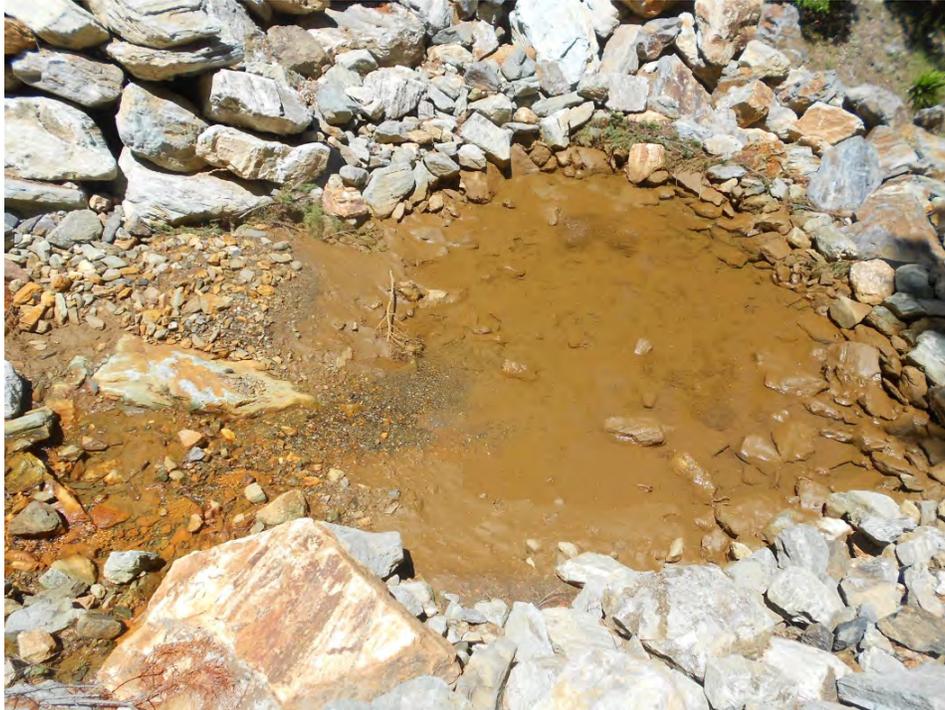
Photograph 13: Sediment/pH Treatment Basin 1D.
Blue Ledge Mine, Rogue River - Siskiyou National Forest, CA
Photographed by: Randall West (ERRG)

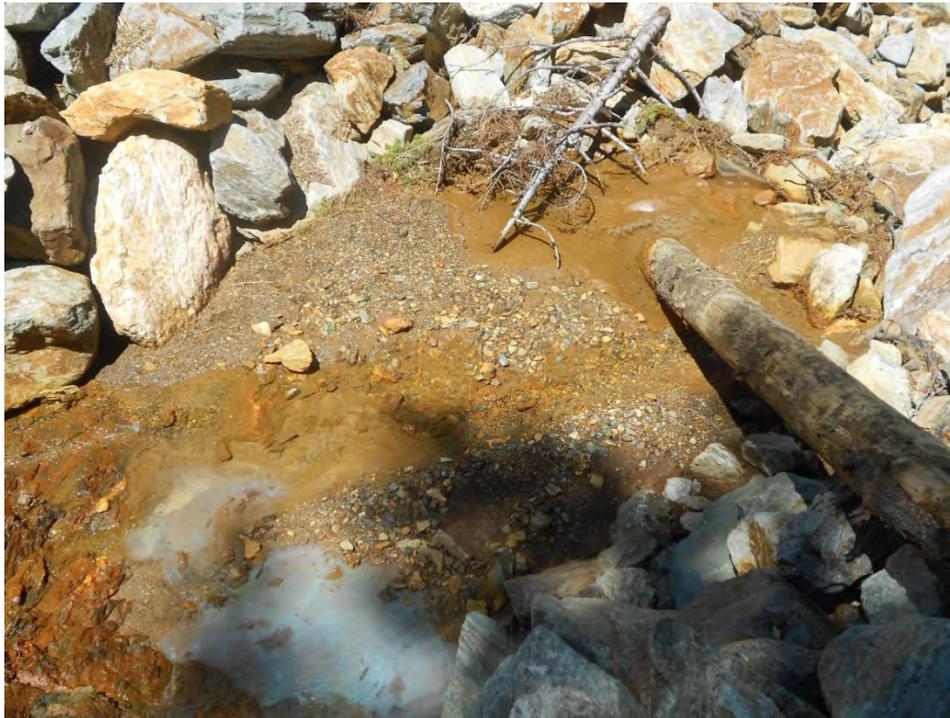
Photograph 14: Sediment/pH Treatment Basin 1E.
Blue Ledge Mine, Rogue River - Siskiyou National Forest, CA
Photographed by: Randall West (ERRG)

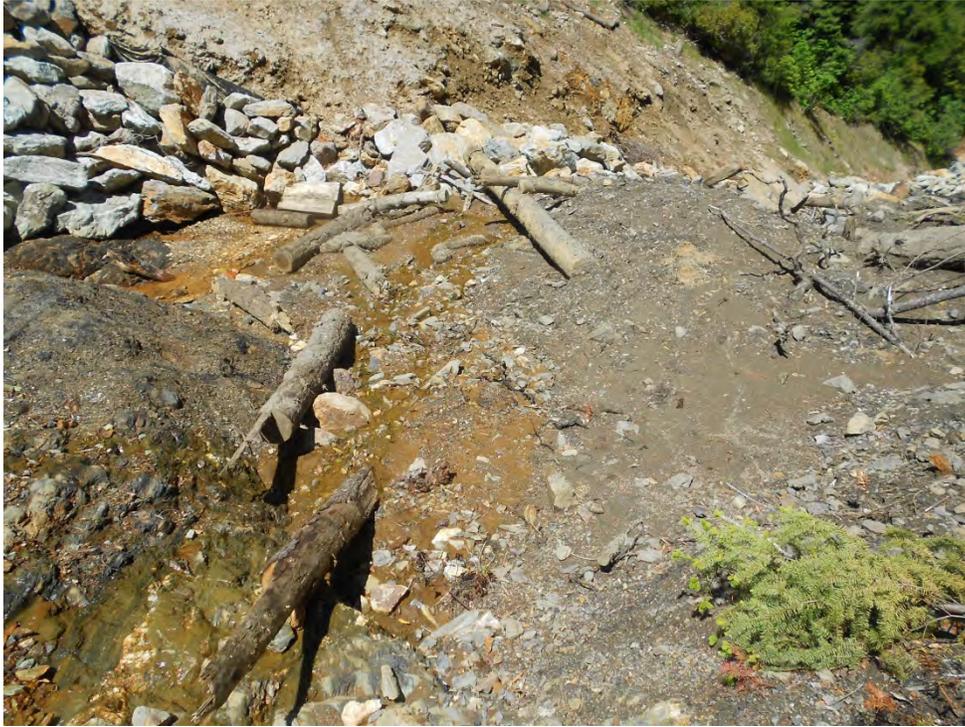
Photograph 15: Sediment/pH Treatment Basin 1F.
Blue Ledge Mine, Rogue River - Siskiyou National Forest, CA
Photographed by: Randall West (ERRG)

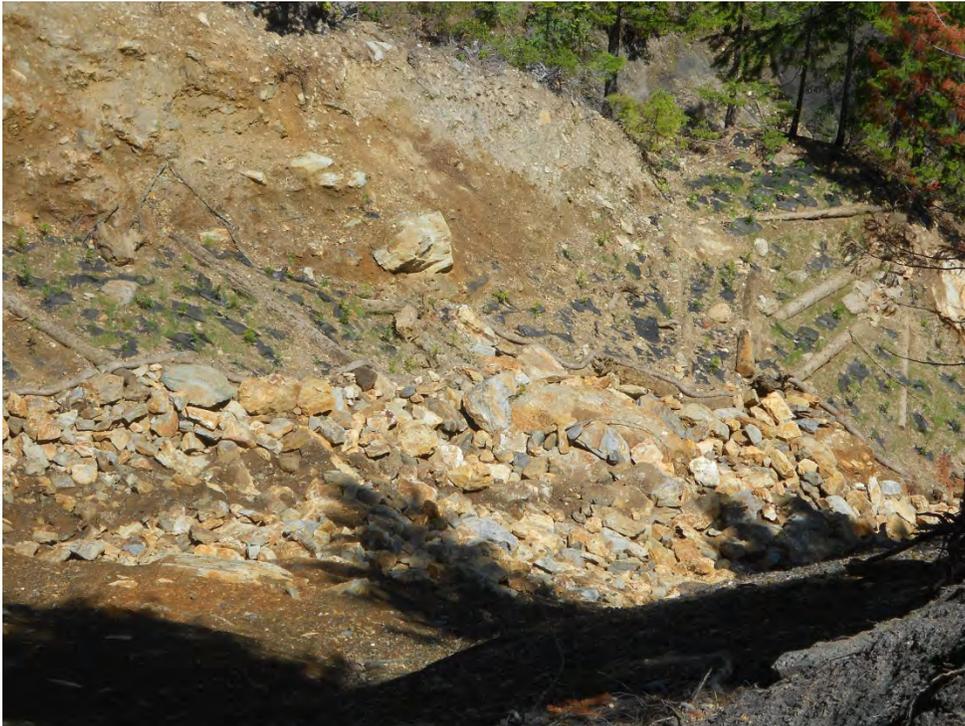
Photograph 16: WRP-1 reclamation area.
Blue Ledge Mine, Rogue River - Siskiyou National Forest, CA
Photographed by: Randall West (ERRG)

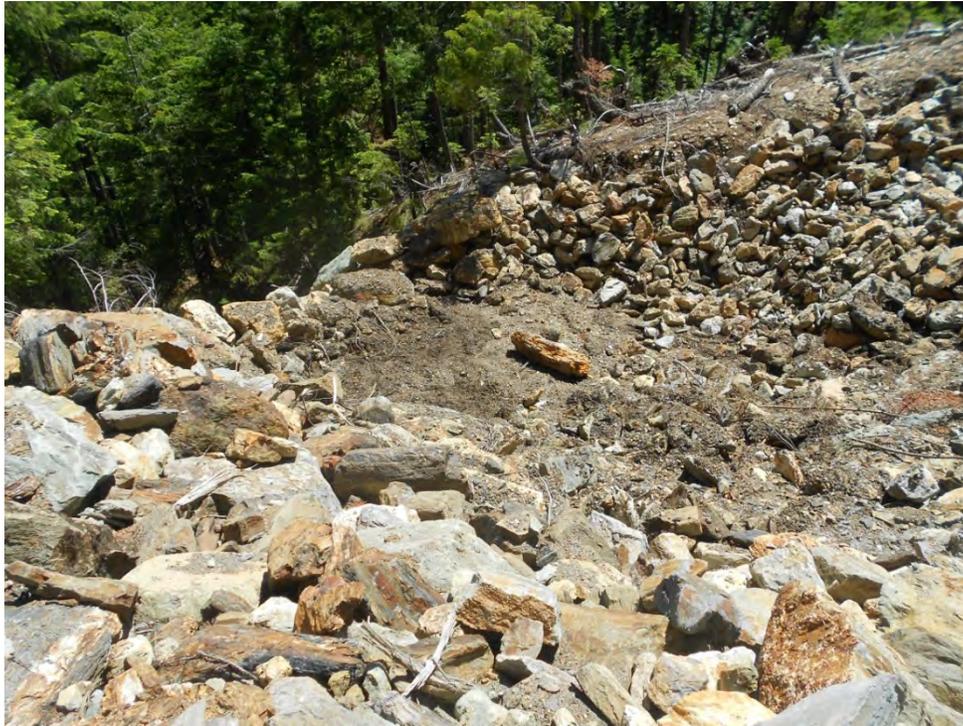
Photograph 17: Sediment/pH Treatment Basin 2B.
Blue Ledge Mine, Rogue River - Siskiyou National Forest, CA
Photographed by: Randall West (ERRG)

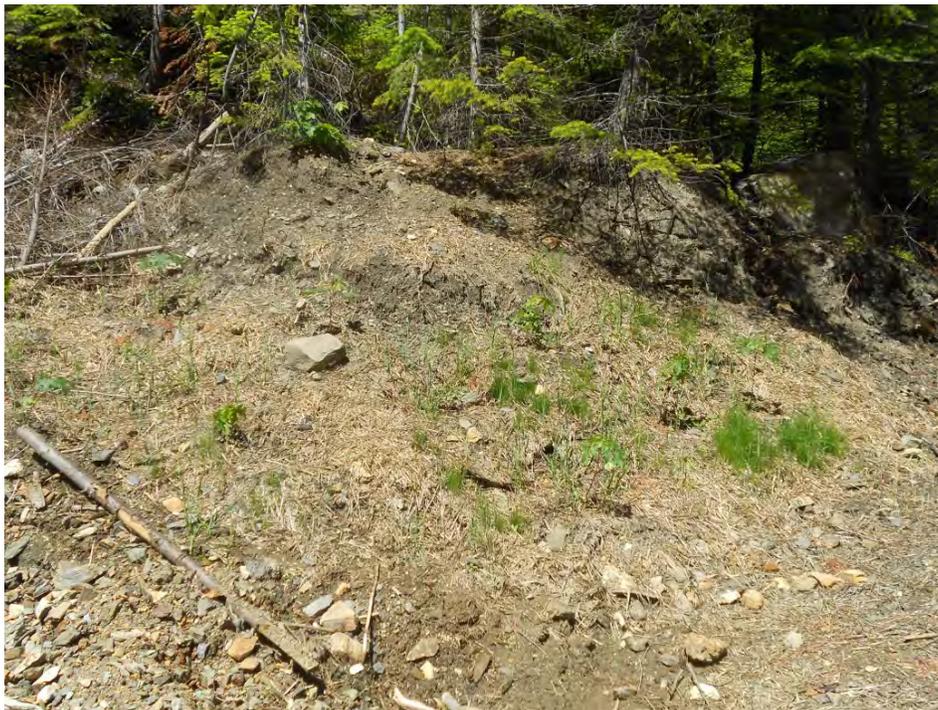
Photograph 18: WRP-2 reclamation area.
Blue Ledge Mine, Rogue River - Siskiyou National Forest, CA
Photographed by: Randall West (ERRG)

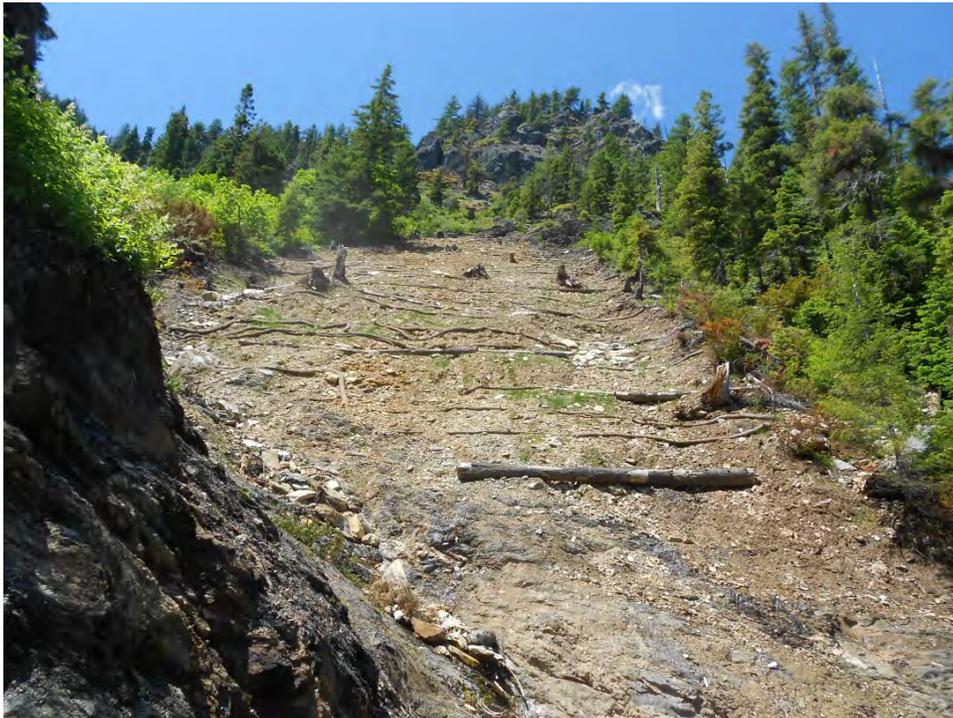
As observed during the May 2012 inspection, a significant number of plants (up to 30 percent) have died on WRP-3; the plants were primarily Douglas Fir. During the July 2012 site inspection, no additional plants had died during the period between the June and July inspections. WRP-3 will also be inspected during a site inspection on July 17, 2012, as noted above. Grass was broadcasted at WRP-3 in June and has not yet germinated.

Comments: Some wattles require repair and some areas under the log wattles need to be filled in. This work will be conducted during the Summer maintenance event.

Photograph 20: WRP-3.

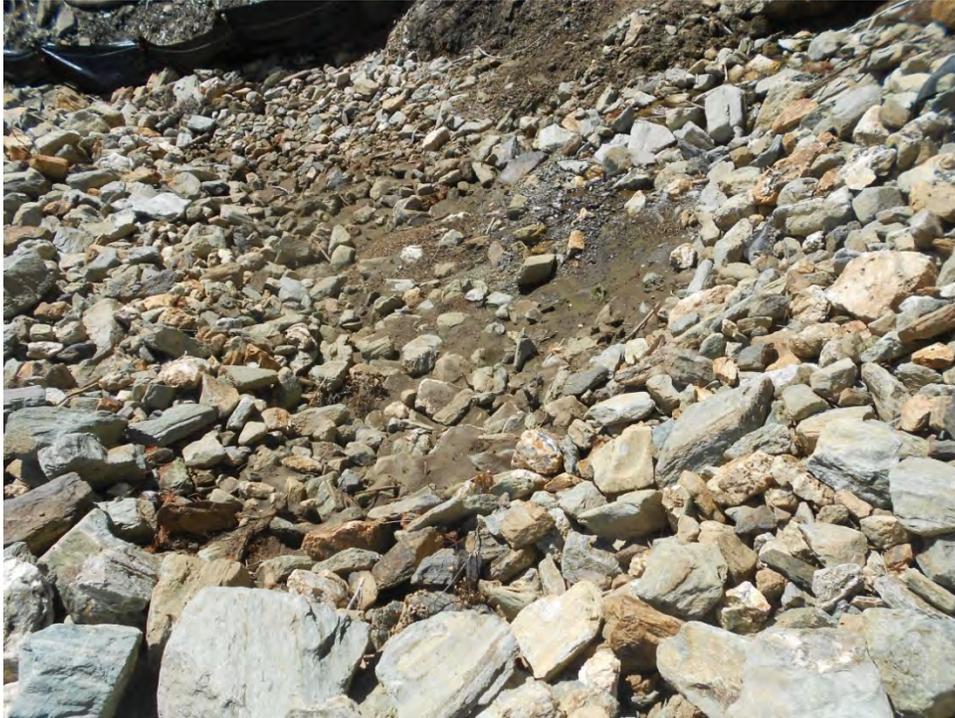
Photograph 21: Sediment/pH Treatment Basin 3.
Blue Ledge Mine, Rogue River - Siskiyou National Forest, CA
Photographed by: Randall West (ERRG)

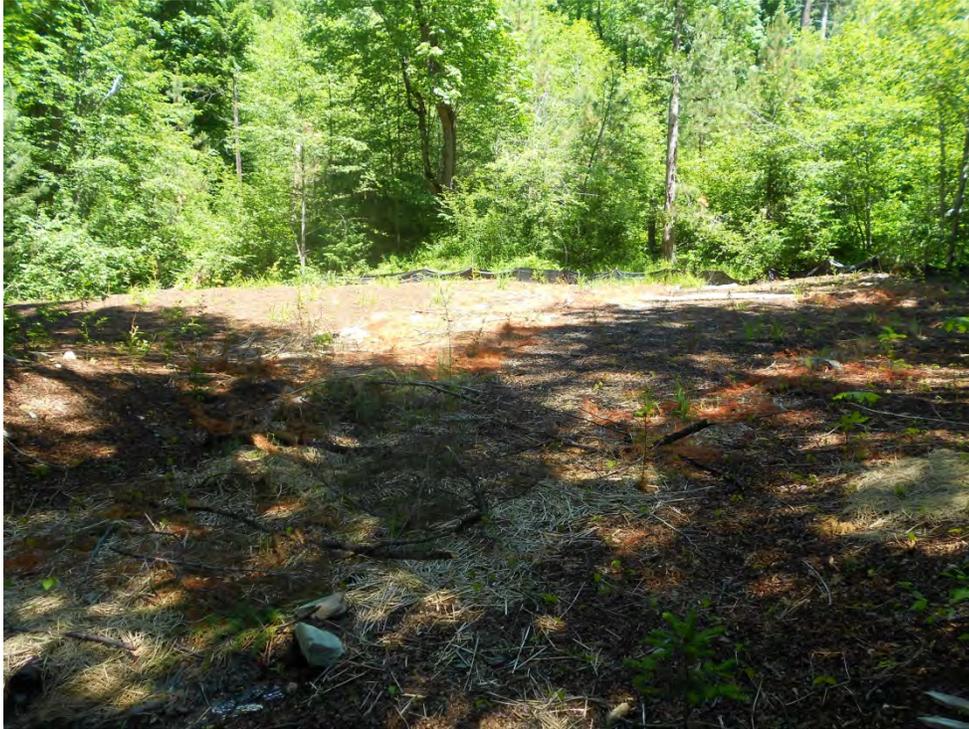
Comments: No repairs required.

Photograph 22: South Storage Area.

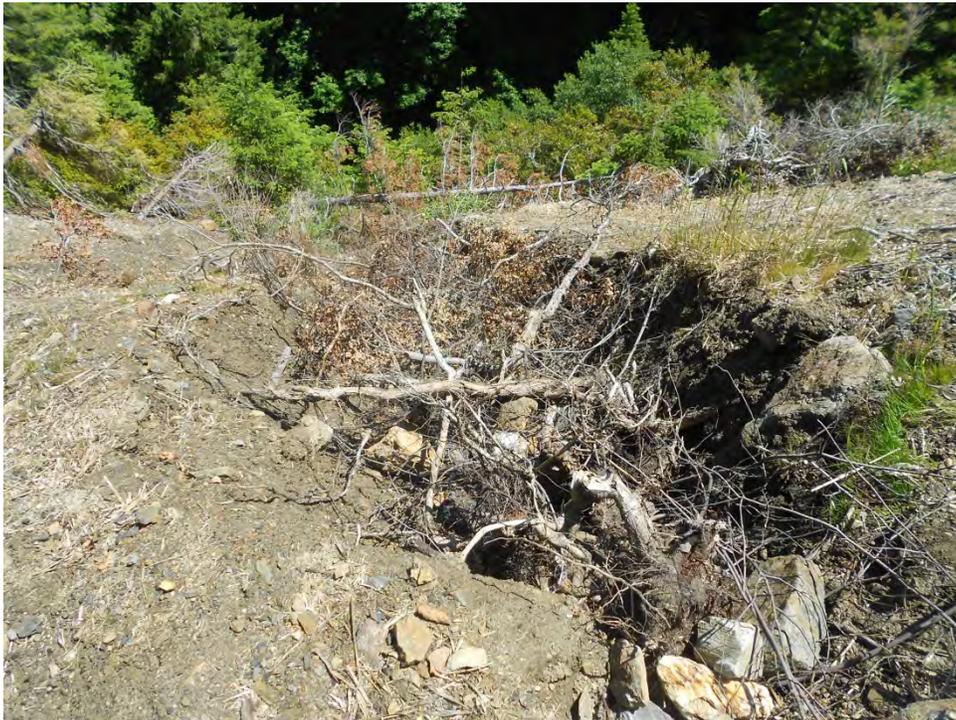
Photograph 22: Erosion on the side of Haul Road 4 requiring repair.
