Geology Recommendations for Hayden Flat Campground for Flat Fire

By Melanie Stevens, Shasta-Trinity Geologist

27 July 2012

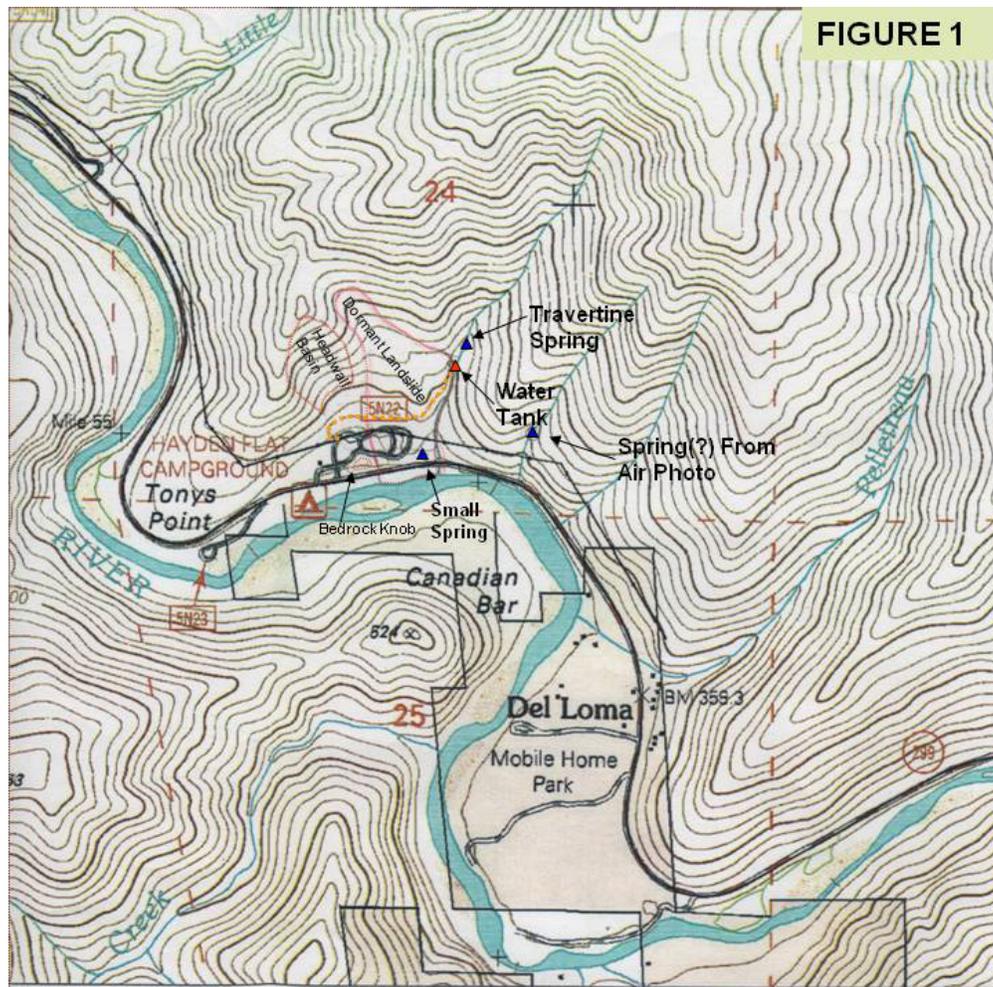
The steep slopes immediately above Hayden Flat Campground burned with low intensity in the Flat Fire and therefore have little to no increase in landslide potential that will immediately affect the campground area. Slopes on the eastern part of the campground, near the water storage tank, burned with moderate intensity and have a slightly increased landslide potential. These slopes slope into the unnamed drainage located east of the campground.

There is moderate risk in rockfall potential in the slopes above the campground due to the burning of ground vegetation. There is evidence of historic rockfalls within the campground area (large boulders near the first vault restroom past the campground host), along with a mapped headwall basin located upslope of the campground (Figure 1). The potential for rockfall will be highest with the first heavy rains of the fall or with intense summer storms and then decrease over the next few years. A second possible trigger for rockfall would be an earthquake with strong local ground shaking.

It is recommended to post signs within the campground to warn visitors of the potential rockfall hazard, along with an information sign of potential warning signs and noises of an impending rockfall and what to do. If further mitigation is needed, it is recommended to close the campsites located near the northwest hillslope that burned.
