Monjeau Lookout: Jewel of the Southwest

by Mark Gutzman, New Mexico FFLA Chapter Director

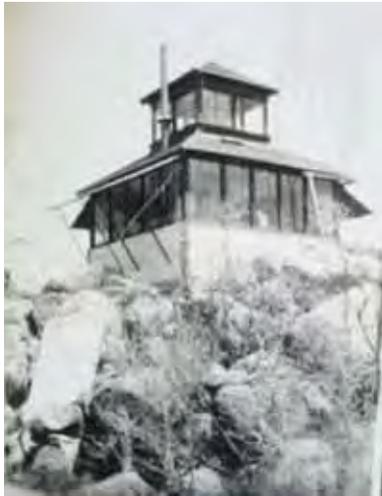
The history of the Monjeau Peak Lookout began in 1936 with the construction of a D-6 cupola type ground-house lookout by the Civilian Conservation Corp (Figure 1). The D-6 provided living quarters for the lookout in the main 14'X14' cabin, and access from a ladder into the 1/4 scale observation cupola on top.

Figure 1. Monjeau Peak's D-6 Lookout circa 1936.

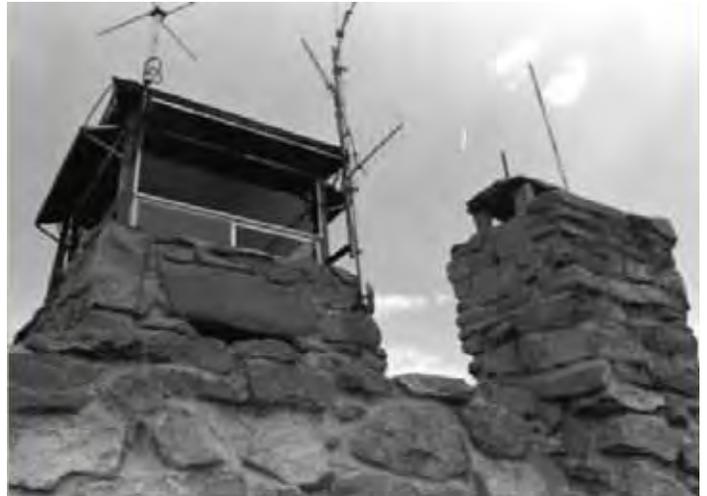
Figure 3. The 1960s alteration of the windows provided an unobstructed view of the surrounding landscape.

Sometime in the 1960s, the windows were changed to provide an unobstructed view through panoramic panes (Figure 3). These windows were replaced with the original style during the 2006 restoration of the lookout; although there was verbal opposition during the planning stage by fire personnel, stating that the full paned windows were better, providing optimal unobstructed viewing (Figure 4).

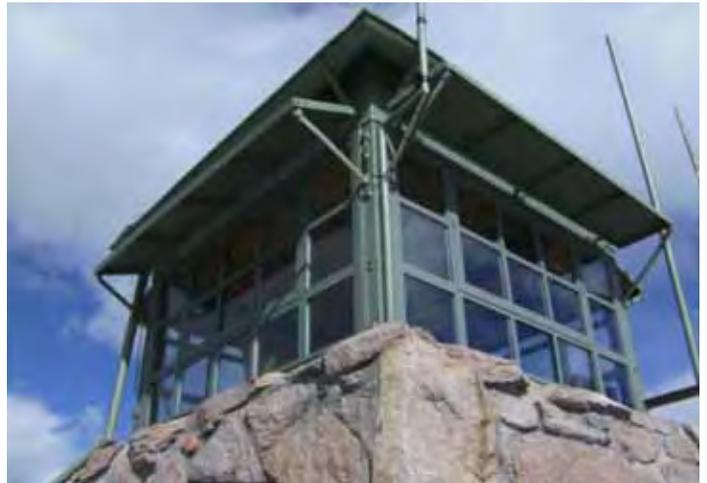
Figure 4. Monjeau cab after 2006 restoration.

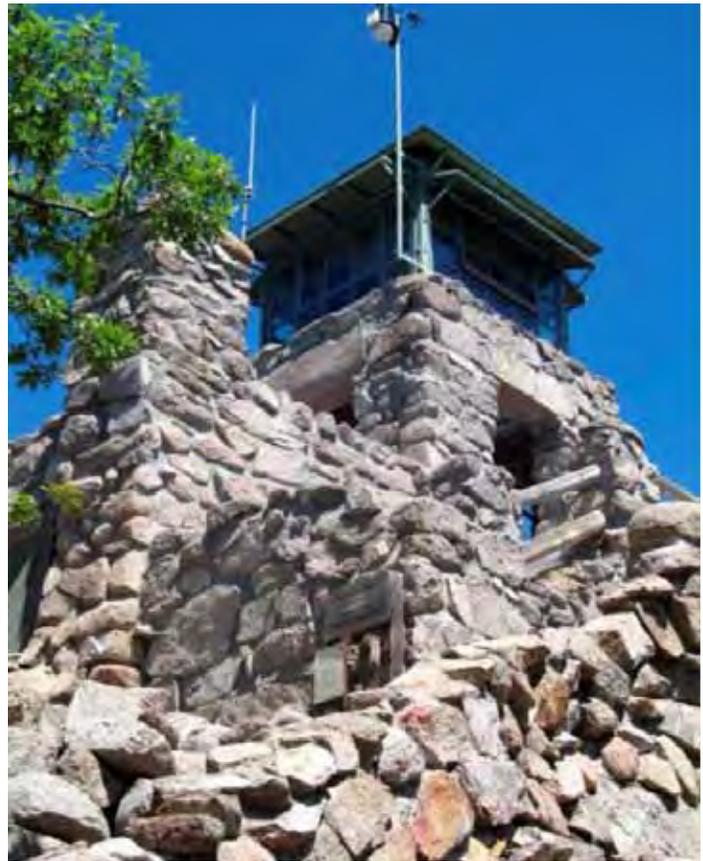
approximately 44,330 acres. The fire started just south of Elk Point, at an elevation of 10,200 ft., near the head of the Gamble Canyon-Three Rivers and Upper Rio Bonito watersheds. On June 6th, Lincoln NF employee Linda Cole took a photo of Monjeau still under clear blue skies (Figure 6).

Figure 6. Monjeau Lookout under blue skies.

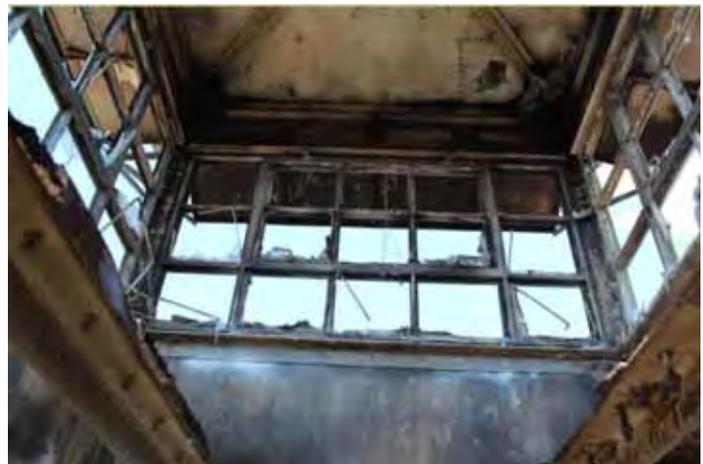
Late on the 8th of June, 30-40 mph winds began to cause significant spotting across the fire line; and the fire quickly grew from 8,000 acres the morning of the 9th, to 15,000 acres by that evening. Since the lookout cab was the only part of the lookout that sustained significant damage, it appears that superheated winds blowing through Monjeau's breezeway probably ignited the wooden floor of the cab which then began to consume its interior from the bottom up (Figure 7). All of the window glass, chair, Osborne pedestal (the Osborne Firefinder

was taken from the site before archaeological staff arrived, and is missing), and the various other accouterments of observation not totally consumed by the fire were found in a pile on the observation deck (cabin roof) floor. The only damage to the Observer's cabin were a couple of minor cracks in two of its windows.

Figure 7. Photo taken standing in the breezeway looking up.

The tower structure itself appears to have passed through the fire unscathed save for a coating of soot. In fact, the timber hand rails, and wooden description sign (and NHLR register plaque) did not burn.

Assessments are currently being made by USFS Archaeologists and Facility Engineers to restore this jewel of the southwest to its former glory; and hopefully by the 2013 Western Conference it will be.
