**GLENGARRY MILL-SITE ADIT CLOSURE  
CONSTRUCTION REPORT JULY 21<sup>ST</sup> – AUGUST 22<sup>ND</sup>, 2008**

**CONTRACT AND TASK ORDER NO. AG-0398-C-07  
MODIFICATION 0002**

**NEW WORLD MINING DISTRICT  
RESPONSE AND RESTORATION PROJECT**

**USDA Forest Service  
Gallatin National Forest  
Bozeman, Montana**

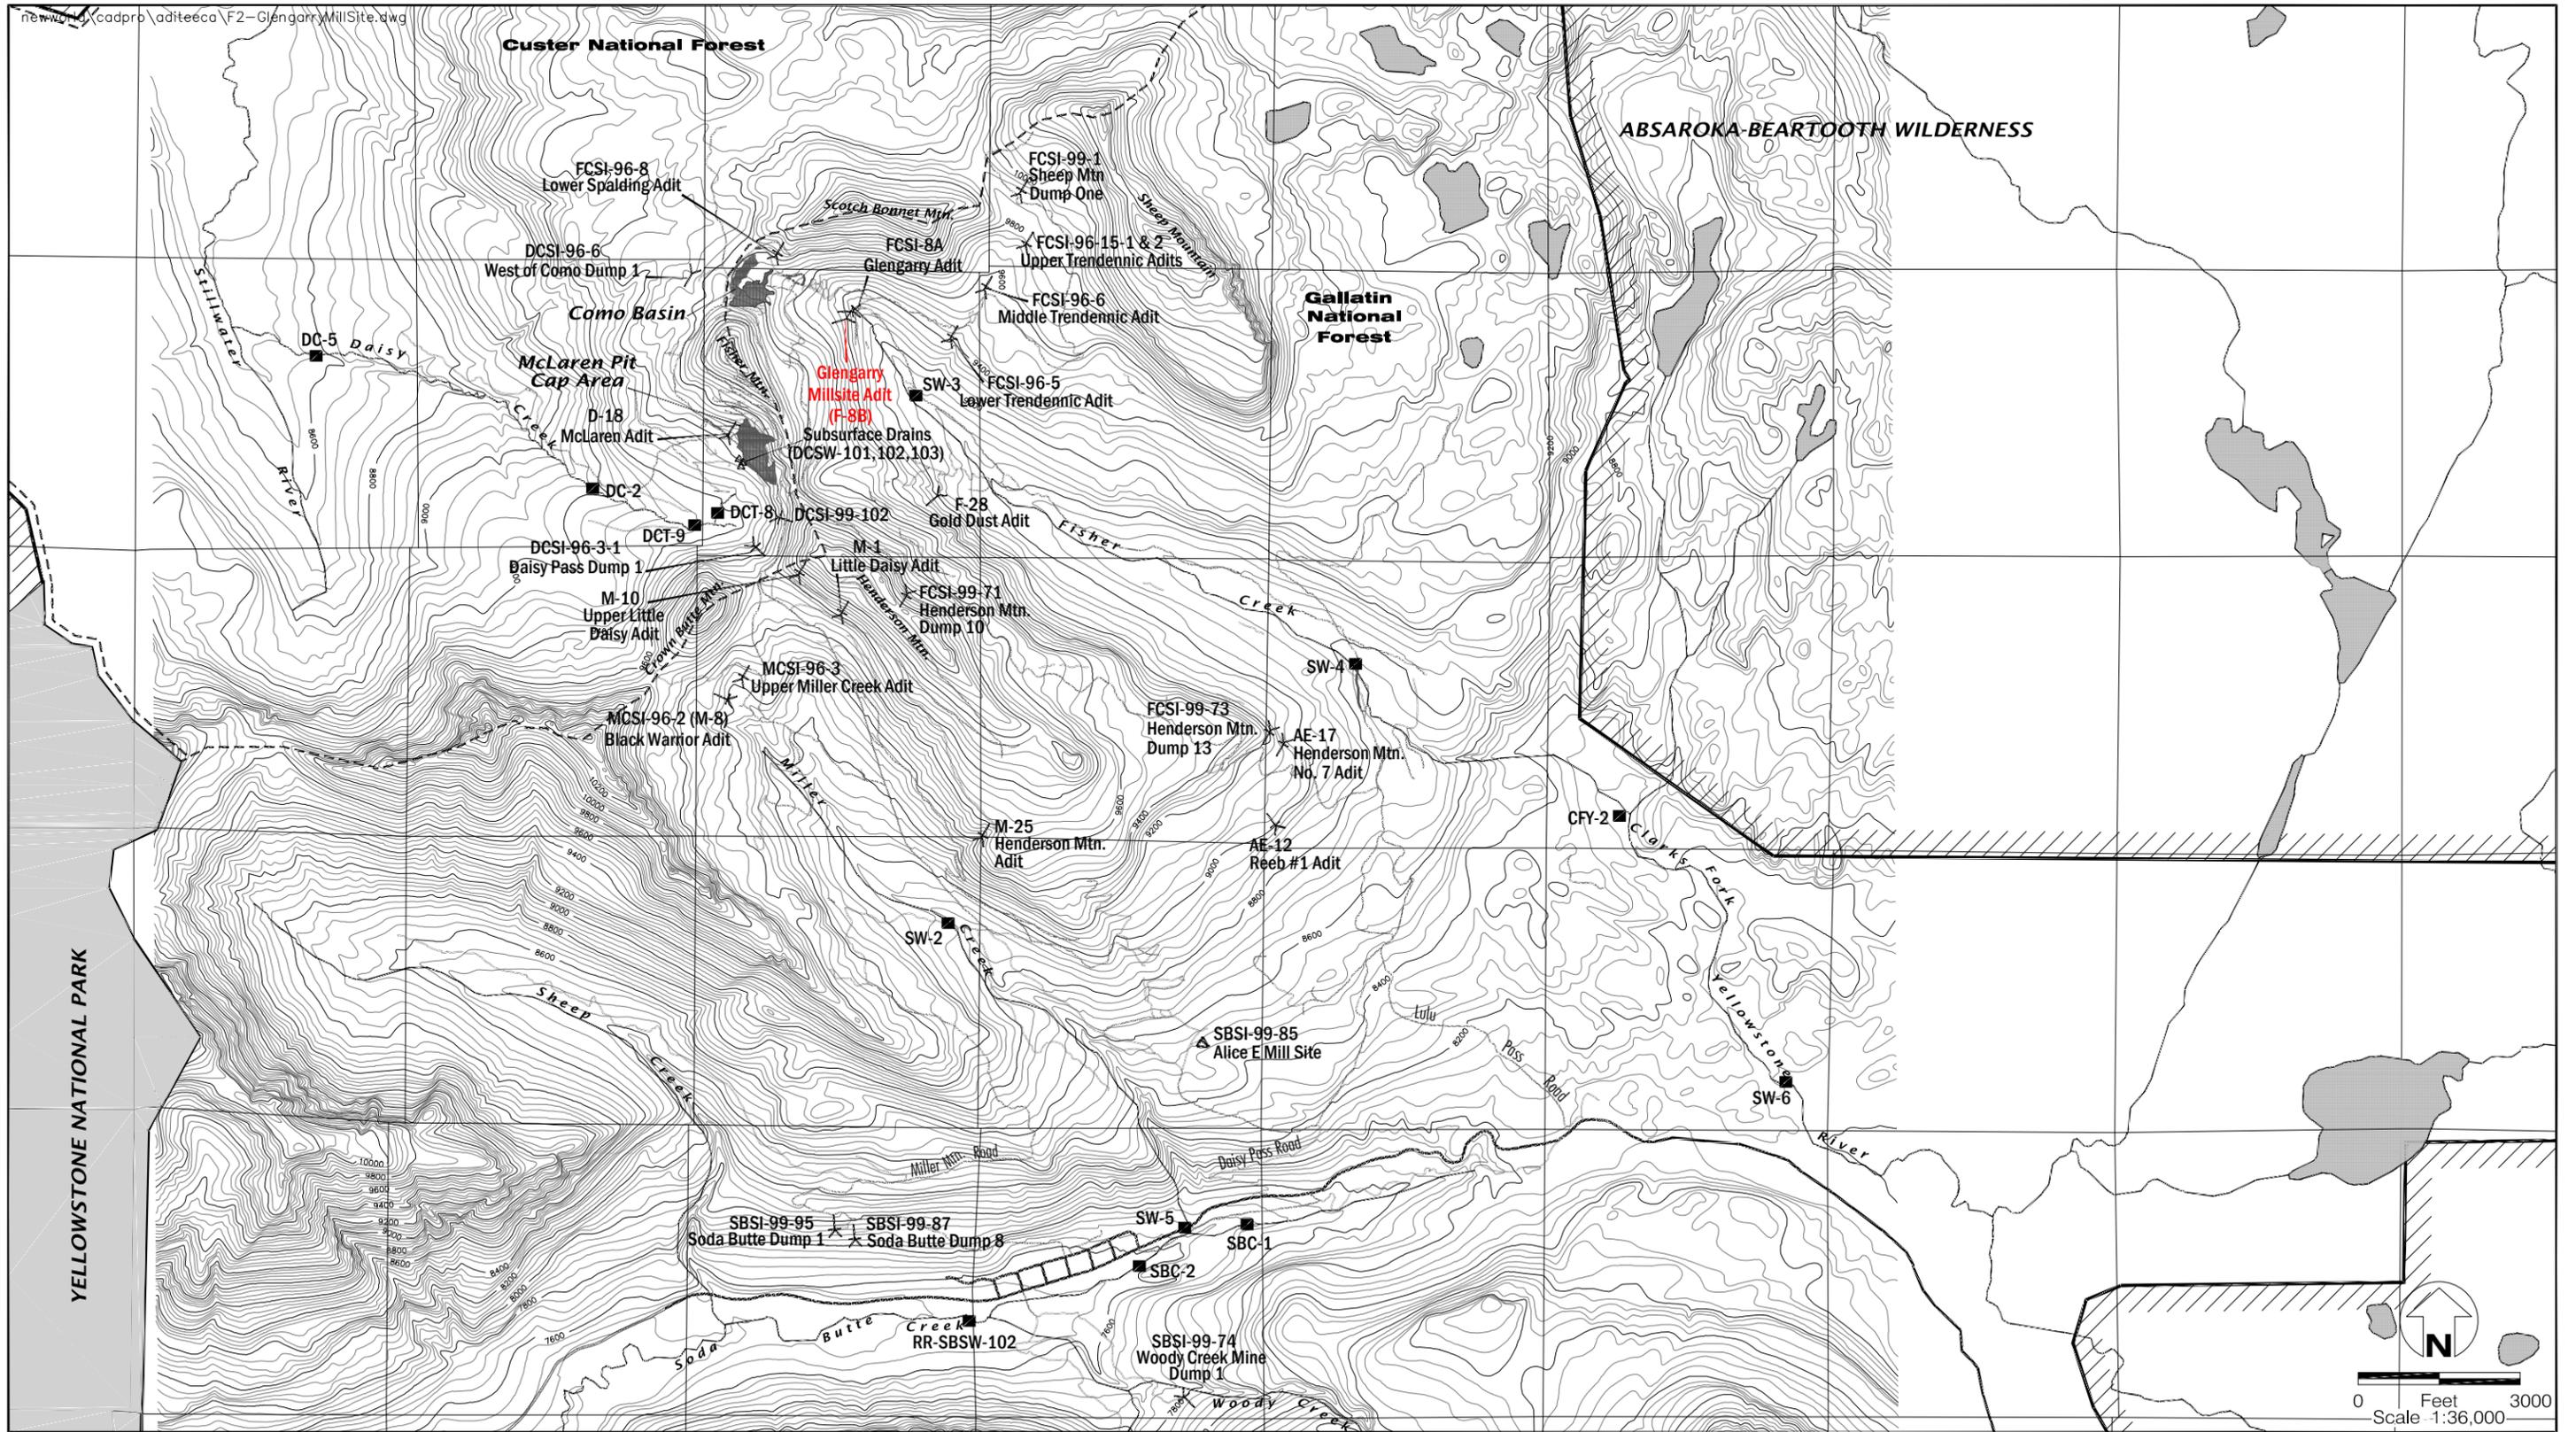
Map of Upper Fisher Creek Showing Glengarry Mill-Site Adit  
New World Mining District  
Response and Restoration Project  
Cooke City Area, Montana  
FIGURE 2

The significant mine workings in the upper Fisher Creek drainage/Lulu Pass area, to which the Glengarry Mill-site Adit is ancillary, are comprised of the now closed Glengarry adit and Como raise (**Figure 2**). Together, these features make up a large portion of the now-closed Glengarry Mine's workings, which were driven between 1925 and the mid-1930's in part to access the Como stratabound massive sulfide replacement deposit, which is hosted in the Meagher Limestone Formation at the surface in the Como Basin. From 1974 through 2003, water flowing from these workings was identified as a major source of acidic metal laden adit discharge to Fisher Creek. Consequently, between 2003 and 2005, a major remediation and reclamation plan that included grouting, backfilling and placement of hydraulic cement plugs at strategic locations in the Glengarry Mine and Como Raise was designed and implemented. Ultimately, this work led to a very large reduction of flow from the Glengarry Mine and a major reduction in the contaminant metal load in Fisher Creek (Tetra Tech, 2007).

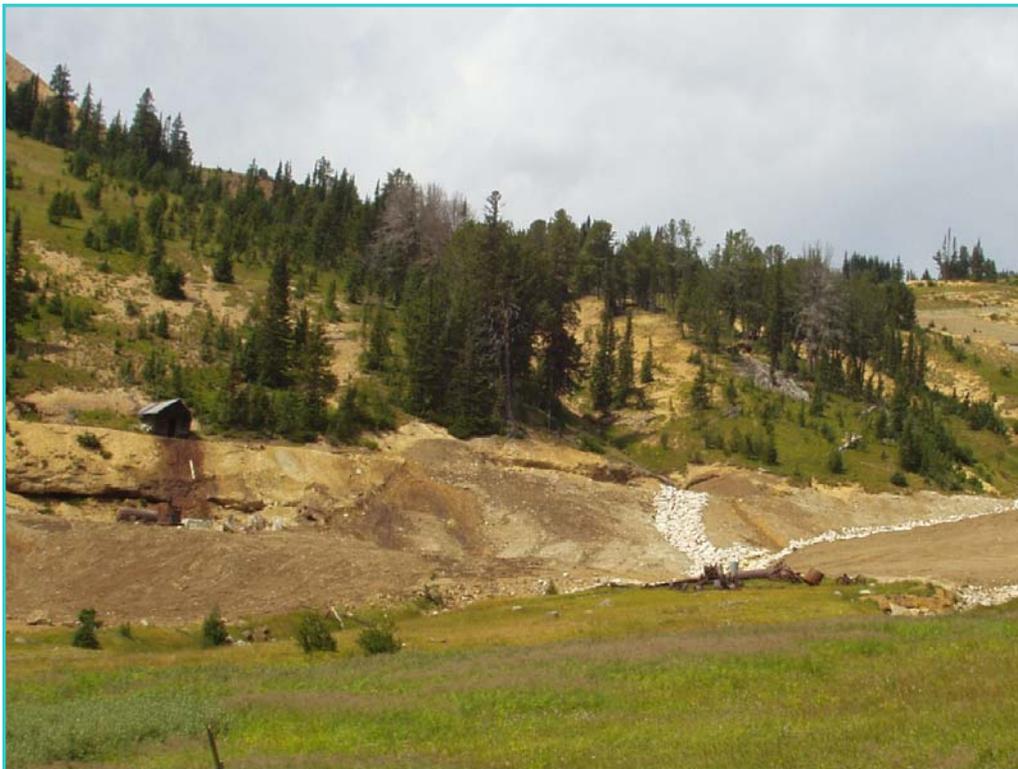
The Glengarry Mill-site Adit (site F8-B; **Figure 2 and Figure 3**) is located immediately south of the reclaimed main Glengarry Adit, above the upper reach of Fisher Creek and south of Lulu Pass. This adit consists of a single horizontal drift extending approximately 13 meters (42 feet) into the east flank of Fisher Mountain. The Glengarry Mill-site Adit was likely driven to provide extended storage space behind a small wooden building that stood at its portal. No remediation or reclamation work has previously been completed on the Glengarry Mill-site Adit.

Water discharging from the adit flowed over an extensive ferricrete bench outside of the portal (**Figure 3**), around the old Mill-site, and infiltrated into colluvial materials directly below the Mill building foundations approximately 46 meters (150 feet) from Fisher Creek. This shallow groundwater likely reports to Fisher Creek. The presence of a sizable lithified ferricrete bench outside of the portal and ferrihydroxide mud within the workings suggests that groundwater, rich in reduced iron, is seeping from fractures in the country rock and precipitating iron-hydroxides upon contact with the atmosphere at the surface. Indirect age-dating of Ferricrete in the area has shown that these deposits areas much as 8,800 years old (Furness and Hinman, 1998), and indicate that these processes were occurring long before underground mining in the area.

**Figure 3. Glengarry Mill-site Adit site, view to west-northwest.**

The wooden building (**Figure 3**) at the Adit portal was dismantled and hauled away for disposal. A small settling basin was constructed approximately 75 feet south of the Adit on a partially reclaimed historic roadbed (**Figure 4**). The settling basin was constructed to contain muck and debris removed from the Adit during rehabilitation and to allow suspended sediment to settle from water discharging from the adit during construction (**Figure 5**).

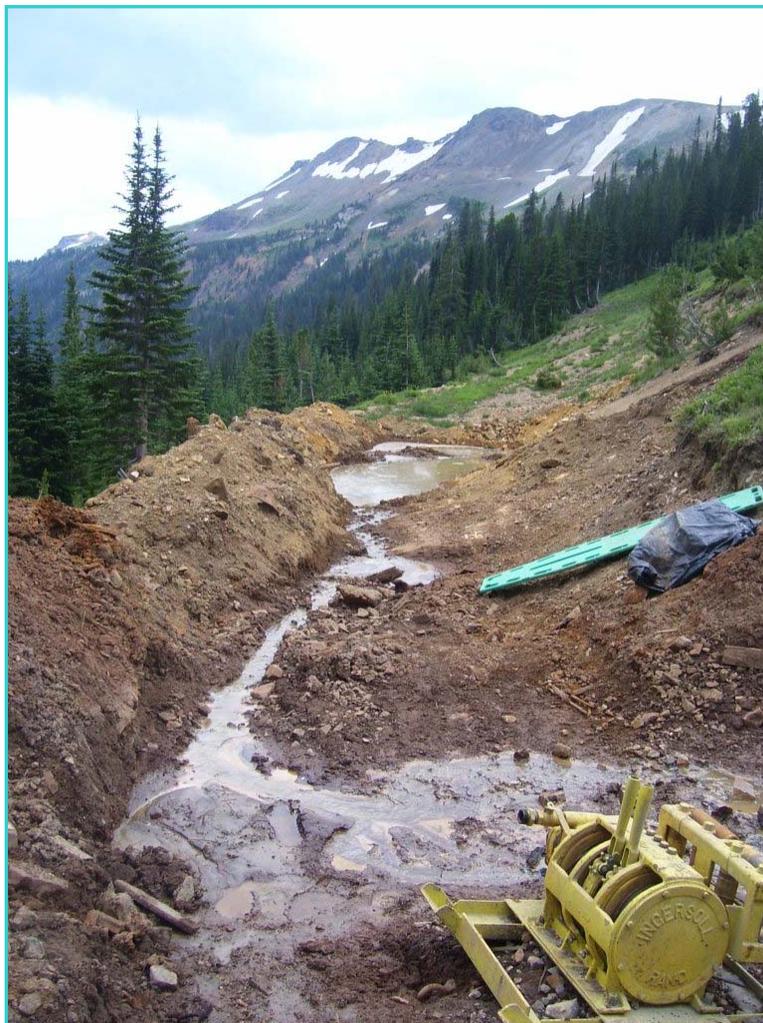
**Figure 4. View of muck/settling basin and drainage channel from portal.**

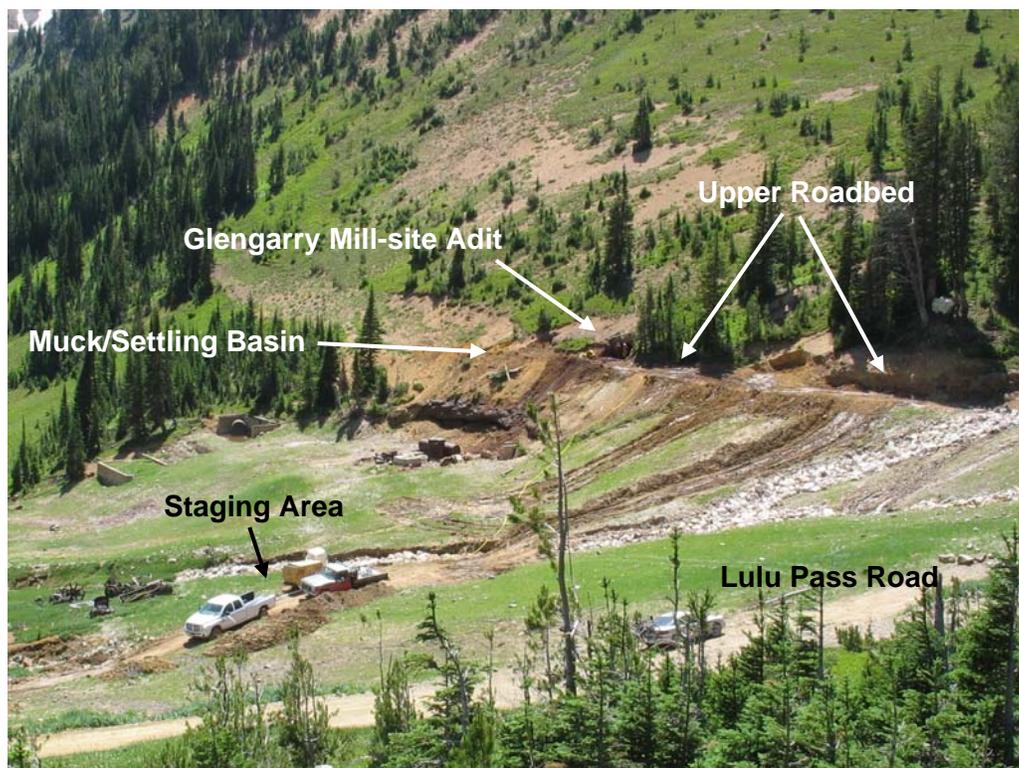
**Figure 5. Overview of Glengarry Mill-site from Lulu Pass road, view to southwest.**

The entire upper roadbed (**Figure 5**), from south of the settling basin to the Glengarry Adit, was reclaimed by backfilling using the spoils from the cut slope. In addition, the access trails to the adit from the lower staging area created a disturbance that also required reclamation. The access disturbance was re-graded and new rock was added to a stream channel that had been bridged. All re-contoured and graded areas were scarified, top-soiled as needed and seeded. Erosion mat was placed to prevent rills from forming during germination in the first growing season.

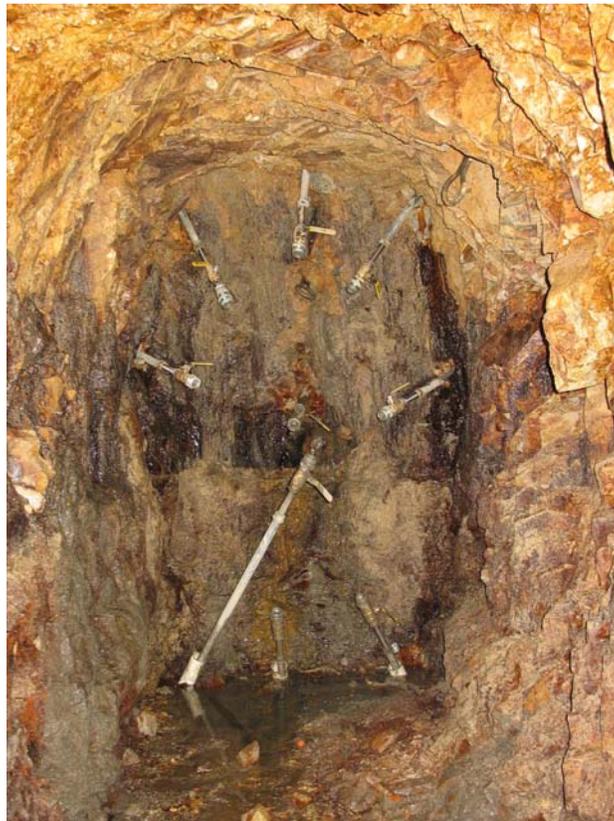
**Figure 6. Packers set in holes comprising the first grout ring.**

The contract proposed that cement grout curtains be installed by drilling about five groups of eight holes in a radial (“ring”) pattern around the adit (**Figure 6**). Rings were to be initially spaced approximately eight feet apart, beginning at the face and continuing toward the portal. Grouting was conducted based on this general plan and took place between August 5, 2008 and August 15, 2008. Secondary rings of holes could have been drilled halfway between the primary rings (4-feet) if water flows between rings determined that this was necessary. No circumstances were encountered that suggested that secondary rings or holes needed to be drilled. A typical ring was installed and grouted as follows:

- Five to eight approximately 3.25 centimeter (1.25 inch) holes were drilled into the rock in a radial pattern to a depth of approximately 3 meters (10 feet) using either a pneumatic jackleg drill or a sinker rock drill for down-holes in the sill (**Figure 6**),
- Pump-through packers were inserted into the holes and sealed in place,
- Portland cement grout was pumped under pressure (generally between 40 and 100 pounds per square inch) into each hole until the fractures in the rock adjacent to the holes would no longer take grout or until grout flowed out of an adjacent hole, demonstrating connectivity, and
- After all holes in a ring had been grouted, valves were removed from the packers and the packers were permanently sealed.

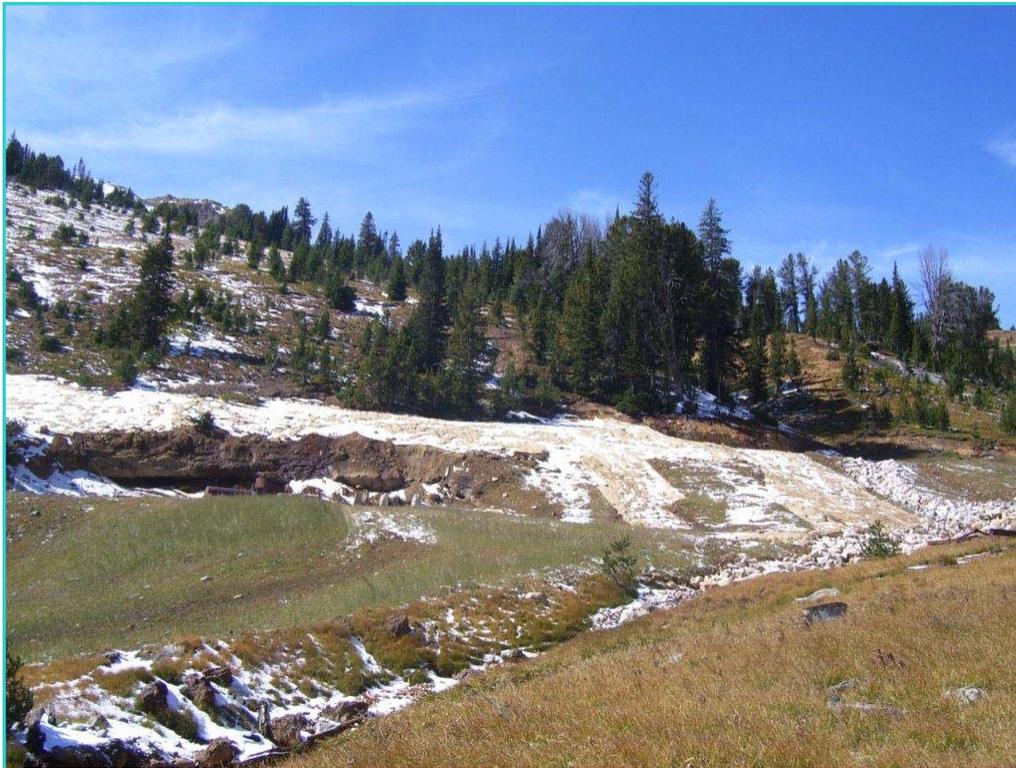
**Figure 7. Reclaimed Glengarry Mill-site Adit site, view to west-northwest.**

After the mining crew and equipment had been demobilized, the portal was closed under a contract addition. Initially, the reclamation and portal closure was to be completed by the US Forest Service. The project site was recontoured and revegetated in order to restore the area to a more natural appearance (**Figure 7**). To provide a post mine contour and allow adit drainage the portal opening was filled with large rocks (about 0.5 to one meter (18 inches to three feet) in diameter) from the sill to the back using excavation equipment. The gaps in the face of the portal plug were then hand-filled with smaller rocks. To provide for any remaining adit discharge, an infiltration basin was sized and constructed at the front of the portal by excavating an area approximately six meters (20 feet) in diameter down to the ferricrete bench (about 0.5 meters [18 inches] deep). The basin was filled with gravel (1" to 3") and covered with a non-woven geotextile. Muck and ferricrete mud that were removed from the Adit and placed in the settling basin during the project were allowed to dry and were then re-contoured in place.
