# Appendix W | Socio-economic Survey of the Lake Tahoe Region

## Introduction

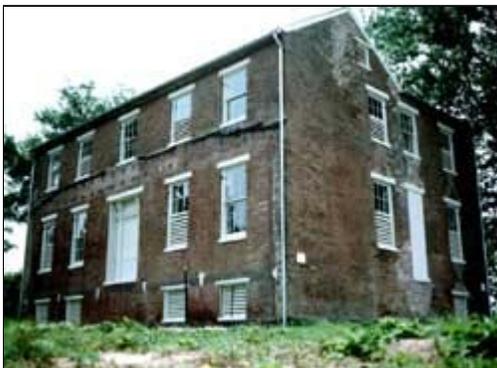
This building has been successfully mothballed for 10 years because the roof and walls were repaired and structurally stabilized, ventilation louvers added, and the property maintained. Photo: NPS files.

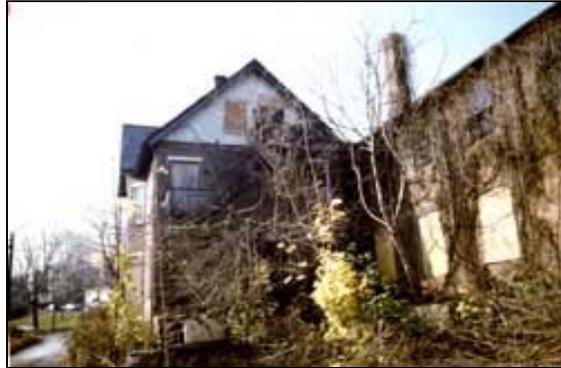
Boarding up without adequate ventilation and maintenance has accelerated deterioration of this property. Photo: NPS files.

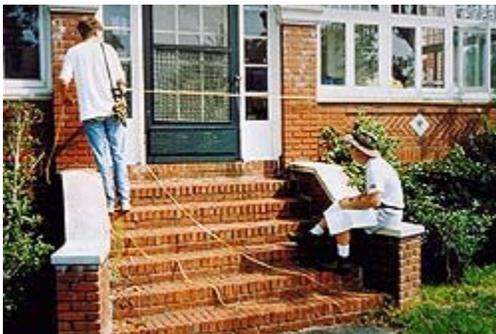
**Documenting a building's history and assessing its condition provide information to set priorities for stabilization and repair, prior to mothballing. Photo: NPS files.**

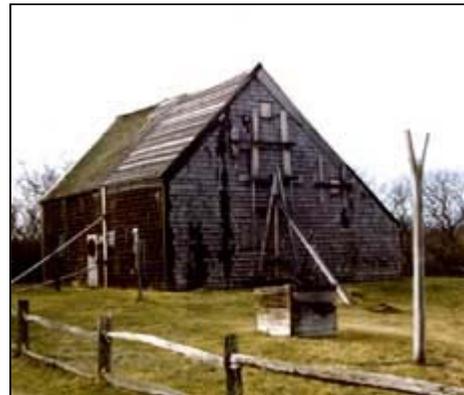
**Buildings seriously damaged by storms or deterioration may need to be braced before architectural evaluations can be made. Photo: John Milner Architects. Photo: NPS files**

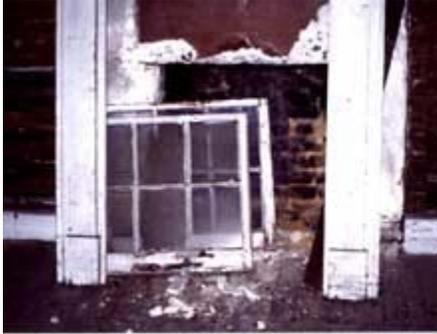
Loose or detached elements should be identified, tagged and stored, preferably on site. Photo: NPS files

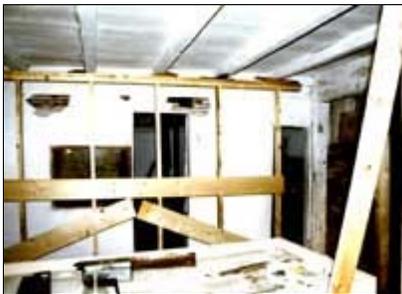
Interior bracing which will last the duration of the mothballing will protect weakened structural members. Photo: John Milner Architects.

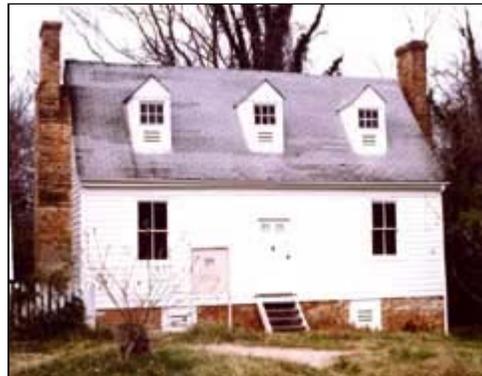
Regrading has protected this masonry foundation wall from excessive damp during its 10-year mothballing. Note the attic and basement vents, temporary stairs, and interpretive sign. Photo: NPS files.

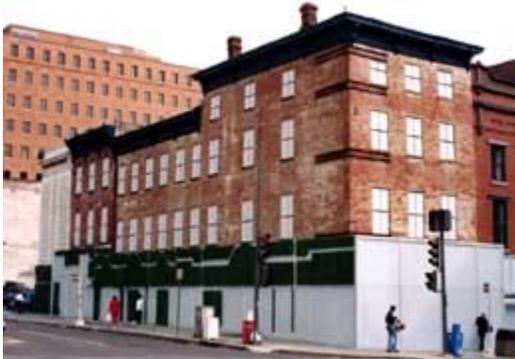
**Urban buildings often need additional protection from unwanted entry and graffiti. This commercial building uses painted plywood panels to cover its glass storefronts. The upper windows on the street sides have been painted to resemble 19th century sash. Photo: NPS files.**

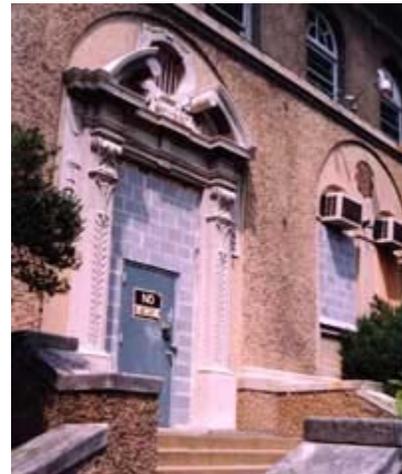
The first floor openings of this historic building have been filled with cinder blocks and the doors, window sash, and frames removed for safe keeping. The security metal door features heavy duty locks. Photo: NPS files.

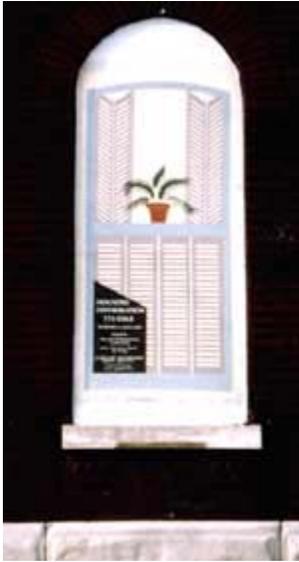
This painted trompe l'oeil scene on plywood panels is a neighborhood-friendly device. Photo: NPS files.

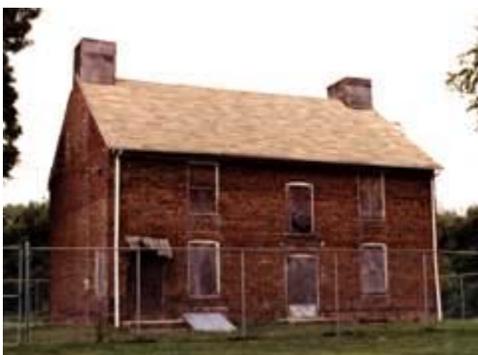
A view showing the exterior of the Brearley House, New Jersey, in its mothballed condition. Photo: Michael Mills, Ford Farewell Mills Gatsch, Architects.

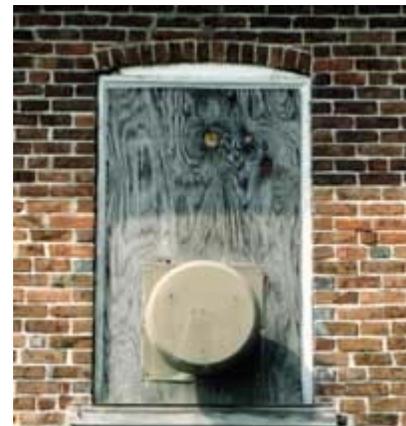
This exhaust fan has tamper-proof housing. Photo: Michael Mills, Ford Farewell Mills Gatsch, Architects.

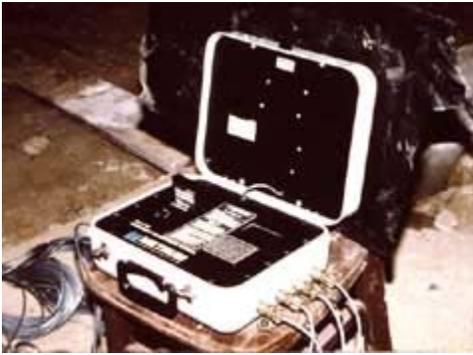
Portable monitors are used to record temperature and humidity conditions in historic buildings during mothballing. Photo: NPS files.
