**Implementation and Effectiveness Monitoring of
Wetland Best Management Practices on
The Tongass National Forest**

October 2011

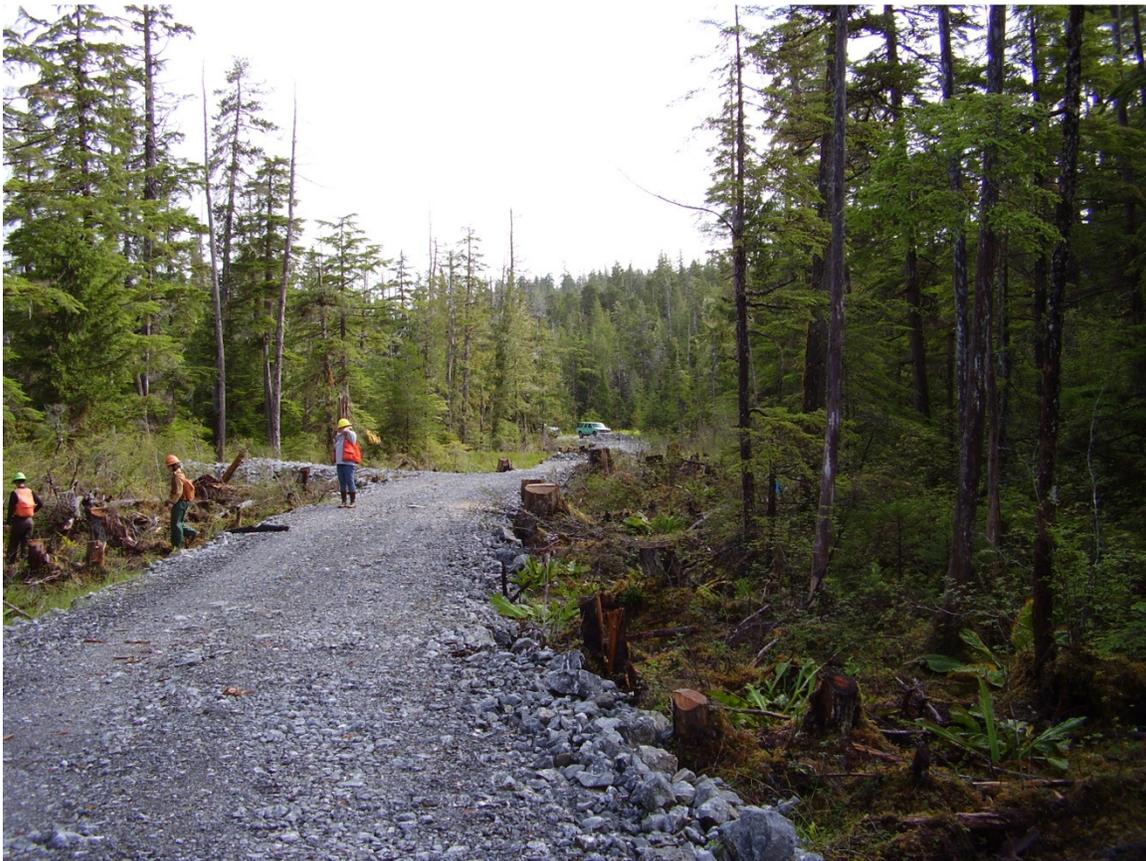
Newly Constructed Road through a Forested Wetland on the Logjam Project Area.

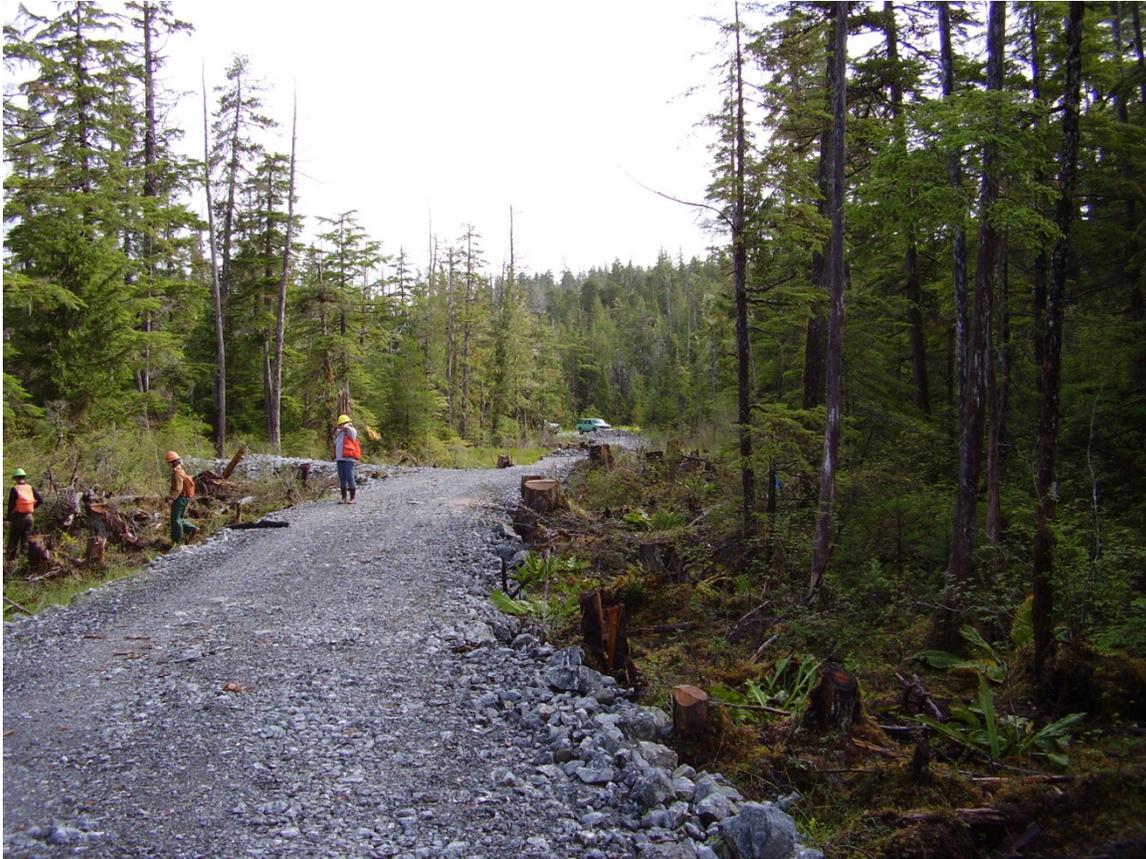
Figure 2. Overlay road construction through a forested wetland on the 577-35 temporary road segment. Disturbed soil widths averaged less than 23 feet through this wetland.

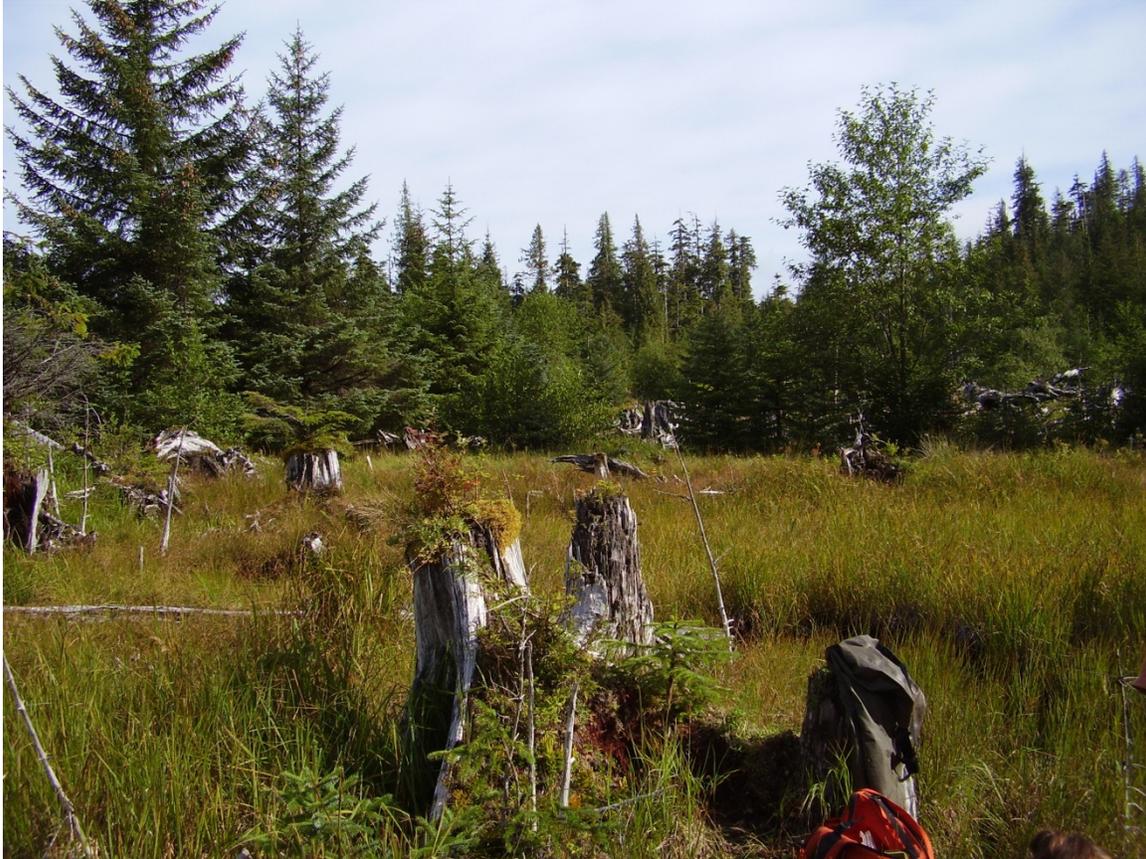
Beaver can have a major influence on the hydrologic regime of wetlands by changing water table depths over localized areas. The wetland and uplands around the decommissioned 30 road at Little Ratz Harbor experienced a change in water table depth following beaver activity in the area. The wetland under and adjacent to the decommissioned 30 road appears to be wetter than indicated by the pre-construction and pre-harvest air photos. Portions of the site that were forested 50 years ago are no longer supporting coniferous vegetation because of beaver ponds and raised water tables. In this case a wetter wetland had a negative effect on the forest vegetation and beneficial effect on the sedge vegetation at the site. Based on site conditions and our monitoring of similar sites without beaver activity, we estimate that the road had little to do with changing water tables at the site. The timber harvest may have created vegetation more suitable for beaver colonization, but the effects of the road on the hydrology of the site appear negligible.

Figure 3. This once forested wetland along the decommissioned 30 road segment was converted to sedge wetland by beaver influence following timber harvest and road construction.

Beaver dam construction also changed the soil moisture status and vegetation along the decommissioned 30 road. A wetland that was forested and logged in 1964-65 is no longer forested and supports sedge vegetation.
