Restoration Effectiveness in Cookhouse Meadow

In 2005 and 2006, the USFS implemented a stream channel/floodplain restoration project in Big Meadow Creek through Cookhouse Meadow, located adjacent to Highway 89 just below Luther Pass. Restoration activities included the construction of 2,400 feet of new stream channel to replace 1,400 feet of existing deeply incised and eroding stream channel. The existing channel became incised over a period of 30 years, as a result of installation of a culvert under Highway 89 and over grazing, as illustrated in the photos to the right.

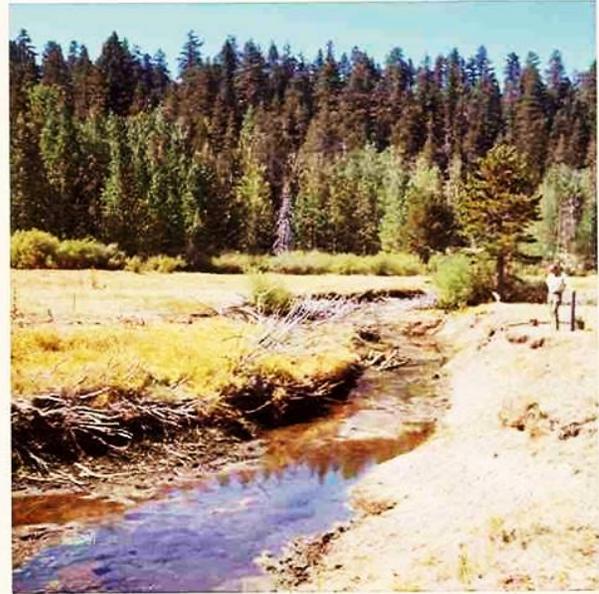
Big Meadow Creek in Cookhouse Meadow -1968

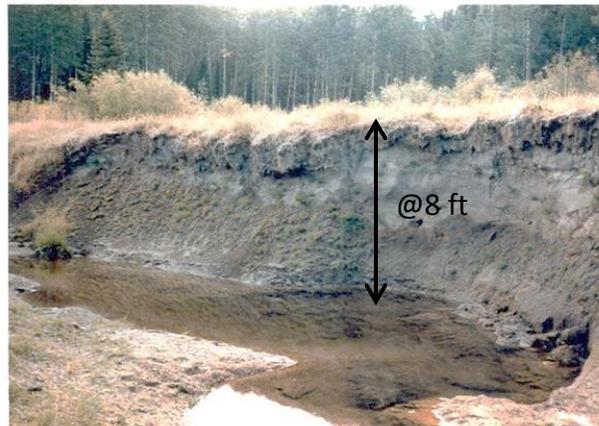
Big Meadow Creek in Cookhouse Meadow - 1981

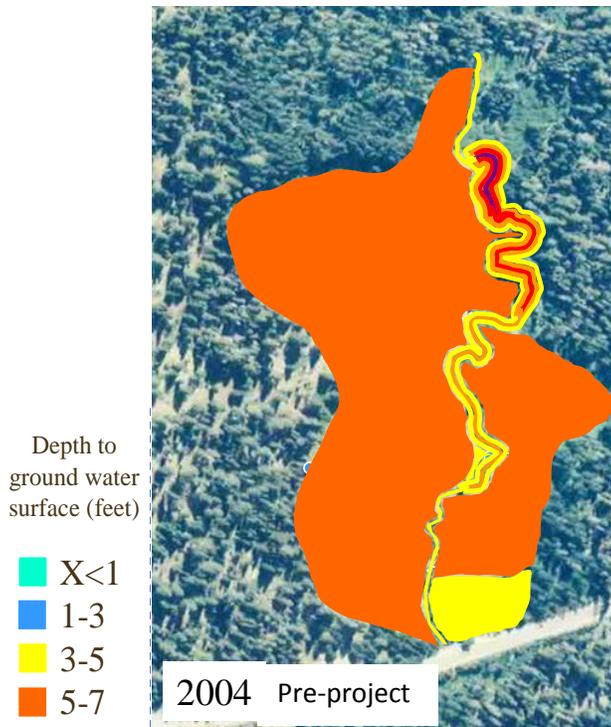
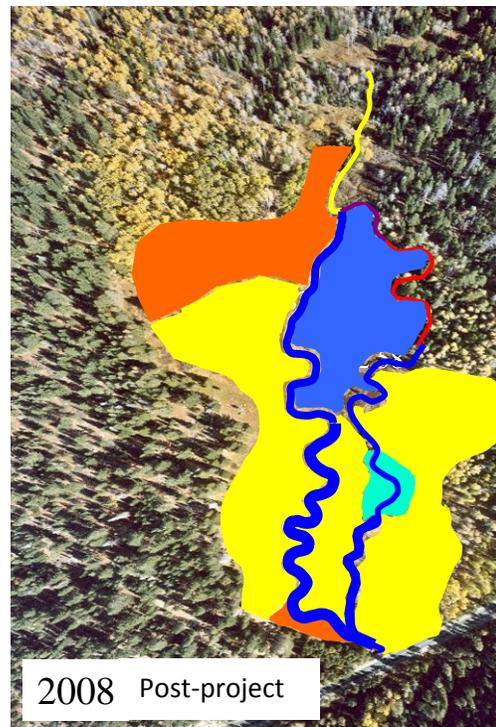
In addition, the restoration project has resulted in a 2 to 4 foot increase in groundwater levels, increasing the duration of available water for meadow vegetation. The images below illustrate mapped pre and post project groundwater levels, utilizing

groundwater depth measurements during the late summer period, for similar water year types (both below average).

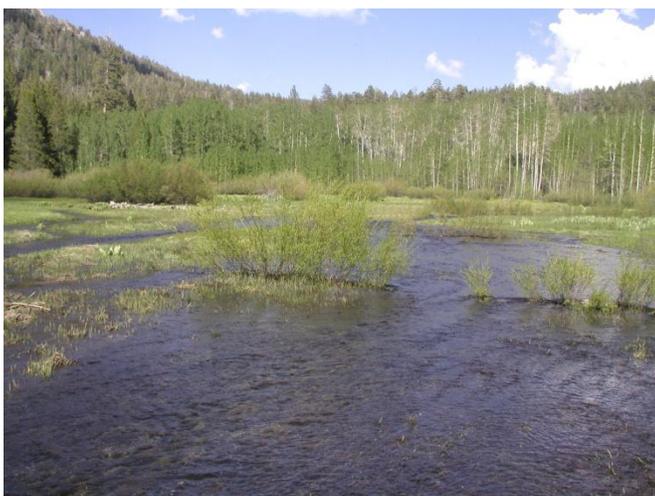
Flooded Meadow during Spring of 2011

Prior to restoration out-of-bank flows had not occurred in this meadow for approximately 30 years. Some degree of over bank flooding has occurred every spring post construction, and during the record

water year of 2011, up to 3.8 acres of the meadow was flooded for approximately 70 days during spring runoff. Based on analysis of data collected after spring runoff, approximately 24 tons of fine particles (silt/clay) were deposited in the floodplain.

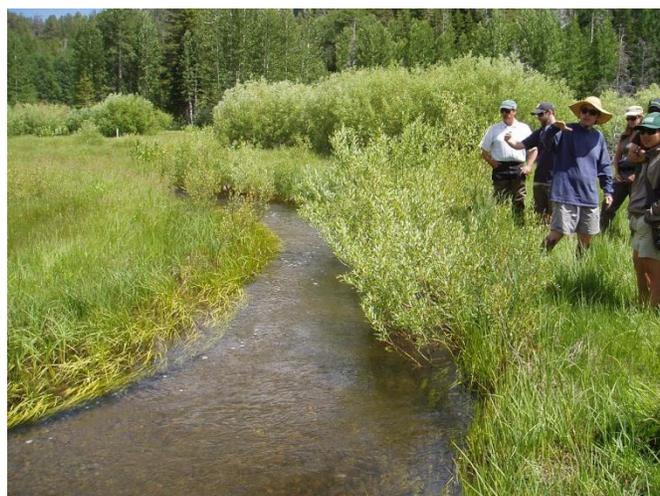
Meadow and Channel Riparian Vegetation – 2011

The vegetation community responded favorably to increased groundwater. Sod harvesting, willow staking, and willow mat data indicated a high success rate (approximately 90% survival). Also long term monitoring plots to measure vegetation community response indicate an increase in the proportion of obligate and facultative wet wetland species.
