CUSTER NATIONAL FOREST, SIOUX RANGER DISTRICT RILEY PASS NEWSLETTER

MARCH 2013

RILEY PASS RECLAMATION

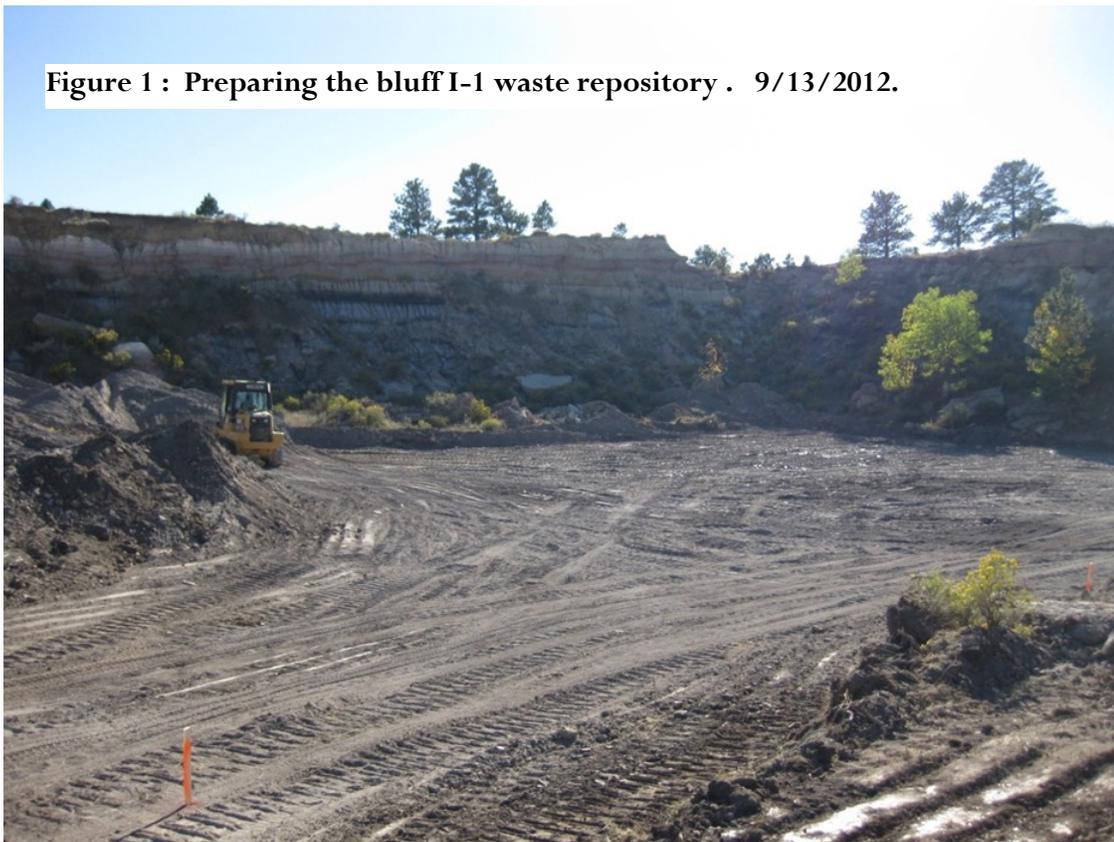
Figure 1 : Preparing the bluff I-1 waste repository . 9/13/2012.

Belair Builders, Inc. of New Brighton, Minnesota was awarded the contract for bluffs I-1, I-3 and bluff F reclamation. Work began in September 2012. Materials at the repository were removed down to sandstone bedrock (Figure 1). The bedrock was then lined with compacted bentonite to form the repository base. Mine waste placed in the repository was compacted and covered with spoils to prevent water infiltration. Areas where waste and spoils were removed (Figure 3) were covered with uncontaminated soil from a nearby soil borrow area. Removal areas were then capped with compost, seeded and covered with biodegradable erosion matting (Figure 4).

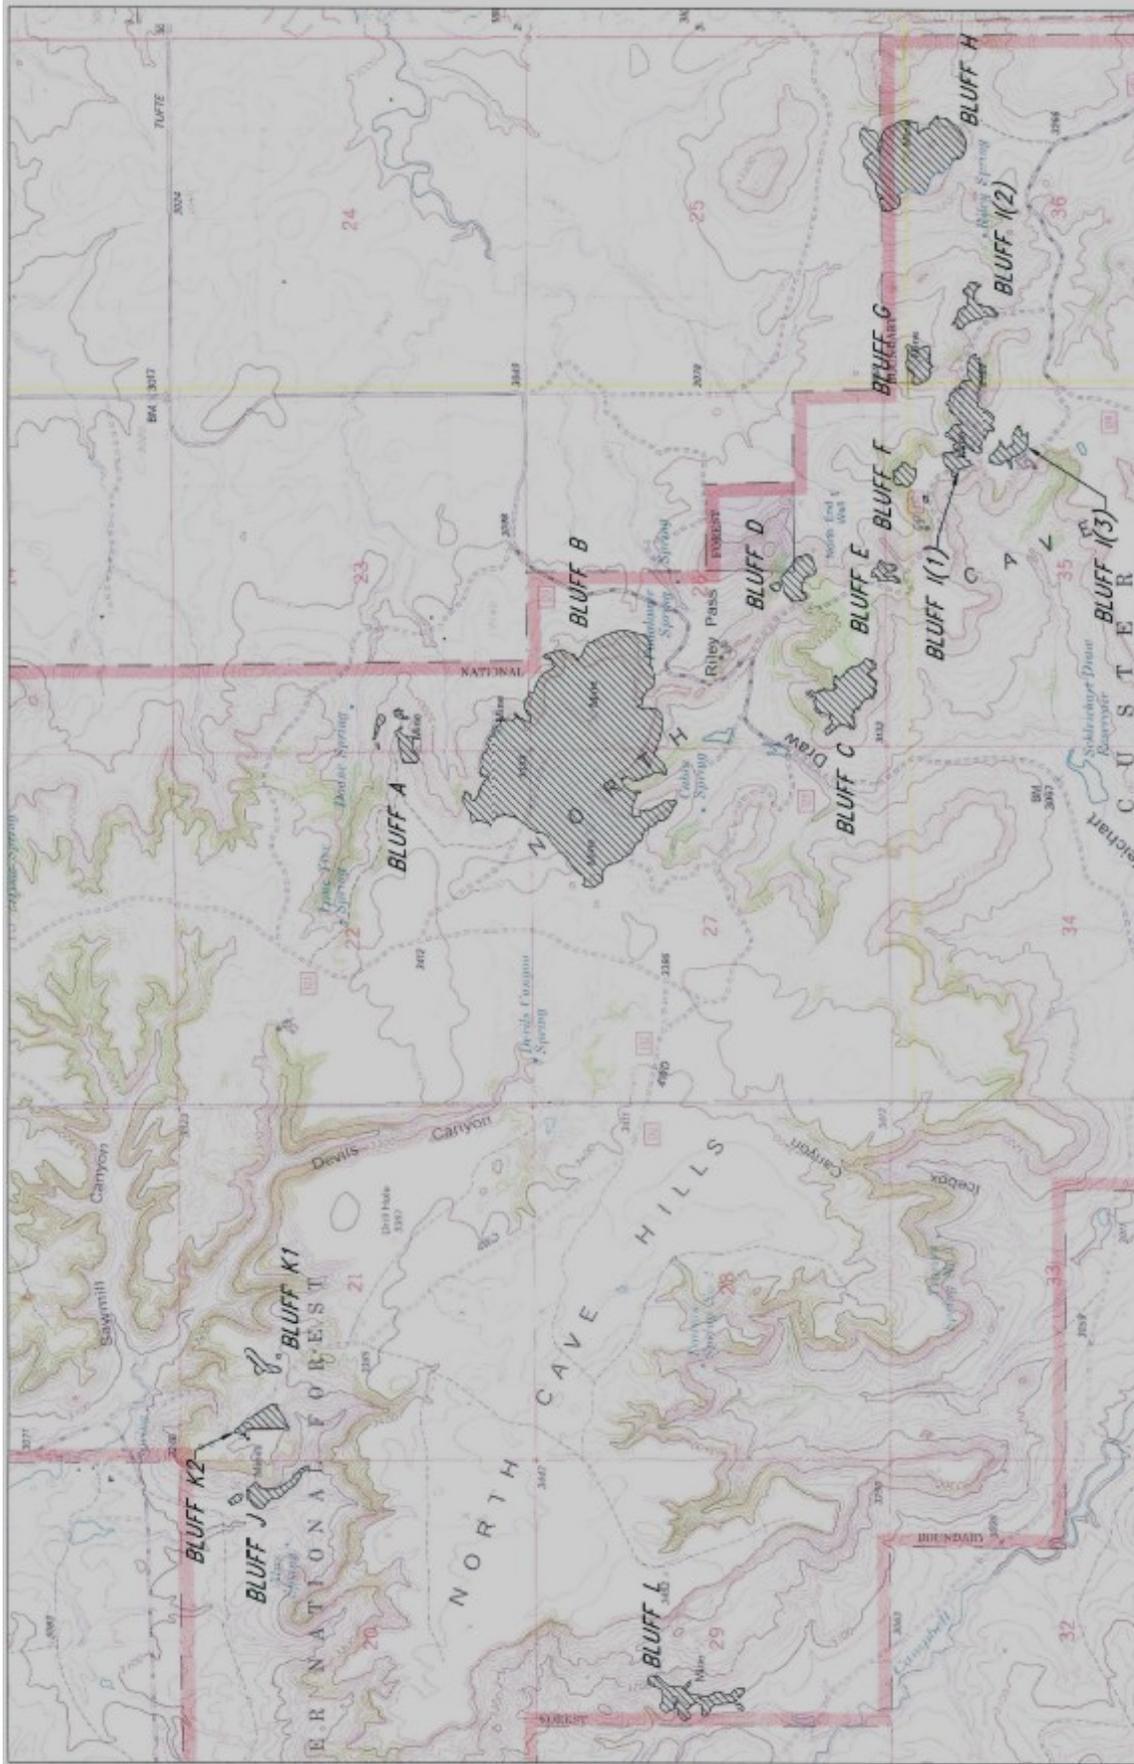
FIGURE 2. BLUFF IDENTIFICATION MAP

RILEY PASS SITE
 SOUTH DAKOTA
 BLUFF IDENTIFICATION MAP
 SCALE: 1"=2000'
 DATE: 10/3/06

The site consists of 12 bluffs first mined in the 1950s (Figure 2). Tronox LLC has been determined to be the potentially responsible party for reclamation across approximately 205 acres and is legally required to pay for work in areas referred to as Tronox bluffs. The Forest Service is funding work at other bluffs, which are referred to as non-Tronox bluffs. Mined bluffs range in size from a few acres to 150 acres and contain mine wastes with hazardous substances including arsenic, molybdenum, thorium, radium, and uranium. Human health and environmental concerns are related to levels of arsenic and gamma radiation from radium 226. Risk-based clean-up levels have been established for the Riley Pass site.

The final step is to cover disturbed areas with clean soil, compost and seed. In 2010 and 2011, bluffs J and K were the first Riley Pass bluffs to be reclaimed (Figure 2). 2011 and 2012 reclamation has focused on reclaiming portions of the non-Tronox bluff I and bluff F areas and improving site access roads (Figures 1 through 6). Based on post-reclamation monitoring, reclaimed areas are remaining stable and revegetation is successful.

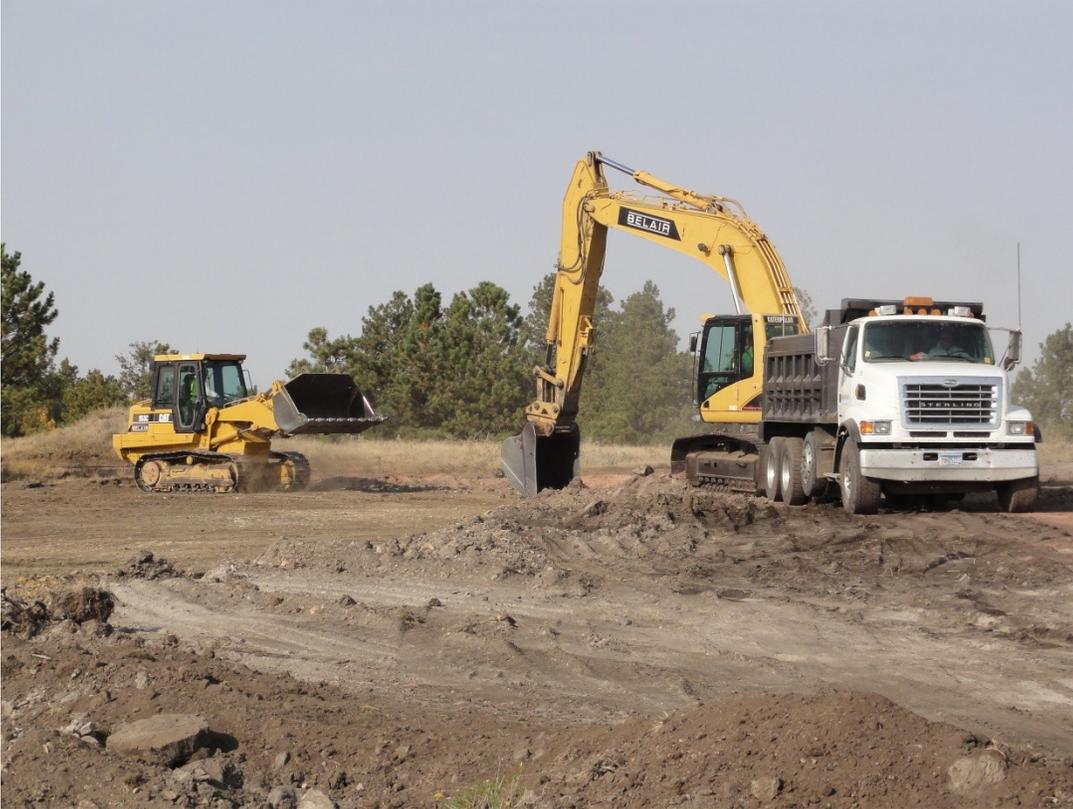
Figure 3. Removing mine waste at bluff I1-1. 9/26/2012.

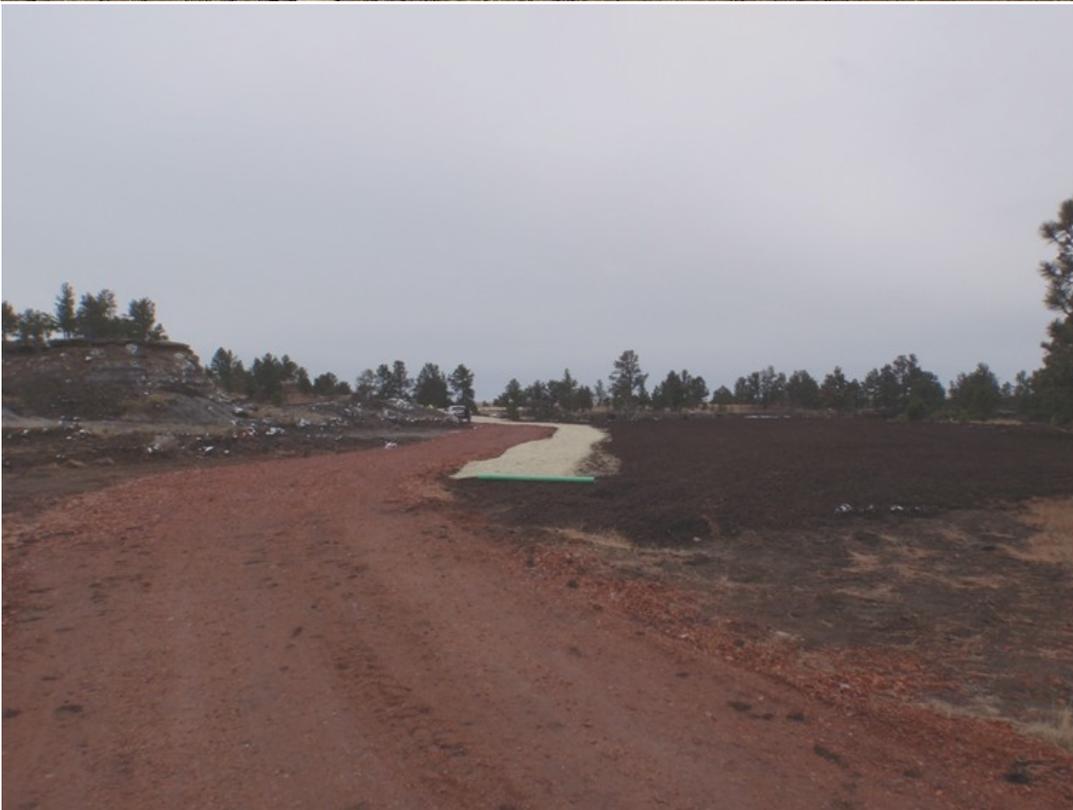
Figure 4. Placing erosion control matting (tan-colored material) over dark-colored compost and seed at bluff I1-1. Red material is newly placed, locally sourced scoria used as road surfacing. 10/24/2012.

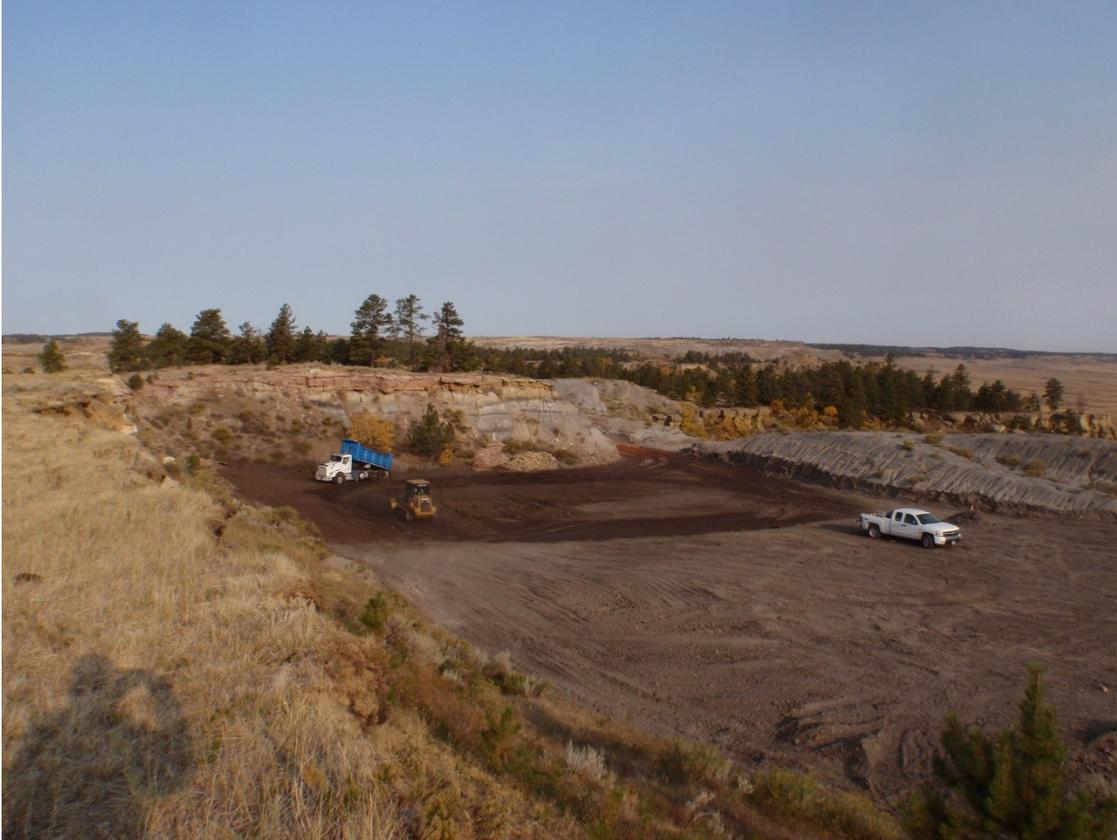
Figure 5. Placing mine waste in the bluff I-1 waste repository . 9/25/2012.

To date 9,423 cubic yards of mine wastes were excavated, consolidated and compacted into the bluff I-1 repository (Figures 5 and 6). An additional 18,097 cubic yards of mine spoils were also placed in the repository. Contracted work was completed by late October 2012 for a total \$436,322 cost. While mine waste placed in the repository was compacted, it was not capped or covered. The repository will be capped and re-vegetated either after it is filled to capacity or upon completion of all reclamation in the vicinity of bluff I-1. Current plans call for placing additional mine waste and mine spoils into this repository area as future funding allows. This will include removing additional waste and spoils from bluffs I-1, F, and G and placing it in the I-1 repository.

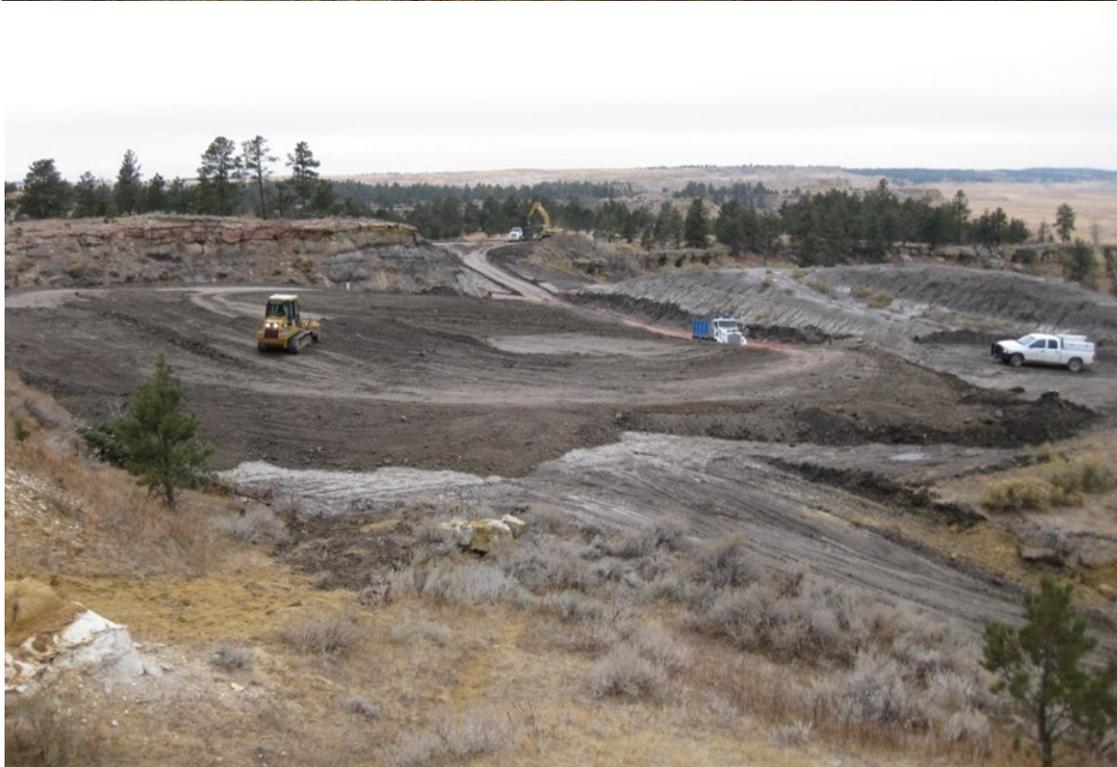
Figure 6. Placing mine waste and spoils in the bluff I-1 waste repository. 10/24/2012.

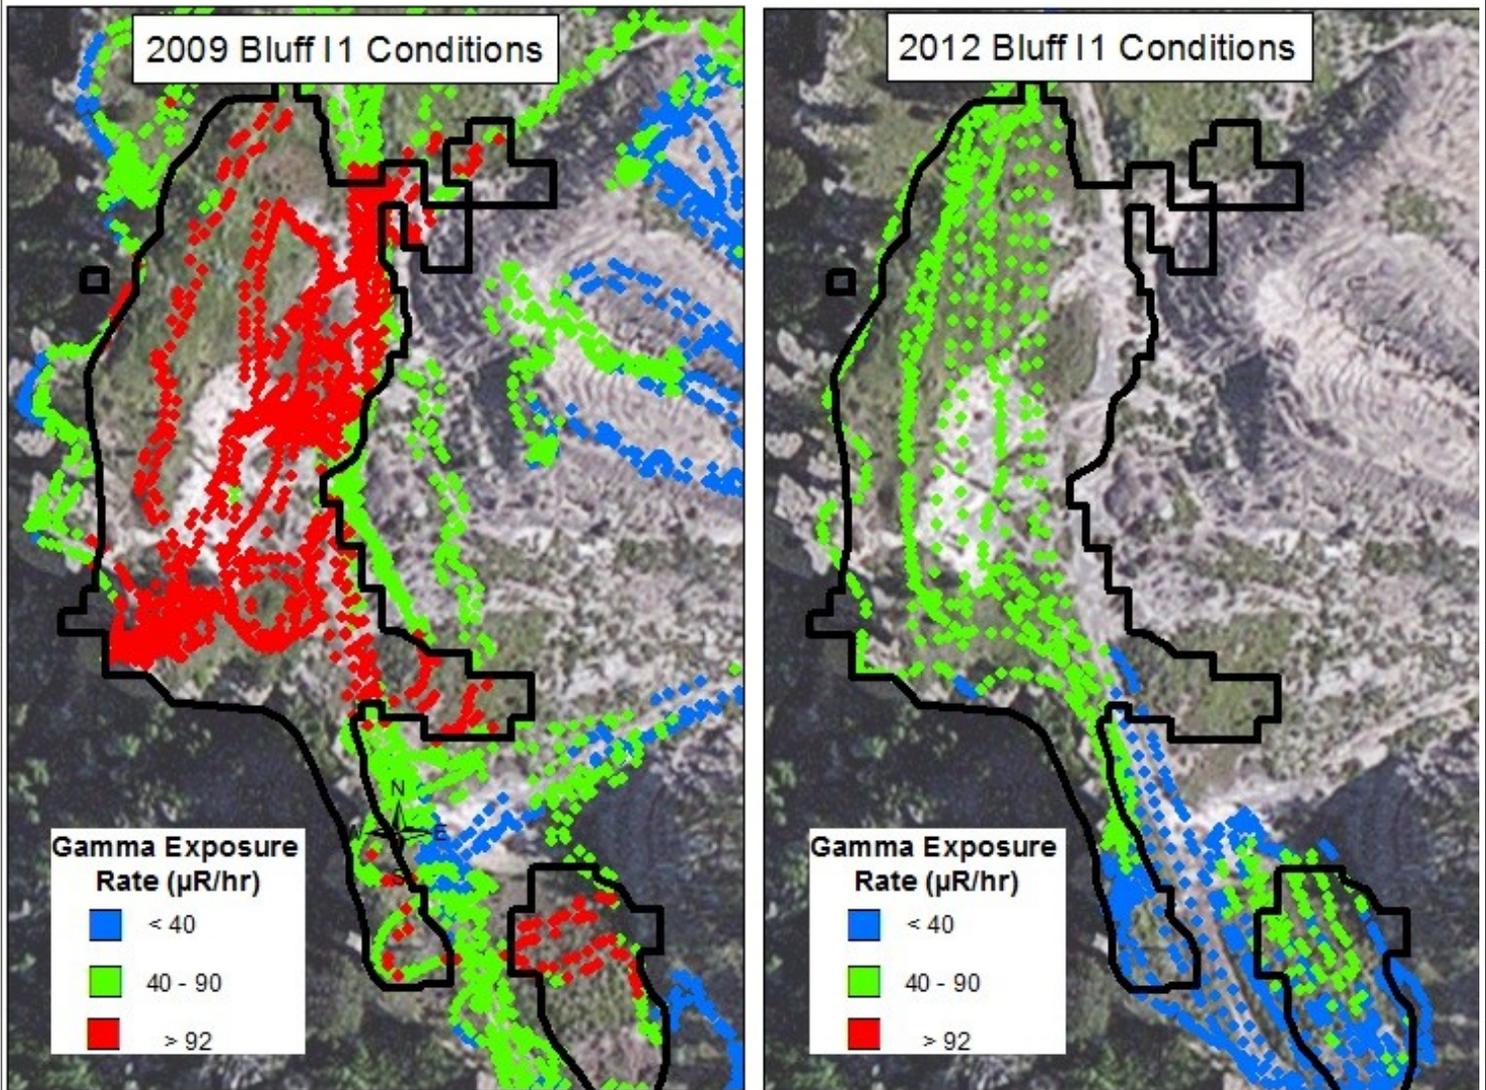
Figure 7: Bluff I1-1 estimated 2009 soil radiation concentrations prior to reclamation and 2012 post-reclamation concentrations.

To ensure that mine waste was adequately removed and to minimize future human health risks, clean-up quality assurance surveys were conducted through a contract by TetraTech of Fort Collins, Colorado and DJA Consulting Engineers of Missoula, Montana. Surveys were conducted after Belair Builders had removed waste and prior to placement of topsoil, compost, seed and erosion matting. Based on survey data, the initial removal action successfully remediated bluffs I-1, I-3 and F and reduced residual radium 226 and arsenic concentrations to acceptable levels. Figure 7 shows measured bluff I-1 gamma radiation levels prior to reclamation in 2009 and after reclamation in 2012.

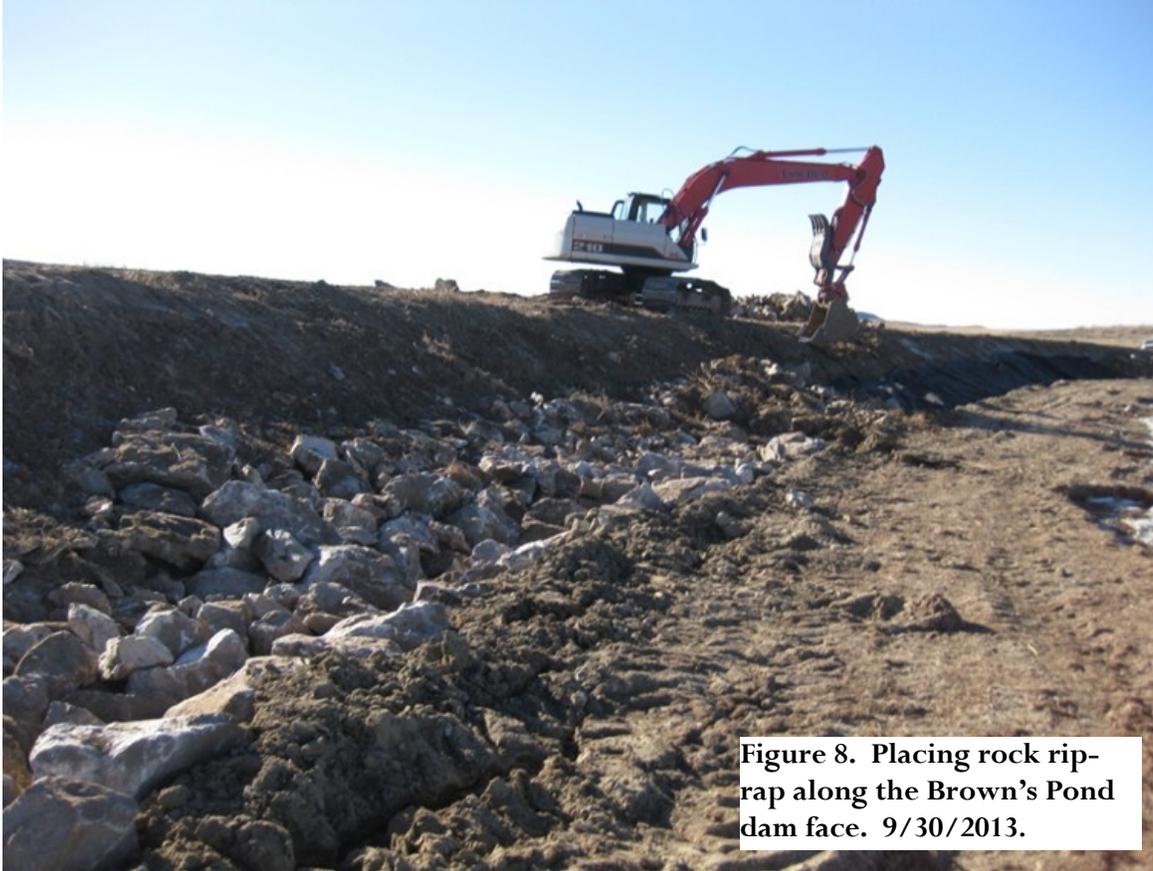
Figure 8. Placing rock rip-rap along the Brown's Pond dam face. 9/30/2013.

Brown's Pond and Schleichart Reservoir also capture water and sediment draining from bluff B. Dam stabilization work was completed at both these structures in 2012 (Figure 8). Work included spillway repair and placement of rock rip-rap, both intended to stabilize the dams so they can continue to function. Hafner Construction, Inc. completed contract work for an estimated \$59,324.

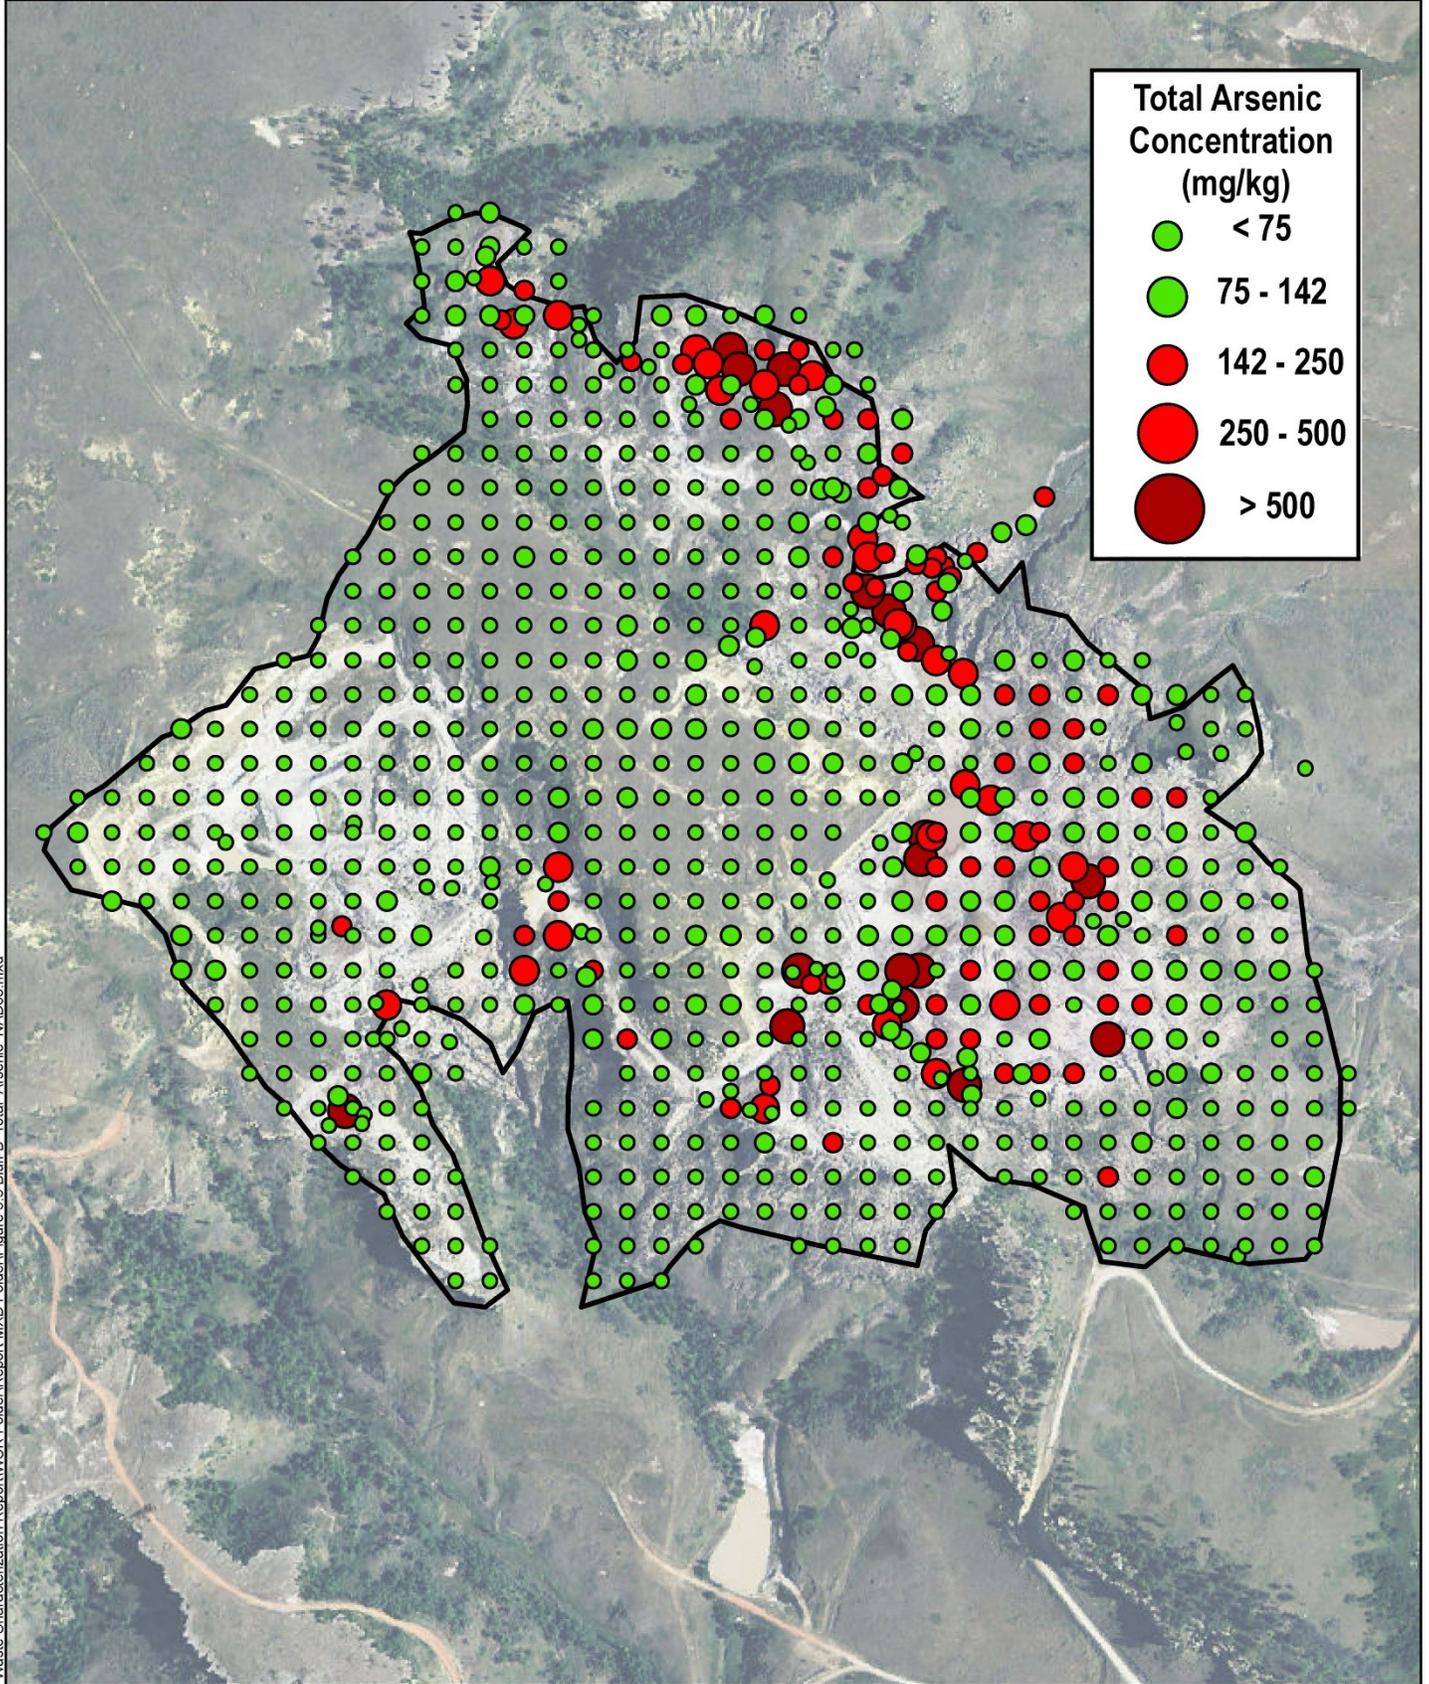
Bluff B Total Arsenic Concentration Map

Figure 9 . Draft map of Bluff B arsenic levels at 2012 XRF survey data points

Tronox bluffs reclamation needs are being further identified and engineering design work is underway. To accomplish this, the Forest Service has issued several task orders on an existing contract with TetraTech EC of Denver, Colorado. Work completed to date includes an extensive waste characterization program at the Tronox bluffs. Waste characterization work included : 1) Collecting 1,350 in-situ X-ray fluorescence (XRF) measurements and 69 soil confirmation samples; 2) collecting more than 167,000 individual gamma radiation exposure rate measurements and 11 soil correlation plot samples; 3) collecting 25 sediment samples from sediment ponds; 4) evaluating erosion impacts and vegetation status; and 5) estimating the areal extent of contaminated soils. Figures 9 and 10 provide an example of how XRF sample point data is used to determine areas of arsenic contamination at bluff B. Gamma radiation levels (Figure 11) and metals concentrations will be combined to map the contaminated areas at each bluff. Additional metals levels will also be considered and utilized to ensure that reclamation is designed to address areas contaminated by other potentially hazardous substances, such as molybdenum, selenium, and uranium. TetraTech and the Forest Service will use waste characterization information to guide removal design and management of contaminated materials at the Tronox bluffs. Due to the size and complexity of the Tronox bluffs, engineering design work could take several months.

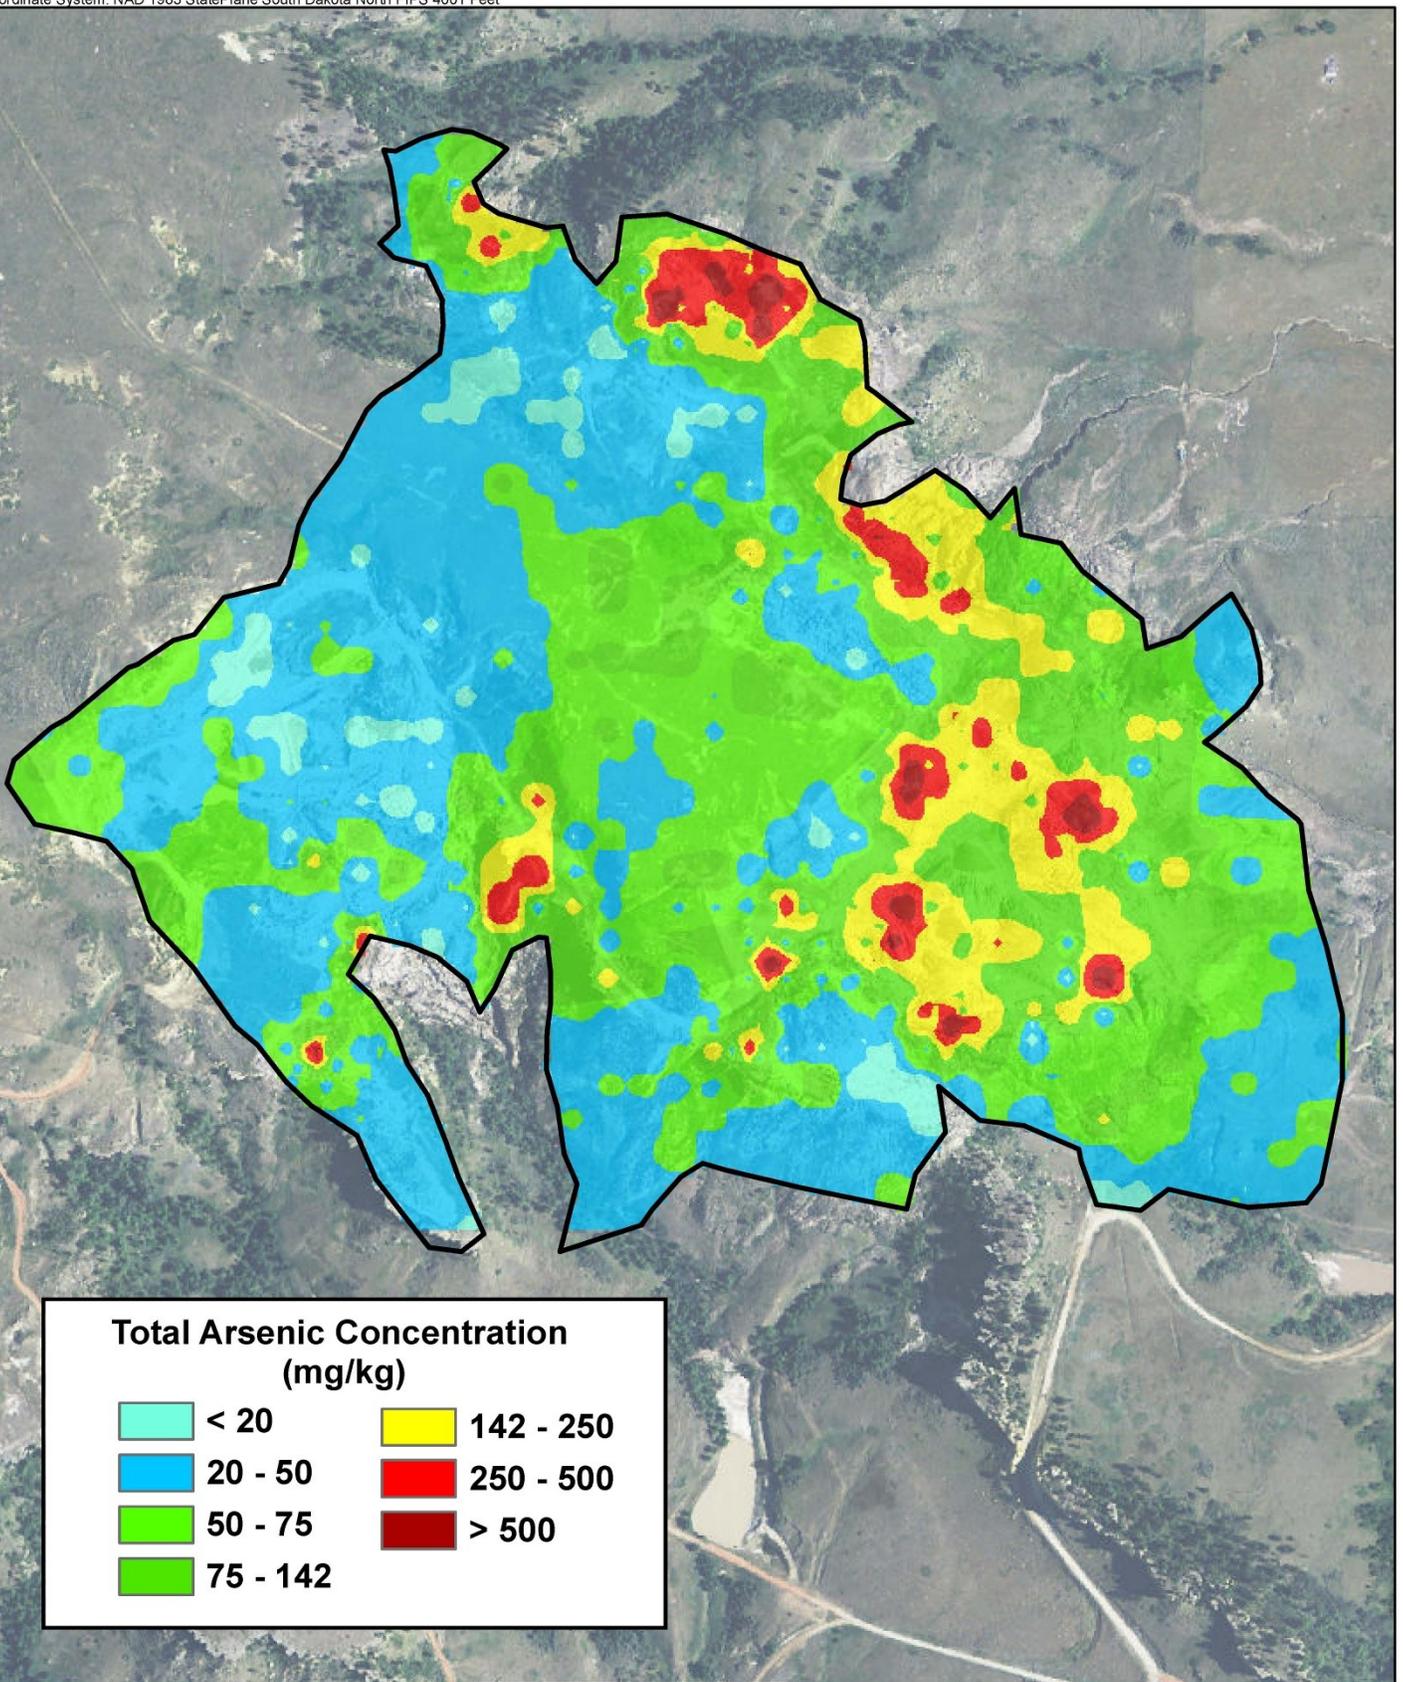
**Bluff B - IDW Map
Total Arsenic Concentration**

Figure 10. Draft map of Bluff B arsenic contamination levels based on 2012 XRF survey data.

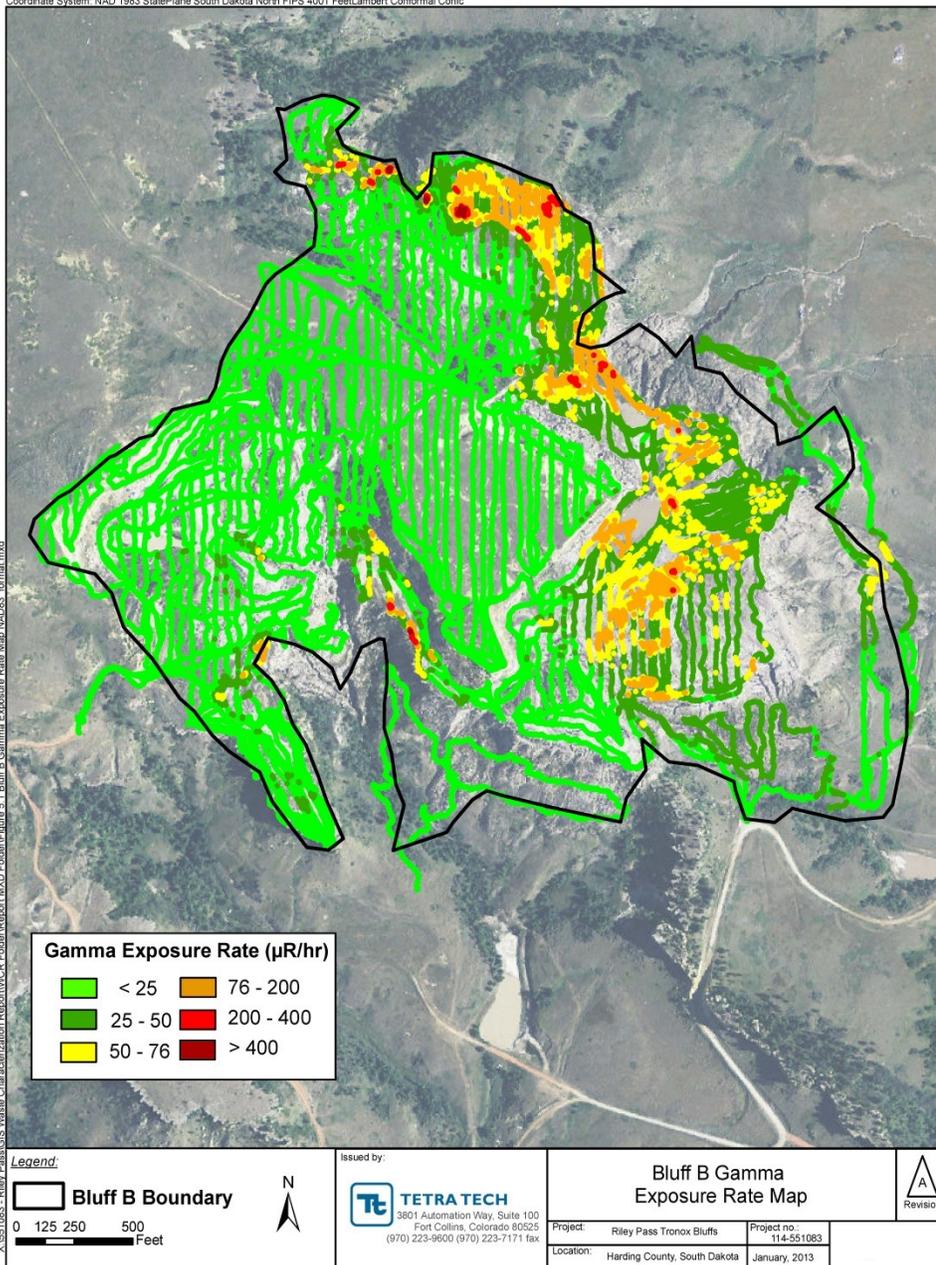
Figure 11. Draft map of Bluff B gamma exposure rates.
