Soil and Water Question 2a Appendix

Best Management Practices Implementation and Effectiveness Monitoring Wrangell Ranger District Road Storage Trip Report – Whale Trail Road September 25, 2012

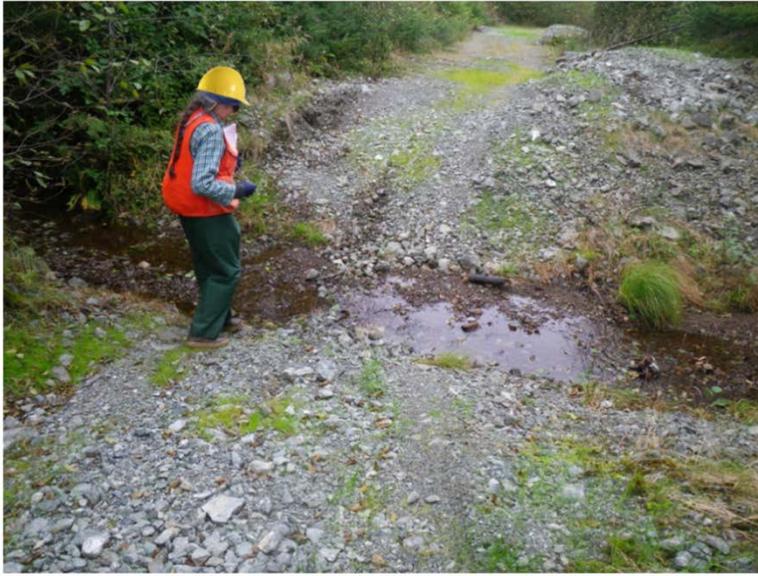
Picture 1. Culvert removal at MP 0.710 and verified fish stream.

The slopes going into and out of the crossing in picture 1 are about eighteen percent, which is well within the desired 3:1 slope. However, due to the low angled slopes, width of road, and the lack of a barrier at the start of the road, there is evidence of a pickup truck. The objective of this road was to restrict the usage to only OHVs and foot traffic. The motorized vehicle has caused some sedimentation and erosion into the stream.

Width of excavated material at water bars (picture 3) was intended to provide a four to six foot OHV travel way. The width tended toward six feet or wider, and this was not effective in excluding pickup traffic. Even at six feet, it is likely that high clearance vehicles could drive over the excavated material and cross the water bars and a few fish streams (see picture 1).

An ATM change analysis needed for change from non-motorized use to OHV trail. The decision memo did not address the ATM or Forest Plan Standards and Guides for Old Growth Reserves (page 3-60): "Designation of motorized routes for off-highway vehicles is generally not allowed. Designation may only occur where documented local traditional use has occurred and the route does not degrade water quality or flow. Barriers and signs need to be installed to exclude pickup traffic. The current travel way allows for pickup access across first fish stream and potentially across second fish stream.

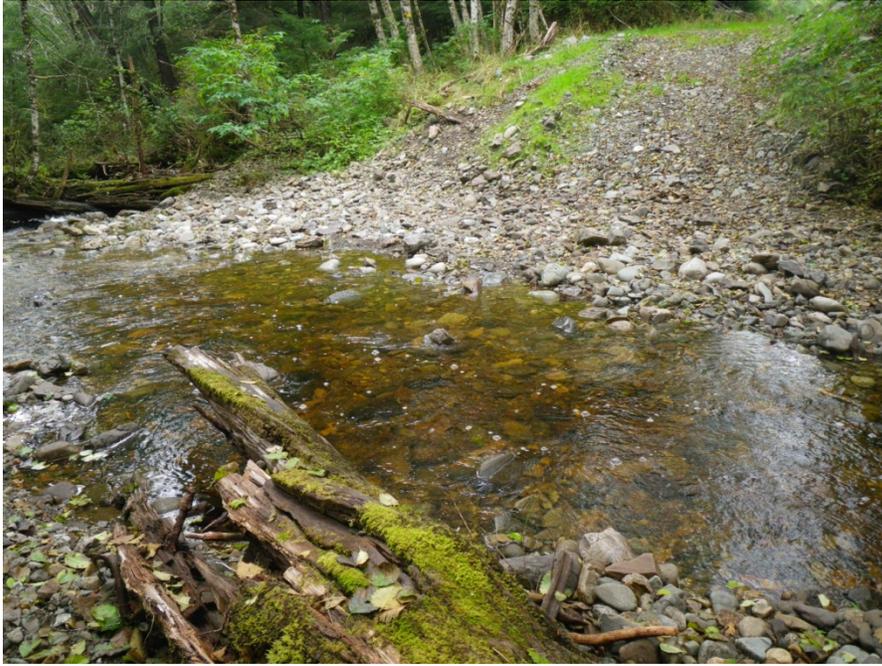
Picture 2. Bridge removal at MP 1.740 and verified fish stream.

Road slopes in picture 2 meet the desired 3:1. No signs of erosion or sedimentation. There is evidence of seeding (part of the road storage contract); native grasses are germinating on the road surface.

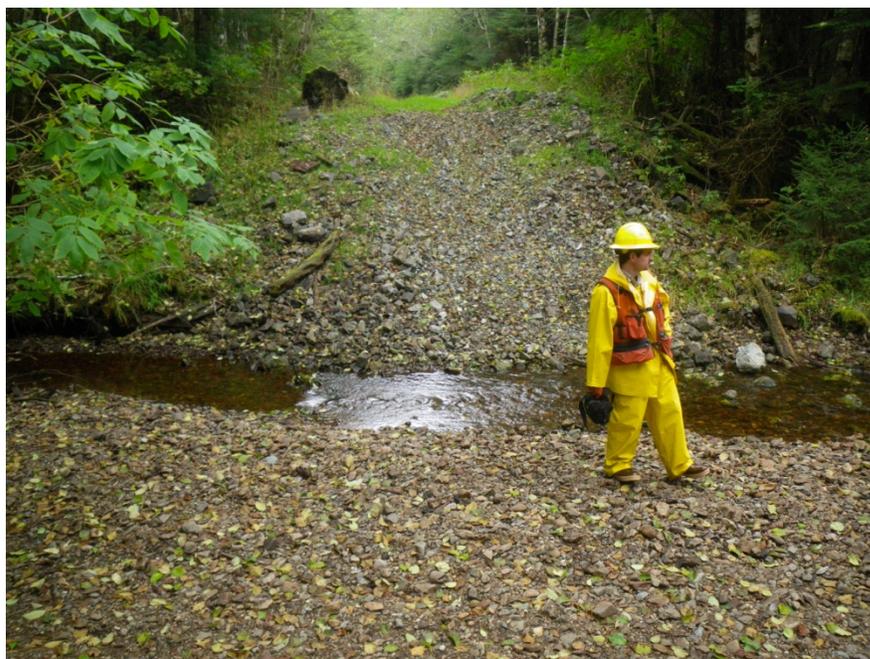
Picture 4. Bridge removal at MP 1.490

The stream in picture 4 is a verified fish stream. The slopes were very close to the 3:1 ratio, at about thirty-one percent. There was no sign of erosion. There was sign of seeding.
