LUCKY DOG RANCH DOCUMENTATION
BIG SPRINGS, IDAHO

PREPARED FOR
USDA FOREST SERVICE
CARIBOU-TARGHEE NATIONAL FOREST
REPORT No. TG-11-908

OLIVER CONSERVATION GROUP
MARCH 2011

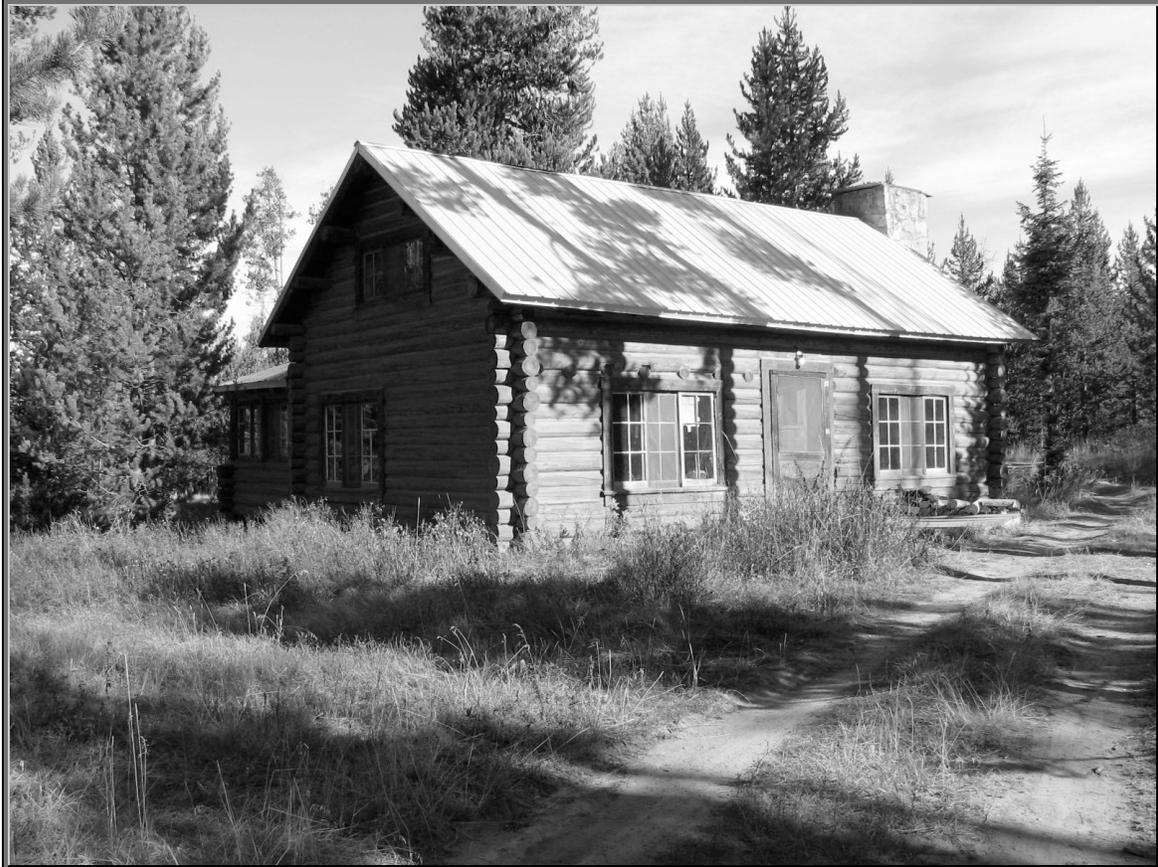
CABIN

The Lucky Dog Ranch cabin is a one and one-half story log building located on the south edge of Lucky Dog Spring at an elevation of about 6,400 feet. It was built in the early to mid-1930s by the local craftsman Johnny Sack for the owners Percy and LaBlanche McLain. The isolated cabin and its associated buildings (cookhouse, springhouse/bunkhouse, barn, workshop, outhouse, and pump house) are sited in a lodgepole forest on ground that slopes gently to the north toward a large, wet meadow. In 1996, the land was transferred to the Caribou-Targhee National Forest (CTNF), which is within Region 4 of the USDA Forest Service. The cabin is the most recently constructed building on the site (with the exception of the pump house) but, historically, is the most significant due to its craftsmanship, furnishings, and association with Johnny Sack.

The cabin is a rectangular structure measuring 31'-0" east to west and 28'-10" north to south, with log walls and a gable roof. Typologically the building is a rustic, single-pen, side-gabled structure with a hipped-roof sleeping porch across the north side and a large stone chimney on the east end. The well-constructed building provided living and sleeping accommodations for the property's owners, relegating the original cabin to a cookhouse and bathhouse. Few alterations have been made to the cabin other than the installation of a kitchen in the sleeping porch after 1995, and all elements discussed below are considered to be original unless otherwise noted.

The foundation is composed of concrete piers supporting sill logs at the corners and at the midpoints of the long north and south walls. A simple, low deck of wood boards abutting the center of the south wall provides an approach to the cabin's only entrance. The walls comprise partially peeled logs, saddle-notched on the bottom side. The log ends project about 8" at the building corners, and the logs that form the rafter plates on the north and south walls project even further to support the gable-end fly rafters. On the main part of the building, logs are tapered at door and window surrounds to fit neatly behind board trim, while vertical log sections separate the windows of the sleeping porch and support continuous log lintels. Exterior joints between the logs have recently been filled with modern daubing compound. No paint was noted on the building exterior.

The Lucky Dog Ranch cabin retains a very high degree of architectural integrity and is in very good condition. What few repairs are evident have been compatible with the original materials, and alterations are also reasonably compatible and reversible (e.g., the metal roof and insertion of a kitchen on the sleeping porch).

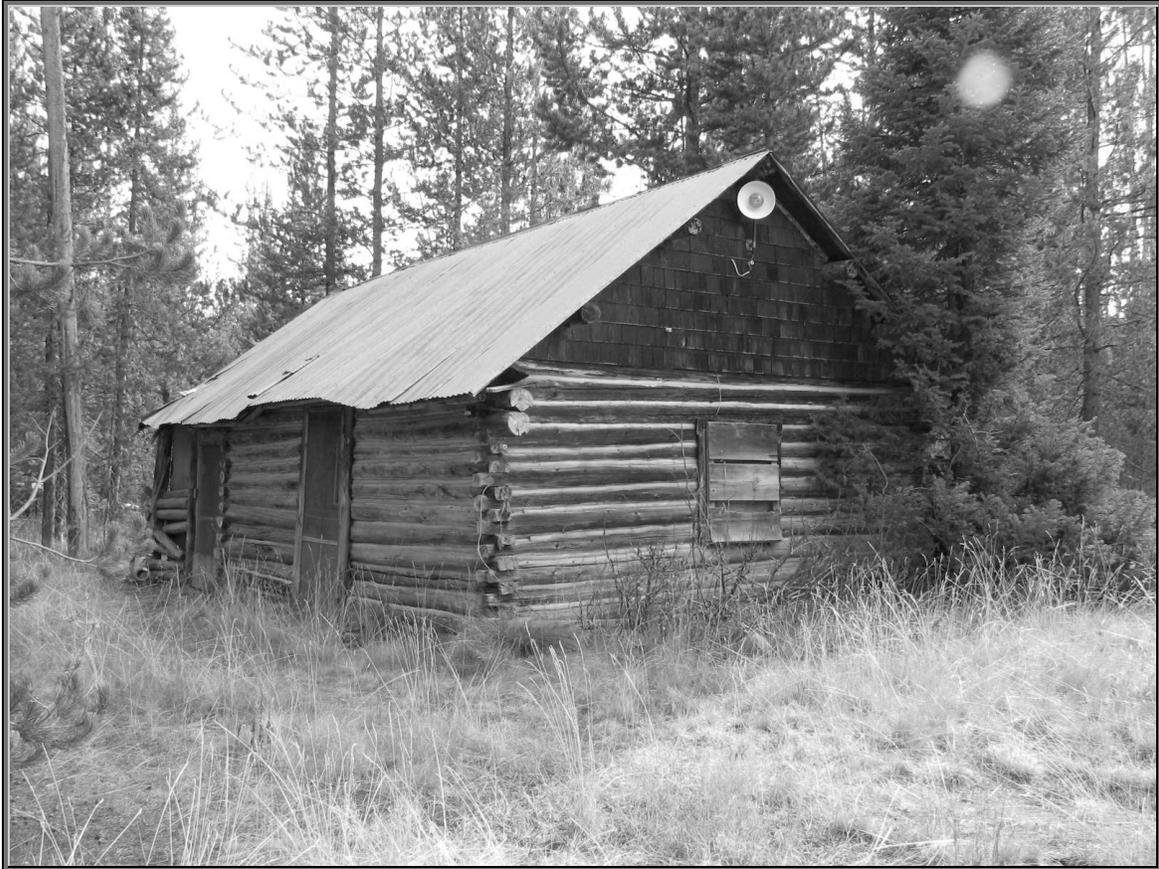
COOKHOUSE

The Lucky Dog Ranch cookhouse is a one story log building located about 100 feet east of the cabin. The rectangular building measures 15' north to south by 29' east to west; typologically it is a traditional, single-room, side-gabled cabin typical of early twentieth century log construction in the region, although somewhat unusually the roof structure was extended east to create a covered porch or storage area. Built by Judge James G. Gwinn and perhaps Dr. D. L. Blevins during the time they owned the property (1906-1928), it served as the principal building on the site until a new cabin was built in about the early 1930s. After that time the old cabin was relegated to the status of a cookhouse (with bathing facilities in the open porch). The main (west) section fell into disuse after 1995, when kitchen facilities were added to the sleeping porch of the main cabin, although the east end was upgraded with a toilet and shower at about the same time.

The original foundation is not visible but was probably minimal, consisting of sill logs set on rocks or laid directly on the ground. Concrete slabs have since been poured to create new floors for the kitchen, shower and toilet, but these are not part of the foundation. On the main (west) portion of

The entire roof is presently covered with sheets of corrugated metal; this overlies a layer of green asphalt roll roofing or shingles. The original roof was almost certainly covered with wood shingles, although these were not observed. The open eaves are formed by the ends of the sheathing boards on the north and south walls, and peeled poles have been nailed along their edges to form a fascia. The eave is subtly arched over the door in the north wall to allow the screen door to open outward. The gable ends feature the exposed ends of the purlins and ridgepole, and the joints between the walls and roof are finished with quartered poles. The cabin has no chimney, but woodstoves were originally located in the northeast corner of the kitchen and the northeast corner of the open porch; neither stove remains.

The Lucky Dog Ranch cookhouse dates to the period of significance and retains a high degree of architectural integrity. With the exception of the metal roof, recent alterations are confined to the interior and the building is considered a contributing site feature. The kitchen is unmaintained and dated but the building is in good condition and appears structurally sound.

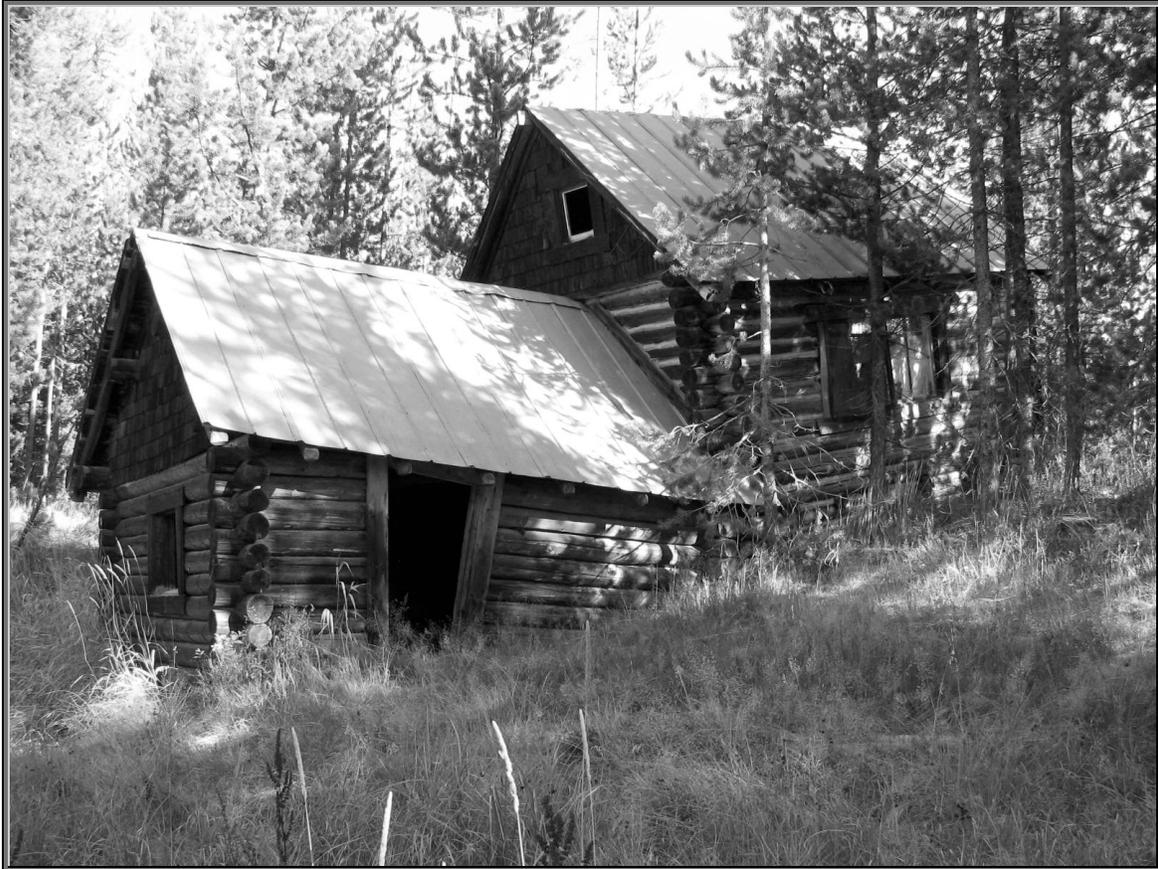
SPRINGHOUSE/BUNKHOUSE

The Lucky Dog Ranch combined springhouse and bunkhouse is a two-level log building located about 100 feet north of the cabin. The lower level is the original single-room springhouse, which was constructed on the east bank of Lucky Dog Creek against the side of a rise, just below the headwaters and over a lesser spring. The upper level is a single-room bunkhouse built against the east gable end of the springhouse. The springhouse measures 13' east to west by 12' north to south, and the bunkhouse measures 14'-6" east to west by 11'-10" north to south. Just fifteen feet south of the springhouse is a small wood dock that projects into Lucky Dog Creek.

The springhouse foundation is formed by sill logs resting on grade, although rough chunks of early concrete may have been used sporadically to support floor joists. The walls comprise logs about 6" to 7" in diameter, saddle-notched on the bottom side and projecting 5" to 6" at the corners. The walls are unchinked and undaubed on the exterior, but on the interior the joints are chinked with bark floss or animal hair and finished with quartered poles. The gable ends comprise horizontal sheathing covered with wood shingles. (The east gable end was covered by the bunkhouse addition and now forms part of its east interior wall.)

The springhouse interior is in poor repair but it appears that a full or partial board floor once spanned the room, supported by log joists that were in turn supported on chunks of concrete set in the spring stream. A metal pipe is visible on the streambed that may have provided water to a different part of the property. The walls and ceiling are unfinished.

The Lucky Dog Ranch springhouse/bunkhouse dates from the site's period of significance and retains a high degree of architectural integrity; it is considered a contributing site feature. The bunkhouse appears to be an early addition and the only other significant alteration is the metal roof covering. Unfortunately, the building is in poor condition and structurally unsound due to the failure of the east end of the springhouse and the resultant subsidence of the west end of the bunkhouse that it supports.

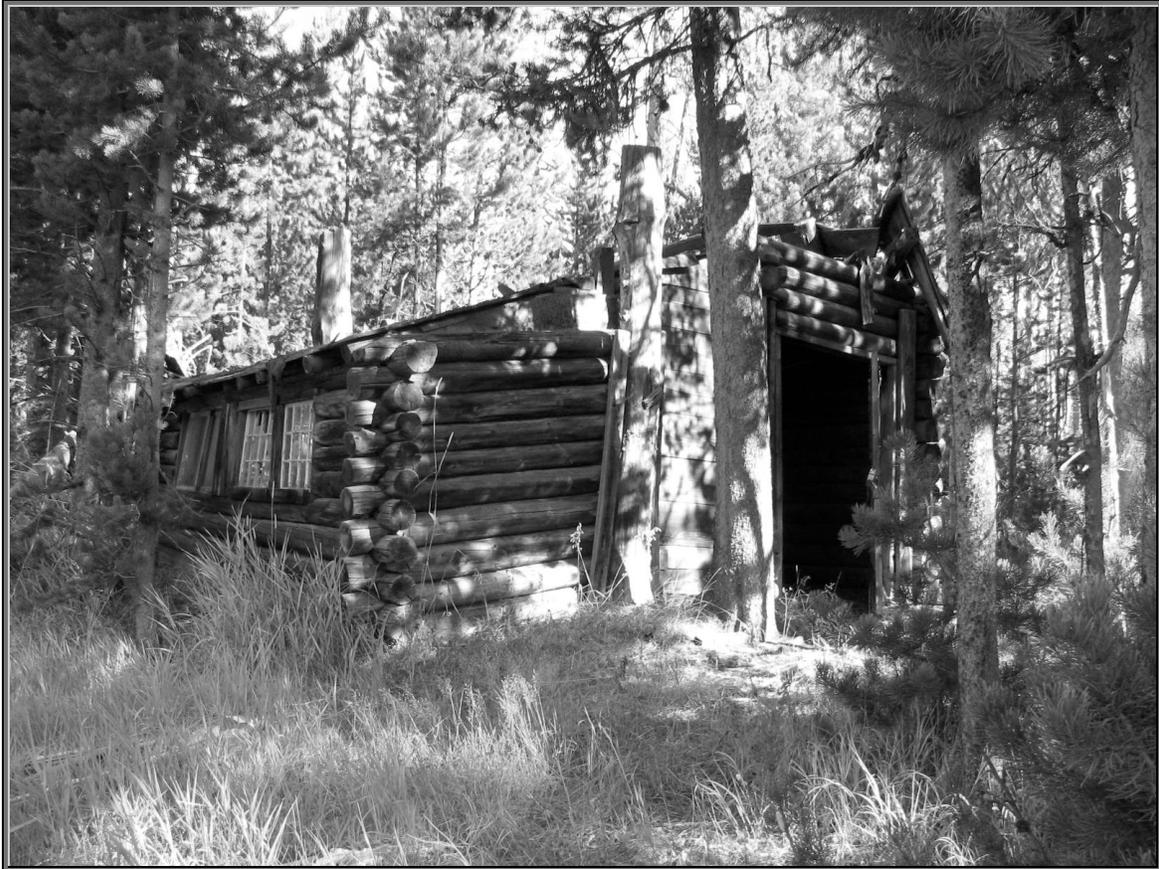
BARN

The Lucky Dog Ranch barn is a one and one-half story log building located about 110 feet north of the springhouse/bunkhouse, on the east bank of Lucky Dog Creek. The unusual building measures 19'-0" north to south and 14'-4" east to west. The narrow, side-gabled, one and one-half story section on the east end is only 5'-10" wide (see the sketch plan); this may be the remnant of what was reportedly a once-larger barn, the east part of which had deteriorated significantly by the 1980s and which is now missing. The upper story of this section has recently collapsed but the debris has not been removed (see the partial elevation drawing for a reconstruction). When the larger barn was intact, the one-story, shed-roofed addition to the west was added to create a larger single room on the west end of the first floor. It appears that, originally, the west end of the barn may have been a roofed porch or manger with only half-height log walls. The remains of a pole corral about the building on the west, north, and east sides; the west section was constructed into the creek to provide water for livestock. Adjacent to the south side of the corral, a small wood dock projects into Lucky Dog Creek.

On the original (east) section, the barn foundation is formed by sill logs resting on grade. The north, east and south walls comprise logs that are joined at the corners by saddle notching on the bottom side; the logs are also planed along their length on the top and bottom surfaces to reduce or eliminate the need for chinking and daubing. (The only daubing present is a poorly executed cement-based mortar of recent vintage on the east exterior wall.) The lowest three or four logs on the north wall originally extended a few feet to the west (these are now incorporated into the north wall of the addition) and were saddle-notched with an equally low log wall extending south (a short section of this projects from the north interior wall and divides the single room into two areas). A similar low, short section of wall extends from the south interior wall; it may originally have been connected to the east wall but any trace of this connection was removed when a doorway was constructed in the south wall. The purpose of the low walls is unclear, but they may indicate the remains of an original roofed porch or manger on the west side of the barn, one that was soon fully enclosed by the west addition. The gable end walls of the second floor (now collapsed) were formed by true 12"-wide horizontal boards nailed against vertical log posts.

The barn interior is in poor repair but retains a number of early or original features. The board floor runs east to west and comprises 5-1/2" boards in the original section and 9-1/4" boards in the addition. The interior walls and ceiling are unfinished. Several workbenches and a shelf are built into the walls and a stickwork kindling box is built into the southwest corner. Access to the second level is provided by a massive log in the northeast corner with steps notched into it. When first built, it appears that the barn had no mechanical systems. An old metal cook stove remains in the room, manufactured by the M. Seller Company of Portland, Oregon; this may have been brought to the barn when it was converted to a residence in the 1970s. The plastic-coated electrical wiring was probably installed at the same time.

The Lucky Dog Ranch barn dates to the period of significance but has lost much of its architectural integrity due to the collapse of the east part of the building and alterations made to the west end in the 1970s and 1980s. It is considered a non-contributing site feature.

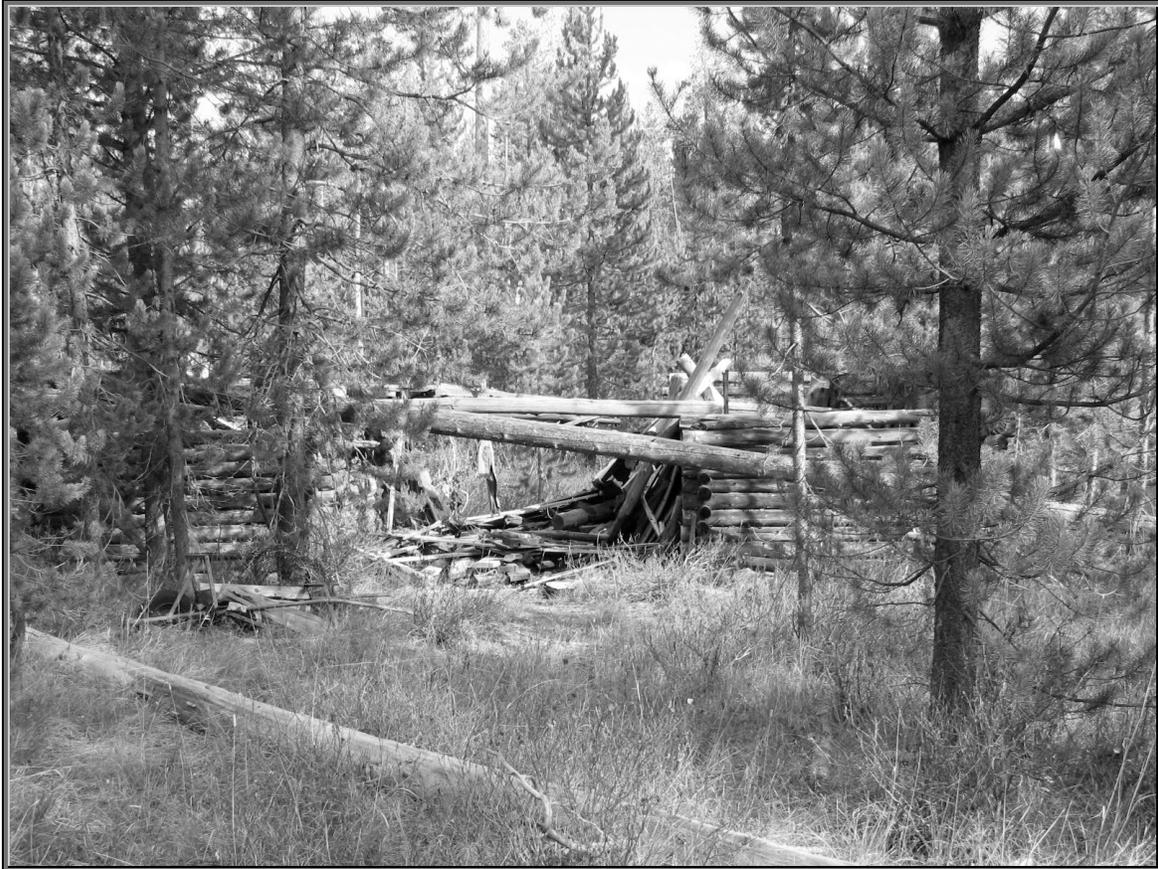
WORKSHOP

The Lucky Dog Ranch workshop is a one story, double-pen log building located about 30 feet northeast of the cookhouse. The rectangular building measures 28'-10" northwest to southeast and 12'-6" southwest to northeast. Typologically it is a traditional, two-room, side-gabled structure with an open central passage (or dogtrot) typical of early twentieth century log construction. It was most likely built by Judge James G. Gwinn and perhaps Dr. D. L. Blevins during the time they owned the property (1906-1928), although it may date to the 1930s. The building's original function is unclear but it was being used as a workshop and to house the generator that supplied electricity to the property in the early 1970s. When underground electrical service was brought to the site, the generator was removed and the building was used as a tack room, workshop, and storeroom (Barbara Hammer interview). The building fell into disuse after 1995 and the roof has since collapsed.

The interior is in poor condition due to the loss of the roof, but various stored items remain in place, including storm windows, bed frames and springs, assorted hardware, and electrical supplies. The workshop has no remaining mechanical systems, although it may once have had electricity supplied by the generator.

The Lucky Dog Ranch workshop is in fair condition and dates to the site's period of significance. It retains enough architectural integrity to be deemed a contributing site feature, although this has been compromised by the collapse of the roof.

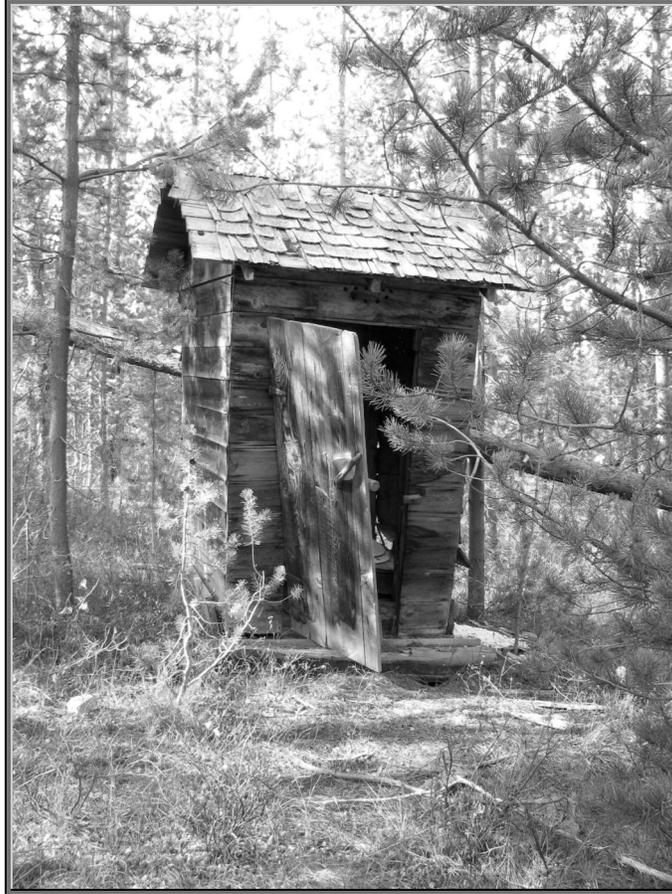
OUTHOUSE

The Lucky Dog Ranch outhouse is a small, wood-framed, rectangular structure located about 30 feet southeast of the cookhouse; it measures about 3' x 5'. The structure's design and the use of nominal lumber indicate that it was built in about the 1930s by the McLain family. For certain the outhouse was in use until about 1995, when a new toilet room was built into the east porch of the cookhouse (Barbara Hammer interview).

The outhouse is built on heavy, squared logs. The wood-framed walls are clad in horizontal shiplap siding with a 7" exposure. The side-gabled roof is framed with nominal 2" x 4" lumber, sheathed with boards and finished with wood shingles. Rafter tails are exposed on the east and west walls. The door in the east wall comprises three vertical boards, Z-braced on the interior side, and features a wood handle formed from a branch on the exterior and wood latch and stop on the interior. Circular vent holes have been drilled toward the tops of the north, south, and east walls. On the interior, the floor is composed of 2" x 12" boards; walls and ceiling are unfinished. Two plastic toilet seats are mounted on a wood bench along the west wall.

The Lucky Dog Ranch outhouse has been unmaintained for the past ten years and is in poor condition, largely because a falling tree knocked it from its foundation. However, the outhouse apparently dates to the site's period of significance and retains its architectural integrity; it is therefore deemed a contributing site feature.

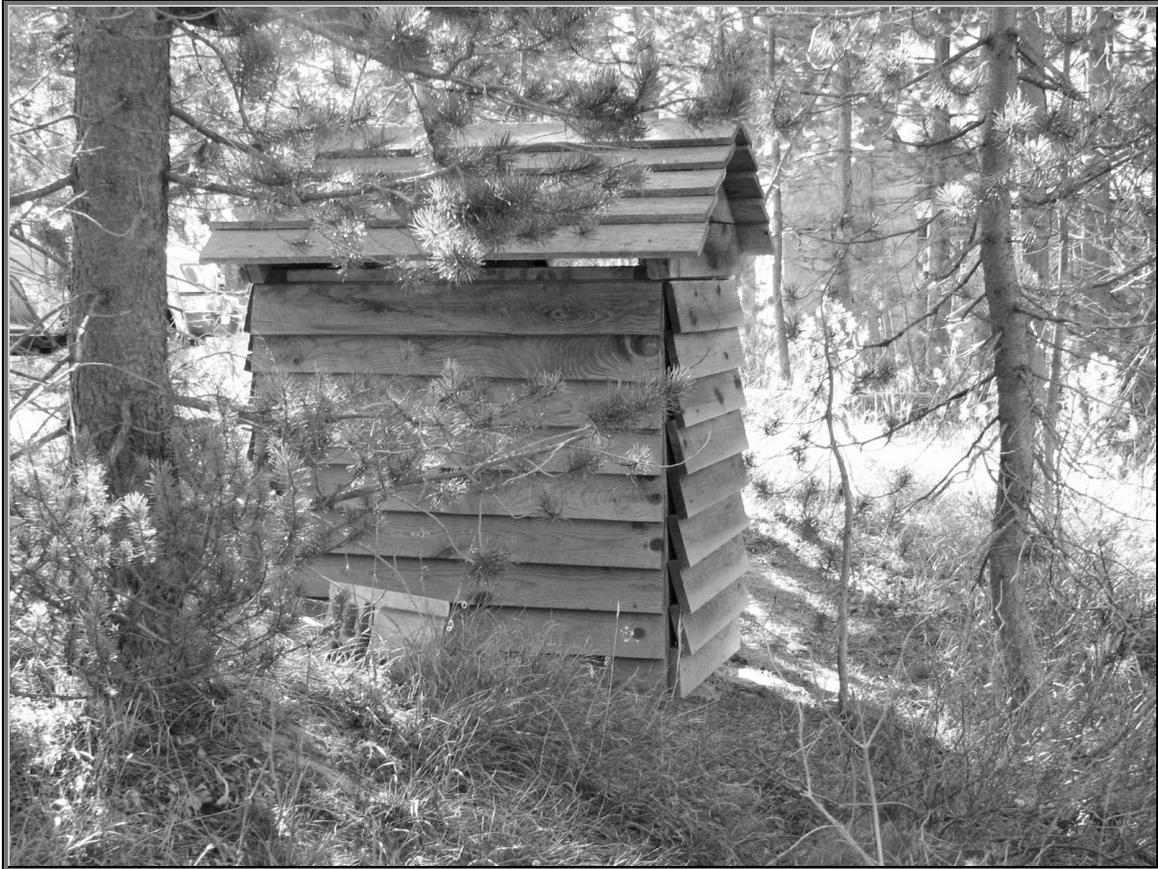
PUMP HOUSE

The Lucky Dog Ranch pump house is a small, wood-framed, rectangular structure located about 15 feet northeast of the cabin; it measures about 2' x 3'. The structure's design and the use of nominal lumber confirm that it was built in about the 1970s or 1980s by the Hammer and Parks families. The structure houses a pump that draws water from an underground well and delivers it to the cookhouse and cabin via underground pipes. The system replaced a more primitive one where water was delivered from barrels on the cookhouse porch into the adjacent kitchen (Barbara Hammer interview).

The pump house is built on a cinder block foundation. The wood-framed walls are clad in horizontal lapped boards with a 5-3/4" exposure; the gabled roof is covered with the same lapped boards. Rafter tails are exposed on the north and south walls. The structure has no door, window, or other visible means of access.

The Lucky Dog Ranch pump house is in good condition and retains its architectural integrity. However, it was built outside the period of significance for the site and is considered a non-contributing feature.
