# MEYERS LANDFILL

U.S. FOREST SERVICE LAKE TAHOE BASIN MANAGEMENT UNIT

## MEYERS LANDFILL FACT SHEET UPDATE ON REMEDIAL ACTIVITIES AND SUPPLEMENTAL GROUNDWATER INVESTIGATION MAY 2013

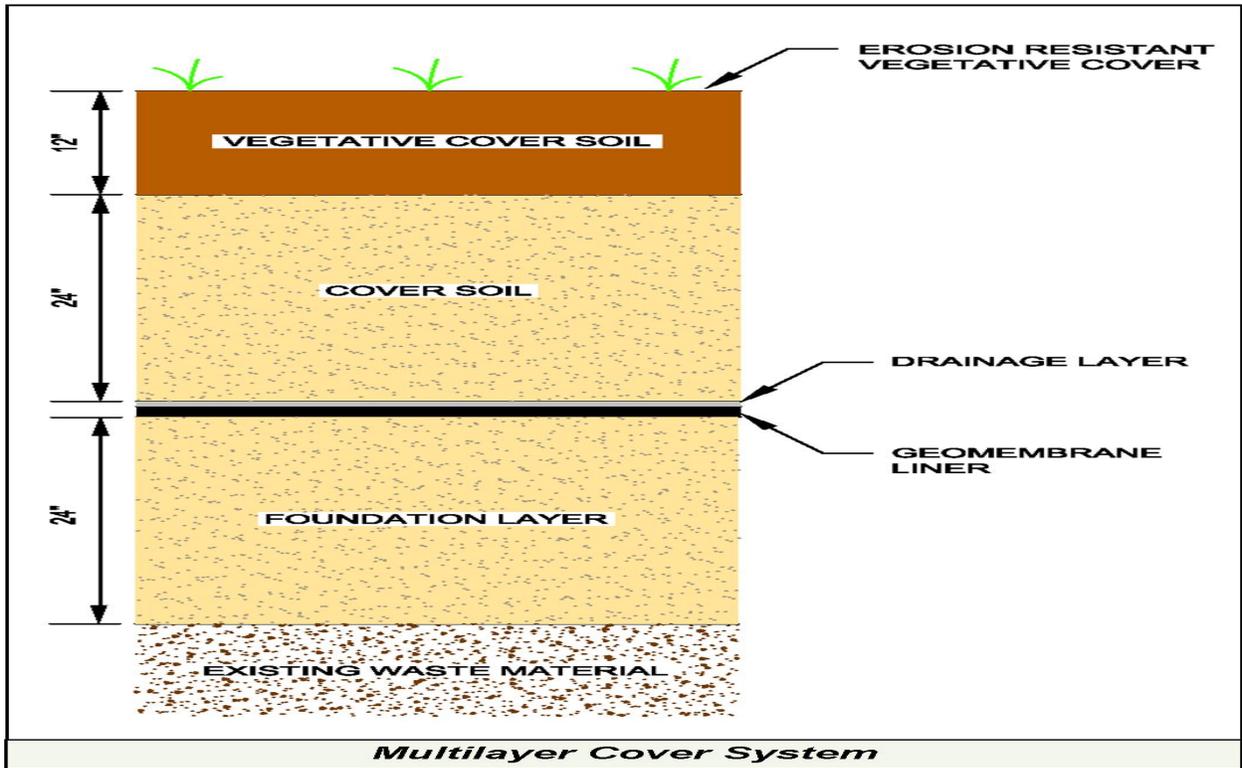
Figure 2: Landfill schematic layers

system, which includes consolidating waste, capturing and diverting shallow groundwater coming from off-site, directing and controlling surface water drainage, venting landfill gases emitted from waste decomposition, and revegetating the surface. Properly covering the landfill will minimize further migration of contaminants into groundwater beneath the Site. A schematic of the cover is shown on Figure 2 and the final cover design and drainage features are shown on Figure 3.

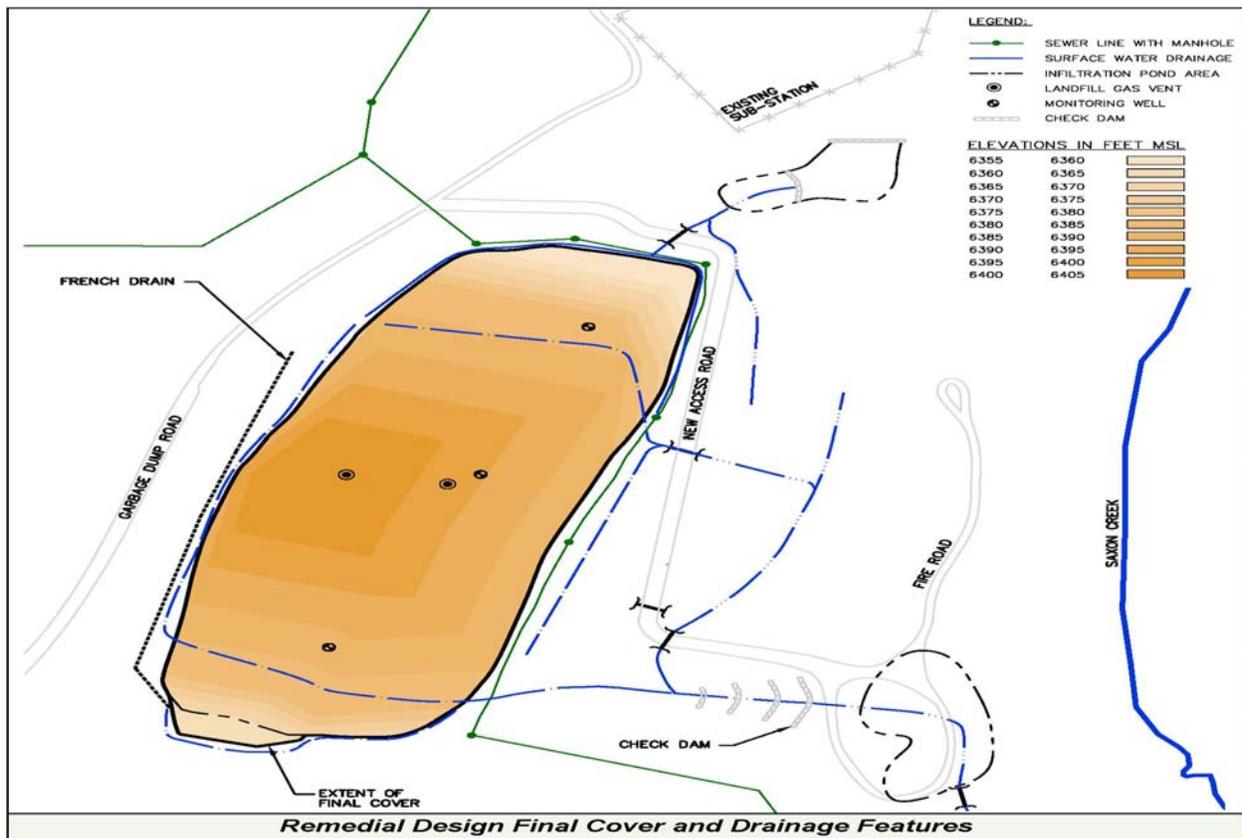
Figure 3: Landfill cap overview

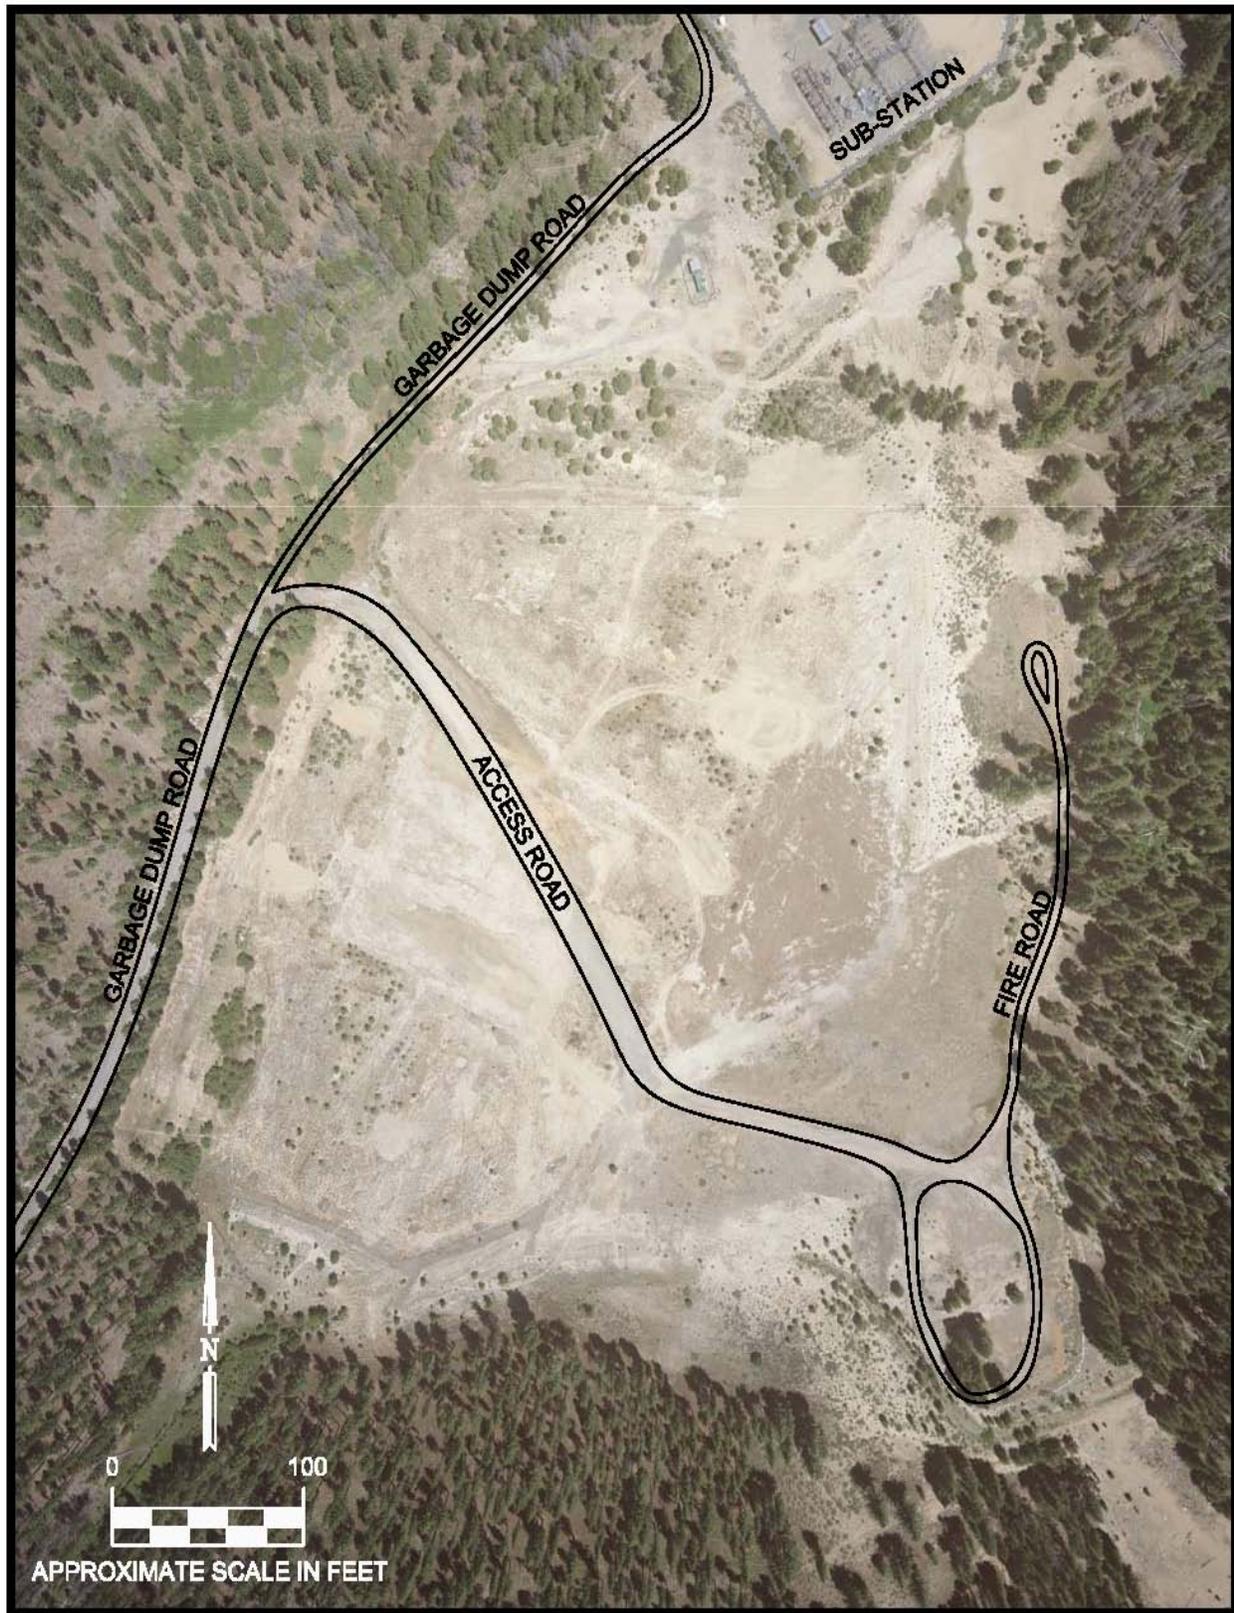
Figure 4: Landfill surface prior to remedy installation.

The Remedy was constructed during the 2010 through 2012 construction seasons. The final Remedy component is applying seeds, fertilizer, and mulch (hydroseeding) to the landfill surface and surrounding areas of the Site with native plant species to encourage vegetative cover. The pre-remedy landfill surface is shown on Figure 4 and the post-construction surface of the landfill is shown on Figure 5.

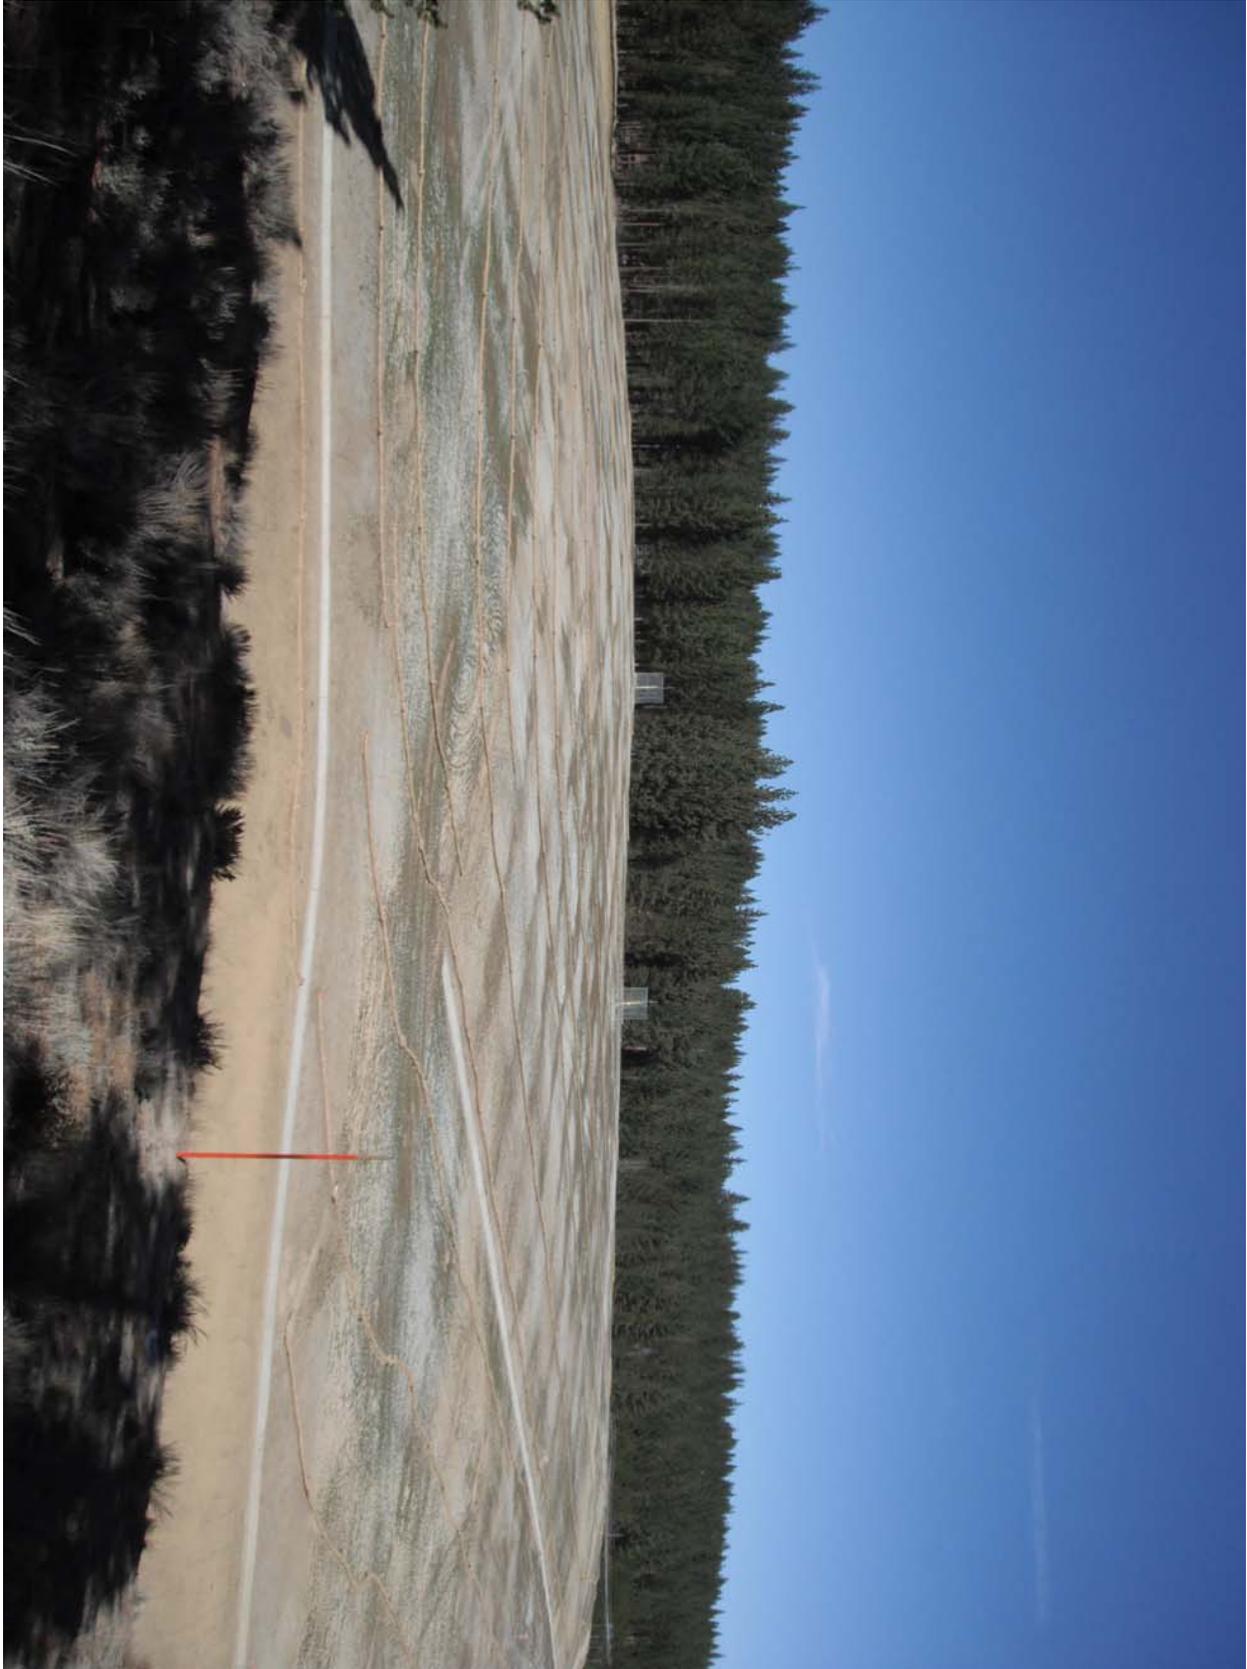
**Figure 5: Post-construction photo**

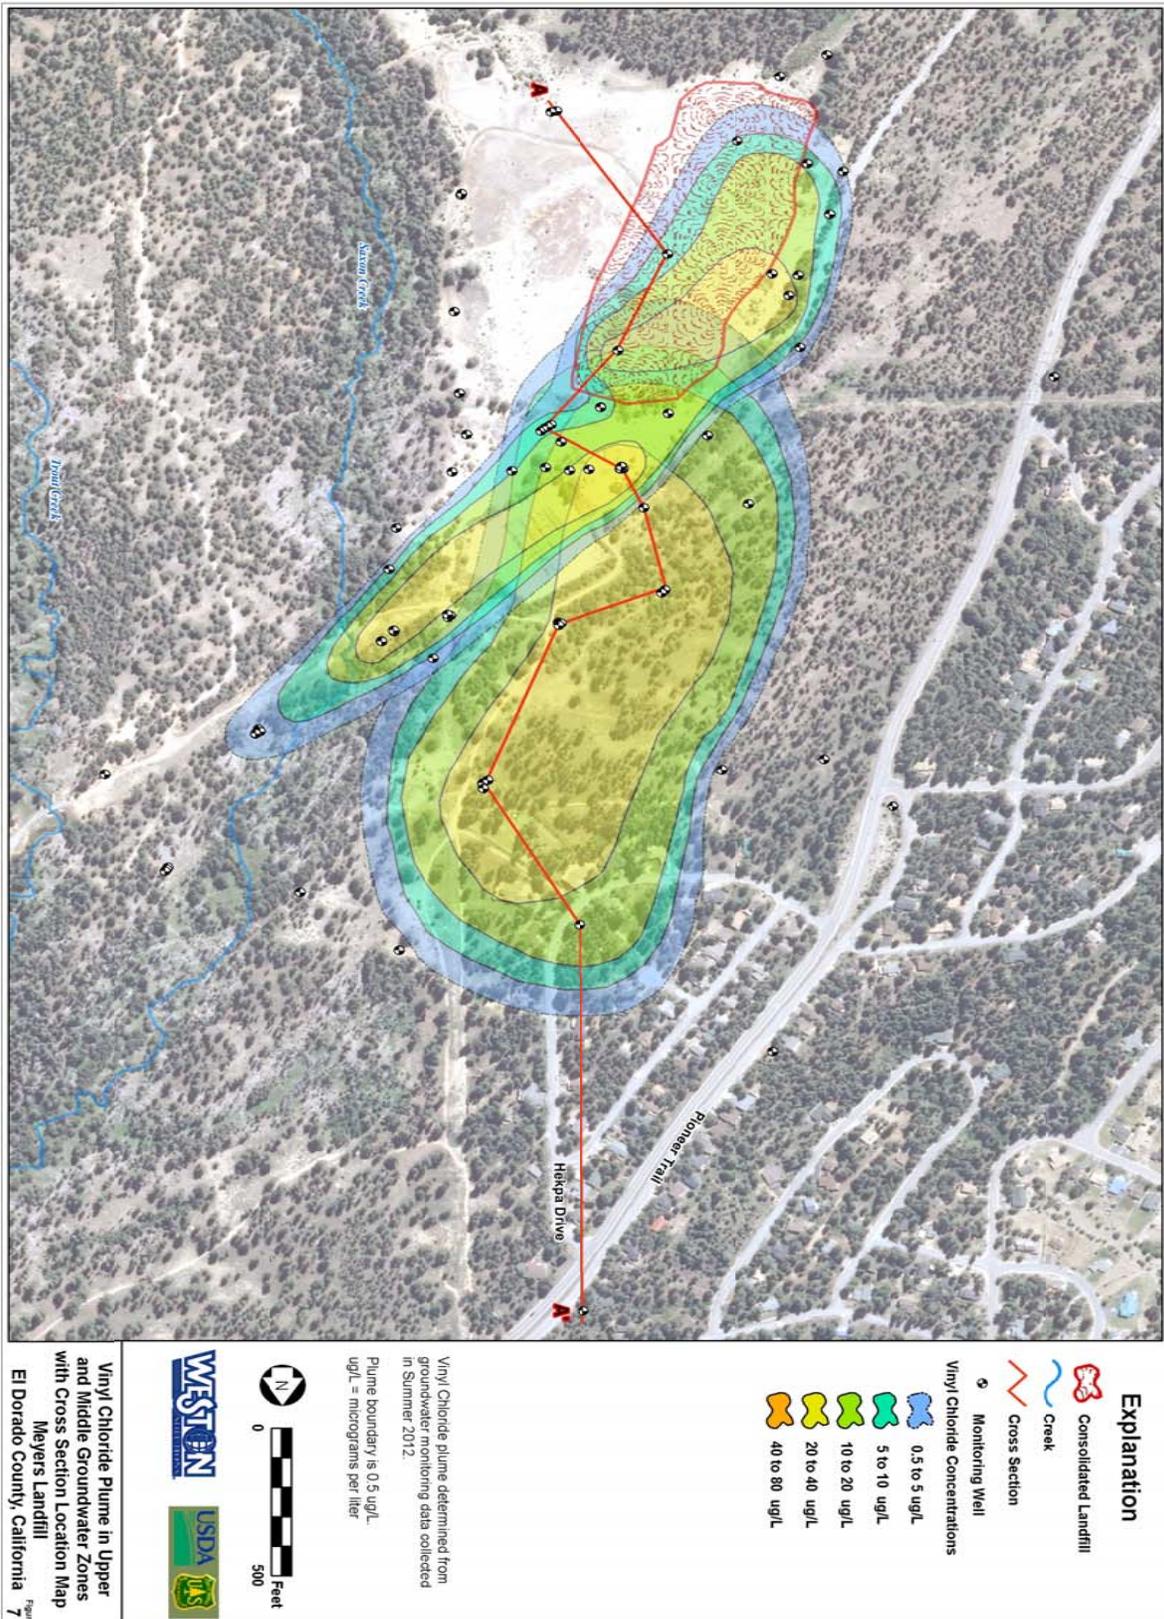
Figure 7: Vinyl chloride migration

The investigation to date shows that groundwater is present in two interconnected zones, the Upper Groundwater Zone (UGZ) and Middle Groundwater Zone (MGZ), and in a separate deeper zone, the Lower Groundwater Zone (LGZ). The UGZ and MGZ are impacted by vinyl chloride and other VOCs. Figure 7 shows the known extent and migration direction of vinyl chloride in the UGZ and MGZ as of September 2012.

Current groundwater investigation efforts indicate that contaminated groundwater in the UGZ appears to be moving northeastward parallel to Saxon Creek and that groundwater in the MGZ is moving in a more northerly direction toward Pioneer Trail. The OU-2 investigation has adequately defined the extent of VOCs in ground-

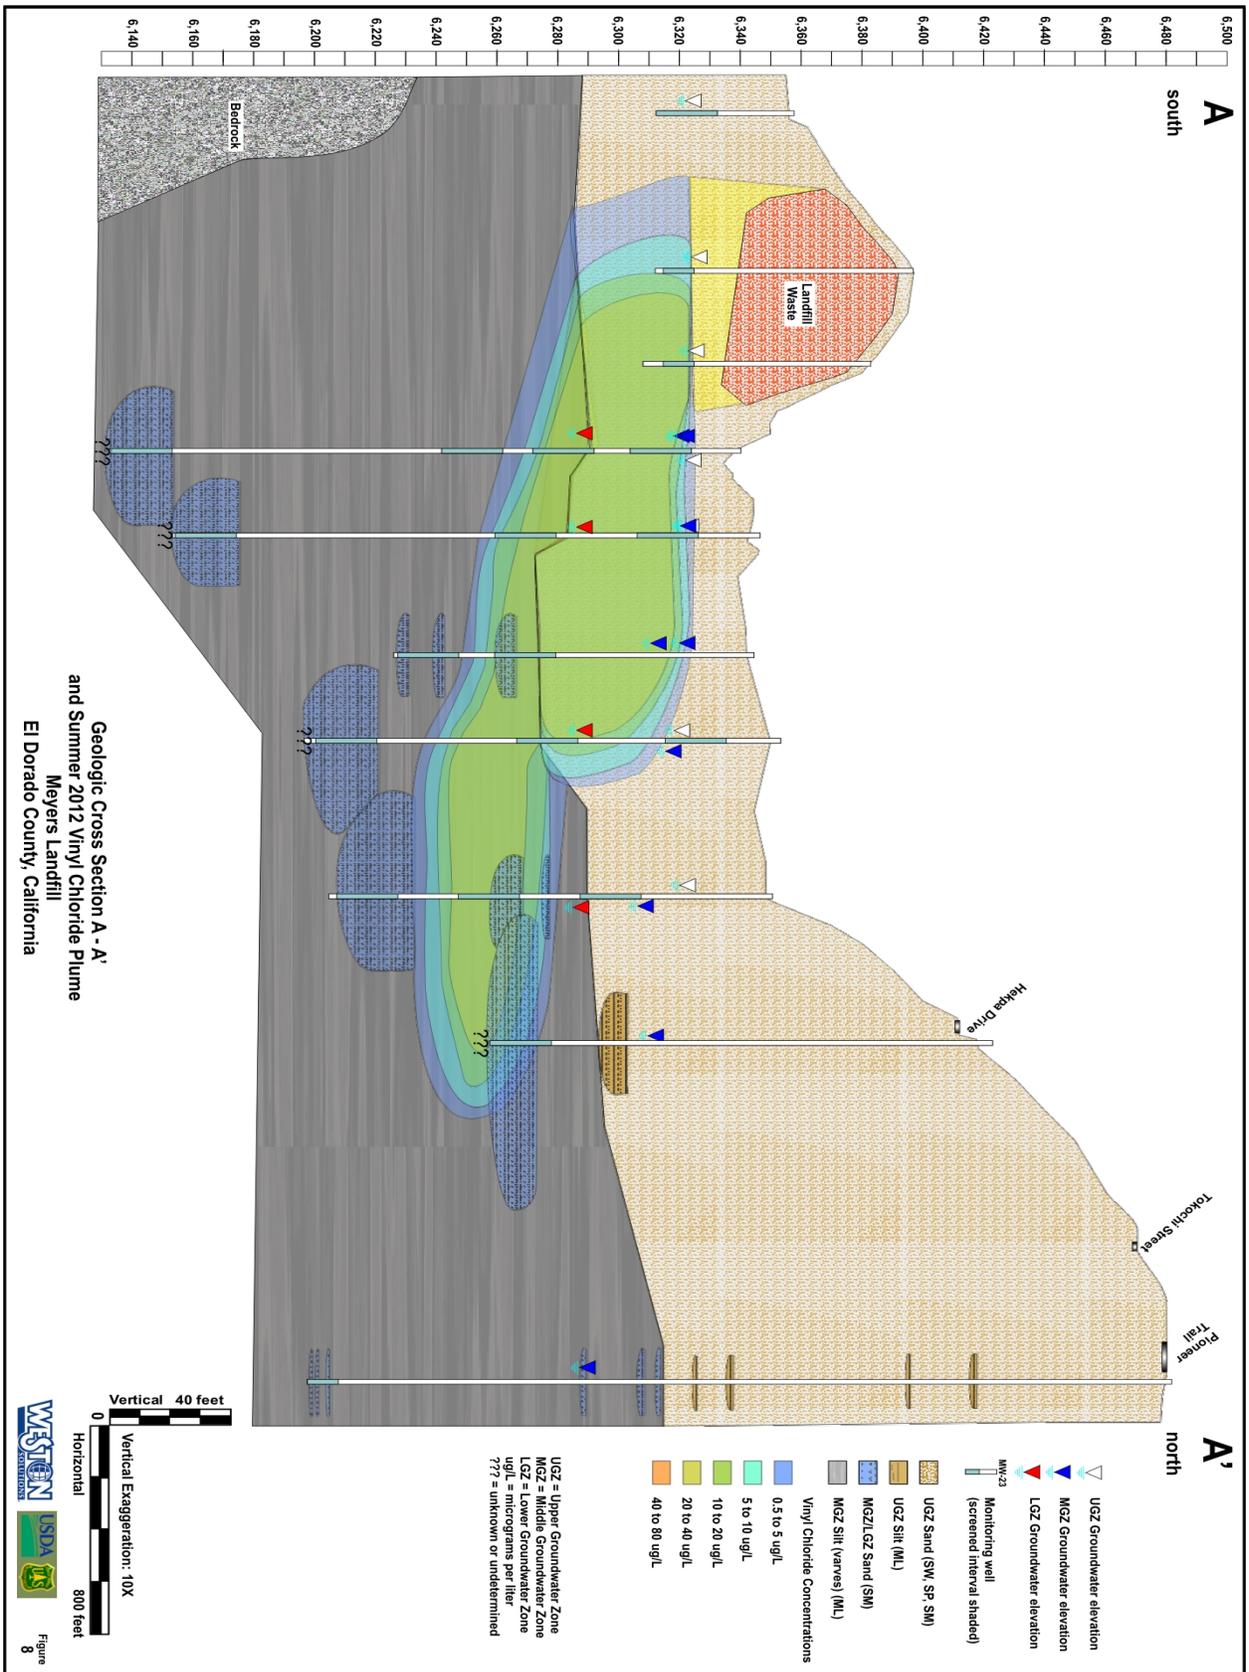
Figure 8: VOC contaminant plume

Vinyl chloride concentrations in the UGZ and MGZ have historically ranged from less than 0.5 parts-per-billion (ppb) to 100 ppb. A ppb is about one drop in 13,750 gallons of water. Sampling has not detected VOCs in the LGZ. Figure 8 shows a cross section of the VOC contaminant plume.
