USDA-FOREST SERVICE

Date of Report: August 5, 2013

**BURNED-AREA REPORT**  
(Reference FSH 2509.13)

The Mountain Fire began on Monday, July 15, 2013, on private lands, but quickly spread onto land administered by the San Jacinto Ranger District, San Bernardino National Forest. Driven by steep terrain, low relative humidity, and wind, the fire spread quickly, burning into Agua Caliente Indian Reservation, California State Park Wilderness, and Bureau of Land Management jurisdictions. At its height, approximately 3,900 firefighters and support personnel were assigned to the fire, with a very steep ramp up of resources.

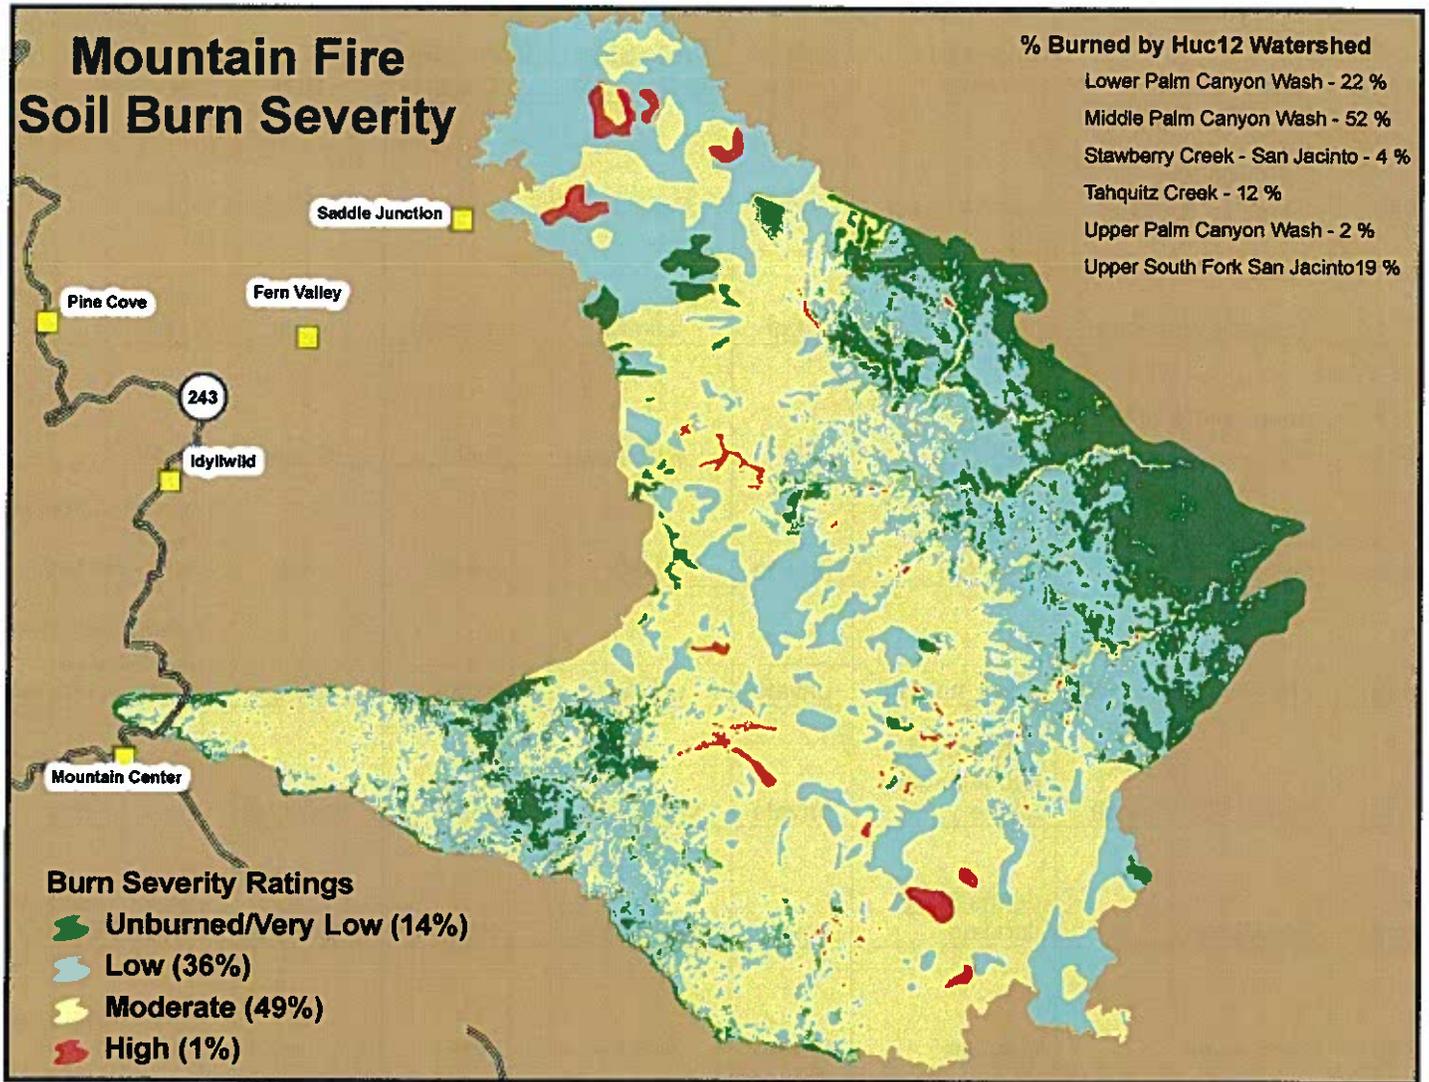
Mountain Fire Soil Burn Severity Map:

Approximately 50% of the burn area burned at a high and moderate soil burn severity (see soil burn severity map below). The rest of the fire was either low or very low soil burn severity. It is very important to understand the difference between *fire intensity* and *burn severity* as discussed by fire behavior, fuels, or vegetation specialists, and *soil burn severity* as defined for watershed condition evaluation in BAER analyses. Fire intensity or burn severity as defined by fire, fuels, or vegetation specialists may consider such parameters as flame height, rate of spread, fuel loading, thermal potential, canopy consumption, tree mortality, etc. For BAER analysis, we are not mapping simply vegetation mortality or above-ground effects of the fire, but soil burn severity. Soil burn severity considers additional surface and below-ground factors that relate to soil hydrologic function, runoff and erosion potential, and vegetative recovery.

General trends: Oak/brush areas were moderate to high soil burn severity especially on east and north-facing slopes; South and west-facing buckbrush and manzanita areas had moderate soil burn severities; Areas in low lands and meadows where grass and small bushes were prevalent mostly experienced a low soil burn severity.
