# Land Management Plan Monitoring and Evaluation Report

## Cleveland National Forest Fiscal Year 2012

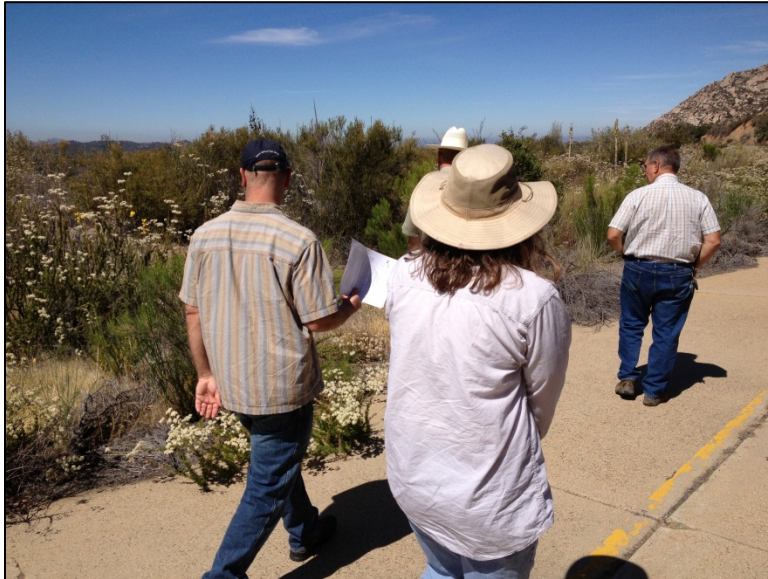
*The Monitoring Team surveys the control of invasive Spanish broom along Los Terrenitos Road.*

Continue to monitor the site for new infestations and retreat as necessary.

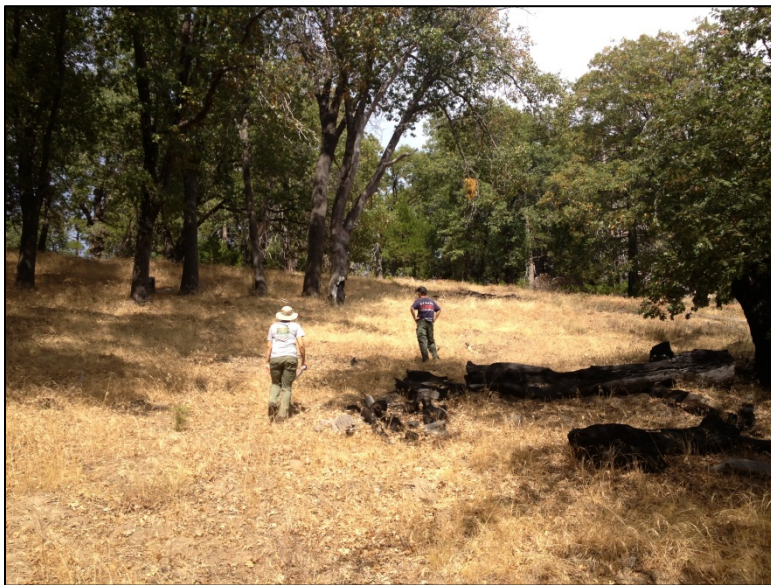
*The Monitoring Team searches for surviving seedlings from a reforestation effort on Palomar Mountain.*

Ensure that project Purpose and Need are clearly outlined and agreed upon by all project staff. Refer to the signed Decision document before implementing the project to avoid going beyond authorized project boundaries. Initiate replanting efforts swiftly after wildfires to promote survival, and focus on areas that are deforested or understocked and in need of reforestation, following prescribed reforestation procedures. Promote coordination among resource and fire management staffs for both planning and fieldwork to avoid conflicting activities.

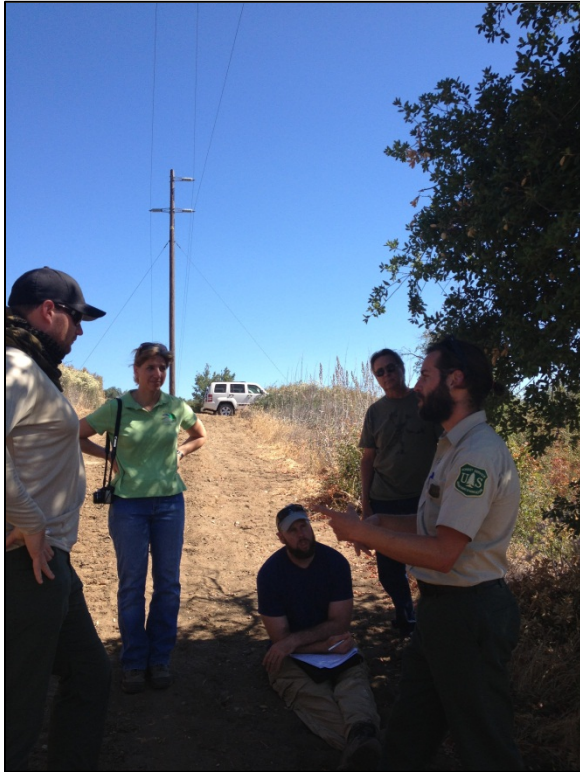
*The District Recreation and Lands Officer tells the Monitoring Team about the road maintenance associated with an electric line restringing project in the Cedar Creek watershed.*

Ensure that whenever a project leader departs the Forest, their projects have clearly designated leaders for the future. Request notification from SDGE of upcoming maintenance operations to a single Forest point of contact.

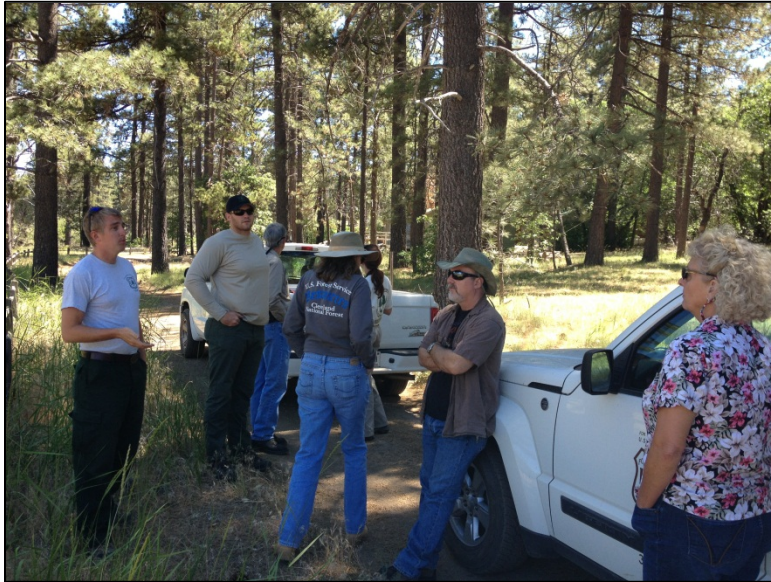
*The District Recreation and Lands Officer describes the management of the Laguna Recreational Residence Tract to the Monitoring Team.*

Continue administration in accordance with the new permits. Fix the fence that protects the Laguna Meadow. Move cleared fuels to collection site and post notice indicating that instruction for the future. Investigate whether San Diego County does regularly inspect Recreational Residence septic systems.

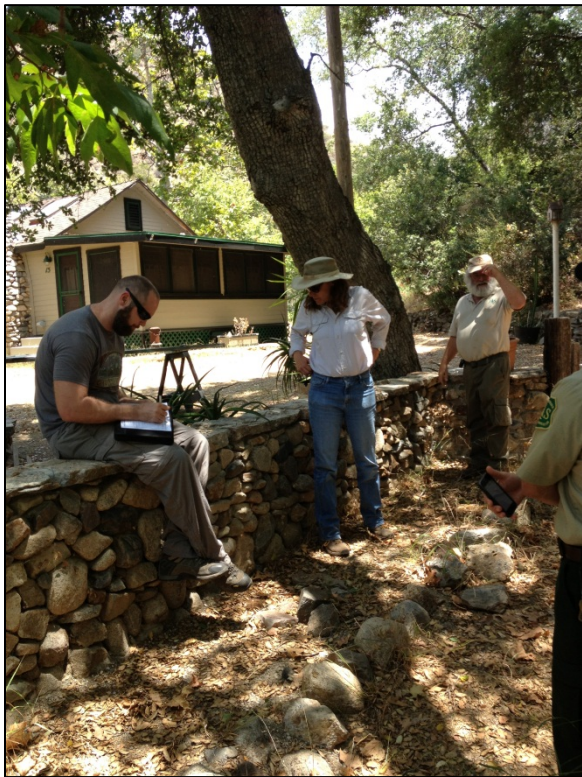
*The Trabuco District Ranger and Monitoring team assess the San Juan Recreation Residence Tract.*

The Trabuco Ranger District should continue managing this tract in the direction of full compliance and desired conditions. Funding should be sought for invasive weed treatments and building foundation removal.

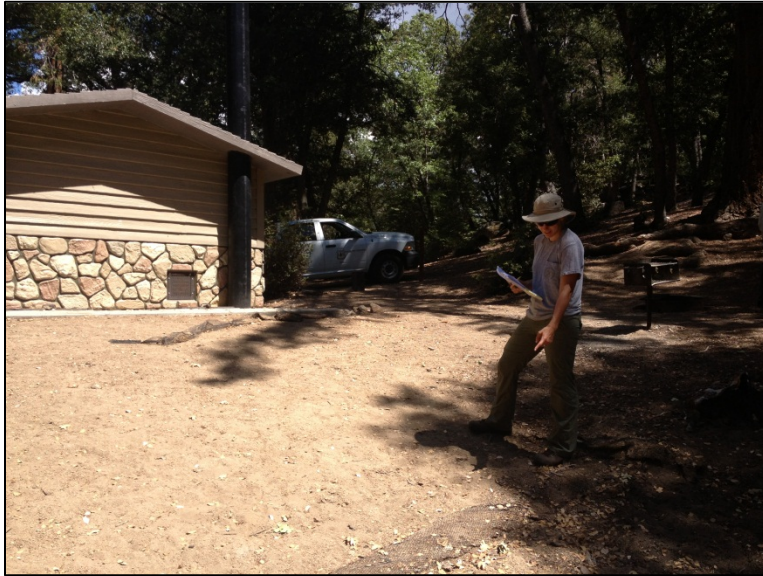
*The Forest Hydrologist shows a wattle left behind to control erosion after the upper restroom was installed at the Fry Creek Campground.*

Pursue funding both to stormproof the campground by stabilizing eroding campsites, maintaining degraded culverts, and redesigning and maintaining the upslope roads. Install trail signage.

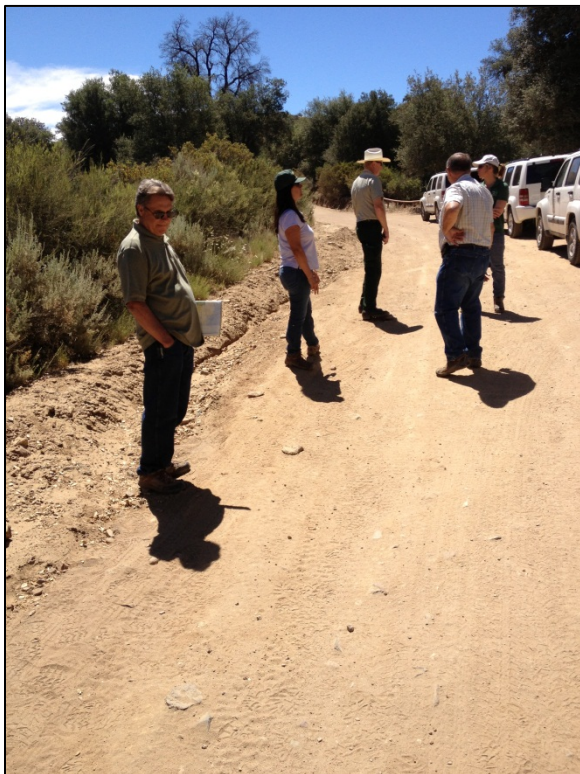
*The Monitoring Team and Descanso District Ranger evaluate soil erosion on Bear Valley Road.*

In order to comply with Best Management Practice requirements for roads, a decision should be made about whether to close Bear Valley Road regularly after wet weather, ensure that maintenance occurs every year, or redesign the road to withstand wet weather use without compromising water quality.

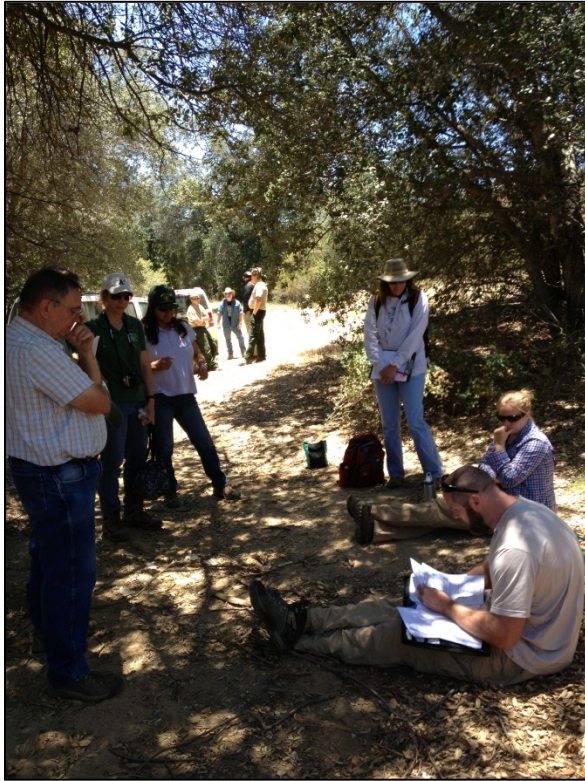
*The Monitoring Team assesses the maintenance of Long Valley Loop Road.*

Continue wet weather closures of Long Valley Loop Road. Install barriers to contain vehicles to a single crossing of the riparian area at the western end of the loop.

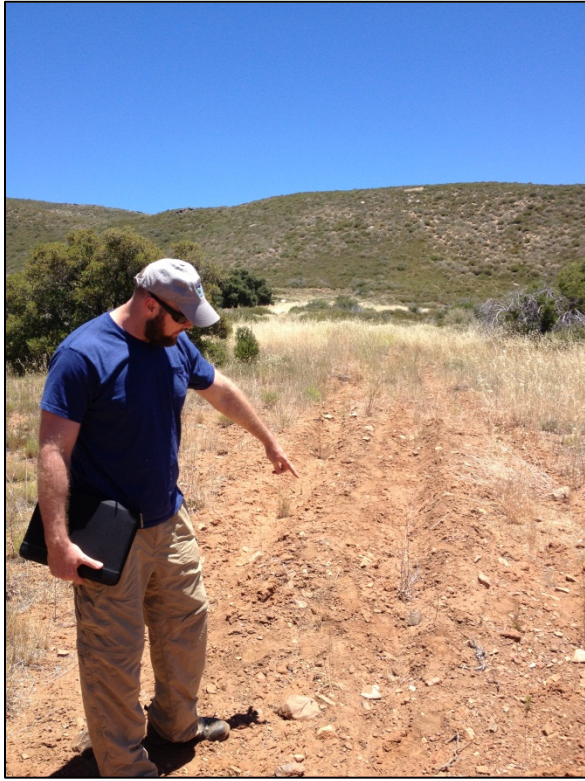
*The Monitoring Team Hydrologist points out trenches left behind by the decommissioning of an unauthorized route off Deer Park Road.*

Most importantly, road decommissioning projects should not be implemented without signed NEPA decision documents in place. In addition, all Forest staff involved in decommissioning should be advised that pocking is the preferable method over scarification and particularly ripping. Finally, all Contracting Officer Representatives on the Forest should be made aware to use US Forest Service BMPs, rather than those of CalTrans, for protecting water quality.

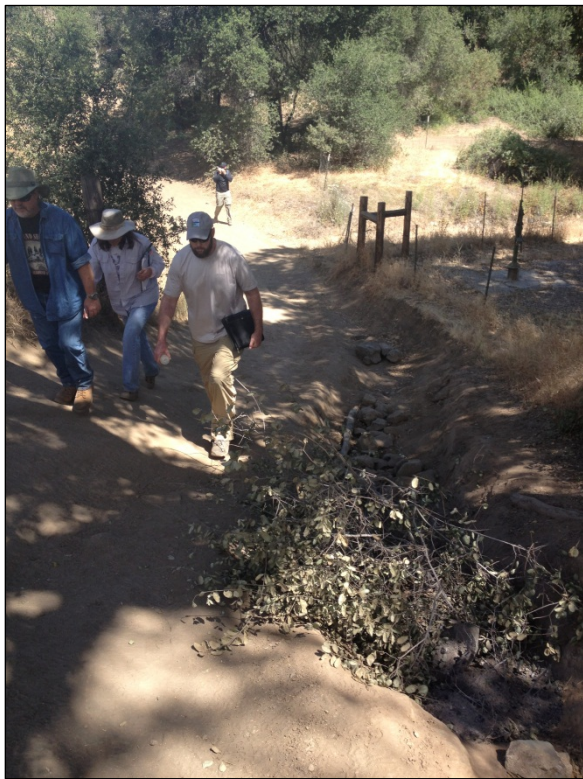
*The Monitoring Team climbs up an OHV trail alongside the gully that contributes sediment to a stream adjacent to Corral Canyon Campground.*

Ensure that NEPA decision documents clearly convey the instructions for all components of a project. Perform annual monitoring to evaluate soil erosion throughout the Corral Canyon OHV Area, and seek funding for tread maintenance to repair existing issues, like the gully adjacent to the campground, and prevent future issues. Seek funding to decommission unauthorized routes.
