**The Technical Newsletter of the National Stream and Aquatic Ecology Center**  
*Fort Collins, Colorado*

*May 2016*

### **Case Study: Jackknife Creek Watershed Restoration**

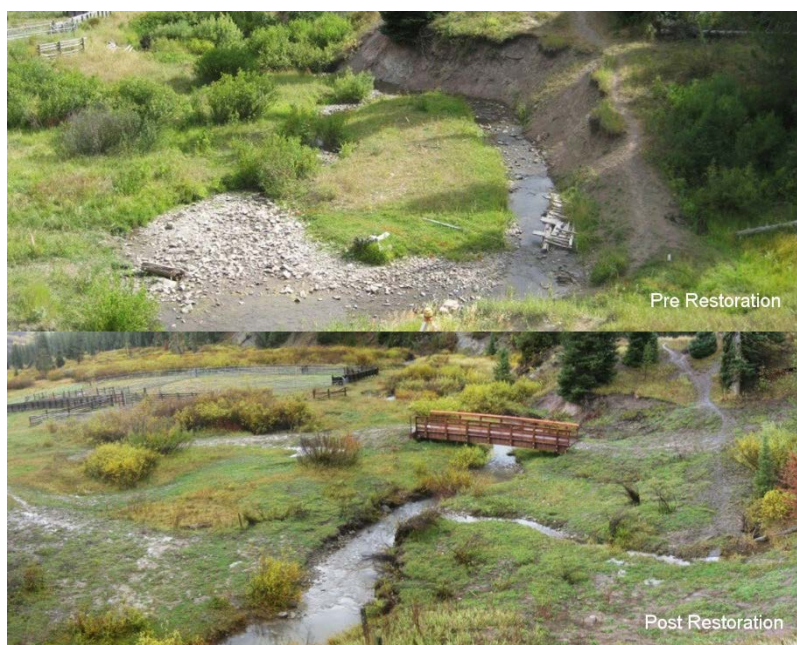
**Figure 1:** Pre- and post-restoration condition at a crossing of Squaw Creek, a tributary of Jackknife Creek.

initiated in 2006 to improve watershed health and conditions. The Jackknife Creek subwatershed (30,425 acres, -95% on National Forest) was selected as a priority watershed in 2011 following the implementation of the [Watershed Condition Framework](#), with the watershed rated in fair condition and considered on the verge of change. By 2014 it was one of 10 watersheds out of more than 15,000 on Forest Service-managed public lands where efforts (Figure 1) culminated in a changed condition class. “No one agency, no one

A washed out trail timbered bridge was replaced with a 35 foot bridge to more effectively span the active channel and a portion of the floodplain. A degraded reach of Squaw Creek and a tributary confluence was also restored (Figure 1).

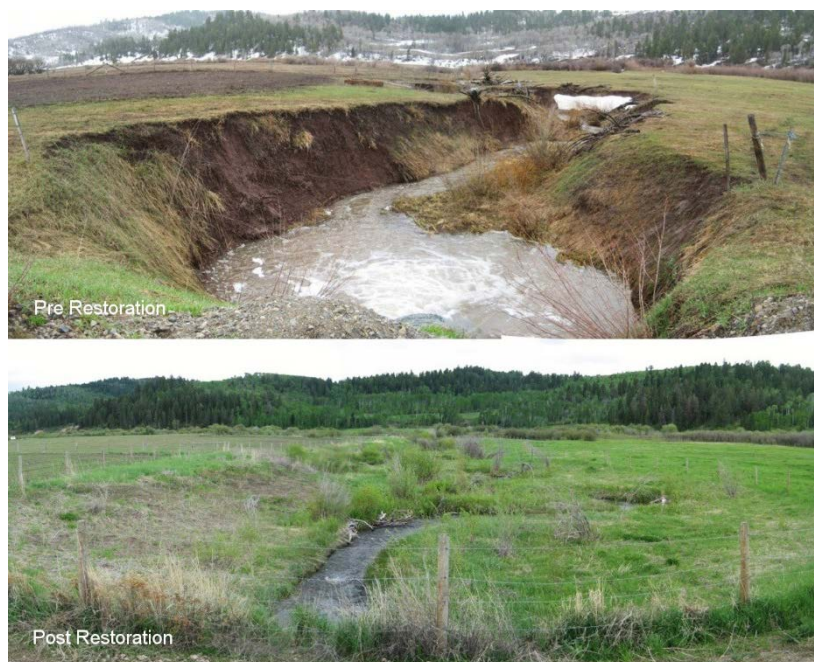
**Figure 2:** Deep Creek, before and 4 years after restoration.

Deep Creek is the lowest tributary drainage in the watershed, with the headwaters on National Forest. Improved road-stream crossings and a stream restoration (on private land) were the primary restoration components. The Caribou-Targhee National Forest cooperatively worked with Rec Spackman (the private landowner), Bonneville County, Trout Unlimited, and other partners to replace a fish barrier culvert on Deep Creek and restore over 1,100 feet of straightened and incised stream channels (Figure 2).

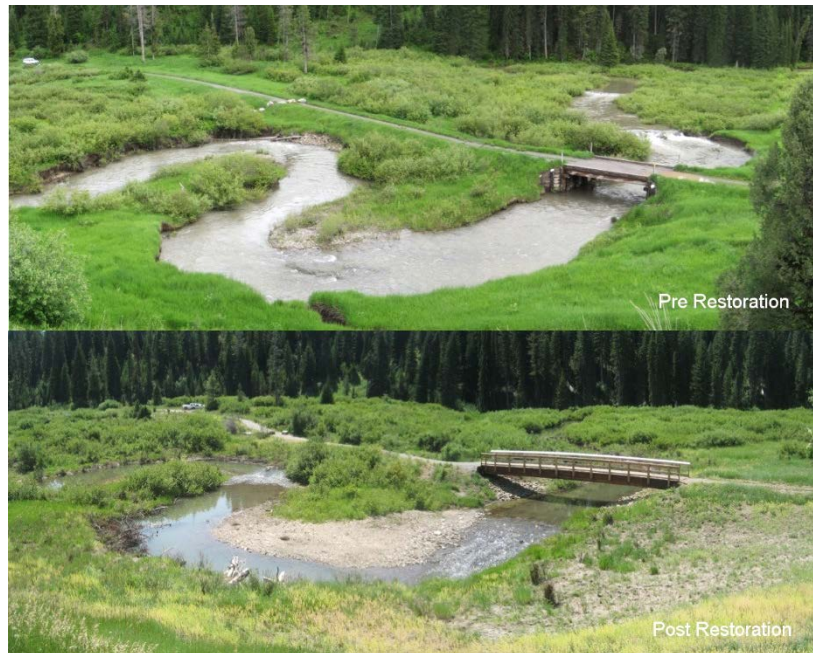
**Figure 3:** Jackknife Creek road bridge replacement and conversion to a wider-span, non-motorized trail crossing. Before and after restoration photos are provided.

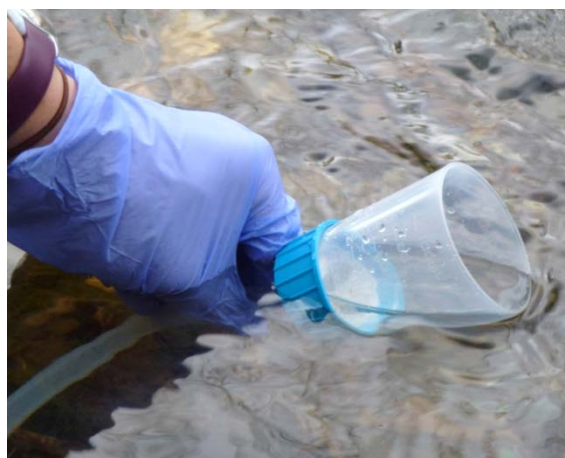
**Figure 6:** An eDNA sample being collected. It generally requires 8–9 minutes to filter 5 L of clean stream water.

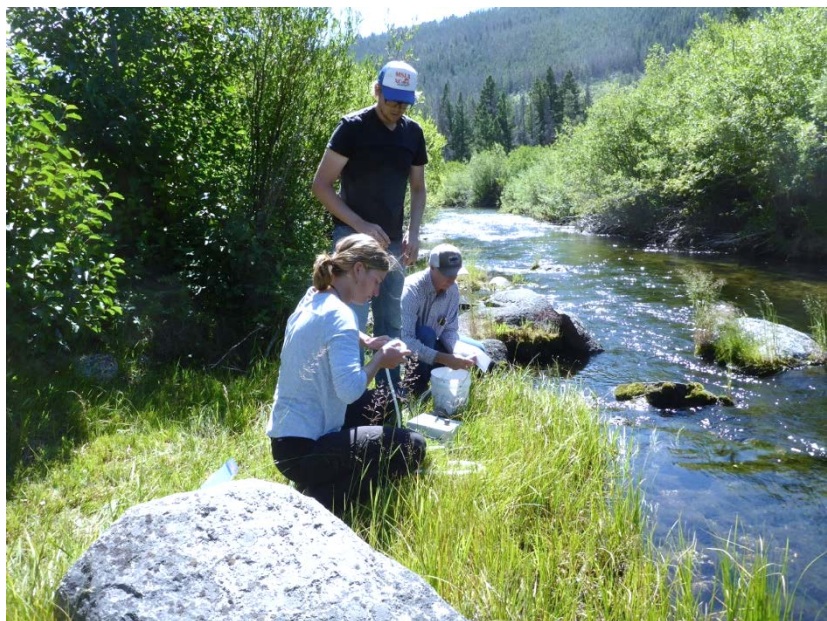
**Figure 7:** eDNA sampling field training. The technique can be learned in about 30 minutes.

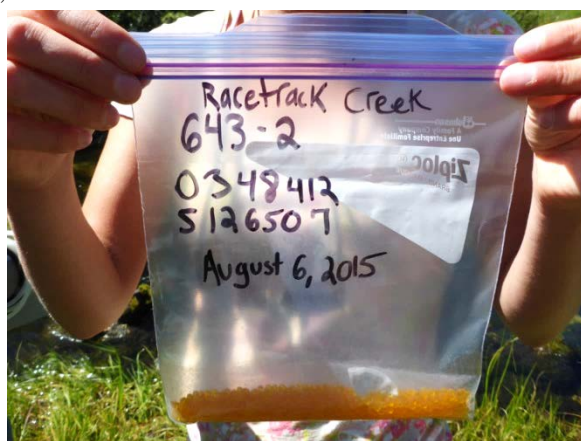
**Figure 8:** The collected sample is stored in desiccant, with associated data recorded on the storage bag.

eDNA sample (Figure 8). Moreover, the equipment needed to collect a sample can be carried by a single person in a daypack. By adopting this protocol, we used eDNA sampling to describe the distribution of federally listed bull trout across 98 km of 1st- to 3rd-order streams in 8 days (McKelvey et al. 2016). Furthermore, eDNA-based methods have detected species at very low densities in streams. We achieved 100%
