Malibu Coastal Land Conservancy

*Malibu Creek Bridge at Cross Creek Road
October 17, 2004 through January 10, 2004 Rain Storms*

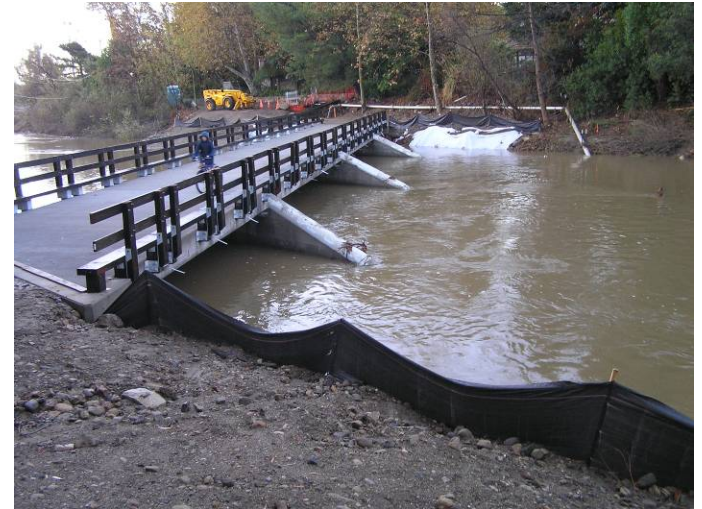
On October 26, 2004 there was another 2.3 inch storm. The picture to the right was taken in the early morning of the 27th, just after the storm ended. By this time all false work had been removed and additional erosion control measures added. At that time it was anticipated that the Creek would not dry up until the late spring. The temporary water line was relocated; the K-Rails used for water diversion were removed and the construction access road for vehicles entering the Creek removed.

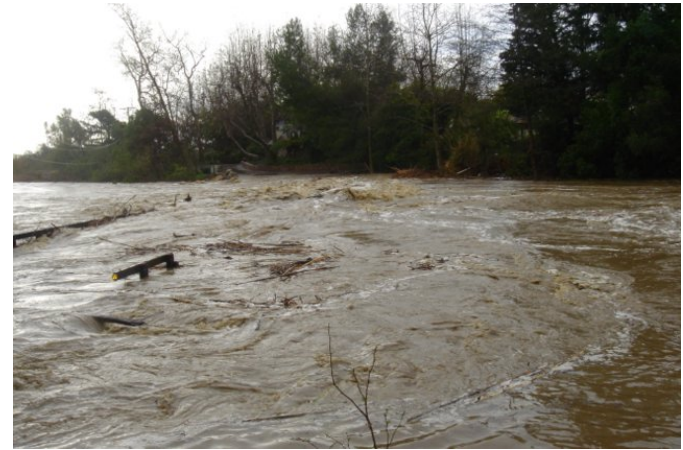
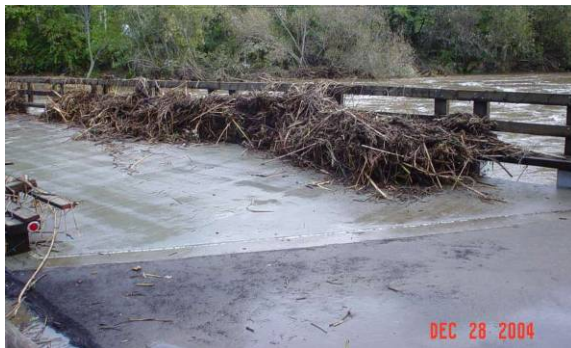
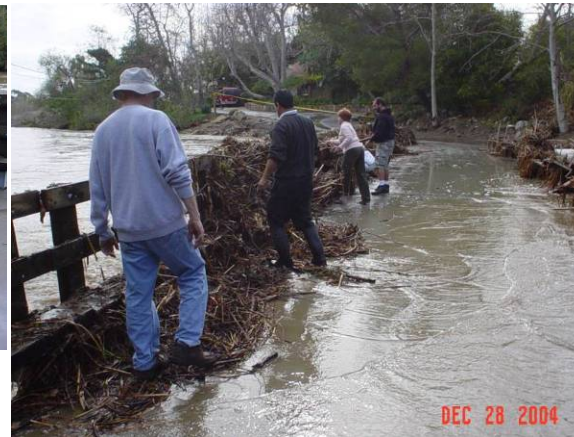
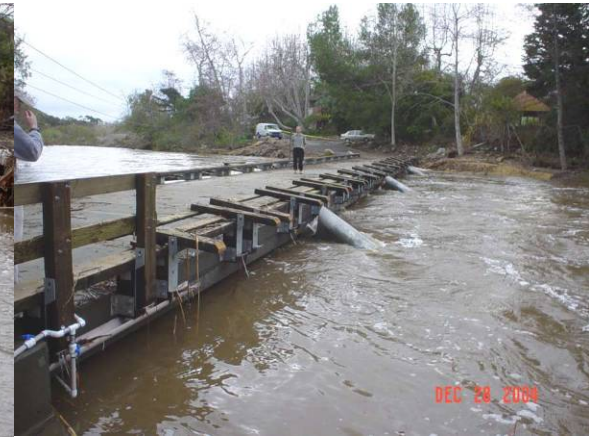
The next set of storms began on December 28, 2004 and extended through December 29, 2004. **4.96** inches of rain fell. The ground was saturated and the soil was not absorbing the rain. The storm water over topped the bridge and carried lots of debris, much of it dead arundo. The picture on the right shows how high the water went over the bridge deck. The release mechanisms for the rails did not work as specified. At a lull in the storm on the 28th the local residents released the shear pins used on the down stream rails; collapsed any upstream rails that did not fold; and cleaned debris. The bridge was returned to service shortly after water dropped below the road way.

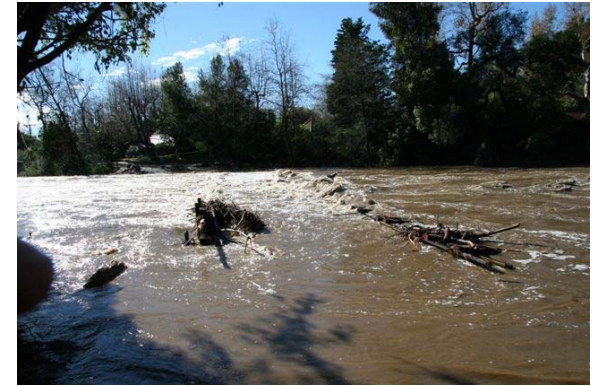
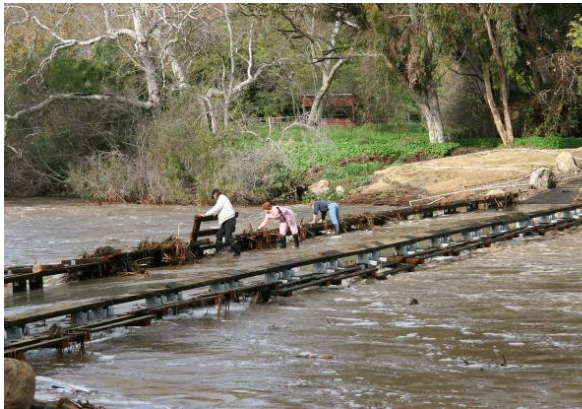
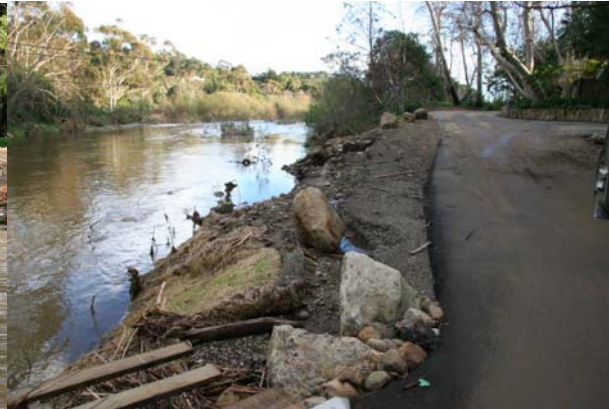
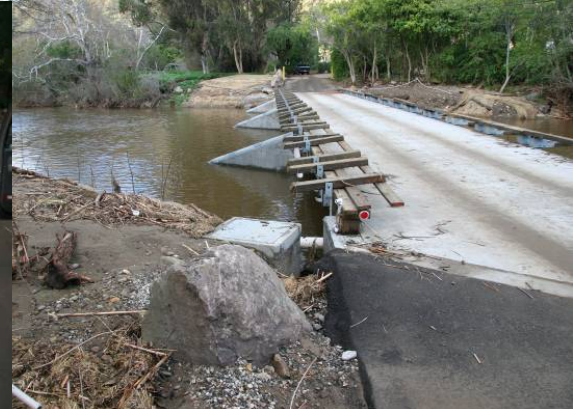
Again on January 2 and 3 another storm deposited **3.6** inches of rain. The bridge was again over topped. By keeping the rails collapsed the damming phenomena experienced in the December 28, 2004 storm was avoided. After the water subsided the bridge was restored to service. The down stream West side bank experienced some erosion. The upstream West side bank experienced erosion around the filter. This has been filled in preparation for the next storm. The East side downstream bank is being carefully watched. Rip Rap was installed many years ago under a Coastal Permit. Some erosion occurred in the first storm close to the abutment. The area has been filled with gravel.

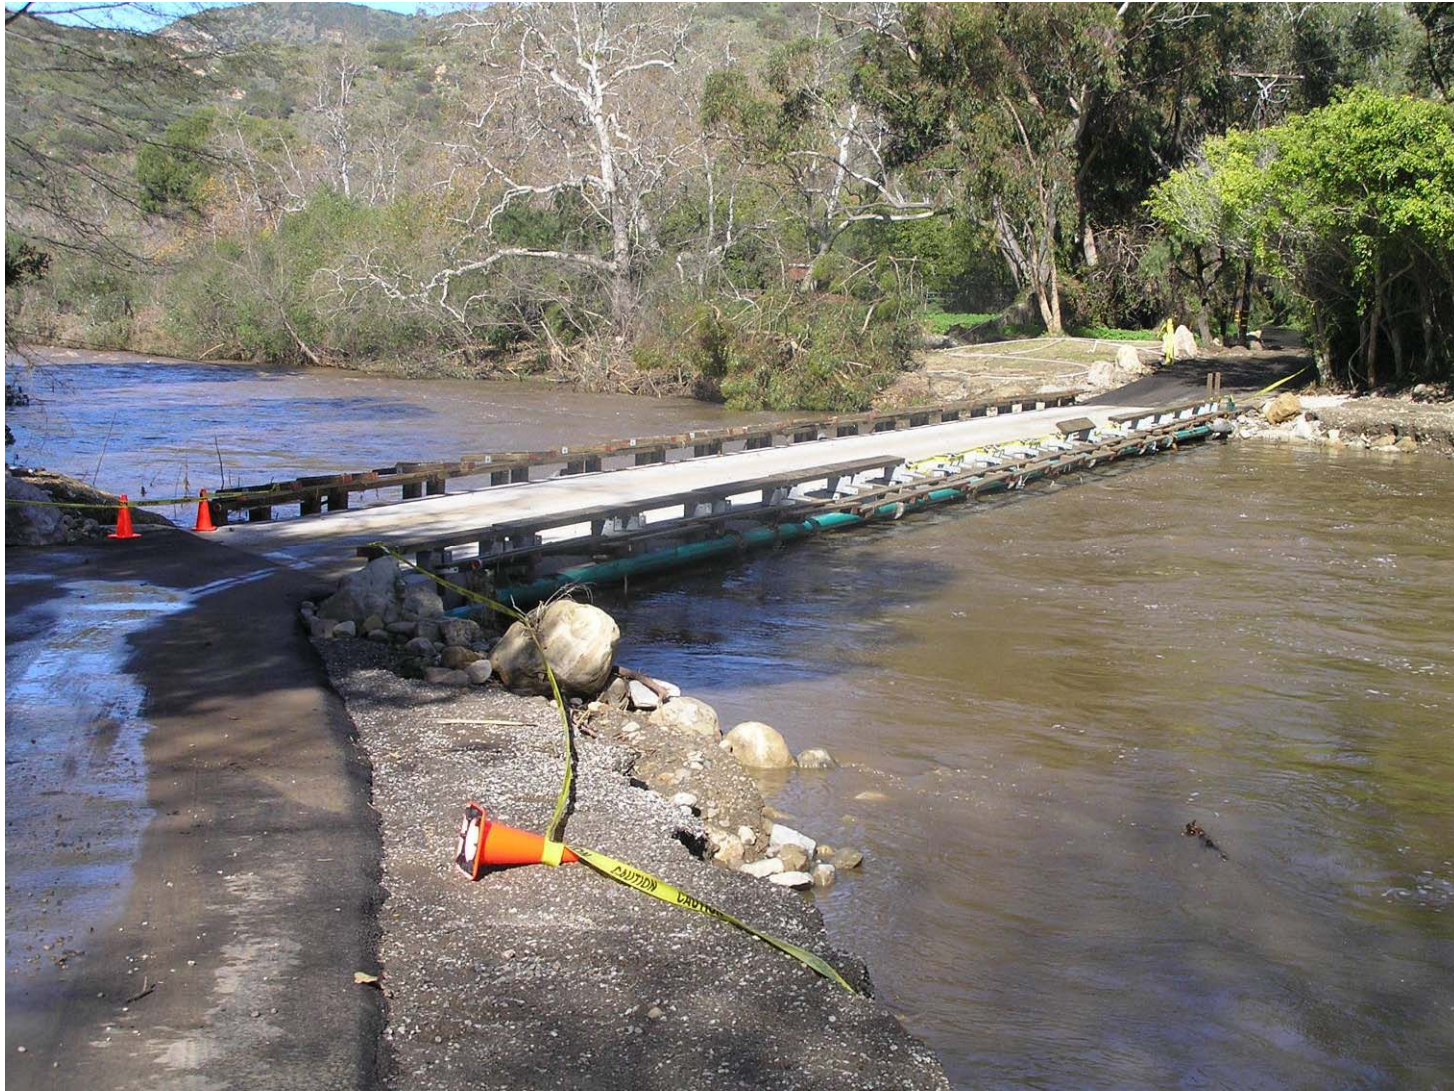
The bridge is returned to service in the morning of January 11, 2004 after **5.58** inches of rain

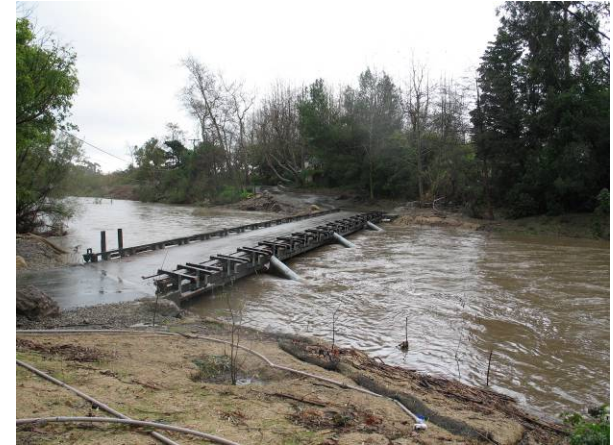
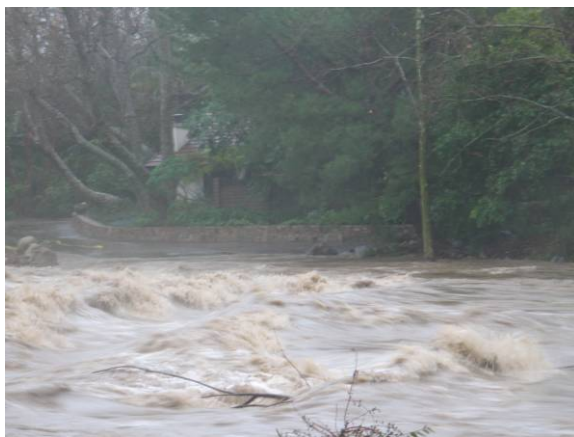
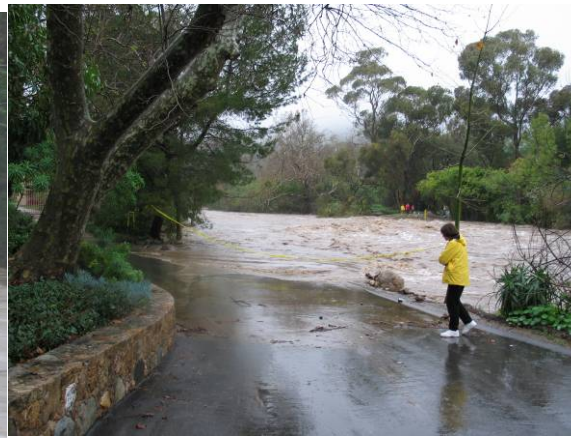
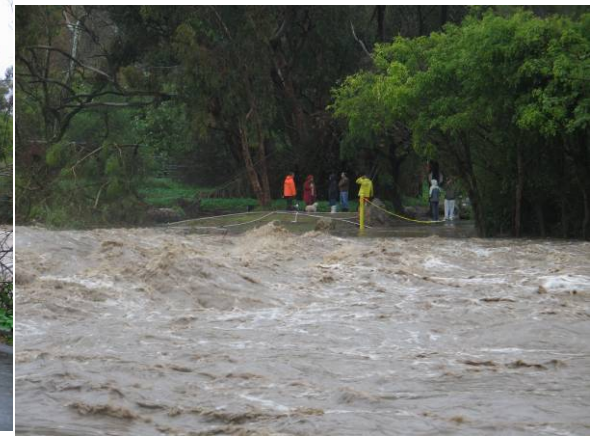
The rains keep on coming. A smaller storm measuring only **2.2** inches occurred on January 7, 2004. The railings are down and the bridge is ready for the raging water expected in a series of storms over the next few days. Notice the grass popping through the straw mat; the sycamores still in place; and the willows sprigs in the water. Unfortunately, time between completion of the bridge and stabilization by the bio-engineered erosion and vegetation planning was insufficient to properly protect the banks. The new storms continued on January 9 and 10 with **5.58** inches of rain. The expected storm on January 11 did not materialize. The pictures below taken on January 9th show the storm reaching the exit road level. Water over the bridge continued until morning on January 11th.
