# Field Evaluation of the Long-Term Performance of Geocomposite Sheet Drains

Jim McKean  
Department of Geological Sciences  
University of Canterbury  
Christchurch, New Zealand

Ken Inouye  
USDA Forest Service  
Vallejo, CA  
January 21, 1999

Edited By  
USDA Forest Service  
Technology and Development Center  
San Dimas, California  
December 2000

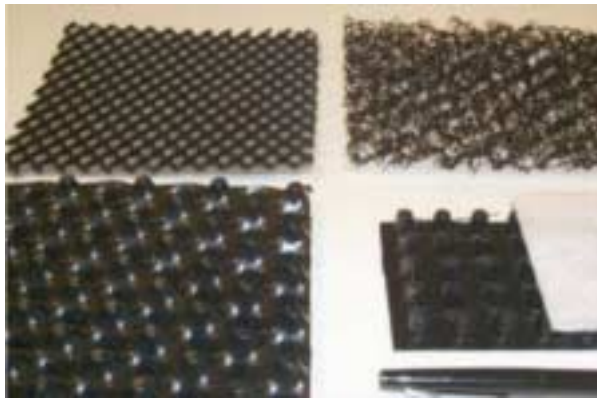
*Figure 1—Typical geocomposite drains. The core can vary from a geonet (upper left), a plastic sheet that has been shaped to form cusps (lower left), cylinders (lower right), or mesh (upper right). The pen is provided for scale.*

In the past 20 years, prefabricated geocomposite drains have become a standard method of groundwater drainage for a wide variety of purposes. In many cases these drains are cheaper, easier to construct, and require less space (as they are thinner) than conventional drains constructed using aggregate wrapped in a geotextile. Geocomposite drains are composed of a three-dimensional core surrounded by an appropriate geotextile. The core is usually either a geonet or a semirigid plastic sheet deformed or extruded with a pattern of cusps or small cylinders that project at a 90 degree angle to the plane of the drain. The geotextile may be stretched tight across the core and glued in place or placed loose around the core. The geotextile must span the gaps between the net strands or cusps in the drain core to keep them open for water flow. Some typical prefabricated geocomposite drains are shown in figure 1.

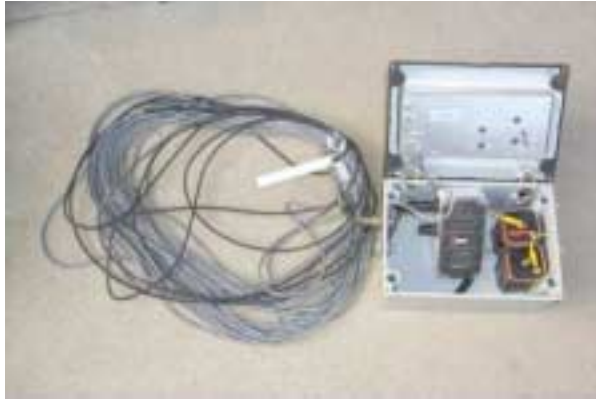
Figure 3—Groundwater level measuring equipment. The piezometer (white cylinder at the end of the cable) measures the water pressure, the datapod (small black box) records the data, and the large outer box powers the piezometer and conditions the electrical signal.

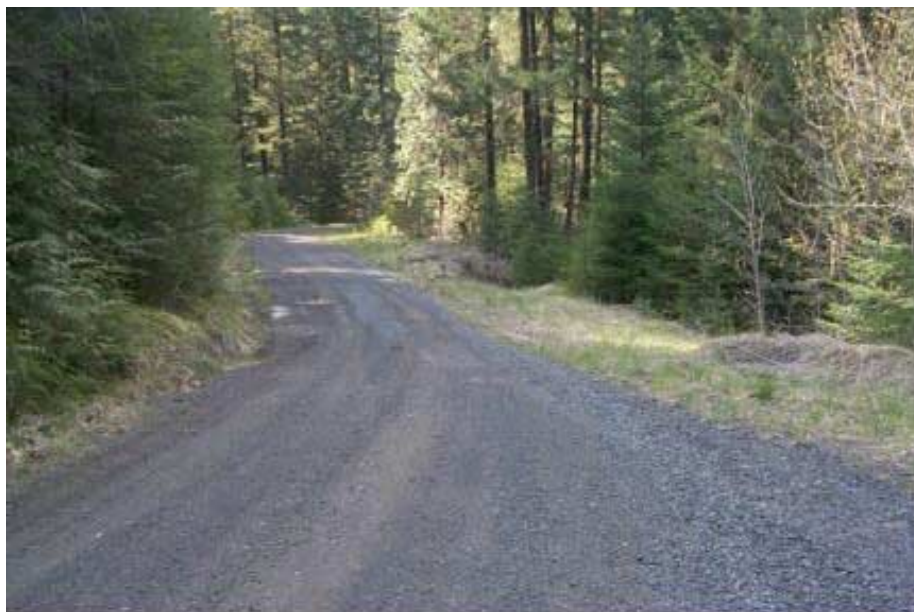
Figure 6—At the Willamette National Forest site, seasonal elevated pore water pressure has caused the road to sag several meters.

At the Willamette National Forest (NF) site, the geocomposite is Hitek Stripdrain 75, installed in a vertical trench 2.4-meters deep along the inside edge of a single-lane aggregate surfaced road (figures 4 and 5). The site was chosen for study because the local water table is high during each 6-month winter period and the road has sagged vertically several meters over the years in a slow creeping movement. Apparently this is caused by seasonal elevated pore water pressures. Precipitation is dominantly rainfall from November through April and no sustained snow pack. The site is shown in figure 6.

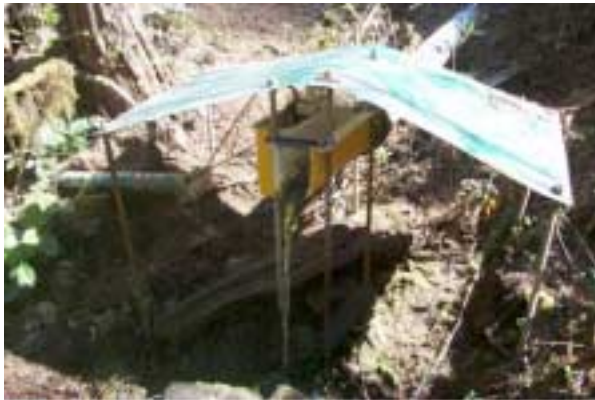
Figure 7—Flume at drain outlet. The water level in the stilling basin on the left side of the flume is measured and converted to a flow volume.

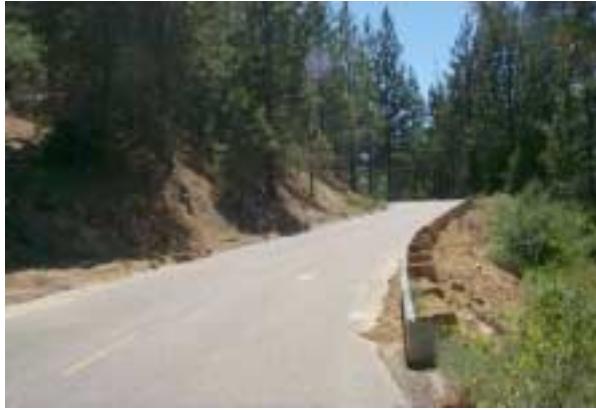
Figure 10—Sierra National Forest site. The drain is installed along the inside edge of the road.

An Eljen Drain was constructed at the back of an excavation site, as a reinforced soil type retaining wall on the Sierra National Forest in 1984 (figures 8 and 9). This wall is the repair of a landslide that destroyed the two-lane paved road during the winter of 1983. The wall height ranges from 4.6 to 6.8 meters. The local geology is granodiorite bedrock, that weathers to a grus, overlain by a colluvial soil. The grus still retains much of the bedrock structure and both the grus and the colluvium classify as SM materials. The back of the excavation for this wall extends through the colluvium and well into the saprolite. The climate at the site is Mediterranean with essentially all of the annual precipitation occurring during the winter months (between November and May) as either snow or rain. Groundwater at the site drains from the hillslope south of the road. The site and retaining wall are shown in figures 10 and 11.

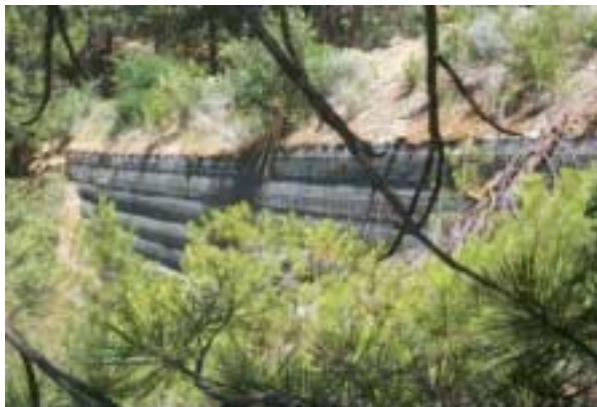
Figure 11—Retaining wall at the Sierra National Forest site.

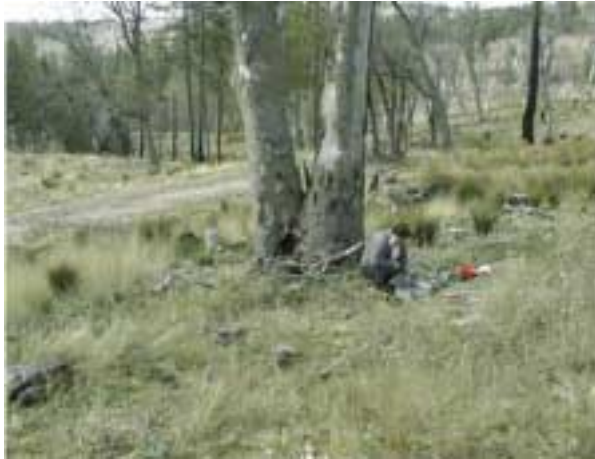
*Figure 14—Stanislaus National Forest site.  
View is downslope to the north.  
Well 1 is to the left of the large tree.*
