2500 Watershed & Air Mgmt  
August 2002  
0225 1202—SDTDC

# Riparian Protection and Restoration: Road Design Techniques

**James R. Bassel, P.E.**  
Civil Engineer

San Dimas Technology and Development  
Center  
San Dimas, CA

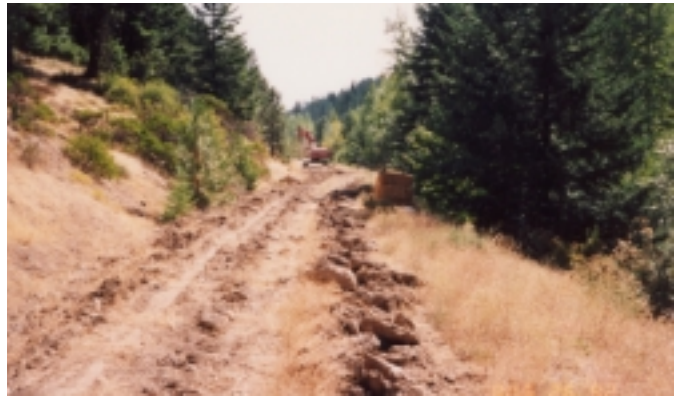
Figure 1—The berm blocking the road was removed to allow fertilizer and bales of mulching straw to be placed every tenth of a mile.

1. Straw and fertilizer were hauled in and placed every tenth of a mile along the roadway prior to any obliteration work. This method was chosen due to difficulty in transporting materials following excavation (figure 1).
2. An excavator dug up and removed existing culverts (figure 2).
3. A dozer ripped the roadbed 2- to 3-ft deep to loosen the compacted soil and alter the natural subsurface waterflow.

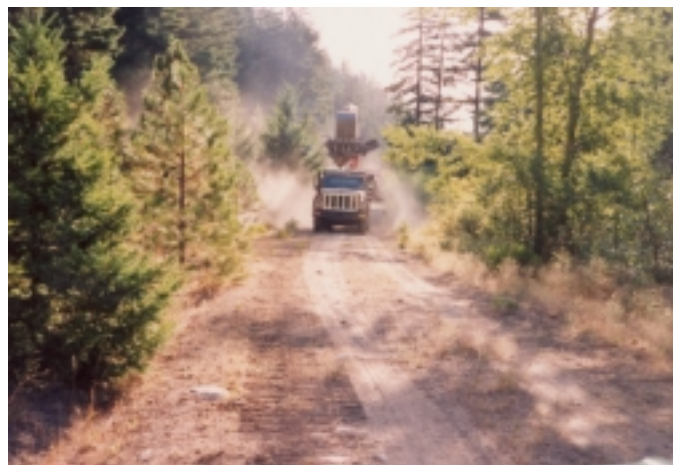
Figure 2—The excavator pulled culverts from the front (junction) of the road to the back.

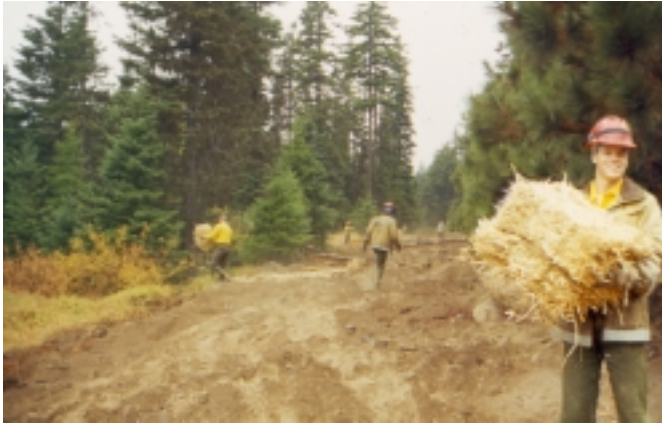
Figure 3—The district project crews seeded and broadcasted fertilizer and mulch (straw).

4. The Link-Belt 4300 excavator pulled back the road fill material from the end of the road and completed the project at the upper portion of the road. Large boulders and shrubs disguised the entrance to the obliterated road.
5. The district project crew seeded and broadcasted fertilizer and mulch (straw) to prevent erosion (figure 3).

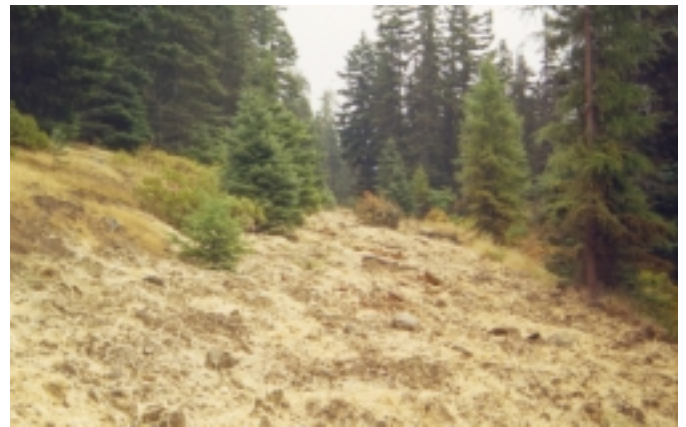
Figure 4—The district project crew hauled in seed and used it with fertilizer and mulch that was already onsite.

**Results**—Grass with mulch proved to be the fastest and cheapest method for controlling erosion, the primary objective of the Rail Hollow Road Project. Seeding was prescribed rather than using native plants to regenerate the area. The seeding mixture allows for good root development for erosion control, but still gives native vegetation an opportunity to reestablish itself (figure 4).

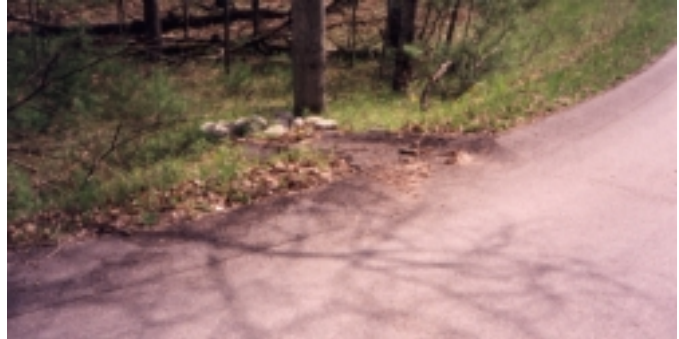
Figure 6—Curbing and drainage structures channel runoff flows off the roadway and into fields or sediment beds.

water into drainage structures. The drainage structures allow runoff to flow off the roadway, away from the river, and into fields or sediment beds (figure 6). Researchers estimate that this upgrade eliminates 50 tons of sediment per year. The upgraded road has also restored degraded salmonid habitat for approximately 4 mi downstream.

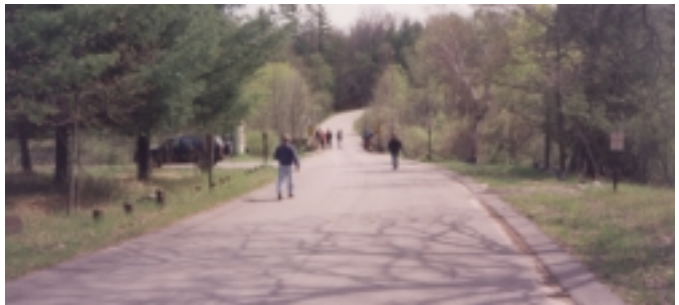
Figure 7—Another positive result of paving is a barrier-free parking area near the bridge that provides fishing opportunities for physically challenged individuals.

As a result of this upgrade, the USDA Forest Service was able to construct a designated barrier-free parking area near the bridge that provides fishing opportunities for physically challenged individuals (figure 7).

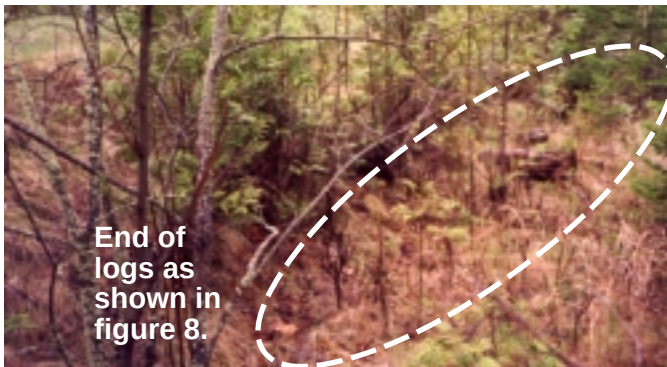
Figure 9—Log corduroy (selected area) was used for cross drainage on this road.

If log corduroy is used for cross drainage, geotextile material should be applied above and below the corduroy (figure 9). If log corduroy is not used, other cross-drainage structures should be considered.

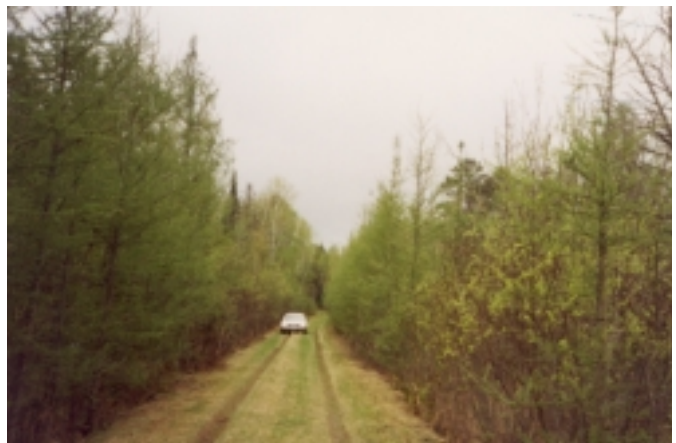
Figure 10—This road still maintains a free flow of water through the roadbed while providing a stable road surface.

**Results**—In most cases this technique works well. The site shown is 20 years old and is still maintaining the free flow of water through the roadbed while providing a stable road surface (figure 10).

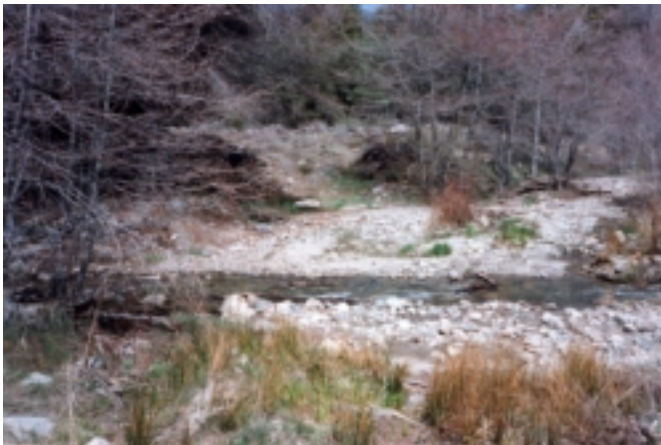
Figure 11—One of the natural river crossings (roadbed in background) that agitates sediment in the stream.

**Problem**—One 3-mi segment of this road has four natural river crossings with no previous approaches or riverbed improvements. Assistant Forest Engineer Bill Crane said, "Vehicles passed through the river agitating the river with road grime and sediments. The water crossings are a problem for engineering because of maintenance and damage to the resources which result in poor fish habitat." The following problems were identified at the crossings (figure 11).

- Vehicles using the crossings disrupt streamflow, import contaminants, agitate sediments, and degrade the environment for aquatic life.
- The road cut interrupted the natural flow of ground and surface water through the meadow.

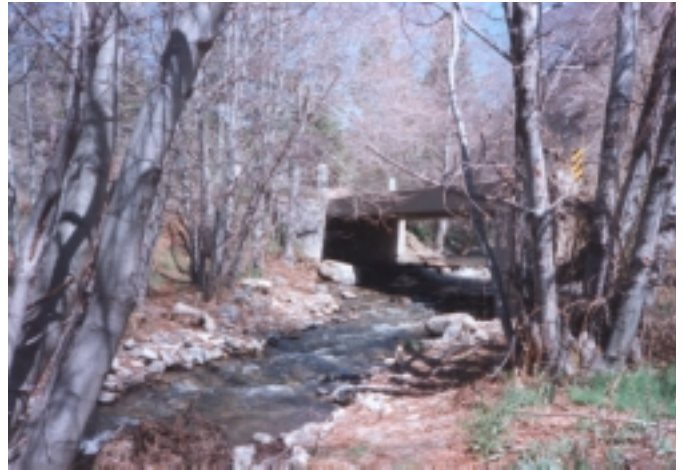
Figure 12—Four precast, 40-ft concrete, single-lane bridges were constructed to replace the natural water crossings and improve aquatic life.

**Solution**—The USDA Forest Service replaced the natural river crossings with four precast concrete, single-lane bridges that are designed to improve aquatic life (figure 12). The bridges keep vehicles out of the river, with less maintenance required on the ap-

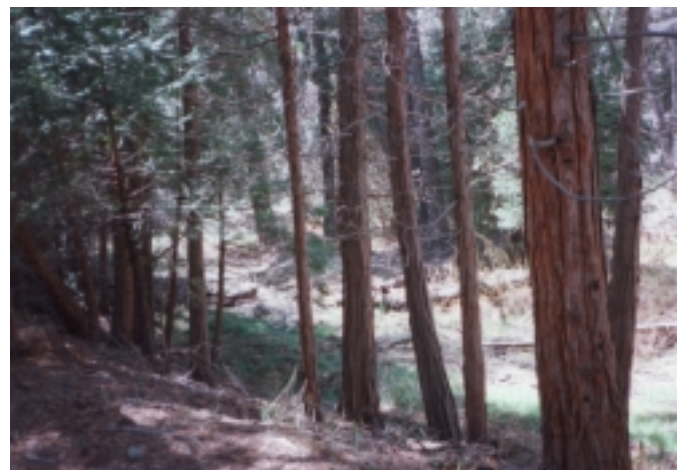
Figure 13—The reestablishment of native vegetation hid all evidence of the original water crossing into the meadow.

To relocate the approach out of the meadow, the planner located the bridge a short distance downstream from the river crossing. The old approach was blocked with multiple 4-ft-high dirt mounds and the remainder of the approach was scarified and raked and left unseeded, allowing the native vegetation to reestablish itself (figure 13).

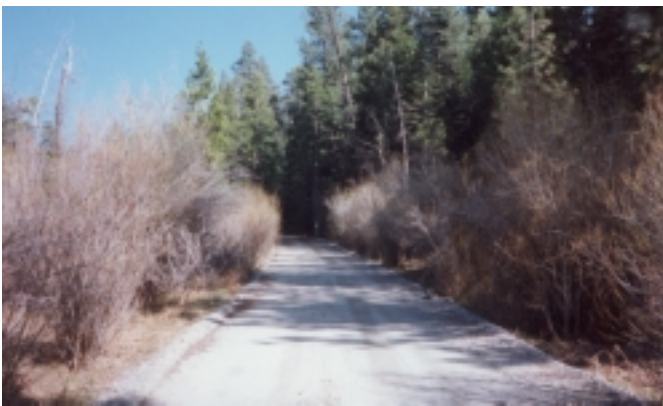
Figure 15—The roadbed was rebuilt using nonwoven geotextile, coarse drain rock, and 3/4-in surfacing aggregate to make a dry road surface.

For the subsurface drain, the forest road crew excavated 12 in below the road surface. A nonwoven geotextile served as the bottom layer, with 6 in of coarse drain rock above the layer of geotextile, and another geotextile layer on top of the rock. The road crew finished with a 6-in layer of 3/4-in aggregate surfacing (figure 14). The finished french drain is shown in figure 15.

The under-the-road drain dried the roadway's surface, while allowing the meadow groundwater to flow freely under the road. This is an excellent example of keeping a riparian area intact. The traffic has a good aggregate surface and the functional integrity of the meadow was not destroyed (figure 15).

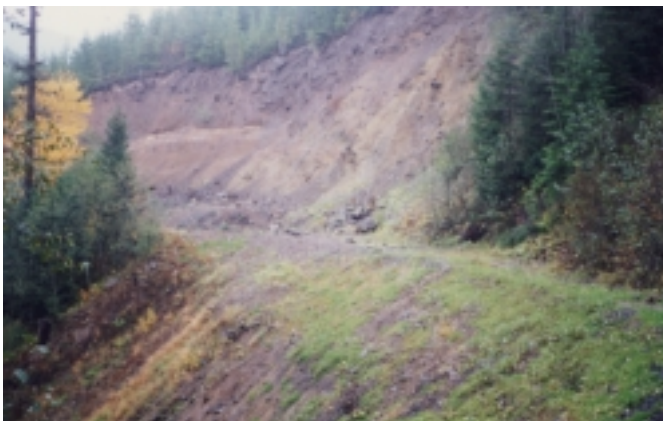
Figure 16—The largest slide on the Greenwater River Road removed 300 ft of roadbed in the inner gorge.

**Problem**—Winter storms during 1995 to 1996, caused extensive flooding of the Greenwater River, triggering several massive landslides along the Greenwater River Road and dumping a torrent of debris into the river. The largest slide removed 300 ft of road in the inner gorge (figure 16) and delivered an estimated 23,000 yd<sup>3</sup> of sediment into the river channel. Massive amounts of sediment from the landslides and debris torrents moved the river from its established channel and floodplain. As a result, the USDA Forest Service closed the road to traffic.

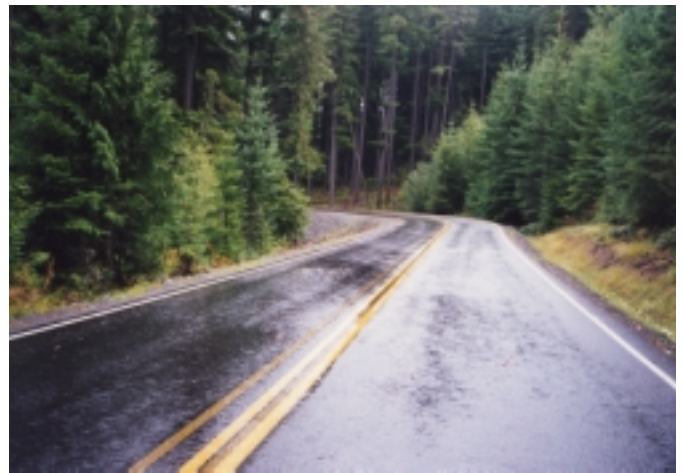
Figure 17—The newly relocated Greenwater River Road.

**Solution**—According to Forest Representative Wayne Hamilton, the damaged road was relocated to the outside of the inner gorge because of the high risk and probability of future failures in the inner gorge. The newly constructed road portion is a two-lane, asphalt-paved road with very few shoulders or turnouts (figure 17). A new portion of road was constructed using a timber-hauling road for a short distance and the remainder of the 3.2-mi section is on virgin land.

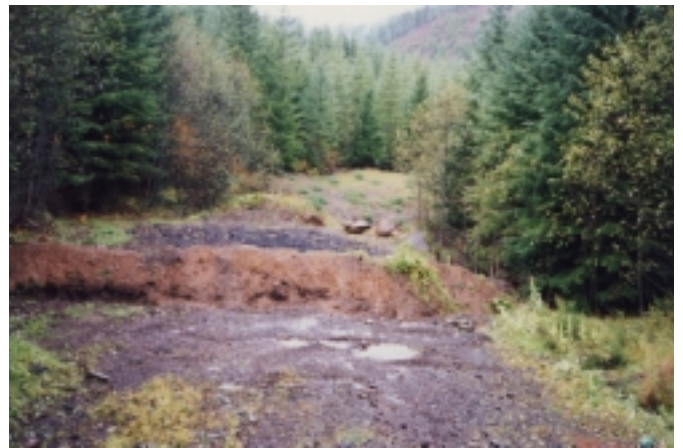
Figure 18—By blocking the two entrances, pulling all culverts, and seeding and mulching the roadbed and sideslopes, the upper road closure affected only 2.9 mi of the existing road.

Only 2.9 mi of the old existing road was closed. It was abandoned by blocking the upper entrance, pulling all culverts, and seeding and mulching the roadbed and sideslopes (figure 18). While removing the culverts, the crew ensured that the trench matched the slope and width of the original ground to maintain the identical stream hydrology.

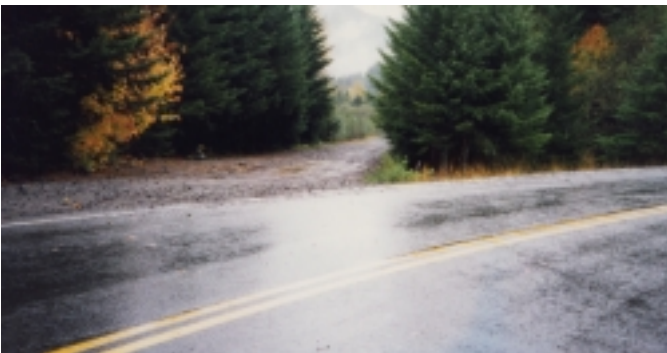
Figure 19—The beginning of the road relocation. The old road (to the left) goes to a dispersed campground.

The following summer, the crew came back, dug deep trenches, and made a larger berm, which proved successful. Researchers discovered that it is important, after initial closure of entrances, to follow up soon afterward to ensure that blockages are intact. The road's lower end was not closed because it was used to access dispersed camping (figure 19).

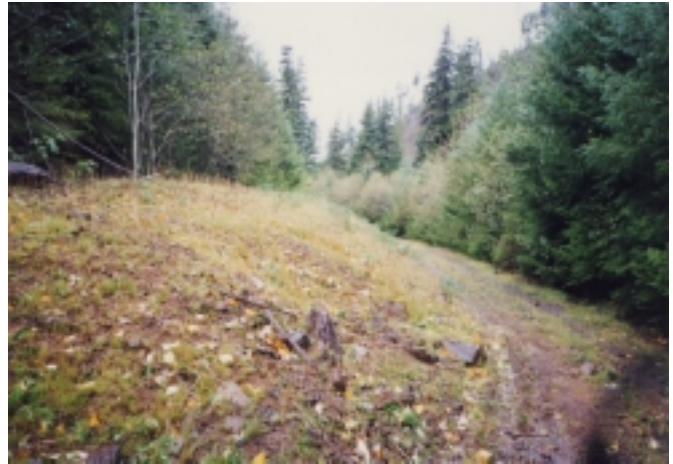
Figure 20—Native vegetation has started to grow back after two growing seasons.

Seed and mulch treatment placed on the rehabilitated roadbed was successful (figure 20). After two growing seasons, no evidence of erosion remains and native vegetation is growing. The culvert removal sites are functioning with no signs of erosion.

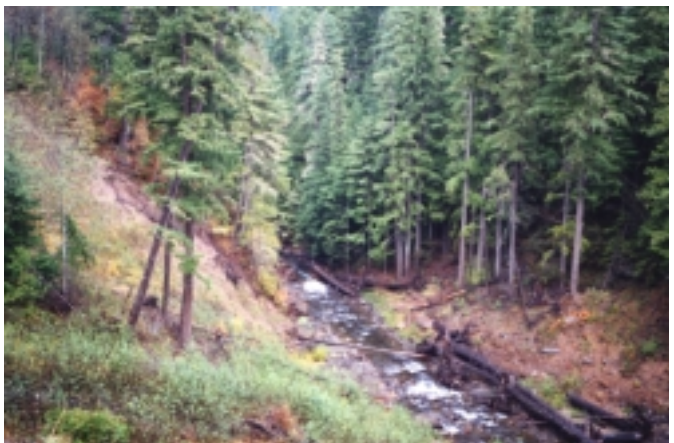
Figure 21—The river below the landslide. The removal of the road from the inner gorge provided an opportunity for riparian restoration.

The road, removed from the inner gorge, reestablished the riparian area (figure 21). Removing a log stringer bridge from over the river allowed a larger amount of bedload movement in the river during high flows and flood events. Culverts that impede fish passage are being removed and other improvements continue. A plan to reconnect the stream channel to its original channel and restore the riverbanks is in the design stage.

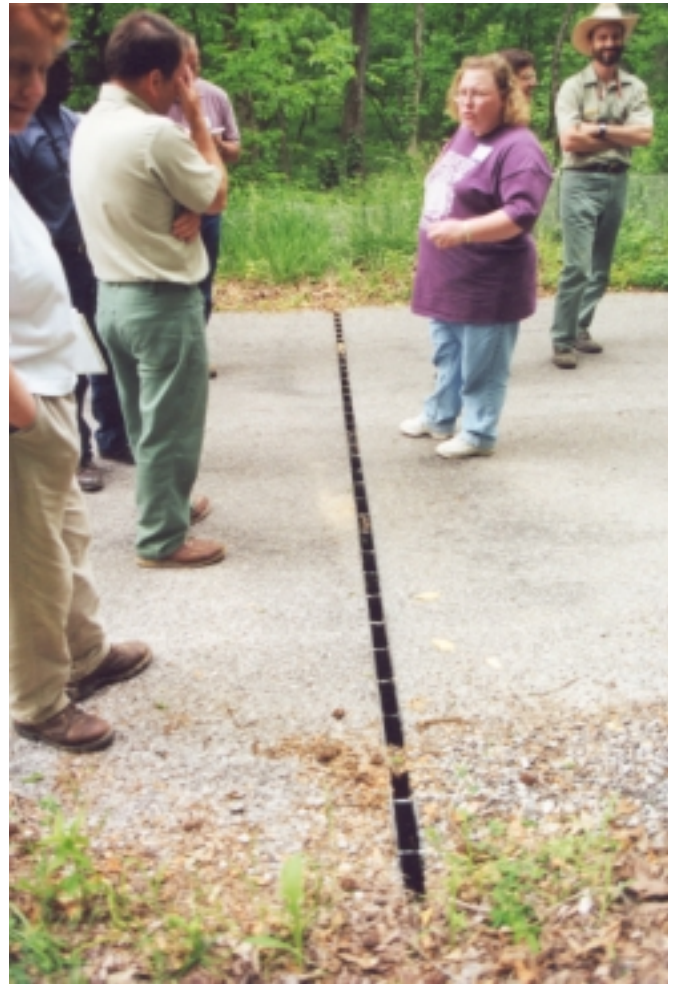
Figure 22—Closeup view of the slot in the roadbed.

According to Cynthia Morris, Shawnee National Forest, three crossings were installed during the road resurfacing at locations where there was evidence of heavy snake activity. The installations are similar to an 18-in culvert with a 12-in extended slot. The culvert was installed under the road and the slots were placed on top. The slots penetrate the roadbed, allowing sunlight and air to enter the culvert used by the reptiles (figure

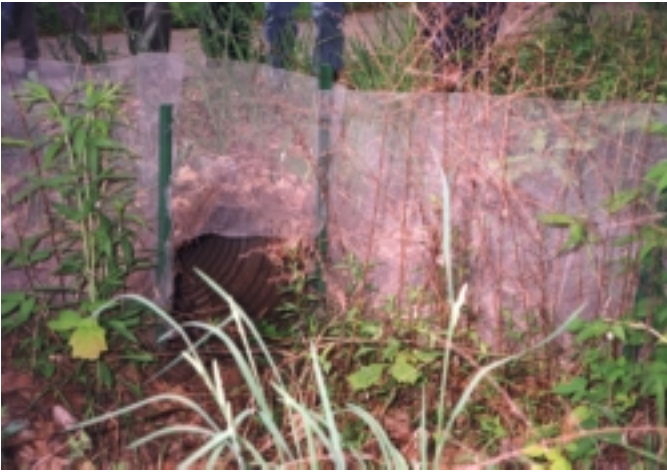
Figure 23—A culvert was installed under the road with plastic webbing to guide the reptiles into the culvert.

22). Plastic webbing was installed for 50 ft along the side of the roadbed to funnel the reptiles into the crossing (figures 23 and 24).

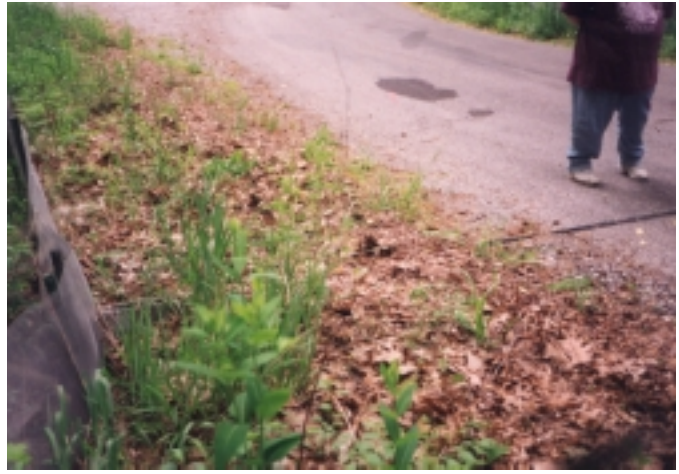
Figure 24—Plastic webbing and slot as viewed from the road.
