# Transportation Management Tech Tips

March 2009

## GlasGrid Fights Pavement Reflective Cracking at Diamond Lake

*Gordon L. Hanek, Geotechnical Engineer, Umpqua National Forest*

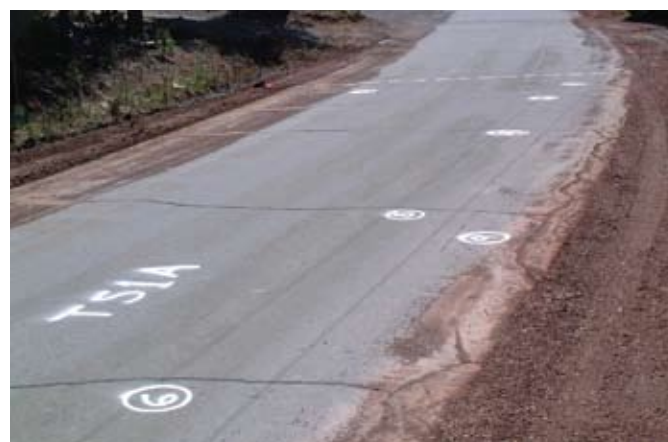
*Figure 1—Test section 1, exhibiting large, regularly spaced thermal cracks.*

In the summer of 2001, two segments of the paved loop road around the Diamond Lake Recreation complex on the Umpqua National Forest were treated using a hot-mix asphalt overlay. The first road segment accesses a winter-sports area with a sledding hill and snowmobile rental shop near the lake. The pavement in this road segment suffered from severe regularly spaced thermal cracks, many that were 1/2- to 1-inch wide (figure 1).

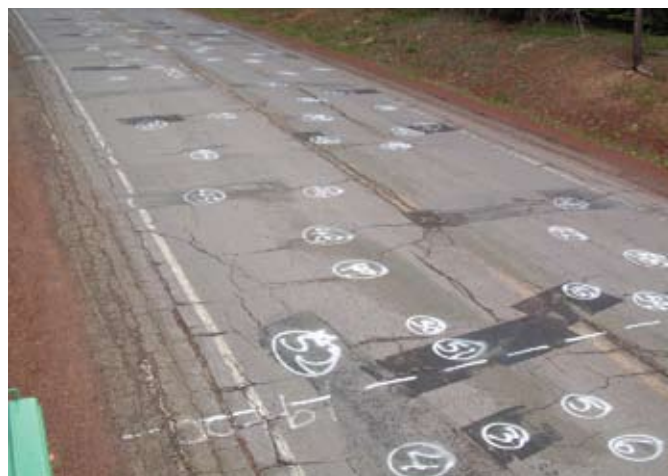
*Figure 2—Test section 2, exhibiting a variety of pavement-cracking distress types.*

The second segment was a portion of the old State highway (figure 2) that originally served the area and was over 40 years old. The surface was severely cracked due to heat, age, and load distress (exhibiting block, longitudinal, thermal, and alligator-type cracking).

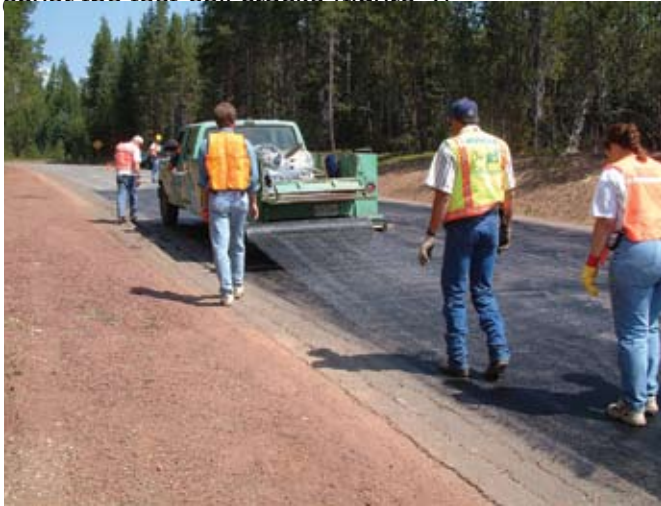
Figure 3—Placing GlasGrid from the spool, which is attached to a trailer hitch.

The GlasGrid arrived in 5-foot-wide rolls that were spooled off a trailer-hitch device as needed to cover the test cell cracks (figure 3).

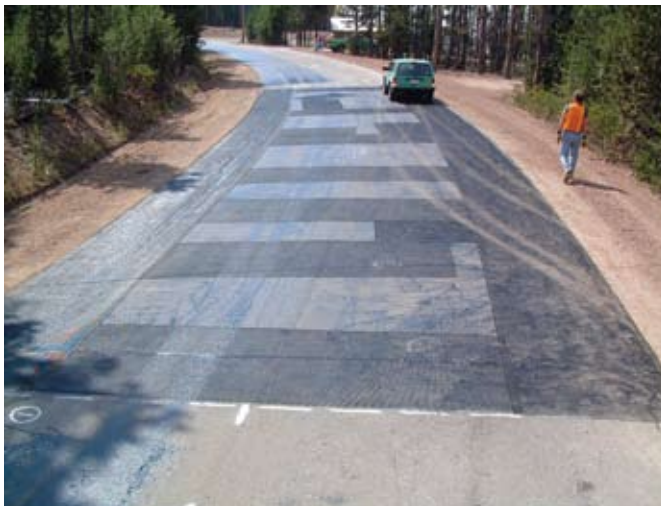
Figure 4—GlasGrid Type 8502 was used to treat the individual thermal cracks in test section 1. The darker areas are those covered by the GlasGrid.

The 8502 product is twice as strong in one direction as the other and is intended for use over individual cracks. It was used in test section 1 where the individual-crack treatment was applied (figure 4).

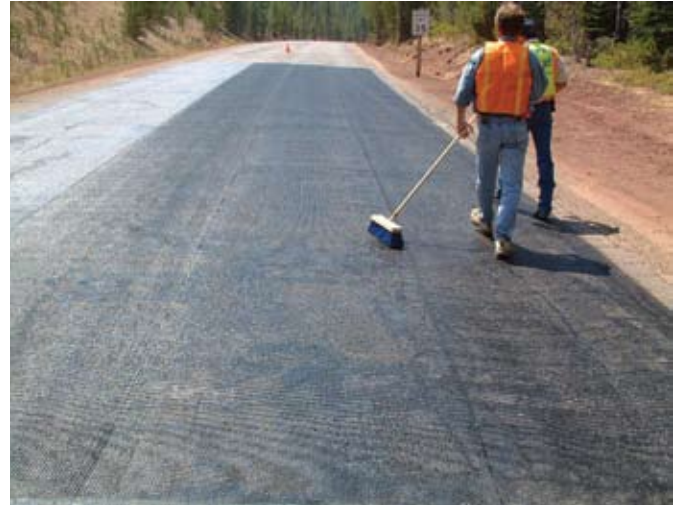
Figure 5—GlasGrid Type 8501 was applied with 100-percent coverage in test section 2. A 2-inch overlap was used at all seams.

The 8501 product is intended for use where cracking is widespread. It was used to cover 100 percent of the cell in test section 2 (figure 5).

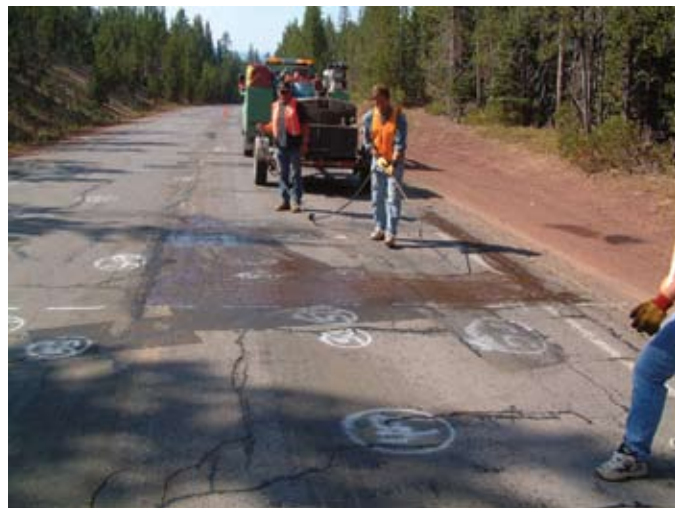
Figure 6—A quick-set tack was applied to GlasGrid test cells to ensure good bond.

GlasGrid comes with a pressure-sensitive adhesive backing that, according to the manufacturer, is sufficient to hold the product in place on fresh asphalt surfaces, such as a leveling course or between overlay lifts. However, since this project was a single 2-inch asphalt lift on older asphalt surfaces without any preleveling, a special quick-set tack was applied prior to placement of the GlasGrid (figure 6).

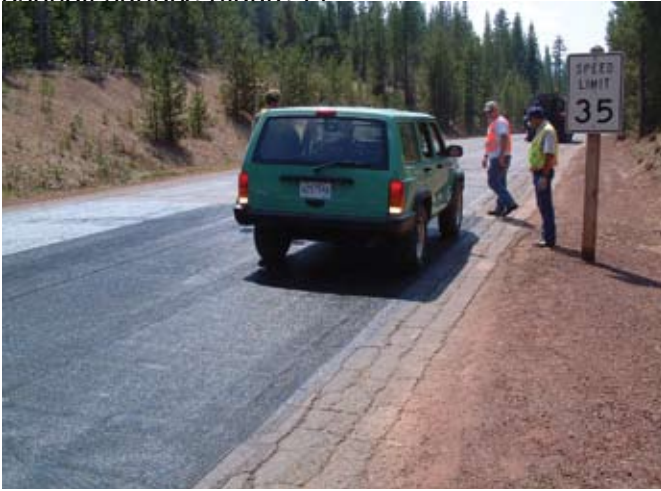
*Figure 7—Seating the GlasGrid by rolling with a light-duty vehicle.*

Following placement, a light-duty vehicle was used to roll the GlasGrid and seat it securely to the asphalt surface (figure 7).

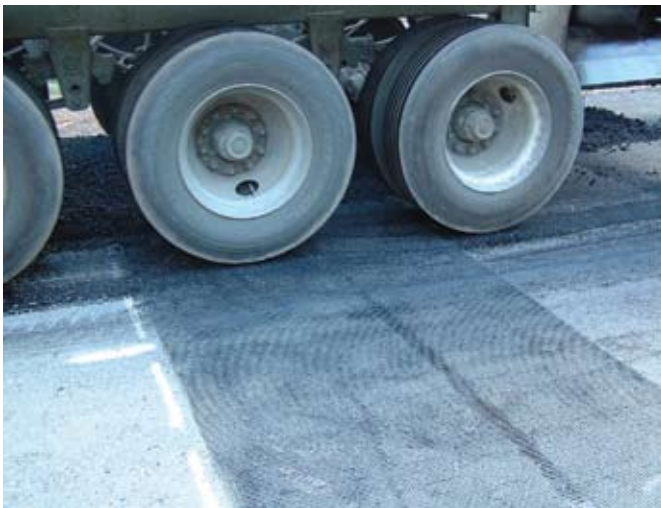
*Figure 8—GlasGrid remained bonded to the underlying surface during paving operations.*

Paving occurred the same day as the GlasGrid placement, and no problems with grid movement under the paver machine or asphalt-concrete delivery trucks were observed (figure 8).

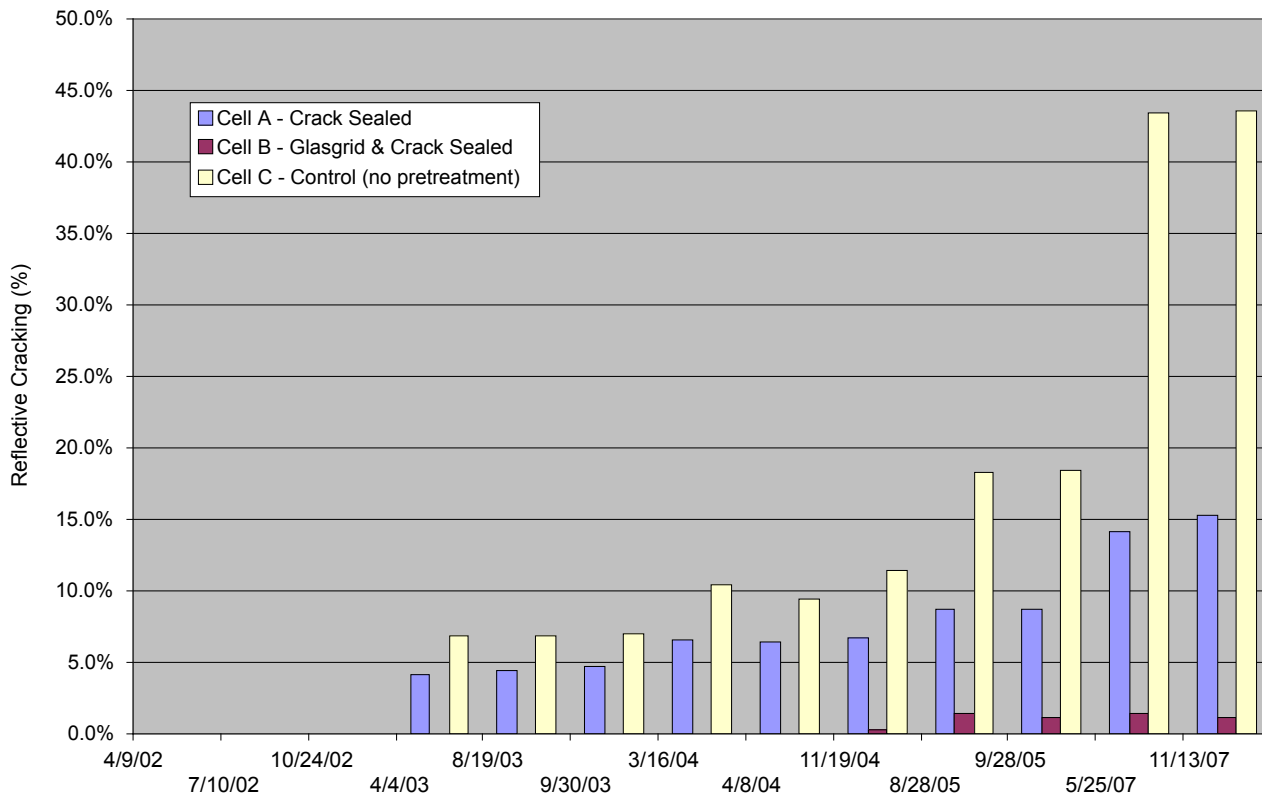
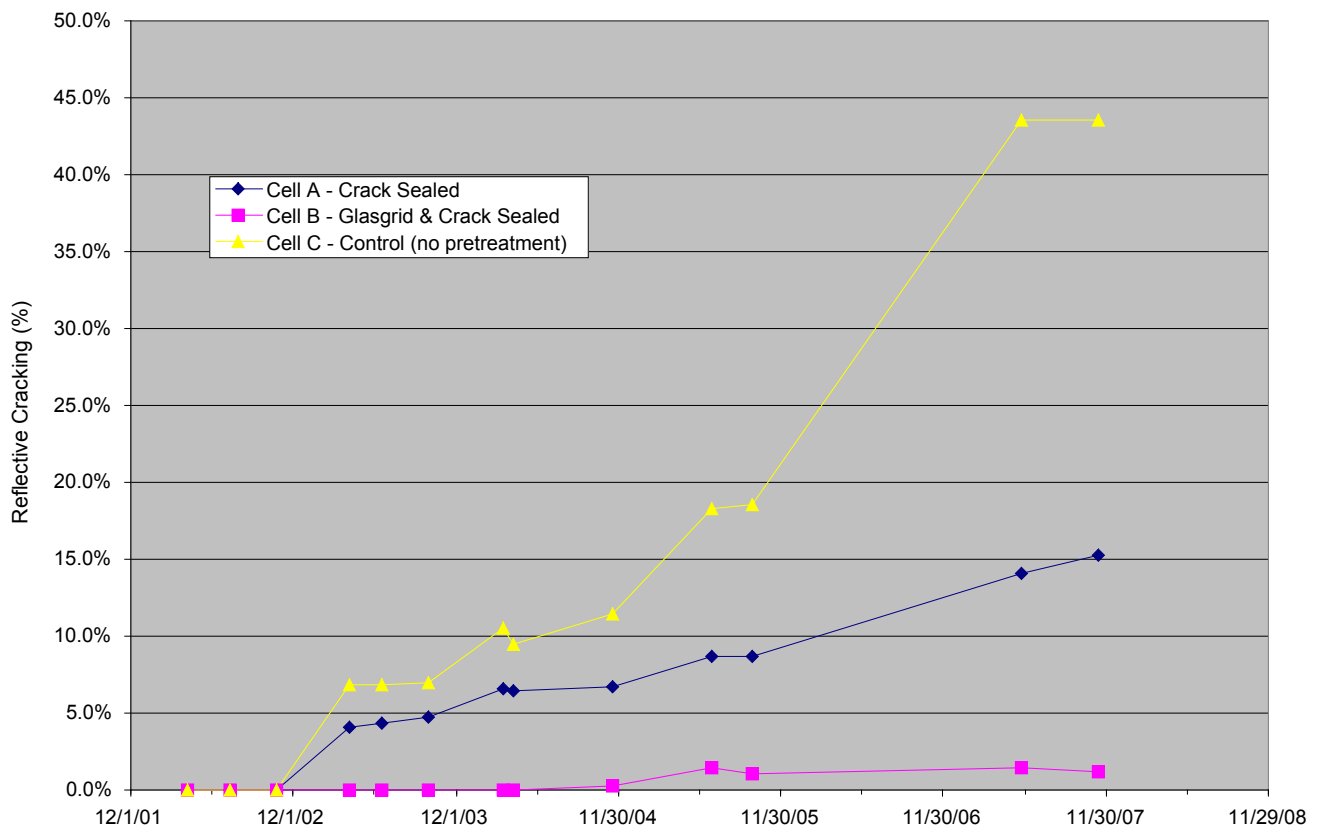
Figure 9—Test section no.1.

Figure 11—Test section no.1.

Periodic inspections of all test cells were made over a 6-year period. Average daily traffic counts during this time varied from about 150 to 900, depending on the time of year, and consisted primarily of recreational and administrative vehicles. The site inspections were generally held once in the spring and once in the fall of each year. During each inspection the locations, lengths, orientations, and type of cracks were noted. Photos were taken of any developing reflective cracks as well as the overall site conditions. Table 2 is a summary of the reflective cracking observed in the two test sections. Initial pretreatment-crack types (linear versus area) and lengths are shown for comparison. Linear cracks consisted principally of thermal and longitudinal cracks or other single-crack features. Area cracking consisted of block and alligator cracking along with areas covered by older geosynthetic patching (see figure 2). A composite-crack length was calculated that sums the linear-crack length and the linear length associated with area cracking to provide a more representative picture of the extent of reflective cracking. This was done since none of the reflective cracking progressed to the point of being “area” cracks during the 6-year observation period (although some linear-reflective cracks did appear over locations with underlying “area” cracking). Table 2 results are shown in figures 9 to 12.

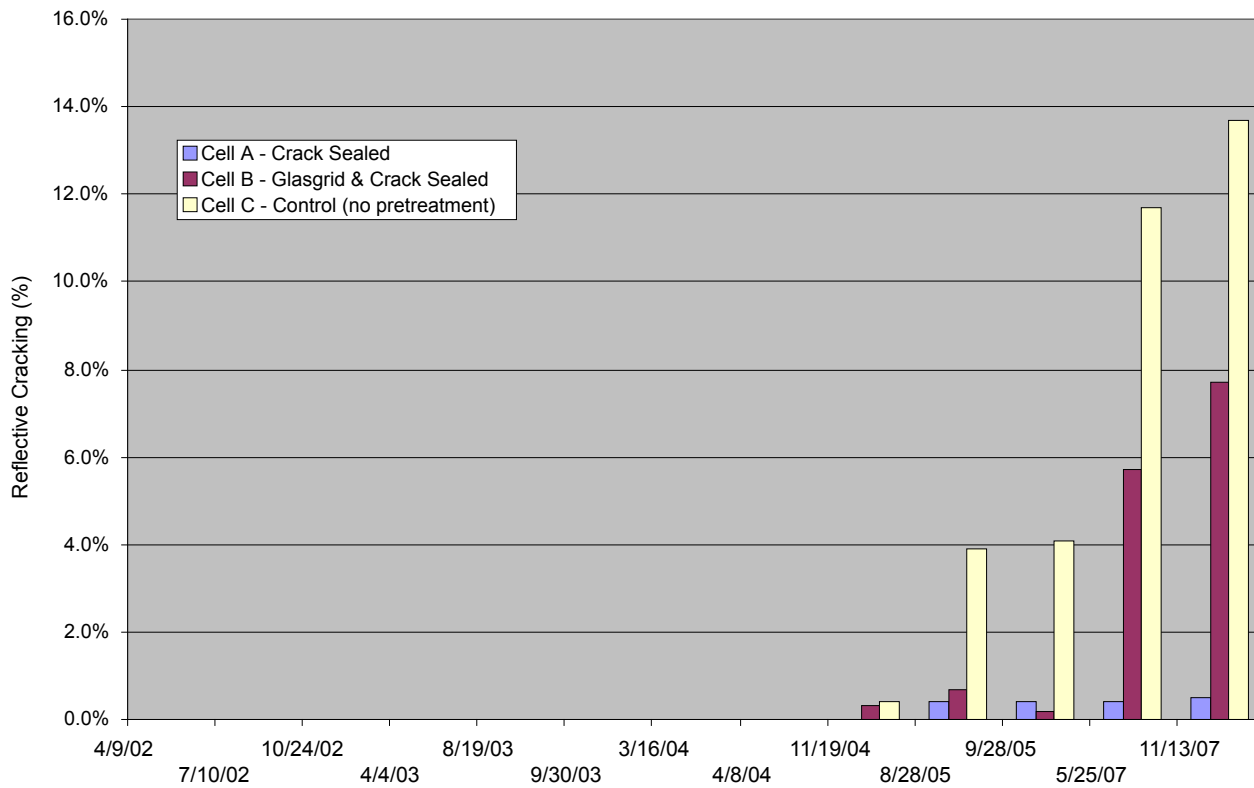
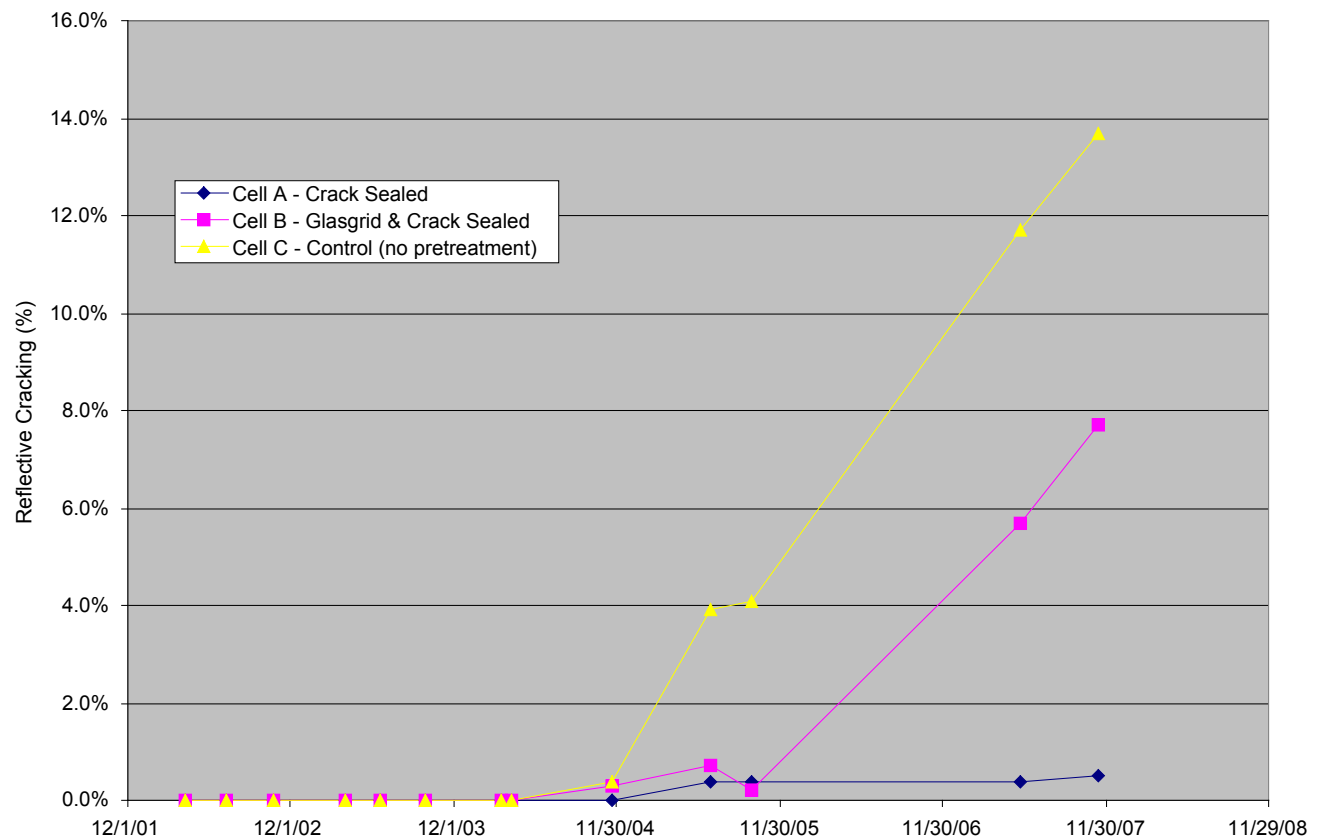
Figure 10—Test section no.2.

Figure 12—Test section no.2.

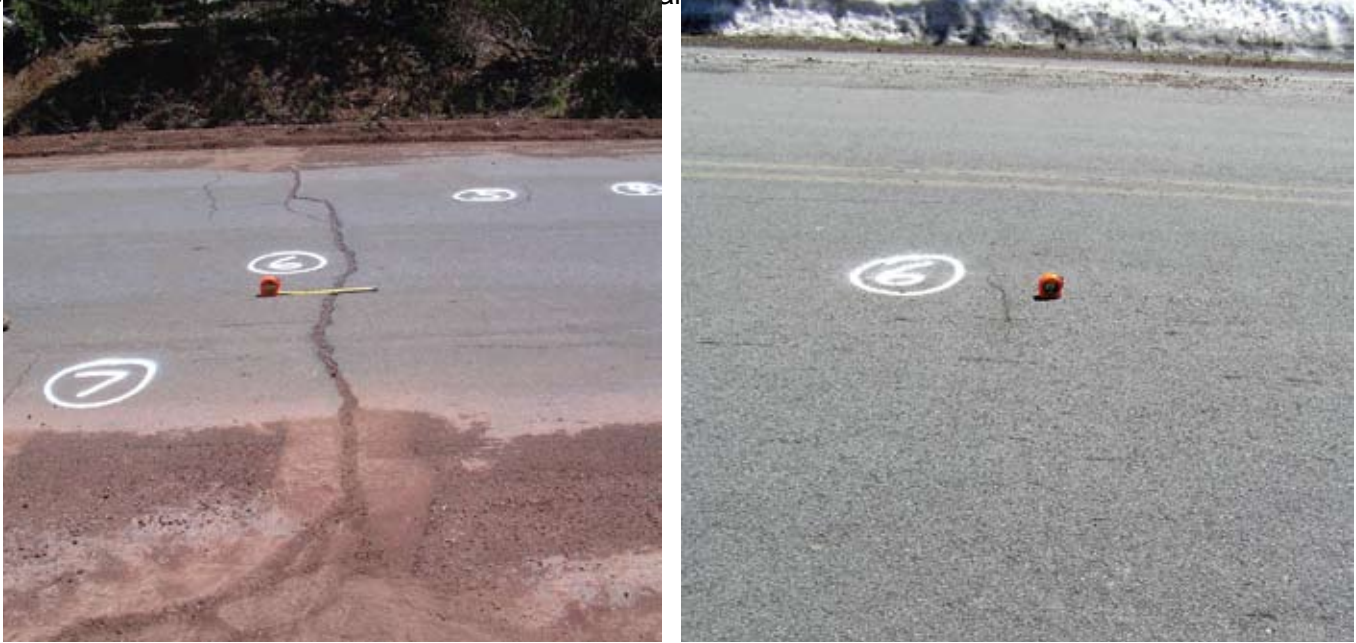
Figure 13—Comparison of reflected crack in GlasGrid-treated cell of test section 1 after 6 years.

The GlasGrid-treated cell in test section 1 (where large, regularly spaced, thermal cracks were the primary distress) has performed significantly better than either the control cell or the cell with only a crack-sealing pretreatment (figures 13 and 14). After 6 years, less than 2 percent of the crack length has reflected through in the GlasGrid section versus almost 45 percent in the control section. Originally, crack severity in test section 1 was generally medium (mean-crack width greater than 1/4 inch) to high (mean-crack width greater than 3/4 inch), whereas all cells after 6 years still have generally low-severity (mean-crack width less than 1/4 inch) cracks though a few medium-severity cracks have developed in the cells without GlasGrid. Reflective cracks are occurring over original cracks that were of medium and high severity.

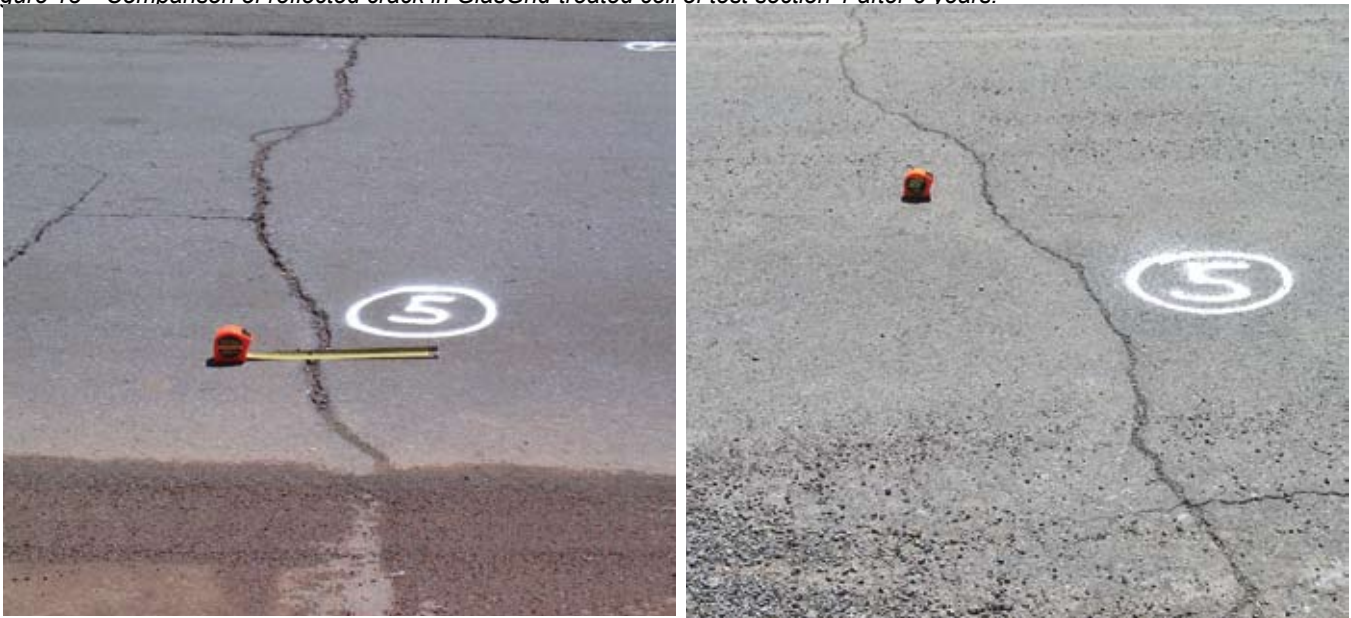
Figure 14—Comparison of reflected crack in control cell of test section 1 after 6 years.

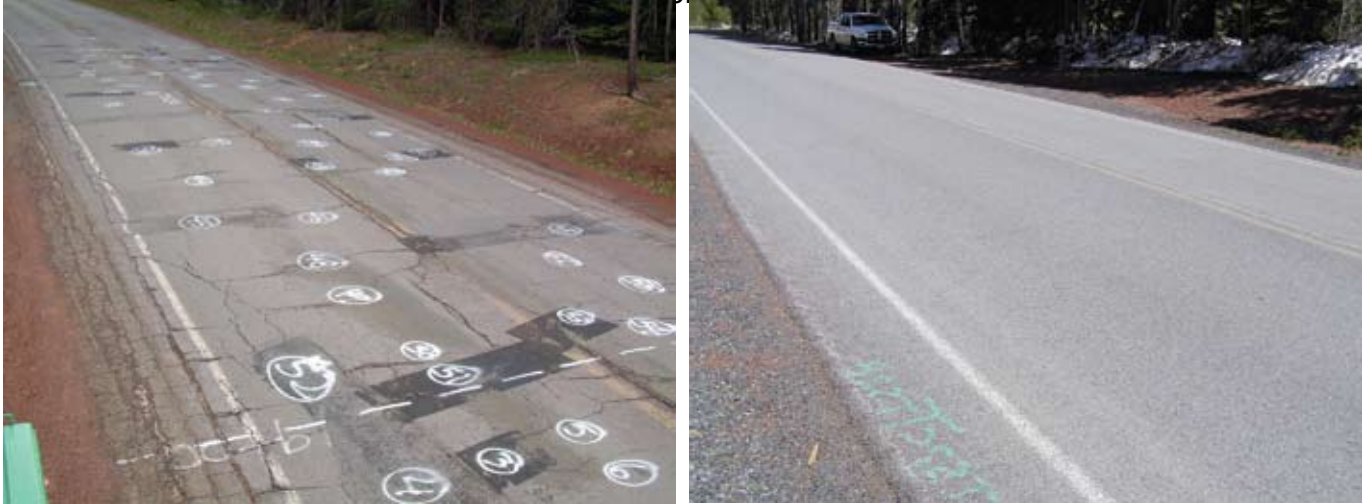
*Figure 15—Comparison of test-section 2 surface after 6 years.*

In test section 2, where a variety of crack-distress types including block, alligator, longitudinal, and thermal occurred, the GlasGrid-treated cell experienced less reflective cracking than the control cell but more than the cell with only crack sealing as a treatment. It appears that the GlasGrid was not as successful in retarding the more generally distributed and greater variety of cracking-distress types present in this test section. However, given the relatively small amount of overall reflective cracking that has occurred in test section 2, it may be premature to draw conclusions until additional future observations can be made. As was the case with test section 1, the pretreatment defect-severity in test section 2 was also generally medium. After 6 years, the defect severity in all cells of test section 2 is low (figure 15).

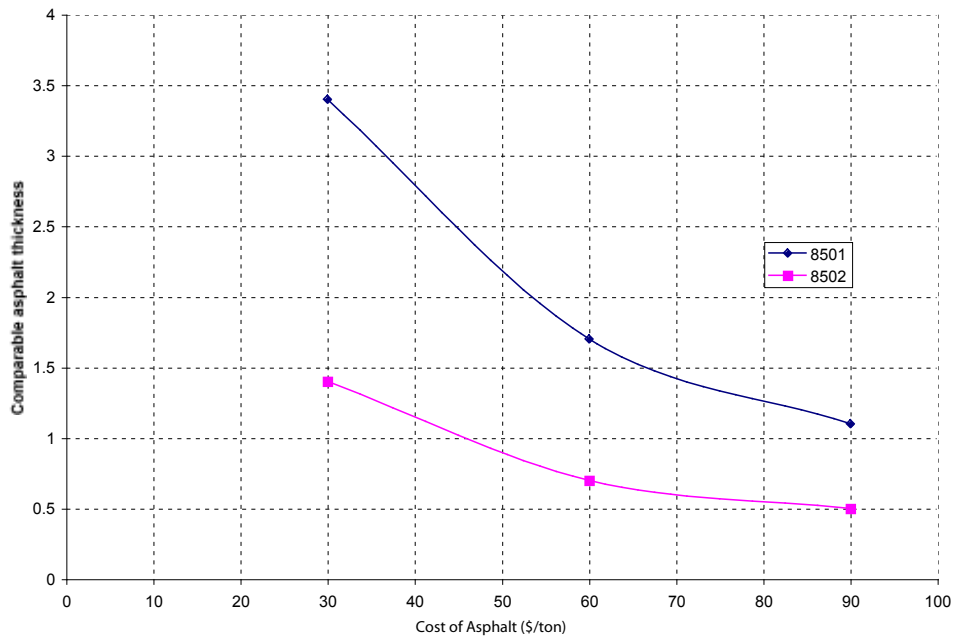
Figure 16—The thickness of asphalt that would be comparable to the square-foot cost of GlasGrid, where 100-percent coverage is assumed for GlasGrid 8501, and 33-percent coverage for GlasGrid 8502.

Current material costs (2008) for the GlasGrid 8501 and 8502 are \$0.50 per square foot and \$0.64 per square foot, respectively. Installation costs are about \$0.08 to \$0.11 per square foot. Figure 16 shows the thickness of asphalt that would be a comparable cost to that of GlasGrid, per square foot, where 100-percent coverage is assumed for GlasGrid 8501, and 33-percent coverage (i.e., thermal cracks at 15-foot spacing) for GlasGrid 8502. So, the cost of 100 square feet of GlasGrid 8501 would be similar to 100 square feet of asphalt 1.7-inch thick, at \$60 per ton.
