## Case Study 4. Forest Road 732 Jersey Barrier Fords

Northern Arizona. Prescott National Forest. Verde Ranger District. Cienega Creek. Forest Road 732, Squaw Peak Road.

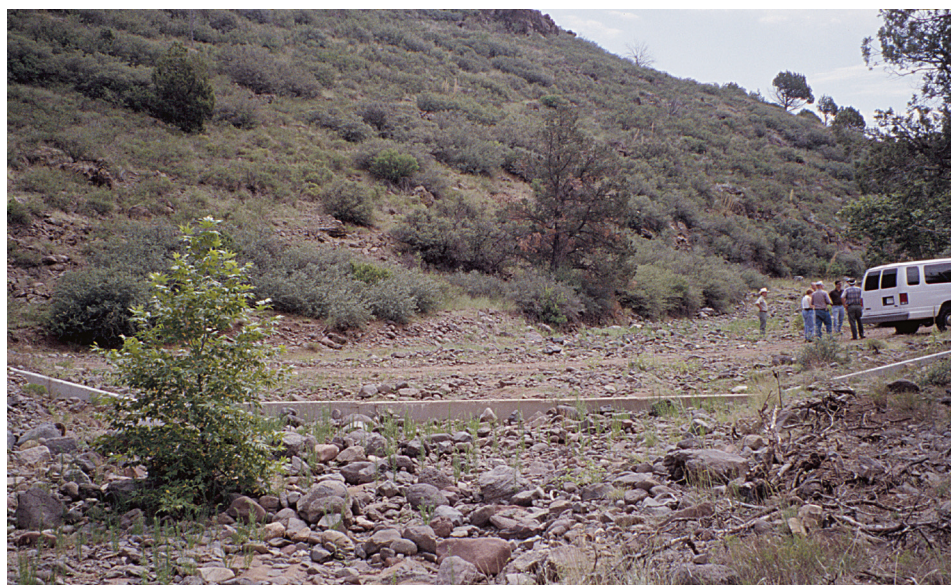
Figure A16. Jersey barrier ford, FR 732.

These crossings are unvented fords on an ephemeral channel that transports up to boulder-sized rock during floods. Jersey barriers and large riprap support the downstream edge of the road. The jersey barriers also function to trap sediment and prevent channel downcutting occurring due to land use in the area.

Channels in this area flood 4 to 5 times each year during summer thunderstorms and are dry the rest of the time, making unvented fords feasible structures. Jersey barriers act as a retaining structure, providing support for the road. They also work to control channel downcutting. These structures are simple, easy, and inexpensive to construct with road maintenance equipment, and they have low maintenance requirements.

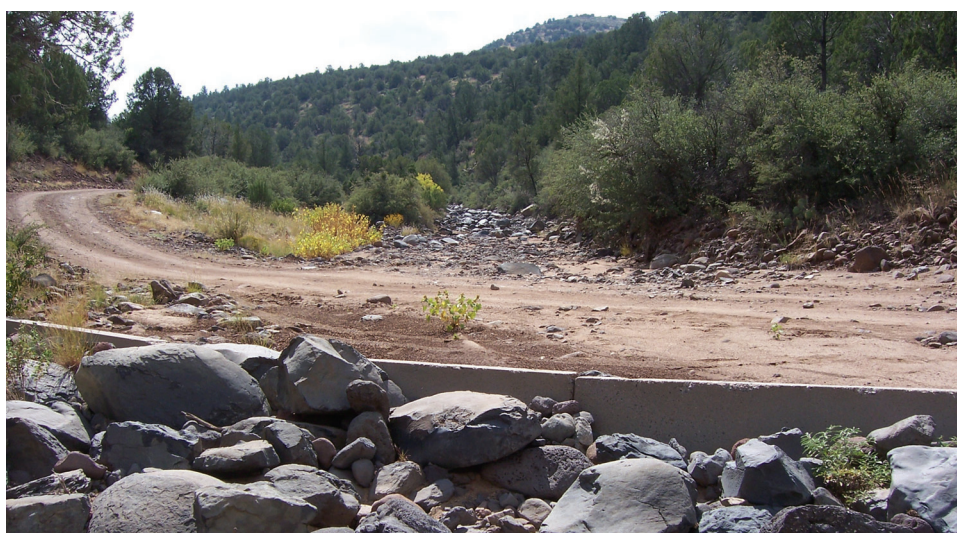
Figure A17. Looking upstream across another jersey barrier ford on FR 732. Sloped road approaches prevent diversion and large rock is placed downstream to prevent scour.

The fords are backfilled with native rock material and large riprap is usually placed downstream to prevent scour (figure A17). Experience has shown that the downstream edge of the jersey barriers should be protected from scour by gabions or an engineered riprap fill (figure A18c) unless the channel is highly resistant to erosion.

**Bank stabilization and approaches:** Road approaches slope down into the crossing to prevent diversion down the road.

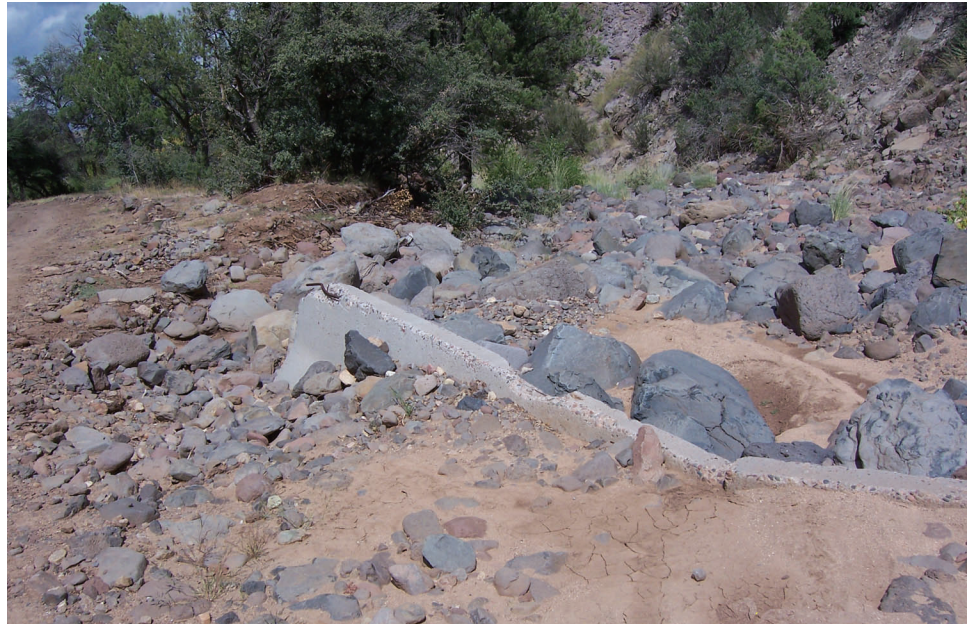
Figure A19. High flows have outflanked one of the ford structures.

No significant flood events have occurred since these structures were installed in 1993, and no maintenance has been done. Some of the structures are now showing the need for repair. For example, in figure A19 the jersey barriers were not extended high enough to control high flows, and water has gone around the ends of the barriers. Part of the reason for this could also be that sediment has been deposited and revegetated upstream of the crossings.

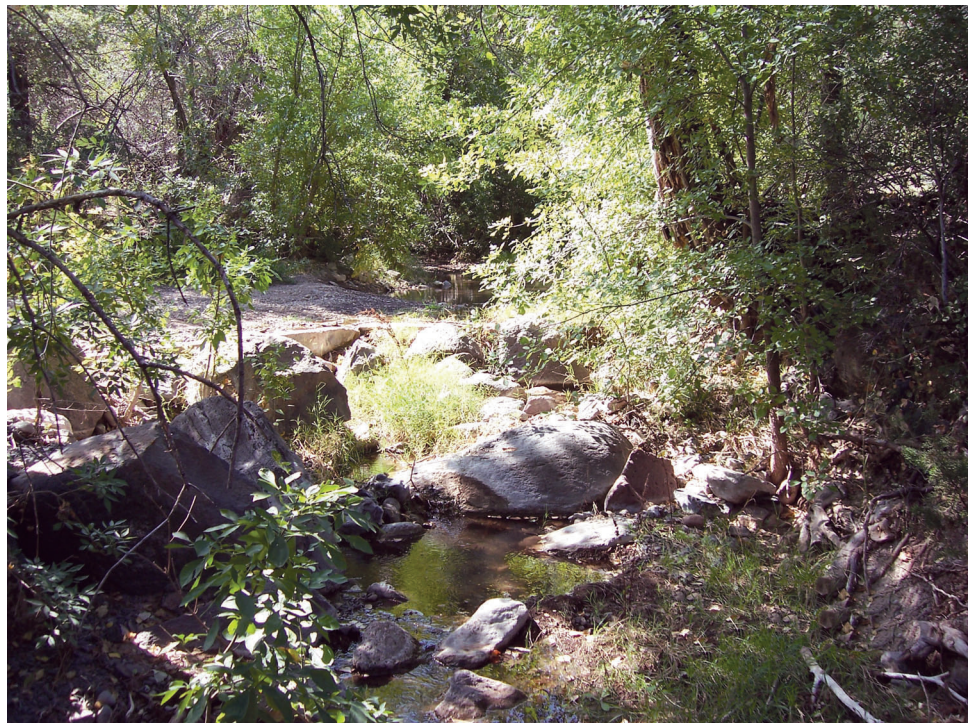
Figure A20. Jersey barrier ford on FR 136 has helped control channel downcutting and restore the riparian area in Copper Canyon. Photo is looking upstream at the ford.

The Prescott National Forest has used the same design on crossings in the Copper Canyon drainage (FR 136). Concentrated runoff from Interstate 17 drains directly into the canyon, and was accelerating channel downcutting. In 1991, Jersey barrier fords were installed in a series at several stream crossings that had been unarmored natural fords. The fords have worked well to retain sediment and foster the growth of riparian vegetation (figure A20). They are working both as stream crossing structures and as riparian improvements.

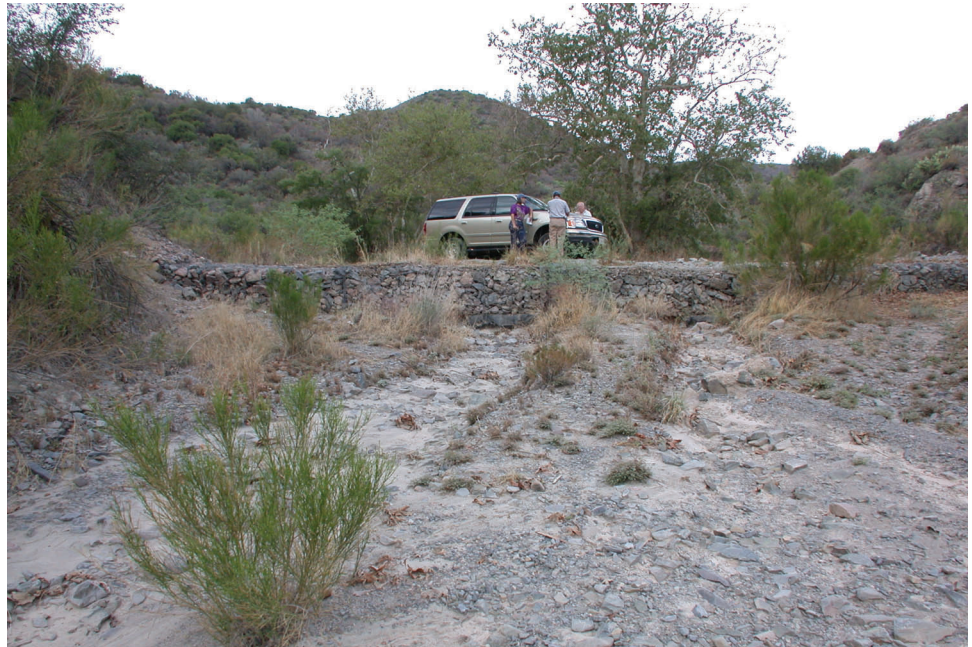
Figure A21. This jersey barrier-gabion ford on the 7-Springs Road on the Tonto replaced a bridge washed out in a flood.

The Tonto National Forest, just south of the Prescott, also uses jersey barrier fords, sometimes adding gabion basket energy dissipators to control downstream scour (figure A21). Jersey barrier fords generally create a downstream drop, and require scour protection to avoid being undermined. When they fail, it is often because of downstream degradation or outflanking when floodwaters rise above the protected approaches. Upstream aggradation can exacerbate problems with outflanking, and care is required to create enough sag and armor the approaches high enough to avoid it.
