Case Study 6. Fitzpatrick Creek Cable Concrete Block Mat Ford**Location**

Southwest Oregon. Bureau of Land Management Coos Bay District. Fitzpatrick Creek. BLM road 23-8-11.0.

This ford was constructed in 2000 on a deeply incised perennial stream where passage for salmon, steelhead, and woody debris are major issues. Cable concrete block mats and riprap were used to make a stable driving surface that mimicked natural channel characteristics as closely as possible. The crossing is outsloped at approximately the same grade as the stream (4 percent), and the mat was set just under the final streambed elevation, with the expectation that a low-flow channel would develop to promote juvenile fish passage across the structure. Traffic use at this site is low, and occasional log haul is restricted by agreement with the National Marine Fisheries Service.

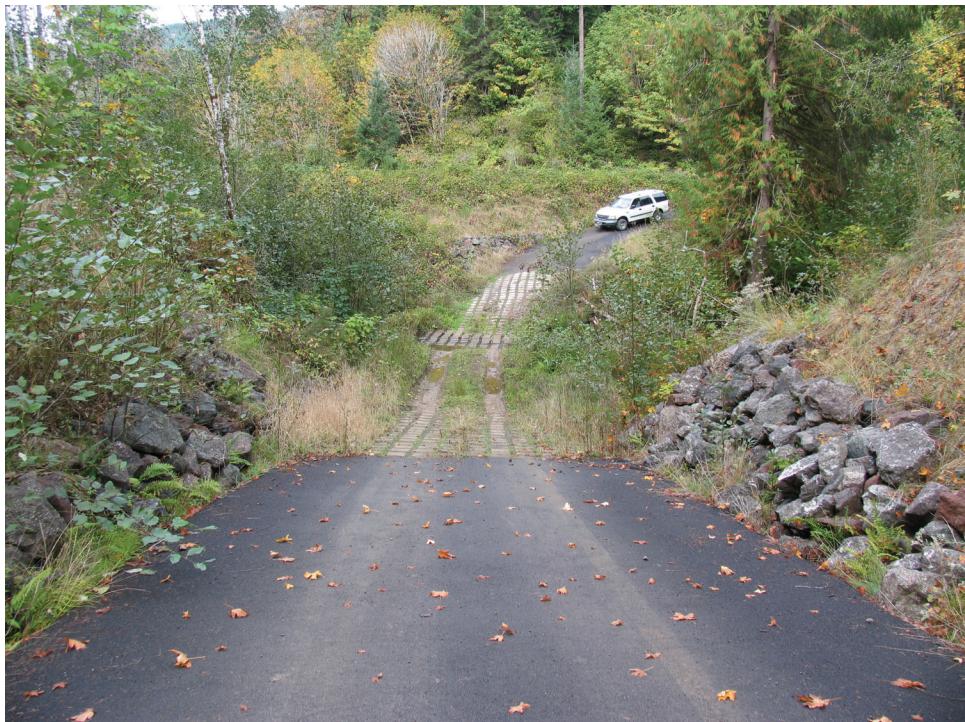
Figure A27. Fitzpatrick cable concrete mat ford.

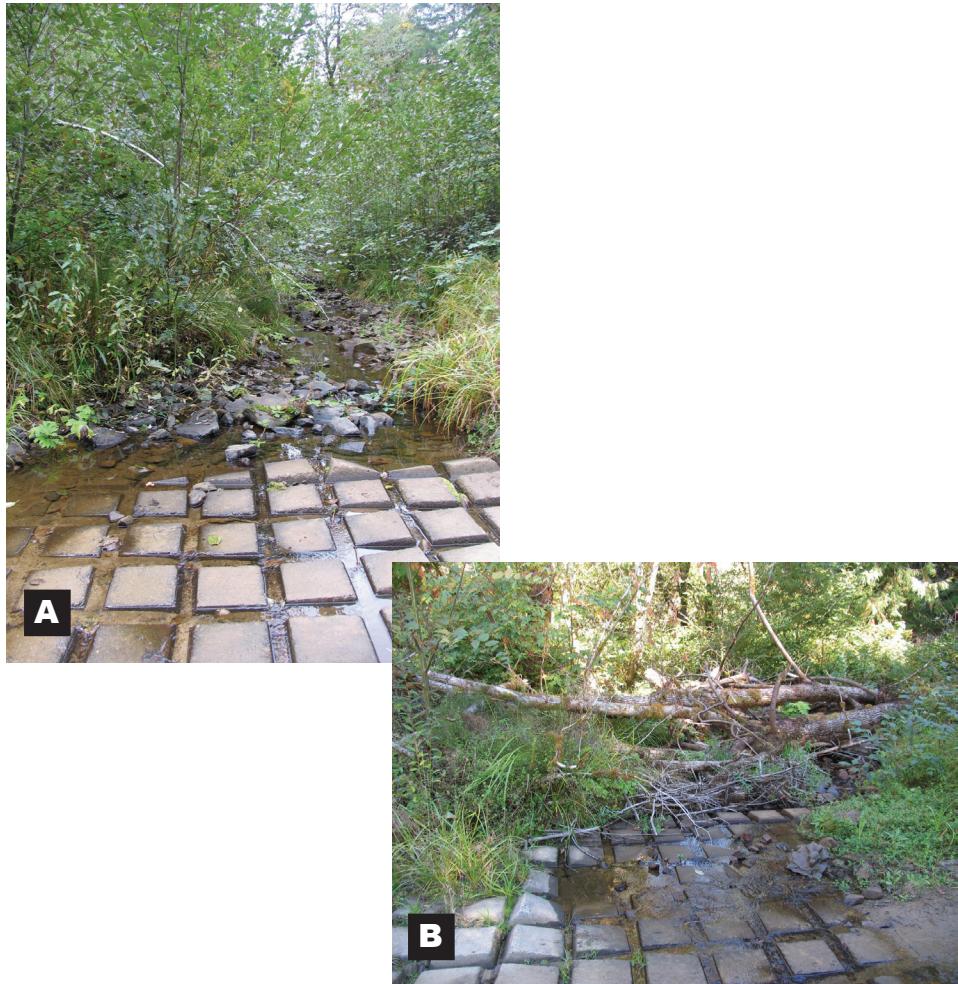
Figures A28a and A28b. Channel character (a) looking upstream (b) looking downstream.

Channel Description: The channel is a Rosgen A3, with a 4-percent slope and low sinuosity. It is confined between stable 25-foot-high slopes that are well-vegetated with deep-rooted shrubs and trees (figure A28). Debris jams are not uncommon. The crossing is located immediately upstream of a bend.

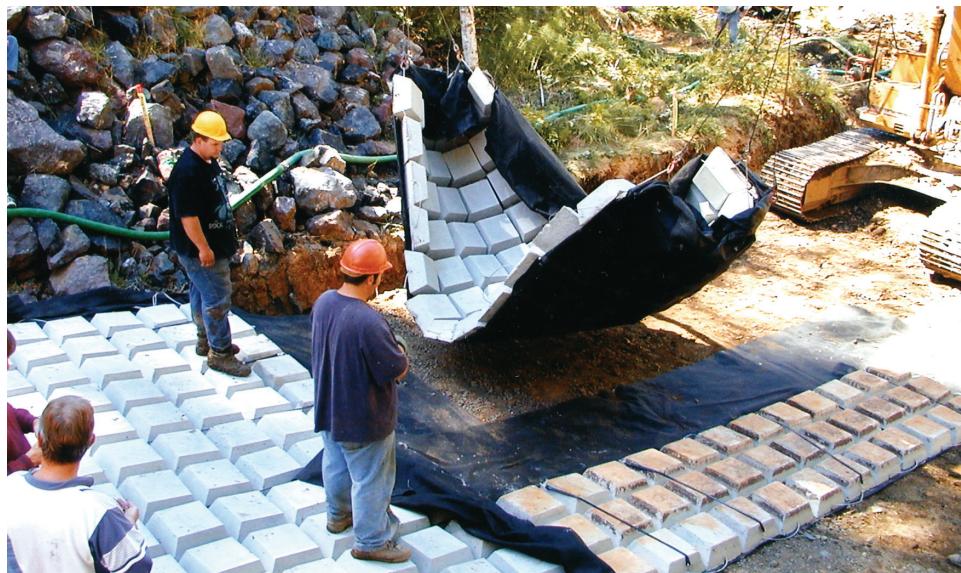
Figure A30. An excavator installs the mats with geotextile backing.

Structure: The cable concrete mat is 16 feet wide and 104 feet long, extending to approximately the elevation of the 50-year flood (figure A29a). The blocks are sized for the 100-year event, according to manufacturer recommendations. Mats are fabricated with stainless steel cables embedded in the blocks to link them together in both directions. Geotextile fabric is attached to the bottom of blocks to prevent blocks from sinking into soft subbase, and to avoid erosion of fine material from the base. Mats were laid out on a 6-inch base of 1½-inch crushed aggregate to provide both support and a level surface (figure A30).

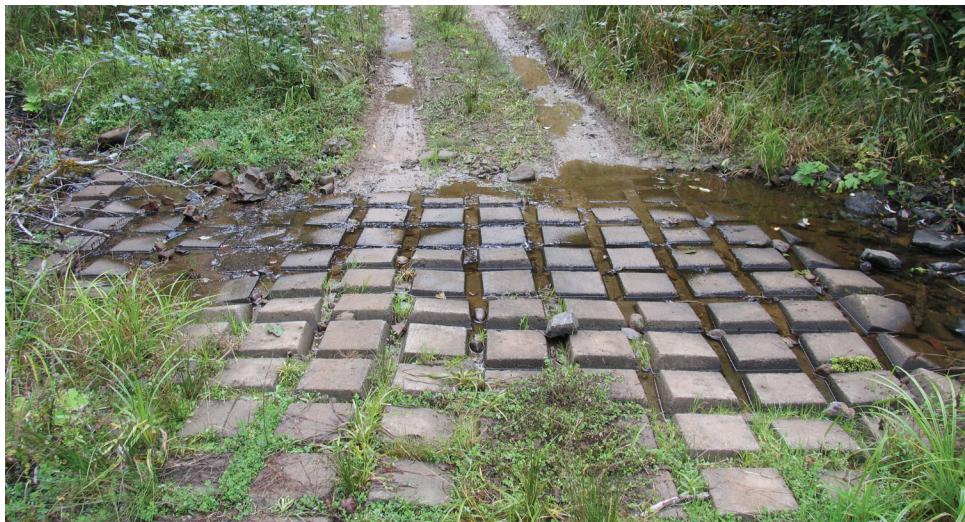
Figure A31. The ford permits low flow passage for aquatic species even though the blocks have settled unevenly.

As originally laid down, the Fitzpatrick Creek mat was uneven. The installers were able to smooth it by running over it with the excavator, but as figure A31 shows, some of the blocks sank unevenly and disrupted the driving surface at the edge of the structure. The Big Horn National Forest sites (see below) are more severe examples of this problem.

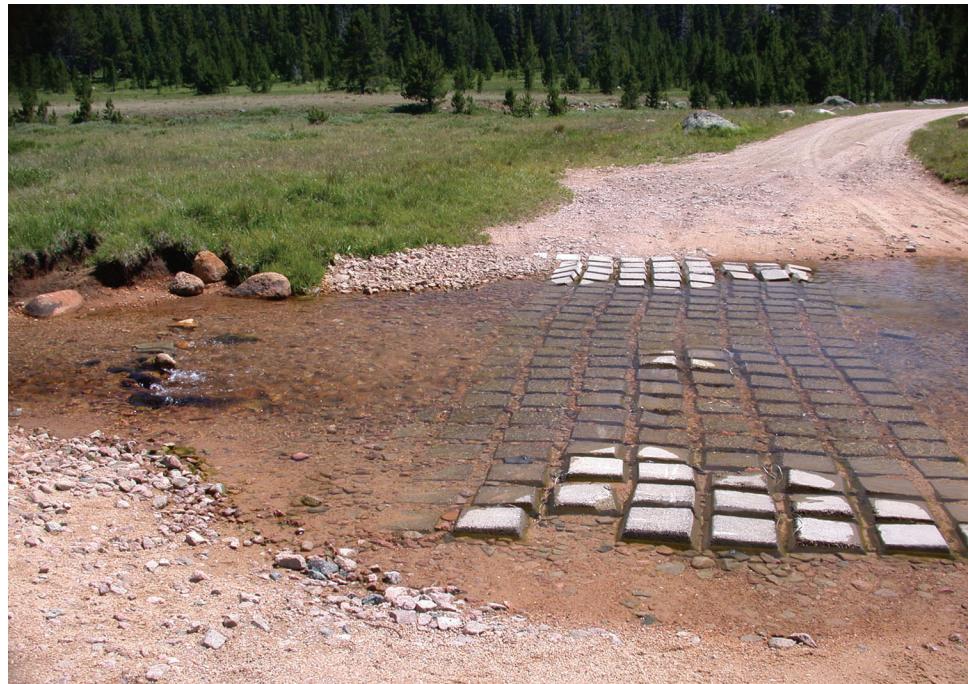
Figure A32. East Fork South Tongue River cable concrete block mat crossing. Note tilted blocks, exposed cables, and short mat length. Traffic is driving around the mat and the river has outflanked it.

The Bighorn National Forest in Wyoming has used cable concrete mats in several locations with variable success. At one site on the East Fork South Tongue River, soil consolidation after the mat was installed caused the ends of the mat to sink lower in elevation, so that the stream runs around the ends even at low flow (figure A32). Without a firmly compacted base and secure anchoring, the mat has settled unevenly and some of the connecting cables are exposed. Horse and recreational-vehicle trailer hitches tend to catch on the cables. As a result, drivers choose to drive next to the mat rather than on it, and in this wide grassy flood plain there is nothing to restrict that access. Given the high-value fishery in this perennial river, this is an unacceptable situation, and the forest is considering a culvert replacement to disconnect the road from the stream. The tradeoff will be the need to either reroute the road or construct an elevated roadfill across this very wide, active flood plain.

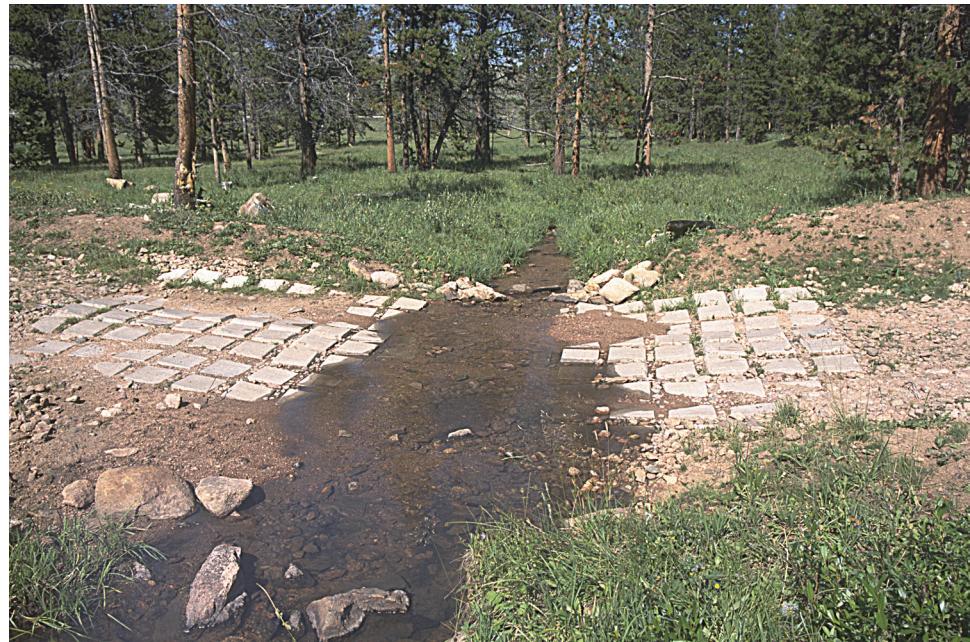
Figure A33. Copper Creek tributary, Bighorn National Forest. At this drier site with less traffic, the mat is considered the best crossing option because of its low maintenance requirement and installation cost.

On Copper Creek, a much smaller stream with very low summer flow (figure A33), cable concrete mats are considered more successful. Again, the lack of a firmly consolidated base caused the blocks to tilt, making an uneven driving surface, and exposing cables that were then snagged and broken. Even so, the blocks remain in place and functional. At Copper Creek, the mat does extend high enough to contain bankfull flows, and there are no problems with water outflanking the structure (figure A34). The forest considers this a successful crossing in this situation where the road is used mostly by hunters in the fall. It has required no maintenance since construction in 1999. The structure is well-suited to the wide, flat valley site because it does not require a roadfill that would interrupt flows on the flood plain during the extended snowmelt season. This means that overbank flows are more naturally distributed. Flood-plain water storage processes and riparian vegetation are fully maintained, and erosion due to floodwater concentration through a constricted structure such as a culvert is minimized.
